The effect of cutting speed and feed rate on hole surface integrity in single-shot drilling of metallic-composite stacks

2nd CIRP Conference on Surface Integrity (CSI)

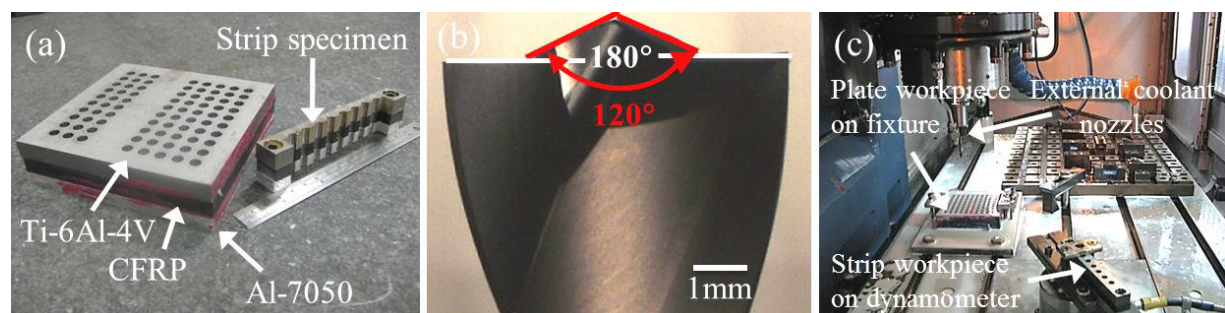
Fig. 1. (a) Ti/CFRP/Al stacks; (b) CVD diamond coated drill; (c) experimental setup

Al-7050-T7651 aluminium alloy. The Ti workpieces were supplied in the annealed condition with yield strength and Young's modulus of 880MPa and 114GPa respectively [13]. The CFRP laminates were composed of 36 unidirectional plies (each 0.18mm thick) involving high tensile strength (HTS-268-12K) carbon fibres pre-impregnated (pre-pregs) within an epoxy based matrix laid up according to an orientation of $[45^\circ/0^\circ/135^\circ/90^\circ/45^\circ/0^\circ]_{3S}$. This resulted in a fibre volume fraction of 56% giving a tensile strength of 1200MPa and Young's modulus of 145GPa [14]. In contrast, the Al alloy was age strengthened to provide a yield strength and Young's modulus of 550MPa and 72GPa respectively [15]. The individual workpiece materials had dimensions of 120×120mm and were bonded together (in the order of Ti/CFRP/Al) using a thermosetting modified epoxy film adhesive. The overall stack thickness was 27mm. Thin strip workpiece samples (120×17×27mm) joined using two M6 screws were also employed at intervals for force measurement and subsequently cross-sectioned for surface integrity investigation, see Fig. 1(a). The drills evaluated (recommended by tool supplier) were 6.38mm diameter CVD diamond coated WC with a two-stage point angle of $120^\circ \times 180^\circ$, helix angle of 30° and relief angle of 14° ; see Fig. 1(b). Table 1 details the mechanical/physical properties of the CVD diamond coating.

All experiments were undertaken on a Matsuura FX-5 CNC machining centre with a maximum spindle rotational speed of 20000rpm rated at 15kW, see Fig. 1(c) for the test setup. Preliminary tests (Tests 1 and 2) involving feed rates of 0.08 and 0.15mm/rev were initially performed with a cutting speed set of 30/120/120m/min (Ti/CFRP/Al). These values were subsequently increased by 20% to 36/144/144m/min with further trials undertaken at 3 different feed rate levels of 0.05, 0.08 and 0.12mm/rev, see Table 2 for test array. A water-miscible emulsion with a 7-8% volume solution of mineral oil was utilised in all tests, which was delivered via external coolant nozzles at a fixed pressure of 70 bar and flow rate of ~ 47 l/min.

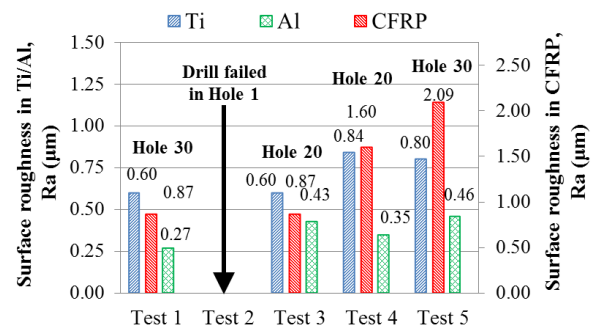
Fig. 2. Hole surface roughness in each material at last hole drilled

maximum flank wear criterion. Fig. 2 details surface roughness results measured at the last hole drilled for all tests. Under the low speed/intermediate feed rate regime (Test 1), average hole roughness in the Ti, CFRP and Al sections at test cessation was 0.60, 0.87 and 0.27 μ m Ra respectively. Equivalent values for the Ti and CFRP layers were obtained in Test 3 after 20 holes, when operating at the higher cutting speed of 36/144/144 m/min and lower feed rate of 0.05mm/rev. The Ra in the Al section however was ~ 59% higher.

Increasing feed rate from 0.05 to 0.12mm/rev (at 36/144/144 m/min cutting speed) led to a ~ 140% rise in average hole surface roughness within the CFRP section, which was ~ 2.09 μ m Ra in Test 5 at hole 30. In terms of the Ti layer, roughness was 40% higher when operating at 0.08mm/rev compared to 0.05mm/rev, but remained approximately stable despite a further increase in feed rate to 0.12mm/rev. In contrast, no clear trend was apparent in the Al sections due to changes in feed rate, with the surface roughness varying between 0.35 and 0.46 μ m Ra.

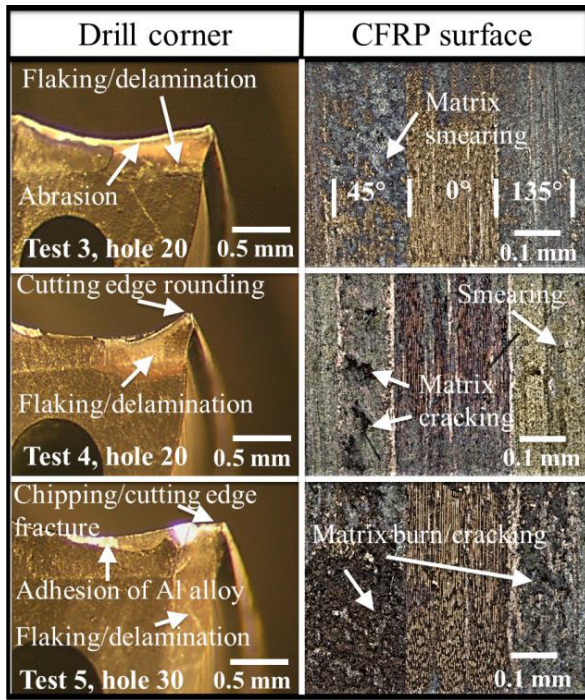
Fig. 3. Wear micrographs of drill corner and corresponding CFRP surface at last hole drilled in Tests 3, 4 and 5

The principal wear mode of the drills was flaking/delamination of the CVD diamond coating, irrespective of operating parameters. This was observed primarily on the tool flank face near the peripheral corners as well as at the chisel point. Micrographs of the worn CVD diamond coated drills for trials undertaken at the higher cutting speed level (Tests 3, 4, 5) together with corresponding hole surfaces in the CFRP section of the stack are shown in Fig. 3. Rapid abrasion of the exposed WC substrate was also prevalent in all tests, which increased cutting edge rounding and the corner radius of the drill. Wear was generally more severe at higher feed rates, with gross fracture of the chisel point occurring in Test 4 (0.08mm/rev) and chipping/fracture of the peripheral corner in Test 5 (0.12mm/rev). No significant wear/damage however was seen at the chisel section of the drill employed in Test 5 even after 30 holes, see Fig. 4, which was possibly due to the shorter tool-workpiece interaction time. Evidence of workpiece adhesion on the cutting edges was however visible.

Smearing of melted epoxy resin was the primary damage mode observed on the surface of the CFRP layer after 20 holes when drilling with the lowest feed rate of 0.05mm/rev, see Fig. 3. Greater deterioration of the workpiece surface occurred as feed rate increased, with matrix cracking and burning evident in the last holes drilled for Tests 4 and 5 respectively, which explains the surface roughness results detailed previously in Fig. 2. This was possibly due to the higher cutting temperatures generated from the increased feed rate and tool wear levels. No signs of grooves or significant material loss however were detected in any of the samples evaluated. In addition, defects were generally most severe in the 135° ply positions, as shown in the high resolution SEM micrograph and corresponding 3D topographic map (1.25 x 0.5mm scan area near the centre of the hole) of the machined surface (hole 30, Test 5) in Fig. 5.

Fig. 7(a) and 7(b) detail cross-sectional micrographs of the machined Ti and Al subsurface respectively from the last hole drilled in Test 5. No appreciable change in material microstructure was visible in both workpiece samples, despite chipping of the peripheral drill corner (Fig. 3). This was representative of results seen in the other trials.

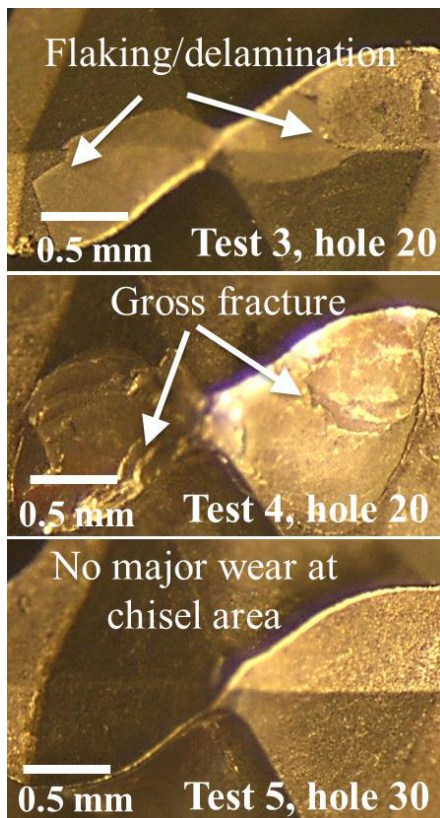
Fig. 4. Micrographs of worn drill chisel section in Tests 3, 4 and 5

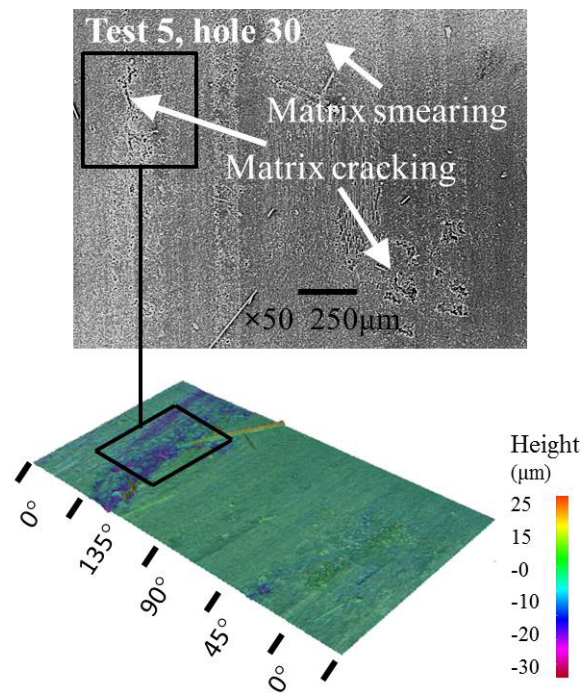
Fig. 5. SEM micrograph and 3D topographic map of CFRP hole surface in Test 5

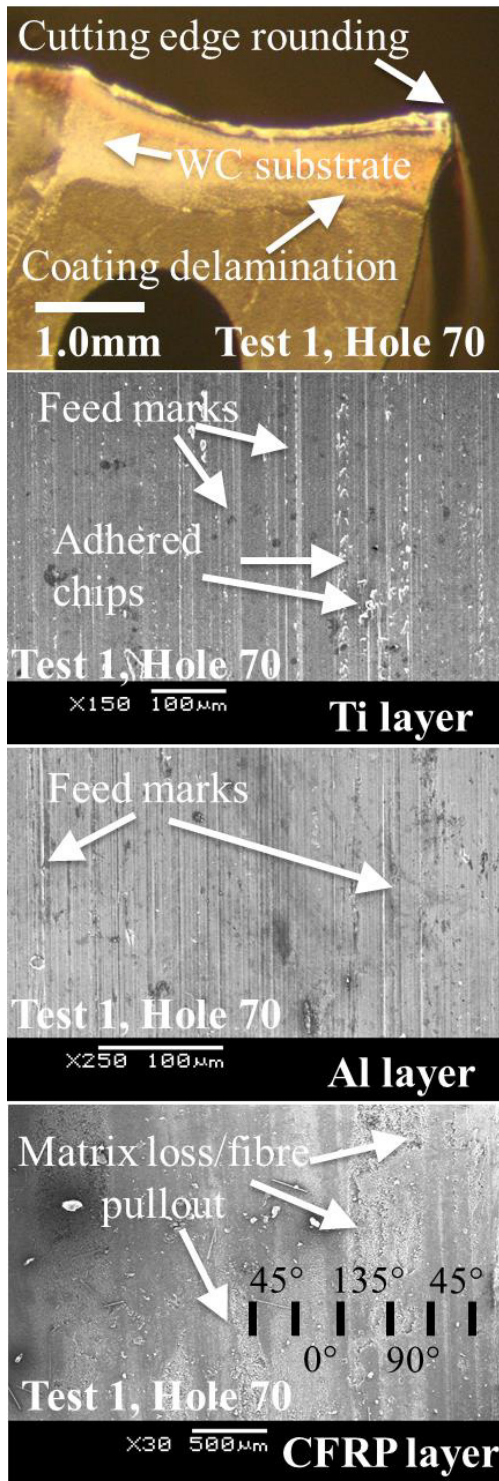
Fig. 6. Wear micrograph of the drill used in Test 1 and SEM images of the machined surfaces in each layer of the stack in hole 70

Test 1 was subsequently extended to 70 holes in order to investigate drill wear progression and its consequent influence on workpiece integrity. Fig 6 shows a micrograph of the drill after hole 70 together with associated SEM images of the machined surfaces in each material layer. Flank wear increased to ~ 1mm with near complete delamination of the coating from the cutting edge. Evidence of sporadic re-deposited chips was seen on the surface of the Ti layer while the Al section appeared to be relatively free of major flaws. In contrast, the highly worn drill caused substantial degradation of

the CFRP surface, with gross fibre loss and matrix pullout particularly at the 45°, 90° and 135° orientated plies.

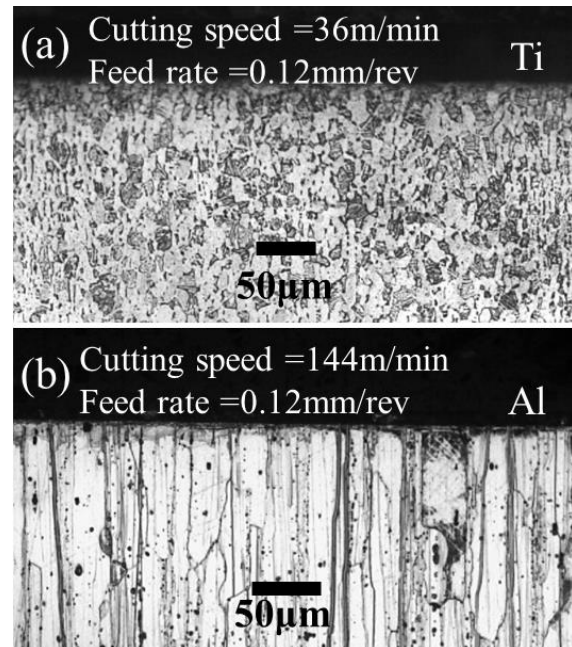
Fig. 7. Cross-sectional micrographs of the machined (a) Ti; (b) Al layers for last hole drilled in Test 5

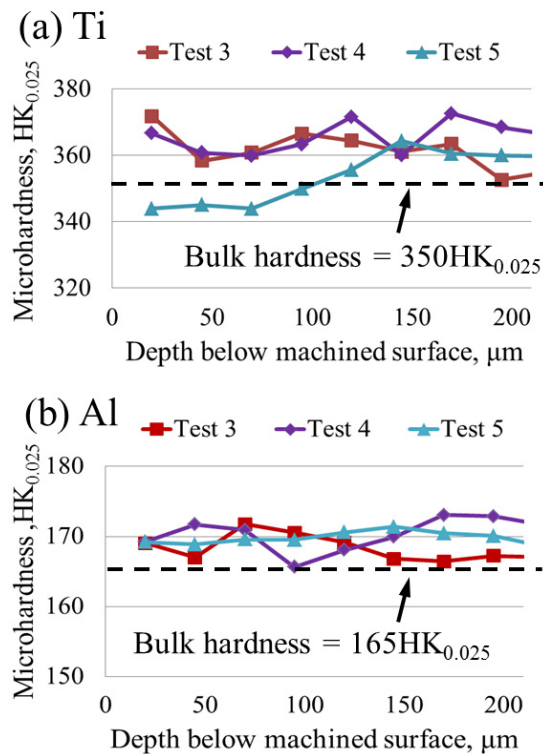
Fig. 8. Microhardness depth profile at test cessation when drilling at 36/144/144m/min cutting speed in (a) Ti; (b) Al layers

Fig. 8 details microhardness depth profiles of both the Ti and Al layers at the last hole drilled for Tests 3, 4 and 5 (cutting speed of 36/144/144m/min). No significant variation in microhardness was observed for the Ti layer in any of the trials evaluated; see Fig 8(a). This was despite measured thrust forces showing a rise of ~ 41% (~690 vs. 980N) as feed rate was increased from 0.05 to 0.12 mm/rev. Corresponding torque values ranged between ~2.3 and 3.6Nm at test cessation. Similarly, an analysis of the Al sections revealed no substantial changes in subsurface microhardness due to changes in feed rate; see Fig. 8(b). Here, thrust forces and torque for the last hole drilled varied from ~278 to 410N and ~0.75 to 1.3Nm respectively, as feed rate increased from 0.05 to 0.12mm/rev. The results suggest that neither strain hardening nor thermal softening played a major role.
