Cavitation erosion resistance and wear mechanisms of active screen low temperature plasma nitrided AISI 410 martensitic stainless steel

CAVITATION EROSION RESISTANCE AND WEAR MECHANISMS OF ACTIVE SCREEN LOW TEMPERATURE PLASMA NITRIDED AISI 410 MARTENSITIC STAINLESS STEEL

Quenched and tempered AISI 410 martensitic stainless steel specimens were active screen plasma nitrided in a mixture of 75 % of nitrogen and 25 % of hydrogen during 20 hours at 400 °C. The microstructure of the nitrided case was characterized by optical microscopy, scanning electron microscopy and microhardness measurements. The phases were identified by X-ray diffraction and the nitrogen content as a function of depth was measured using wavelength dispersive X-ray spectrometer coupled to SEM. Nanoindentation tests were carried out in order to assess hardness (H), Young modulus (E), H/E and H^3/E^2 ratios and the elastic recovery (W_e) of the nitrided layer. Cavitation erosion tests were carried out according to ASTM G32 standard during 20 hours, with periodical interruptions for registering the mass losses. Additional cavitation erosion tests were performed to identify the wear mechanisms in both specimens, thro

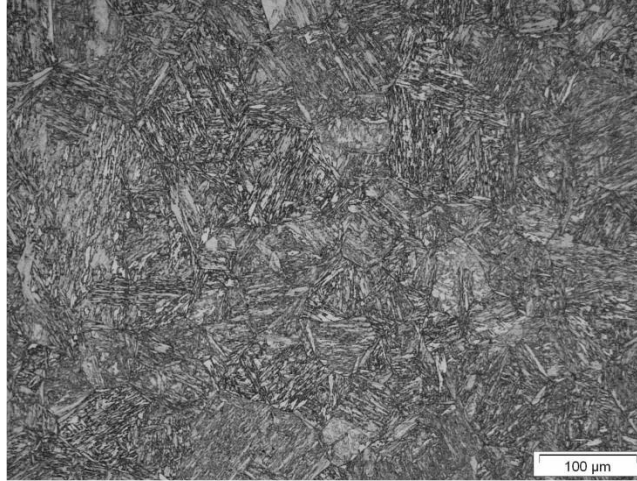
Figure 1 shows the microstructure of the quenched and tempered AISI 410, it can be seen that the microstructure is composed of tempered lath martensite as expected for the heat treatments conducted in this stainless steel. The average microhardness was 387 ± 7 HV0.01.

Figure 1 Quenched and tempered AISI 410 containing tempered lath martensite. OM image.

The active screen technique avoided crack formation and the massive precipitation of big iron nitrides observed in the first 5 μm deep region of the nitrided case obtained through conventional DC low temperature plasma nitriding of AISI 410, reported in a former work [5]. In addition, the microstructure of the nitrided case, shown in figure 3, remains almost the same in comparison with the original microstructure of the quenched and tempered AISI 410, shown in figure 1.

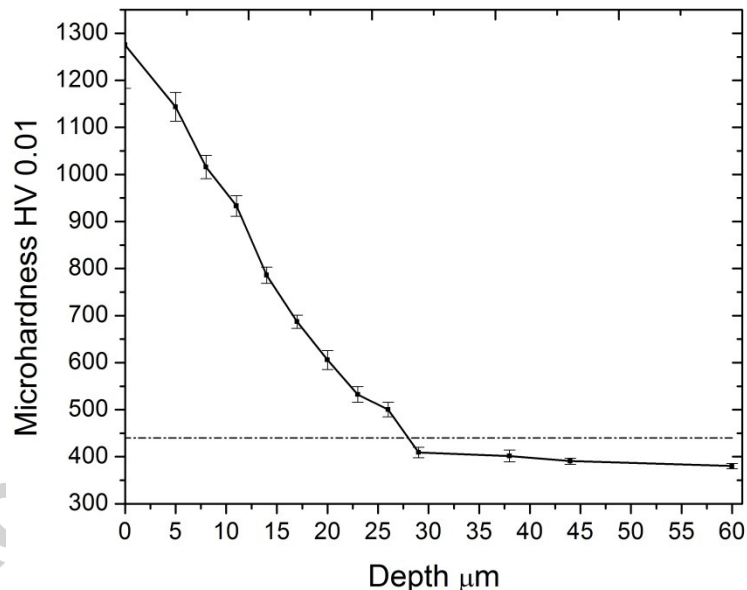
Figure 2 shows the microhardness variation as a function of depth for the nitrided specimen, together with the respective standard deviations.

Figure 2 Microhardness variation with depth of nitrided specimen.

The maximum hardness of 1275 ± 92 HV0.01 measured on the surface continuously decreases as a consequence of the reduction of nitrogen content with depth, till the hardness of the substrate is achieved. The microhardness gradient is very gentle throughout the nitrided case. According to the nitriding hardness depth – NHT criterion [19], the nitrided case is around $28 \mu\text{m}$ thick, as shown in figure 2.

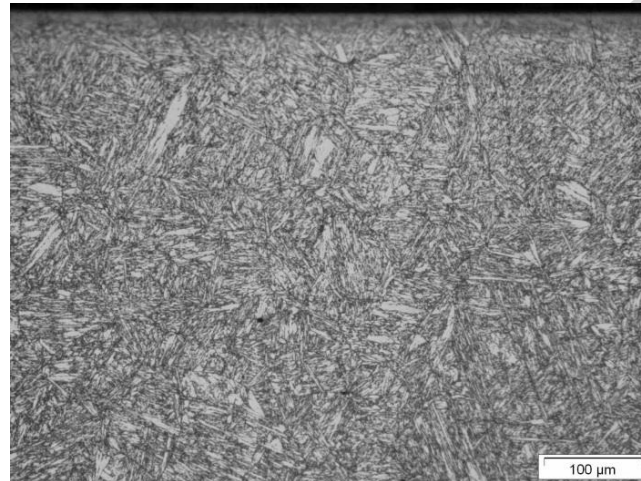
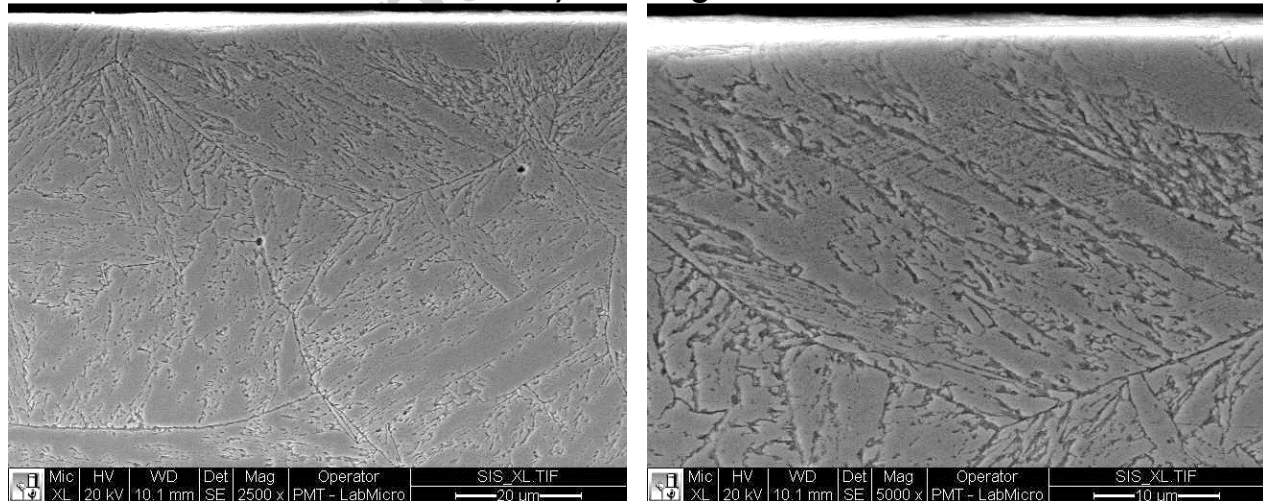
Figure 3 Cross-section view of the nitrided specimen, a) OM image, b) SEM images.

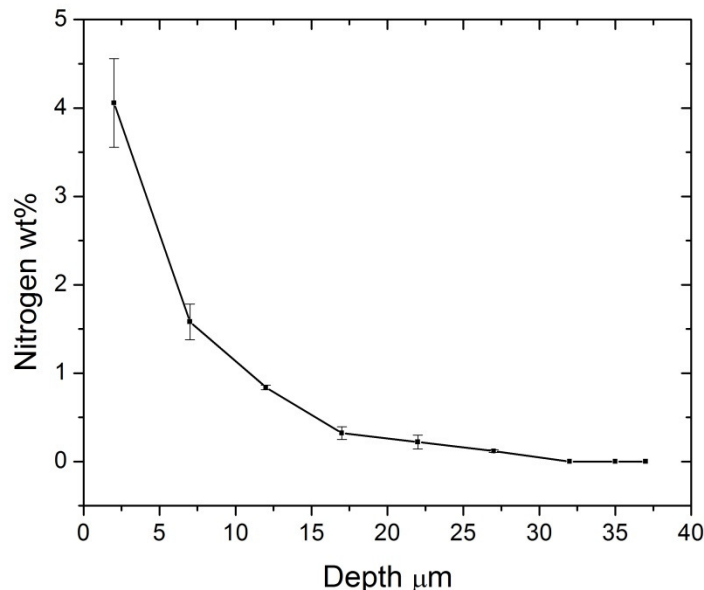
Figure 4 shows the nitrogen variation (wt. %) along the depth of the nitrided case together with the respective standard deviations.

Figure 4 Nitrogen variation along the depth of the nitrided case.

One can see in Figure 4 that the nitrogen content decreased from ~4 wt. % measured at 2 μm beneath the surface to ~0.1 wt. % at around 27 μm depth. These high nitrogen values are responsible for the increase in hardness of the nitrided specimen. It should be noted that the nitrogen content profile not only agrees with the gentle behavior of the microhardness profile, shown in figure 2, but also shows a similar value for the case depth, around 27 μm.

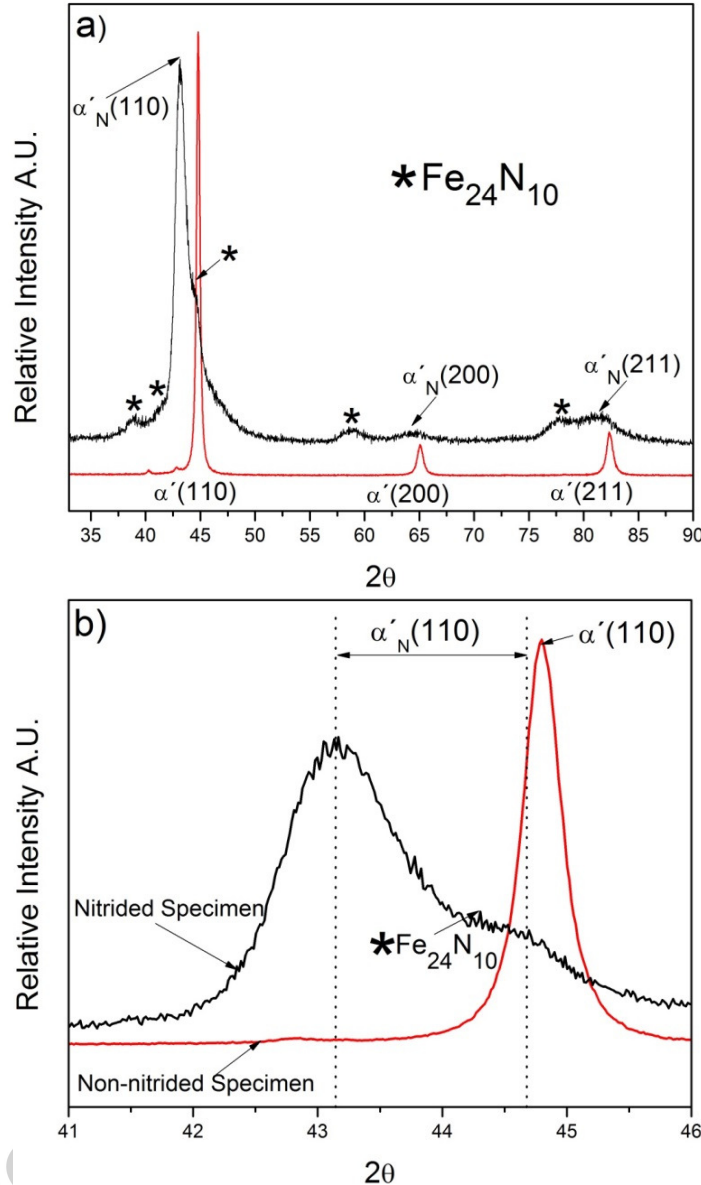
Figure 5 shows the X-ray diffraction patterns for both specimens. As can be seen in figure 5a, the non-nitrided specimen shows typical BCC martensite peaks (ICDD #06-0696) located at 2θ angles of 44.81 65.06 and 82.33. On the other hand, in the nitrided specimen those 3 martensite peaks were broadened and shifted to the left due to the nitrogen gradient along the nitrided case, which produced a different lattice parameter (interplanar spacing) as a consequence of the different nitrogen amounts dissolved at the interstitial sites of the crystal structure. It should be noted that part of the expansion is due to development of compressive stresses in the nitrided case [23]. The peaks located at 2θ angles of 43.12 64.11 and 81.60 correspond to a nitrogen supersaturated phase, known as expanded martensite. The $\alpha'_N(110)$ expanded martensite region of the X-ray pattern lies between 43.12° and 44.66°, as shown in Figure 5b, indicating a nitrogen gradient inside the nitrided case. This conclusion is supported by the microhardness gradient shown in Figure 2, the microstructure shown in figure 3 and the nitrogen gradient measured in the nitrided case shown in Figure 4. In addition to the expanded martensite peaks, the nitrided specimen diffraction pattern shows hexagonal ϵ -Fe₂₄N₁₀ iron nitrides peaks (ICDD #73-2103), structurally similar to ϵ -Fe₃N.

Figure 5 X-ray diffraction patterns for nitrided and non-nitrided specimens.

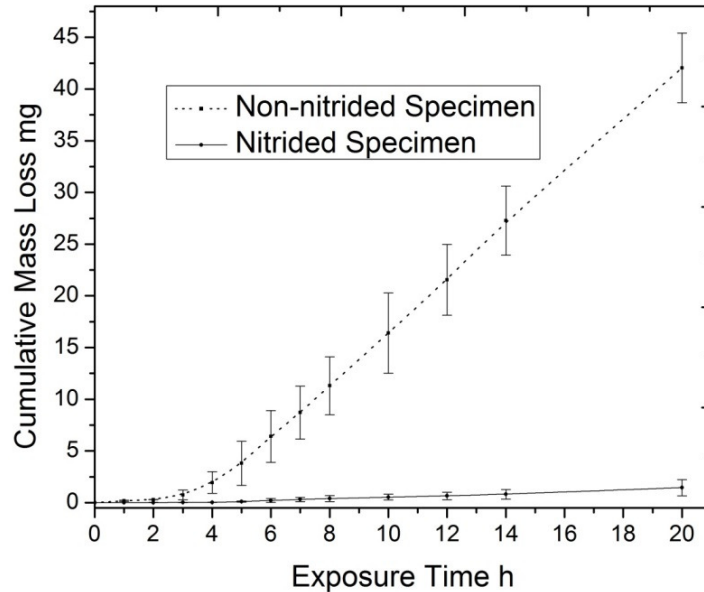
Cumulative mass losses variations as a function of exposure time are shown in figure 6. The scatter bars comprise one standard deviation.

After 20 hours of testing, the non-nitrided specimen lost ~42 mg and the nitrided specimen lost ~1.5 mg. The nitrogen addition decreased 27 times the mass loss of the quenched and tempered AISI 410. The erosion rates were calculated from the slope of the straight line plotted from the fifth hour on, as shown in figure 6, accordingly, the erosion rates were 0.085 mg/h and 2.56 mg/h for nitrided and non-nitrided specimens, respectively.

Figure 6 Cumulative mass losses variations as a function of exposure time for nitrided and non-nitrided specimens.

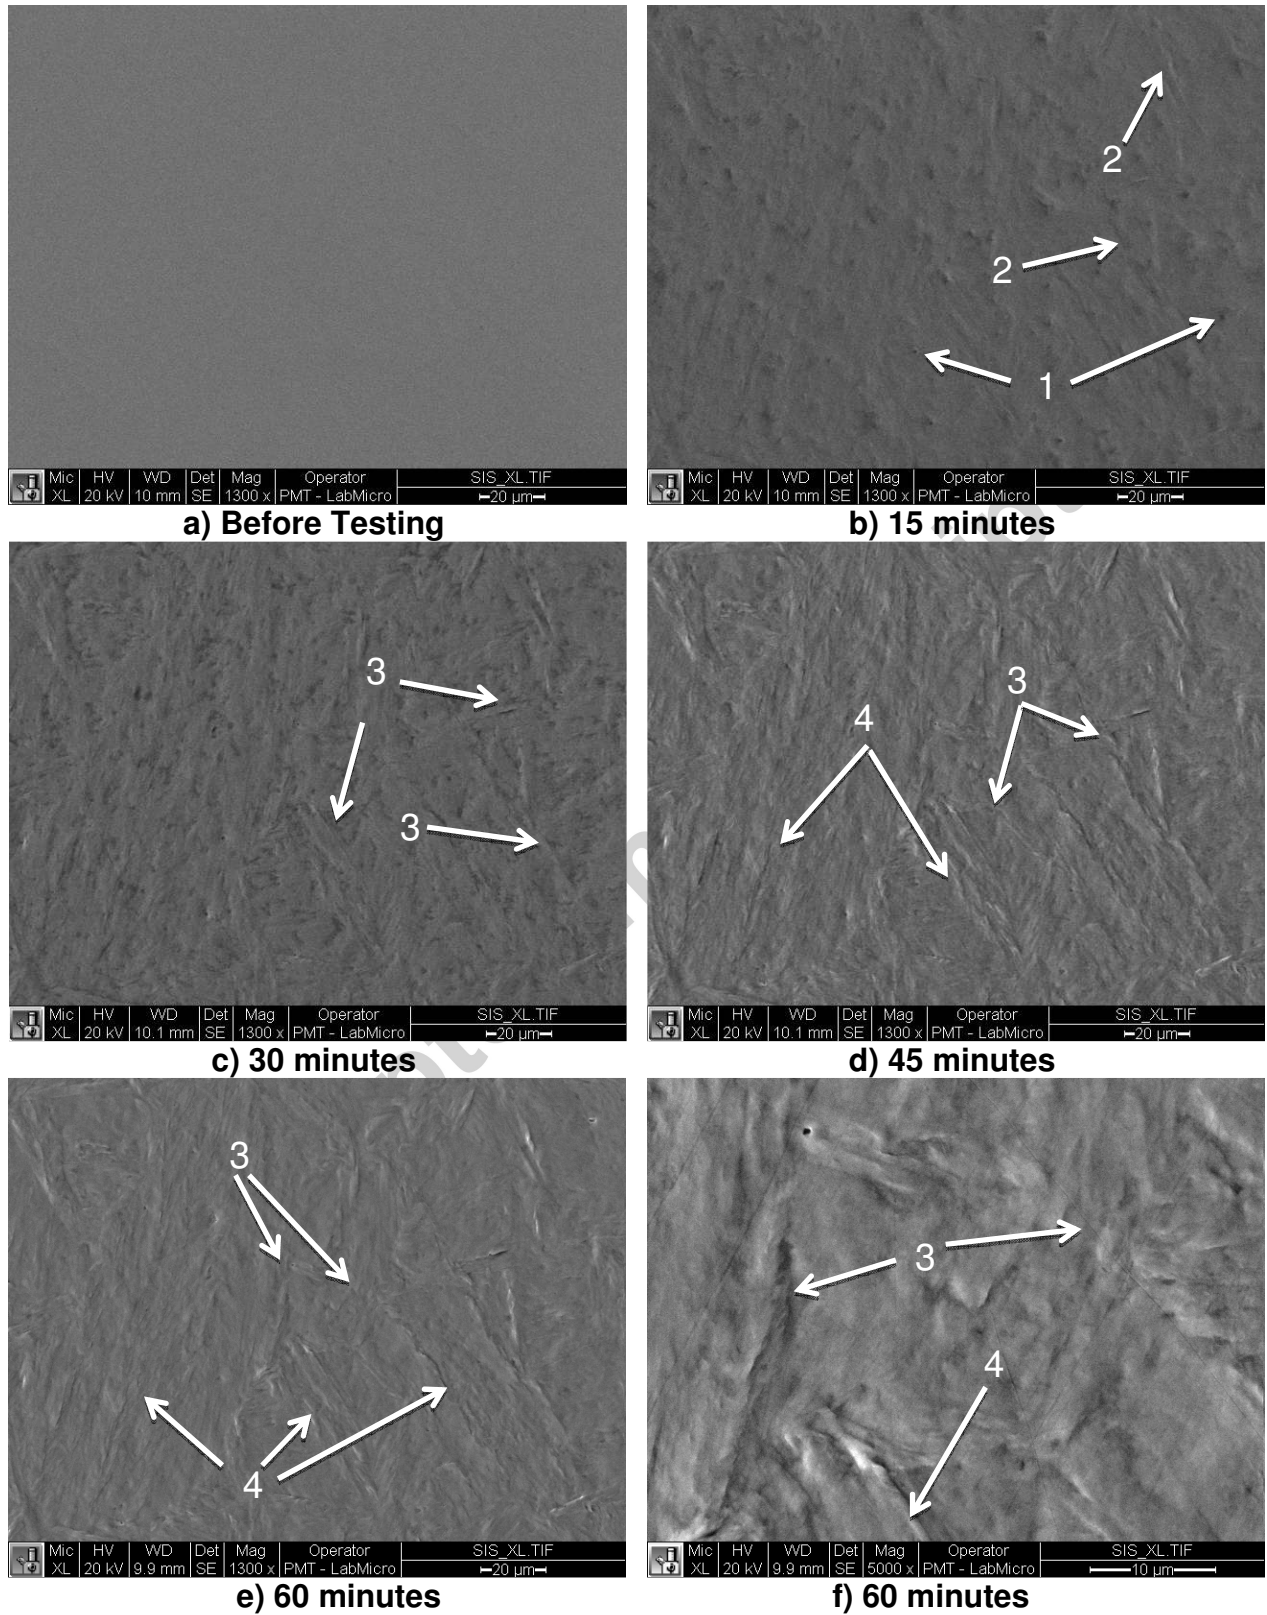
Figure 7 shows the evolution of the damage during the first hour of testing in non-nitrided specimen. Prior to the cavitation test, the surface was ground with emery papers up to ASTM 1,200 and then polished with 6, 3 and 1 μ m diamond paste.

It can be seen from figure 7b) that a significant change occurs at the surface within the first few minutes of testing: a slight relieve was created due to the formation of very small pits (1) and smooth grooves (2), indicating that the surface is undergoing plastic deformation. In figure the sequence 7c to 7f it may be seen that the grooves revealed prior austenitic grain boundaries (3), delineated due to material flow. In addition, martensite lath boundaries (4) were also revealed, as a consequence of plastic deformation. At this time, the mass loss was very low (~0.19 mg) and the main damage at the surface was plastic deformation.

Figure 7 Evolution of the damage during the first hour of testing in non-nitrided specimen, a) before testing b) 15 minutes of testing, c) 30 minutes of testing, d) 45 minutes of testing, e and f) 60 min. SEM images.

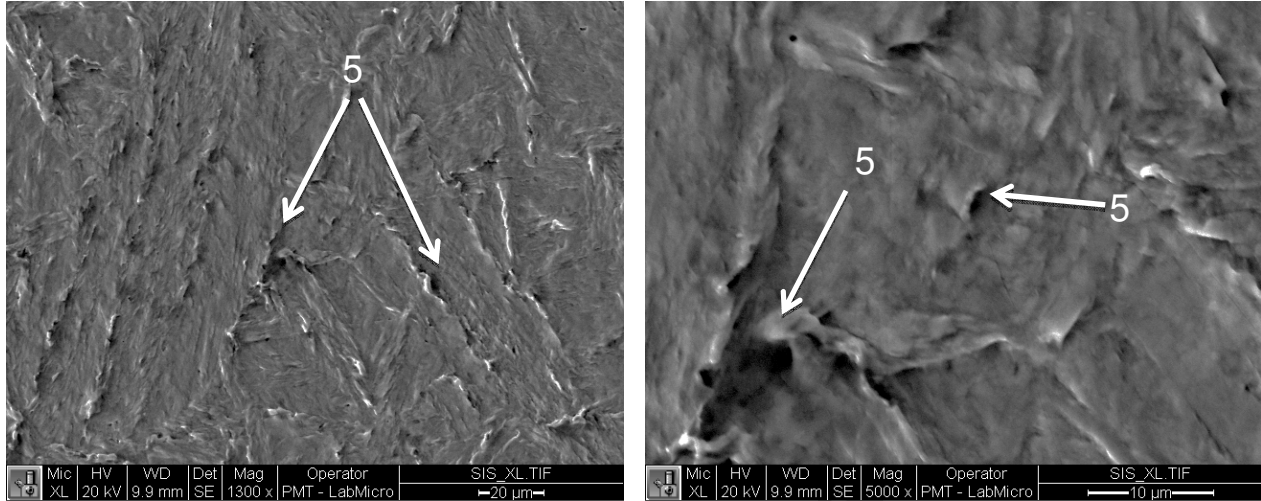
Plastic deformation increases and cavities (5) are formed along martensite lath boundaries and prior austenite grain boundaries. Furthermore, lath boundaries and grain boundaries act as barriers to material flow, causing an accumulation of strained-mass at these imperfections, creating protruding lips on the surface, shown in figure 8.

Figure 8 Cavities (5) and surface steps created due to mass accumulation at twins and grain boundaries after 120 minutes of testing. SEM images.

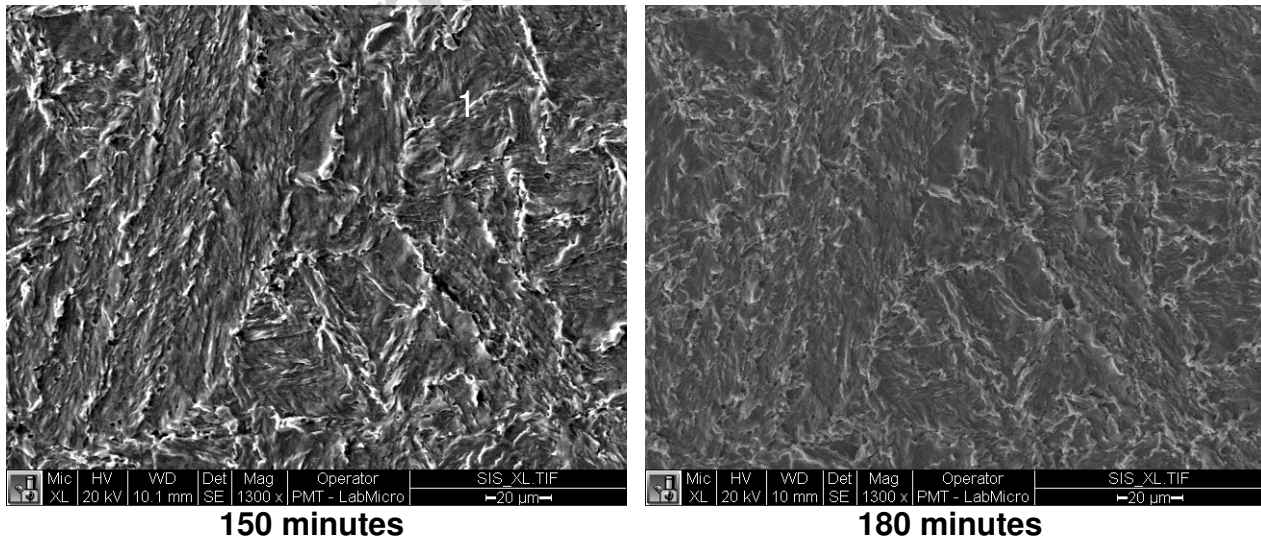
After 120 minutes of testing, the cumulative mass loss is around 0.30 mg indicating that some material was detaching from the protruding lips. Moreover, one can see that detachment of particles from these lips occurred mainly by a ductile mechanism, leaving very thin walls due to necking. In the interval between 150-180 minutes, the surface appearance strongly changed due to removal of the protruding lips, as shown in figure 9. Cavitation damage occurred by plastic deformation, possibly by fatigue and finally by ductile fracture mechanisms. The cumulative mass loss after 180 minutes of testing was ~0.75 mg.

Figure 9 Material detachment from the strained mass accumulated at protruding lips, due to a ductile fracture mechanism within 150 – 180 minutes of testing. SEM images.

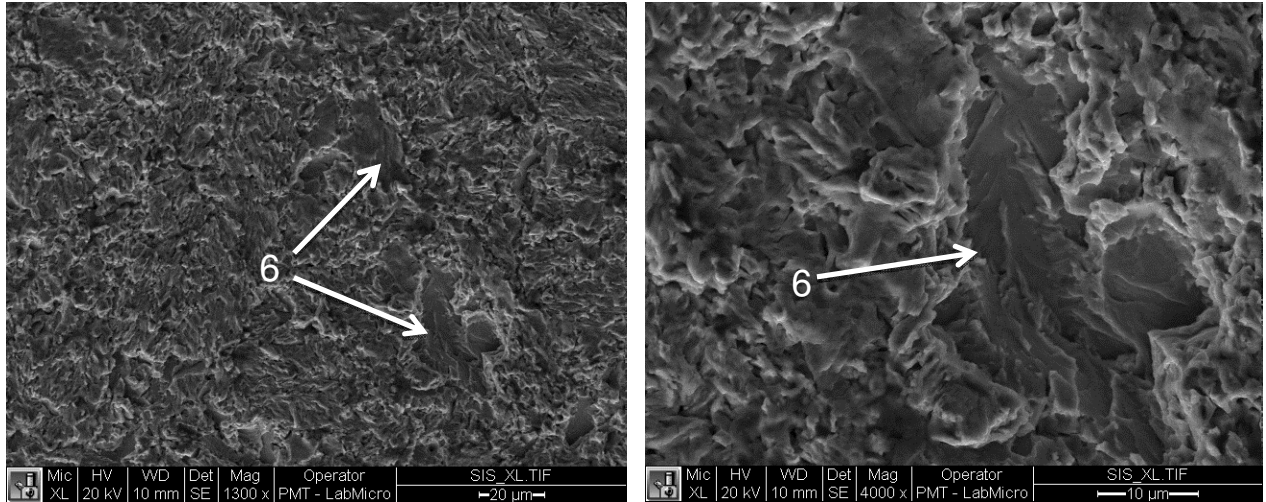
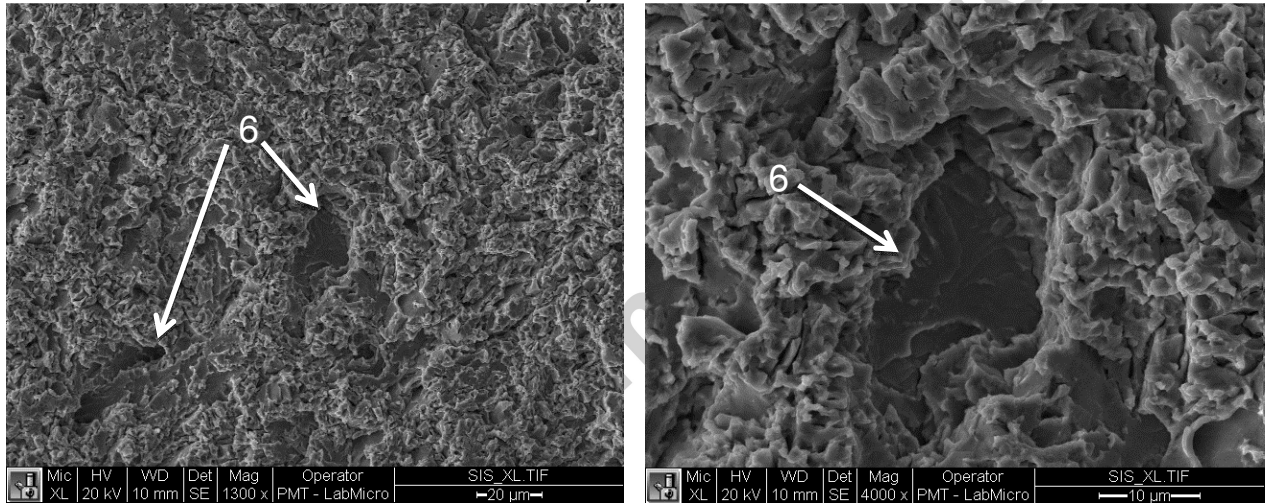
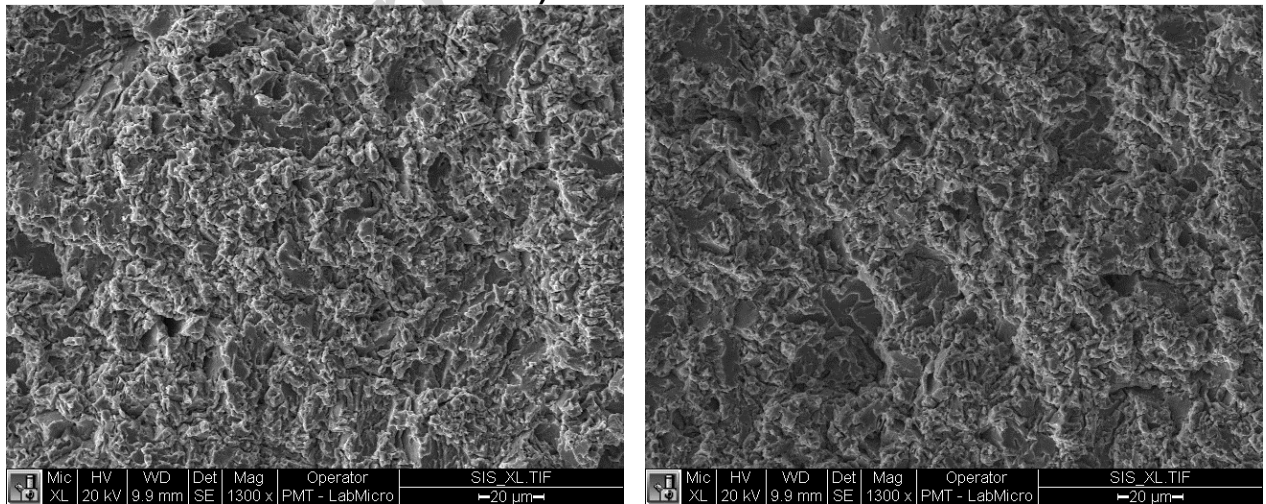
Figure 10 Material detachment due to cleavage from ~180 minutes of testing until the end of the test, a) 240 minutes of testing, b) 360 minutes of testing, c) 720 minutes of testing and d) 1200 minutes of testing. SEM images.

However, from 180 minutes of testing on, it seems that the non-nitrided specimen changed from ductile to brittle behavior. Most probably, due to the presence of small cavities on the surface, the shock waves induced more complex states of stresses, changing the mechanical behavior of the deformed surface from ductile to brittle. Consequently, cracks are able to propagate rapidly by cleavage (6) without significant plastic deformation. The non-nitrided specimen showed this brittle response until the end of the test, as shown in figure 10.

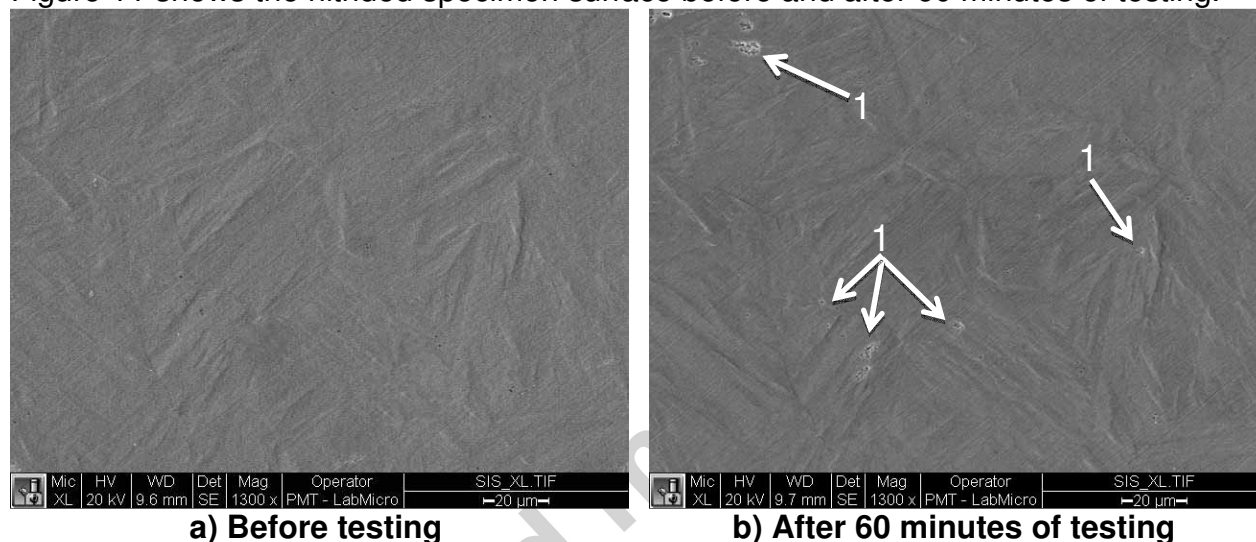
Figure 11 shows the nitrided specimen surface before and after 60 minutes of testing.

Figure 11 Nitrided specimen surface, a) before the test and b) after 60 minutes of testing. SEM images.

During the first 60 minutes of testing, some tiny pores (1) appeared inside some grains; but, generally speaking, the nitrided specimen surface did not show any significant change and most of the grains remained intact, supporting the fact that the expanded martensite elastically absorbed the shock-waves impact, without plastic deforming. After 105 minutes, the number of pores inside the grains was increased (2) and new pores were nucleated, not only in other grains (3) but also at grain boundaries (4), as can be seen in figure 12.

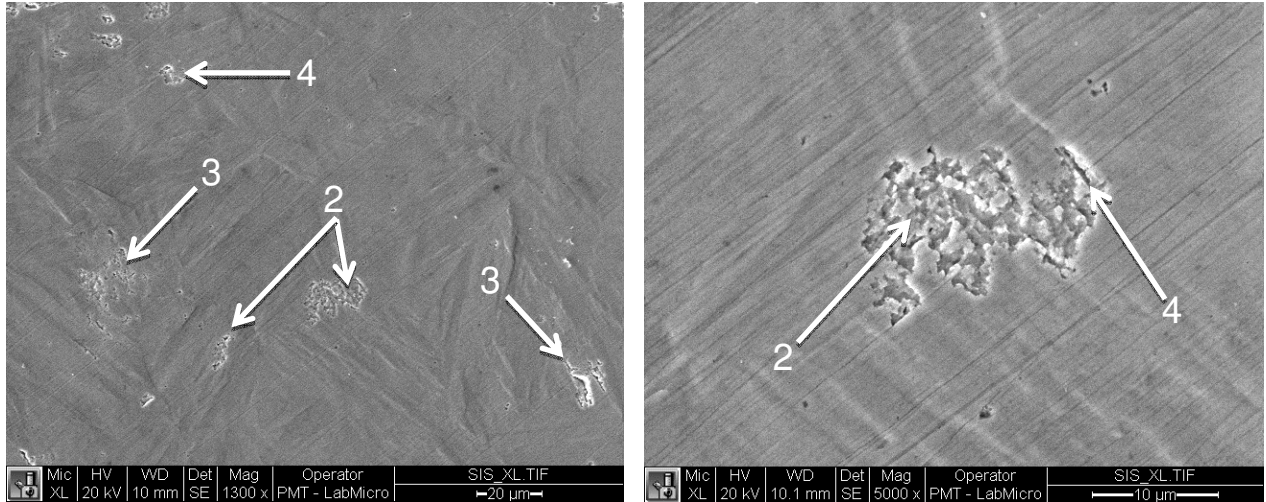
Furthermore, it can be seen in figure 12 that the damage inside the grain was nucleated at the martensite lath boundaries.

Figure 12 New pores nucleation in other grains (3) and at grain boundaries (4) after 105 minutes of testing. SEM images.

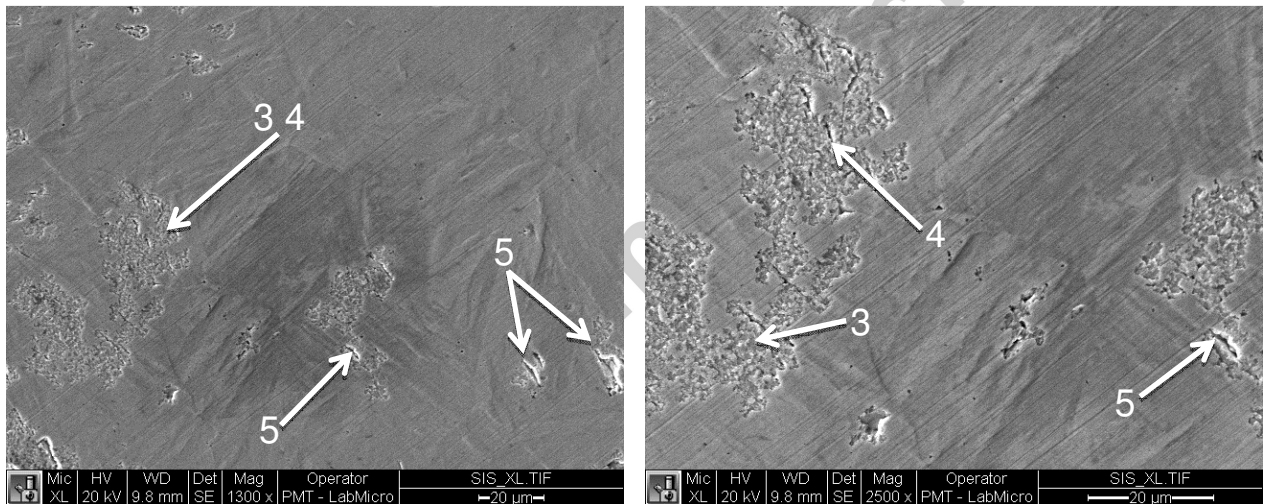
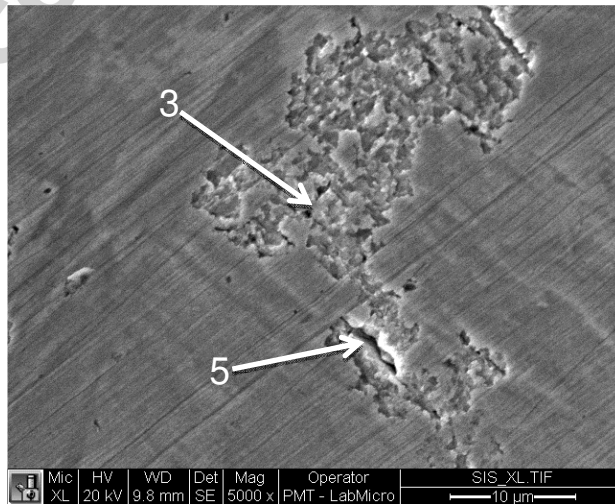
The pores nucleation process, along the surface within grains and at grain boundaries, increased with the exposure time, wear particles were detached from the surface, as can be seen for 180 and 300 minutes of testing time in figures 13 and 14 respectively. Moreover, some former pores increased their size and depth, becoming craters (5), particularly those located at martensite laths. It can be inferred that the material removal is due to brittle fracture without plastic deformation.

Figure 13 Increase on pores nucleation within grains and at grain boundaries after 180 minutes of testing. SEM images.

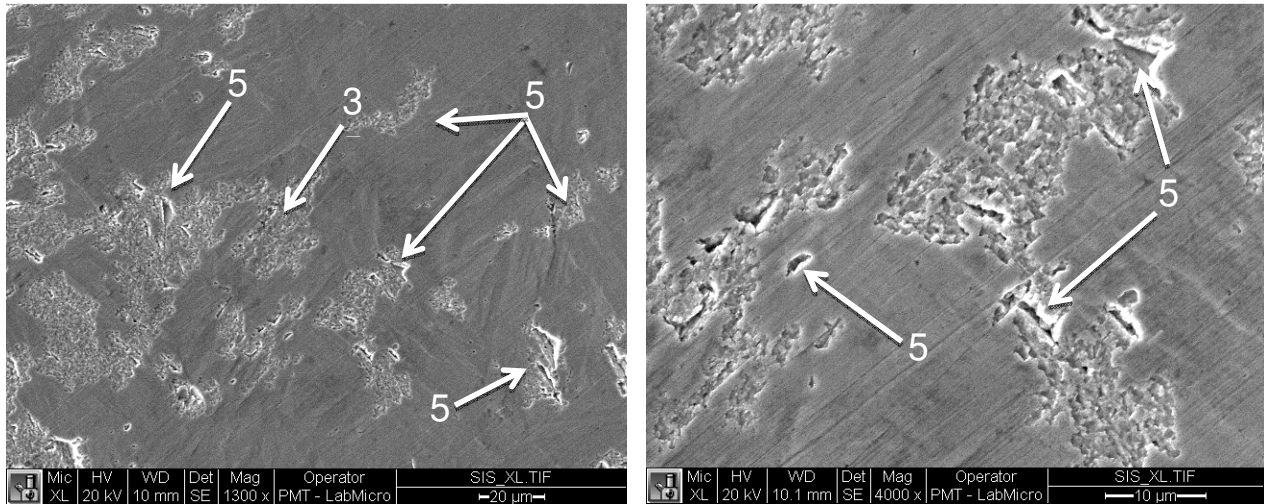
Figure 14 Increase on pores nucleation within grains and at grain after 300 minutes of testing. SEM images.

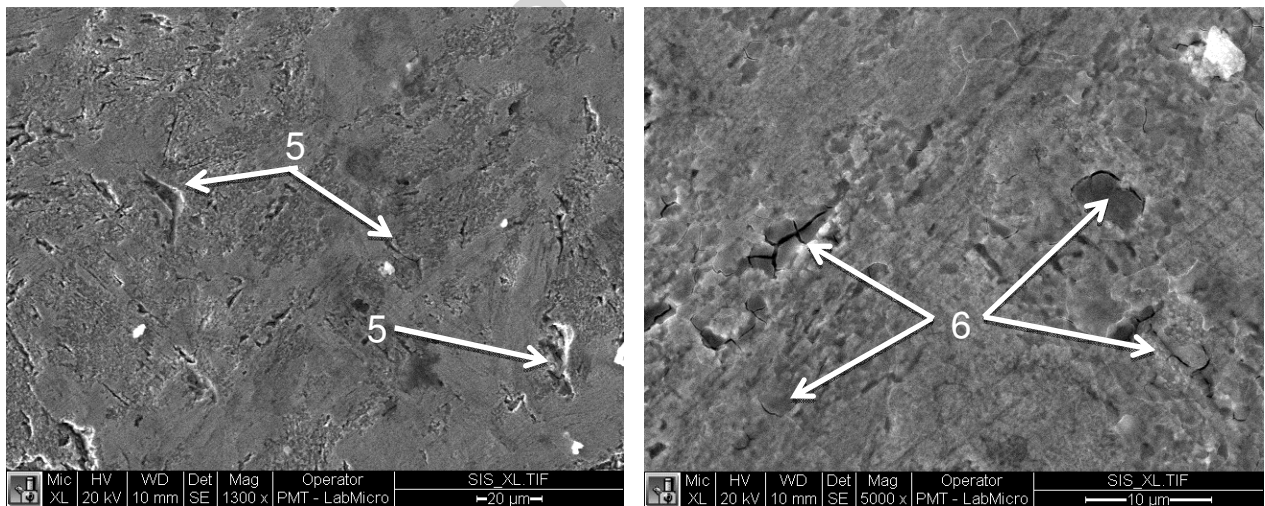
Pores nucleation and growth proceeded and spread over the entire surface till around 600 minutes of testing, as shown in figure 15. The original surface was completely removed, but grain boundaries and craters are still observed. The nitrided case shows a brittle behavior and some cracks (6) nucleated inside the craters. At this time the cumulative mass loss was ~ 0.54 mg, indicating that mass removal occurs in a thin layer at the surface instead of penetrating deeper regions; in other words, the erosion penetration depth into the nitrided specimen was very low.

Figure 15 Surface appearance of the nitrided specimen after 600 minutes of testing. SEM images.

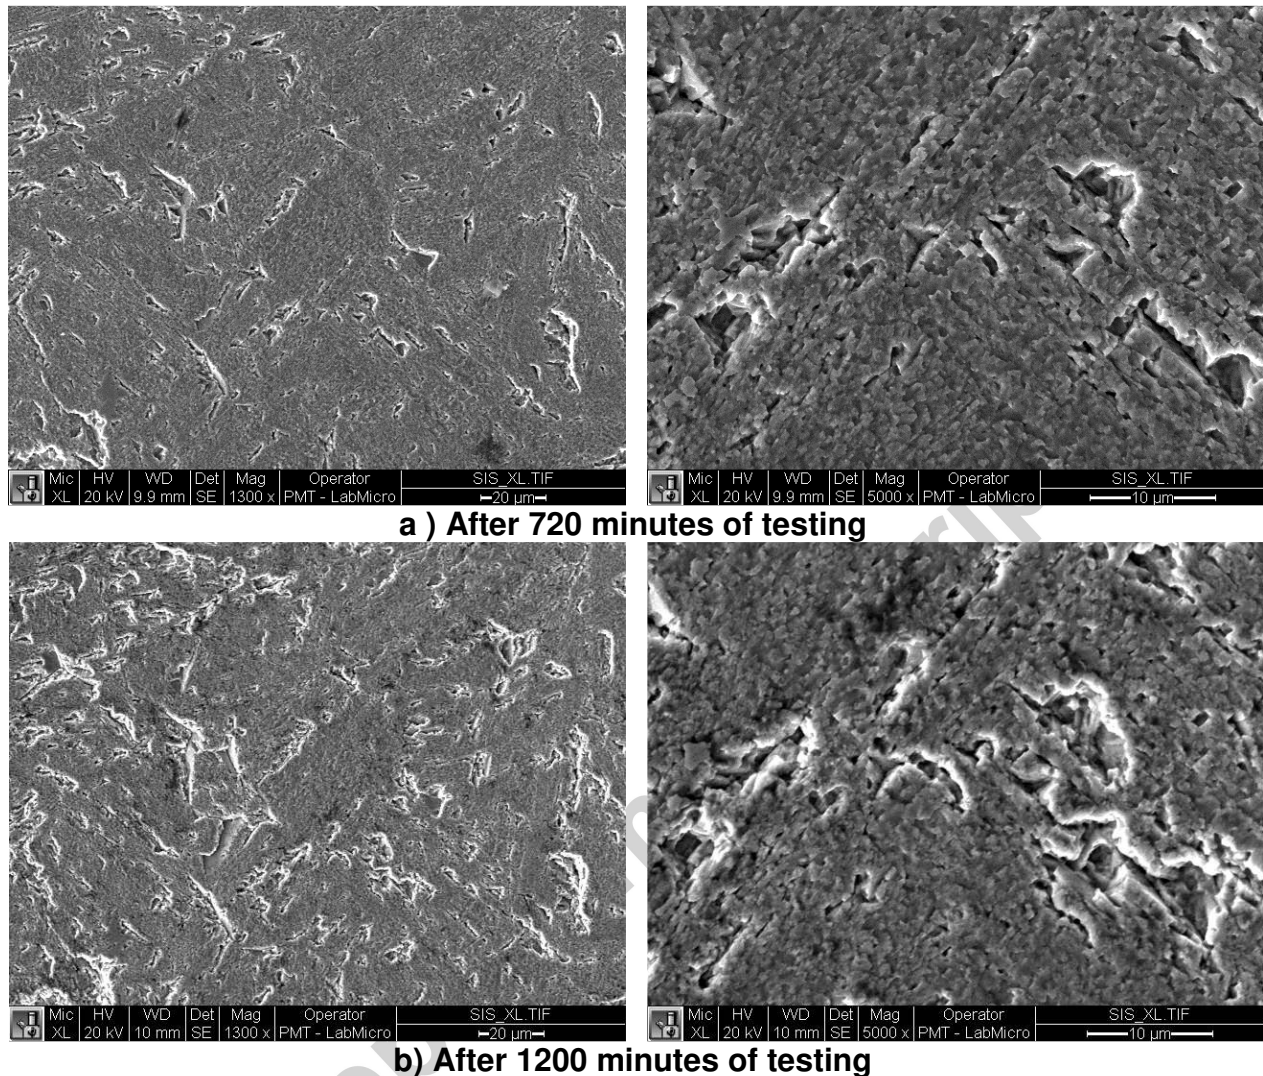
Figure 16 shows the evolution of the damage at 720 and 1,200 minutes of testing. The wear mechanism remained unchanged along the test. New craters were formed; the nitrided specimen continued losing mass from the craters and by debris detachment from the grains surfaces, due to brittle fracture, without evident plastic deformation.

Figure 16 Nitrided specimen surface, a) after 720 minutes of testing and b) after 1200 minutes of testing. SEM images.
