Online condition monitoring of rolling stock wheels and axle bearings

Abstract

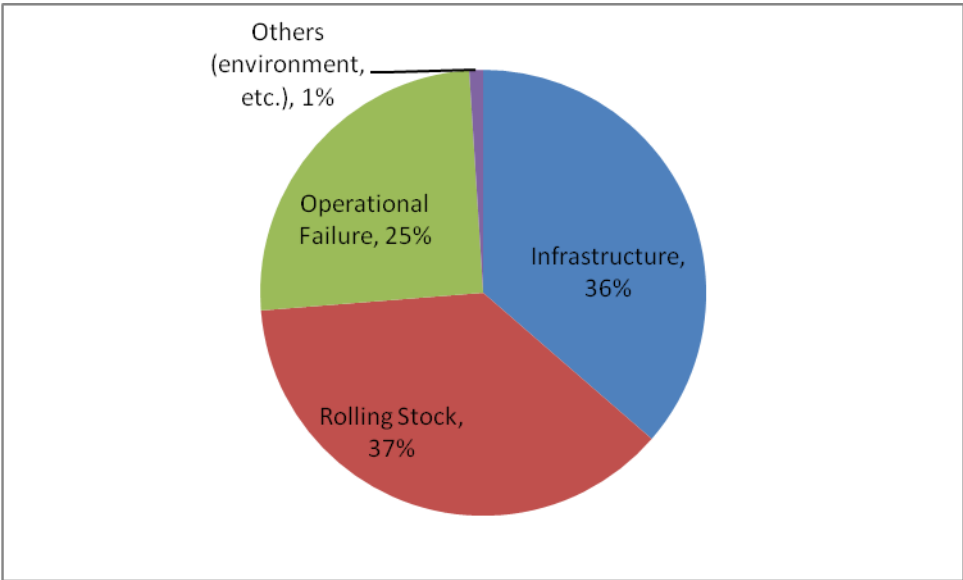
Figure 1: Railway accidents considered in the D-RAIL FP7 project by cause [taken from reference 5].

A recent study published by DNV as part of the D-RAIL FP7 project considered the railway accidents that have been reported in 23 countries over the past years [5]. It was revealed that out of the 700 accidents considered, 37% of them were due to rolling stock faults (figure 1). Moreover, 84% of all rolling stock-related accidents were confirmed to have been caused by wheelset and bogie-related defects (figure 2).

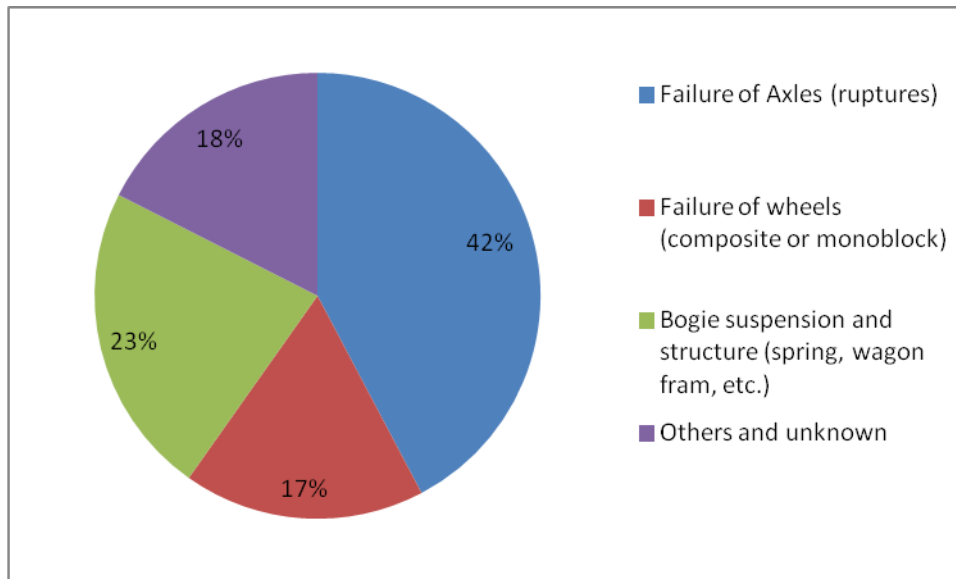
Figure 2: Rolling stock related accidents by cause [taken from reference 5].

According to the findings of the D-RAIL FP7 project, 41 % of all rolling stock accidents were due to axle failure which in the vast majority was caused by a faulty bearing. Almost 60% of all rolling stock accidents were due to wheelset failure, thus accounting for one in five of all railway accidents considered in the study.

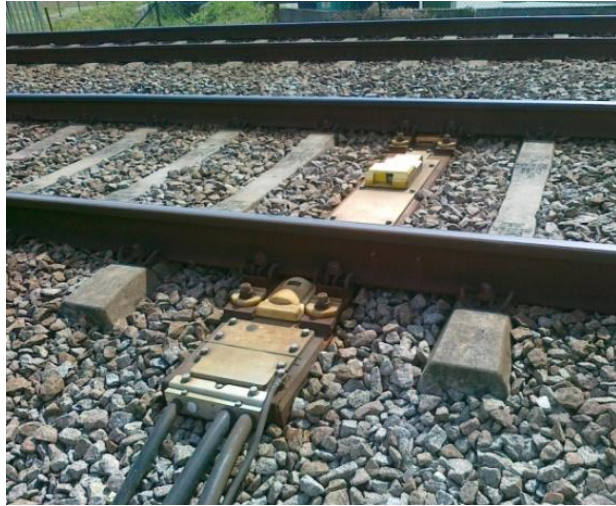
Figure 3: A Hot Axle Box Detector installed on the Portuguese rail network (REFER).

HABDs such as the one shown in figure 3 employ infrared sensors to detect overheating bearings and stuck brakes. WILDs are able to detect flats, metal build-up and shelling in the wheel tread by measuring the loads sustained by the rail as rolling stock goes over the instrumented rail track section. Reactive-based systems raise an alarm only after the critical threshold set has been exceeded and thus they are not appropriate for historical trending. However, it is possible to use reactive systems to follow a particular wheelset during a single run as the rolling stock of interest passes from each check-point.

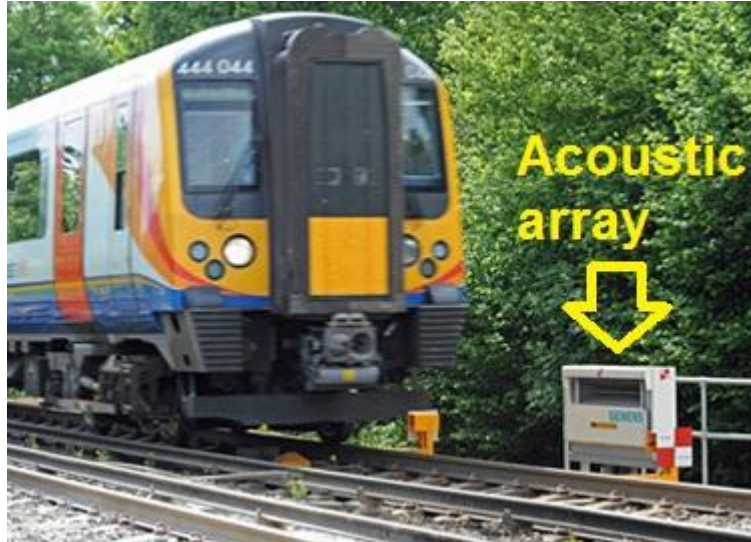
Figure 4: A RailBAM trackside acoustic array detector installed on the British rail network near London (the photograph is courtesy of SIEMENS).

Trackside Acoustic Array Detectors (TAADs) use arrays of microphone to record the noise produced by the bearing. An example of TAADs is shown in figure 4. TAADs are capable of detecting the acoustic signature of early bearing defects using spectral analysis and data trending [10]. The maximum operational frequency range of the microphones used in trackside acoustic arrays is normally 22-44 kHz. At this operating frequency range the microphones can be affected by surrounding environmental noises as well as noises from the measured train itself. Noises from the wheel-rail interface and the train engine can contaminate the signal acquired by the acoustic array possibly resulting in false alarms or missed faults.

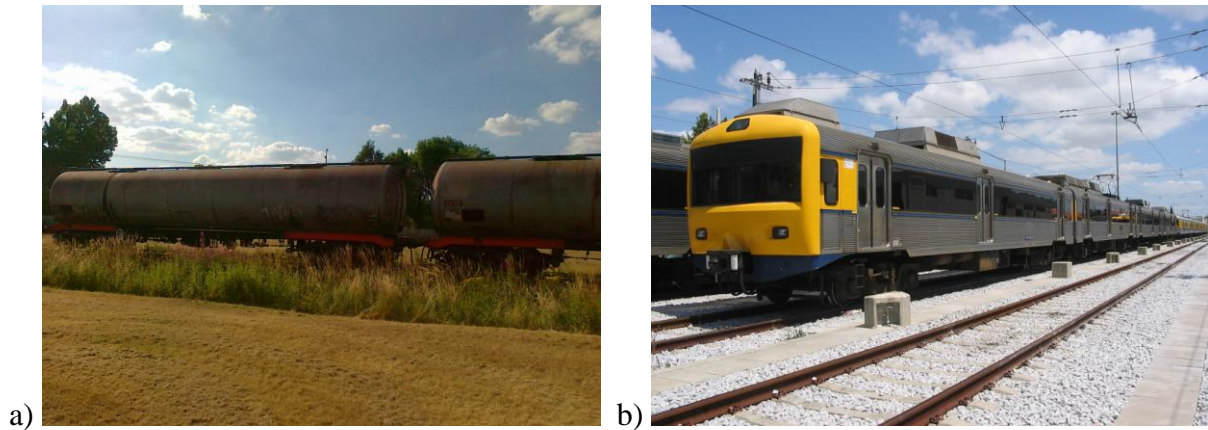
Figure 5: a) Tanker freight wagons with several axle bearings artificially damaged in the roller or race using a power tool, b) EMU with one defective wheel (tread shelling) used for experiments in Portugal.

The first set of experiments were carried out on tanker freight wagons with artificial damage induced on several axle bearings. The test wagons are shown in figure 5a. Testing took place in the Long Marston rail track, UK. From the acquired data and subsequent analysis it is evident that acoustic emission has the capability of detecting faulty axle bearings at various stages of evolution, well before they cause final failure of the bearing.

The second set of experiments were carried out on the Portuguese Rail Network managed by REFER on an Electric Multiple Unit (EMU) operated by Comboios de Portugal (CP) for suburban passenger services on the line between Lisbon City Centre and Cas-Cais. The test vehicle concerned in this paper is shown in figure 5b. It comprises of three carriages and operates at a maximum speed of 90 km/h. One of the wheels of the EMU considered in this study has developed shelling on the tread naturally during normal operation shown in figure 6. Vibration measurements carried out during a normal operational run from Cas-Cais to Lisbon showed that the tread defect could easily be detected and evaluated using appropriate signal processing.

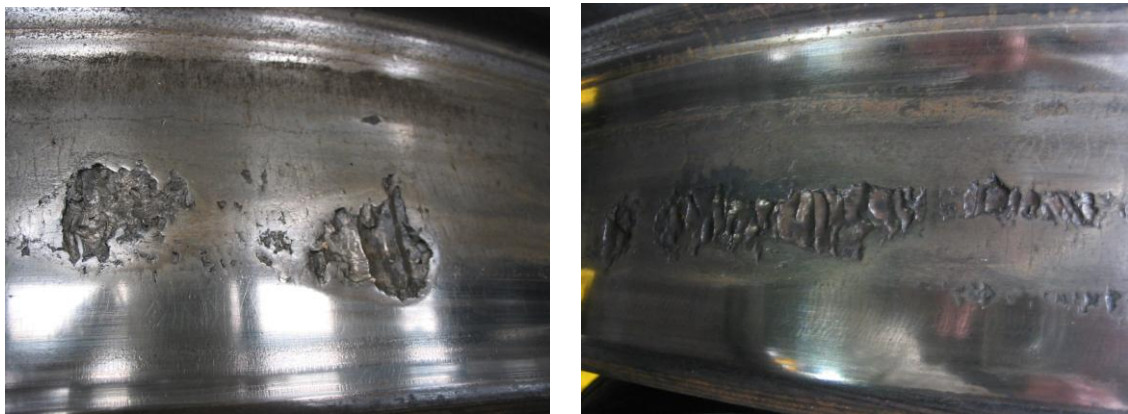
Figure 6: Photographs showing shelling on the tread of the damaged wheel of the EMU tested.

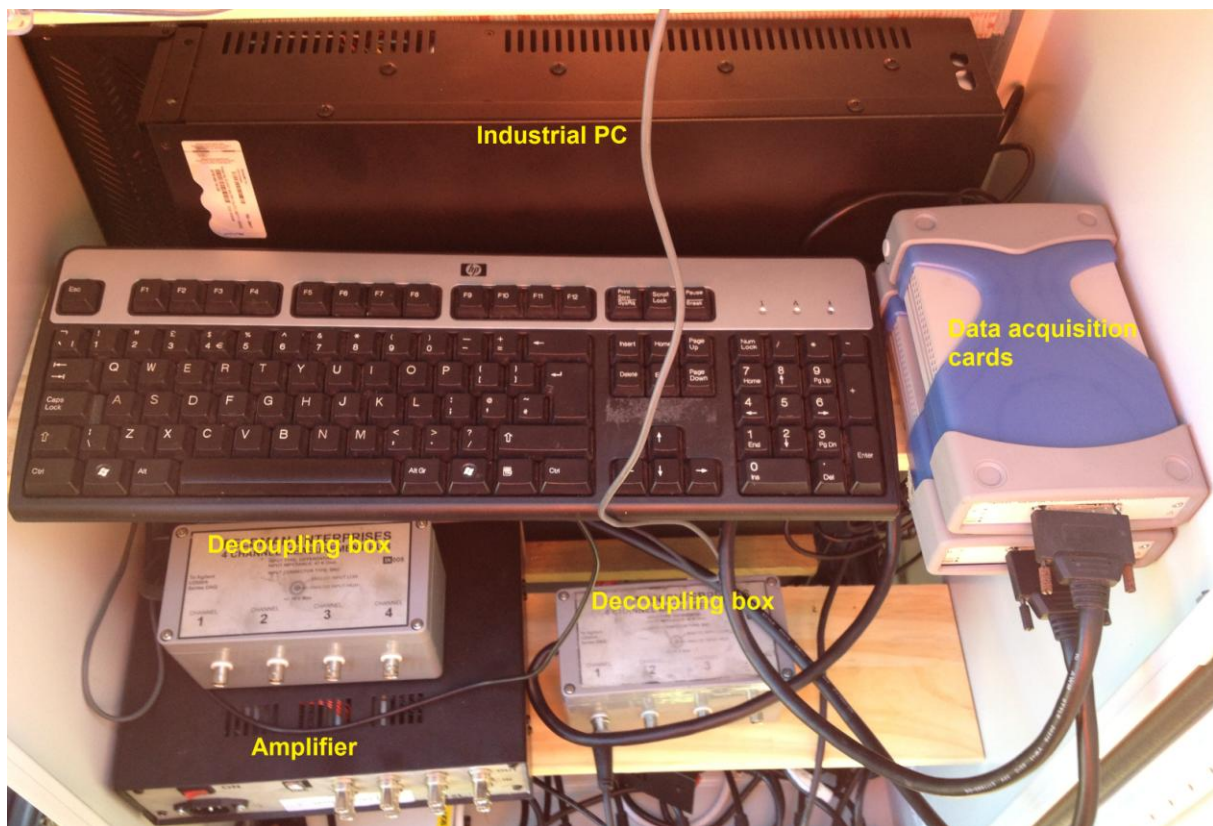
Figure 7: The customised data acquisition equipment used during trials in Long Marston.

The customized AE/vibration analysis system consists of the following components: a) R50A resonant acoustic emission sensors manufactured by Physical Acoustics Corporation (PAC), b) 25kHz high frequency accelerometers with sensitivity 100mV/g manufactured by Wilcoxon, c) pre-amplifiers manufactured by PAC, d) digital amplifiers manufactured by Krestos, e) accelerometer power supply manufactured by Krestos, f) four-channel decoupling hub manufactured by Krestos, g) 2531A Agilent four-channel data acquisition card with a maximum sampling rate of 2 MS/s in single channel mode and h) Amplicon industrial

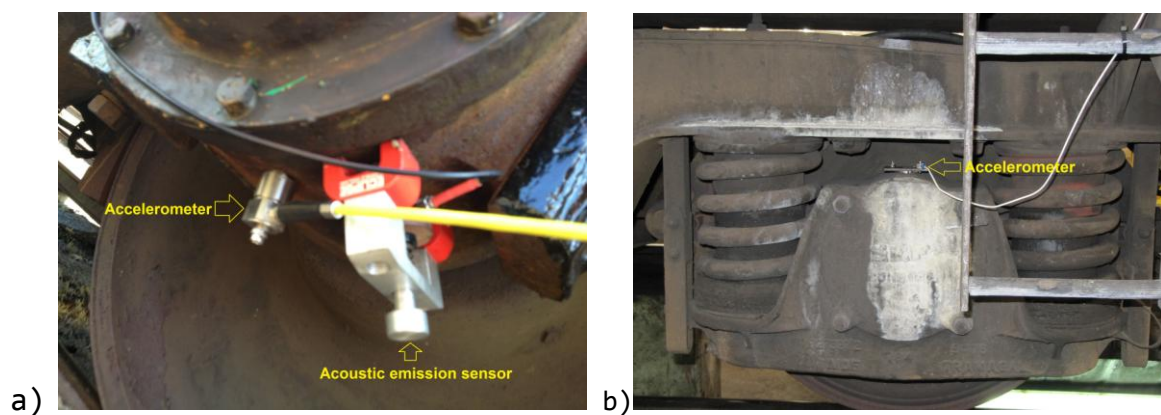
Figure 8: a) AE sensor and accelerometer installed in one of the axle bearing of the tanker freight wagons tested in Long Marston, UK and b) accelerometer installed in one of the two wheels of the EMU tested in Cas-Cais, Portugal.

computer with customised data logging and analysis software developed by the authors. The AE sensors and accelerometers were mounted using magnetic hold-downs as shown in figure 8a.

AE sensors and accelerometers were mounted using magnetic hold-downs. The area where the sensors were mounted was slightly ground to improve contact. Vaseline was used to couple the AE sensors on the surface of the axle bearing casing in order to maximize the transmissibility of ultrasonic waves produced from axle bearing to the piezoelectric sensing element. The acquisition system during testing was triggered manually.

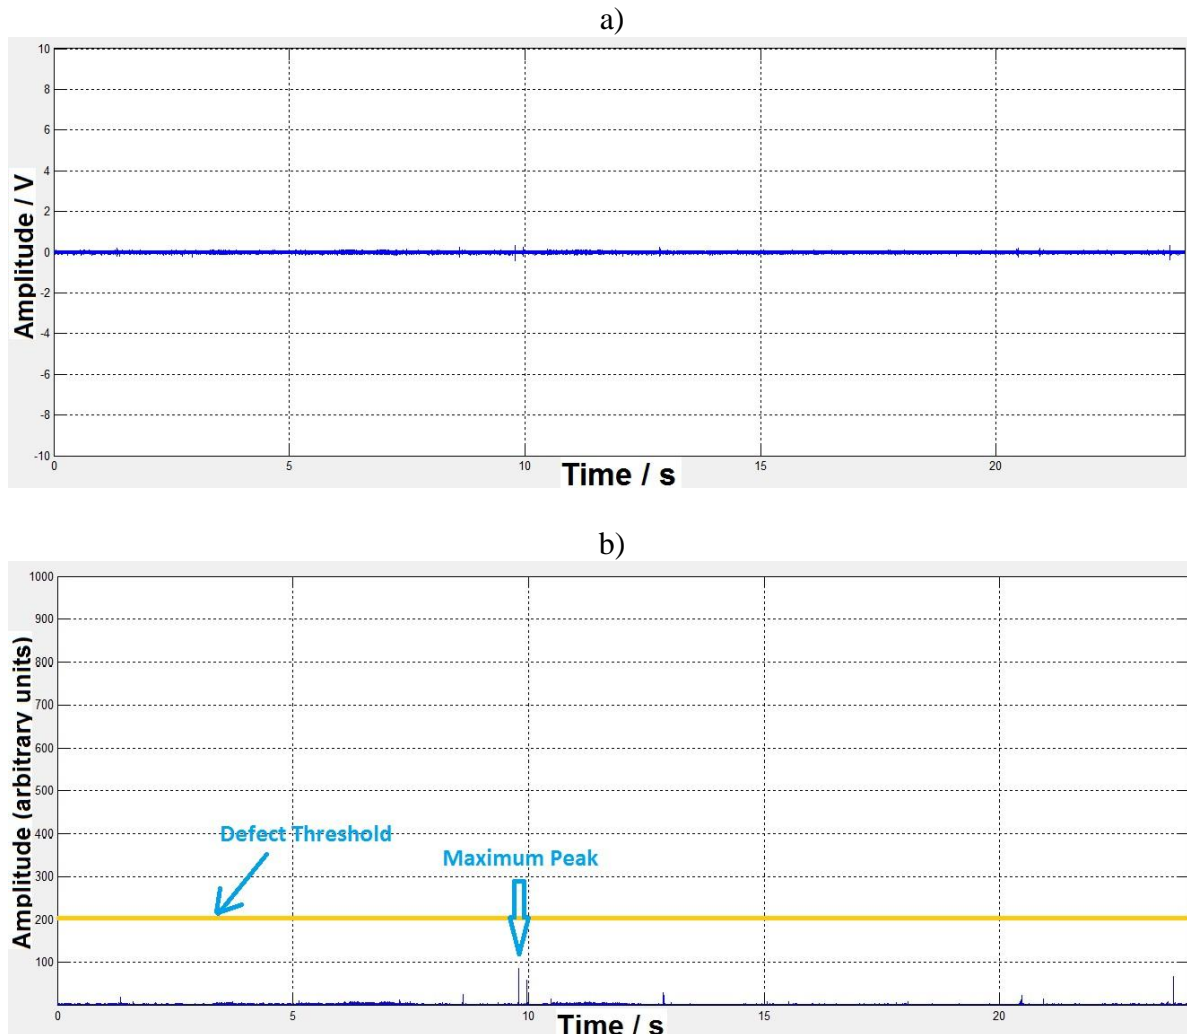
Figure 9: a) Raw AE data acquired from a healthy bearing and b) its moving RMS plot using a filtering time window of 60 μ s.

Some typical results of bearing defects are listed below from onboard measurements carried out in Long Marston. These tests have been carried out to verify the actual presence of the artificially induced defects and their severity as well as to confirm that the axle bearings considered to be in good condition are indeed healthy. The plot in figure 9a shows the onboard raw AE measurement of a healthy bearing carried out at a speed of 24 km/h. The plot in figure 9b is the normalised moving RMS of the signal filtered using a time window of 60 μ s. It is evident that the AE signal contains very little noise. This is manifested also in the RMS plot of the raw signal where peaks below 100 arbitrary units are seen.

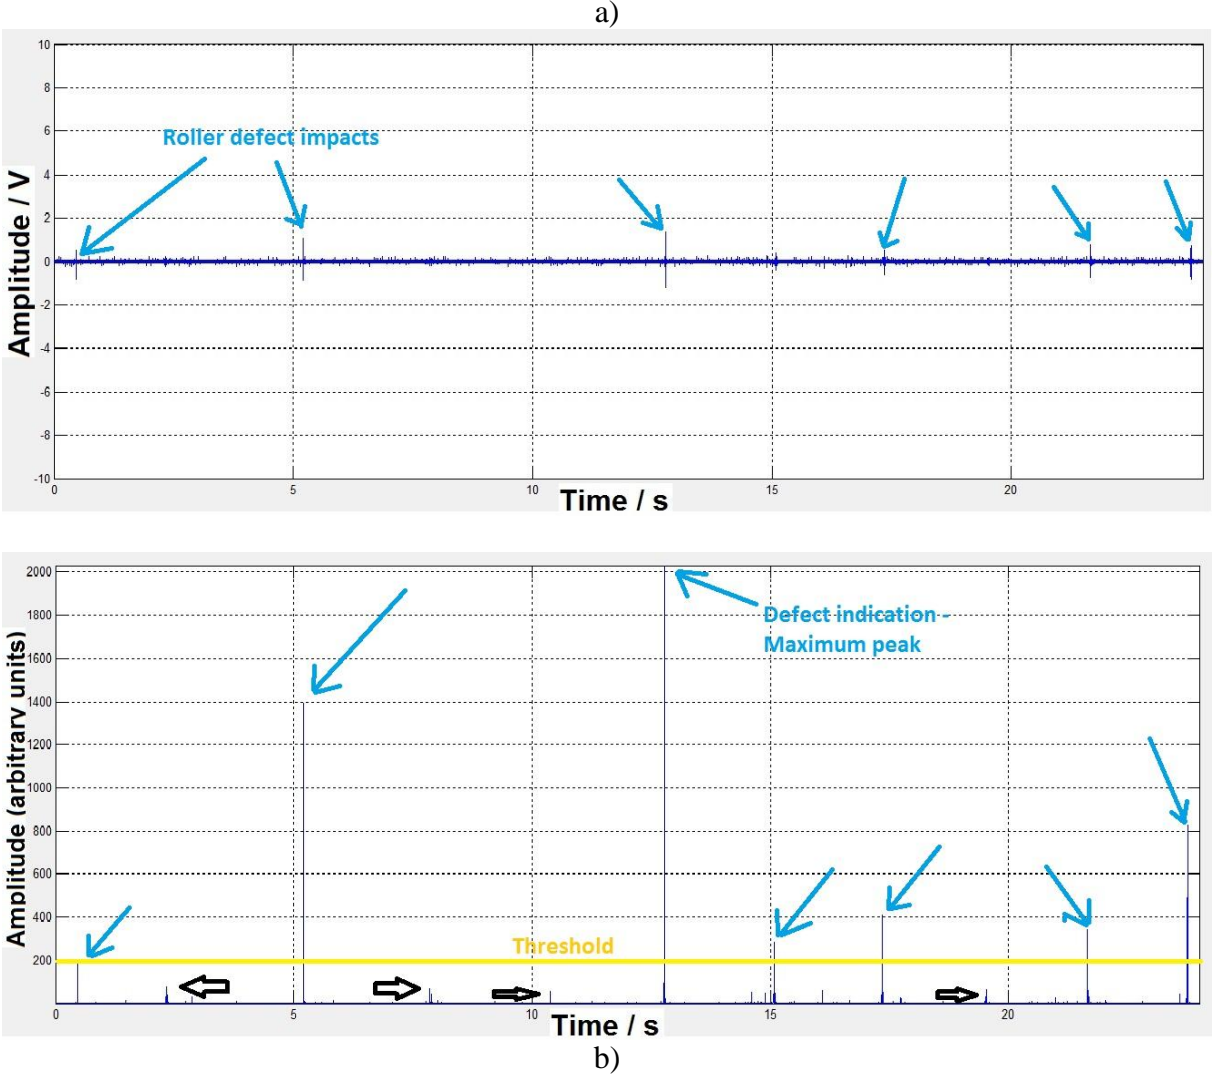
Figure 10: a) Raw AE data acquired from a bearing with a 4 mm roller defect and b) RMS processed results. Notice the amplitude of the strong RMS peaks.

Figure 10a shows the onboard AE measurement for a 4 mm roller defect which was artificially induced using a power tool. The signal appears to be slightly noisier than the healthy one. The peaks seen in the raw AE dataset correspond to the impact of the defective roller as the bearing rotates. By converting the raw data to normalised moving RMS we can see that a number of peaks are evident in the plot, some of which exceed significantly 200 units indicating the presence of a defect. Peaks no more than 200 units have been determined after the analysis of several tests in the field and laboratory to be associated with noise rather than actual defects. The highest peak for the 4 mm roller defect has maximum RMS

amplitude of 2000 units, well above the predefined threshold. The variability in the resulting moving RMS maximum peak per location should be taken into consideration. Although in the raw dataset amplitude variations seem to be smaller the energy of the impact is not the same and depends on the speed of the train as well as the quality of the rail track and the wheel. The more the bearing is loaded as it rotates the more energy will be released.

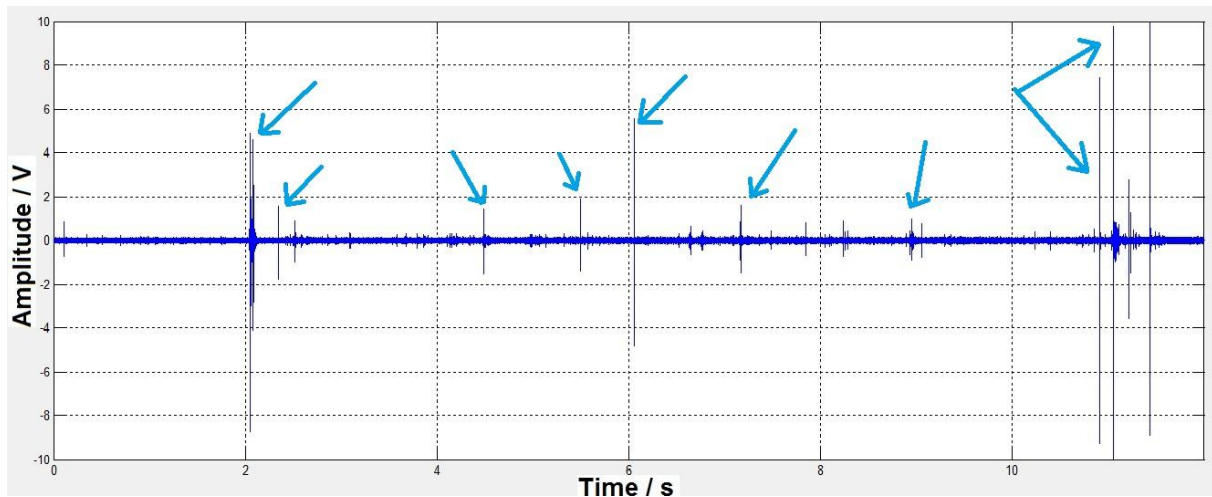
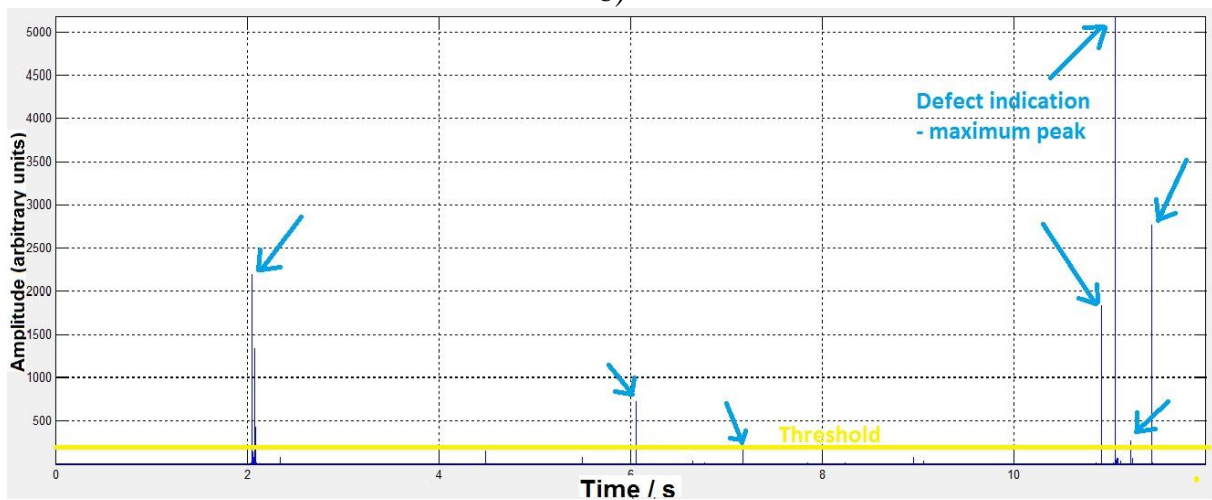
Figure 11: a) Raw AE data acquired from a bearing with a 8 mm roller defect and b) RMS processed results. Notice the amplitude of the strong RMS peaks which is much higher than the RMS for the 4mm roller.

Figure 11a presents the raw AE data and 11b the moving RMS from an 8mm roller defect. Note the increasing maximum peak amplitude (~5100 arbitrary units) of the RMS signal indicating the higher severity. However, the variability in each axle bearing rotation remains with some of the peaks falling even below the threshold limit despite the much higher amplitudes recorded in the raw signal. This is another indication that the amplitude is not sufficient indicator and the energy the signal carries need to be considered. Also in order to safely assess the severity of the signal we need to trend the maxima from several measurements in order to reach a reliable conclusion.

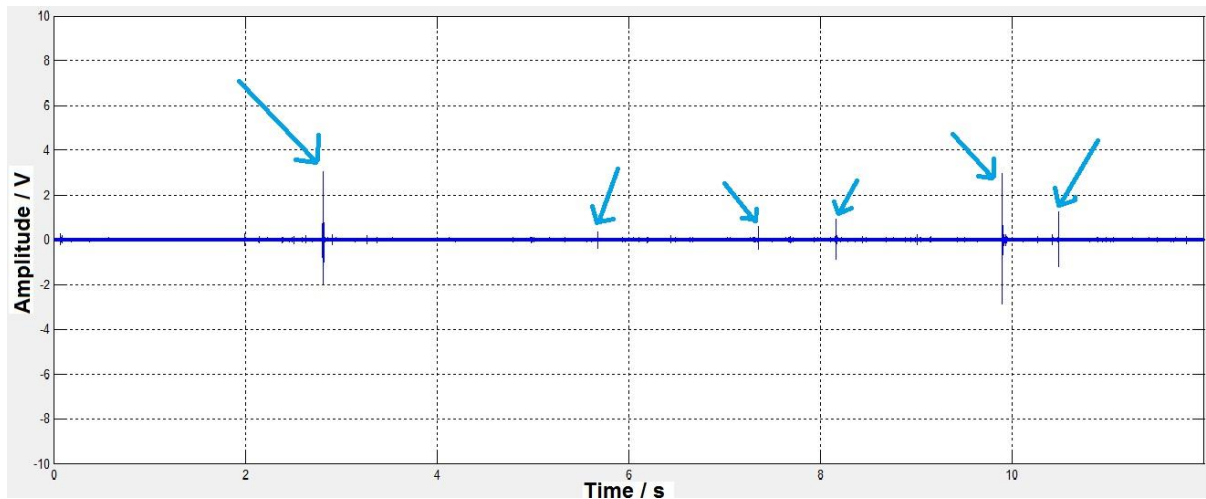
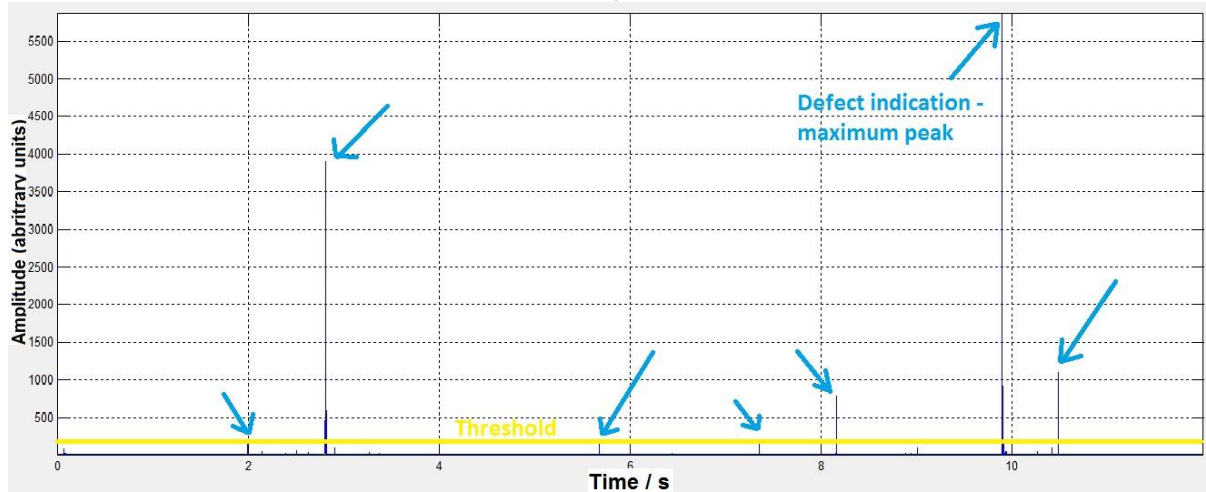
Figure 12: a) Raw data of 8 mm race defect and b) moving RMS processed results.

Figure 12a shows the raw AE data and 12b the moving RMS acquired from a bearing with an 8 mm race bearing defect. It is noticeable that the raw AE amplitude varies significantly from measurement to measurement but the moving RMS provides a consistent analysis method for evaluating the severity of the defects provided that the maxima are trended and compared.

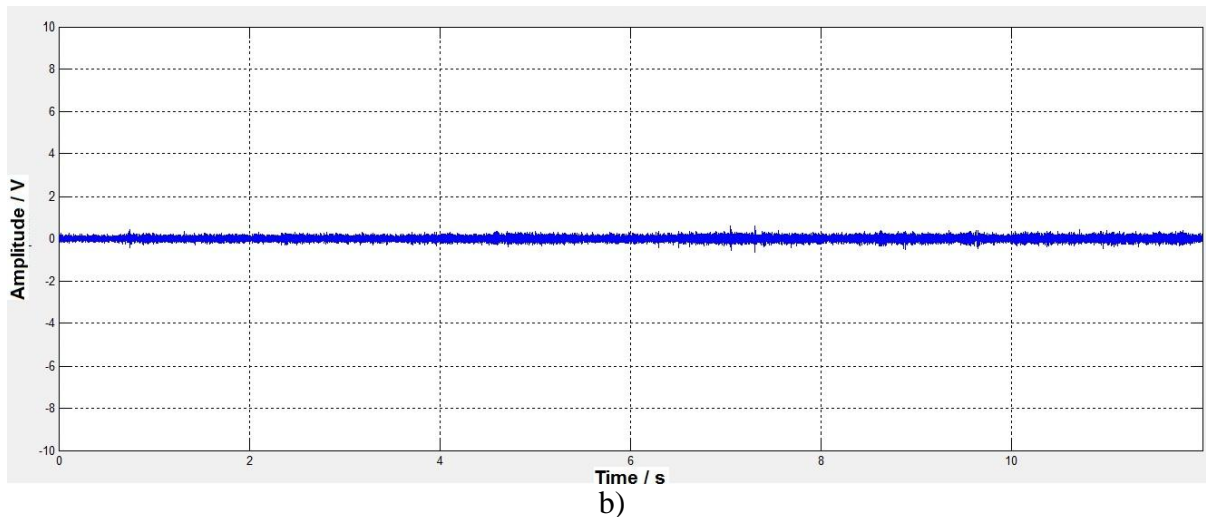
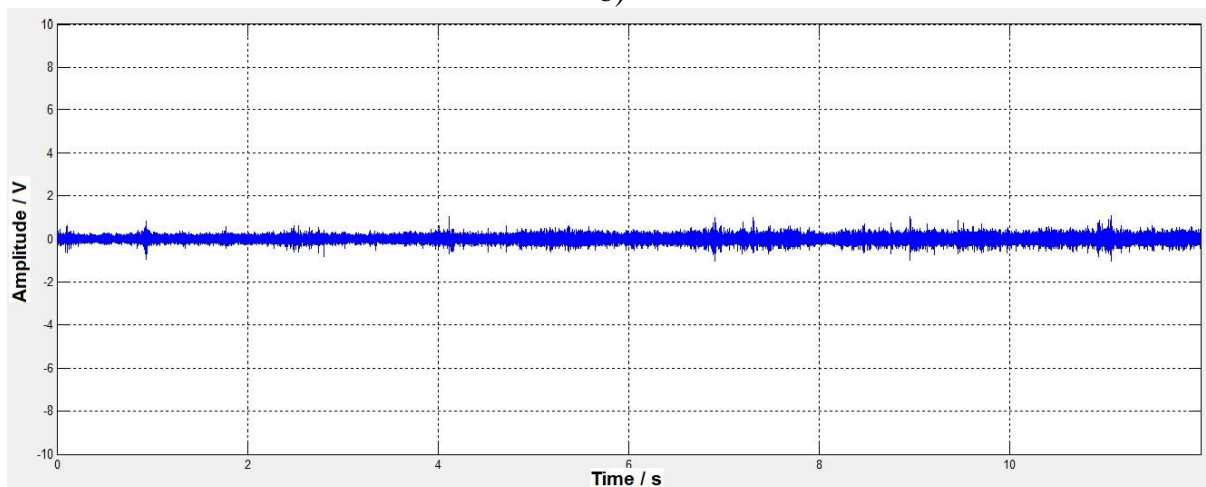
Figure 13: a) Raw acceleration for a healthy axle bearing and b) raw acceleration for an axle bearing containing a 2mm roller defect.

Figure 13a shows the raw vibration response for a healthy bearing and 13b for the axle bearing containing a 2 mm roller defect. The raw acceleration appears to be a bit more noisier for the defective axle bearing. However, it is not possible to arrive into safe conclusions by just looking into the raw measurements.

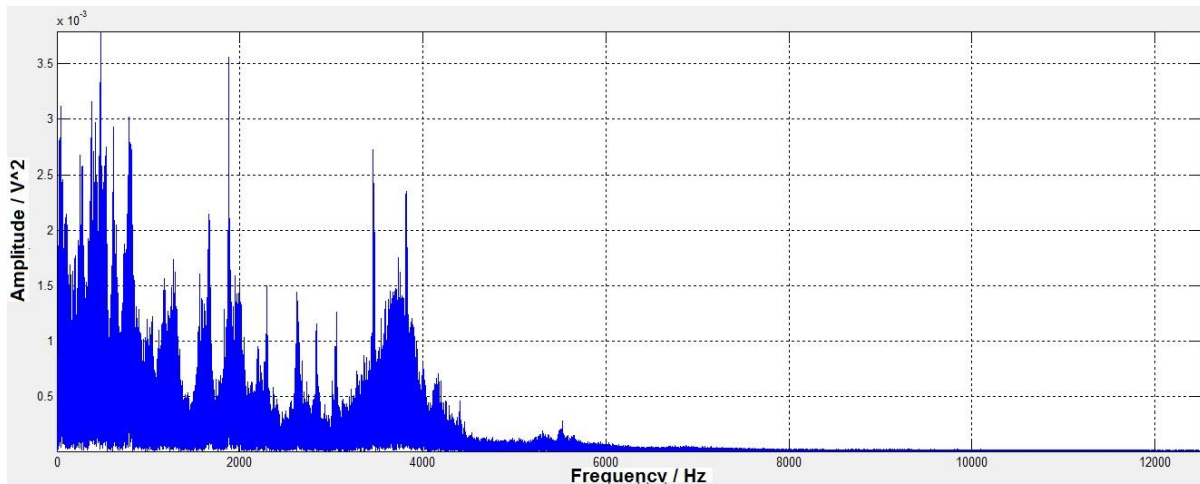
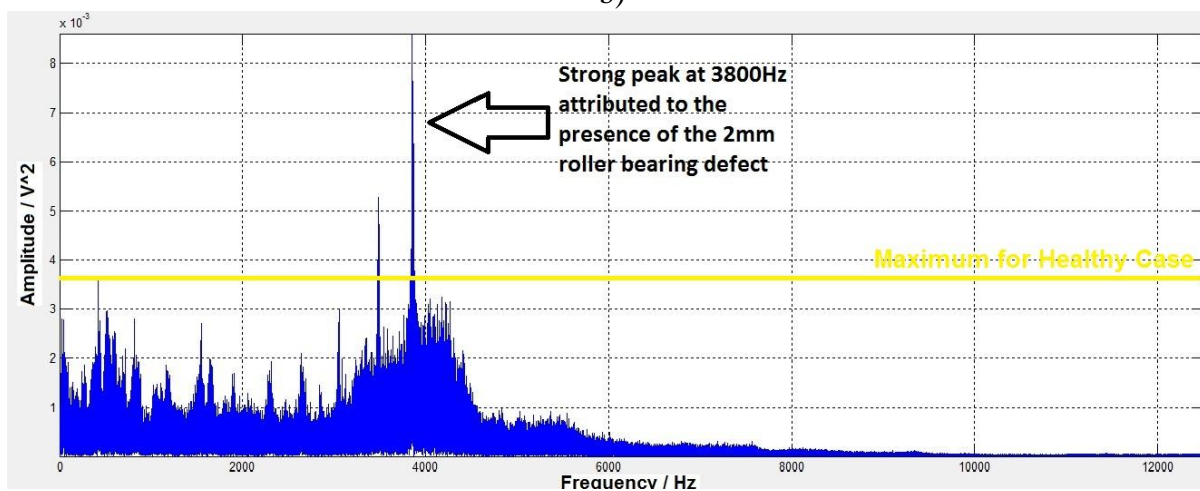
Figure 14: a) Power spectrum of the healthy axle bearing and b) power spectrum of the faulty axle bearing containing a 2 mm roller defect.

By converting the time-domain signal into frequency-domain using Fast Fourier Transform (FFT) it is evident that for the faulty axle bearing a considerably strong peak appears in the power spectrum plot in figure 14b at approximately 3800 Hz. This peak also exists in the healthy axle bearing power spectrum in figure 14a but its magnitude is significantly lower. The repeated measurements carried out on both axle bearings indicated the persistence of the strong peak at 3900 Hz in the power spectrum of the signal for the defective axle bearing. This suggests that the significant increase in the 3800 Hz peak is likely to be associated with the roller defect present. However, it is not possible to evaluate the severity of the defect using the vibration measurements and through this analysis it is only possible to qualitatively evaluate the possible presence of a problem in the axle bearing under evaluation.

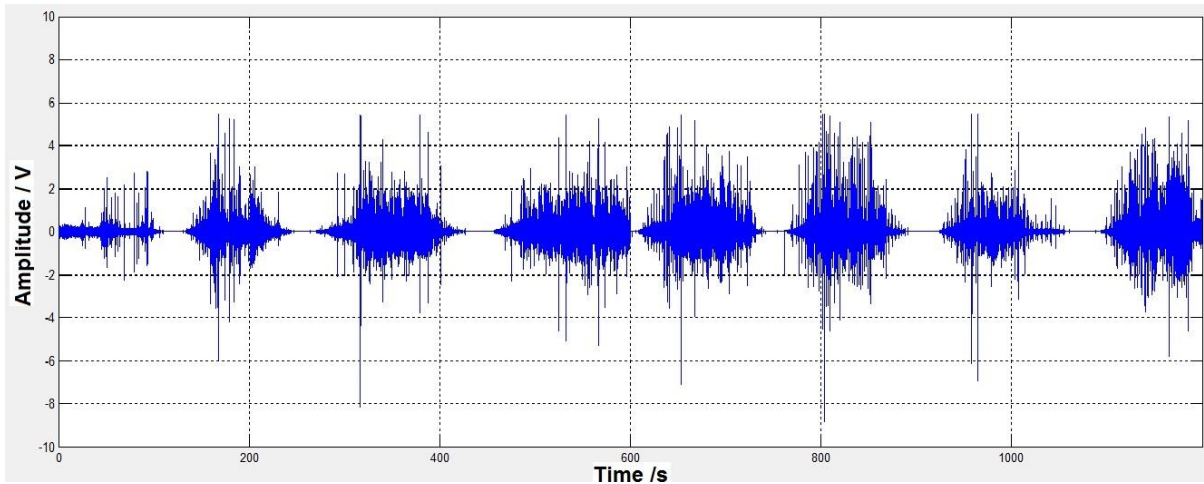
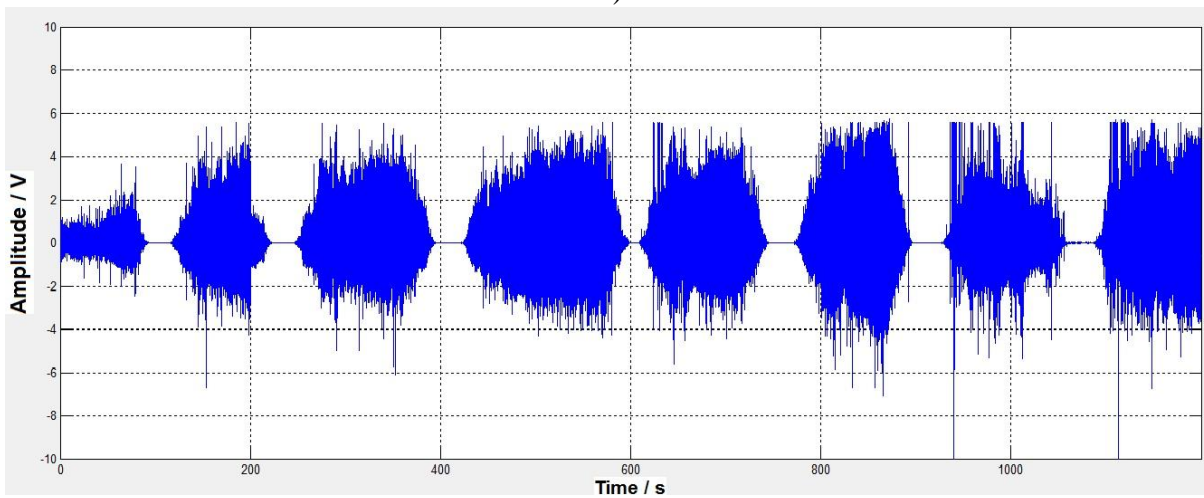
Figure 15: a) Raw vibration data for healthy wheel and b) raw vibration data for defective wheel.

During the EMU trials in Portugal, acceleration measurements were collected for a wheel free of defects and a defective wheel containing shelling on the tread surface. The average train speed during tests was 75 km/h or 20.70 m/sec. The plot in figure 15a shows the raw vibration signal for the healthy wheel and 15b for the wheel in the deteriorated condition. Although the raw vibration plots generally differ in each wheel condition, it is not sufficient to arrive in a safe conclusion since the vibration data will differ from wheel to wheel regardless of their actual condition. It is crucial to be able to identify from the vibration measurements the origin of the fault. A flat or spalling should give different pattern from a bearing defect. Approaches based on peak to peak levels alone should be considered more dependable on the measurement conditions as load, speed, wheel profile quality and rail track quality.

Thus it is impossible to assess the severity of the defects present on the damaged wheel based on the raw data alone. For this reason further analysis was carried out using moving RMS, spectral analysis (FFT) of the raw signal and spectral analysis of the demodulated signal (FFT of the envelope of the signal).

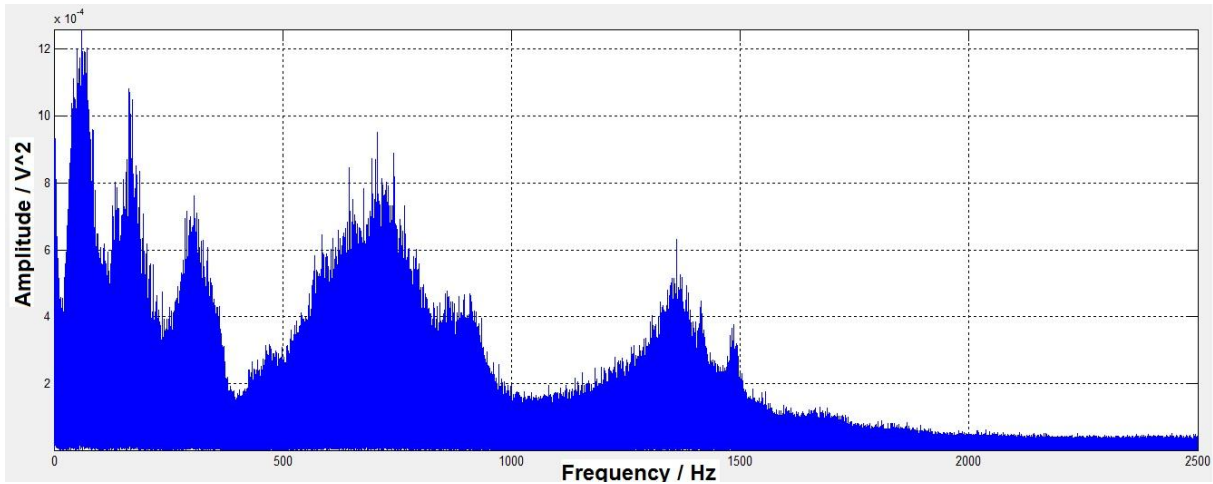
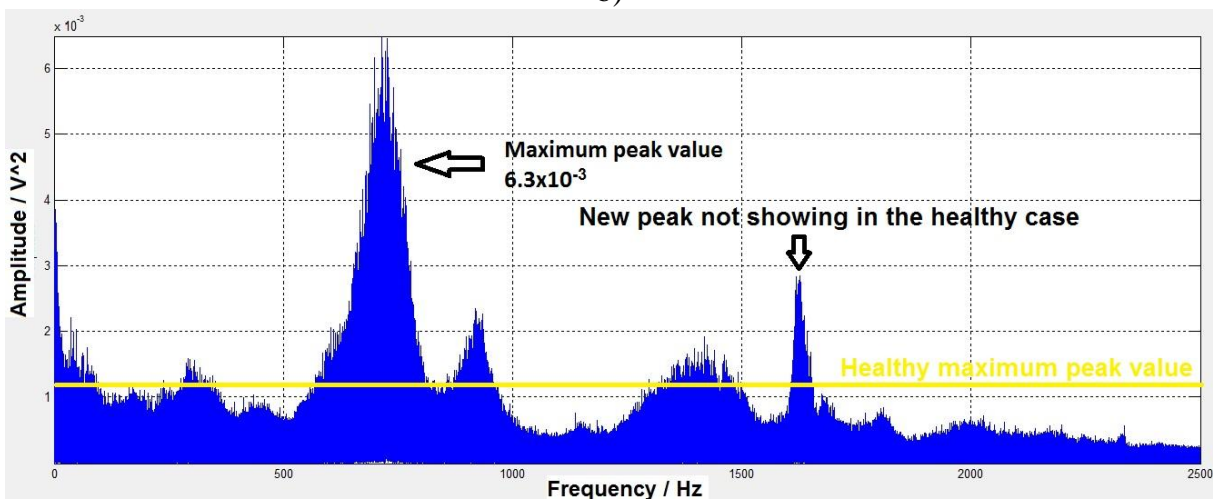
Figure 16: a) Vibration power spectrum for the healthy wheel and b) vibration power spectrum for the defective wheel.

Figure 16 shows the power spectra for the healthy (16a) and defective wheel (16b). A new significant peak is evident at approximately 1600 Hz in the power spectrum for the defective wheel which is not present in the power spectrum of the healthy bearing. Furthermore, the peaks at approximately 700 Hz and 900 Hz are much stronger in the power spectrum of the defective bearing in comparison to the one for the healthy bearing indicating a potential problem as expected which indeed indicates the presence of a problem but does not provide an indication of the fault's origin.

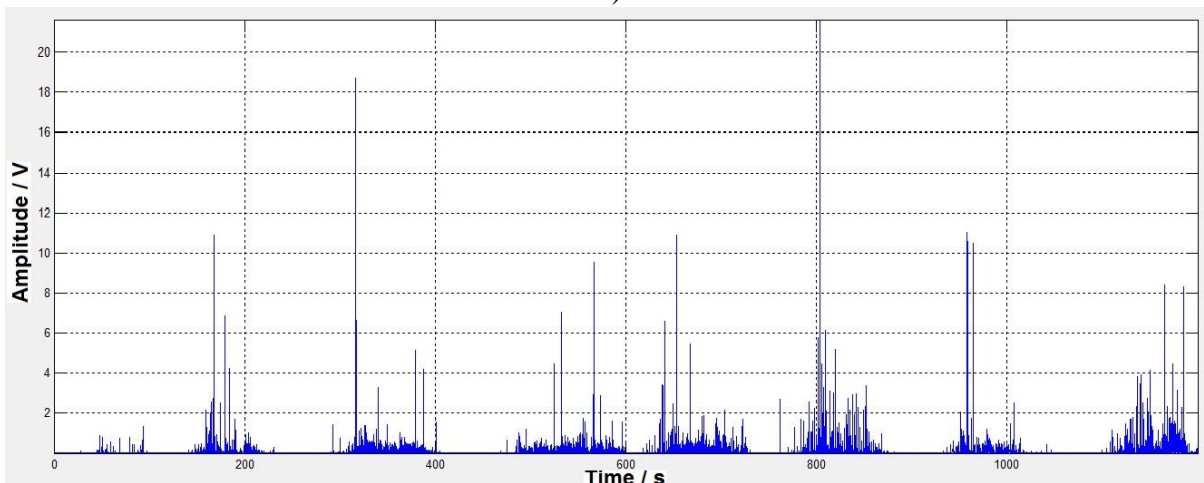
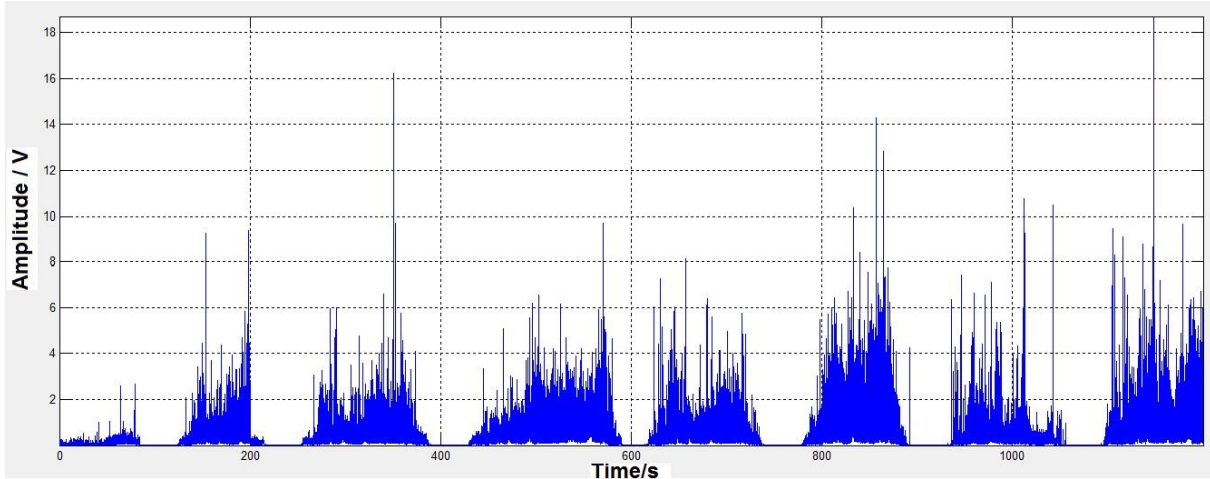
Figure 17: a) Moving RMS for healthy wheel and b) moving RMS for defective wheel.

The plots in figure 17 show the moving RMS of the raw vibration signal for the healthy (17a) and defective wheel (17b). Although in the case of the defective wheel the moving RMS is far more noisier due to the vibrations caused by the defective tread area of the damaged wheel than the moving RMS of the healthy wheel it is not possible to ascertain safely the defect and its nature. More in depth analysis is required.

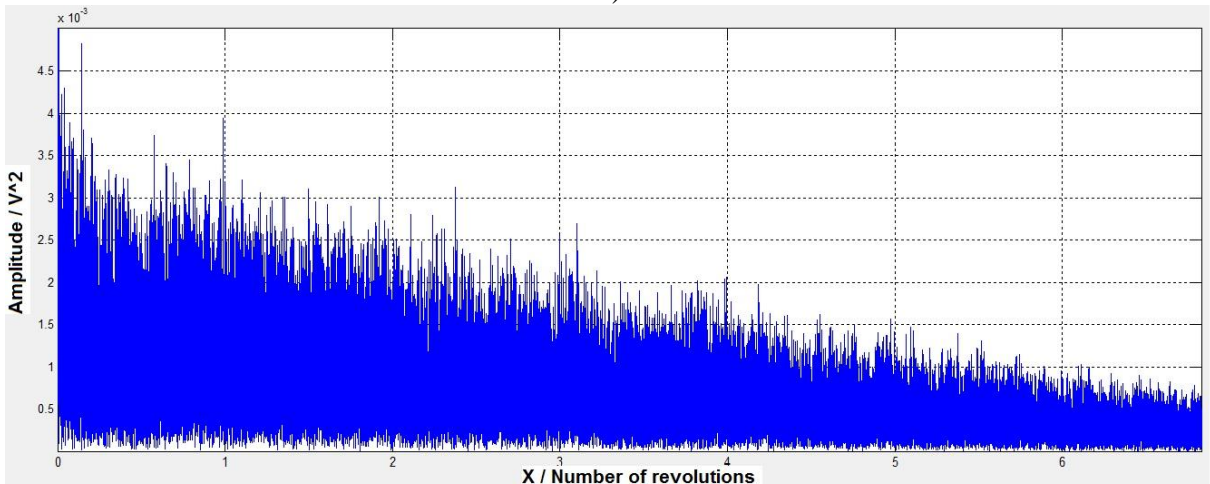
Figure 18: a) Demodulated power spectrum for the healthy wheel showing no harmonics and b) demodulated power spectrum for the defective wheel showing clear evidence of multiple harmonics up to 4X. Note also the significant difference in the amplitude of the two signals.

Since shelling is expected to impact on the rail during each wheel revolutions or 1X the low frequency power spectrum and harmonics should be employed in order to identify this specific fault. The plots in figure 18 show the low frequency demodulated power spectrum of the acceleration signal up to 7 wheel revolutions (7X) for both the healthy (18a) and defective (18b) wheels. The demodulated power spectrum signal in figure 18b shows clearly the 1X peak and associated harmonics up to 4X for the defective wheel indicating the presence of a fault on the tread. In the plot of figure 18a these harmonics are not present for the healthy wheel. Thus, this analysis clearly identifies wheel faults and a clear separation between healthy and deteriorated condition has been achieved. It is possible to relate the result directly to any wheel problems present thanks to the multiple harmonics showing up if the train speed is taken into account.
