Van Loon, Anne; Te Brake, Bram; Van Huijgevoort, Marjolein; Dijksma, Roel

Van Loon, A, Te Brake, B, Van Huijgevoort, M & Dijksma, R 2016, 'Hydrological classification, a practical tool for mangrove restoration', PLoS ONE, vol. 11, no. 3, e0150302. <https://doi.org/10.1371/journal.pone.0150302>

# Hydrological Classification, a Practical Tool for Mangrove Restoration

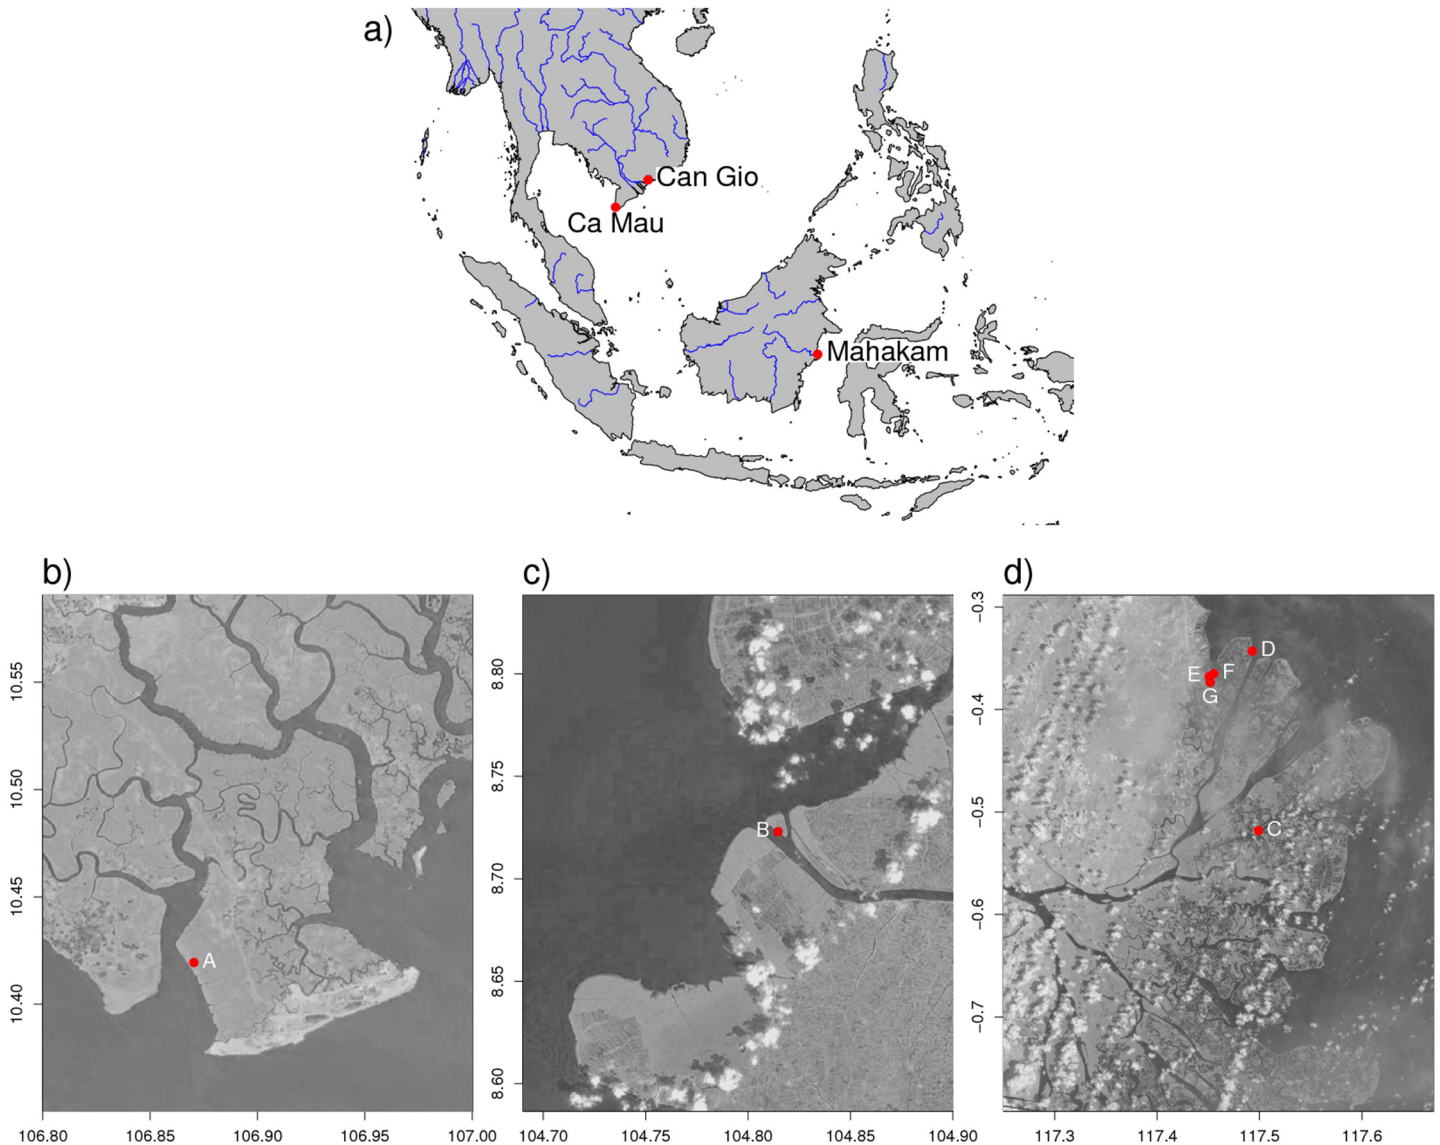
**Fig 1. Location of study regions and measurement locations.** a) study regions in south-east Asia (made with Natural Earth), b) measurement locations in Can Gio—Vietnam, c) Ca Mau—Vietnam, and d) Mahakam—Indonesia. Landsat data available from the U.S. Geological Survey.

The fieldwork for this study was done in three mangrove regions in south-east Asia: Can Gio and Ca Mau in Vietnam and Mahakam in Indonesia (Fig 1a). In this section, we give a description of the geography, climate, tidal regime, and vegetation of each of the three regions and indicate the measurement locations that were chosen within these regions.

(May–October) and a dry season (November–April). Can Gio is a low-lying delta area; almost the entire area has an elevation between 0 and 2 m above sea level [48]. It consists of a complex network of rivers, channels, creeks and gullies (Fig 1b) and topography is dynamic. The soil of Can Gio is composed of river clay and silt deposited by the Saigon-Dong Nai river [49] and marine sands from the South China Sea [50]. The rivers in Can Gio show a pronounced variation in discharge between the wet and dry season, despite the regulating effect of reservoirs upstream.

Mui Ca Mau National Park is located in the Ca Mau peninsula, the southernmost part of Vietnam (Fig 1a). There are no major rivers discharging into the peninsula, only a channel intersecting the peninsula connecting the South China Sea to the Gulf of Thailand (Fig 1c). This means that the geomorphology of Ca Mau is dominated by wave action instead of fluvial processes. The tidal regime is a combination of a diurnal regime with 0.5–1.0 m amplitude in the Gulf of Thailand and an irregular semi-diurnal regime with 2.5–3.8 m amplitude in the South China Sea. The combination of both tidal regimes and the complex creek system in Ca Mau peninsula causes water interactions that are not fully understood [53]. The climate of Ca Mau is similar to that of Can Gio, with slightly higher temperature and precipitation (Table 3). Soils in the Ca Mau peninsula are highly determined by sediments from the Mekong river, transported by the South China Sea, and forming sandy beach ridges on the coast and deposition of finer sediment more inland. The entire peninsula is a low-lying area, within a 2 m range. Soil texture is clayey or loamy for 95% of the soils [53].

The Mahakam Delta is located on the east coast of Kalimantan, Indonesia (Fig 1a). It is a fan-shaped mixed tide—fluvial dominated delta system, formed by deposition of sediments from the Mahakam river upstream catchment [56, 57]. The Mahakam branches out before entering the Makassar strait (Fig 1d). The tidal regime of the Makassar strait at the Mahakam coast is irregular semi-diurnal [58] with an amplitude of 0.5–1.7 m [59]. The area has a tropical rain-forest climate [56] with a constant temperature of 25.5 degrees Celsius and a precipitation of

Measurements were taken at several locations in the delta focusing on natural (C and D) and hydrologically disturbed (E, F and G) conditions (Fig 1d). Location C is on an elongated island in the river about 9 km inland from the coast (Fig 3a). The vegetation has a natural mix of different species (Table 4). Location D is in the northern part of the delta at the coast (Fig 3b). Measurements were done in a transect of 100 m perpendicular to the coast (Fig 3c). Vegetation shows a distribution from *Sonneratia alba* J.Smith at the coast to *Acrostichum Aureum* L. inland (Table 4).

Locations E, F and G were chosen as examples of restoration sites with disturbed hydrological conditions (Fig 1d and Table 4). Location E is a shrimp pond abandoned since 2008 and with dikes around the pond still present (Fig 4a and 4b). There are some natural *Nypa Fruticans* Wurmb and planted coconut palms around the edges, but no vegetation inside the pond. Site F is a shrimp pond in the process of restoration with 10 years of new growth in and around

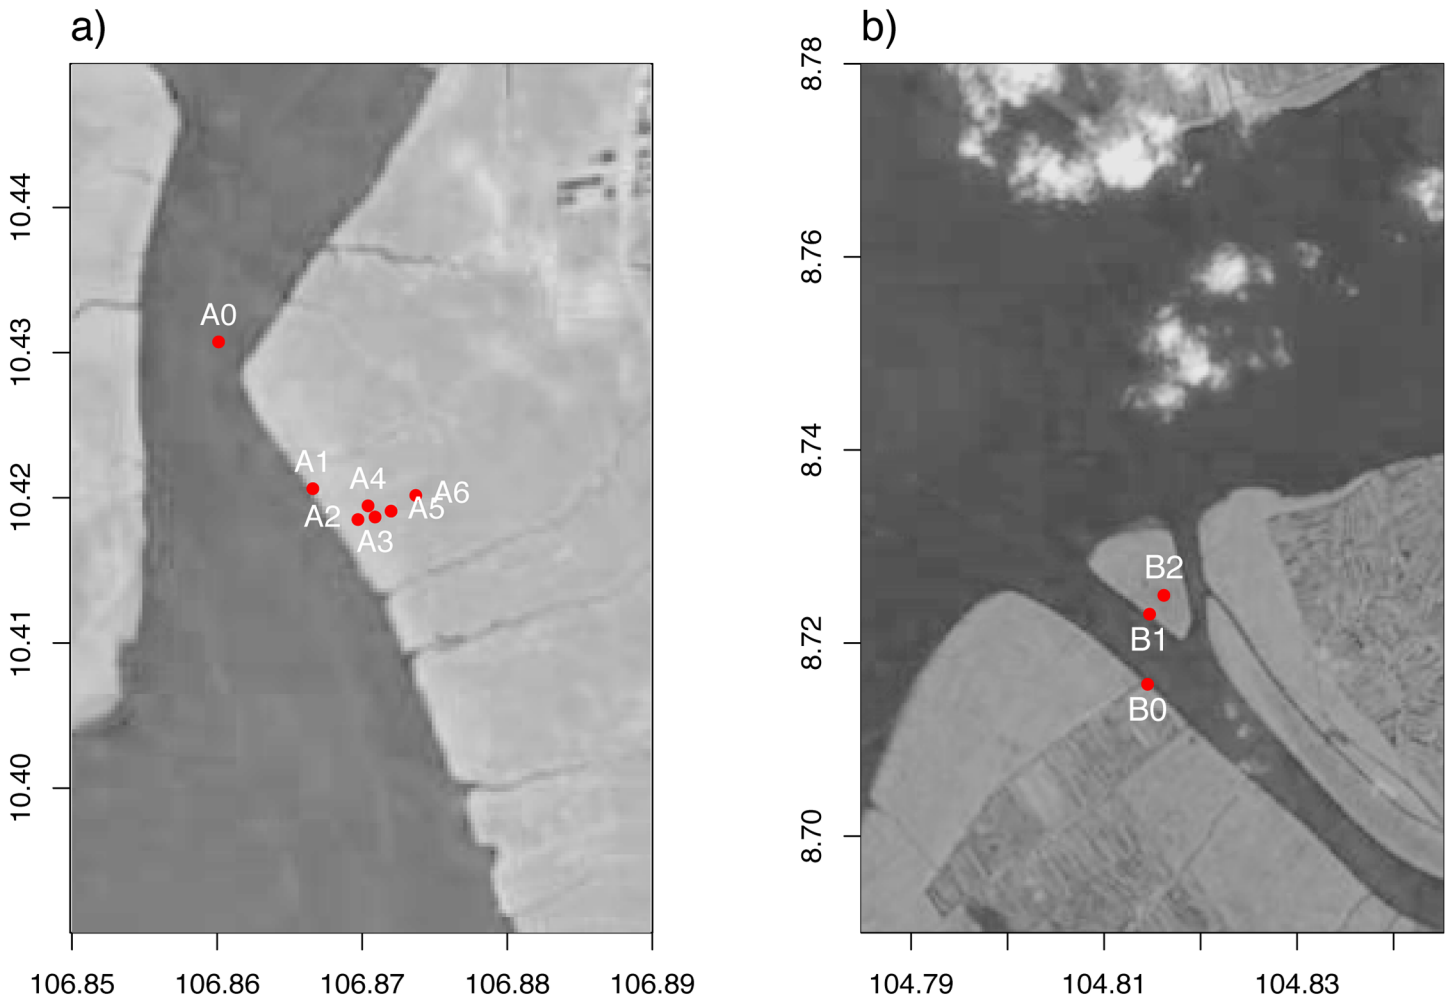
**Fig 2. Location of measurement sites in Vietnam.** a) Can Gio, b) Ca Mau. Measurement sites in open water (A0, B0) and in the mangrove forest (see Table 4). Landsat data available from the U.S. Geological Survey.

Measurement location A is a transect perpendicular to the Dong Tranh river, with a total length of 700 m (Fig 2a). Vegetation shows a clear distribution from *Avicennia alba* Blume close to the river to *Rhizophora apiculata* Blume further inland, with zones with higher biodiversity in between (Table 4).

Measurement location B is on the Con Ngoi island in the Cua Lon channel (Figs 1c and 2a). This island is located in the strict protection zone of the Mui Ca Mau National Park. The mangrove forest on this recently formed island is completely naturally generated (Table 3) and consists mainly of *Avicennia sp.* and *Rhizophora sp.* combined with some other species (Table 4).

Water levels were measured in open water and in the mangrove forest ([Figs 2 and 3](#)). The open water sites were located in the river system close to the forest sites. Measurement sites in the forest were set up in a transect in locations with a clear mangrove zonation (location A and D) and had a more scattered distribution elsewhere. The objective for the selection of sites was to obtain a range of characteristics (e.g. elevation, vegetation, history of human disturbance). For the natural locations (A–D), diversity in vegetation and elevation was desired. For the disturbed locations (E–G), we additionally took into account the history of the location (restoration or not, time since restoration, etc.).

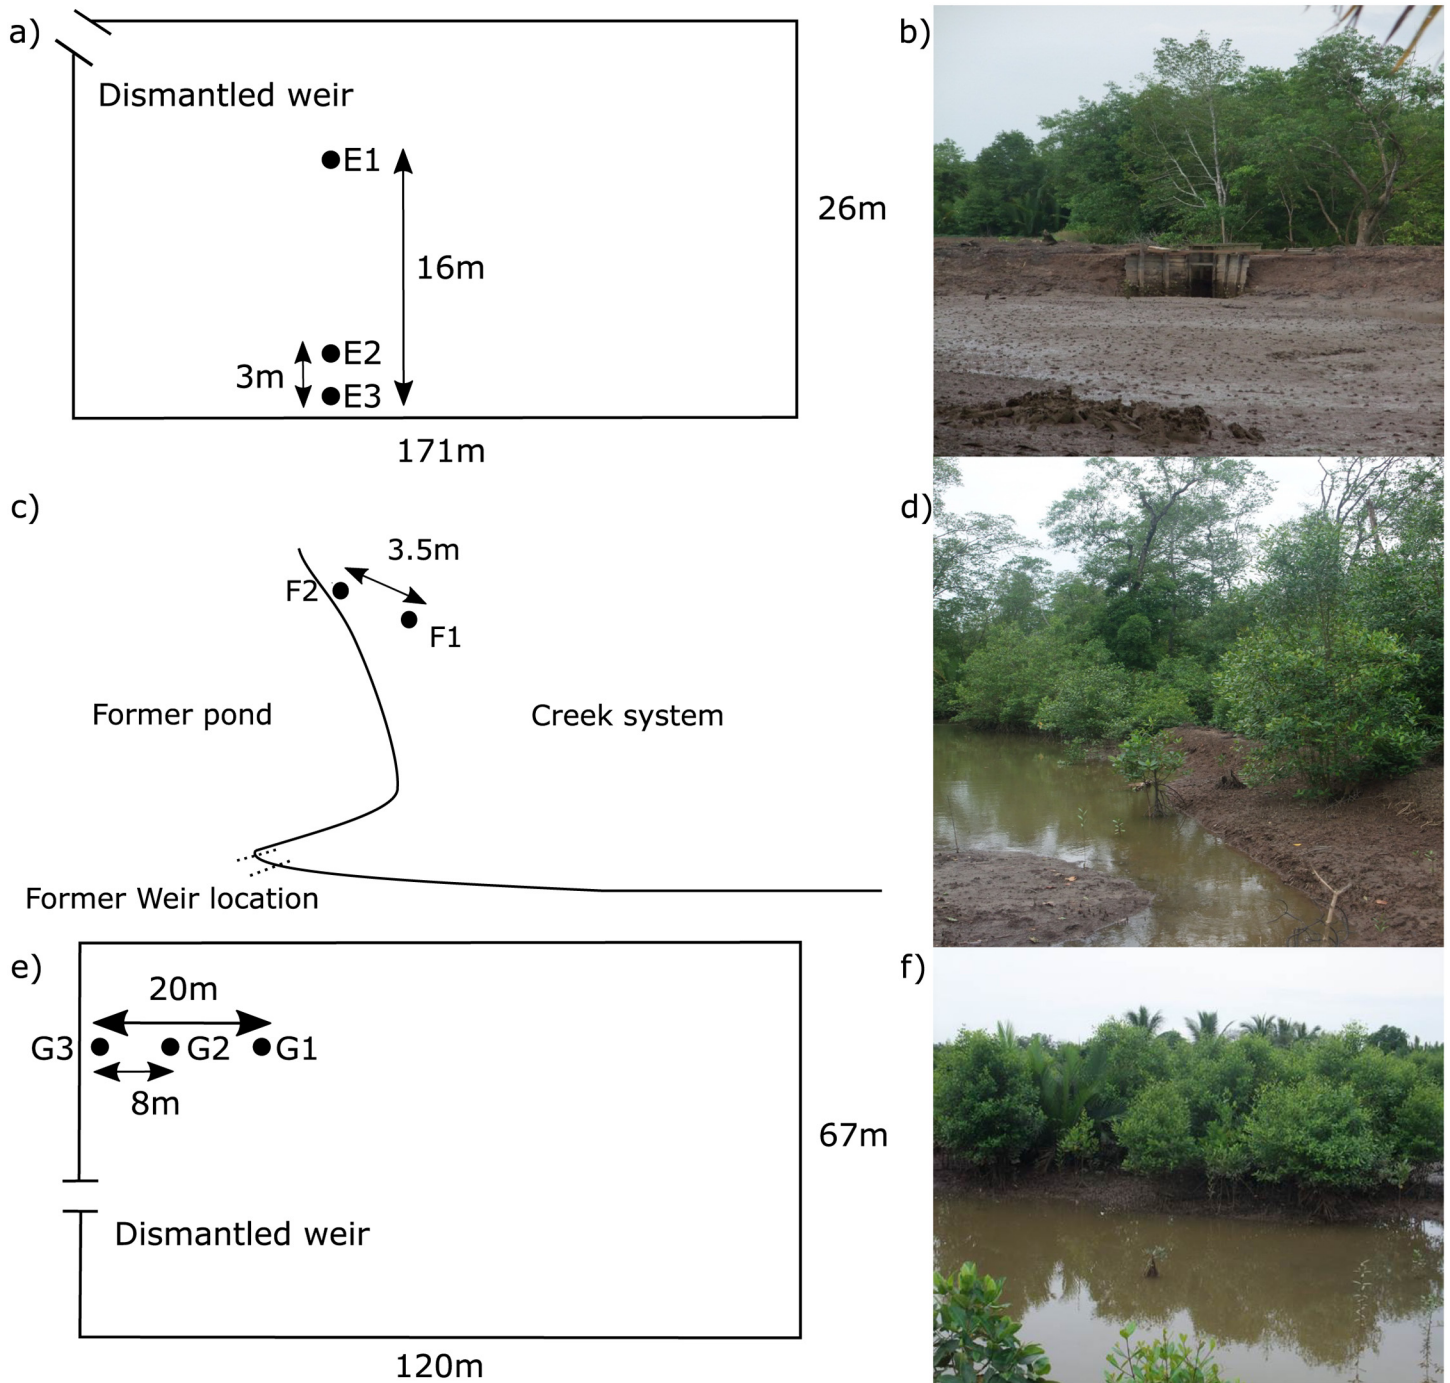
**Fig 4. Measurement sites in location E–G in Mahakam—Indonesia.** a) measurement setup location E, b) photo location E, c) measurement setup location F, d) photo location F, e) measurement setup location G, f) photo location G.

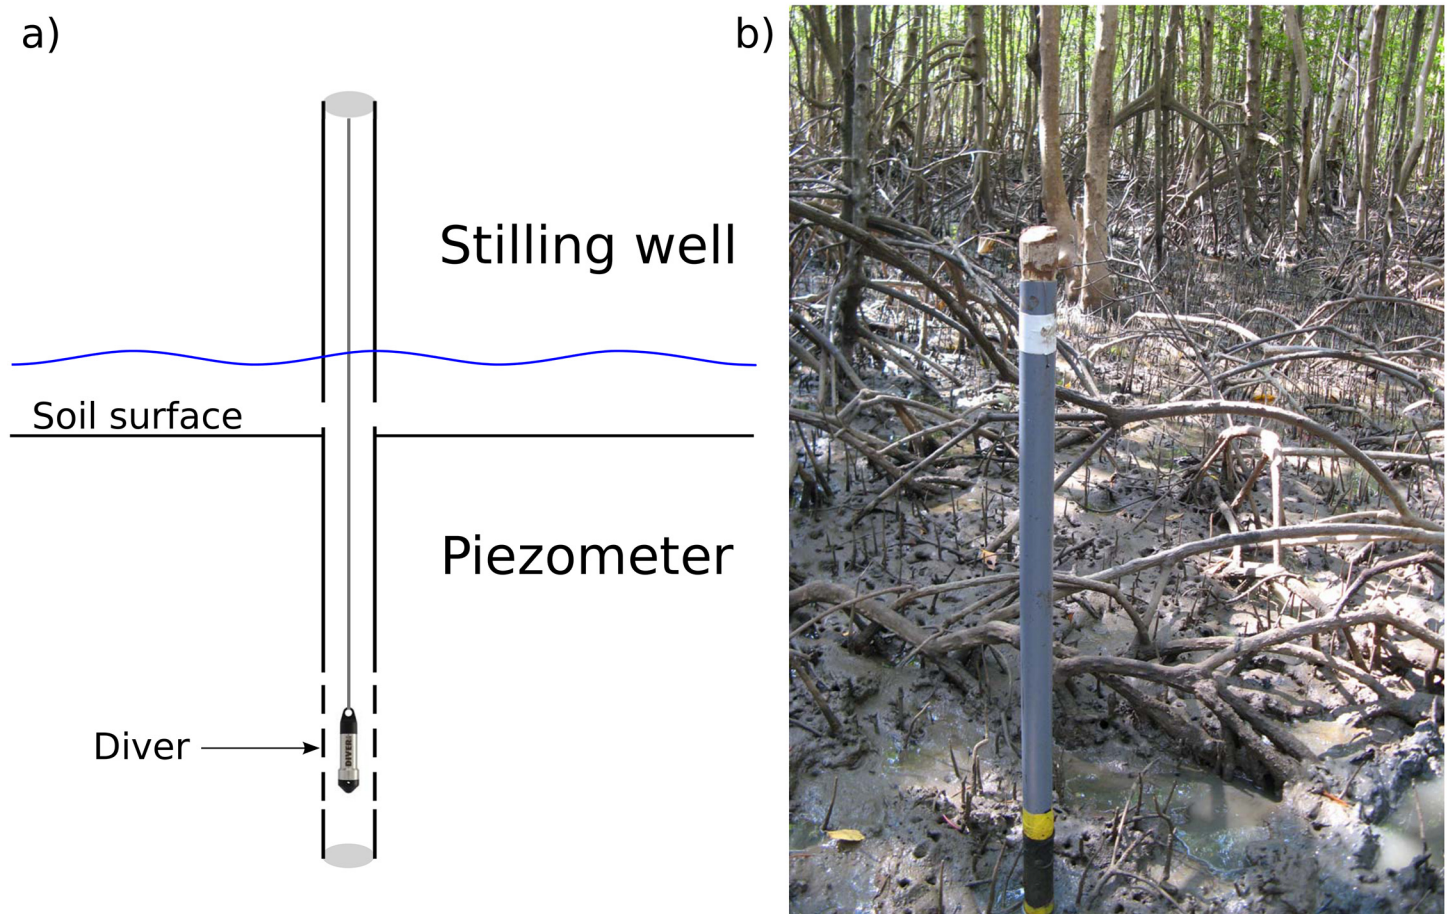
**Fig 5. Water level measurement set up.** a) diver installed in tube that serves as stilling well above soil surface and as piezometer below soil surface, b) installation in the field.

Since the observed water levels represent water both on and under the surface, we had to estimate surface level for each site. We used a method to derive surface level directly from the water level data. At ebb, measured water levels drop following the tide until surface level is reached, after which reduced subsurface flow velocities result in a lower falling rate of water

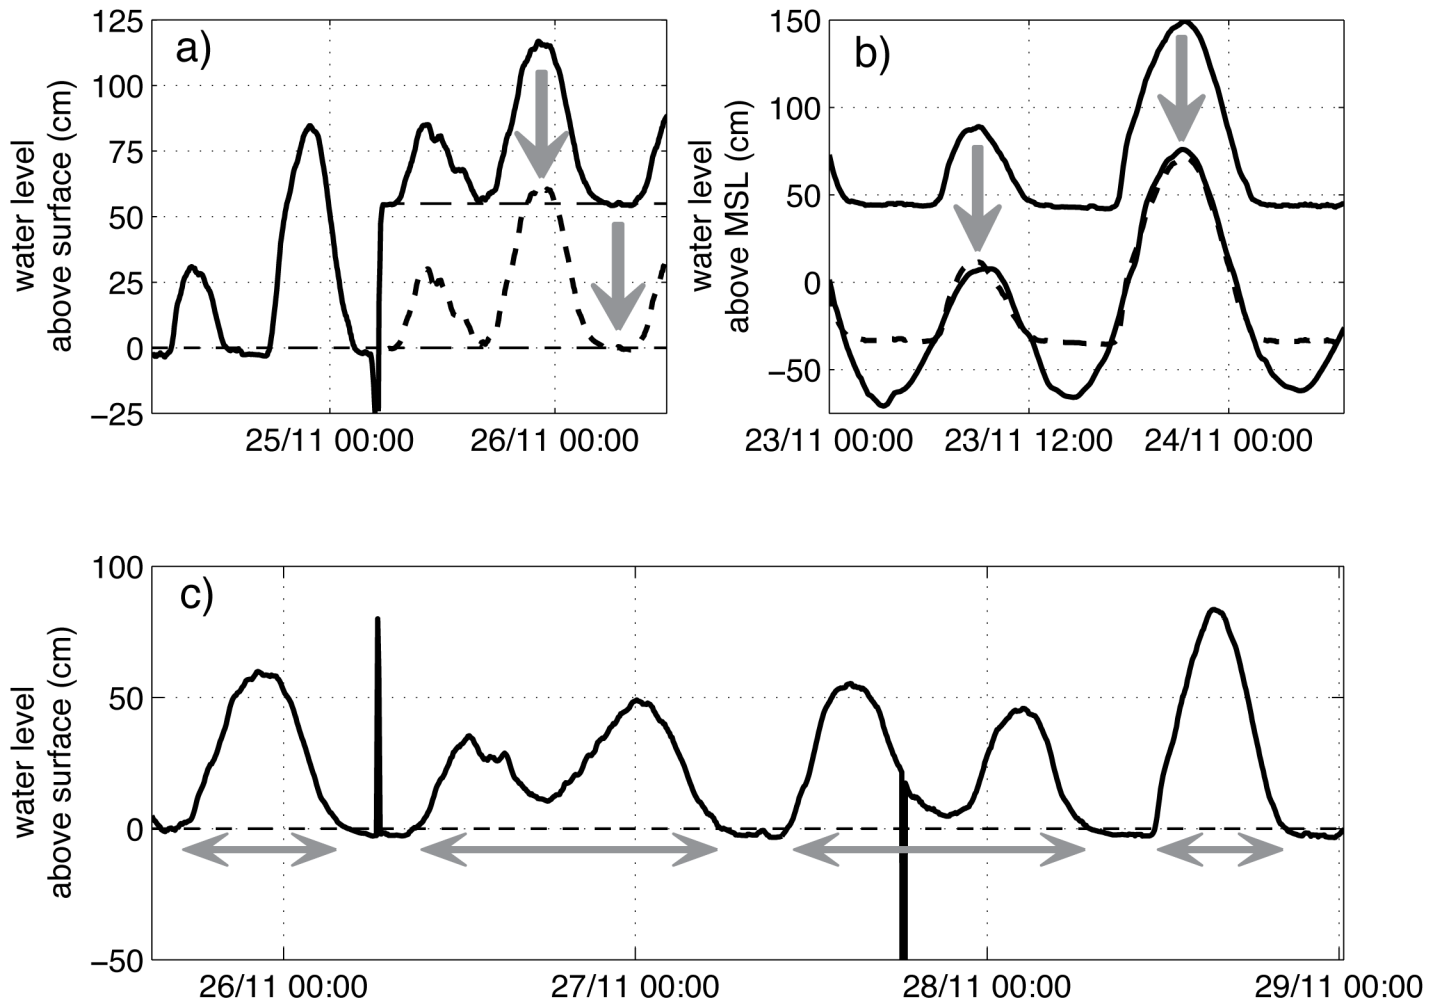
**Fig 6. Example of time series of water levels to show the methodology used for time series analysis.** a) estimation of surface level from nod point and correction of changes in reference level, b) estimation of elevation with respect to mean sea level, c) correction of measurement errors and calculation of duration of inundation. The horizontal dashed lines represent estimated soil surface level.

The nod point was not constant over the entire period of observation because of changes in the height of the diver after replacing the diver when reading the data, and changes in surface level around the piezometer due to soil processes and animal and human disturbance (Fig 6a—right side). Because of these variations in time, the method of determining surface level from water level observations was found to be much more accurate than measuring the length of the cable of the diver and the height of the top of the tube above surface level, even when this was done repeatedly [40].

By counting the measurement intervals with water levels above soil surface level, inundation durations and number of inundations were obtained. The minimum duration of inundation and dry-fall was set at 15 minutes to remove measurement errors, outliers, and small fluctuations in water levels (Fig 6c). [65] and [30] found that duration of inundation is most important in determining mangrove species distribution. We applied two variables related to duration of inundation (i.e. average duration per inundation and per day) that are relevant in irregular tidal regimes [39]. Based on these two variables, sites were then classified into hydrological classes using Table 2.

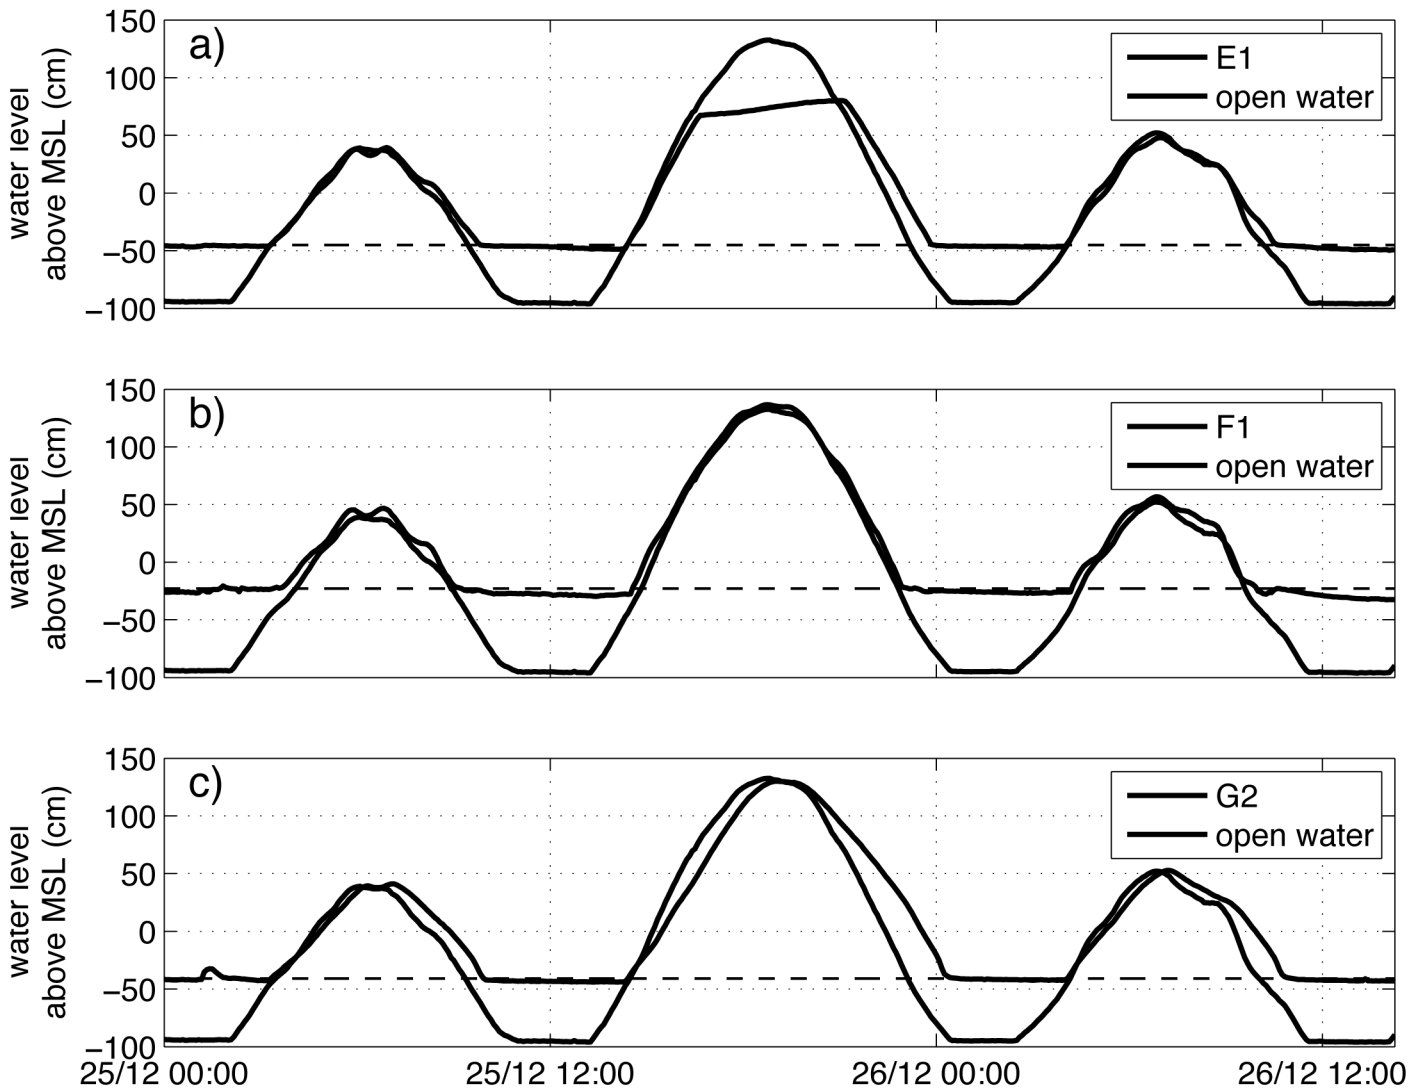
Fig 7. Time series of water levels in three hydrologically disturbed sites in Mahakam (E1, F1, G2) and their respective open water site.

To evaluate the reasons for certain hydrological and vegetation conditions and possible mismatches between them in the restoration sites, we studied water level time series of some selected sites (E1, F1 and G2) in more detail and compared them with open water levels ([Fig 7](#)).

At site E1, we see a clear capping at the higher high tides; water levels never reach above 80 cm, which is up to 50 cm lower than the tidal maximum for the measurement period. The reason for this capping is unclear, but might be related to obstruction of dikes. It does, however, not influence inundation duration. The obstruction of dikes also causes tailing (i.e. higher water levels than expected during ebb), which does result in longer inundations, on average 2.6% longer in *min per day* and 10% longer in *min per inundation* compared to a situation with free outflow ([Table 6](#)). This effect of tailing is reflected in the resulting class. Site E1 has a lower class in reality (i.e. wetter conditions) than expected from the open water levels ([Table 6](#)).

At site G2, tailing is obvious ([Fig 7](#)). During ebb, outflow is restricted, resulting in a longer duration of inundation. Inflow is also restricted at this site, but less than outflow. Without these restrictions, site G2 would have had shorter inundations, on average 23% shorter in *min per day* and 8.5% shorter in *min per inundation*, and a higher class, so drier conditions ([Table 6](#)).
