Onboard detection of railway axle bearing defects using envelope analysis of high frequency acoustic emission signals

Arash Amini*, Mani Entezami, Mayorkinos Papaalias

Birmingham Centre for Railway Research and Education, The University of Birmingham, Birmingham, B15 2TT, UK

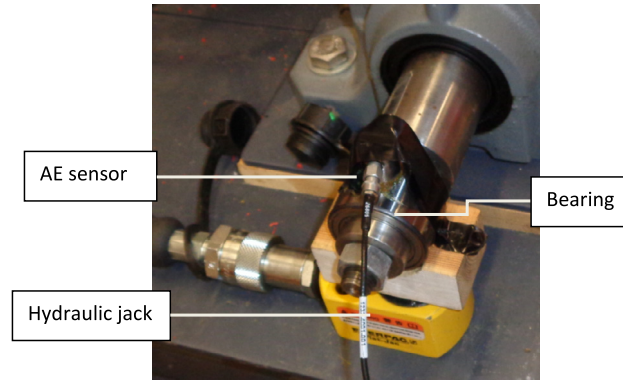
Fig. 2. Photograph of the customised test rig built at the University of Birmingham where the experiments on healthy and faulty bearings were performed.

Laboratory tests were carried out on healthy and defective bearings using a customised test rig with capable of rotating sample bearing from 100 up to 1000 Revolutions Per Minute (RPM). In order to minimise the effect of the predominantly low frequency mechanical background rolling and engine noise and maximise the detection of the high frequency signals arising from axle bearing fault suitable resonant AE sensors have been employed. A piezoelectric type R50 α resonant AE sensor procured from Physical Acoustics Corporation (PAC) was mounted on top of the bearing case using a magnetic hold-down [13]. The AE sensor was coupled on the bearing case using Vaseline. The AE signals were amplified using a pre-amplifier and amplifier also from PAC by 43 dB. The AE signals were digitised using an Agilent 2531A data acquisition card (DAQ) with 500 kS/s sampling rate. Data acquisition was carried out for 5 s (2×10^6 points) during laboratory testing and 12 s (6×10^6 points) during the Long Marston tests. Customised software written in MATLAB by the authors was used to log and analyse the captured data. Fig. 2 shows the test rig used for this work.

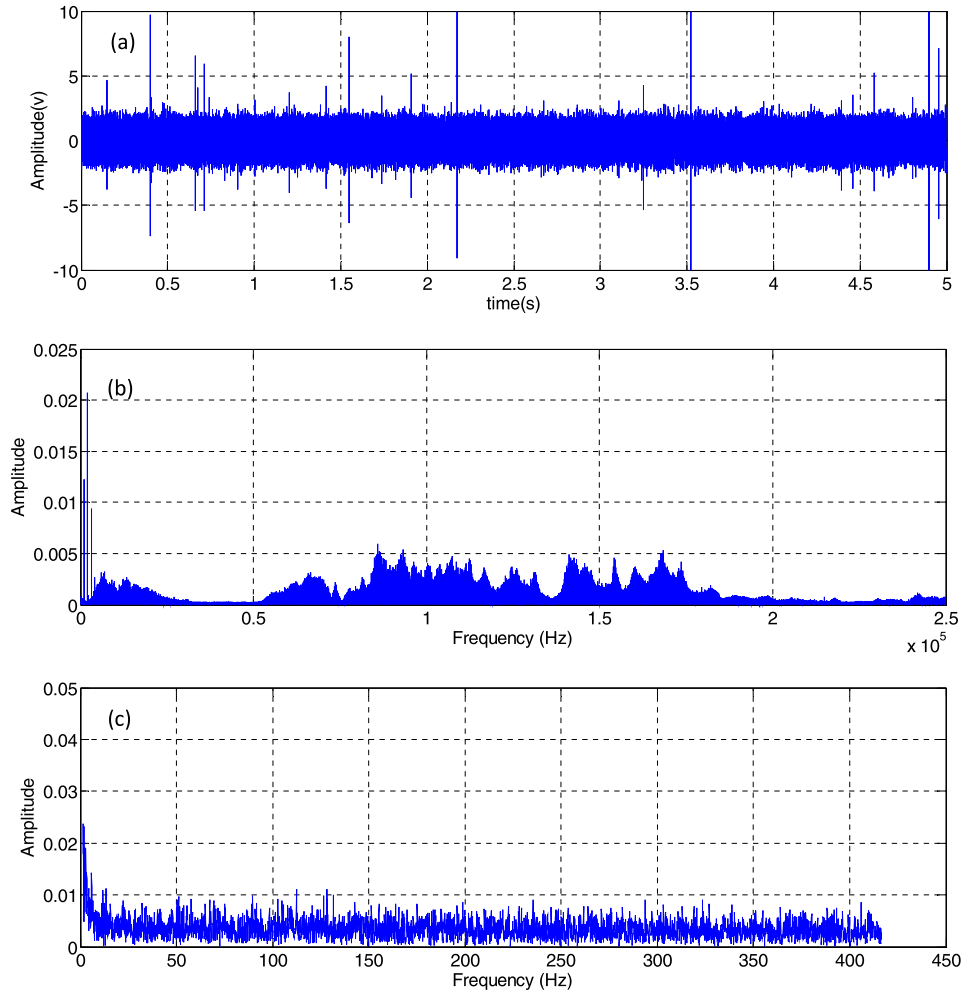
Fig. 3. Healthy bearing rig test: Raw data (a) – Power spectral analysis (b) – Envelope analysis (c).

Fig. 3 shows the AE signal envelope and power spectral analysis on a healthy bearing from the test rig. It is evident that no indication appears in the envelope analysis approach confirming that there is no defect present. If the severity of the defect is high (in stage 3 of the bearing failure), the fundamental frequency of the defect appears in lower frequency which can be simply detected by FFT analysis. However if the severity level is low, the fundamental frequency of the defect is only visible in the resonance frequency (demodulated signal) which can be revealed by the envelope analysis.

It should be noted that the optimum bandpass frequency used in the envelope analysis was evaluated based on the resonance frequency of the bearing. An impact test, also called excitation measurement, was used to determine this frequency. A central frequency of 6 kHz with a bandwidth of 2 kHz was applied for the envelope analysis.

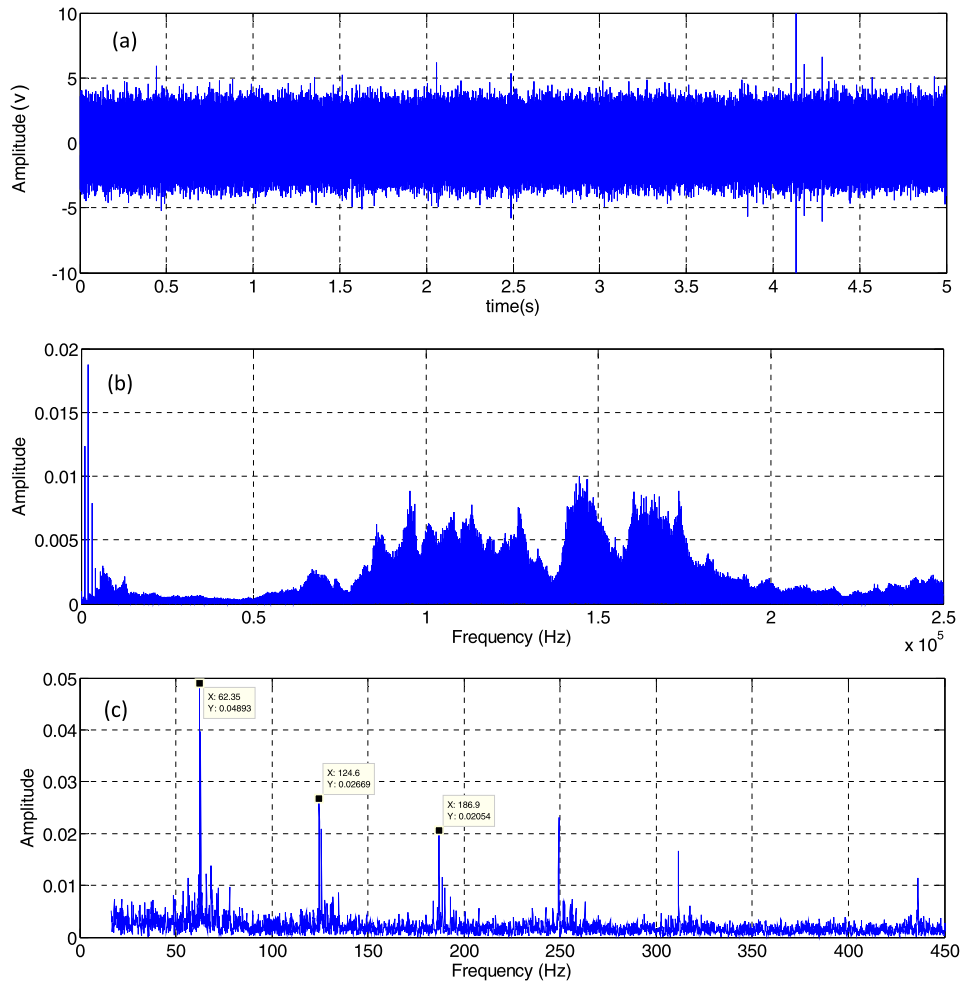
Fig. 4. Defective outer race bearing rig test: Raw data (a) – FFT analysis (b) Envelope analysis (c).

defect are shown in Fig. 4. From the envelope analysis carried out a peak at the characteristic frequency of 62 Hz is evident. The peak seen at the aforementioned characteristic frequency confirms the presence of the roller fault as it is in agreement with the fundamental frequency of the bearing at the rotating speed used during testing. There is a slight offset between the characteristic frequency given by the analysis and the table which is caused by a slight variation in the rotating speed during the test.

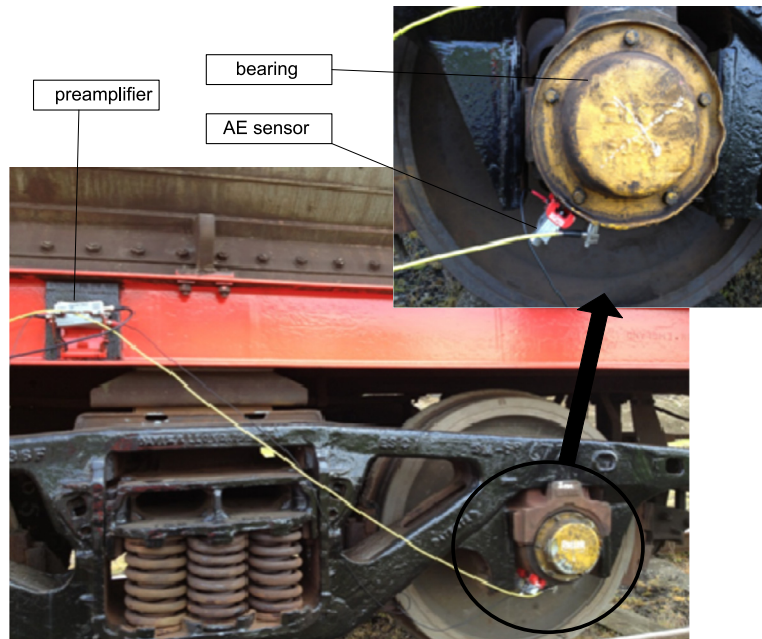
Fig. 5. Onboard mounting of the AE sensors on the bearing with 8 mm roller defect using a magnetic hold down.

Fig. 5 shows the onboard setup on the axle bearing casing of the test wagon employed. AE data were collected using the same R50 α AE sensor as for the laboratory tests. There were a number of artificially induced faults include wheel flat, lubricant contamination, outer race and inner race defects. The defect on the roller and race were in three different sizes of 2,4 and 8 mm. Tests were carried out at a speed of 30 MPH forward and 20 MPH backwards pulling the freight cars over a straight section of welded track for the first and second series and continues track for third and forth series of tests. The length of the track was about 200 metres. The sampling rate for acoustic emission signals was 500 kHz. The AE sensor was attached on the axle bearing casing using magnetic hold-downs. Ultrasonic coupling was achieved using Vaseline. The AE sensor should be installed as close as possible to the bearing, this is to provide a good transmission pathway between the possible damage source and the sensor. It should also be in the maximum load zone where the maximum stresses sustained by the bearing occur. The test wagons were equipped with Timken bearing model 99591-99100.

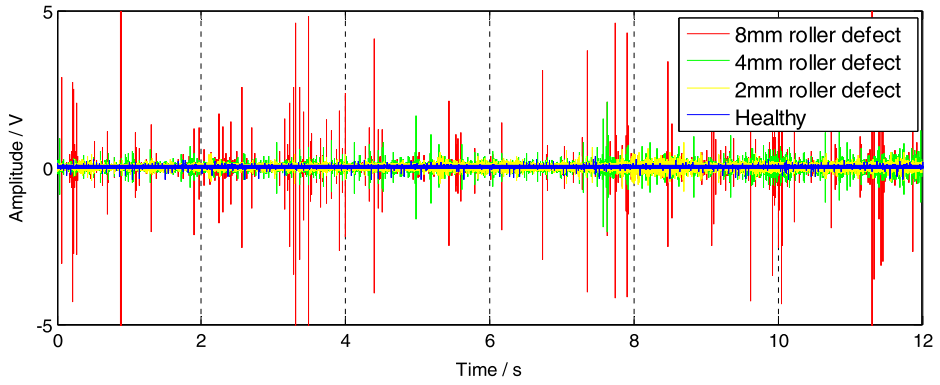
Fig. 6. AE data comparison of the bearings with different defect sizes.

The plots in Fig. 8 show the same analysis on a bearing with only a minor roller defect being present. The lower amplitude in raw data compared to the severely damaged bearing should be taken into account. It is evident that despite using envelope analysis, neither the fundamental frequency nor its harmonics are evident in the signal. This is due to the fact that the signal is affected by other sources of noise (such as wheel–rail interface and brake related noises) which make more difficult the evaluation of the type of the defect. Nonetheless, it is still possible to establish that the axle bearing measured is damaged. This is due to the fact that the defective bearings contain higher AE amplitude in the raw data. Fig. 6 shows the comparison of the bearings with different defect sizes.

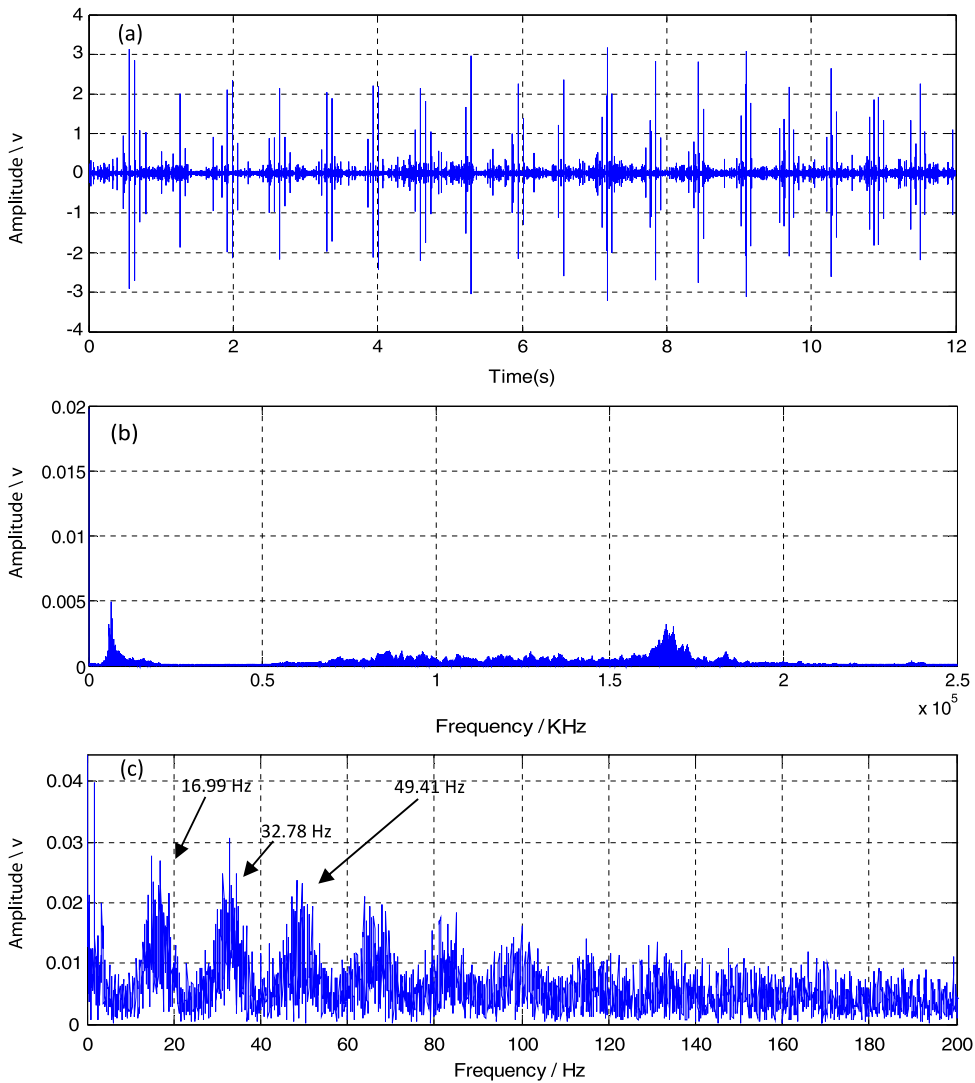
Fig. 7 demonstrates the AE data from onboard measurement carried out on a severely damaged axle bearing. Large peaks in raw data indicate the presence of a defect but not the type of defect. To find the type of the defect, data should be analysed in the frequency domain using envelope analysis. The characteristic frequencies do not appear in conventional FFT, however envelope analysis allow the detection of the fundamental frequency and its subsequent harmonics. The fundamental defect frequency obtained from the envelope analysis is 16.99 Hz followed by its harmonics, which are clearly correspond to the kinematics of the bearing provided by the manufacturer in the relevant technical data sheet. There is a slight offset between

Fig. 7. Onboard AE measurement on bearing with severe roller defect: Raw data (a) – FFT analysis (b) – envelope analysis (c).

the fundamental frequency calculated using manufacturer data sheet and the results due to the speed variation during the field test.

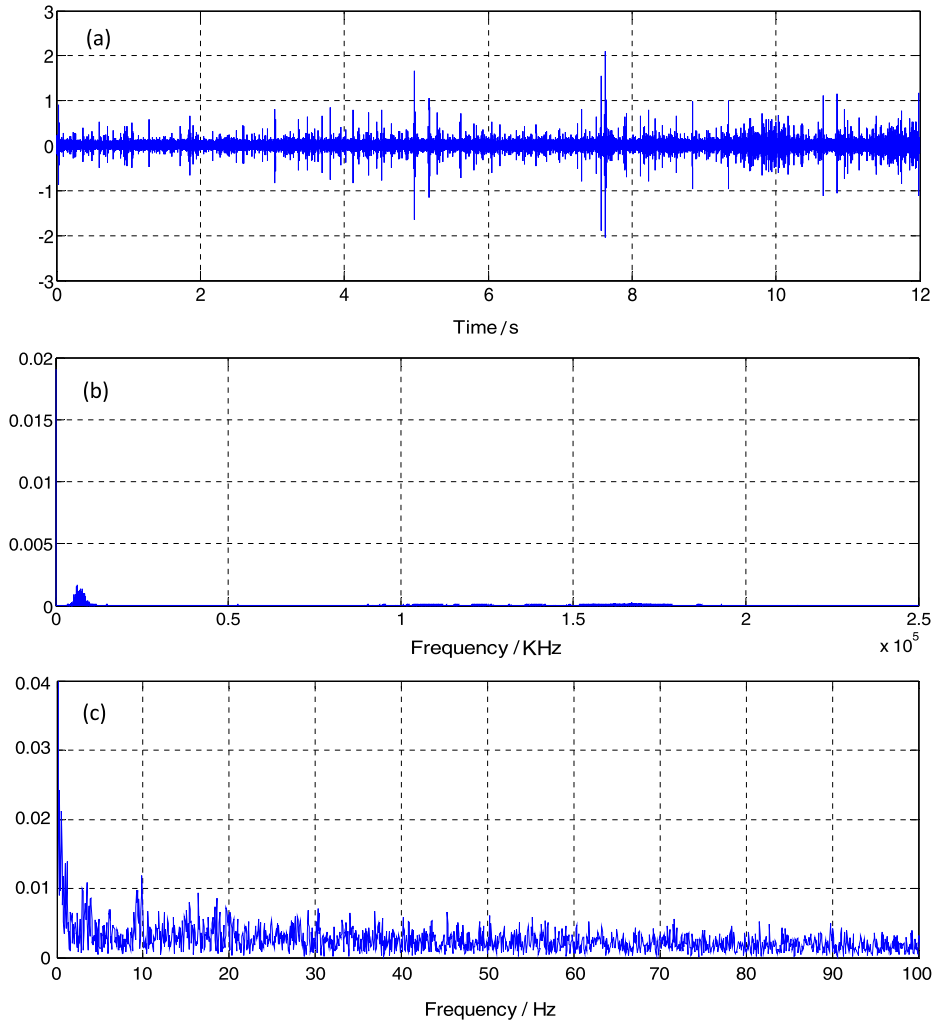
Fig. 8. Onboard AE measurement on bearing with minor defect: Raw data (a) FFT analysis (b) Envelope analysis (c).
