Energy efficiency and preservation of 20th century architecture

The case of the Urbino University Colleges

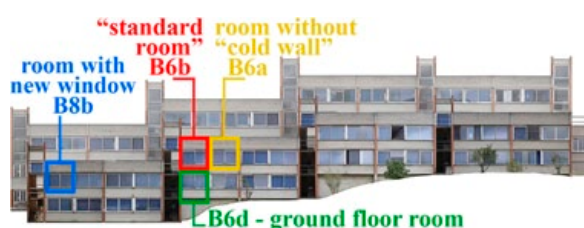
Figure 2. Position of the monitored rooms on the SW façade of the “Aquilone” building.

- in a couple of overlapping rooms located on different floors (rooms B6B and B6D), still retaining their original windows,
- in room B8B, which is situated in a similar position but has a new aluminum frame without thermal break,
- in room B6A, which is representative of the rooms without a cold wall (Figure 2,3).

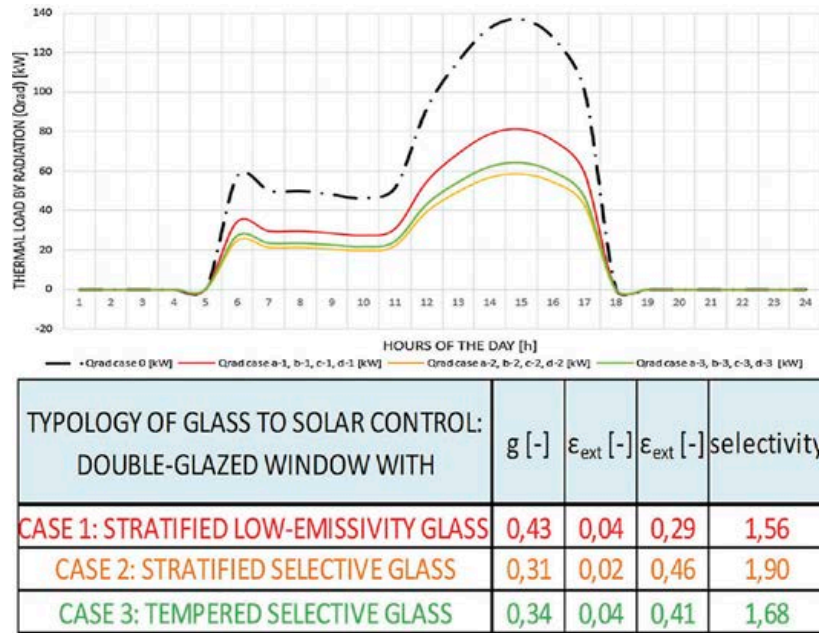
Figure 5. Thermal load by radiation in the windows before/after substituting the glass.

Four scenarios for the insulation of walls and slabs were combined with three scenarios for the improvement of the windows, resulting in twelve scenarios to be compared (Figs. 5 and 6). The energy performance indexes, thermal and primary energy requirements and natural gas consumption were calculated for each scenario, together with the variations of thermal loads in winter and summer conditions. The best choice was made considering the combination of the winter and summer season, and taking into account the data obtained from the energy

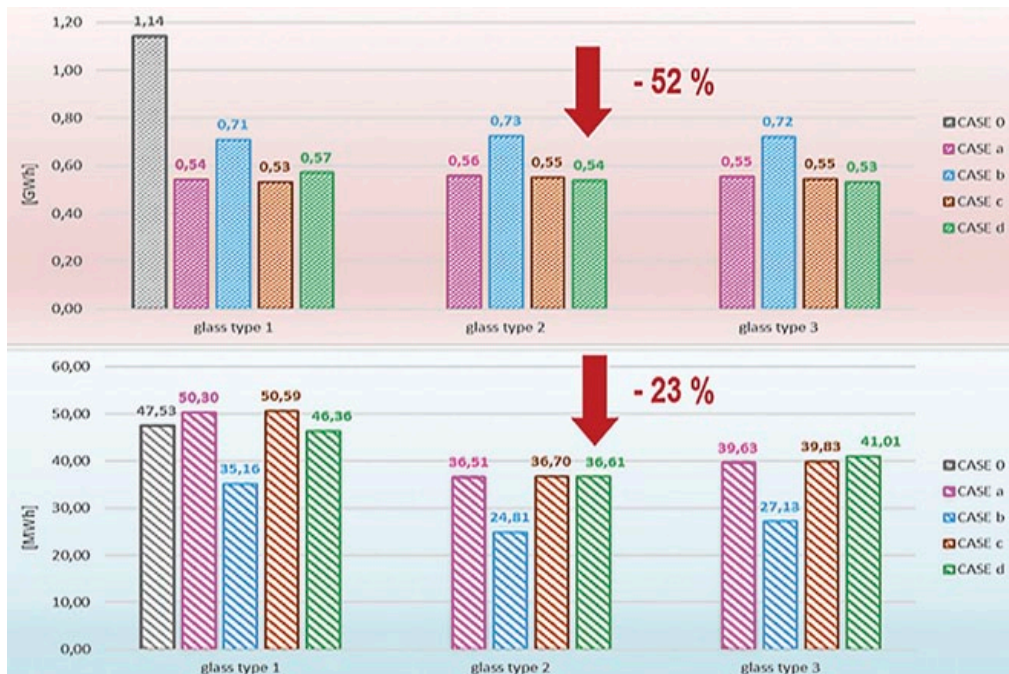
Figure 6. Energy demand for heating (top) and cooling (bottom). Present state vs 12 scenarios of retrofitting.

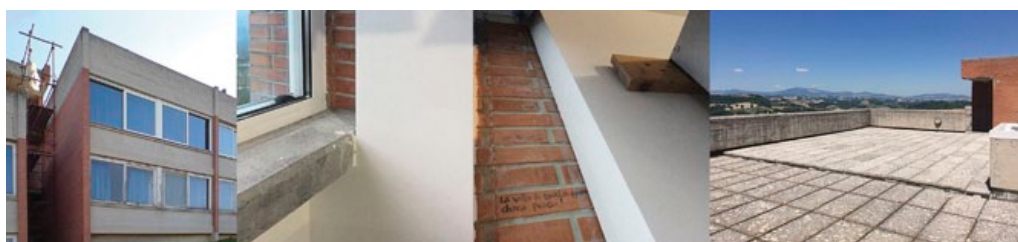
Figure 8. After the pilot site, from left to right: new window, “cold wall” insulation, slab cover.

A pilot site (12/2016–1/2017) implemented the best combination: scenario D (wall and roof slab) + scenario 2 (windows) in rooms B6a and B6b (Figure 7). However, during the pilot site some decisions were reconsidered. The concrete parapet on the top of the building could not be raised up and consequently, for safety reasons, the new slab insulation could not be thicker than 8 cm. An insulating panel was applied to the inner side of the perimeter wall but the panels had to be cut 20 cm before the window, in order to not have them visible from the outside. These limitations clearly resulted into weaknesses in terms of energy efficiency (Figure 8).
