Engineering simulations of a super-complex cultural heritage building: Ica Cathedral in Peru.

Maria Pia Ciocci^{a*}, Satyadhrik Sharma^b, Paulo B. Lourenço^a

Keywords: unreinforced masonry building; *quincha*-adobe system; finite element (FE) modelling; nonlinear analysis; safety assessment.

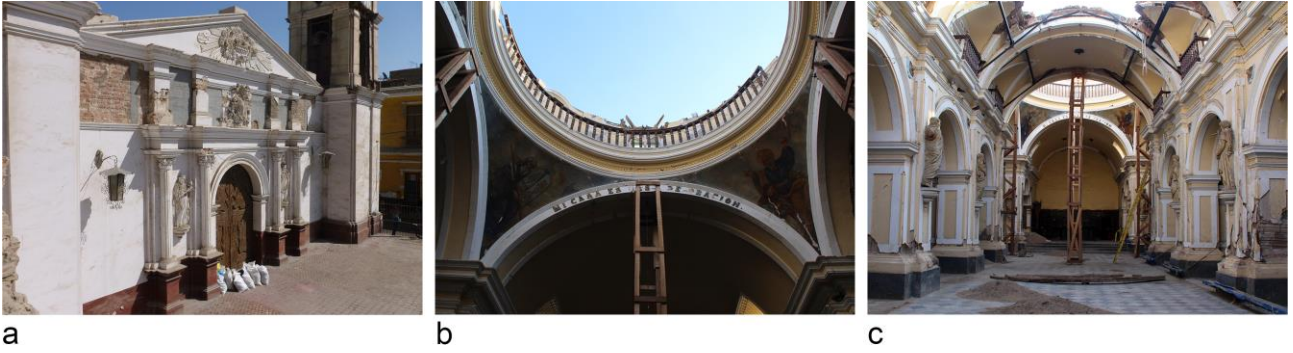
Fig. 1 Ica Cathedral damage after the earthquakes in 2007 and 2009: **a** front façade, **b** main dome at transept, **c** barrel vaults with lunettes and pillars

Since its construction in the 18th century, the cathedral has been subject to a number of seismic events to which its main historical damage can be easily attributed (**Table 1**): the 1813 earthquake (7.5 M_w) provoked the collapse of the front façade, severe damage was caused by the 1868 Arica earthquake (9.0 M_w) and the northern bell tower collapsed after the 1942 earthquake (8.2 M_w). Despite the damage incurred after these earthquakes being heavy, the cathedral was restored to full activity. However, the cathedral is currently in a state of disuse and dilapidation because of recent seismic events. After the Pisco earthquake (8.0 M_w) in 2007 the cathedral suffered partial collapse of the vaults and the main dome, as well as damage of its adobe walls. A later seismic event in 2009 aggravated the already damaged conditions including the total collapse of the main dome (**Fig. 1**) [7, 37, 40].

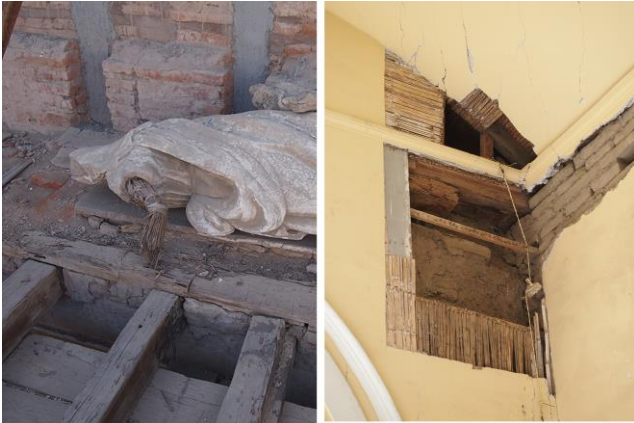
Fig. 3 Connection between the two substructures: **a** front façade/*sotacoro*, **b** piers along the lateral walls/timber beams

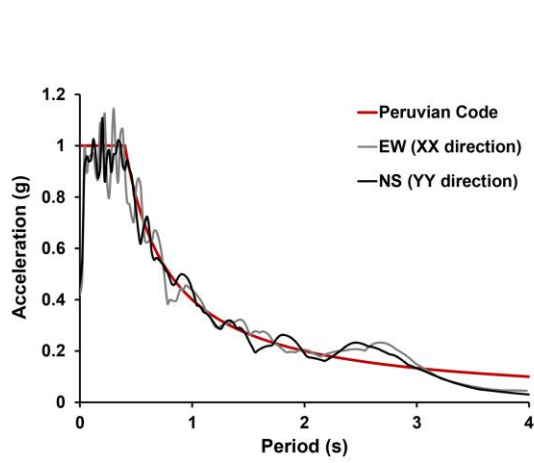
Fig. 18 Ground motions used for the nonlinear dynamic analysis: **a** comparison between the elastic response spectrum of the Peruvian Code and the artificial accelerograms, **b** artificial accelerograms generated for the two directions

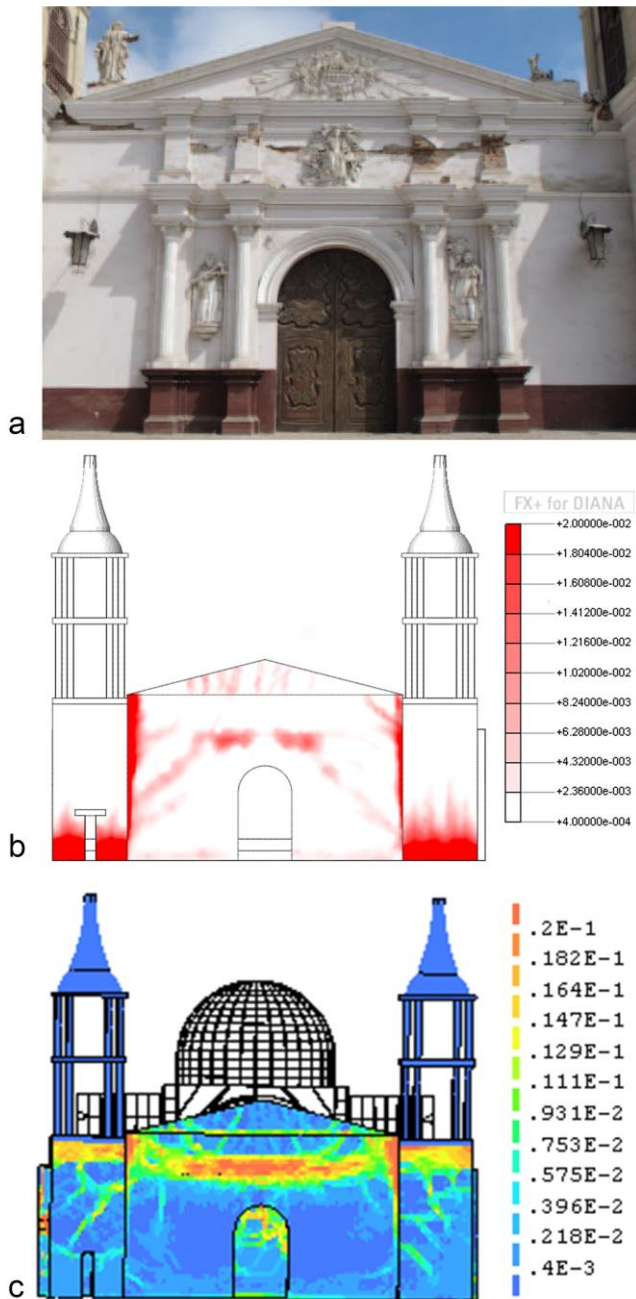
Fig. 20 Correlation of cracks observed in the numerical model and in-situ: **a** detail of damage observed in-situ for the front façade [7], **b** tensile strains from nonlinear static analysis in the XX-direction, **c** tensile strains from nonlinear dynamic analysis

A plot of scan of the maximum principal strains that occurred in the history of the applied loading confirmed this and reflected the severe damage that the model undergone. Critical cracking present in the structure after the earthquakes, such as parallel cracking in the adobe masonry of the northern lateral wall, diagonal cracks in the front façade and separation cracks at the base of the pediment were also reproduced by this analysis confirming the validity of the model. Additionally, damage similar to the failure mechanisms predicted by the pushover analysis was observed in the principal directions in which excitation was applied. It should be mentioned that the nonlinear dynamic analysis also reproduced cracks existing currently in the structure which were not obtained from pushover analyses, where the lateral load was applied monotonically, increased up until the failure and in only one direction (**Fig. 20, Fig. 21**).
