**Structural assessment and seismic vulnerability of earthen historic structures.  
Application of sophisticated numerical and simple analytical models.**

**Short Title:** Seismic vulnerability of earthen historic structures

The current study discusses the structural performance and seismic assessment of the Church of Santiago Apóstol de Kuño Tambo, in Acomayo, Cusco, in Peru and is part of the Seismic Retrofitting Project (SRP) of the Getty Conservation Institute (GCI), USA. The correlation with the existing structural damage and the structural capacity were obtained through nonlinear pushover and time history analyses, based on a macro-modeling approach, with a total rotating strain crack model, with compressive and tensile softening behavior, incorporating fracture energy [Lourenco 1998]. Capacity curves of lateral resistance and

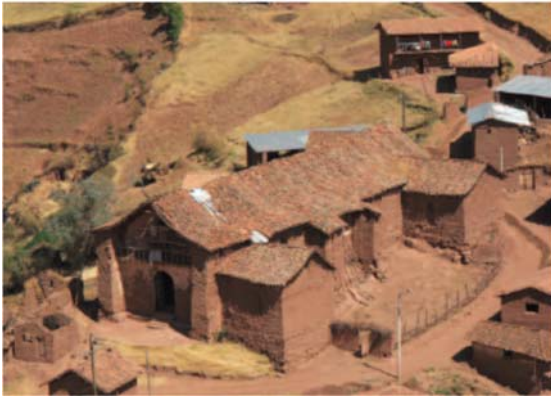
Figure 1. Kuño Tambo church: (a) aerial view [Cancino et al. 2013]; (b) 3D CAD model (light grey), with the highlight of various openings in red and the base masonry course (dark grey).

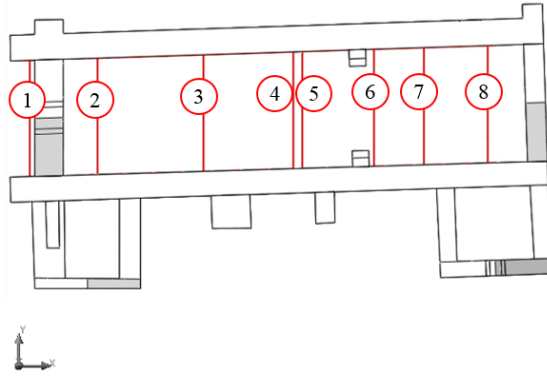
Figure 3. Representation of timber tie beams in plan view.

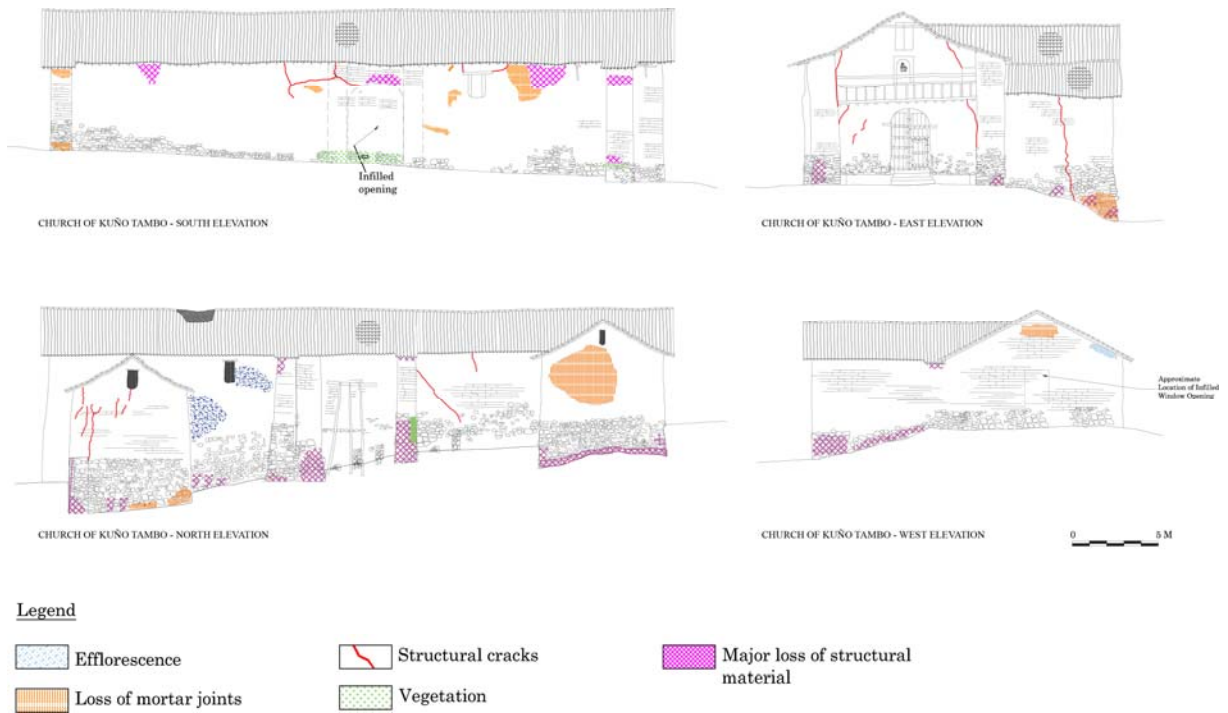
Figure 4. Damage maps in each facade [Zanotti 2015].

The damage configuration, is highly influenced by the low mechanical properties of the adobe masonry, the poor level of confinement of structural parts, and the high level of exposure of the exterior surfaces to erosion, from improper drainage, maintenance and, possibly, condensation. The east façade shows signs of discontinuity with the lateral walls, with evident vertical cracks at both ends, in the entire elevation and thickness. The size and extent of the

cracks are indicative that the east façade behaves largely independently, with out-of-plane critical modes in case of a strong earthquake. Yet, no horizontal cracks at the base are present. The south lateral wall exhibits outward displacements, loss of mortar and units, while the base course has evident signs of erosion and deterioration in many parts of the exterior surfaces, with loose stones and missing mortar from joints.

The baptistery exhibits several vertical cracks, located in the middle span of the sidewalls, which appear to be related to seismic actions or settlements, triggered by the difference in the thickness. The vertical crack at the south corner of the gable wall is characteristic of a separation mechanism of orthogonal walls, from pounding during earthquake events and / or soil settlements [Tolles et al. 1996]. The presence of damage in all the facades is presented in Figure 4 [Zanotti 2015].

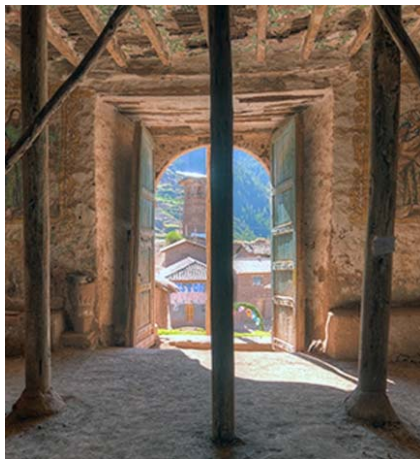
Figure 8. (a) 3D view of the FE model with base course foundation in brown and ties in red; (b top) timber anchor on the southeast corner of the lateral wall; (b bottom) closer view of the timber anchors and their connectivity in the south adobe wall; (c) interior view of the main entrance; (d) modelling of the entrance of the nave.

A 3D FE model was built in Midas FX+ Version 3.3.0 for DIANA software, according to the generated 3D CAD model. The model, as seen in Figure 8a includes the nave, with the adjoining buttresses, the sacristy and baptistery, the corresponding base course foundation, with the differences in elevation, and the system of timber ties and anchors. The base connection was modelled as fixed, while all intersecting adobe walls and the connection between the plinth and adobe were modelled with full connectivity. Given the low tensile strength of the materials, cracks can easily arise upon increasing loading.

Regarding the openings, timber elements were assigned in the spans. Limited information regarding their geometry and mechanical properties is available, but visual inspection indicates that no damage is present. Square linear elastic timber lintels of 30 cm thickness were chosen for the large openings, with a bearing length of 50 cm, while for the small ones, a size of 25 cm and a load bearing length of 20 cm were considered (Figure 8c and d).

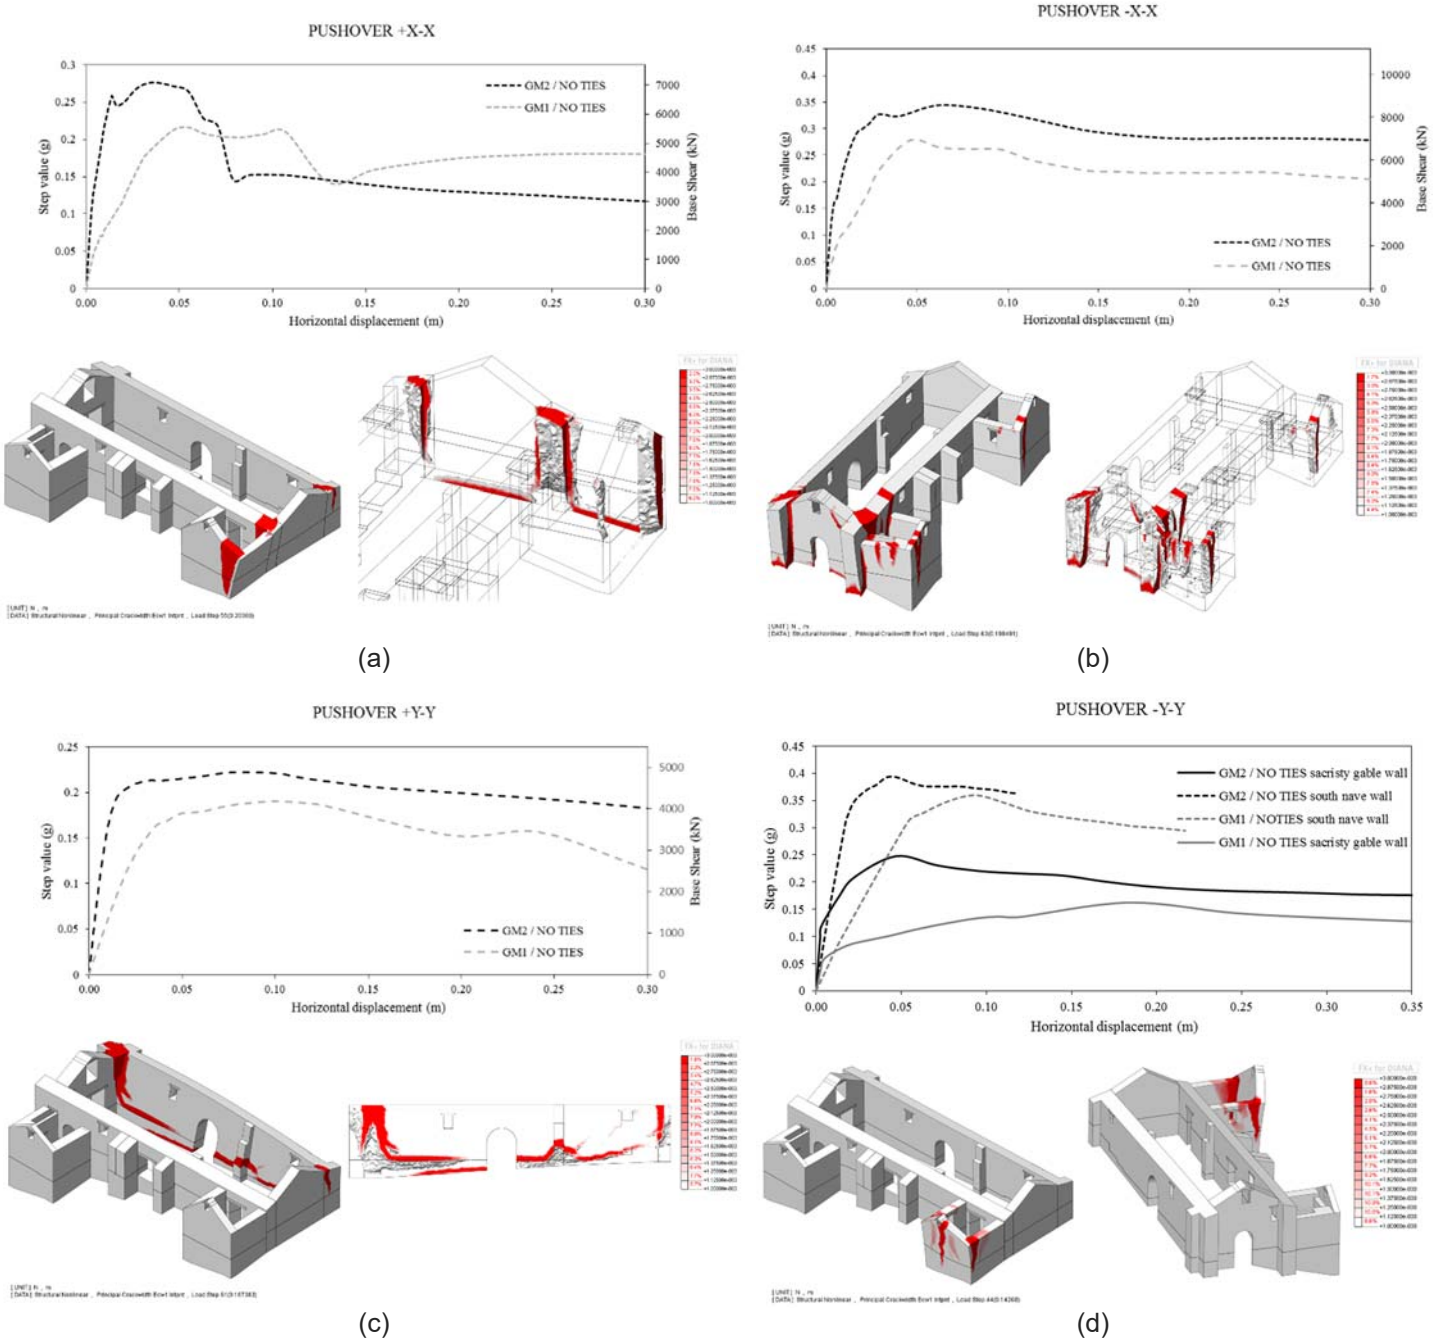
Figure 12. Lateral response in all directions, for Models GM1<sub>no-ties</sub> and GM2<sub>no-ties</sub> and crack pattern at ultimate stage in model GM1<sub>no-ties</sub>, from lateral loading due to earthquakes: (a) +x-x (E-W); (b) -x-x (W-E), (c) +y-y (N-S), (d) -y-y (S-N).

The results from the pushover analyses in the positive x-x direction (see Figure 8 for the model axes), for Models GM1<sub>no-ties</sub> and GM2<sub>no-ties</sub>, are presented and superposed in Figure 12a. Model GM1<sub>no-ties</sub> exhibits the minimum lateral capacity of 0.22g, while Model GM2<sub>no-ties</sub> is stiffer and the lateral capacity is around 30% higher. By comparing the failure modes for Model GM1<sub>no-ties</sub>, at a load step near collapse, with a maximum total displacement of about 25 cm, the

damage is more concentrated on the west part (Figure 12a). The failure mechanism consists of vertical separation cracks, along the corners, in the west part of the church, covering the entire elevation and thickness, with horizontal hinge lines at the bottom of the base course foundation, which results in the collapse of the west gable and side walls. As the tensile damage propagates along the entire thickness of the walls, the west part becomes structurally independent.

When the lateral load is applied in the negative x-x direction, the failure mode consists mainly of the out-of-plane overturning of the east façade, together with adjacent fragmented front parts of the lateral walls, as shown in Figure 12b. The minimum obtained lateral capacity is 0.28g (GM1<sub>no ties</sub>), with the first tensile damage (cracks  $\geq$  1mm) initiating at 0.10g at both corners of the east façade, organized in a vertical fragmentation and increasing in thickness. At 0.27g the vertical separation of the east façade is completed, while vertical cracks appear at the middle span of the east side wall of the baptistery and at both the gable walls of the baptistery and sacristy. Also horizontal hinge lines initiate at the adobe-stone masonry interface of the east façade. The respective load step for the stiffer model (GM2<sub>no-ties</sub>) corresponds to 0.34g.

The resulting tensile damage seems to efficiently reproduce the existing damage pattern in the east façade and the gable wall of the baptistery, as shown in Figure 12b of (GM1<sub>no-ties</sub>), with crack widths up to 8 cm. Due to the varying stiffness caused by the staircase void in the east baptistery wall, tensile damage is initiated near the middle span, which can be correlated with the documented vertical crack at the same place (Figure 14). In particular, the initiation of vertical cracks in the side walls of the baptistery appears to be triggered by seismic loads, but according to the in situ observation, the vertical cracks fully propagated in elevation. Thus, the documented damage appears to be the result of seismic action and settlements.

As shown from the distribution of the principal crack widths in Figure 12c, in load steps of corresponding lateral displacements of about 0.25 m, the south lateral wall follows an out-of-plane collapse mode, with significant tensile failure zones at the intersections with the west and east façade. Under the formation of a continuous flexural crack, at the interface with the base course foundation and at base, a rigid out-of-plane body motion is defined. Following the lateral loading in progress, in Model GM1<sub>no-ties</sub>, the first tensile damage (cracks  $\geq 1$  mm) initiates at 0.05g, at the top of the southeast corner, propagating diagonally at the thickness of the connection. At 0.11g, cracking at the southwest corner appears, and at 0.17g, the horizontal flexural crack at the base of the foundation base initiates. Next, propagation of the horizontal hinge line follows the adobe-stone masonry interface and is associated directly with the vertical fragmentations at both corners, forming the collapse mode of the south lateral wall. The large peak, in terms of incremental displacements, occurs during the post-peak behavior, at a lateral displacement of about 14 cm. In the following steps, the south lateral wall is in rigid body motion with large incremental displacements. The stiffer model (GM2<sub>no-ties</sub>) exhibits a similar collapse mechanism. Due to the higher Young's Modulus in adobe and rubble stone masonry the structure enters the plastic range and sustains a moderate damage level with higher residual capacity.

The results from the pushover analysis in the negative direction of the y-y axis are presented (Figure 12d). The lateral capacity is controlled by the early failure of the sacristy gable wall and in this case is 0.16g and 0.25g, for Models GM1<sub>no-ties</sub> and GM2<sub>no-ties</sub> respectively. The capacity of the south lateral wall is much larger than in the positive y-y axis, due to the external lateral parts and buttresses contributing much more to the overall stiffness of the nave. In both models, the sacristy is severely damaged, with vertical tensile failure zones in the

corners of the side and gable walls, as seen from the ultimate principal crack width distribution, with a displacement of about 26 cm (Figure 12d). Yet, no such damage exists on current state. Specifically, the structure in model GM1<sub>no-ties</sub> enters a rigid body motion mechanism at 0.08g, while the horizontal hinge line at the base of the south lateral wall is formed, when the local lateral capacity reaches 0.36g. In model GM2<sub>no-ties</sub>, the south lateral wall behaves as a structural mechanism at 0.39g and a corresponding horizontal displacement of about 5 cm.

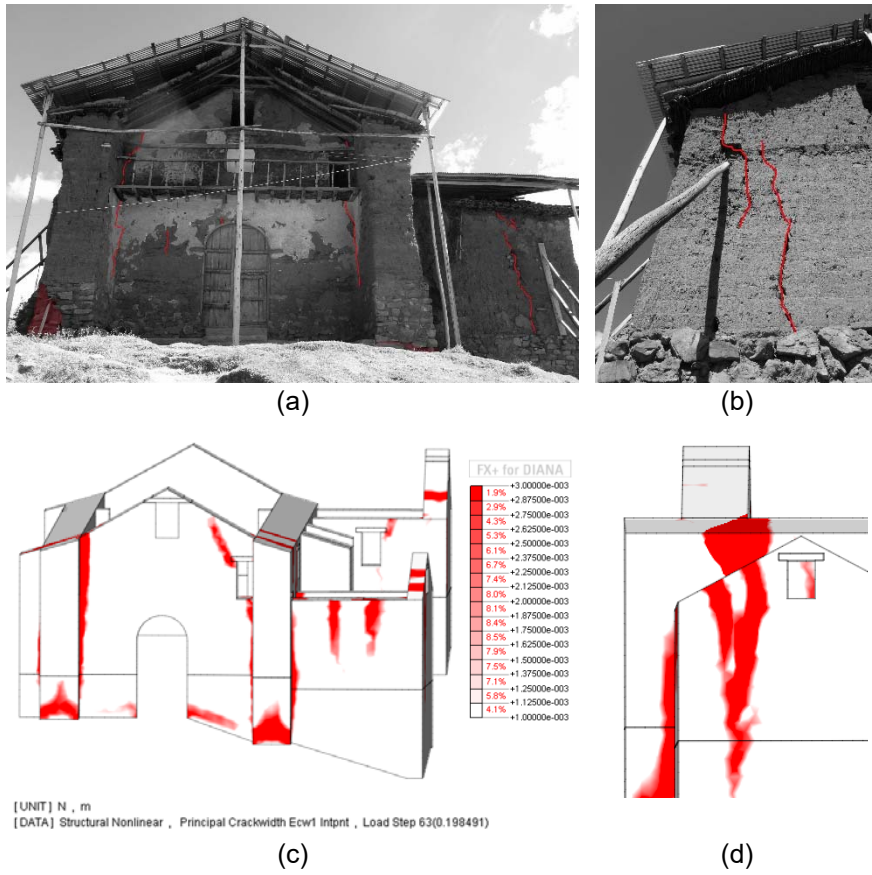
Figure 14. Crack pattern correlation: (a) crack pattern in east façade; (b) crack pattern in the gable wall of baptistery; (c), (d) distribution of principal crack width at collapse (Model GM1<sub>no-ties</sub>).

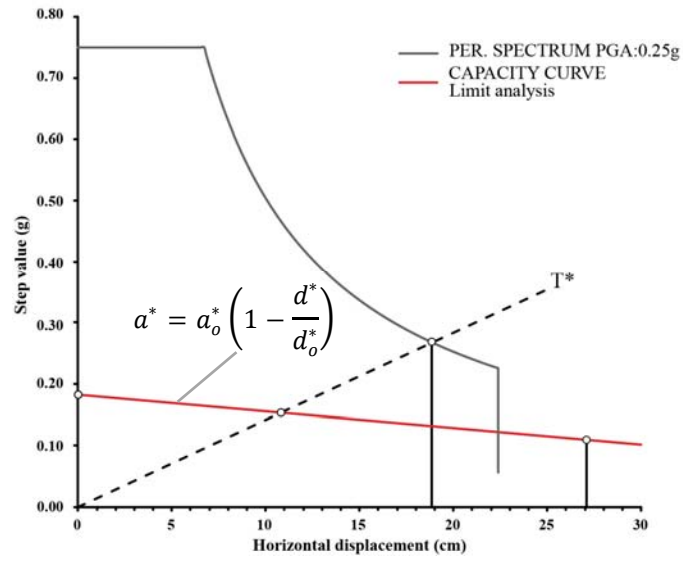
Figure 21. Capacity curve plot, from limit analysis and the Peruvian elastic response spectrum, of the south lateral wall.

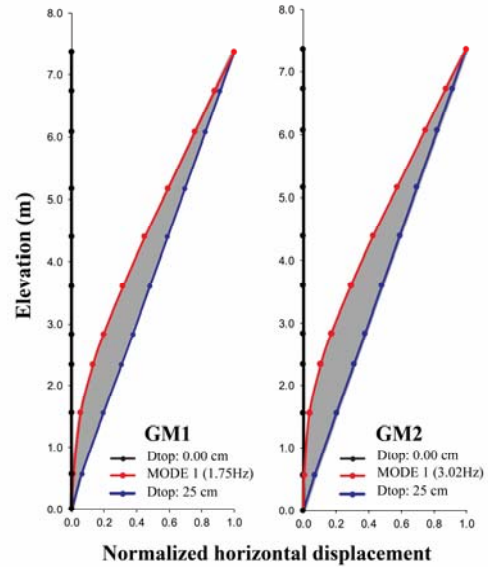
Figure 22. South lateral wall: (a) Out-of-plane failure mode representation and discretized zones; (b) normalized plots of lateral deformed shapes, during the evolution of lateral loads, for models GM1 and GM2 without ties (note intermediate deformed shape trajectories in grey).

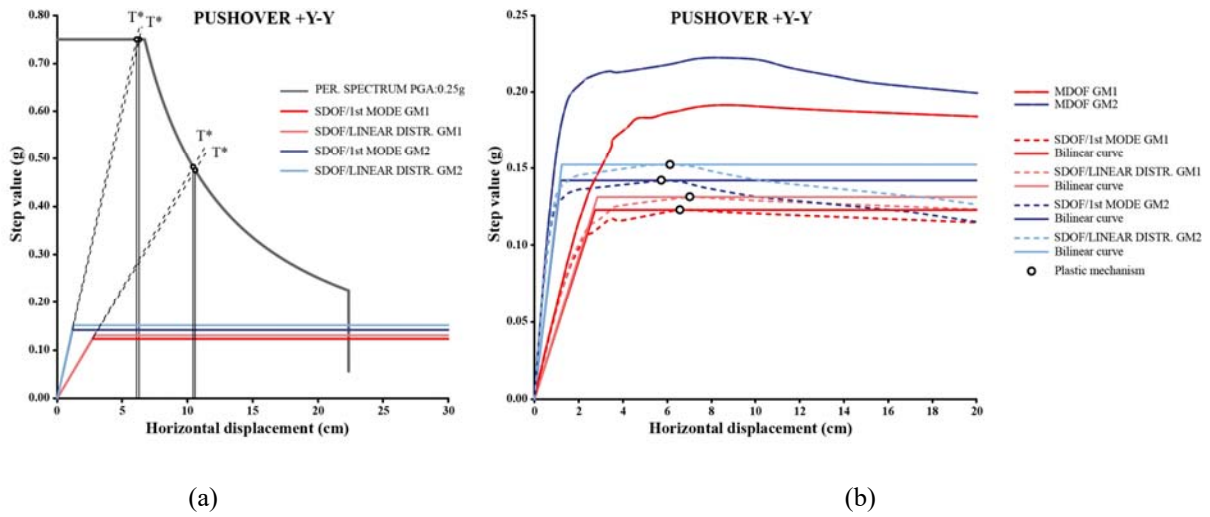
Figure 23. (a) Elastic response spectrum and idealized capacity curves of the SDOF system; (b) capacity curves for models GM1 and GM2 without ties in MDOF and SDOF configuration.
