# **Partial Discharge Classification Using Acoustic Signals and Artificial Neural Networks and its Application in detection of Defects in Ceramic Insulators.**

A thesis  
presented to the University of Waterloo  
in fulfillment of the  
thesis requirement for the degree of  
Masters of Applied Science

In  
Electrical and Computer Engineering

Waterloo, Ontario, Canada, 2019

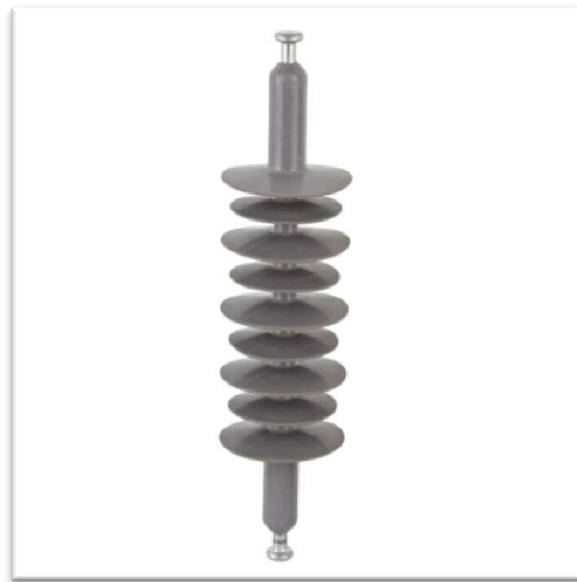
Fig.1.2. A polymeric insulator [11].

Polymeric insulators, also known as composite or non-ceramic insulators, presently dominate the insulator market and are being embraced by utilities. Polymeric insulators represent 60 % to 70% of newly installed insulators [10] and are known for their light weight, resistance to vandalism, superior seismic performance, and flexible design, as well as their hydrophobic nature that enhances their performance under wet and contaminated conditions. A simple polymeric insulator is depicted in Fig. 1.2.

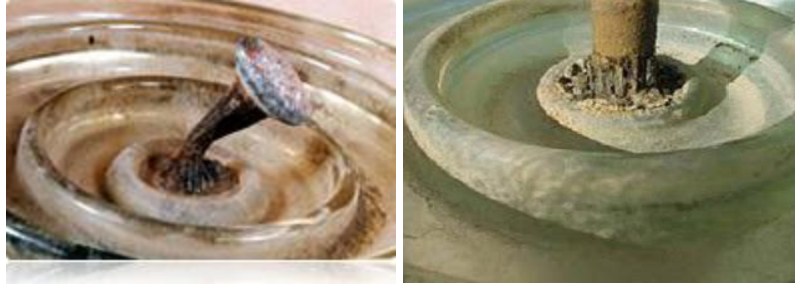
Corona discharge can occur as a result of inappropriate electric stress grading at the cap of the insulator near the line end of a string of insulators. The metallic cap subsequently becomes exposed to corrosion as the discharge slowly degrades the protective galvanizing layer. Leakage current may also flow on the surface of the insulator during contamination and wet atmospheric conditions, which create a salt solution on the surface. Pin corrosion produced by electrolytic action can weaken the mechanical and cross-sectional strength of the pin. Damage of this sort can lead to an event as serious as conductor dropping. Fig. 1.6 is an example of hardware exhibiting a very high degree of corrosion.

Fig 1.6. Corroded pins in suspension-type porcelain and glass insulators [16].

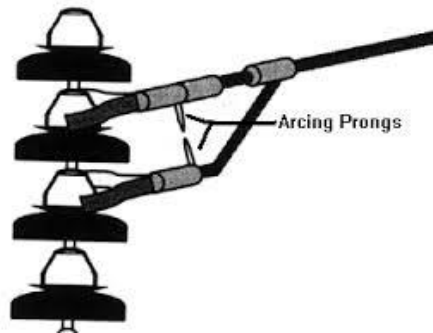
The main principle underlying the buzz method is the potential difference across successive bells of an energized insulator string, which are used as a means of detecting a defective insulator. The testing kit consists of a metal prong connected to a hot stick (see Fig 2.1). The prong is placed across each disc of the string individually. If the insulator is healthy, then the potential difference across the electrodes of the disc is enough to create a partial arc that produces a buzzing sound in the small air gap at the tip of the prong. On the other hand, if the disc is defective, then insufficient potential difference exists to produce the arc, and buzzing sound. Small internal defects are often undetected by this measurement.

Fig.2.1. Buzz method for finding defects in ceramic insulators [21].

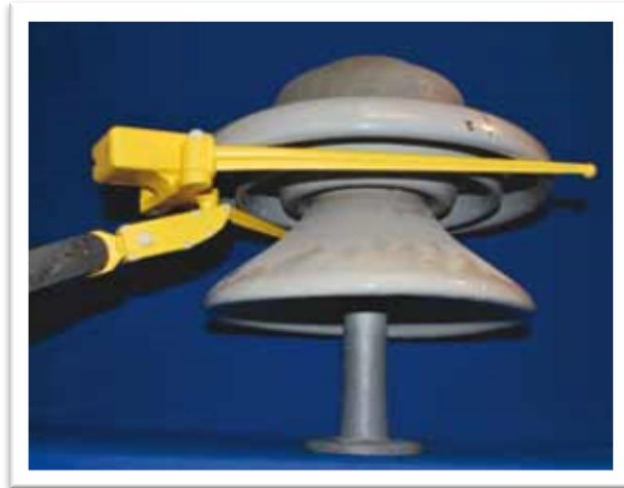
A cracked-insulator acoustic probe (CIAP) is a licensed technology developed by Hydro-Québec and used for inspecting live lines. Cracks in a porcelain insulator and any weakening of the metal-porcelain interface due to exposure to harsh weather can be detected using this technology, which has proven successful for locating cracks in high voltage insulators up to 120 kV [39]. The probe comes with two pairs of plastic feelers that consist of a proximity sensor, a small hammer, and a miniature microphone for picking up sound samples. Only three samples taken at different points on the shed are sufficient for tracking the condition of an insulator [39]. Fig. 2.3 displays details of the mounting of the sensor on the insulator.

Fig. 2.3. CIAP feelers probing a 120 kV insulator shed [39].

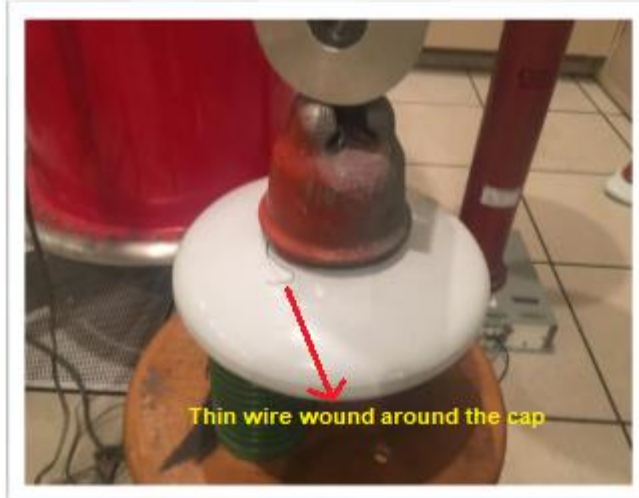
Fig. 3.3 shows a healthy insulator with a thin wire wound around the cap that is used to replicate a hardware corona. This kind of discharge is very common in power systems, but hard to distinguish from other types of severe discharge using the regular online monitoring techniques currently available.

Fig.3.3. Hardware corona generated using a thin wire wound around the cap of a line insulator.

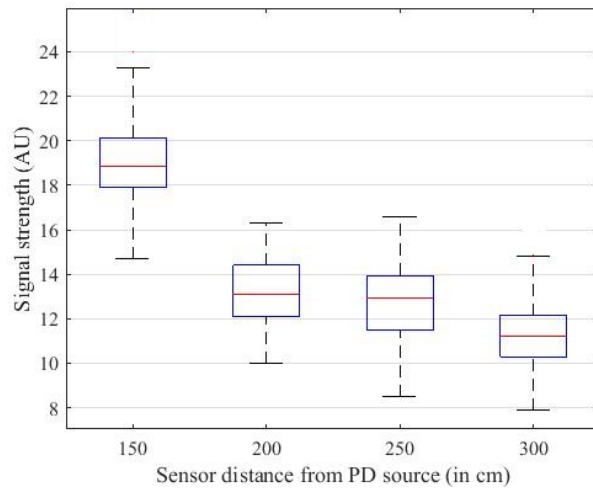
On the other hand, for a surface discharge, only the 120 Hz component exhibits a decreasing trend similar to that for a corona. No consistent trend can be observed for either the 60 Hz or the 180 Hz components. However, for both types of discharge, the total signal strength decreases with distance.

Fig.4.3. Attenuation of the signal strength with distance with a surface discharge for (a) a 60 Hz component, (b) a 120 Hz component, and (c) a 180 Hz component.

The results related to the attenuation rate of the measured acoustic signal frequency components with discharges from a sharp electrode in air (corona) and from a dielectric medium (surface discharge) are shown in Fig. 4.2 and Fig. 4.3, respectively.

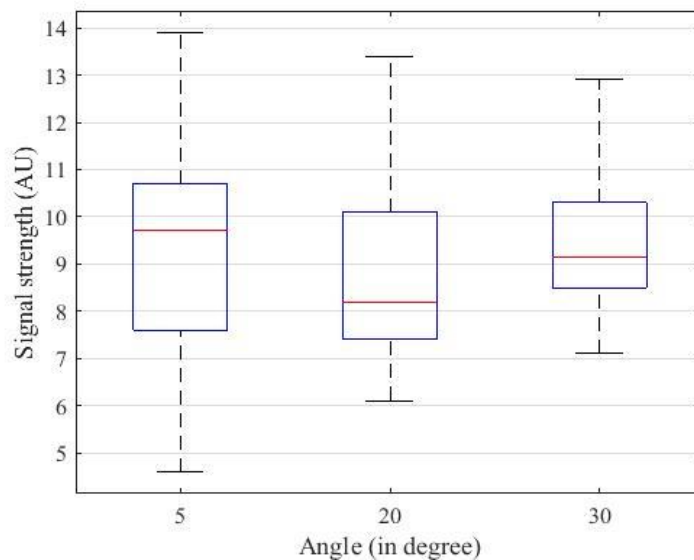
The results reveal that as the angle of deviation from the PD source increases, the 60 Hz component is subject to minimum attenuation. Similar behaviour was observed for the 120 Hz and 180 Hz components.

Fig.4.5. Attenuation of the signal strength with the angle of measurement for a 60 Hz component with corona discharge.

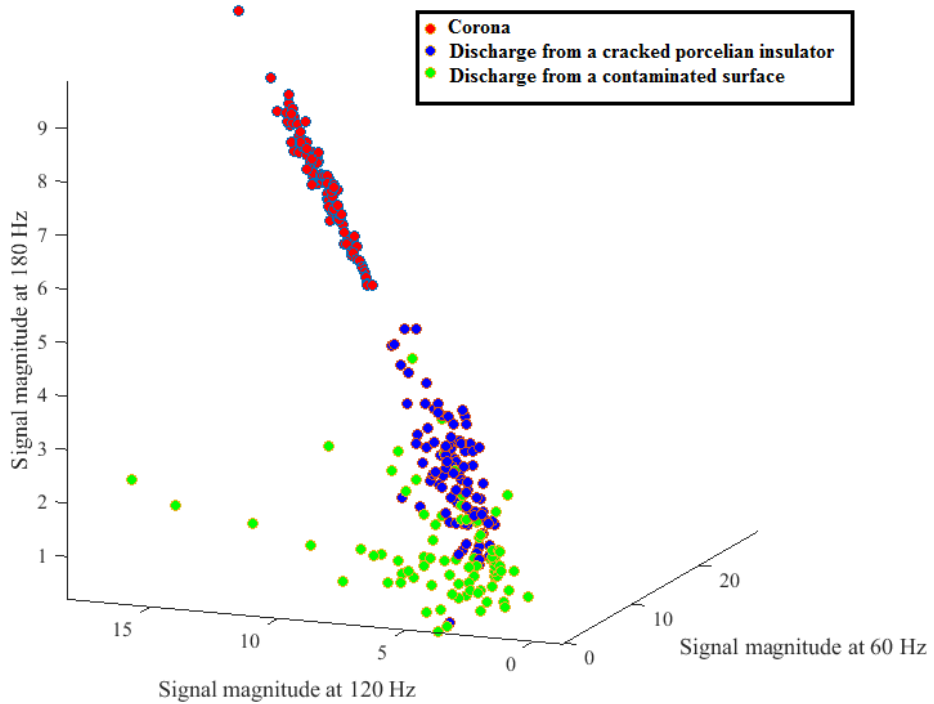
Fig.4.8. Signal magnitudes for 60 Hz, 120 Hz, and 180 Hz frequency components in string insulators.
