Proceedings
Geohazards

Instrumentation of Flexible Buried
Culvert Subjected to Rockfall Loading

Instrumentation of flexible buried culvert subjected to rockfall loading

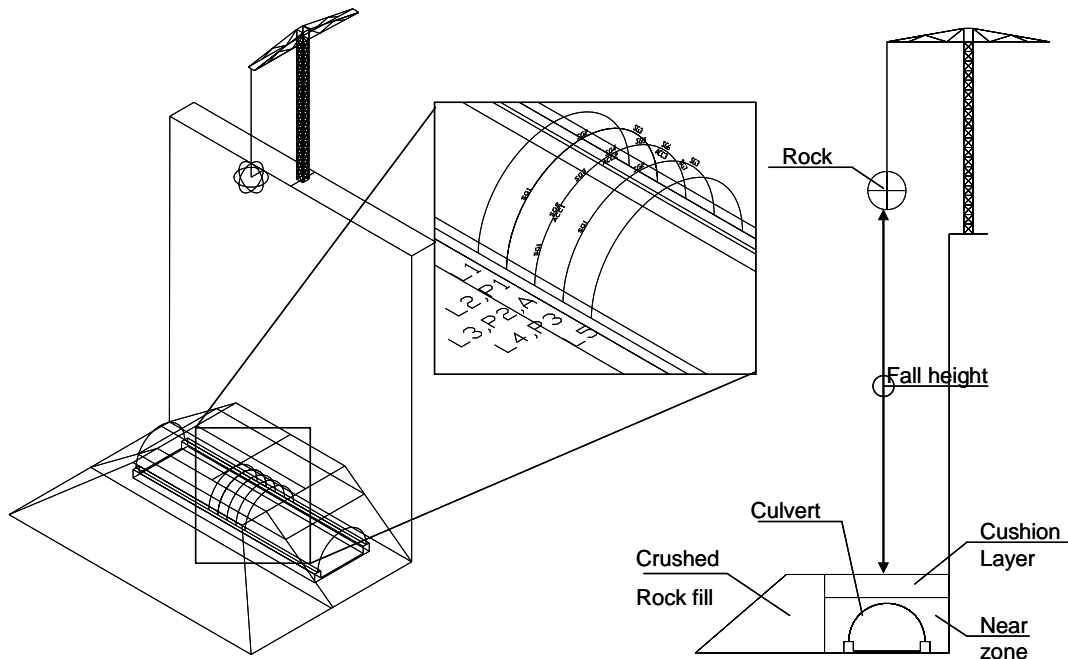
Figure 1: Illustration of experimental setup. Inset shows the different profiles where measurements were carried out.

The 15.0 m long structural plate metal arch culvert was installed on a reinforced concrete plate foundation, Figure 1. 80-200 mm size compacted gravel was used as backfill at the ends.

After completion of installation impact load tests were conducted. In the present study, natural rock boulders have been used, and the impact of these rocks are centered above the crown of the culvert. After each impact test the cushion layer was removed and replaced to same level. Figure 1 represents the experimental setup.

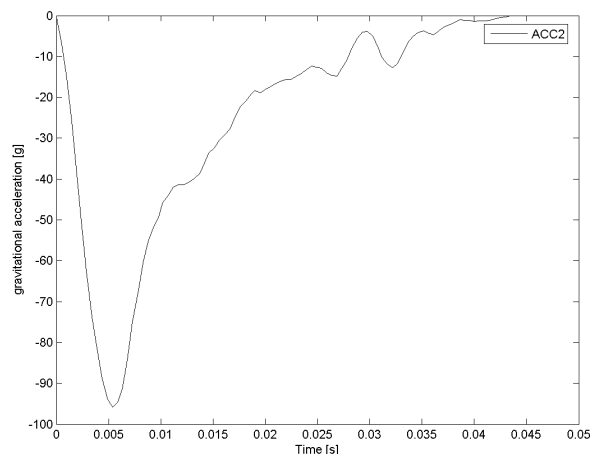
Figure 6: Typical deceleration history of low-energy rockfall impact.

Figure 6 present a typical vertical deceleration history from the rockfall impact tests. Duration of this impact is in the order of approximately 40 ms. Measured peak acceleration is approximately 90 g.
