# A PRELIMINARY STUDY OF THE EFFECT OF SURFACE COATING ON THE INITIAL DEPOSITION MECHANISMS OF DAIRY FOULING

S. S. Ramachandra<sup>1</sup>, S. Wiehe<sup>2</sup>, M. M. Hyland<sup>1</sup>, X. D. Chen<sup>1</sup>, and B. Bansal<sup>1</sup>

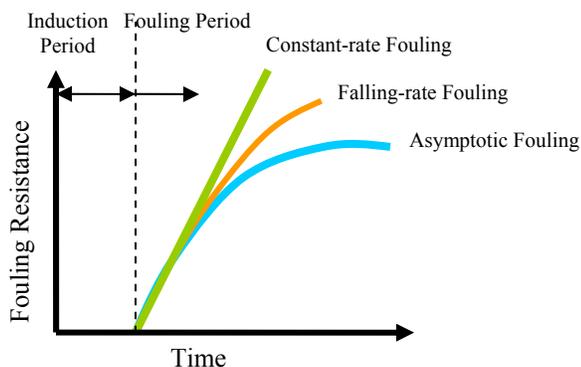
Fig. 1: Change in Fouling Resistance with Time (Fryer, et al. 1995)

Heating in the dairy industry is required in processes such as pasteurization and sterilization for preservation of milk by killing micro organisms (Walstra, et al. 1984). The effect of fouling is incorporated into heat exchanger design by including a fouling resistance,  $R_F$ , in the overall heat transfer coefficient calculation. Fouling behavior is observed by plotting  $R_F$ , against time (Fig. 1).

Initially, there is a period where the heat transfer coefficient does not change significantly and is termed the induction period (Belmar-Beiny, et al. 1992; Belmar-Beiny, et al. 1993; Changani, et al. 1997; Visser, et al. 1997). The induction period is followed by the fouling period. Constant-rate fouling leads to rapid reduction in the heat transfer coefficient, increase in pressure drop, and finally blockage. In food processing, falling-rate and constant-rate fouling are commonly observed (Changani, et al. 1997).

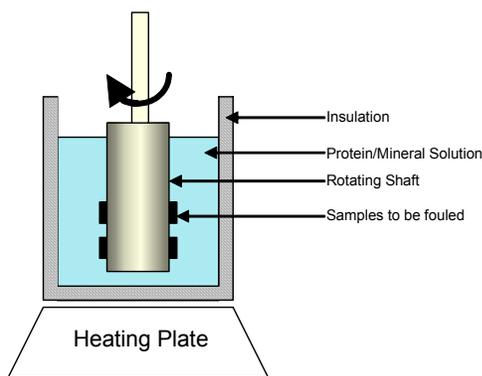
Fig. 2: Schematic of small fouling rig

Fig. 2 shows a schematic of the rig designed for this purpose. The apparatus consists of two concentric cylinders between which the fouling solution is placed. The inner cylinder is attached to an agitator shaft and a motor is used to rotate this cylinder. Samples are soldered onto the surface of the inner cylinder. Heat is provided to the fouling solution by means of a heating plate. The inner cylinder may be heated by placing it in a water bath until the required temperature is reached. To retain the thermal energy gained by heating in the water bath, the inner cylinder is filled with oil which has a high heat capacity. It should also be noted that the purpose of these experiments was to determine the methodology and identify the main obstacles present in the experimental and analysis stages of the investigation.

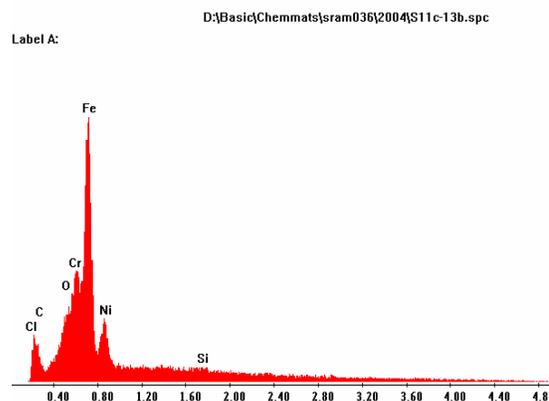
Fig. 3: EDS spectrum for cleaned stainless steel

**Stainless Steel Surfaces.** Cleaned stainless steel surfaces were analyzed using SEM. The surface was found to be reasonably smooth due to polishing to  $0.25\mu\text{m}$ . Compositional analysis using x-ray microanalysis (Fig. 3) shows the main components of Fe, Cr, Ni, and C. Due to the high accelerating voltage and limited surface sensitivity of the technique, the oxide layer expected to form on the surface was not detected strongly. XPS analysis is currently underway to correctly identify the composition.

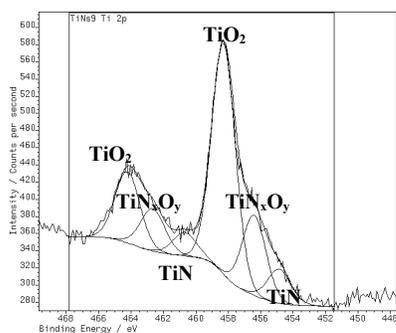
Fig. 4: Cleaned TiN - Ti 2p Narrow Scan (Wiehe 2004)

**Titanium Nitride Surfaces.** TiN surfaces, produced by magnetron sputtering of stainless steel, were analyzed and subsequently used for fouling experiments. XPS analysis showed the TiN surface is covered with an oxide layer due to air-exposure after deposition, as shown in Fig. 4. The oxide layer consisted mainly of  $\text{TiO}_2$ , and intermediate oxynitride ( $\text{TiN}_x\text{O}_y$ ) compounds which form at the beginning of the surface oxidation process. N 1s narrow scans showed the presence of interstitial N due to replacement of N with oxygen during the formation of the  $\text{TiO}_2$  oxide layer. Carbon contamination was identified by the presence of C-C/C-H, C-O, and C=O compounds.

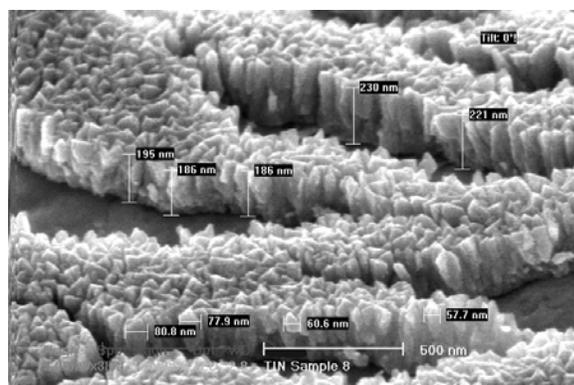
Fig. 5: Cross sectional image of TiN coating (Wiehe 2004)

SEM analysis was performed to study the microstructure and morphology of the TiN coating. Columnar grain formation was identified from cross sectional images of the coating (Fig. 5), with coating thicknesses ranging from 230nm to  $1.29\mu\text{m}$  depending on deposition conditions. The grain size determined from images of the coating surface (Fig. 6) ranged from 42nm to 61nm.

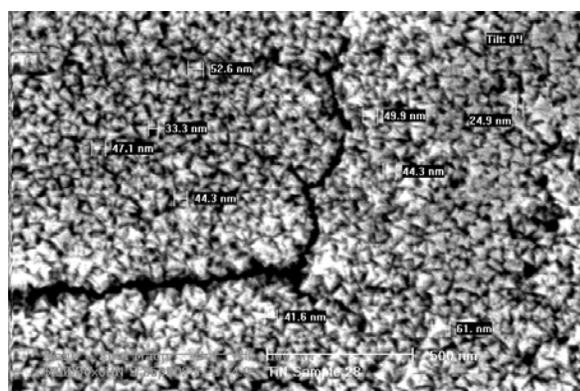
Fig. 6: Top view of TiN coating surface (Wiehe 2004)

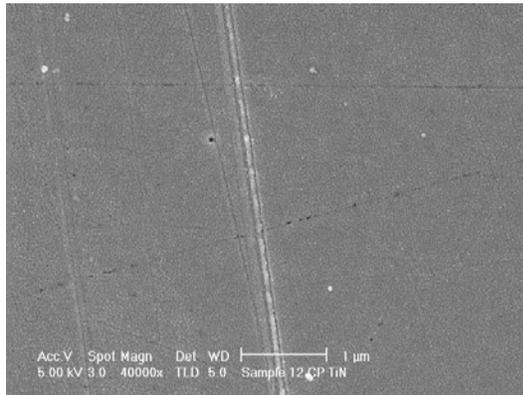
Fig. 7: Stainless steel surface fouled with whey protein

**Stainless Steel Surfaces.** Fig. 7 shows that the whey protein deposit formed on the stainless steel surface is quite thin, following the surface topography, as polishing marks identified earlier in the unfouled surfaces are still seen. A higher magnification image of the surface shows that the surface is in fact covered with a homogeneous layer of deposit which has cracked as a result of drying (Fig. 8). EDS analysis of the surface shows approximately two times the amount of carbon than for unfouled stainless steel. XPS analysis is currently in progress to further analyse the composition of the deposit.

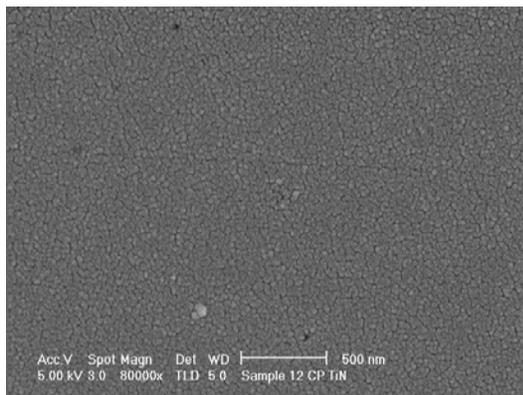
Fig. 8: High magnification image of whey protein fouled stainless steel surface

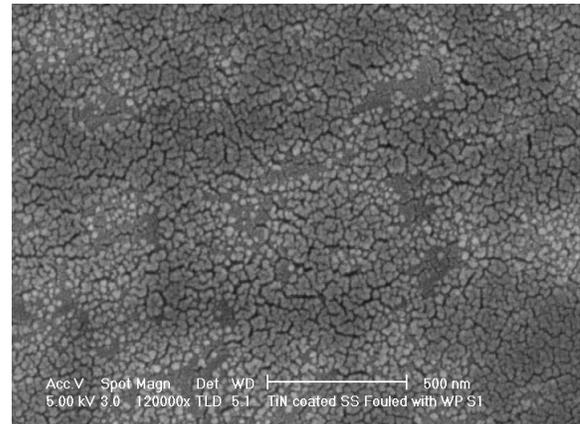
Fig. 9: Whey protein deposit structure on TiN after drying

Fig. 9 is a SEM micrograph of the deposit structure after drying. The appearance of the deposit is similar to the deposit formed on stainless steel surfaces. The dark and light shades of the deposit correspond to thick and thin deposits respectively, according to EDS analysis which showed higher amounts of carbon in darker regions. The deposit is non homogeneous, in that, there are patches in the cracked layer where the surface appears smooth. These smooth patches also seem to be cracked in some places, suggesting it is a sub-layer of deposit rather than the TiN surface.

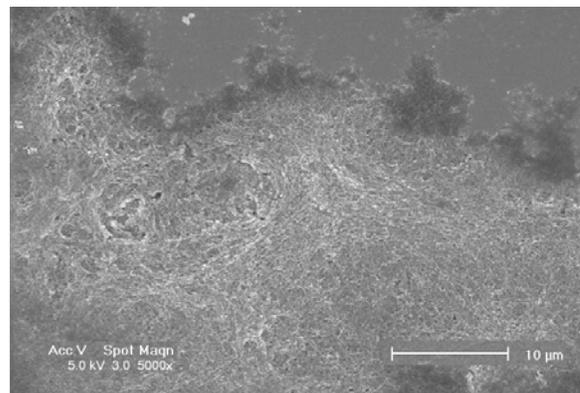
Fig. 10: Crystal matrix deposit formed on surface

**Stainless Steel Surfaces.** Calcium Phosphate runs were performed at room temperature conditions, where both solution and sample were maintained at room temperature. The main feature of the deposit formed is a crystal matrix

type deposit (**Fig. 10**). The stainless steel surface is covered only partially by this deposit, while the remaining parts seem to be the bare stainless steel according to EDS analysis. The crystal matrix seems to consist of small crystal flakes ranging from 200 to 300nm in size. Using EDS analysis, the Ca/P ratio is estimated as 1.4. XRD analysis would need to be performed to confirm the phases formed.

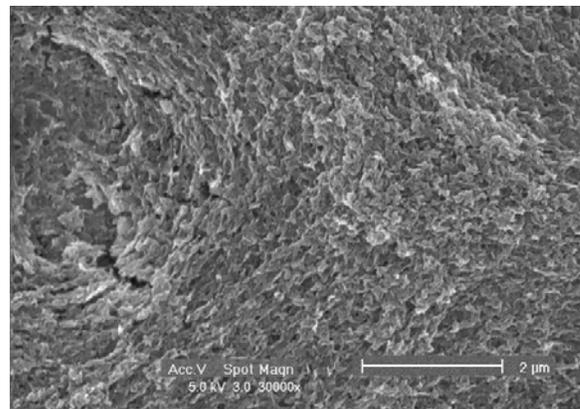
Fig. 11: High magnification image of crystal matrix

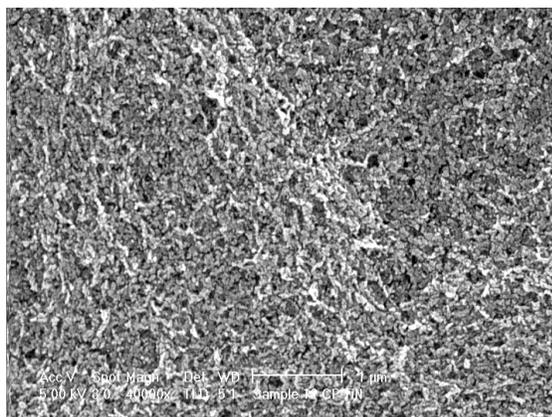
Fig. 12: Crystal matrix of calcium phosphate formed on TiN surface

**Titanium Nitride Surfaces.** Calcium phosphate deposits formed on TiN surfaces were similar to the matrix found on stainless steel surfaces. Again, the surface was only partially covered with the deposit. The Ca/P ratio from EDS analysis was estimated at 1.4. However, the crystal flakes forming this matrix appeared smaller in size than those found in stainless steel (Fig. 12). In addition, a different type of crystal was found in some parts of the surface, and is shown in Fig. 13. This type of crystal seems to be somewhat porous in nature. EDS analysis showed these crystals had a Ca/P ratio of 1.8.

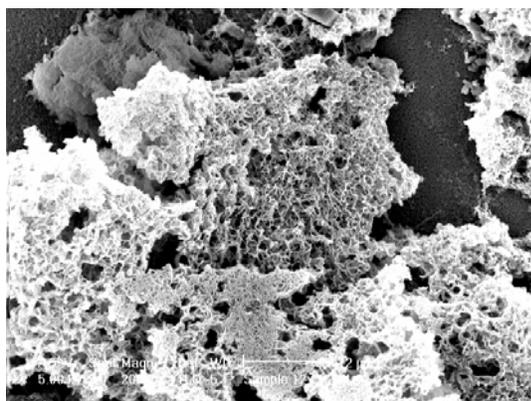
Fig. 13: Second type of calcium phosphate crystal formed on TiN surface
