## Testing of Bearing Materials for Large Two-stroke Marine Diesel Engines

**Klit, Peder; Persson, Sebastian; Vølund, Anders**

12th EDF - Pprime Workshop: "Solutions for performance improvement and friction reduction of journal and thrust bearings"

2013

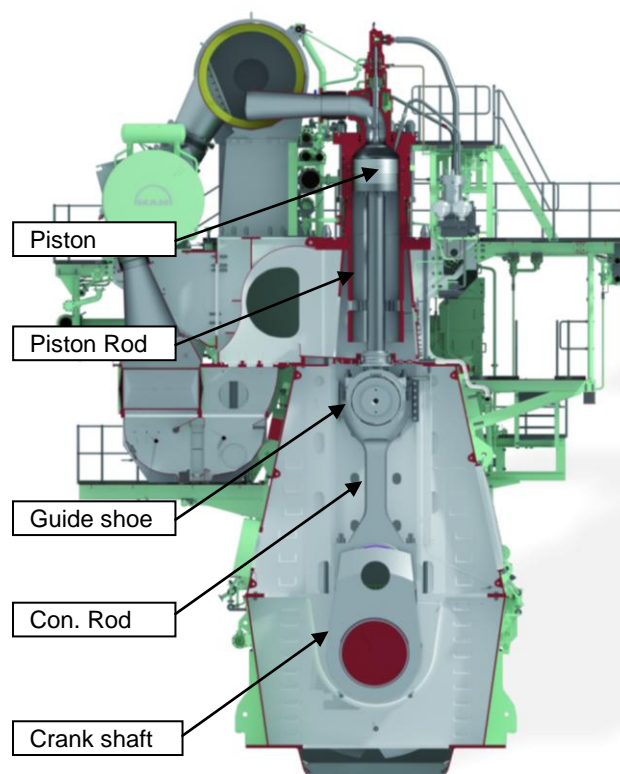
Figure 1: Engine Section

Bearings for large two-stroke marine diesel engines are typically in service for the entire lifetime of the engine – up to 20-30 years is not unusual service life [Figure 1]. The bearing shell is installed in the engine and firmly positioned by the design of the structure surrounding the bearing [Figure 2]. The design of these bearings is to a large extent based on empirical knowledge in combination with simulations. These simulation results are compared to basic design rules and thus assisting in the validation of the new design. The typical white metal bearing shell [Figure 3], consist of a base material (steel) on which the white metal has been applied.

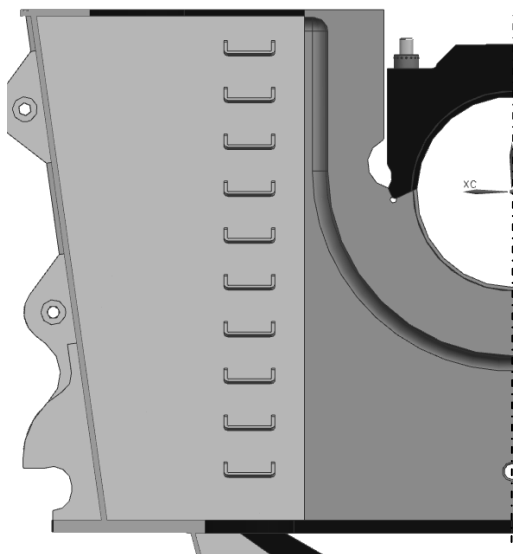
Figure 2: Section view of bottom part of engine section, showing the main bearing structure with bearing shell

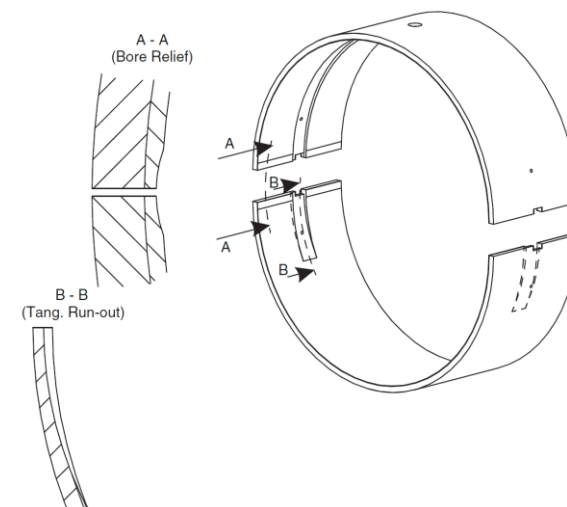
Figure 3: Main Bearing Shell Design (Thin Shell design)

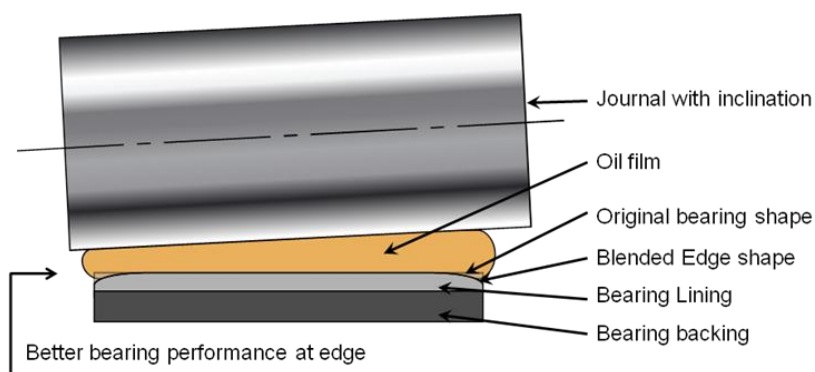
Figure 4: Cross section of concept of blended edge bearing design

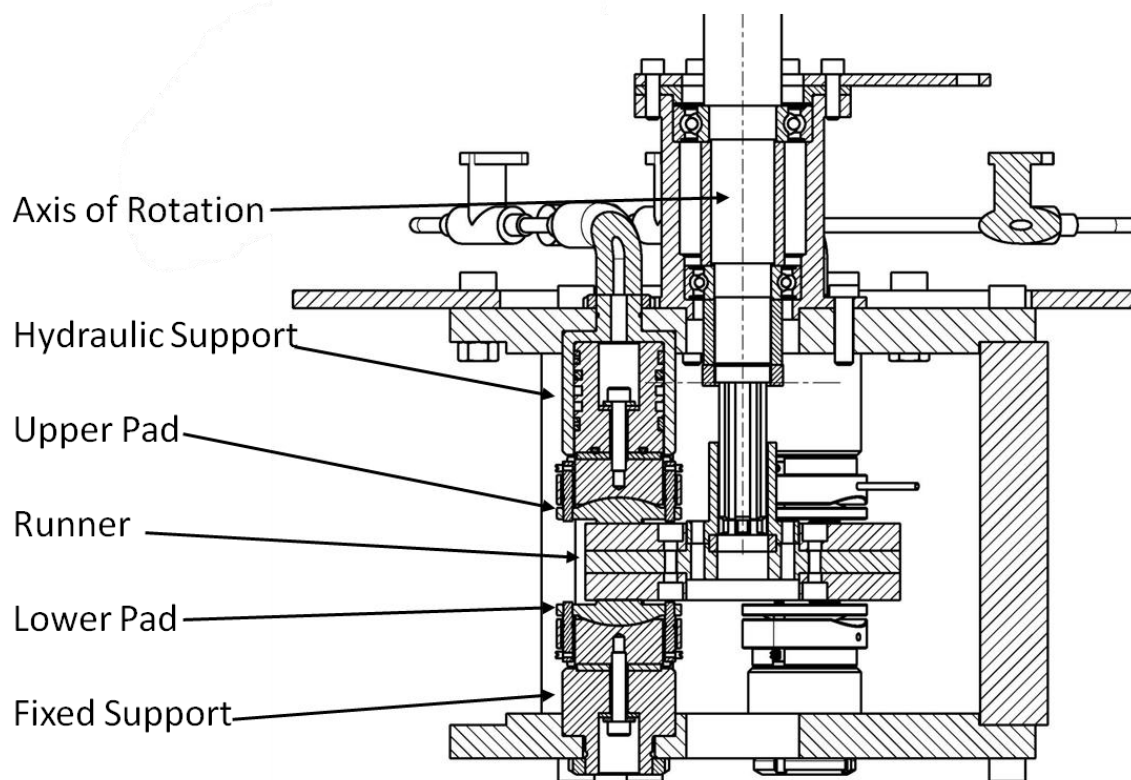
**Figure 5 CAD sketch of DFTR**

The test disc consists of three parts, an upper and lower disc with lined white metal on the outer and a middle disc which is used to assemble the set of discs, see CAD sketch of DFTR - Figure 5. The design allows for two tests with almost the same environment to be tested at the same time. The pressure pads can be shifted 60° in comparison to each other to induce bending stresses in the test disc to replicate the effect of bending stress in backing and coating materials of journal bearings. The amount of bending stress is controlled by changing the thickness of the centre disc. The principle of applying bending stresses to the runner is shown in Figure 6.

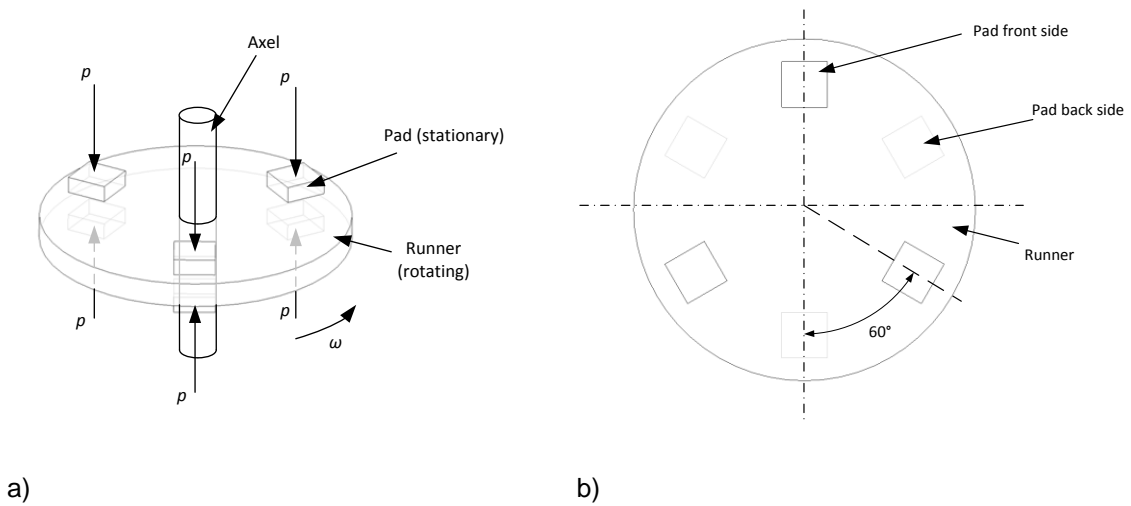
Figure 6. Principal sketch. a) Pads placed on top of each other, b) Pads (viewed from the top) shifted 60° in relation to each other to induce bending moment.

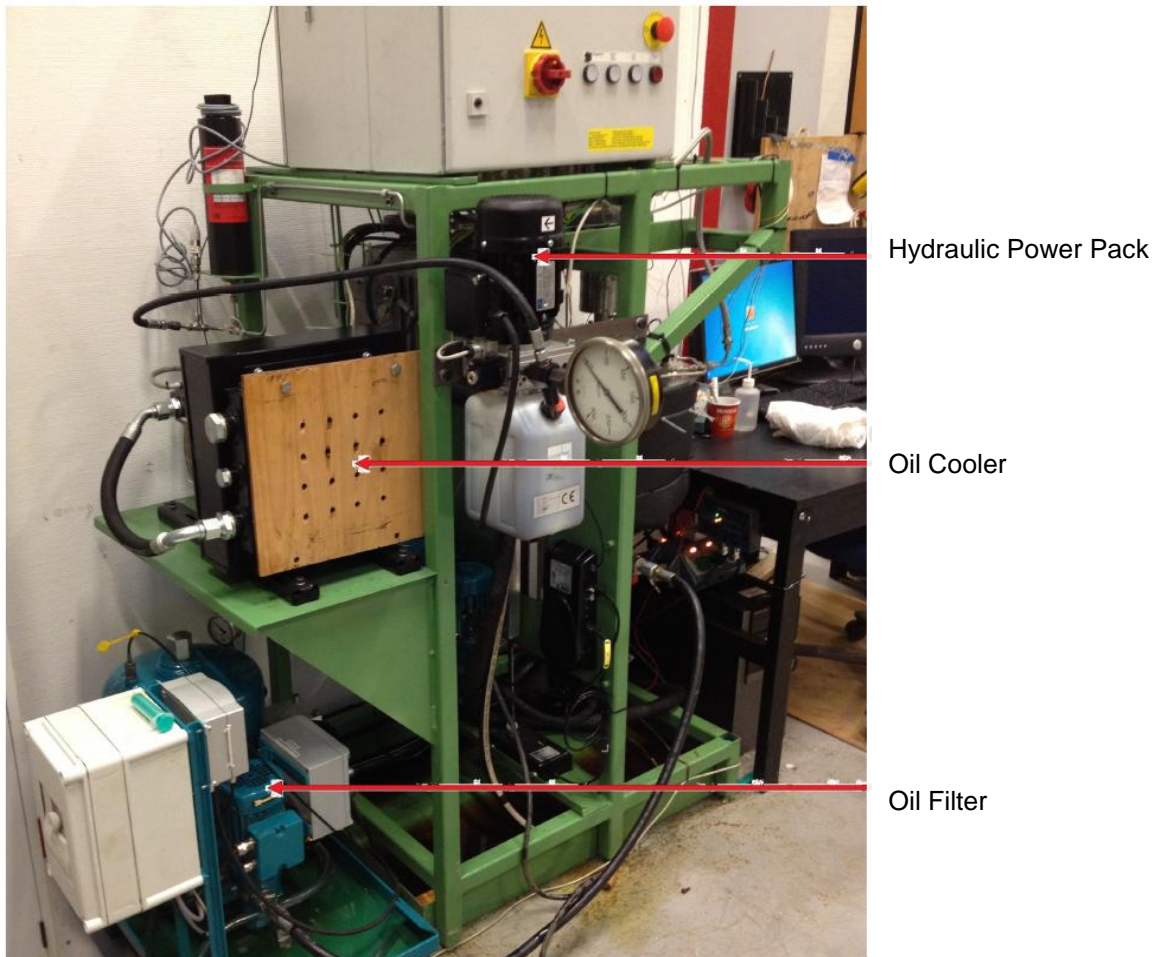
Figure 7 Image of DFTR – Status 2013

The ideas were converted to a physical setup and the result after a few iterations is shown in Figure 7 -Figure 8. The pictures show the frame in which the test piece is installed - Figure 7 and a close-up of the test piece itself in Figure 8

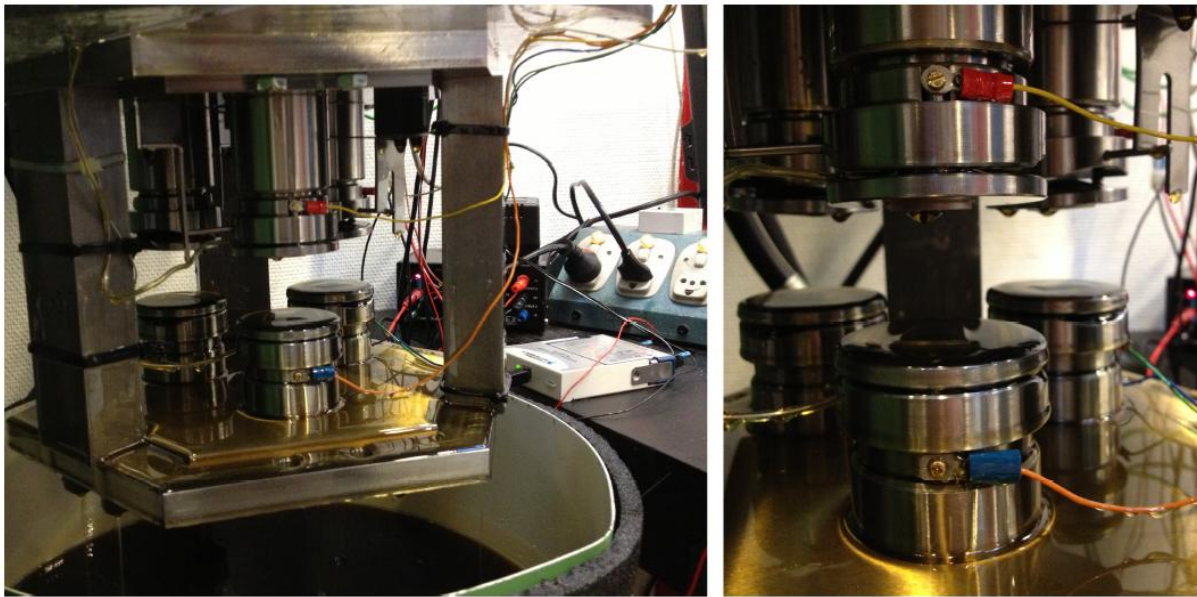
**Figure 8: Hexagon. The pads with wires for the ERM-system can be seen**

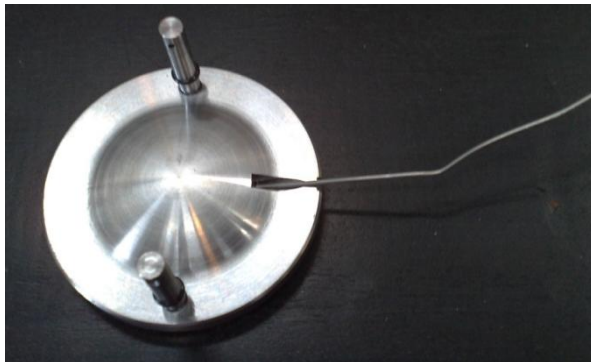
Figure 9. Temperature hole in pad with thermocouple inserted

Figure 10. Graphic illustration of thermocouple holes placement

The temperature is one of the most influential factors in the test rig, both the oil viscosity and the fatigue properties of the bearing material are influenced by the temperature. The temperature is measured in the oil bath and in one of the bearing pads. The lining temperature can be estimated from the temperature in the bearing pad surface and the oil bath temperature – see Figure 9 -

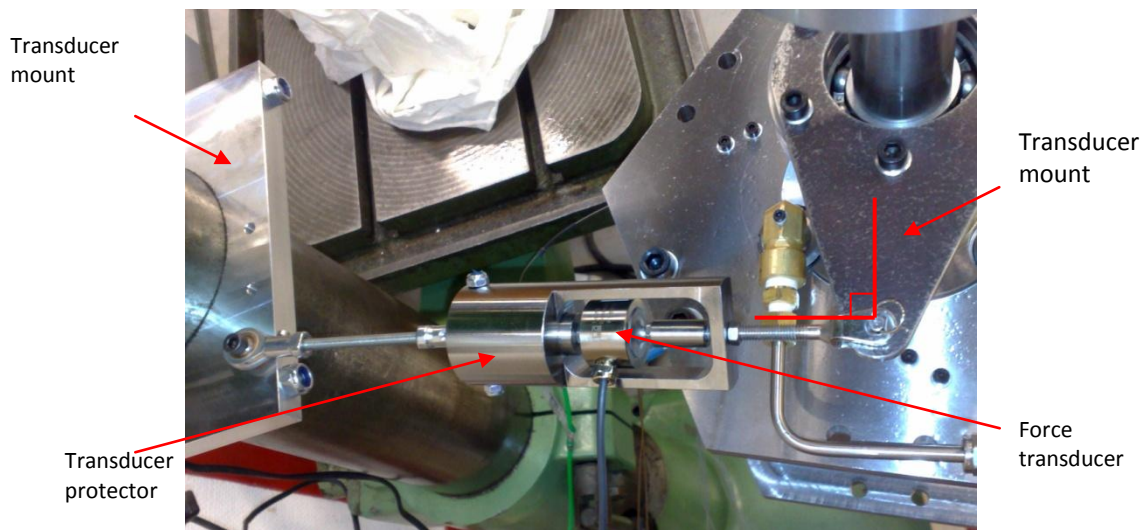
Figure 11. Force transducer installed on the test-rig

The accumulated friction force of all six tilting-pads is measured with a force transducer. The force transducer measures the necessary retaining force to keep the test hexagon from rotating. The friction force may together with a distance measure and a speed measure give an idea of the power loss in the bearing arrangement. See Figure 11.

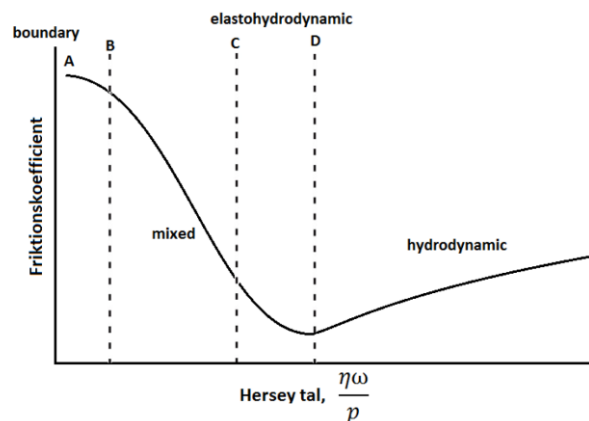
Figure 12: Stribeck Curve

To achieve realistic conditions for fatigue evaluation the hydrodynamic condition must be validated. Before each test a Stribeck curve is created by either changing the speed of rotation or the bearing load. The measured data can then be used to validate that the test parameters lies on the increasing part of the Stribeck curve – see Figure 12. The area of interest is situated in the right part curve – (to the right of D).

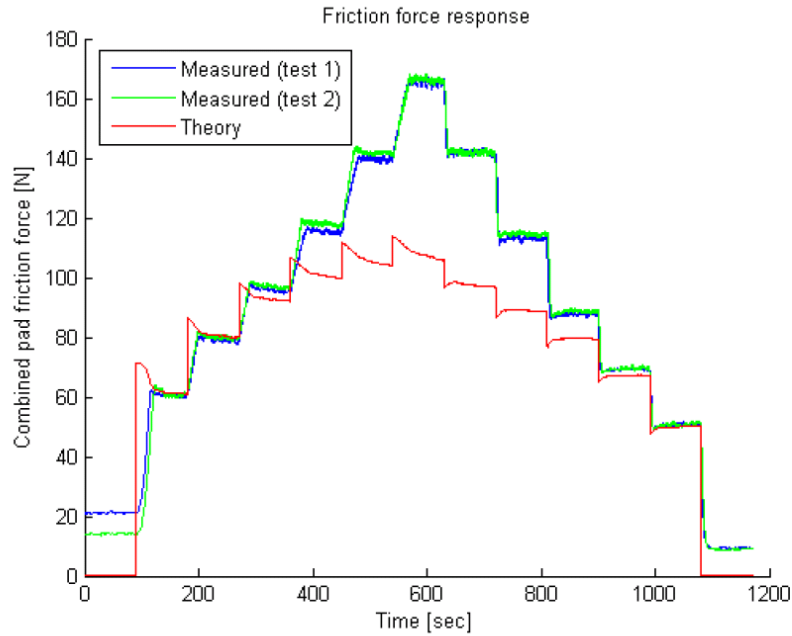
Figure 13: Friction Force versus Time. The friction force shows the same behaviour between different experiments and also between different load cycles. The load was ramped up every 90-100s until the max load was applied after 600 sec. Following that the load was reduced in steps until the load was fully removed.

A step test where either the bearing force or the rotation speed has been changed in steps up and down has been performed to validate that same results is obtained with the same test conditions. The test has shown good repeatability – see Figure 13.

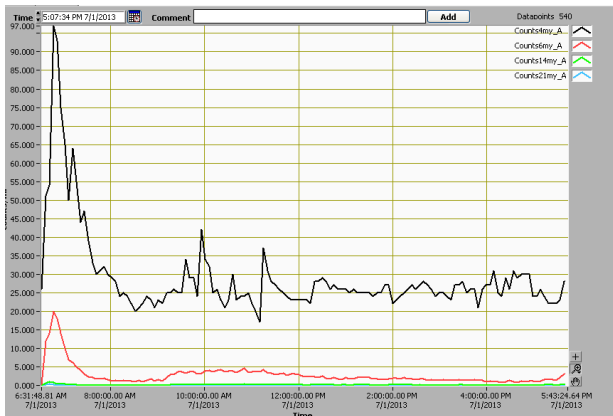
Figure 14 Oil contamination during startup. The figure shows that at the initiation of each experiment a lot of particles are present in the system which need removal, hence a certain start-up sequence is initiated before each experiment.

The oil was filtered during the experiment and the level of particles was monitored during the experiment – see Figure 14. The oil contamination monitoring system has in some cases proved to be a good indicator of crack detection – see Figure 15. But in some of the experiments no apparent increase of particles could be seen although initiation and build-up of fatigue cracks was ongoing.

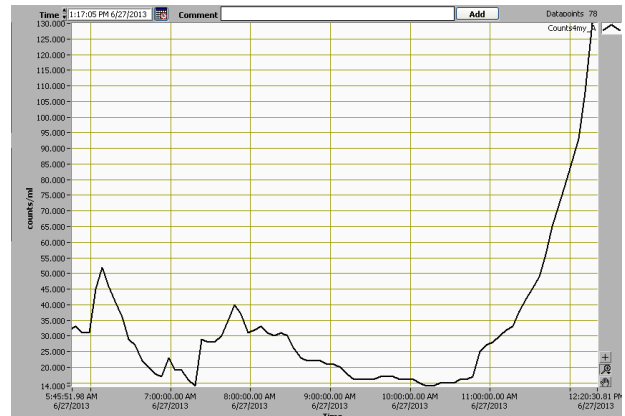
Figure 15 Oil contamination of 4 µm particles suddenly increased. When the experiment was stopped a crack was detected by visual inspection.

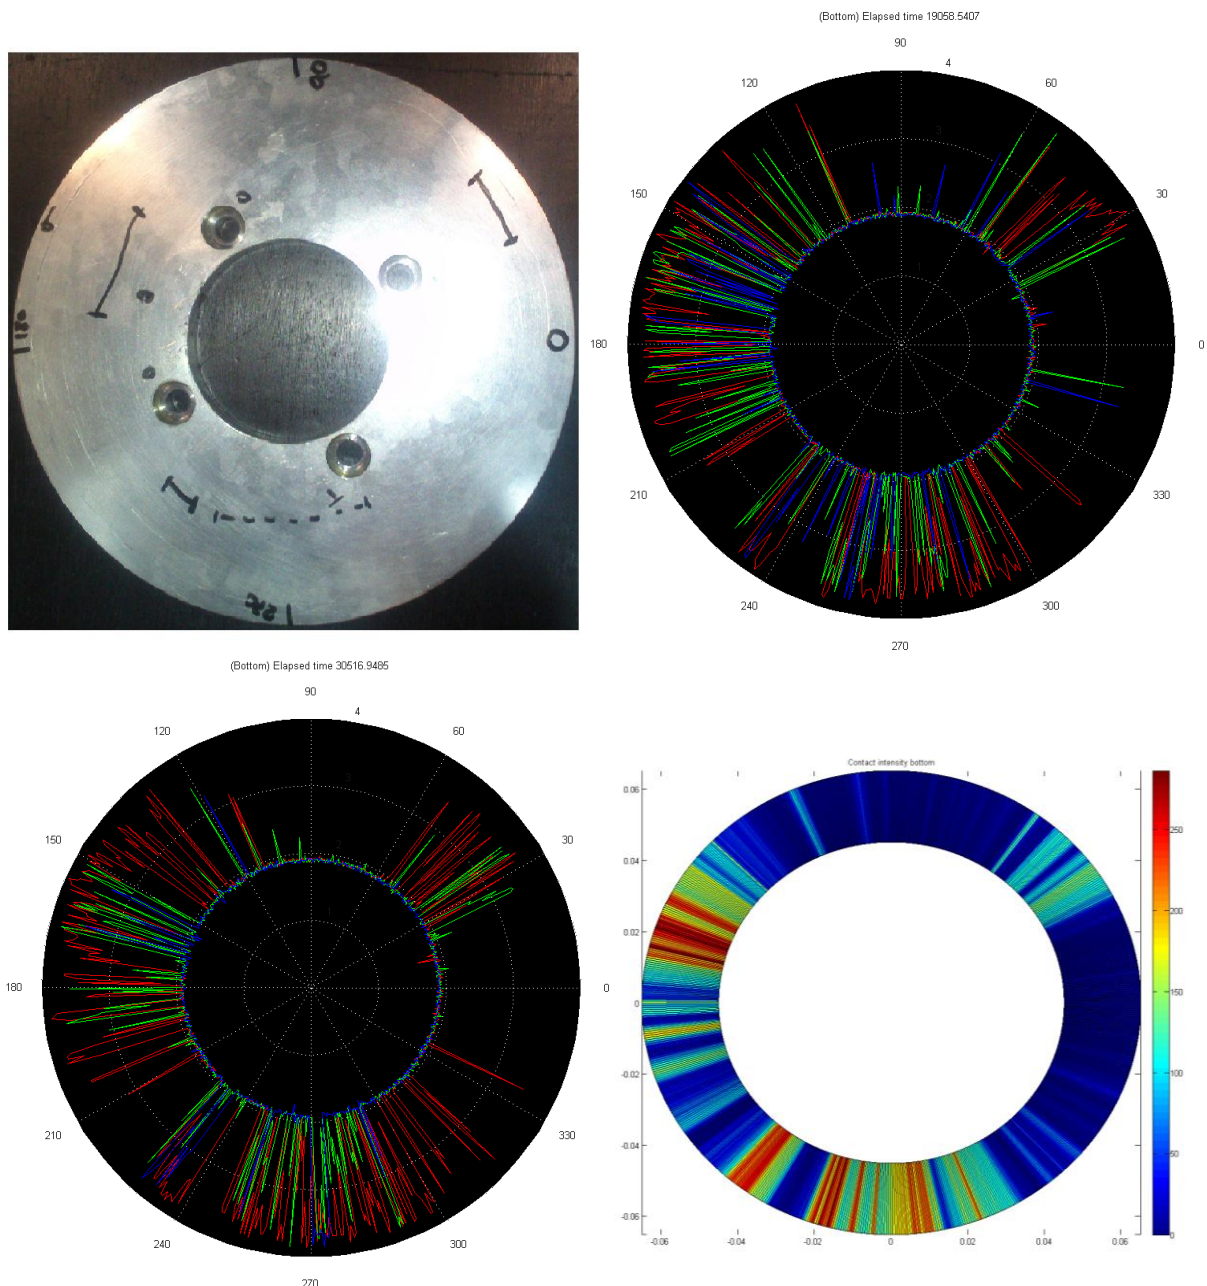
Figure 16 ERM experiment with damaged disc. Upper left: The Markings shows where damages are observed applied. Upper right: Contact during one revolution after 5.3 hours. Lower left: Contact during one revolution after 8.5 hours. Lower right: Accumulated contacts during test.

The ERM method was evaluated by adding scratches on a test disc to simulate fatigue cracks. The scratches results in puncturing of the oil film pressure build up and hence contact between tilting-pad and disc as a result. Due to the low oil film thickness with the specific load of 300 bar the particles in oil also results in contact. In Figure 16 a damaged disc, two momentarily polar plots of the contact voltage and the accumulated contact intensity is shown. For detection of cracks it is intended to use some sort of moving average for the accumulated intensity plot where contact due to particles are filtered.

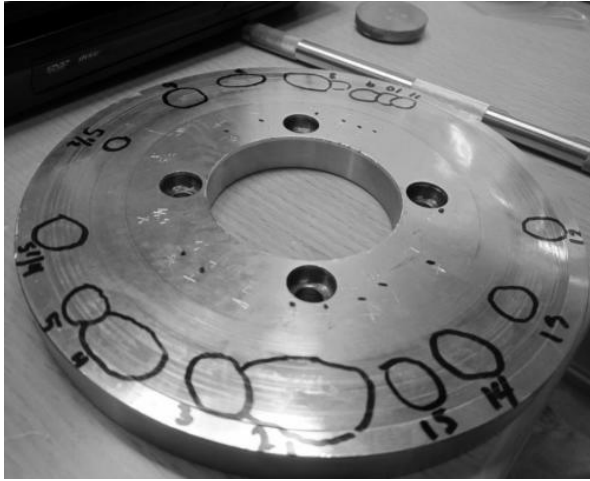
**Figure 17 : Disc With Fatigue Damages**

The initial test after the verification was completed showed that the specification of the DFTR was adequate for establishing fatigue damages in the produced white metal discs – Figure 17. The picture shows markings of individual areas where cracks have been observed.

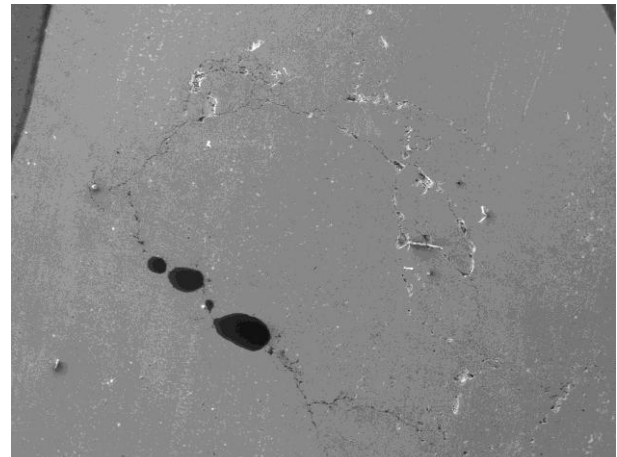
**Figure 18: SEM-image of Fatigue Crack**

These cracks were further examined using a scanning electron microscope (SEM). An example of this may be seen in Figure 18. The cracks are similar in appearance to the cracks typically found in conventional bearings for large two-stroke marine diesel engines. Figure 18 shows an area where multiple cracks are present and thus very interesting. In many of the cracks observed in real engines the cracks spread out and eventually meet each other. This may lead to areas of islands where the white metal island is fully separated from the main body by cracks and eventually disengages from the rest of the structure thus leaving a void – see Figure 19 . The pictures show this tendency of crack evolvment, the pictures originate from an earlier experiment with the DFTR.

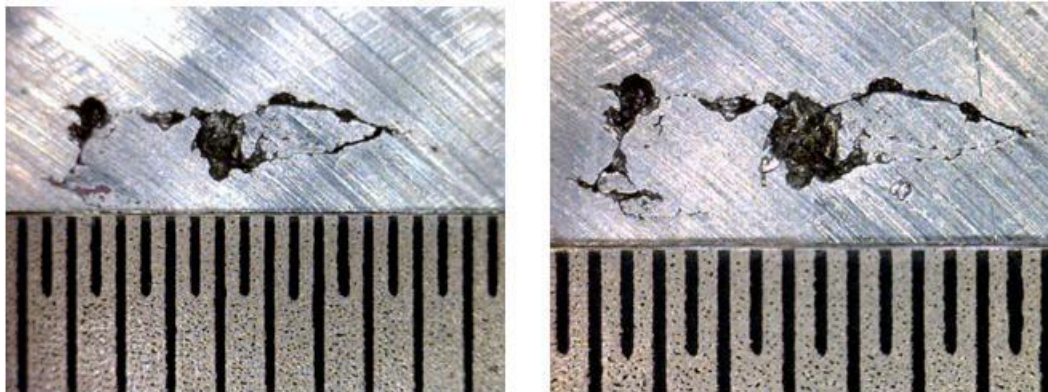
**Figure 19: Fatigue Crack after a) 6.1 Mio. Cycles and b) 7.7 Mio. Cycles**

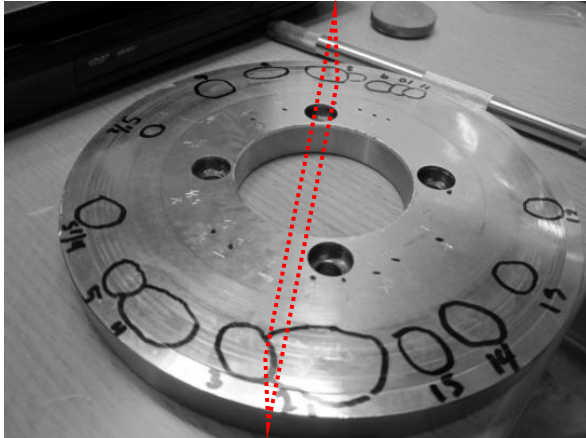
Figure 20: Cutting of Cross-section

Having examined the cracks in Figure 18, a selected part of the disc was cut. The position of the cross section cut can be seen in Figure 20.

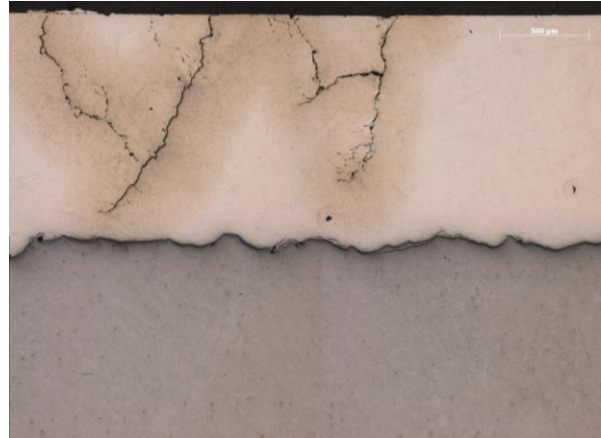
Figure 21: Cross-section of Crack

The cut out was grinded and further inspected in the microscope – see Figure 21. The picture shows the running surface as a line in the upper part of the picture, the white metal layer and the base material (steel). As shown in the picture it is obvious that some cracks (originating on the surface) are crossing each other below the surface thus making it possible for white metal particles of significant size to leave the disc. Furthermore it is observed that the cracks tend to change direction once the crack is getting closer to the steel interface. The examination clearly demonstrates the nature of the crack generation and propagation in white metal bearings. Furthermore it is concluded that the DFTR is capable of producing fatigue behaviour of white metal bearing alloys.
