3D DATA PROCESSING TOWARD MAINTENANCE AND CONSERVATION. THE INTEGRATED DIGITAL DOCUMENTATION OF CASA DE VIDRO

M. Balzani¹, F. Maietti^{1*}, L. Rossato¹

¹ University of Ferrara, Department of Architecture, Ferrara, Italy, (bzm, federica.maietti, luca.rossato)@unife.it

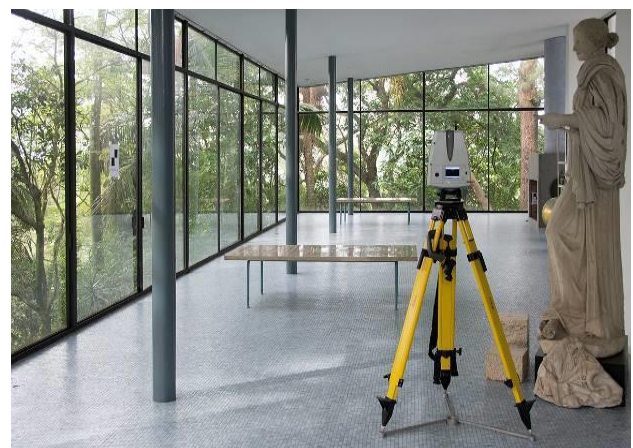
Figure 2: Interior view of Casa de Vidro during the data capturing procedure

These first quick campaigns of laser scanner surveys allowed to verifying the feasibility of a full survey on the building (Bianchini et. al., 2018) towards the restoration and possible insertion of new architectures into the garden as an archive-museum of the Foundation (Figure 2).

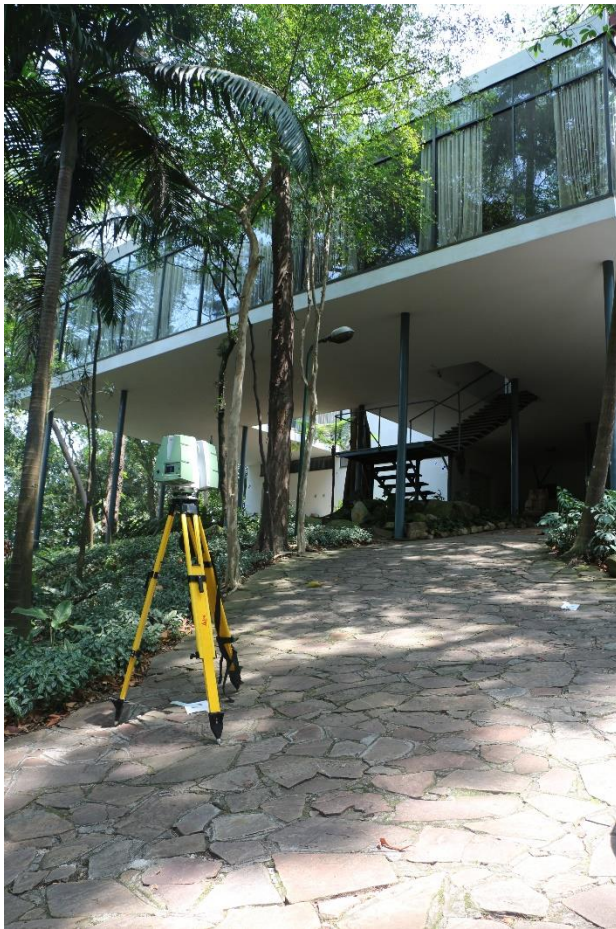
Figure 3: External view of Casa de Vidro during the data capturing procedure

As already mentioned, despite similarities of Casa de Vidro with architectures by Mies Van der Rohe and Le Corbusier, it appears less metaphysical and more linked to the nature. Following its characteristics, the survey had to take into consideration the different architectural features: from the slim metal columns supporting the front of the house, which is defined by the horizontal planes of floor slabs, to the relationship of architecture and nature (Figure 3).

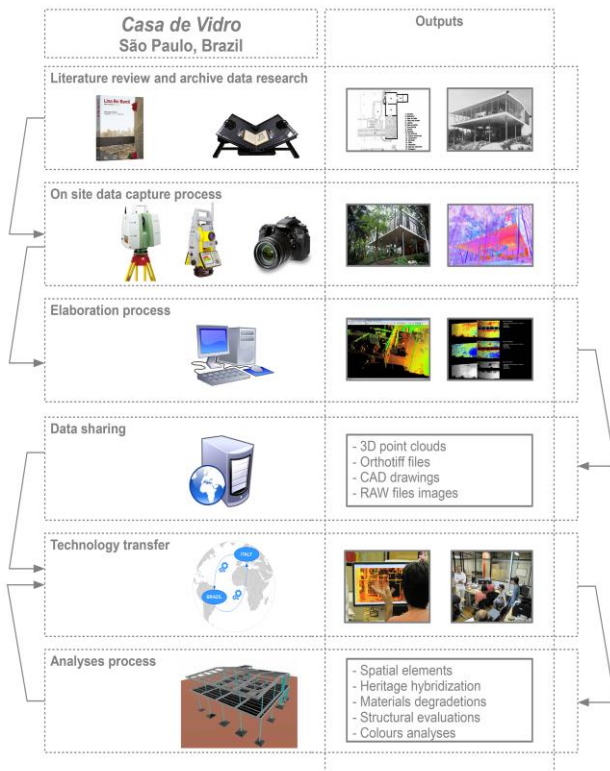
Figure 4: The integrated data acquisition methodology applied during the digital documentation of Casa de Vidro, and the main outputs achieved

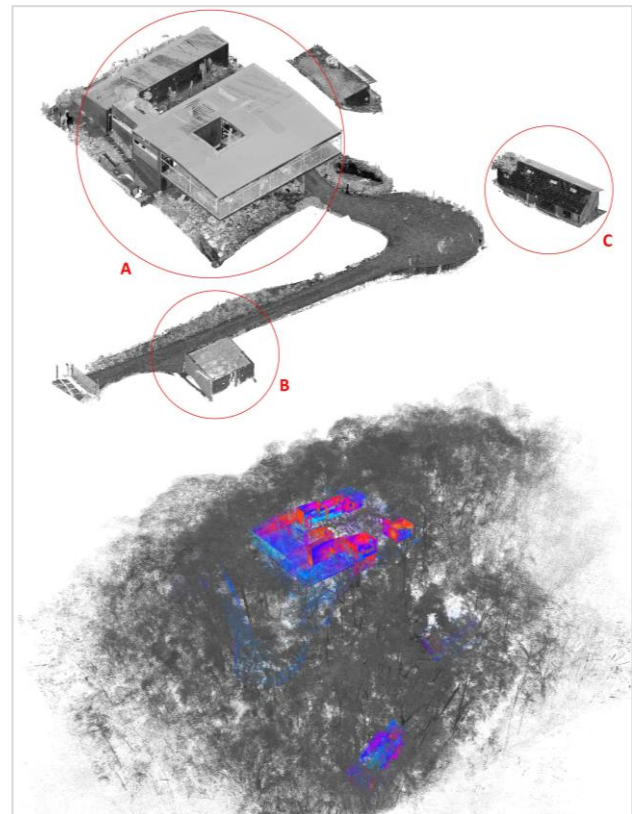
Figure 5: Casa de Vidro and the relationship with the landscape: on the top, image extraction from 3D database of the house, (A) the garage (B), and the Lina Bo Bardi's office (C)

The winding paths in the gardens provided numerous routes for a walk but many trees were more than an obstacle for the laser during the operations (Figure 5);

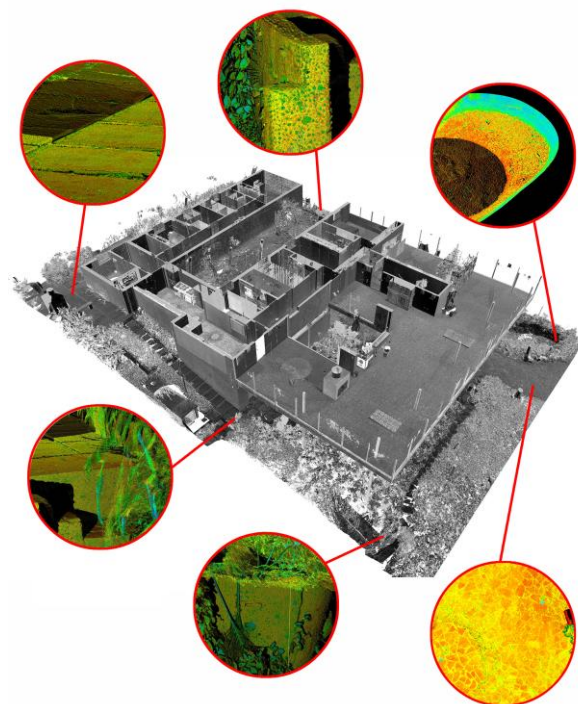
Figure 6: Identification by point cloud analyses of concrete cracks on external walls due to vegetation pressure

The house is currently facing some problems regarding the deterioration of materials (Cacciotti et. al., 2015). One of the main degradation issues is the besetting of vegetation, which is growing on external walls and on horizontal surfaces due to the local climate, making some cracks visible due to the vegetation pressure (Figure 6). The digital survey campaign, including the external areas and the garden, has been integrated by a diagnostic survey to map the state of conservation and the main degradation issues (Kioussi et. al., 2012).

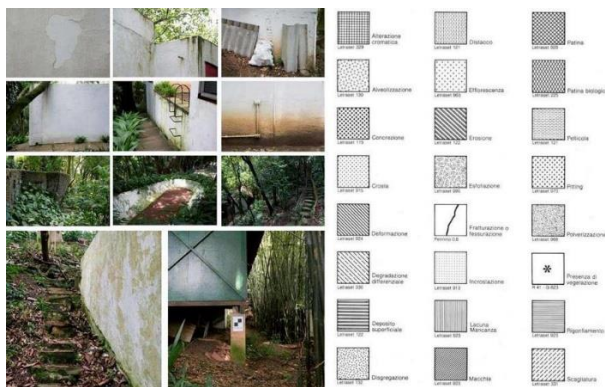
Figure 7: Main degradations affecting the surfaces of part of the house identified during the on-site diagnostic survey

Besides vegetation, the main degradations surveyed on external surfaces are:

- biological patina and biological crust;
- chromatic alteration;
- surface deposit;
- lacuna;
- deformation and detachment.

The main deteriorations on interior surfaces concern:

- lacuna and deformation of the plaster;
- moisture stains and biological crusts.

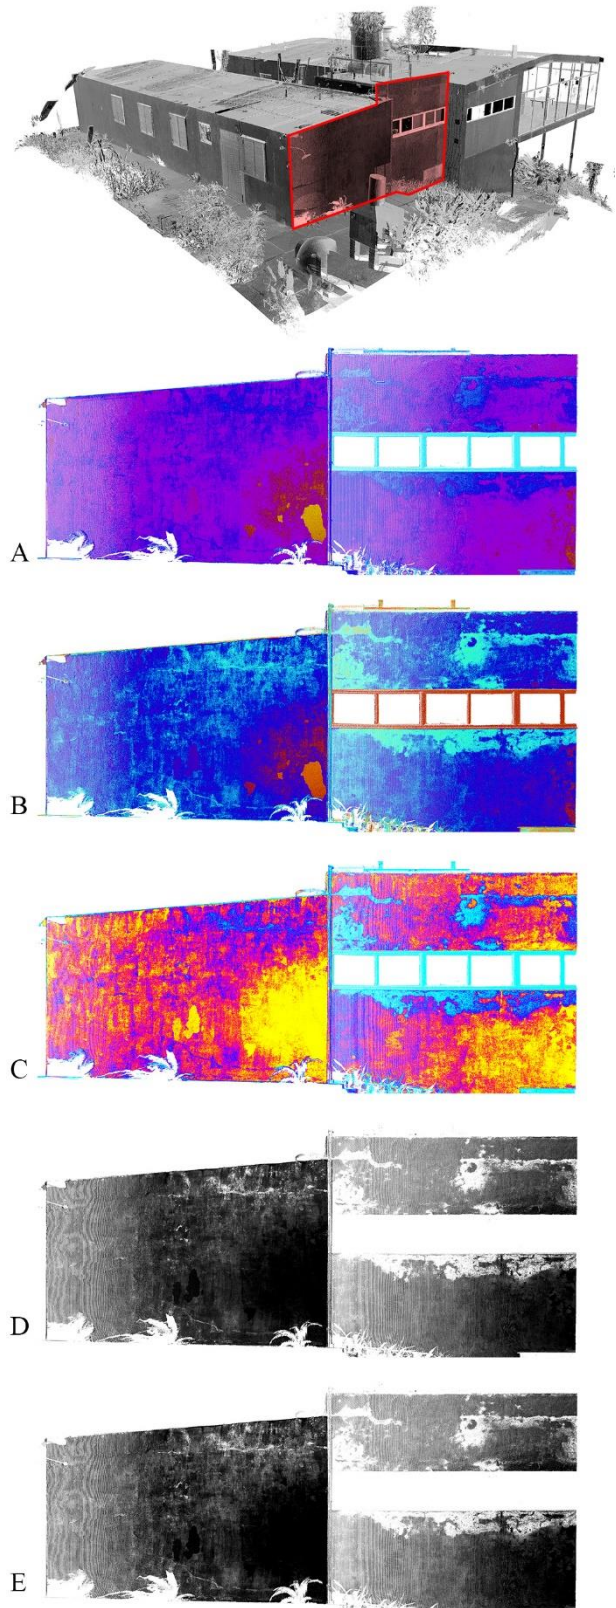
Figure 8: Elaboration of intensity values of the point cloud of Casa de Vidro, processed by several parameters and aimed at visualizing and analysing surface specifications (see Table 2)

Table 2: Intensity values data tested during the post-processing in colours from scanner and greyscale visualization
