46TH TURBOMACHINERY & 33RD PUMP SYMPOSIA
HOUSTON, TEXAS | DECEMBER 11-14, 2017
GEORGE R. BROWN CONVENTION CENTER

Atypical Results from Improperly Sized & Charged Pulsation Dampeners

At a facility with four quintuplex pumps, pulsation dampeners were being used to control pulsations in the discharge line. However, the initial dampeners were both undersized and undercharged for the application. As a result, in addition to some typically expected results, including high pulsations and frequent failures of the internal bladders, the effective volumes of the dampeners and lengths of piping in the system set up an acoustic natural frequency that caused significant safety concern and limited system operability. This natural frequency was in a range that could be excited by the pumps such that the presence of the dampeners in the system was actually causing even higher pulsation levels. This paper will look at the troubleshooting efforts including field testing and acoustic simulations. Results from the modified system will also be discussed.

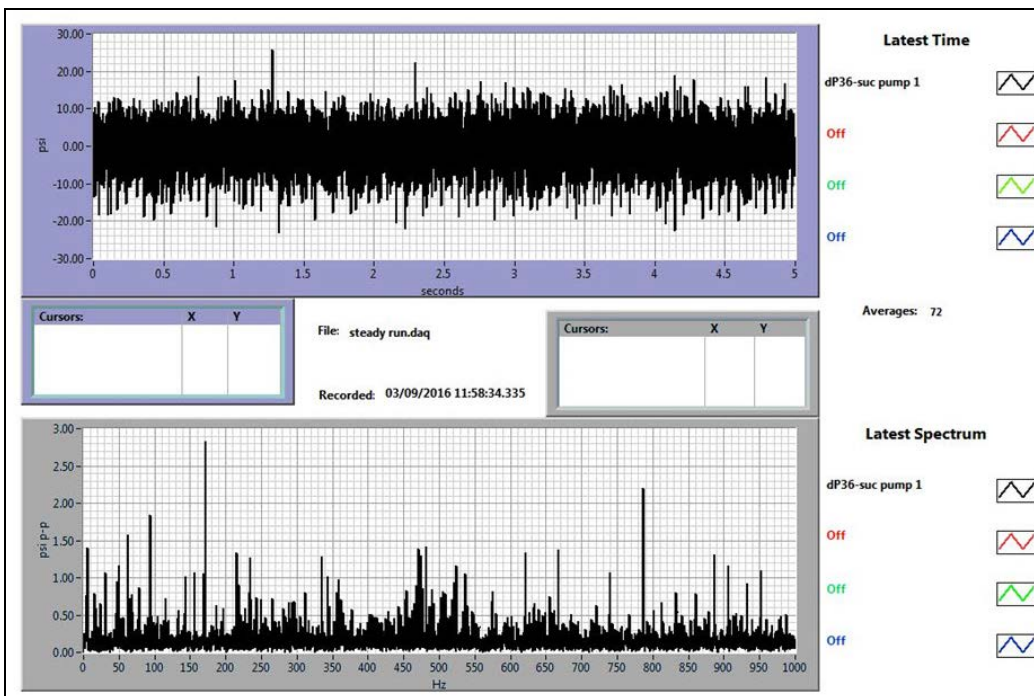
Figure 9: Suction Line Pulsations

Pulsations were also measured on the suction side of Pump 1, example shown in Figure 9, to determine the possibility of cavitation occurring on the suction side of the pumps. Overall and spectral pulsation levels in these signals were significantly less than what was seen on the discharge side. The overall timewave pulsations generally ranged from about ± 20 psi. Given a static pressure of 39 psi, this meant pressure on the suction side dropped to no more than about 19 psi. This pressure would be sufficiently above vapor pressure for the water that the chance of cavitation occurring in the pumps was not considered significant. Additionally, the low levels and overall appearance of spectral pulsation did not indicate the likelihood of cavitation either.

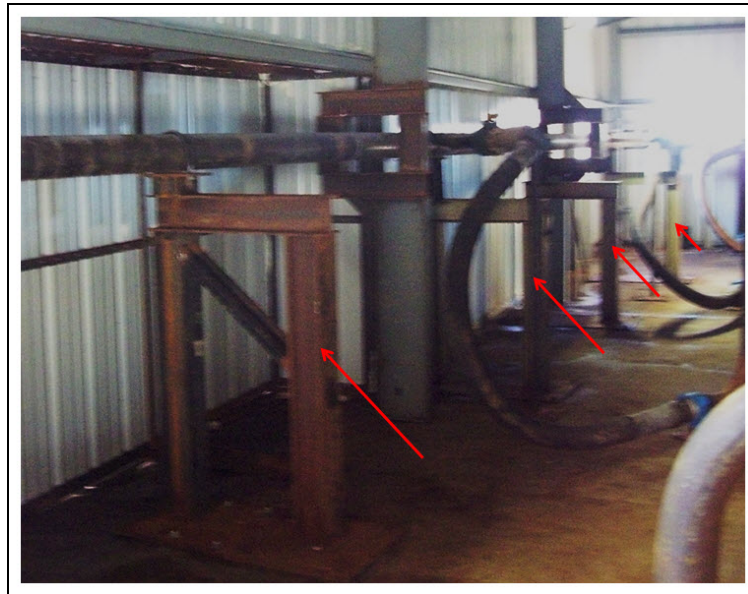
Figure 17: Supports on Header

Besides the discharge piping, a number of supports on the header could have also be altered to improve vibration response. In particular, there are four supports (identified in Figure 17) on the header with similar designs that are prone to mechanical resonance excitation. The very first one in this image was particularly susceptible to vibration, with a resonance at 17 Hz and mode shape as indicated in Figure 18.

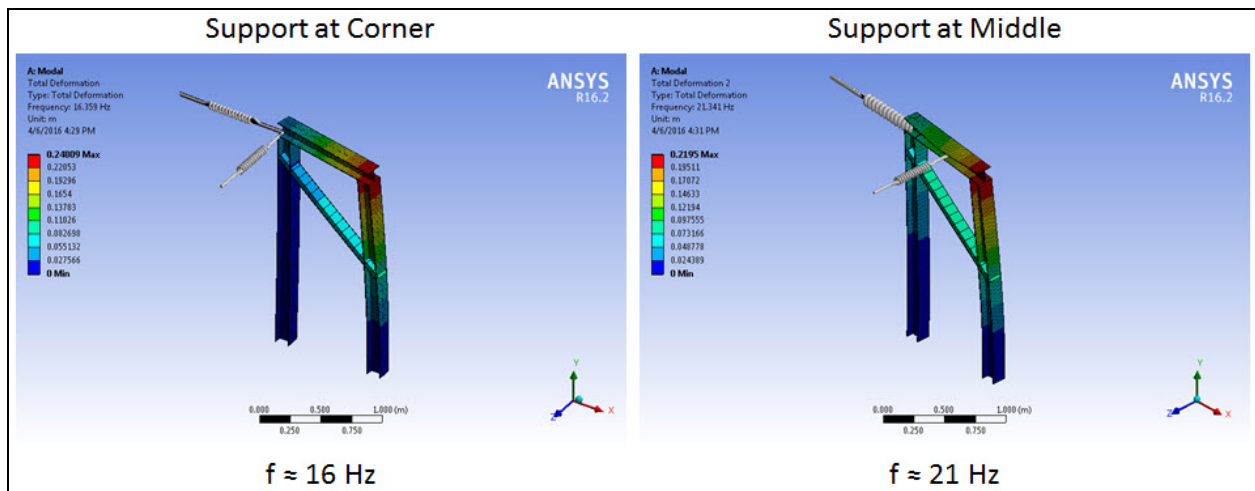
Figure 19: FEA Results for Support Location

Ideally, as previously mentioned, the header would be lowered closer to grade so that it could have shorter supports. Given the necessity to remain at this elevation, however, the next best option is to provide additional bracing to stiffen the support in the direction of the pipe axial direction. At the very least, a rough FEA model of this support shows that by simply moving the support over, so that the pipe is supported in the middle of the cross-beam instead of at the corner, the first natural frequency could be increased as illustrated in Figure 19. (Note: this is not an exact model of the support, but only a conceptual illustration of the possible support; therefore, natural frequencies were not expected to be an exact match to field data.)

As with the supports on the discharge piping, changing the simple U-bolt restraints for strap-type clamps was also recommended wherever the pipe was restrained. Other restraints also existed on the header, as shown in Figure 20, that were in essence only weight supports given the high length-to-diameter ratio of the supporting pipes (yellow arrows). As such, the U-bolt restraints would do little more than possibly wear on the pipe. Replacing the U-bolt restraints with a pair of supporting wedge blocks with proper low friction material would be more adequate. This would also allow for adjustments so that the header piping would be supported given any thermal expansion that could lift the pipe off the support. It was noticed while on-site that the support for the connection of Pump #1 (shown in the upper right image of Figure 20) was only providing limited, if any, weight support as the pipe was lifted off its ground support and could be moved by hand.

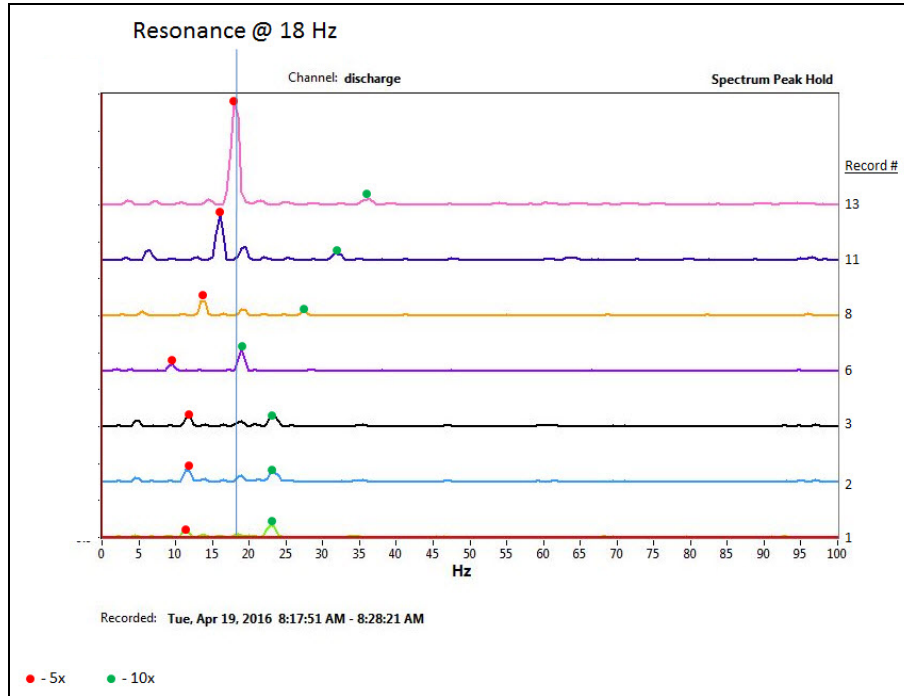
Figure 21: Oil Pulsation Data - Set 1 Discharge Spectra

Based on the first set of data collected by this means, it was determined that a resonance in the system with oil as the working fluid existed at about 18 Hz, as shown in Figure 21. This resonance was seen as the 5x order of running speed neared the resonance (especially during the 13th record), and also when the 10x order of running speed was near the resonance (as seen during the 6th record).

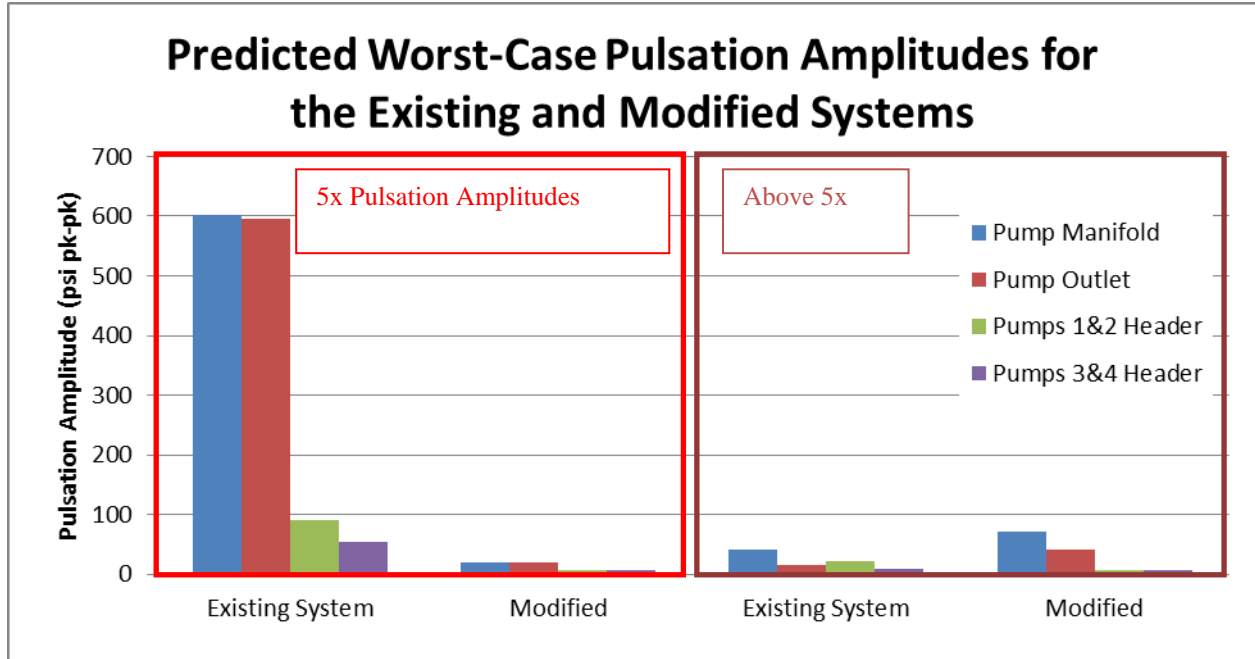
Figure 28: Summary Graph of Worst-Case Predicted Pulsation Amplitudes

The worst-case (assuming worst case phasing between units) predicted pulsations for the existing/original system and modified system, while pumping oil, are summarized in Table 5 and Figure 28. It was predicted that a pulsation amplitude reduction of 97% would be achieved for the worst case 5x pulsations. A pulsation amplitude increase was predicted at orders above 5x; however, the overall reduction in the piping system pulsation amplitudes was considered significant and acceptable. It was predicted that shifting the piping system acoustic resonance to a frequency well below the primary pump excitation order (5x) would result in significantly reduced piping system pulsation amplitudes.
