**ON-SITE DETERMINATION OF THE CONTROL LINE FOR INTEGRALLY GEARED COMPRESSORS FOR AVOIDANCE OF IMPELLER FATIGUE FAILURES**

In this lecture a root cause analysis (RCA) is presented for a fatigue failure of a semi-open impeller of an integrally geared compressor. The compressor had been in service for about one year in an air separation plant, when this failure occurred on the 3<sup>rd</sup> stage impeller.

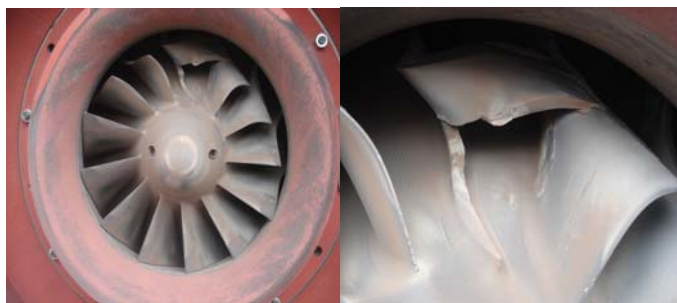
Figure 2: Photographs of failed impeller

In August 2009 one of the two main air compressors, which will be described in the next paragraph, was shut down due to high shaft vibrations. After opening of the machine a damage of one impeller blade at the 3<sup>rd</sup> stage was found, cf. Figure 2.

This impeller had been running from October 2008 till August 2009. The hours in operation till failure were 5272, the number of starts in this period was 35. The damaged impeller was sent to the OEM's shop for further investigation.

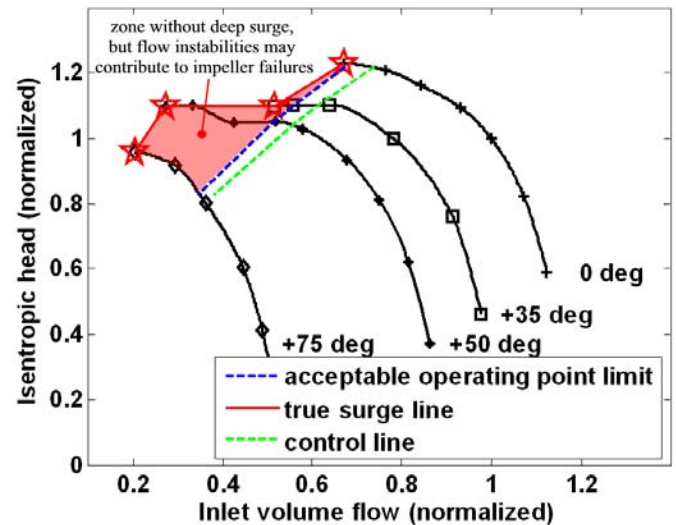
Figure 15: Compressor map from R&D testing

The influence of inducer stall on the operating map of a centrifugal compressor can be exemplarily deduced from Figure 15 and Figure 16. Both figures are valid for constant speed and different settings of the inlet guide vane. The results are derived from a systematic investigation into the near-stall characteristics of an unshrouded impeller at the OEMs R&D test facility. This impeller is similar to the one under investigation in the current root cause analysis. In Figure 14 the isentropic head is plotted on the ordinate versus the inlet volume flow on the abscissa. In Figure 16 the total temperature rise of the test stage is plotted versus the same x-coordinate as used in Figure 15. In both figures the operating points where deep surge was detected are labeled with red stars, connected with a red solid line. This line is the true surge line. It can be clearly seen the true surge line is located far left of the blue borderline, which gives the acceptable operating point limit (the conventional “surge line”). The envelope between the blue and the red line gives the operating regime where local flow instabilities occur, but where the compressor still operates without falling into deep surge. This operating regime is highlighted as the transparent red area. The extent of this area indicates that a distinction between the true surge line and the conventional surge line is advisable for the impeller under investigation. The differences between the two lines are especially pronounced for positive pre-swirl (compare the curves for +50 and +75 deg swirl angle). In the R&D study the blue borderline was defined as the limit, where recirculation did occur. A typical indication for a recirculation zone can be deduced from the total temperature rise in Figure 16: if the total temperature curve traverses an inflexion point when reducing the volume flow this is a strong indication for backflow. In the R&D study this observation could be further confirmed by means of temperature measurements upstream of the impeller (not presented in the paper). Based on the experimental arrangement depicted in Figure 14 the signals of three thermocouples were evaluated, and clearly elevated temperatures were measured when approaching the blue

borderline. It is important to note that for a positive pre-swirl of +75 deg the slope of the isentropic head curve to the left of the border line in Figure 15 does not give any indication of flow instability in the overall compression system. Nonetheless, to avoid inducer stall, the admissible operating range should be restricted to the blue borderline.
