# **Centrifugal Compressor Root Cause Analysis and Case Study (Pulsation and Vibration Issues)**

**Gufran Noor, P.Eng., General Manager, Field Services and  
Bill Eckert, P.Eng., Ph.D., Principal Engineer**

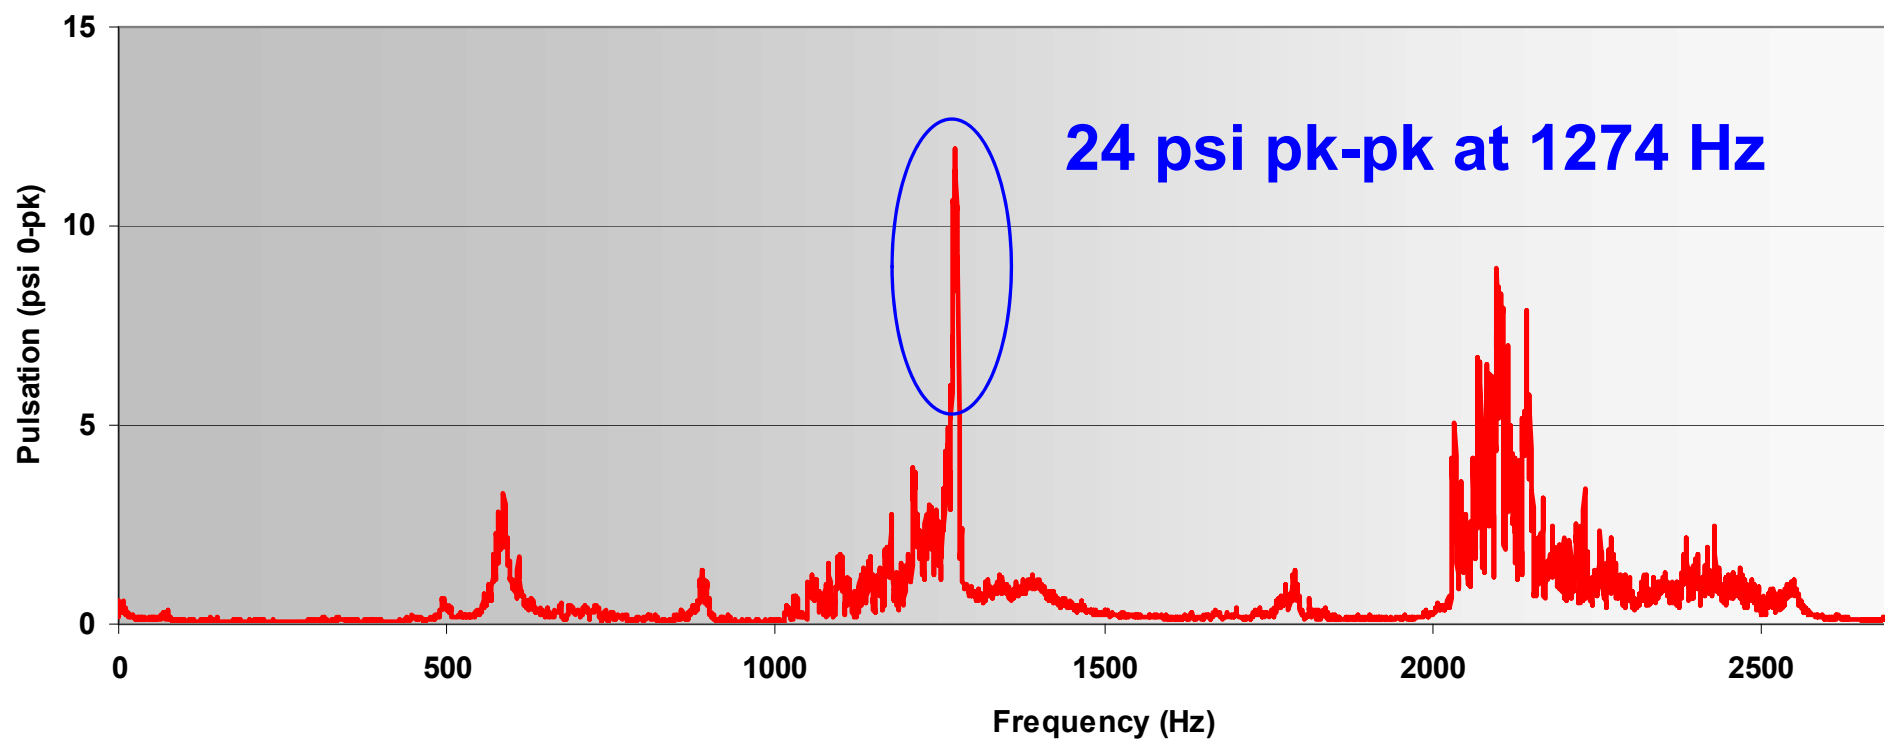
Discharge Piping (3600 – 4500 rpm)

- Peak pulsation = 1.65 bar pk-pk (24 psi pk-pk) @ 1274 Hz
- About 3% of mean pressure
- 1274 Hz = blade pass frequency at 4500 RPM (17 X Run Speed)

- Peak Pulsation Frequency = Peak Piping Vibration Frequency (17X run speed)
  - Impeller Blade Pass = 17X run speed
- Thermowell Vortex Shedding and Natural Frequencies  $\neq$  Problem Frequency
- Occurs at Steady State. Worst when not operating at Best Efficiency Point
- No likely Side Branch Sources
- Most likely source was Pulsation at Impeller Blade Pass

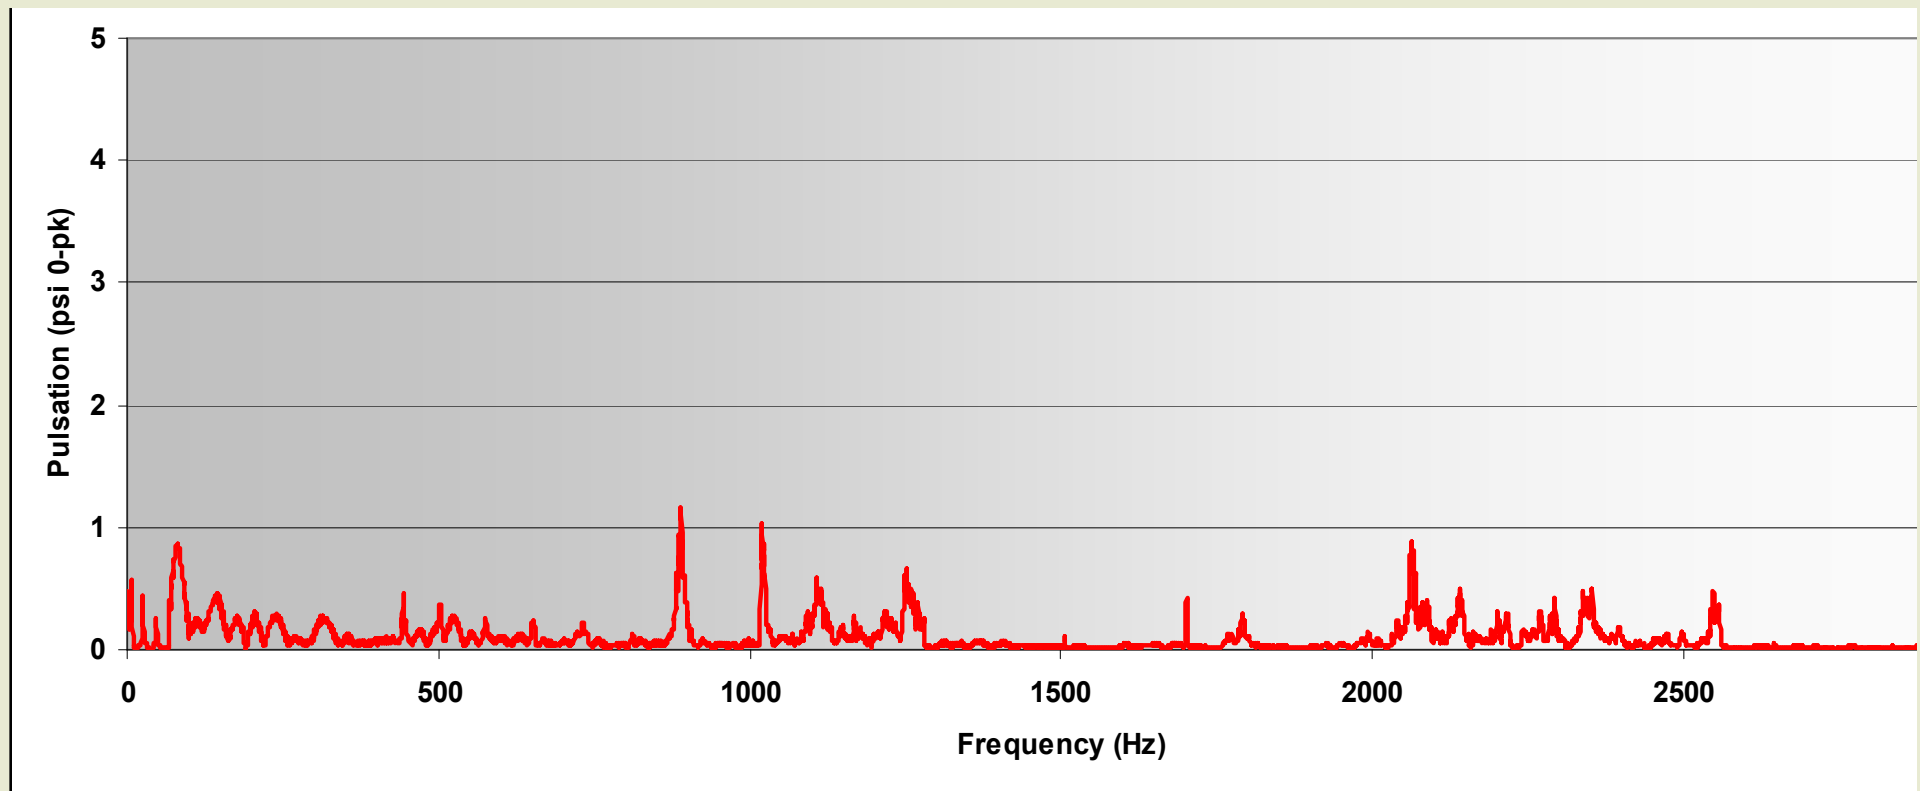
Compressor Suction Eye (3600 – 4500 rpm)

- Peak pulsation = 0.17 bar pk-pk (2.4 psi pk-pk) @ 830 Hz
- About 0.4% of mean pressure
- No Blade Pass Frequency found

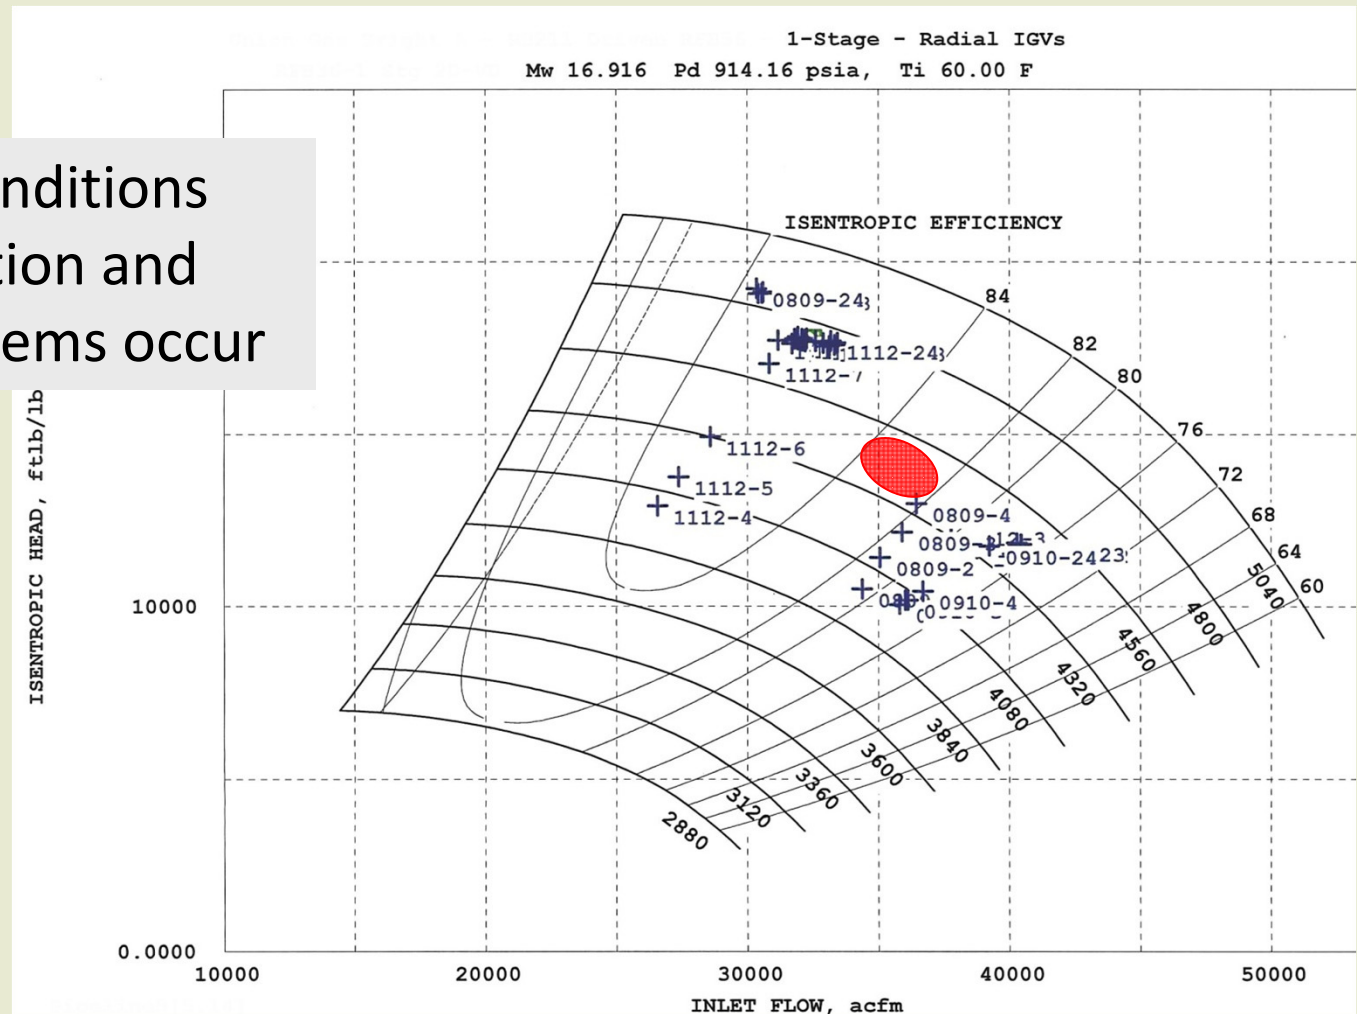
Operating conditions where vibration and pulsation problems occur

- Pulsation strength varies with operating conditions.
- Problems occur when compressor operates off its best efficient point

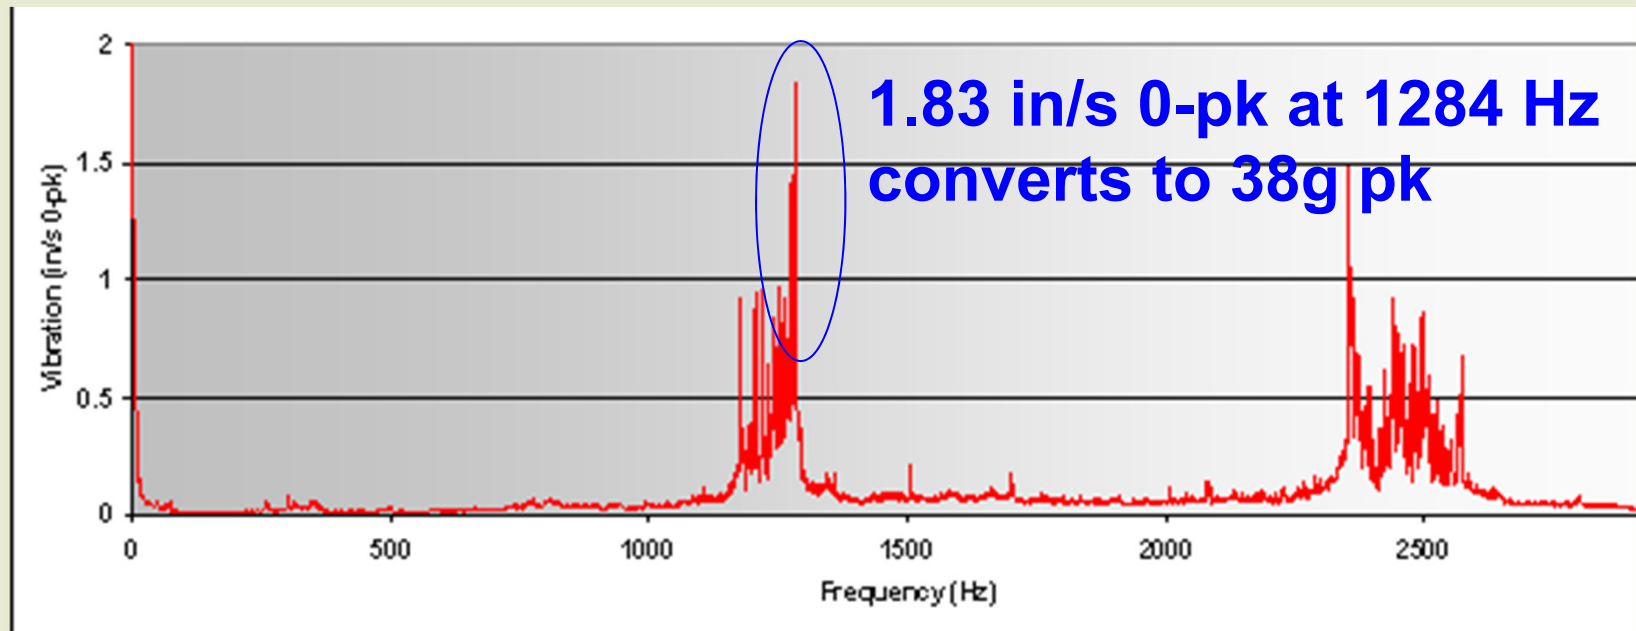
- Peak hold vibration @ speed range (4100 – 4510 rpm)
- 46.5 mm/s pk (32.9 mm/s rms, 1.83 in/s pk) @1284 Hz
- Discharge pipe (36" OD; 0.75" wall thickness)
- 1278 Hz = blade pass frequency at 4510 rpm
- Vibration equivalent to 38 g's pk (instruments rated for 10 g's)....no wonder RTDs failed

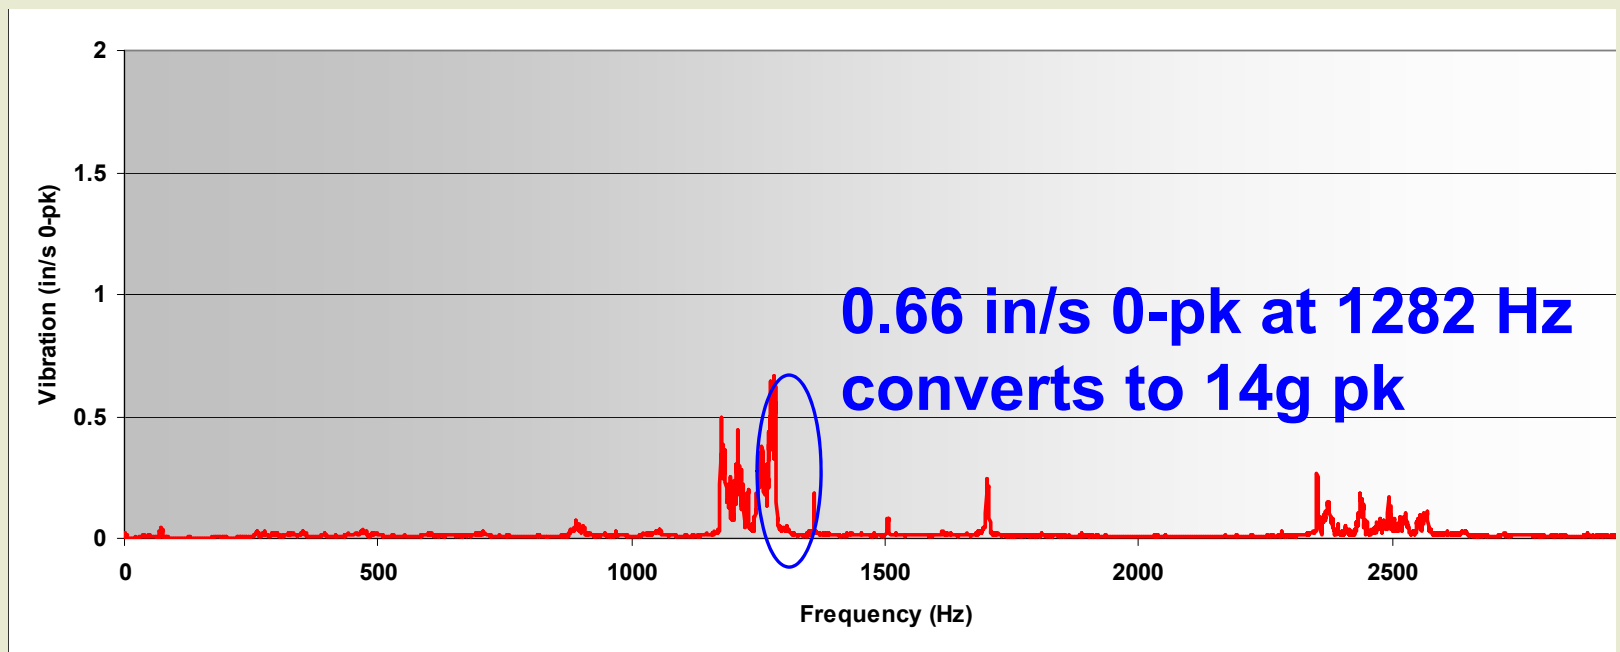
- Peak hold vibration @ speed range (4100 – 4510 rpm)
- 16.8 mm/s pk (11.9 mm/s rms, 0.66 in/s pk) @1282 Hz
- Suction pipe 914.4 mm OD (36" OD); 19 mm wall (0.75")
- 1278 Hz = blade pass frequency at 4510 rpm
- Vibration equivalent to 14 g's pk

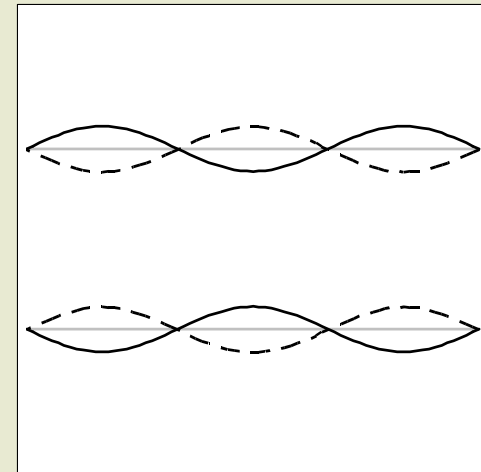
- Calculated ANF
- High frequency – not a simple plane wave
- Many possible ANFs with transverse and axial components
- ANF closely matched measured vibration/ODS
  - 1261 Hz vs. measured 1274 Hz
  - 5 pressure lobes in transverse mode
  - 3 nodes along axial length

Axial acoustic mode
