Testing of a Full-Scale Composite Floor Plate

Dennis Lam, Xianghe Dai, Therese Sheehan

Research**High Performance Structures: Building Structures and Materials—Article****Testing of a Full-Scale Composite Floor Plate**

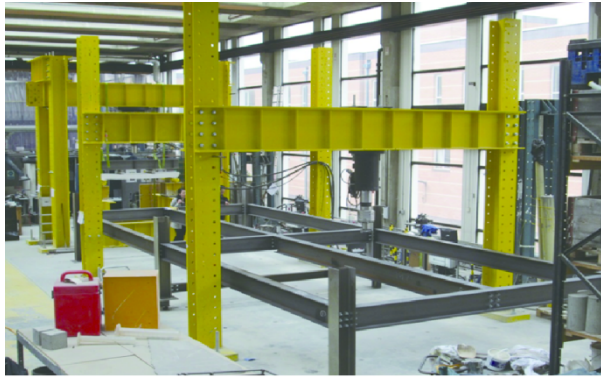
Fig. 2. Layout of the beams and columns in the floor plate test.

The floor beams and columns arrangement are shown in Fig. 2. The columns were 1.0 m high and the two central columns were designed to be 200 mm shorter than the other four corner columns, so that load cells could be placed underneath them to monitor the loads transferred to the central columns. The two central columns were tied to prevent outward movement, since it is possible that a small moment might be generated in the columns through the connections. An endplate with the dimensions 180 mm × 220 mm × 10 mm was welded to the web of the internal secondary beams (IPE300, sections were notched to fit) and bolted to the web of the primary beams (IPE270) using six No. M20 Grade 8.8 bolts (the bolt spacing was 70 mm in the vertical direction and 100 mm in the horizontal direction). An endplate with the dimensions 140 mm × 220 mm × 10 mm was welded to the web of the secondary edge beams (IPE270) and bolted to the web of the HEA200 columns using six No. M20 Grade 8.8 bolts (the bolt spacing was 70 mm in both the horizontal and vertical directions). An endplate with the dimensions 170 mm × 220 mm × 10 mm was welded to the web of the primary beams (IPE270) and bolted to the flange of the HEA200 column using six No. M20 Grade 8.8 bolts (the bolt spacing was 70

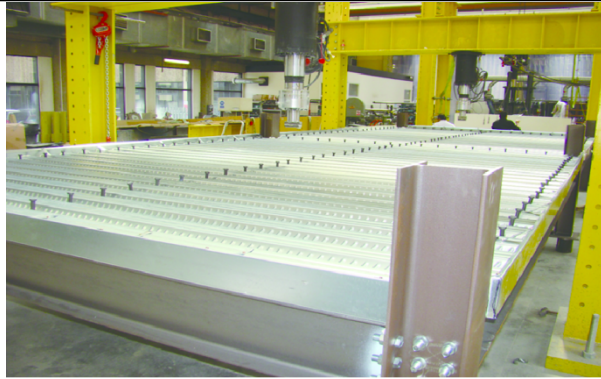
Fig. 4. Steel decking and shear connector arrangement.

The composite slabs consisted of a 130 mm thick slab with a 0.9 mm thick, 58 mm deep profiled decking (Cofraplus 60 from ArcelorMittal S.A.). The deck profile had ribs spaced at 207 mm and allowed the welding of a stud in the middle of the rib. Single 19 mm diameter shear studs (100 mm nominal height) were used, and the spacing of the studs was chosen to be 200 mm for the primary internal beams and 207 mm for all the secondary beams. Since the profiled decking was discontinued at the primary beam, the shear connectors were welded directly to the primary beams while through deck welding was used for the secondary beams. The shear connector details are shown in Figs. 4 and 5.

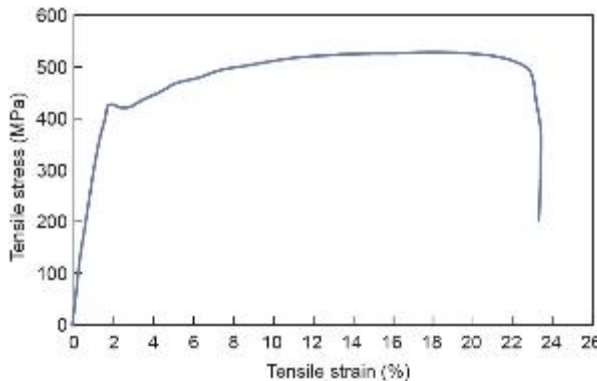
Fig. 7. Stress-strain curve of the steel material.

To monitor the concrete strength development, 15 cubes with the dimensions 100 mm \times 100 mm \times 100 mm were cast when casting the floor plate specimen. The average concrete compressive cube strength measured at 28th day was 32.7 N \cdot mm $^{-2}$ and the average concrete compressive cube strength measured on the test date was 33.8 N \cdot mm $^{-2}$, which is consistent with the target strength of C25/30 concrete. The yield strength and ultimate strength for the steel sections were measured at 420 and 525 N \cdot mm $^{-2}$, respectively. Fig. 7 shows the stress-strain relationship of the steel material from the coupon test.

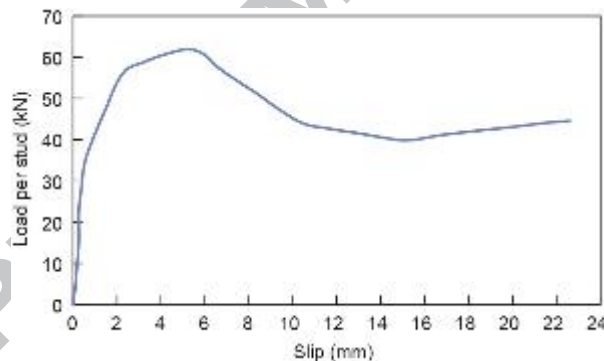
Fig. 8. Load vs. slip curve of the push-off test.

The shear connector resistance was calculated using the equations from EN 1994-1-1 [7] and was determined to be 61 kN for the case where the decking was perpendicular to the beam; this is consistent with the push-out tests carried out by our project partners. Fig. 8 shows the load versus slip curve from the push-off test with the same arrangement.

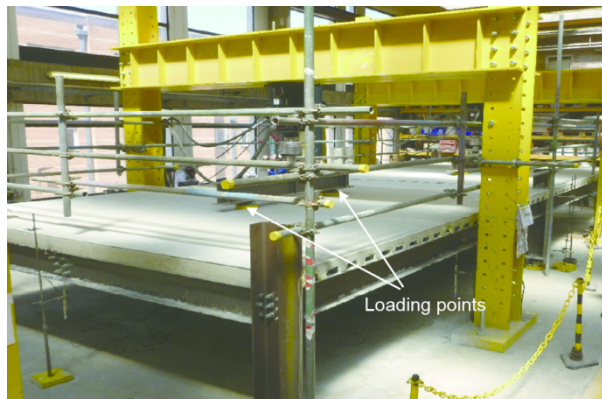
Fig. 11. Loads applied to the internal secondary beam.

The loading of the primary beam occurred through the point loads on the internal secondary beams, as shown in Fig. 11. The load positions on the secondary beams were

placed 1.4 m apart and were placed at a distance of 1.92 m to the web of the supporting primary beams, which is equivalent to 37% of the span; this was done in order to obtain the required moment and shear distribution. For the secondary beams, there were nine shear connectors from the support (primary beam) to the loading point. For the primary beams, there were eight shear connectors from the column face to the beam mid-span (where the internal secondary beam joined the primary beam).

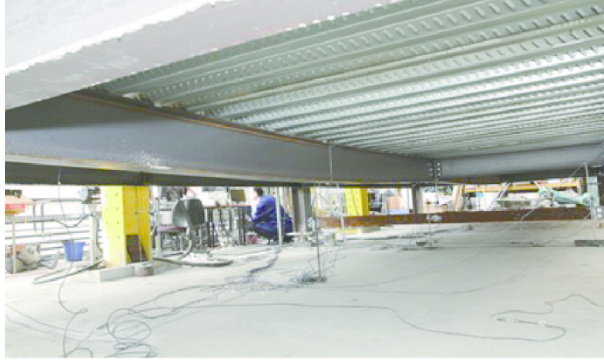
Fig. 12. Deflection of internal secondary beams at maximum load.

Table 1 summarizes the maximum deflections and slips that correspond to the maximum load for each loading cycle and the residual deformation after unloading. Up to the test load of $20 \text{ kN}\cdot\text{m}^{-2}$, the maximum vertical deflection at the mid-span of the edge secondary beam (LVDT 8) was 2.17 mm ; this was about 18% of the maximum vertical deflection at the mid-span of the internal secondary beam (LVDT 2), which was 11.9 mm . The maximum deflections at the mid-span of the central and edge primary beams (LVDT 3 and LVDT 1) were 5.03 and 2.45 mm , respectively. All residual deflections after unloading were very small—less than 2 mm . At the failure load of $46 \text{ kN}\cdot\text{m}^{-2}$, which corresponded to the total equivalent uniform failure load of $49 \text{ kN}\cdot\text{m}^{-2}$ including the self-weight of the slab ($3 \text{ kN}\cdot\text{m}^{-2}$), the maximum deflection at the internal secondary beam (LVDT 2) was 68.3 mm . The maximum deflections for the central and edge primary beams (LVDT 3 and LVDT 1) were 22.3 and 7.14 mm , respectively. The average value of the deflection of the primary beams was 14.7 mm at the failure load, so the net deflection of the internal secondary beam at the failure load was equal to 54 mm ($\text{span}/96$). Fig. 12 shows the deformed shape of the secondary beams.

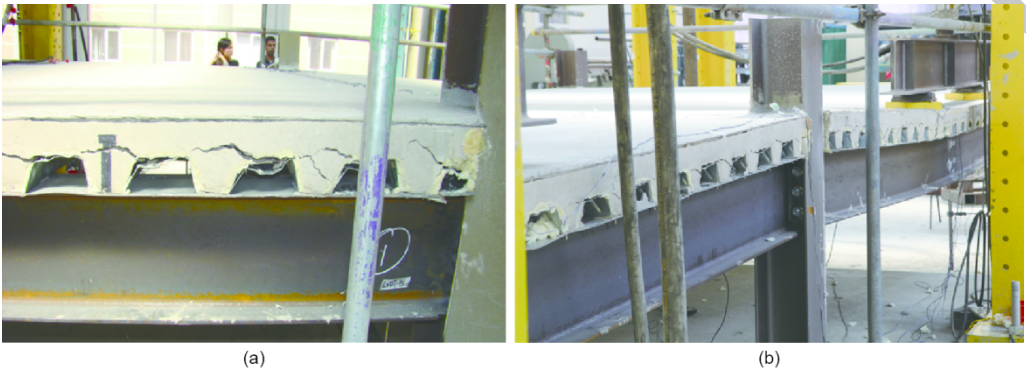
Fig. 19. (a) Crack at the edge of the slab without U-bars at failure, and (b) deflection of the edge beam with U-bars.

Fig. 19 clearly shows the cracking pattern due to the longitudinal shear failure for the edge beam without U-bars and the edge beam with U-bars at failure. For the secondary edge beam with U-bars, the shear connector resistance was assumed to be fully developed and was taken as 61 kN per stud. Given the effective width of the compression flange of the edge beam of $b_{\text{eff}} = 100 + 5240/8 = 755$ mm, concrete cylinder strength of 27 $\text{N}\cdot\text{mm}^{-2}$,

steel yield strength of $420 \text{ N}\cdot\text{mm}^{-2}$, stud central spacing of 207 mm, and nine shear connectors between the support and the point load position, a calculation of the bending resistance of the secondary edge beam according to Eurocode 4 showed that the applied load of 314 kN corresponded to an equivalent uniform load of $57 \text{ kN}\cdot\text{m}^{-2}$. This is about 91% of the actual test load of $63 \text{ kN}\cdot\text{m}^{-2}$. For the edge beam without U-bars, the shear connector resistance reduction factor was calculated by $k_{t,\text{edge}} = 0.5(1 + e/(8\phi))$. By setting $e = 100 \text{ mm}$ and $\phi = 19 \text{ mm}$, and then $k_{t,\text{edge}} = 0.83$, the shear connector resistance was determined to be $61 \times 0.83 = 50.6 \text{ kN}$ per stud. The calculated bending resistance of the secondary edge beam without U-bars according to Eurocode 4 was 298 kN, which corresponded with the equivalent uniform load of $54 \text{ kN}\cdot\text{m}^{-2}$; this was about 91% of the actual test load of $60 \text{ kN}\cdot\text{m}^{-2}$. Both the calculation and test results showed that about 5% reduction of moment resistance due to the omission of the U-bars.

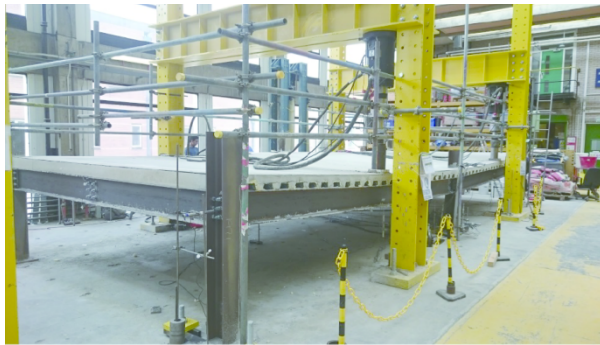
Fig. 22. Deflection of the edge beam due to missing support to the central column.

missing support. The maximum displacement corresponded to an inclination of 1 in 27 or about 2 degrees for the edge beam. The vertical displacement at the mid-span of the edge beams was about 100 mm (LVDTs 8 and 9). No significant horizontal sway was observed from the missing column, as recorded by LVDTs 15 and 16. It is apparent that the maximum load capacity of the floor system had not been reached at the maximum displacement of 190 mm, and a further increase of 20% to 30% in loading might have been possible. This would correspond to a missing column load of 133 kN. The deflected shape of the floor plate at the end of the test is shown in Fig. 22.
