46<sup>TH</sup> TURBOMACHINERY & 33<sup>RD</sup> PUMP SYMPOSIA  
HOUSTON, TEXAS | DECEMBER 11-14, 2017  
GEORGE R. BROWN CONVENTION CENTER

# Reliability Improvement for Booster Reciprocating Compressor in CCR Reformer

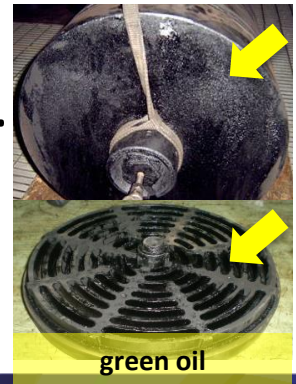
\* green oil formation

- green oil is formed by oligomerization or polymerization of **light olefins** and is catalyzed by **acidic conditions**( $\text{FeCl}_2 + \text{HCl}$ ).
- green oil forms easily at **high pressure and temperature**.

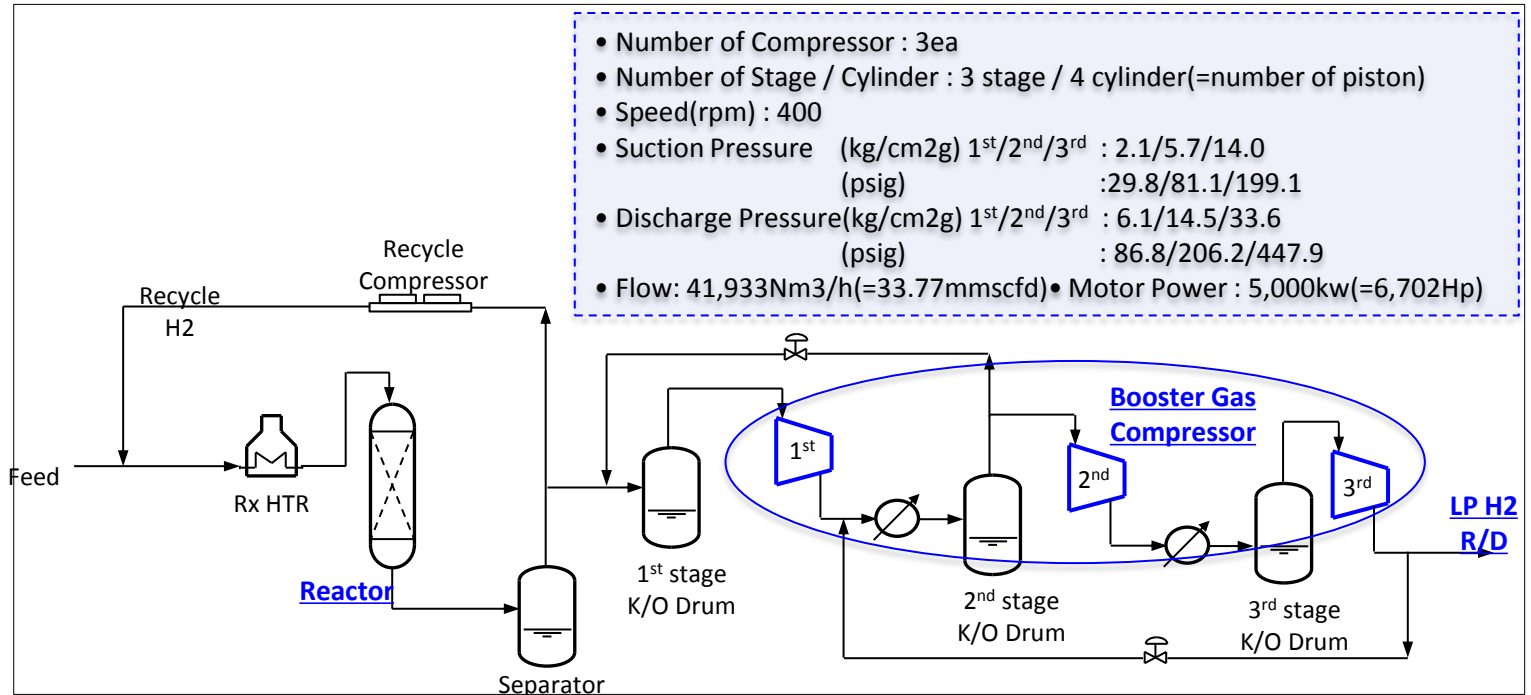
Installed in 2005, the booster compressors in CCR Reformer process **transfer** rich hydrogen(H<sub>2</sub>) gas from reactor to H<sub>2</sub> plant.

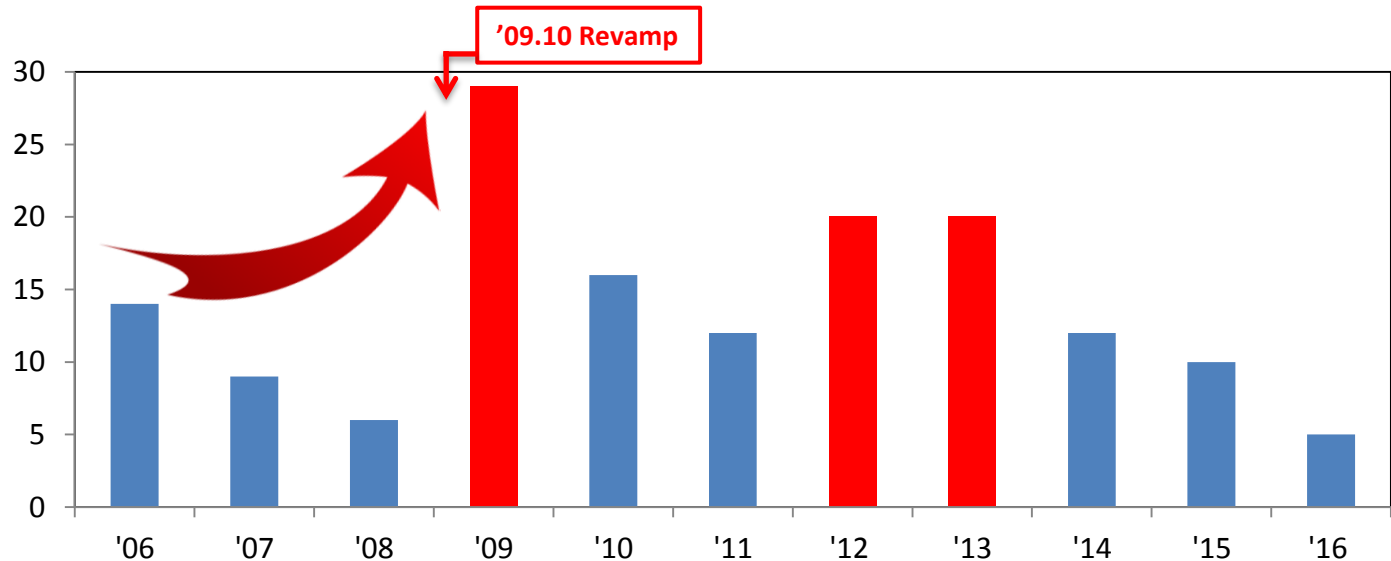
Number of Maintenance Events

Since process revamp in 2009, all three compressors have run without stand-by and the number of compressor troubles increased drastically.

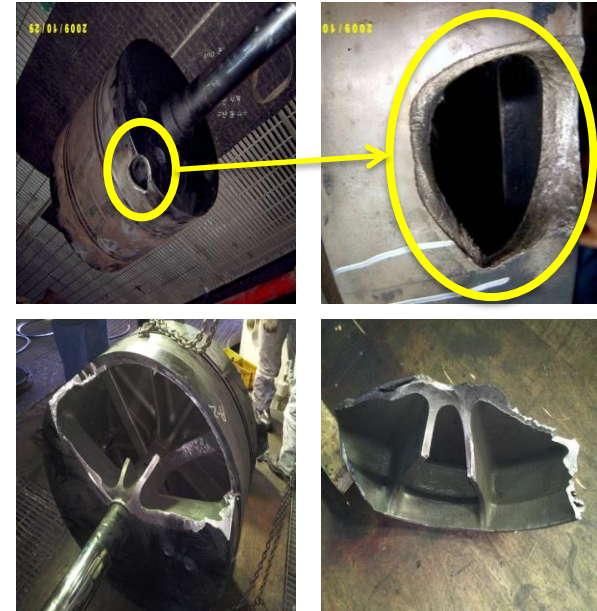
Expected Actual Strength  
Because of **increasing pressure due to green oil** . Actual Stress is higher than design.

Piston Yield Strength(520~630Mpa)

Improve the geometry of a piston to increase its mechanical strength. As the material and method of production changed, the strength increased ~48% above original and without weight change.

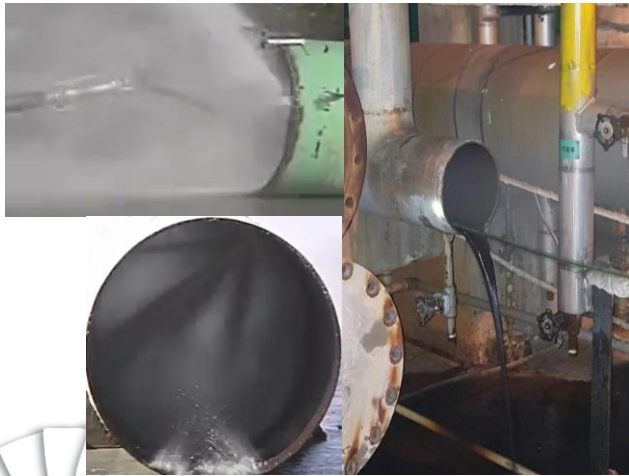
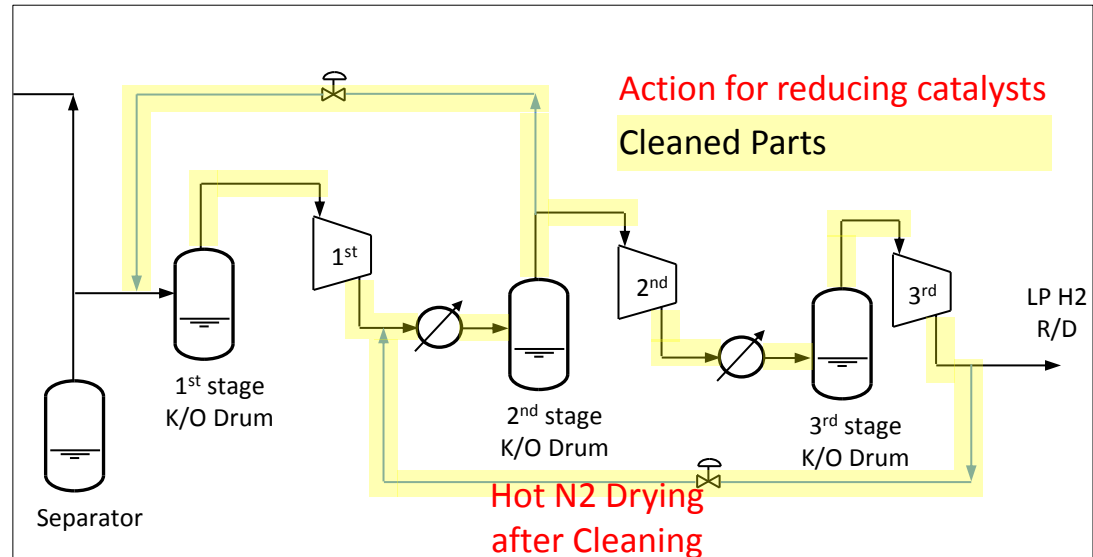
< Cleaning Picture >

To avoid further generation of green oil, during plant turnaround, catalysts like  $\text{Fe}_2\text{O}_3$  and Cl (chlorides) were completely purged from the piping system, from the knock out drum to the discharge line.

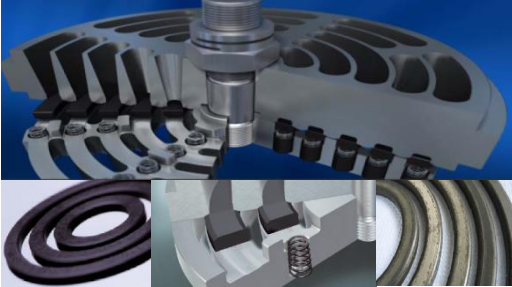
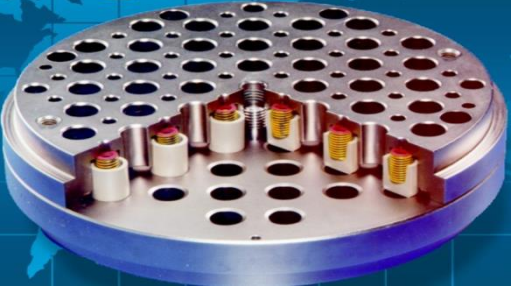
Ring Type	Poppet Type
Appearance

The pros and cons	<ul style="list-style-type: none"><li>- Tight Sealing</li><li>- High Efficiency</li><li>- <b>Weak to accumulation of foreign substance</b></li><li>- <b>Low strength of outer side ring</b></li><li>- <b>High price</b></li></ul>	<ul style="list-style-type: none"><li>- Because of increasing passing area, friction loss is little higher.</li><li>- Advantage of inventory control</li><li>- <b>Higher Stiffness</b></li><li>- <b>Strong against Sticking</b></li></ul>

Replaced original valves with a Poppet type valve, which have high reliability in liquid carry-over and sticking.

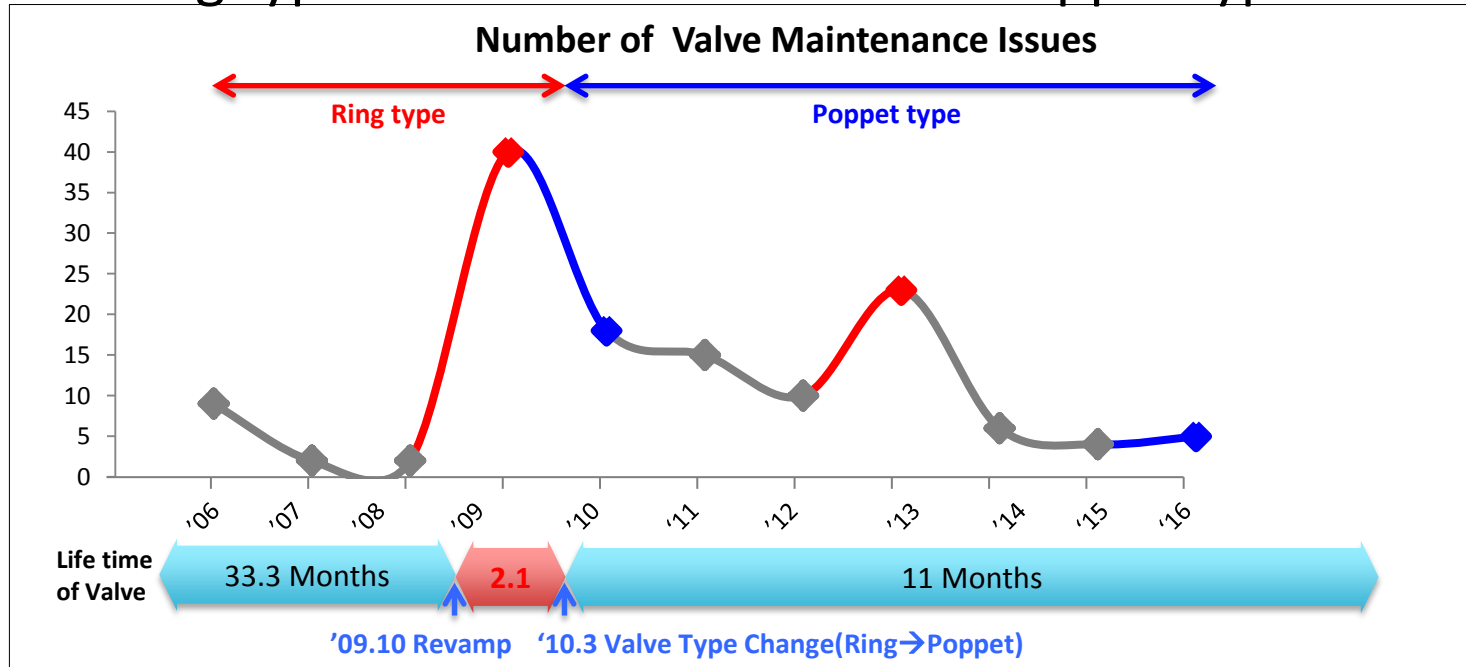
Discharge Valve Type changed from ring type to Poppet type in March of 2010. The mean life time of valve increased from 2.1 months with ring type to over 11 months with Poppet type.
