ASIA TURBOMACHINERY & PUMP SYMPOSIUM
MARCH 2018 | SUNTEC SINGAPORE

CATASTROPHIC FAILURE DIAGNOSIS WITH MODAL ANALYSIS OF GENERATOR ENDWINDINGS

Failure in generator stator phase connection coils

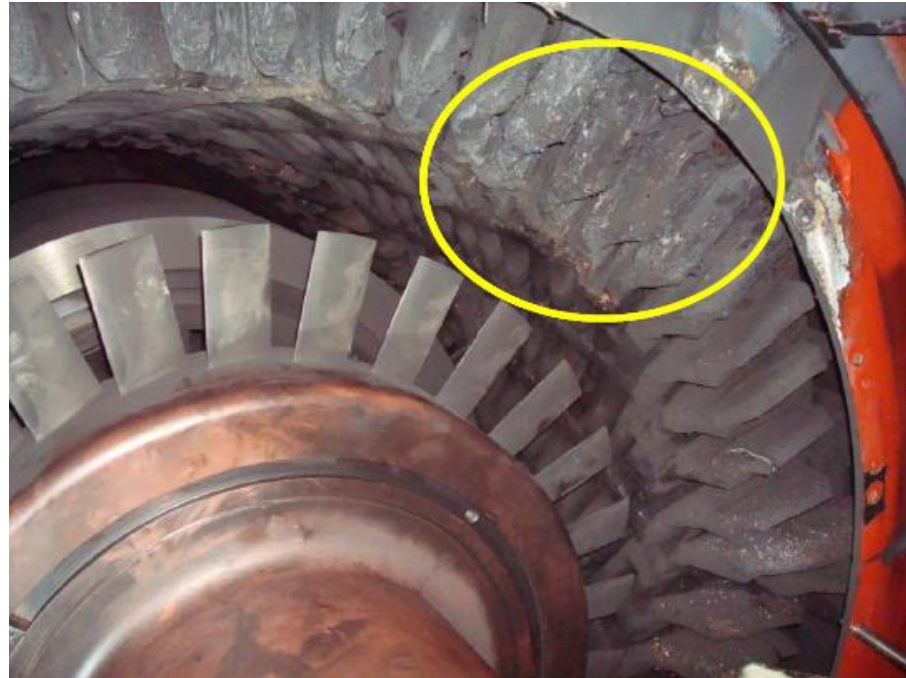
2-pole 360MW generator unit underwent a catastrophic failure nearly 2 years later after it was put into commercial operation.

As part of a root cause of failure analysis, a bump test was requested to be undertaken on a sister unit installed at another site

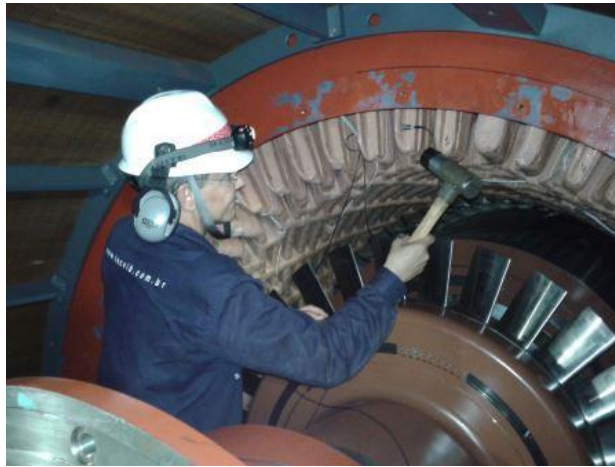
Local tests

- ✓ Impact test of each end-winding individually for radial and tangential directions;
- ✓ Mount accelerometer into the same end-winding being impacted;

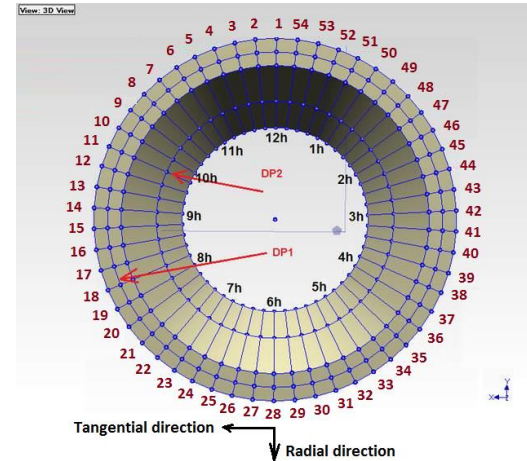
Global tests

- ✓ Divide the cage into a minimum of 12 equally distanced points;
- ✓ One bar head-joint shall be taken as a reference point for the impacts
- ✓ Mount accelerometer on each end winding respective to the 12 selected positions

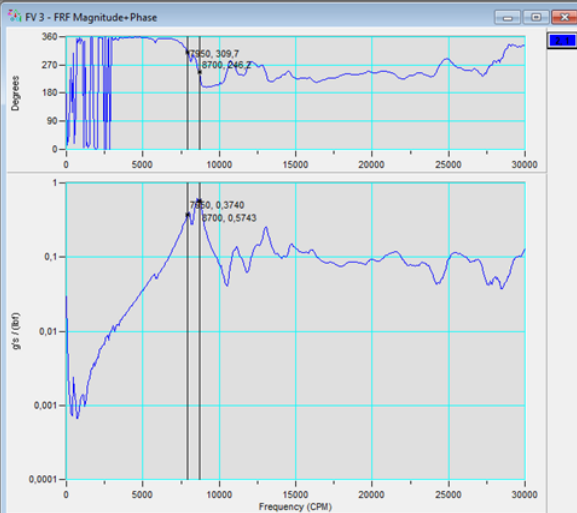
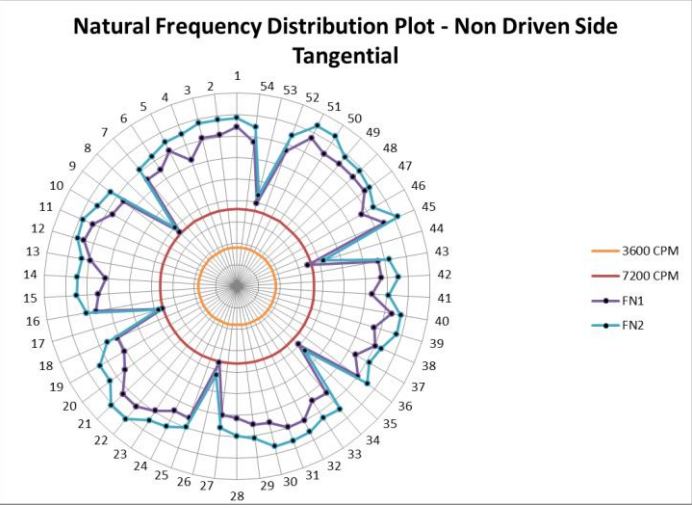
NDE windings:

Unacceptable dynamic conditions according to the results obtained for the tangential direction.

06 coils presented an abrupt drop of their Nfs close to 120 Hz and high excitation response

Resonant condition of phase connections at 120 Hz caused these endwindings to operate under high vibrations.

This most likely caused premature fatigue of insulating material and short circuit among adjacent endwindings.

It was recommended to the generator's OEM a design modification to alter the tangential natural frequency of these phase connection end windings by increasing the tangential stiffness and to improve the tangential damping among them as an effort to decrease its acceleration response.

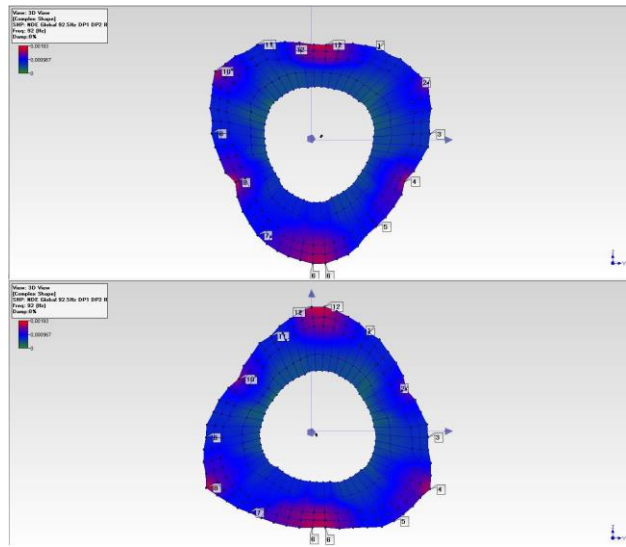
3-lobe mode at 92.5 Hz.
