**POLYMER SEAL USE IN CENTRIFUGAL COMPRESSORS – TWO USERS' EXPERIENCES OVER 15 YEARS****John K. Whalen, PE**Technical Director  
John Crane Engineered Bearings  
Houston, TX, USA**Jim Allen**Senior Rotating Equipment Specialist  
Engineering Technologist  
Nova Chemicals Corporation  
Joffre, Alberta, Canada**Jonathan D. Cardell**Mechanical Engineering Consultant  
Ethylene Technical Group  
DuPont Packaging & Industrial Polymers  
Sabine River Works  
Orange, TX USA**John R. Dugas**Consultant  
Orange, TX, USA**ABSTRACT**

For over 20 years now, the efficiency and reliability of centrifugal compressors has been enhanced by the application of engineered thermoplastic materials to the eye, shaft, and balance piston labyrinth seals. Traditionally these seals have been manufactured from metallic materials (such as aluminum) and have required relatively large clearances for reliability reasons. By upgrading to carefully selected engineered thermoplastics the clearances can be reduced without sacrificing reliability. Polymer seals maintain their clearances even after typical start up rubs, whereas metallic seals open up during these rubs and are then open for the remainder of that run c

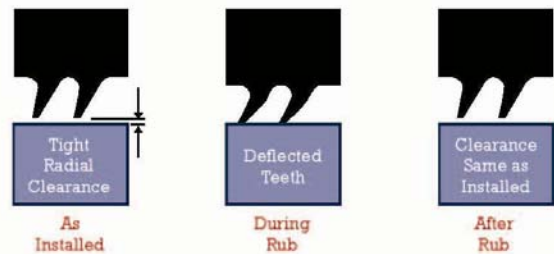
Figure 3. Typical Thermoplastic Seal Pre-rub, During Rub, and Post Rub. (Note the flexing of the tooth during contact and the damage-free rotating element after the rub.)

The drawings in Figure 3 depict a similar scenario but with a thermoplastic seal installed. In this case, the "as-installed" clearance is typically tighter than with the metallic seal. During the rub, the tooth deflects, moving with the rotor during this transient. After the rub the tooth regains its original "as-installed" configuration, no damage occurs to the rotor, and the initially reduced clearances are regained.

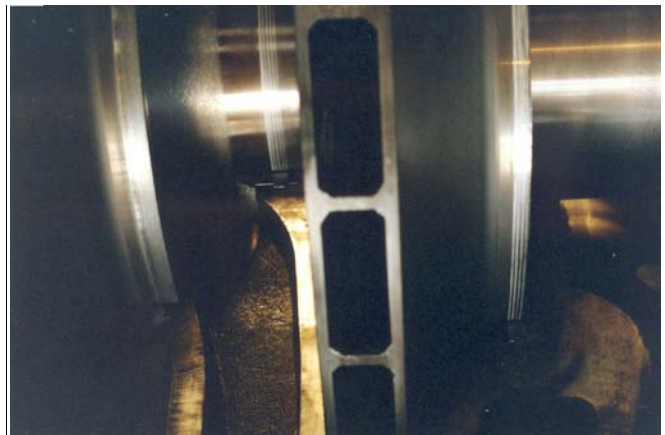
Figure 5. Nova - picture of as found aluminum rotor damage.

An example of the galling damage that can take place when aluminum seals rub against sealing surfaces is illustrated in figure 5. Note the score marks at each tooth location on the eye and shaft sleeve. A newly installed polymer seal is shown in the photograph in figure 6.

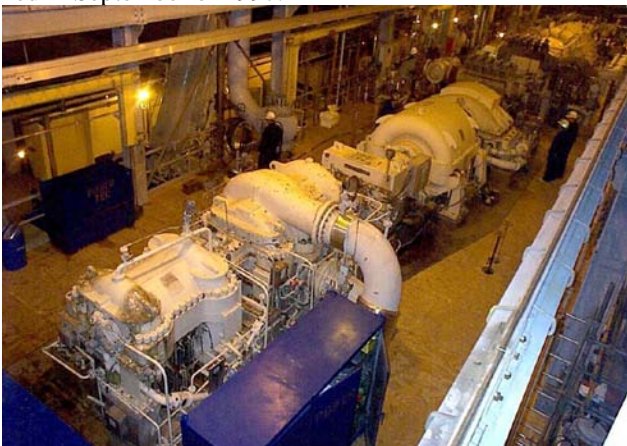
Figure 7. Photograph of DuPont's charge gas train.

This case history follows the upgrade process and includes the upgrade of a single compressor as a benchmark for performance improvement expectations. At this facility, there is a 10,000 hp (7.5 MW) booster compressor ahead of the traditional charge gas train. The charge gas train is shown in the photograph in figure 5 and schematically in figure 6. This booster compressor can be removed from service without forcing the rest of the unit down. It was decided to upgrade this compressor to evaluate thermoplastic seals. The seals were installed in September of 1997.

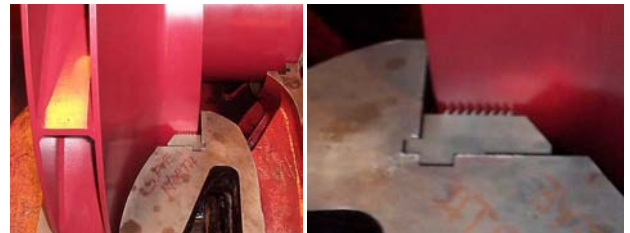
Figure 9. Polymer eye seals installed in DuPont's charge gas compressor.

When the compressor was brought down to install the polymer seals, the only work performed that would affect efficiency was the installation of the upgraded seals. This allowed the efficiency change to be attributed solely to the thermoplastic seals. After the upgrade, the plant personnel determined the compressor flow increased 3.1 percent and the steam turbine driver steam consumption was reduced 2.7 percent. Based upon this, the plant easily decided to upgrade the other six candidate compressors that would be opened during the major turnaround in March of 1999. The compressors upgraded include: the first two cases of the charge gas train (first three compression stages, figure 9), the two propylene compressors, the ethylene compressor, and the purge propylene compressor.

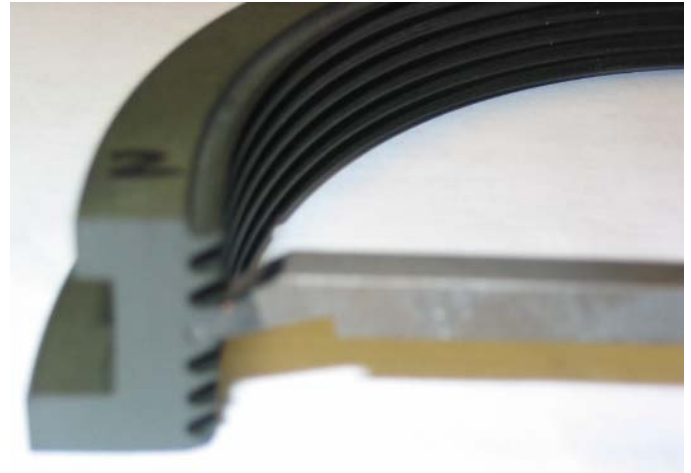
Figure 11. Photograph showing tooth scraper in use.

Even though Nova's process gas was cleaner than DuPont's they still did experience some fouling in the charge gas compressor labyrinths. They wanted a way to scrape between the teeth in an attempt to reuse as many seals as possible. The tool shown in figure 10 was developed to help with this scraping. A used machining insert (an old polycrystalline diamond coated insert that was used to cut the seal teeth) was inserted into a handle for ease of use. Nova found this tool extremely useful and the only real issues they had involved seal removal breakage; getting the seals out to scrape them. As the material vendor noted the material did become slightly more brittle so the chance of breakage does increase over time. Figure 11 is a photograph of the scraping tool as it would be used in a typical seal.

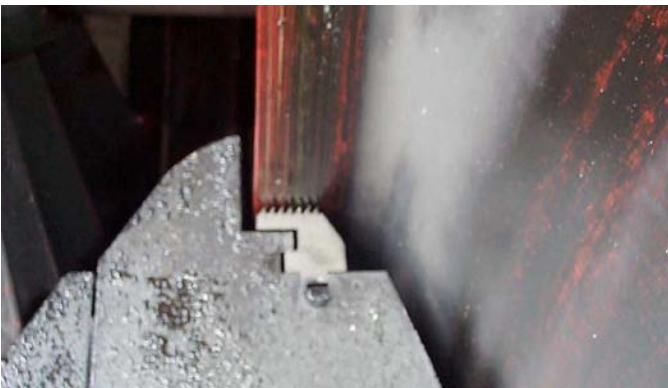
Figure 14. Polymer eye seal in DuPont charge gas compressor after 5 year run.

Seals installed in a charge gas compressor, after a 5 year run, are shown in the photographs in figures 14 and 15. Note that with cleaner sections of this train the seals did not foul, and obviously they did not foul in the clean propylene and ethylene refrigeration compressors.
