# NPSHR (NPSH3) IMPROVEMENT OF A LOW PRESSURE SAFETY INJECTION PUMP

Frank Visser & Mark Ketelaar

This case study discusses the rerate of a set of vertically-mounted singlestage end-suction centrifugal pumps used for low pressure safety injection (LPSI) in a nuclear power plant. The original LPSI pumps were supplied early 1970's and for safety purposes it was decided to overhaul these pumps to improve NPSHR (i.e. NPSH3).

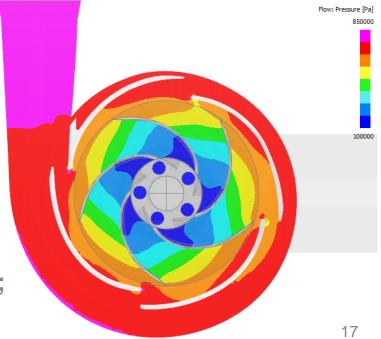
**CFD Simulated Pressure Pulsation** (transient simulation)

Existing impeller @ rated capacity;

Ptotal, inlet: 1.0 bar(abs)

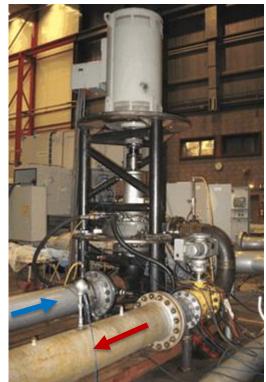
# **Experimental Testing**

- Temperature controlled test loop with injection cooling
- Performance testing in compliance with Hydraulic Institute
  - > ANSI/HI 14.6-2016
