Blade Failure on an Axial Compressor Caused by Unexpected Operating at Choke

Y. Bidaut & Ch. Müller - MAN Diesel & Turbo Schweiz AG

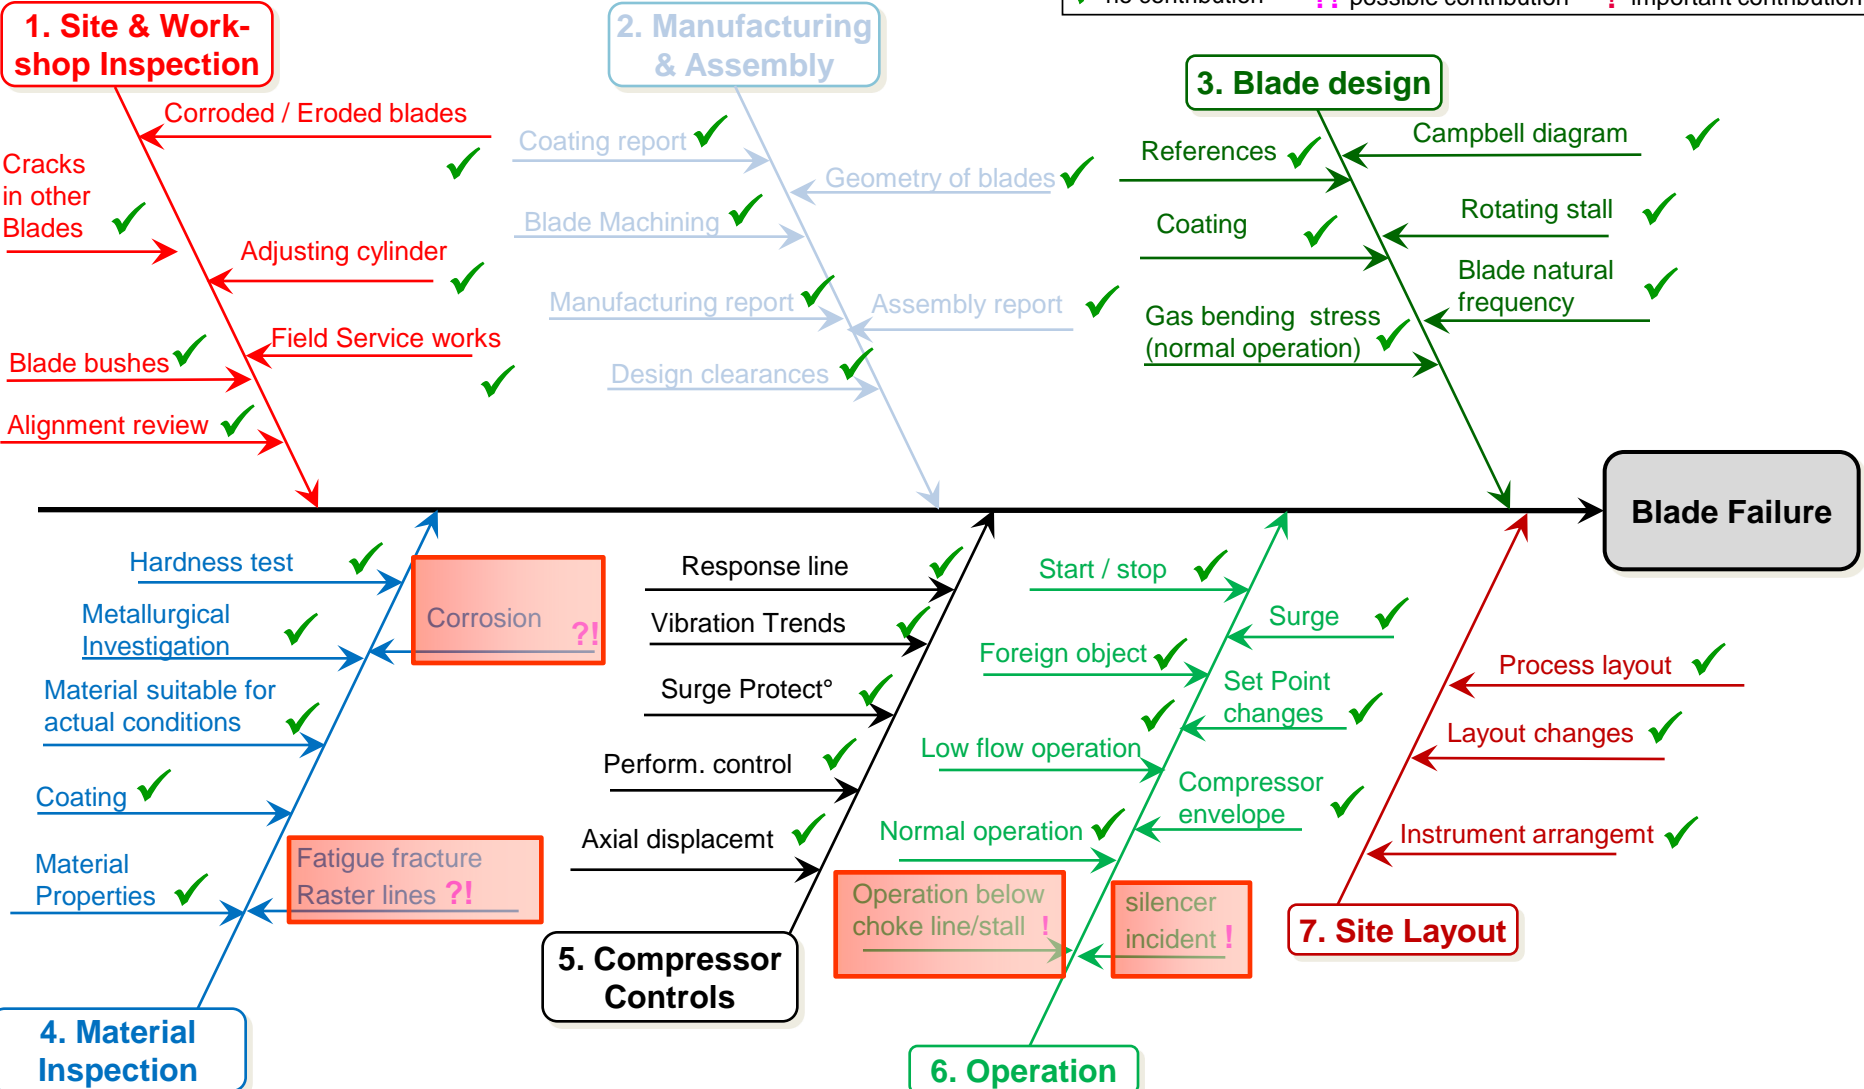
Root Cause Failure Analysis - Overview

✓ no contribution ?! possible contribution ! important contribution

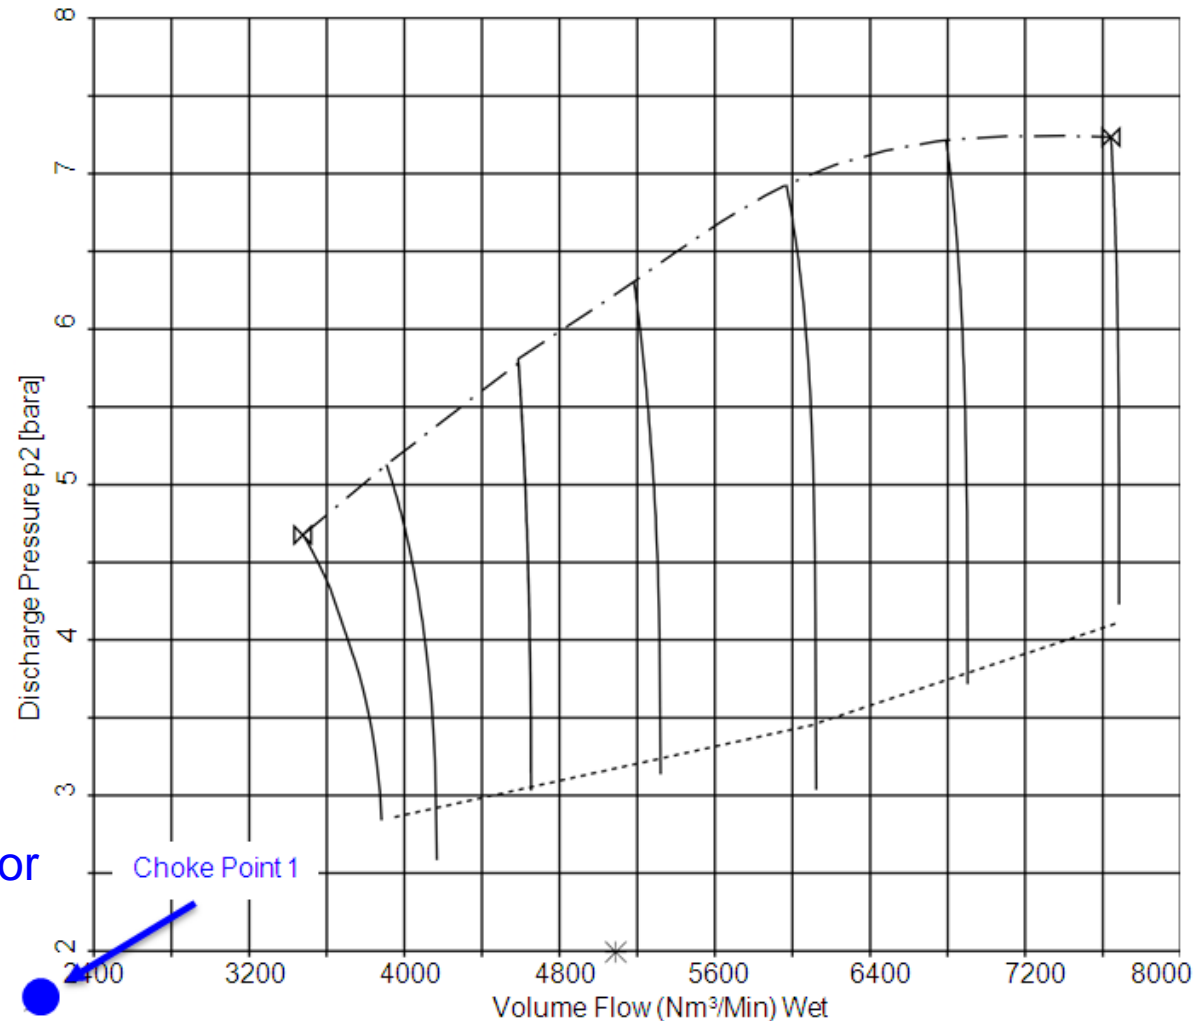
May – June :

- operation at chokepoint 1 for several hundred hours
- standstill of compressor

Reason : warm-up of compressor

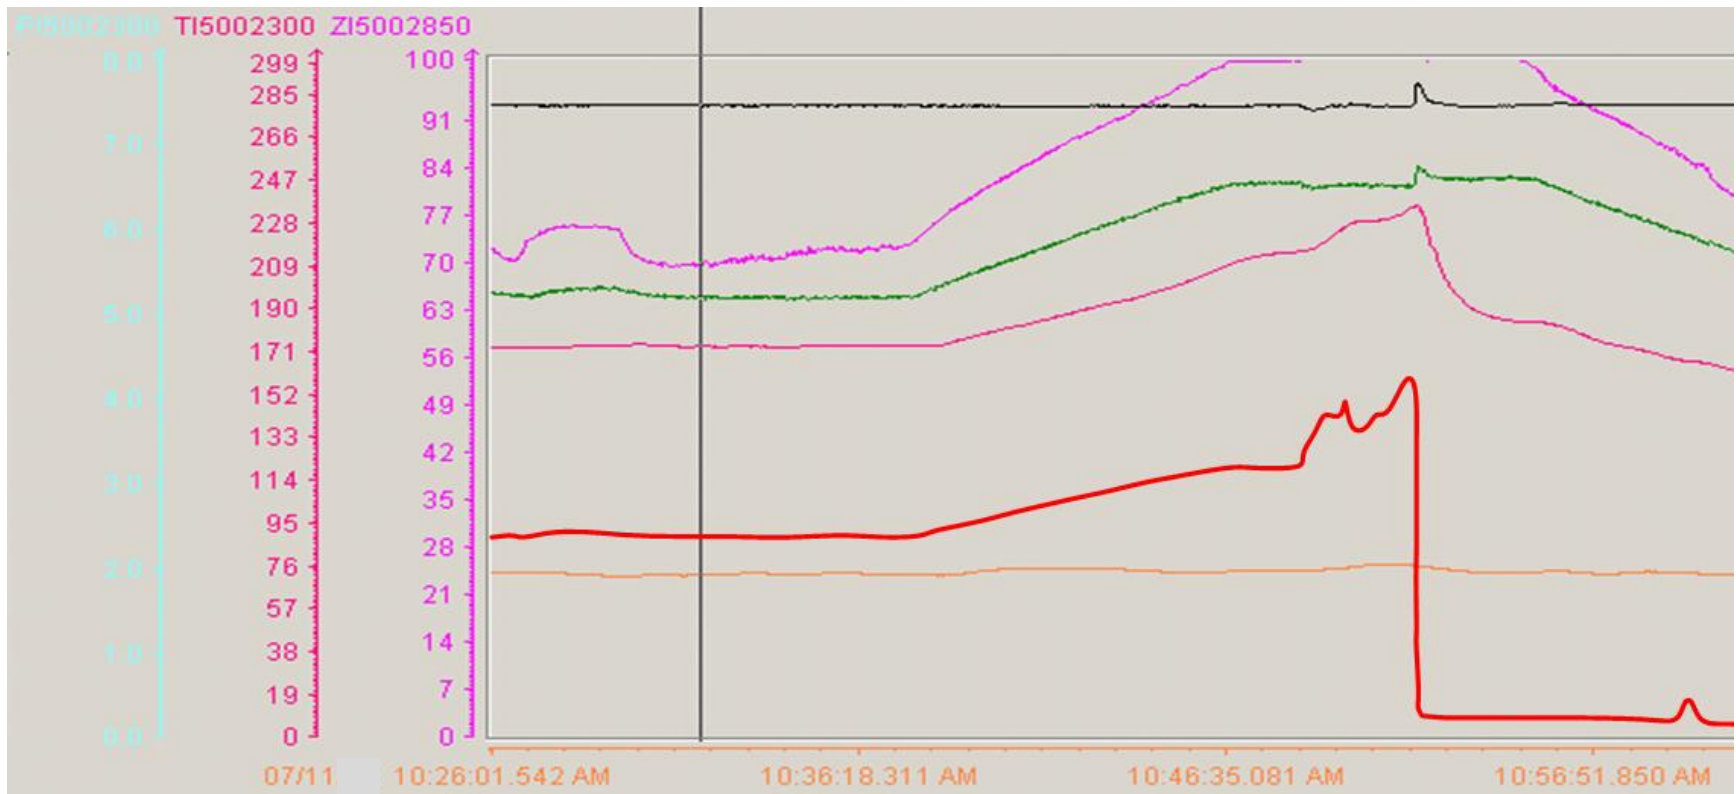
Silencer failure leads to a sudden pressure drop and a resulting negative pressure wave hits the compressor blading.

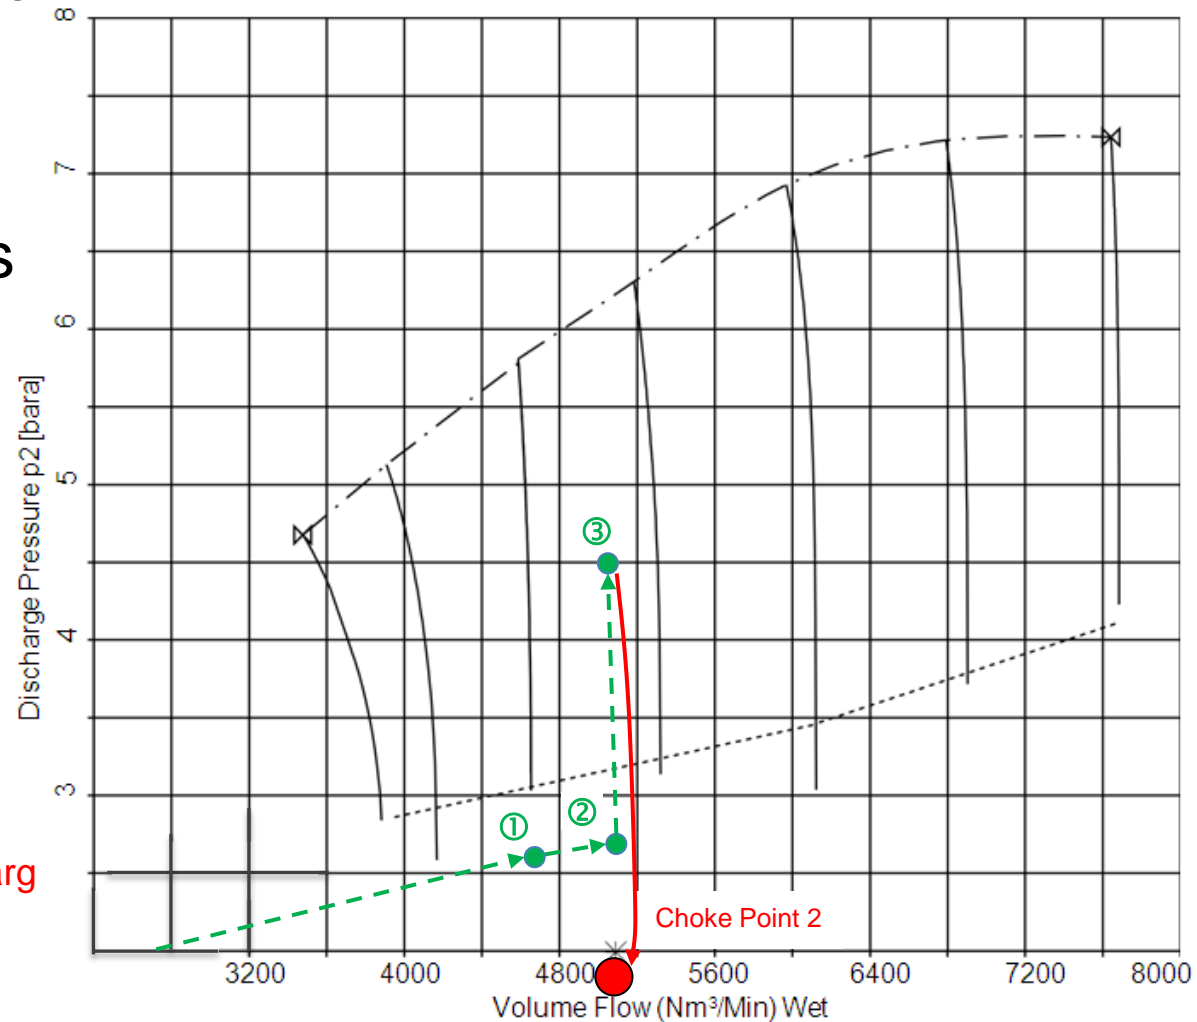
Result of silencer failure:

➤ operation at chokepoint 2 for approx. 8 hours (cumulative) from June 12th until July 31st

- ① - 100% Speed (1.5h)
- ② - Opening of IGV (4 min)
- ③ - Increasing of backpressure (1s)
- ⚡ - Silencer incident
- ④ - Dropping of backpressure to 0.2 barg

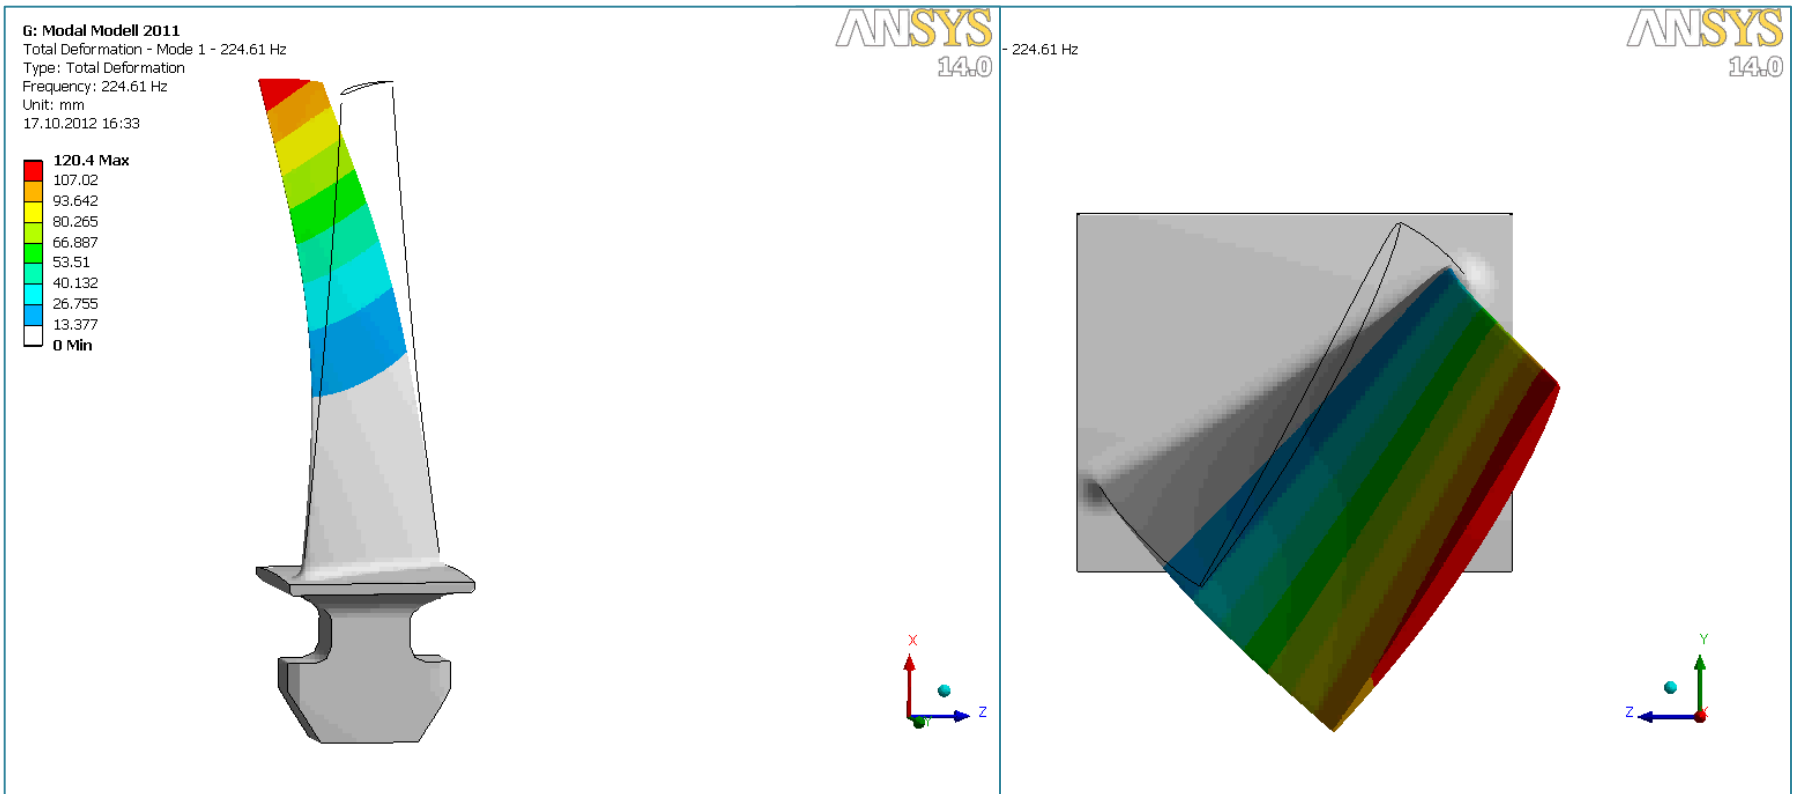
choke operation: first bending mode (B1)

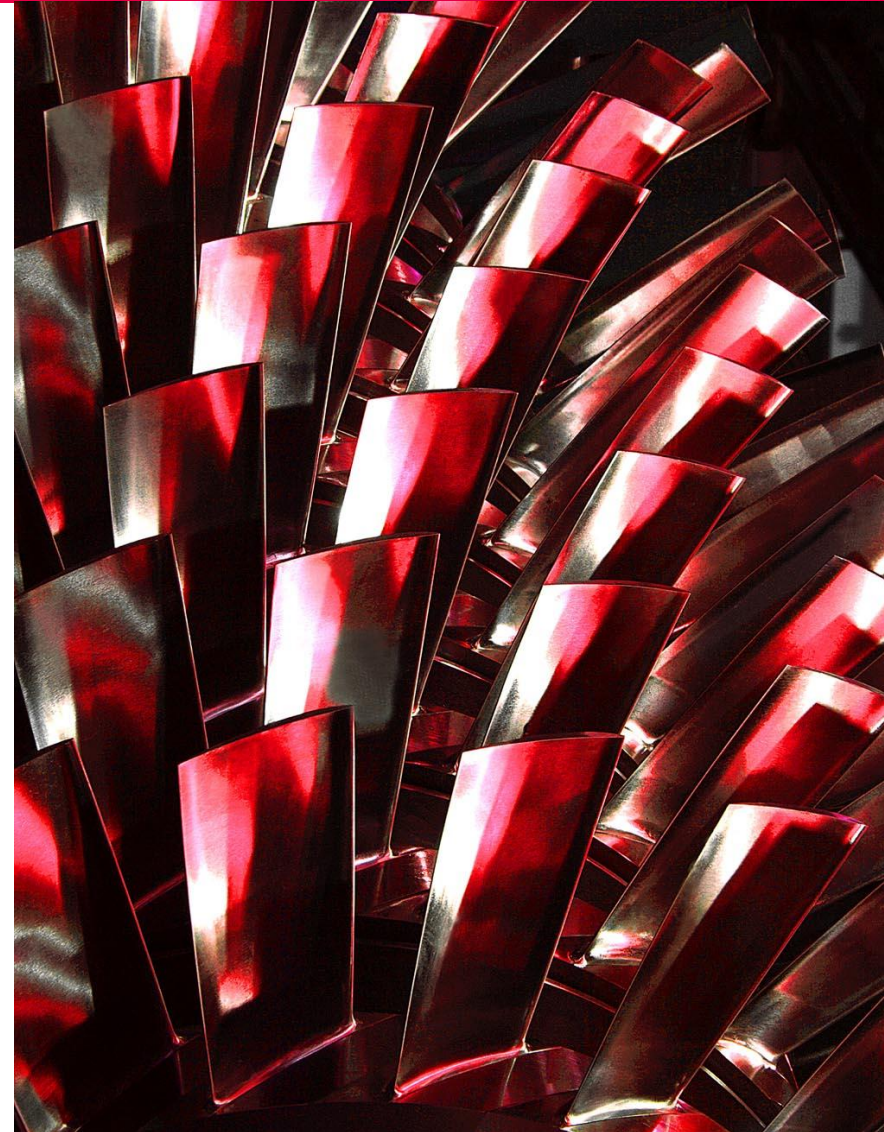
choke operation:
first bending mode (B1)

airfoil cross section
with highest bending
moment

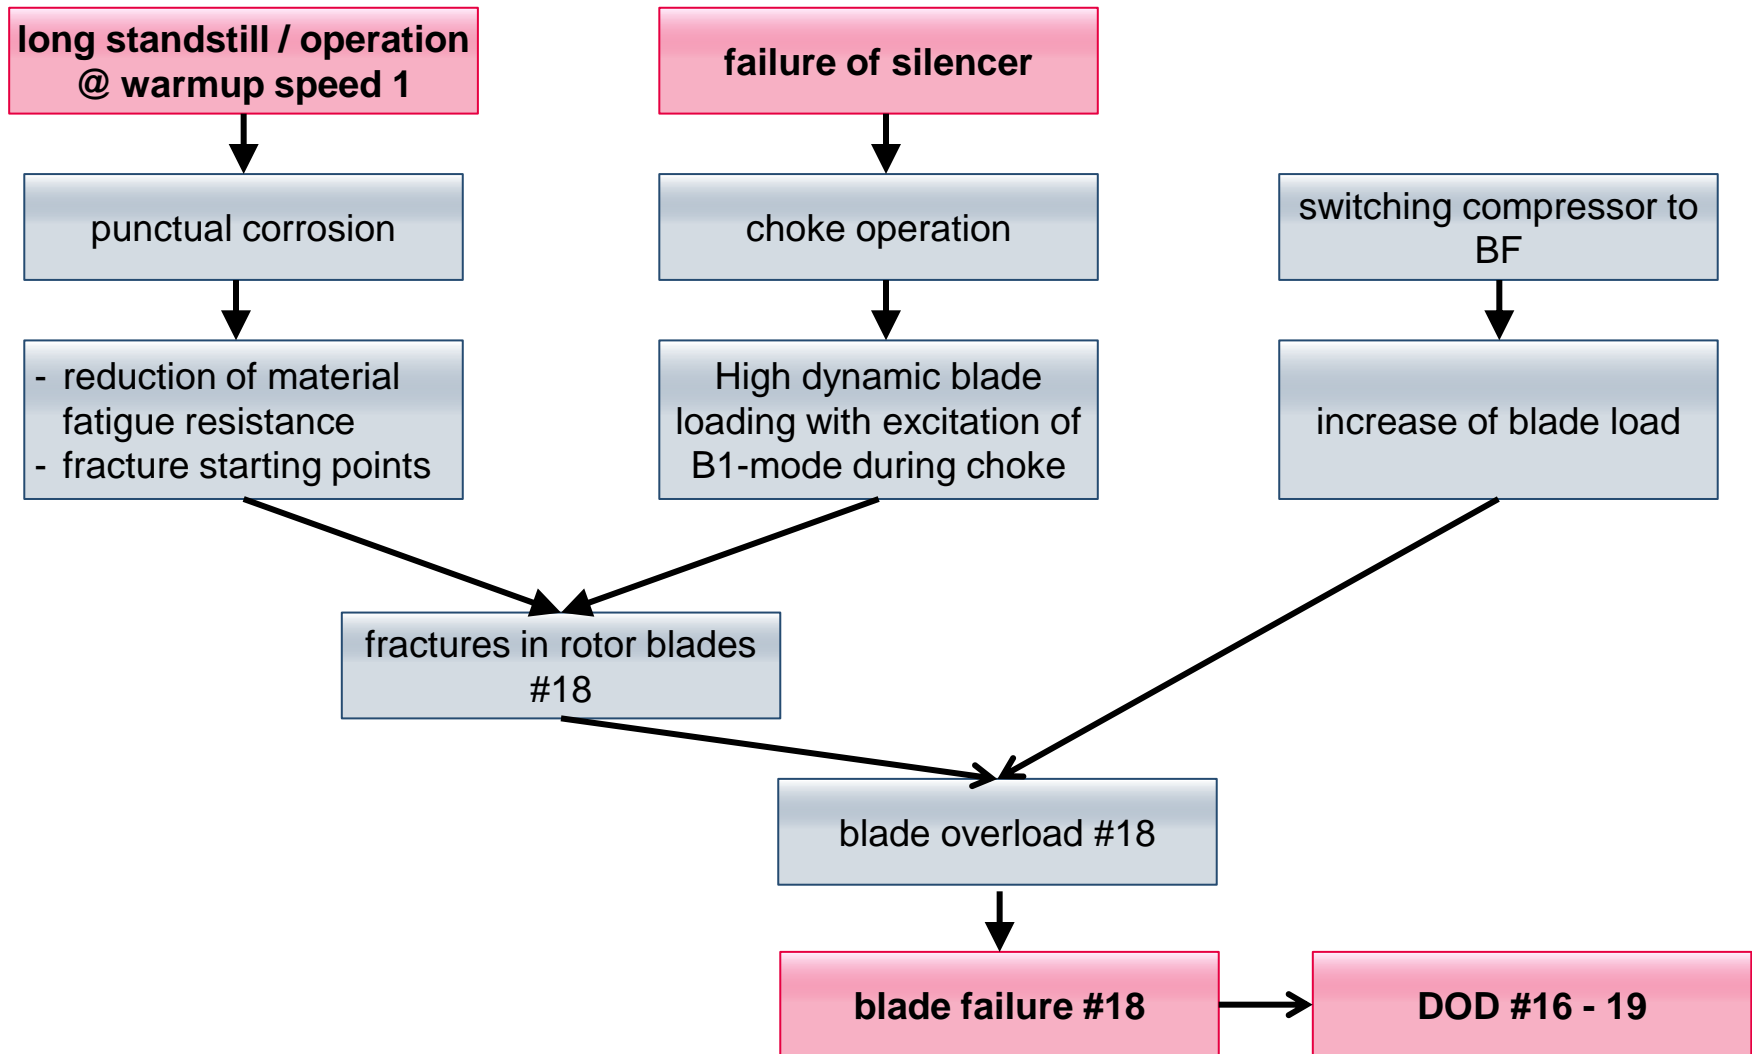
RCFA – Breakdown causes

- The encountered case was the consequence of the concatenation of many factors:
 - Choke operation
 - High load on blades
 - Corrosion
- Not only the surge but also the operation in (deep) choke is an issue for the reliability of an axial compressor
- To prevent any future damage appropriate countermeasures are necessary:
 - Choke control system
 - Increased blade thickness
 - Application of coating
