Evaluation of durability and resistance of steel anchorages in masonry walls

ABSTRACT: Long and short steel anchorages are often used in the strengthening of rubble stone (heterogeneous) masonry walls. At design stage it is important to predict mechanical behaviour and durability of such anchorages, used for rehabilitation of masonry buildings.

This paper presents the results of a study related to an anchoring system, developed by the Portuguese company ZIRCOM Engenharia S.A., carried out on different masonry specimens built up for this purpose. The results include the analysis of durability aspects and mechanical behaviour (observed in pull-out tests) of long and short anchorages embedded in masonry.

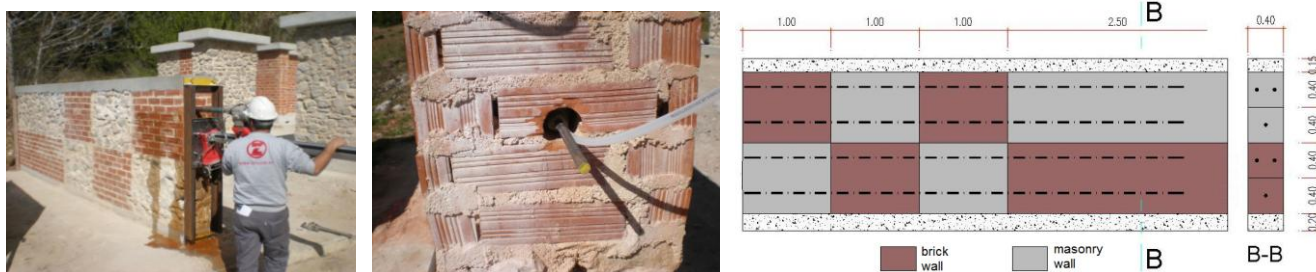
Figure 2. Execution of the steel anchorages in wall M1.

For the tests to check the position of the anchorages, a specimen wall (M1) it was built in January 2012, consisting of alternating sections of stone and brick masonry, Figure 2.

reported in 2012 [3]. For this, a wall consisting of sections of rubble stone and brick masonry was built and the ZAS - Zircom Anchorage System was applied. The system consists on inserting a steel bar, with an elastic sleeve, inside holes drilled in the masonry, and the injection of the sleeve with grout. The sleeve is used to prevent the leakage of grout in case of voids in the masonry. The system is supplied pre-assembled. After the execution of the anchorages, the wall was cut on several vertical sections and the grout cover of each steel bar was analysed;

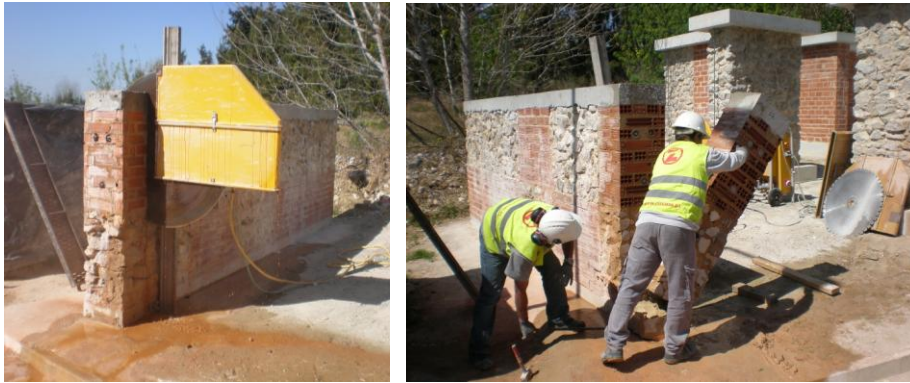
Figure 3. Sectioning the wall specimen M1 [3].

Three months after the construction of wall M1 (March 2012), the ZAS anchorages were executed and the wall was cut into several vertical sections (about three sections per meter), using a saw disc, to analyse the position of the steel bars (Figure 3).

The grout cover thicknesses of the steel bars were registered in anchorages A1 to A6 of specimen M1, in vertical sections S1 to S15 (spaced about 0.30 m, see Figure 3), as presented in Figure 8. In these sections the effective cover, c_{eff} , was measured, i.e. the distance between the bar and the boundary of the hole (edge of grout).

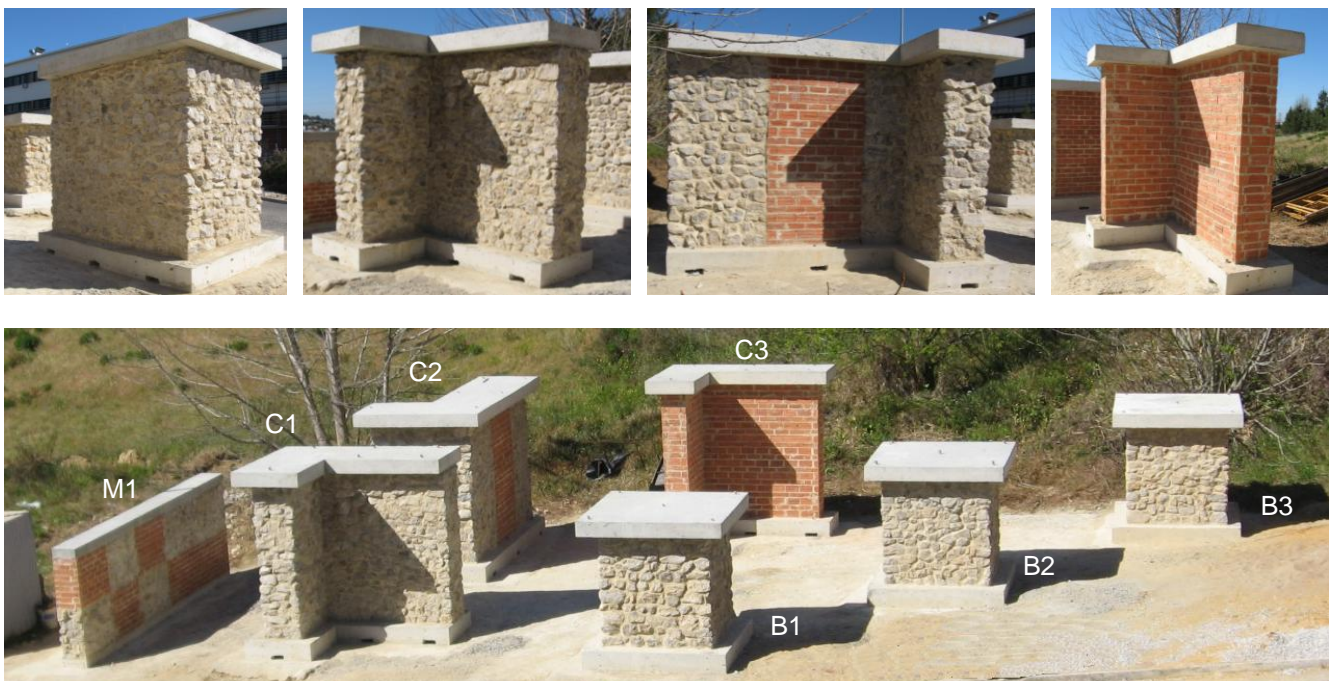
Figure 4. Individual and global view of the seven specimens used in the work.

The construction of these wall specimens took place in January and February 2012. Figure 4 shows pictures of the wall specimens with the lintels and an overview of the seven specimens, including specimen M1.

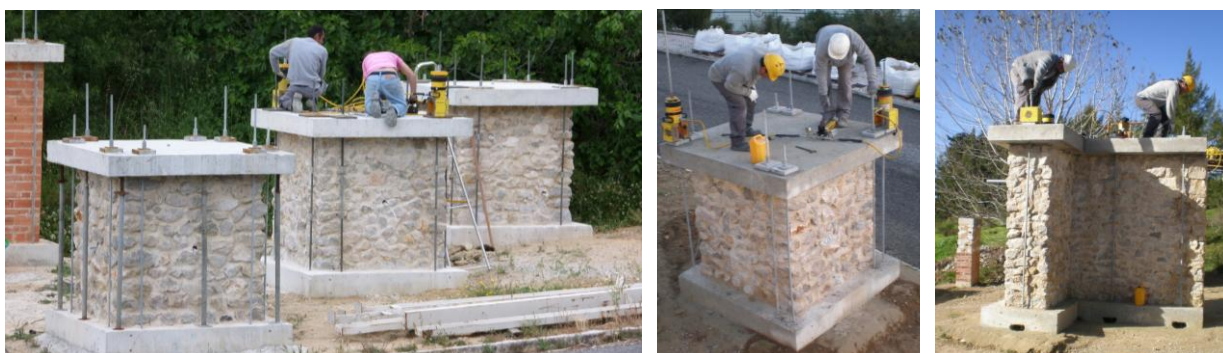
Figure 7. Application of the vertical load.

After the execution of the anchorages, in November 2012, a vertical load was applied in each wall (December 2012), to install global stress about 0.5 MPa, Figure 7. The pull-out tests were carried out on the following dates: April 2013 for walls C1 to C3 and July 2013 for walls B1 to B3.

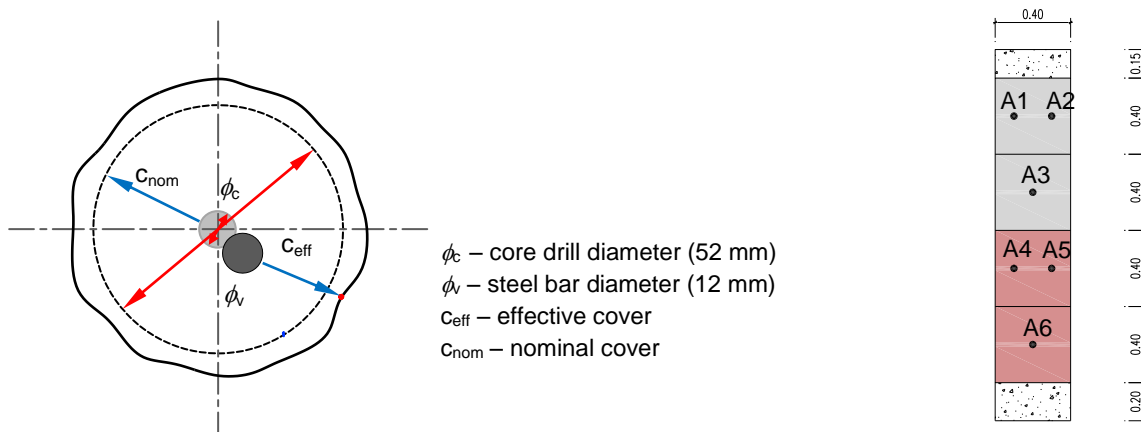
Figure 8. Nominal and effective covers

For a given bar diameter (ϕ_v) and core drill diameter, ϕ_c , the nominal cover, which is a theoretical value, is given by the distance between the surface and the theoretical limit of the bar hole (see Figure 8), as presented in Expression 2:

$$c_{nom} = \frac{\phi_c - \phi_v}{2} \tag{2}$$

In the present study, a core diameter $\phi_c = 52$ mm and a bar diameter $\phi_v = 12$ mm were used, resulting $c_{nom} = 20$ mm.

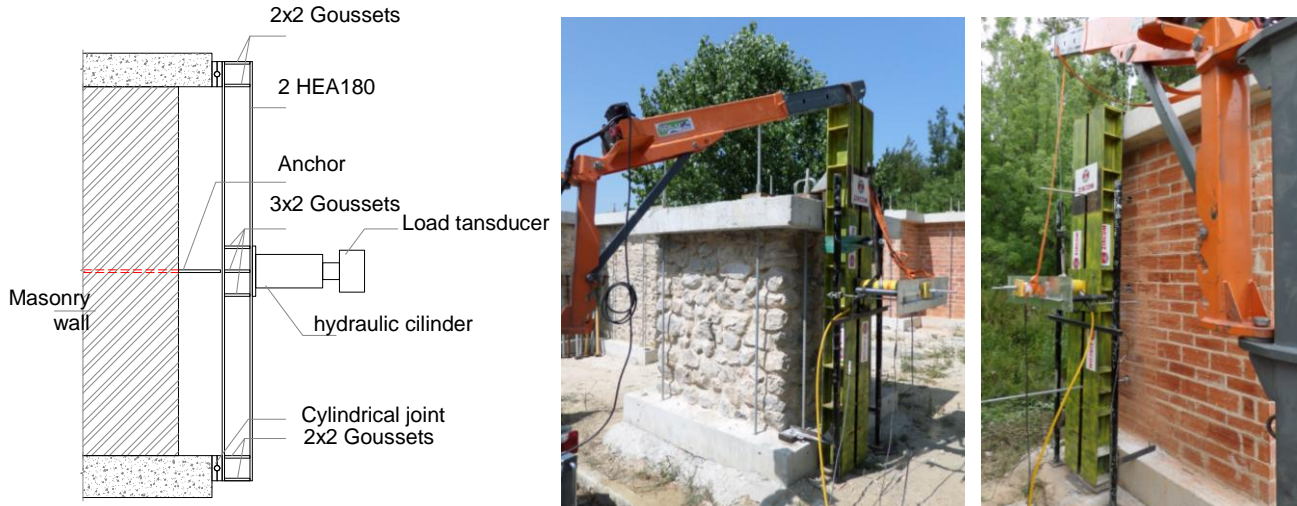
Figure 10. Test layout used in the pull-out tests of wall specimens B and C.

The pull-out tests were performed based on the test layout shown in Figure 10, where two pictures of tests are also presented.

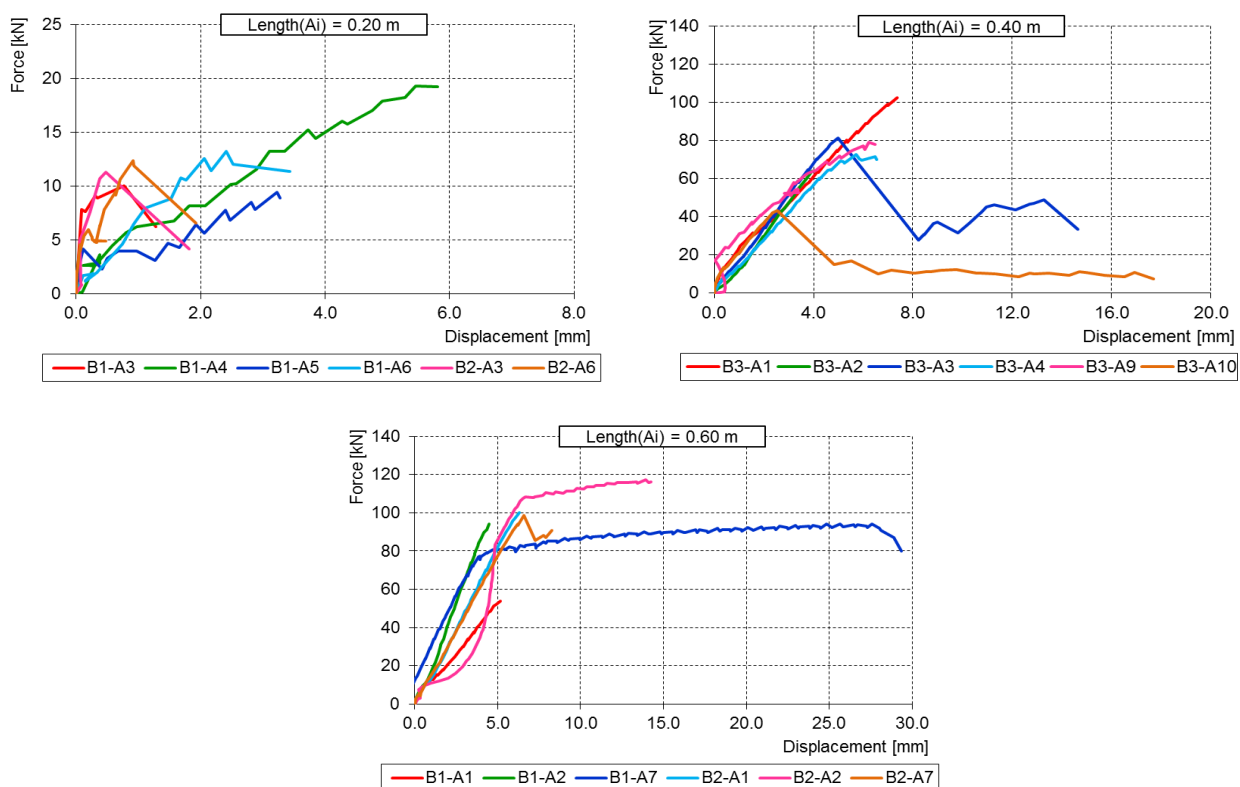
Figure 11. Force-displacement diagrams of tests on specimens B1, B2 and B3 with anchorages lengths of 0.20 m, 0.40 m and 0.60 m.

The load-displacement diagrams resulting from these tests are shown in Figures 11 and 12. In relation to the masonry blocks (short anchorages), the diagrams are represented by the anchorage length: 0.20 m, 0.40 m and 0.60 m. Regarding to walls C1 to C3 (long anchorages), the diagrams are shown per wall, given the specificity of the wall and the equal length of the bars. The maximum values of the forces for all anchorages are presented in Figure 13.

In what concerns to the anchorages with 0.20 m length (Figure 11), the failure is quite erratic because, due to the heterogeneity of the masonry walls, the small length of the anchorage will intersect different material conditions for different anchorages. The failure of these anchorages does

not occur by bonding between the bar and the injection grout, but as a tensile failure of the injection grout and the surrounding masonry.

In the case of the anchorages with lengths of 0.40 m and 0.60 m, the failure occurred in general by bonding between the bar and the injection grout, with much higher failure forces than in the shorter anchorage cases (See Figures 11 and 13). The mean values of these bonding stresses were 3.67 MPa and 3.08 MPa, with coefficients of variation of 0.27 and 0.23, respectively for the lengths of 0.40 m and 0.60 m. Considering a mean value for the bond strength of 3.0 MPa and a mean yielding force for the 16 mm threaded steel bars of 116.2 kN, it may be said that for anchorages shorter than 0.77 m it is quite probable that the failure occurs by bonding between the bar and the injection grout rather than by yielding of the bar. These values depend mainly on the mechanical characteristics of the injection grout, the bar tensile resistance and of the surface bonding characteristics of the bar.

For the longer anchorages (Figures 12 and 13) the failure occurred by axial tension of the threaded bars. Although the testing conditions in the anchorage tests are not equal to a tensile test of bars, since some eccentricities are induced in the bars that do not take place in the standard tensile tests, the mean value of the failure load of the longer anchorages is 117.9 kN, comparable to the mean yielding force and tensile resistance of the 16 mm threaded steel bars (116.2 kN and 128.1 kN, respectively). In these anchorages tests (Figure 12) it is also quite evident the large ductility of the failure mode, denoting that this failure relies on a ductile material (steel) rather than brittle materials as masonry and injection grout (Figure 11).
