## Bulletin of the Geological Society of Greece

Vol. 34, 2001

### Arhaeological evidence for seismic activity in Butrinti (SW Albania) and neotectonics of the area

### ABSTRACT

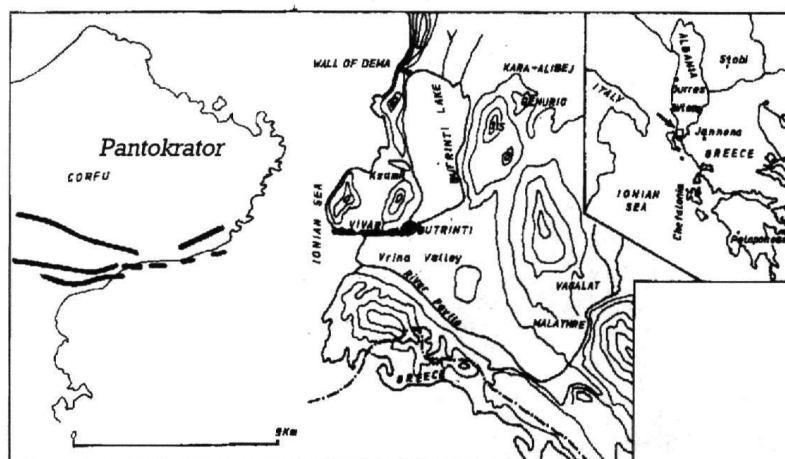
**Fig. 1.** Topographic map of Butrinti and the adjacent area (Ksamil peninsula, Butrint lake, Dema wall of classical times, river Pavlo which indicates the Quaternary asymmetric Vrina depression and N. Corfu island). The main oblique-slip (right lateral) fault of Corfu, which bounds northern "Pantokrator limestone" mountain with the Neogene-Quaternary southern part of the island, is shown. It possibly extends to Ksamil peninsula (Butrinti area). Black arrow at the top right corner map shows the position of the Butrinti area in relation to Albania, Greece and Ionian sea.

In the framework of "Neotectonic mapping of Albania" have been examined critically evidence of supposed earthquakes at the site of Butrinti, or Buthroto, situated in the southern coast of Albania (Corfu strait), close to Greek-Albanian border (fig.1). This site is located in an area of intense seismic activity, where the historical

Butrinti archaeological site (fig. 1) lies at the south western of Albania at the southern edge of the peninsula Ksamil. A long narrow, rocky ridge which links it with the mainland to the north (Saranda district). The hill on which the city was built and developed (altitude 50m) is composed of Jurassic crystalline limestone covered with a hard layer of soil. To the south the Vivary channel separates the hill from the land beyond; thus the town occupies a position naturally well protected. It also enabled Butrinti to function as a port, as it is mentioned in the maritime itineraries of the 3<sup>rd</sup> century BC (Ugolini 1942). On the west side alone, a narrow strip of land, which broadens into a flat, links the hill with the remainder of the peninsula. Butrinti is identified as city for the first time in written sources by Hecataeus, a geographer of the 6<sup>th</sup> century BC and later by Strabo (1st c. BC-1st c AD) as well as by archaeological excavations (Ugolini 1942; Bace & Condi 1990 Butrinti guidebook; Condi and Chatzi personal communication).

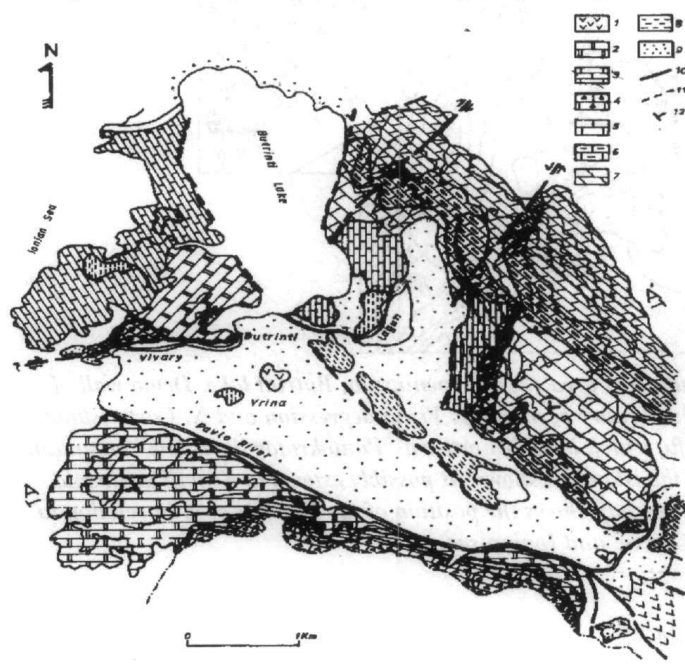
**Fig. 2. Geological map of Butrinti area;**  
**1: Lower Triassic evaporates,**  
**2: Upper Triassic - Lower Liassic platform carbonates (Pantokrator),**  
**3: Jurassic limestone,**  
**4: Cretaceous conglomerates,**  
**5: Paleogene,**  
**6: Eocene flysch,**  
**7: Oligocene flysch,**  
**8: Neogene (Pliocene mainly),**  
**9: Quaternary (Holocene deposits mainly).**

The Butrinti broader region (fig. 2), which is located on the western part of the *Ionian Geological Zone*, occupies the southern part of the *Cika* anticlinal belt. The new Geological map of the Butrinti area (fig. 2) was based on the Geological Map of Albania (1983), Tectonic Map of Albania (1983), Pirrenjasi et al. (1985), Vaso et al. (1990), Neotectonic map of Albania (in press) and our new field data.

The most significant faults strike N-S, delineating the western and eastern sides of the lake (fig. 2). A characteristic fault of this group is located on the N-NW of the Butrinti hill. This is a NNE-SSW trending

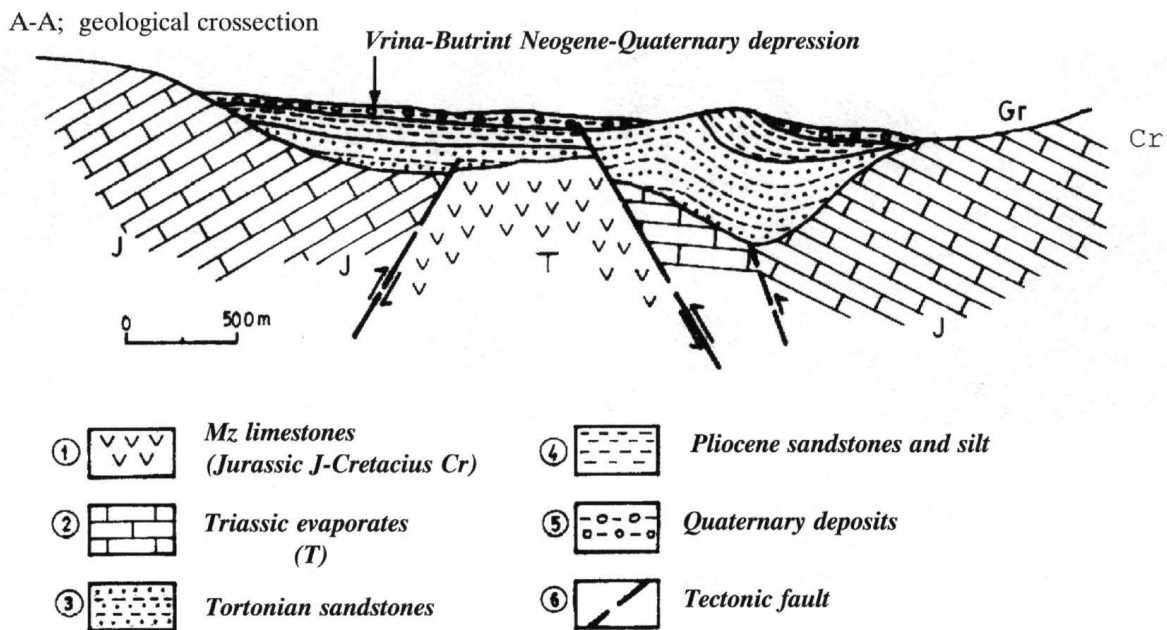
**Fig. 3.** A simplified geological cross-section across the fold of Vrina (Butrinti area). (AA' site at figure 2). A core of evaporates is shown, carbonates as a unit (Mesozoic limestone) and Neogene as Tortonian (Miocene) and Pliocene sandstones-silts. Although the area is dominated by compressional tectonics (anticlines, reverse faults etc) the surface features (Butrinti fault, Vrina-Pavlo depression) show extensional characteristics. Subsidence seems probable (Plio-quaternary sediments). Buried reverse faults have been drawn on the basis of some unpublished seismic profiles, folded or tilting of the overlying sedimentary rocks, as well as on the fault plane solutions of surface earthquakes of the broader region.

The superposed molassic deposits form the upper unit and overlie unconformably the Mesozoic one. The presence of the evaporates in the basement and their continued vertical movement have been the main factors driving the structural and paleogeographical changes during Neogene and Quaternary, especially during Holocene times. These deposits form the Xara-Mursi synclinals that generally strike NW-SE. Southwards, the syncline is divided into two synclines, dipping towards Butrinti Lake (Prrenjasi E. 1985; Geological map of Butrinti-Xara region), by a fault that defines the tectonic contact between the limestones on the east and evaporates on the west. The NW part of these synclinals was moved eastward by a transcurrent fault, which also affects the carbonate rocks. A representative simplified geological cross section of the Butrinti area (Vrina) is shown on figure 3.

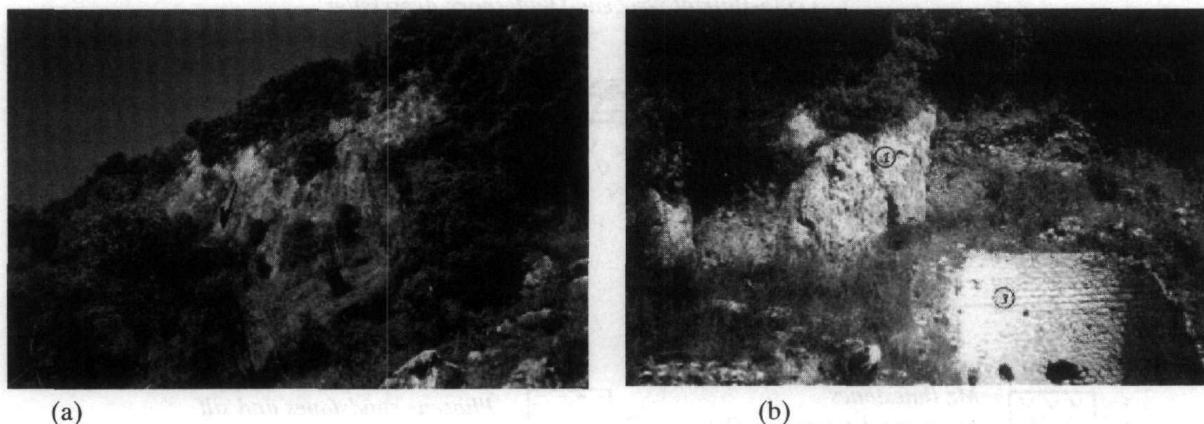
**Fig. 4.** Left (a) : ENE-WSW striking fault surfaces (contact between basement limestone and recent deposits) inside the archaeological site, that is the eastward extension of the fault scarp of figure 6. Arrows indicate the slip vector (striae direction of dip-slip to oblique-slip fault). Right (b) : The same fault surface some meters eastward : 1, fault plane; 2, historical (post-Roman) scree; 3, ruins of a Roman building.

The hill where the Acropolis of Butrinti was built consists of Jurassic “*Pantocrator limestones*”, while the town was developed on the soft Holocene sediments on the southern and southeastern side of the hill. This side is bordered by an E-W to ENE-WSW trending transcurrent fault, which is the extension of a greater strike-slip right-lateral structure of northern Corfu Island (fig. 1). The recent movements of this fault have been identified as normal to oblique-slip structures. It affects basement limestone and molassic deposits, and as expressed on the topography by a steep scarp. NE-SW fault directions (fig. 4) have been observed inside the archaeological site.

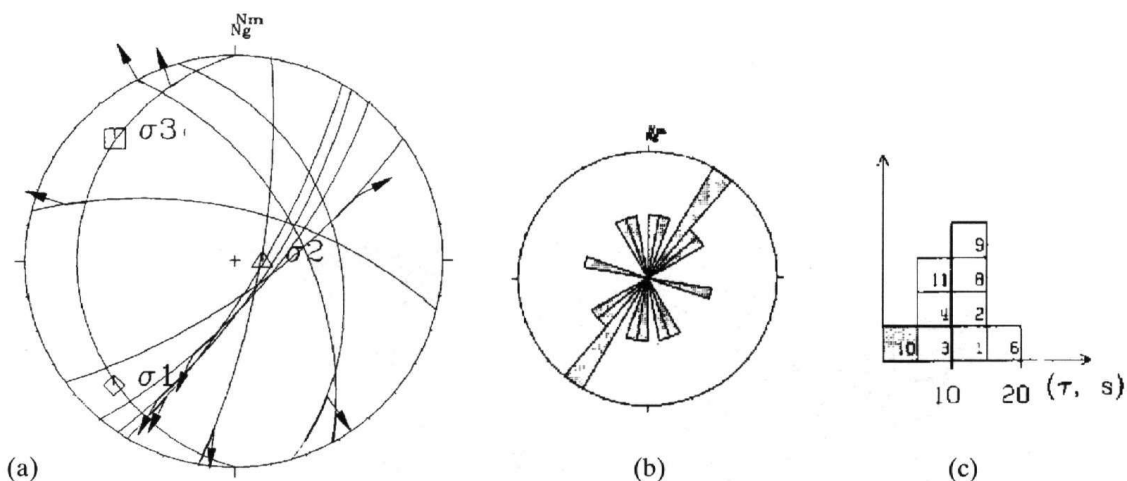
**Fig. 5. Stress analysis on the Butrint main NNE-SSW trending right-lateral fault. a) stereographic projection (lower hemisphere) of the measured striated fault planes (as curves) and slip-vectors (striae) as arrows; b) rose diagram of the measured faults. c) histogram of the measured striation.**

Representative striated faults (as curves with arrows) of the broader Butrinti region are shown on figure 5. In our analysis the “the best mean tensor” (Carey & Brunier 1974) and “conditioned square minima” (Caputo & Caputo 1988) methods have been applied. They give the three principal axes of the stress (or strain) field, as well as some index with the mean standard deviation or angular deviations, which indicate the reliability of the results. The few analysed measurements from the Butrint E-W to ENE-WSW striking normal fault inside the archaeological site indicate a NNW-SSE trending horizontal  $\sigma_3$  (minimum) stress axis (local extensional regime), while the representative data from the broader area (regional stress regime) show typical strike-slip domain, where:  $\sigma_1$  : Az 224° / Dip 100°;  $\sigma_2$  : Az 92° / Dip 75°;  $\sigma_3$  : Az 316° / Dip 11°.

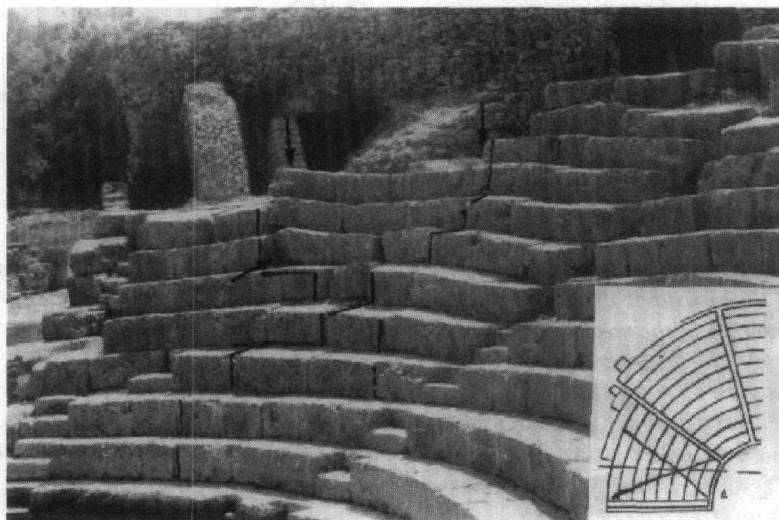
**Fig. 6. Photograph of the 3<sup>rd</sup> century BC terraced seating (auditorium) of Butrinti Theatre. Deformed construction and especially open fissures are shown by arrows at the western side of the auditorium. Right down corner: the sketch of the diagonal shear cracks.**

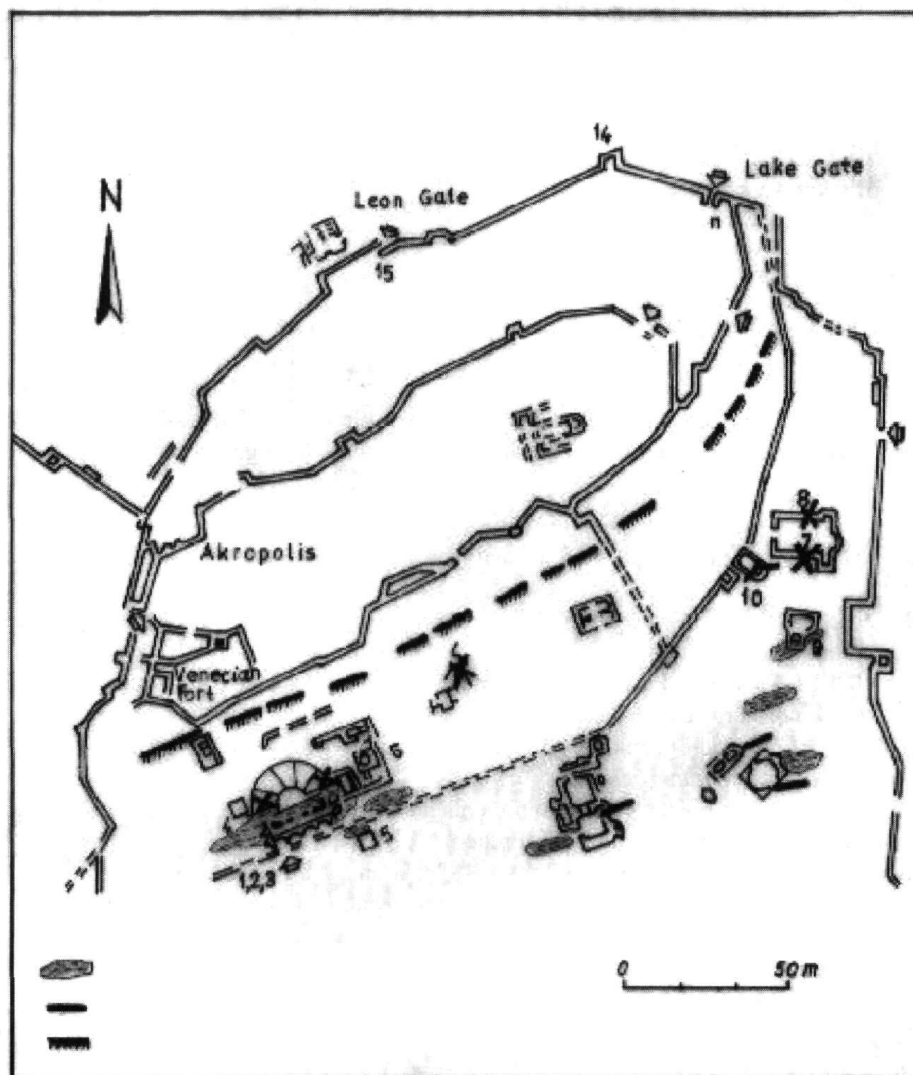
*Fig. 8. Map of earthquake damages observed inside the archaeological site. Numbers indicate the places of observed "seismic" fractures and shadow areas covered by water (under see level). 1,2,3, Amphitheater (3rd-2nd c. BC) and surrounding Hellenistic (?) and Roman walls. 4, Small Temple of Esculap (Aesculapius). 5, Roman house. 6, Greek house foundation. 7,8, Palaeochristian Basilica (Cathedral). 9, Nymphaeum. 10, Tower Gate. 11, Lake Gate. 12, Foundation. 13, Church. 14, Wall. 15, Leon Gate.*

Mapping observed earthquake damage in the city (fig. 8) highlighted two sets of fissure orientations. The older set, trending NE-SW, occurs throughout the site and is concentrated on the NE and SW sides of the monuments. These are generally diagonal shear fissures (striking  $60^{\circ}$  N) and, occasionally, open cracks. The majority of the monuments displaying this type of damage were built before 4<sup>th</sup> century AD, for example the terraced seating of the theatre (3<sup>rd</sup> century BC), Tower Gate (2<sup>nd</sup> century BC) and the Lion Gate (2<sup>nd</sup> century BC). Therefore, this damage is restricted to the western part of the town mainly and around the wall, that is the Hellenistic-Roman area, and remained un-repaired until they were excavated by archaeologists (second quarter

A second set, comprising only shear diagonal fissures, strike  $0^{\circ}$  N, and occur on the N and S walls of the younger Christian basilica (5<sup>th</sup>-11<sup>th</sup> century AD) (Hasani, Xh. 1990), which was built in the 5<sup>th</sup> to 6<sup>th</sup> century AD and reconstructed twice, in the 9<sup>th</sup> and 13<sup>th</sup> century AD. Therefore, this damage is only in the eastern northeastern part of the town where the Byzantine monuments extent. These can probably be related to a possible seismic destruction of the 1153 earthquake, a poorly documented event, as it is also referred in the Albanian earthquake catalogues (Sulstarova 1975; Muco 1996).
