### Preservation of villages constructed on sliding areas - a case study from Karditsa Prefecture, Greece

## PRESERVATION OF VILLAGES CONSTRUCTED ON SLIDING AREAS – A CASE STUDY FROM KARDITSA PREFECTURE, GREECE

**Key words:** *Rotational slides, occasionally inhabitable villages, Petroxori, Argitheia.*

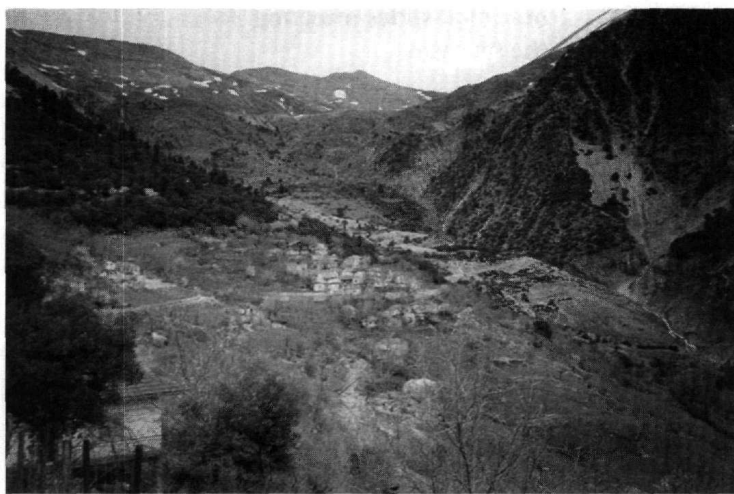
Petroxori village is constructed on the east slope of Karaves hill (south Pindos) on an altitude of 1100 m. The dip angles of the slopes at the proximity of the village are 40° to 50° (Fig. 1). Because of the intensive inclination of the slopes, the area occupied by the village was formed in terraces.

**Figure 1 - A panoramic view of the Petroxori village**

Figure 1 proves that those phenomena were well understood by the old residents of the village, because, despite their initial attempts (Fig. 6), they finally stopped constructing buildings along the zone occupied by the debris materials. In that picture is clearly presented that the majority of the houses were constructed on the north-eastern and the south-western parts of the village; occupied by the flysch formations and the limestones, respectively. On the contrary, the central section of the village was finally used for cultivation. However, the latest owners of the properties ignored the experience of the past and reconstructed houses on the unstable areas (Fig. 5).

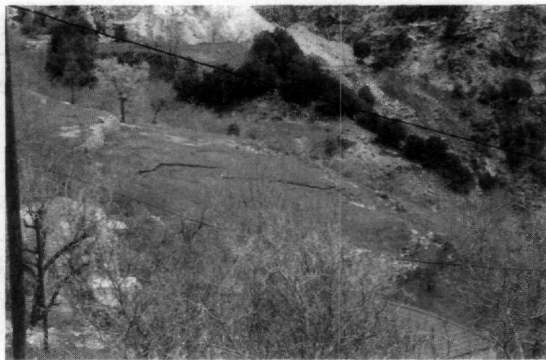
Based on their mechanism, those landslides can be characterized as rotational slides (Varnes 1978) (Fig. 2). They act independently, affecting the terraces, and although they all have the same preparatory causal factors, each one was activated independently.

According to the WP/WLI reporting method (1994), the main preparatory causal factors of those failures are, regarding the ground conditions, the existence of plastic weak material and, regarding the man made processes, the construction of the terraces (Excavation of slope). Note that, the debris materials, as products coming from the erosion of the flysch and the transitional formations, appear high contents of clay materials.

**Figure 2 - Rotational slides affecting the terraces**

- Reconstruction of the retaining walls of the terraces by using gabions. Gabion walls are flexible and they can take over considerable deformations caused by foundation's settlement or by sliding movements without failing. Note that, the old dry stone retaining walls of the terraces deteriorate intensively when deserted. So, the majority of them require reconstruction.

- Tree planting of the terraces. The root strength mechanical effect combined with the gabion walls can reduce, or even more efface, the surface ruptures occurrence in the majority of the terraces.

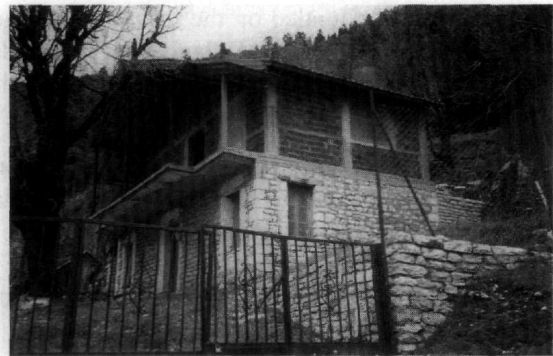
**Figure 3 – Reconstruction and extension of an old house**

According to the same reporting method (WP/WLI 1994), the triggering causal factors of those landslides are, regarding the physical processes, the prolonged high precipitation and, regarding the man made processes, the loading of slopes or their crests and the uncontrolled flow of the surface water through the village (natural irrigation and water leakage from services). The loading of the slope was succeeded by the construction and lately the reconstruction and the extension of buildings (Fig. 3) and the uncontrolled flow of the surface water through the village (Fig. 4) was caused by lack of drainage network.

- Prohibition of the extension of buildings. The construction of additional floors increases the loads of the slopes' crests and triggers the ruptures. Note that, at the moment, those phenomena are confined within the limits of the debris materials. But because of the poor mechanical characteristics of the flysch and the unfavourable dip direction of the limestones' bedding the construction of additional floors must be reconsider all over the village. Further more, the owners of the houses founded along the debris materials must be informed for the unstable conditions of the area in order to prevent them from reconstructing their houses. In those cases it is better to exchange their building sites with other sites, provided by the state, in one of the stable sections of the village.

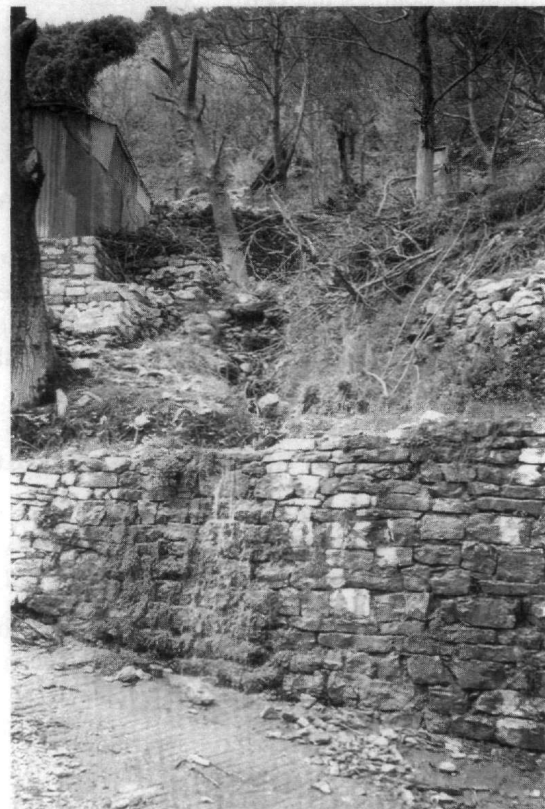
**Figure 4 - Uncontrolled flow of the surface water through the village**

- Construction of surface drains in order to divert water from flowing onto the sliding area (collecting ditches and pipes). Note that, because of the morphology the majority of the surface water precipitating within the limits of the village flows through the sliding area. So the construction of surface drains can reduce the effects of the main triggering causal factor, the prolonged high precipitation.

- Asphalt or concert paving of the roads. The drain network of the roads must be connected with the proposed surface drains extending all over the village. By means of that procedure the roads can work as horizontal barriers of the flowing water and they can help towards the wiser organising of the drain network.

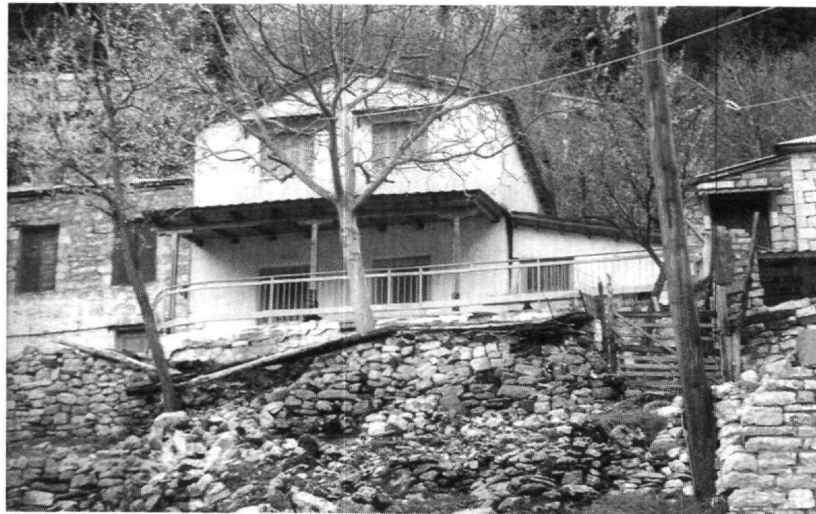
Each failure was triggered by a different combination of triggering causal factors. Except from the prolonged high precipitation that affected all the slopes, all the other factors acted in relation to the local conditions of each slope. For example, the slope presented in figure 5 failed during a year of prolonged high precipitation (2006) because of the increasing loading of its crest caused by the reconstruction and the extension of the house. On the contrary, the slope presented in figure 2, although it is completely unloaded, failed because of the excessive natural irrigation caused by the uncontrolled flow of surface water through the field.

**Figure 5 - A typical example of slope that failed during a year with prolonged high precipitation because of the increased loading of its crest. The landslide caused extended damages to the house**

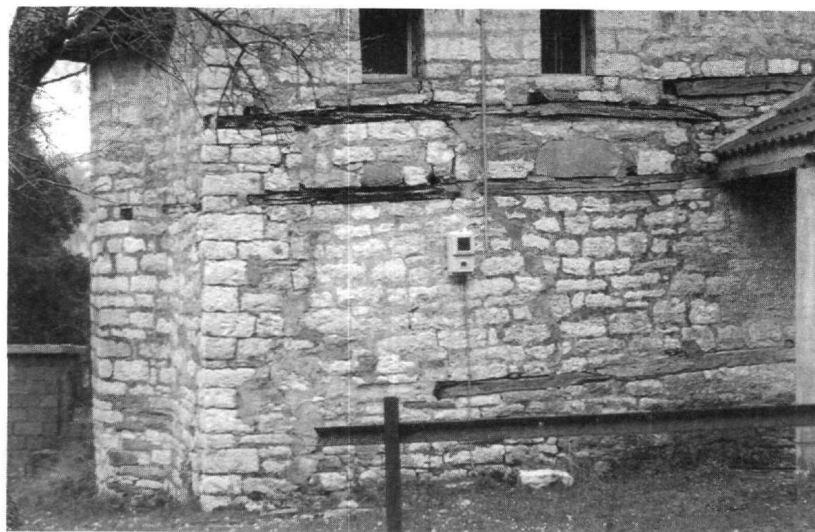
**Figure 6 – Old damages on the church of saint Paraskevy caused by surface raptures. The church was founded on the debris materials**
