Bulletin of the Geological Society of Greece

Vol. 52, 2018

The floods in Greece: the case of Mandra in Attica

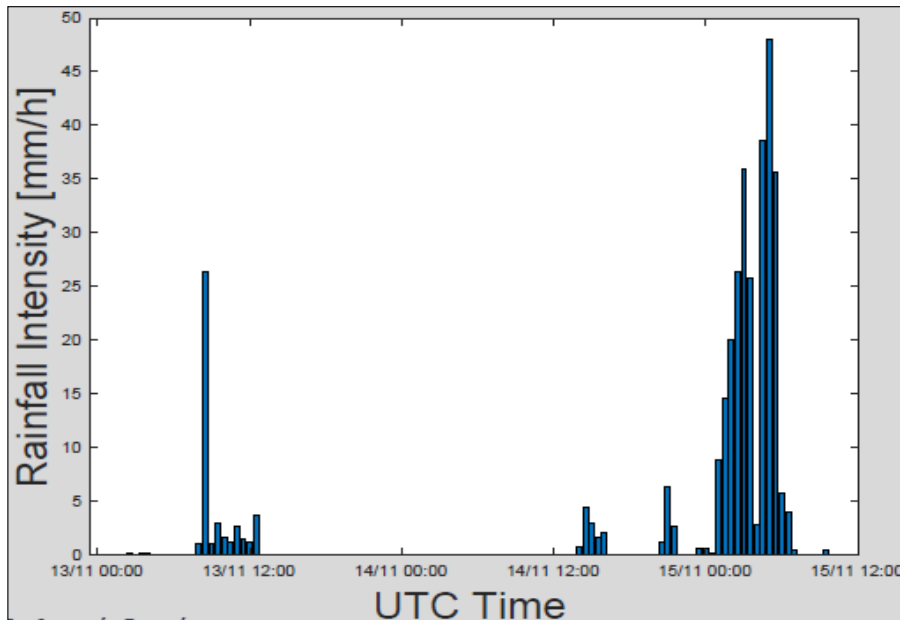
Fig. 3: The time distribution (hyetograph) of the rainfall of 14-15/11/2017 in the area of the streams of Agia. Ekaterini and Soures (according to Nikolopoulos, 2017).

The time distribution for the peak height sections are given in hyetograph in Fig. 3. It appears that at night hours, on the morning of 15-11-2017, a maximum intensity of 47 mm/h was observed, but for a limited time period of about 1 hour, while for a continuous three-hour period (05:00-08:00) the average rainfall intensity was about 39-40 mm/h. These intensity and duration values correspond to one hundred years return period event. Thus, the corresponding flood discharge has been calculated equal to **180 m³/s** for the basin of Agia Ekaterini's and **140 m³/s** for the Soures basin, respectively.

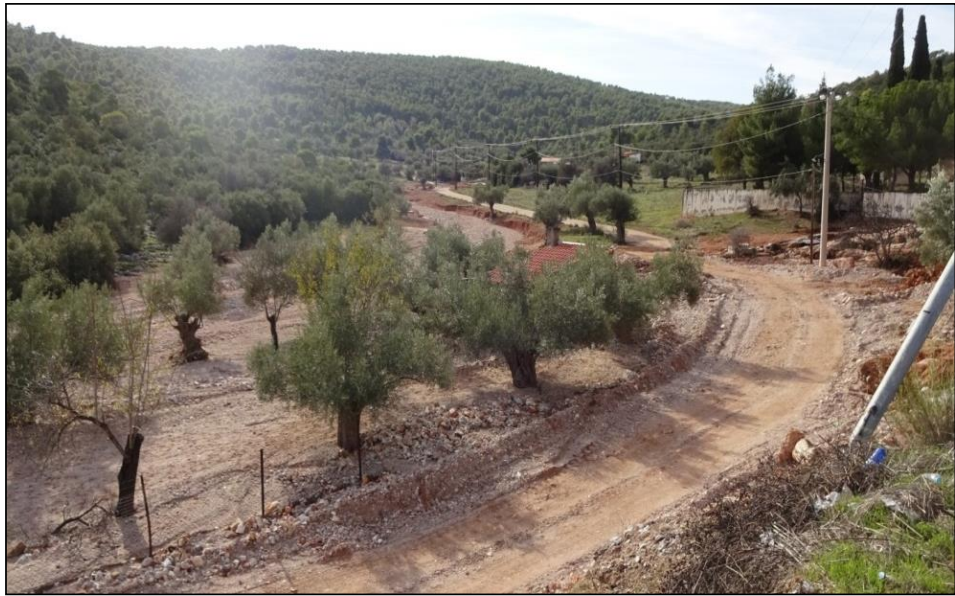
Examination of the streambeds after flood, at points where there was no human intervention, showed that they were overflowing far beyond their corresponding banks (photo Fig. 4), revealing thus that the examining flood was extremely, and unusually large. If that was a normal one, the existing streambeds would have easily accommodated their stream drainage.

Fig. 4: Photograph from the river bed of Agia Ekaterini after the flood of 14-15/11/2017.

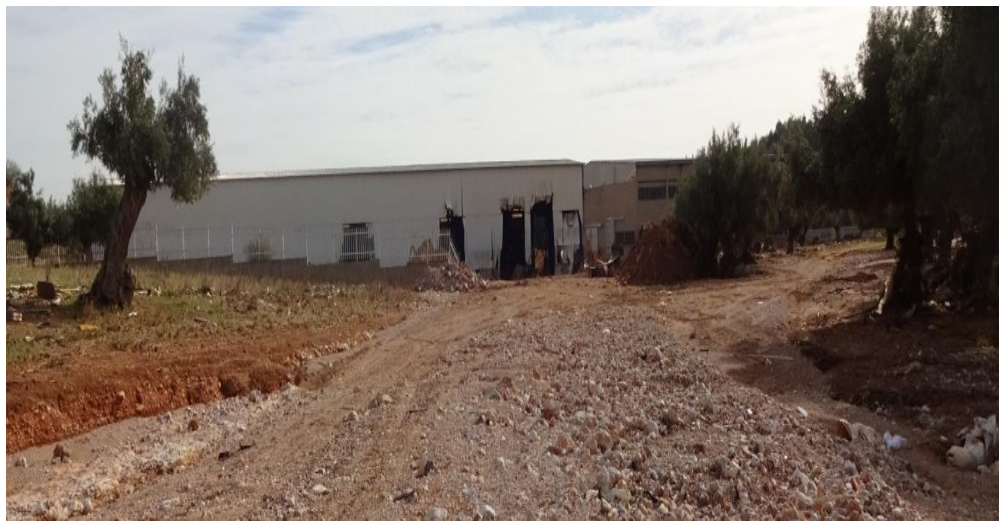
In the picture of Fig. 5. we see a large building that has been built across the streambed of the Soures stream. This building along with other nearby similar interferences, and obstructions, essentially blocked its course towards Sarantapotamos river, resulting in overflowing the nearby road (E962) and flooding the lands and buildings of Mandra eastern urban area. A large part of the E962 lower course was also inundated. At the points of those interferences 5 people were found dead.

Fig. 5: Photograph of the Soures streambed which shows the existence of a massive building across the flow of the stream.

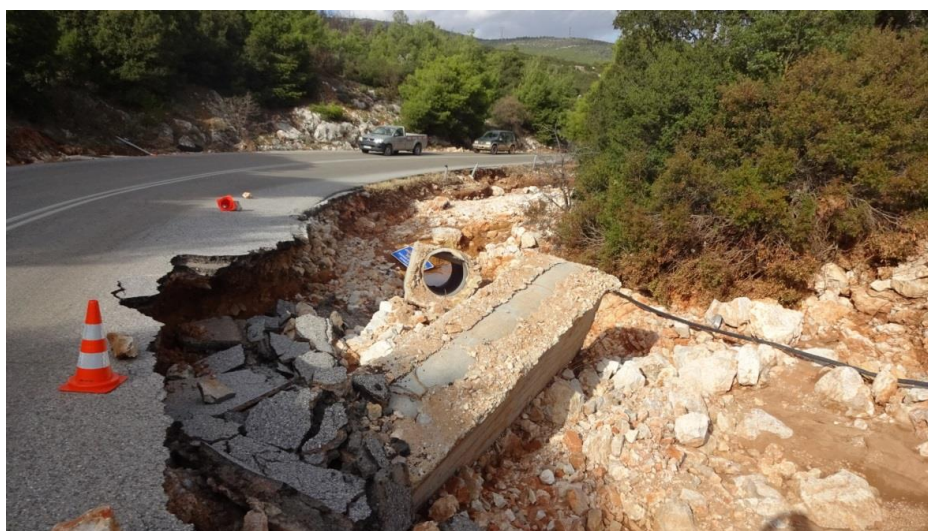
The picture of Fig. 6 shows the erosion of the national road 3 Mandra-Thebes (E962) from the flood waters of the stream Soures. That road was actually a natural stream's channel before its making.

Fig. 6: Erosion of road 3 of Mandra-Thebes (E962) from the flood of 14-15 / 11/2017.

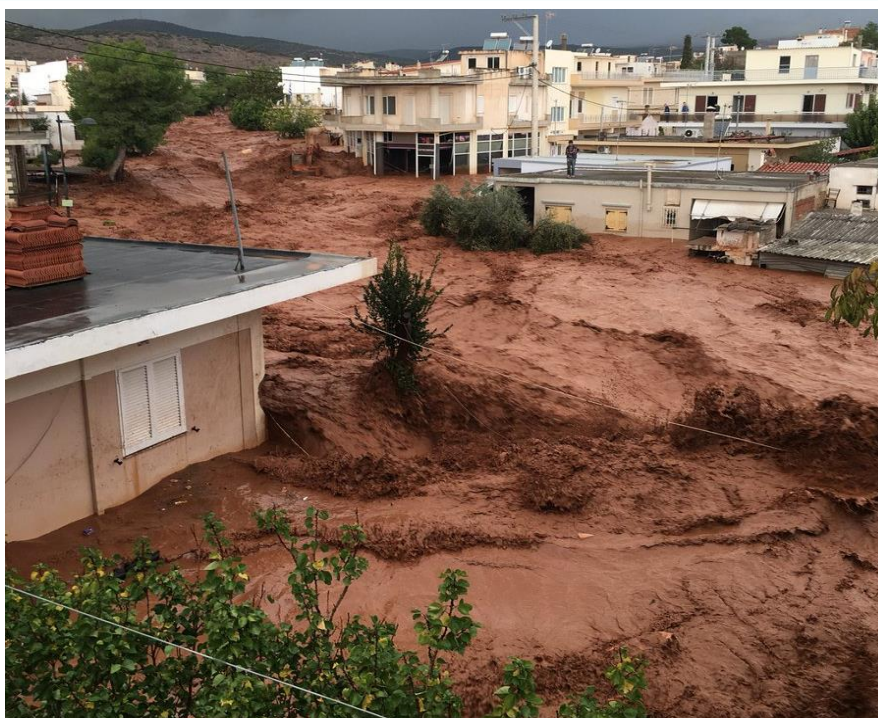
Finally, in the photo of Fig. 7, part of the settlement of Mandra is flooded by the waters of Agia Ekaterini's stream. The waters have covered much of the ground floor of the buildings and were the cause of many deaths. The flood waters "spread" over a large part of the urban area, so the flow had a great cross section. Consequently, the flow velocity was decreased and thus huge amounts of suspended materials have been deposited in the streets, since both the transport and corrosive capacities of the flowing water vary with the third power of its flow velocity.

Fig. 7: The flood flow in the residential fabric of Mandra.
