Bulletin of the Geological Society of Greece

Vol. 40, 2007

Characterization and causes of the building stone decay at the Artemis temple, Brauron, E. Attica, Greece

CHARACTERIZATION AND CAUSES OF BUILDING STONE DECAY AT THE ARTEMIS TEMPLE, BRAURON, E. ATTICA, GREECE

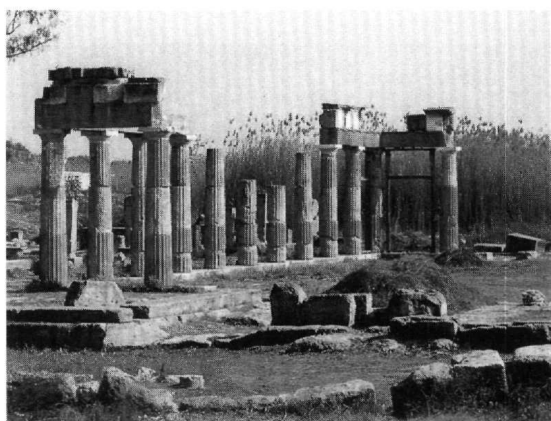
Figure 1 - View of the monument remains

2. Strong colour alteration- calcareous crust formation: observed in many column pieces having deep grey colour, instead of whitish-grey to beige colour of the new column pieces, used at the restoration, (Figs 1, 3, 14)

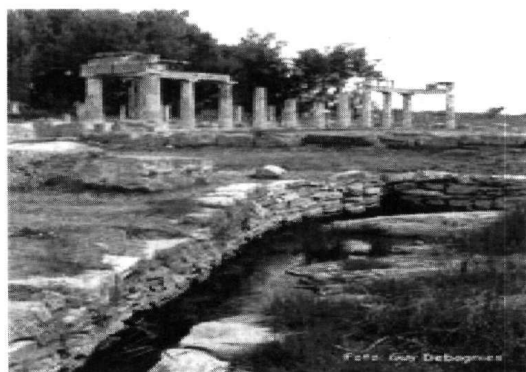
Figure 3 - The temple and Erasinos river

direction of I. Papadimitriou. Restoration of the Stoa was carried out during the years 1950-60 by Prof. Ch. Bouras. The most notable monuments of the site are: The big lodge (stoa) of Doric style with a Greek P (Π)-shaped ground plan. It was built between 425 and 415 B.C. and it framed the big closed interior courtyard, which opened toward the temple of Aphrodite, (Figs 1, 2). The temple of Artemis. A doric prostyle temple with a tripartite cella and deep adyton, built on the site of an earlier archaic temple. It dates to the first half of the 5th century B.C. The temple or heroon of Iphigeneia. (Fig. 4). It was built at the site of the Sacred Cave which was connected with the tomb and the worship of Iphigeneia, when the roof of the cave collapsed. The earliest Cult evidence goes back to the 8th century B.C. It is important to notice that since the 3 century BC the Temple was deserted and gradually the ruins were buried by the flood and brackish deposits of the Erasinos river delta (Figs 2, 3).

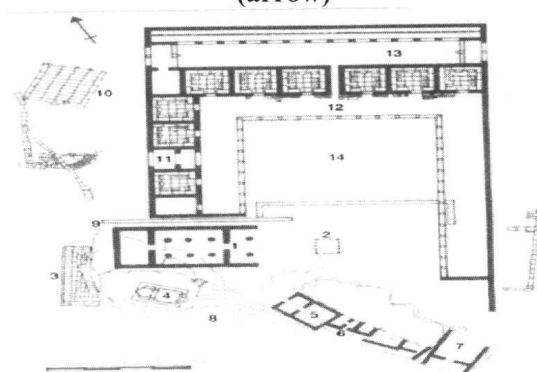
Figure 4 - Plan of Artemis Temple area. 1. Temple, 5. Iphigeneia heroon, 6. Iphigeneia tomb, 7. Sacred house, 12. Stoa 14. Courtyard

- From the building stones used for the construction of a. the Π shaped Portico b. the connected rooms and c. the sacred house, the alter and the tomb of Iphigeneia, (Fig. 4).
- From the sandstone layers of the above-mentioned upper-Miocene formation where the ancient quarries were (figure 4). They are located in a near by hill 500m away from the temple, at northeast and the quarry traces are well preserved, (Buras 1967)

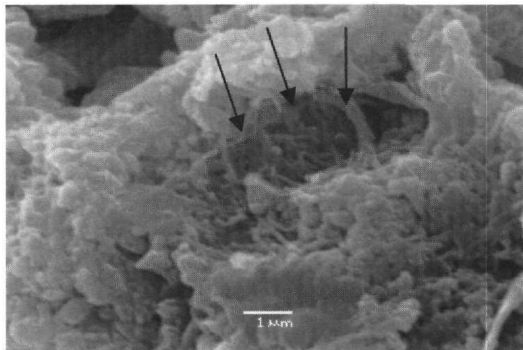
Figure 8 - Micromorphology development in pores

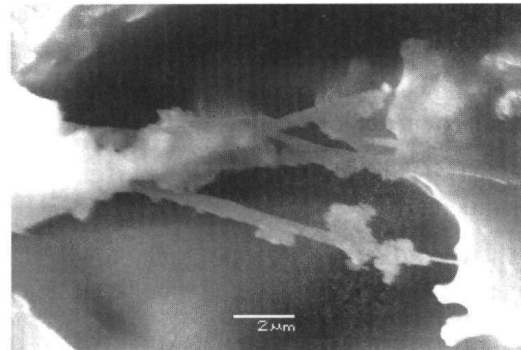
Figure 9 - Tiny crystals of halite

SEM analysis: Initial coarse calcite cement crystals are locally dissolute and secondary recrystallized calcite is formed. The locally presence of germs was observed. They have developed between the grains where the cement is dissolute (Fig. 8) and are bound to the grains. Tiny salt (NaCl) are developed in voids and pores creating bridges between grains (Fig. 9). Zircon also was found as isolated grains or constituent in rock fragments.

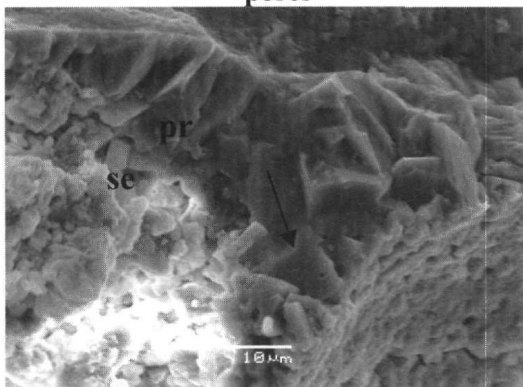
Figure 10 - Secondary calcite cement crystals (se), displaying coarser crystals than the primary calcite cement (pr), with dissolution pits (arrow)

Calcium carbonate recrystallized as secondary cement. These recrystallized crystals formed under supersaturated conditions, of a solution, exert pressure against the pore walls, known as crystallization pressure (Moropoulou and Theoulakis 1991). Salt (NaCl) crystallization in pores increases physical stress and causes breakage of the stone (Cardell *et al.* 2003).

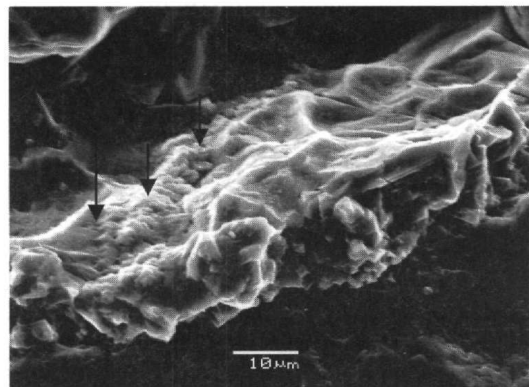
Figure 11 - Dissolution patterns and pits (arrow) on calcite cement, due to solution attack

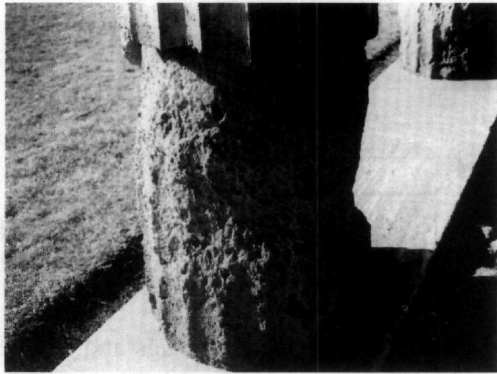
1. Pitting corrosion to cavitation erosion of graduated degree: the presence of vugs and cavities, large enough, approximately of 1-4 cm mean diameter, is very extensive, (Figs 12, 13, 16, 17, 18, 19). These vugs that were observed on many different pieces of the columns, seem to have diminished not only the durability, but also the good appearance of the monument, (Figs 13, 14, 15). When the cavities are getting enlarged they are connected by “bridges” (narrow areas of rock), (figure 13). Eventually bigger pieces are loosening and the result is a complete alteration of the original grooves and progressively of the shape of the column pieces (Figs 12, 13).

Figure 12 - Honeycomb decay of bottom column piece of type I sandstone, and shape alteration

A close inspection of the building stones indicates that in the restored monument pieces of stone found in situ and other new pieces display different degree of decay. For example in figure 12, the lower part of the column, characterized by great material loose was found in situ, whereas the upper part is a new piece. The different stage of deterioration between the weathered source rock and the decayed building stone is quite obvious in figures 22, 23, 24 and 25. In the pair of figures 22-23 and 24-25 under the same magnification, rock samples from the quarries and samples of the building stones that correspond to the same lithotype, I and III, are compared. The degree of decay of the building stones is obvious. The calcareous cement is been partly dissolute. Pits, pores and vugs have developed. Progressive dissolution of cement leads to the formation of bigger pores and cavities. These cavities may be connected by narrow areas as “bridges” (Fig. 13), which progressively will be diminished. That gradually results to grain loose and material removal. The concave surfaces occupied previously by grains are obvious (Fig. 25).

The three sandstone lithotypes are cemented by calcite. This is a feeble characteristic since acid water attack results easily to calcite dissolution, (Fig. 20). Vulnerability of stone to certain decay forms, as soluble minerals, is highly controlled by microstructural and mechanical characteristics of the stone (Leith, *et al.* 1996). When the cementing material is loose through solution, the mechanical properties of the stone are diminished. That results in rapid disintegration of the clasts. The consequence is the development of honeycomb forms, which is a usual decay form of sandstones, (Fig. 12).

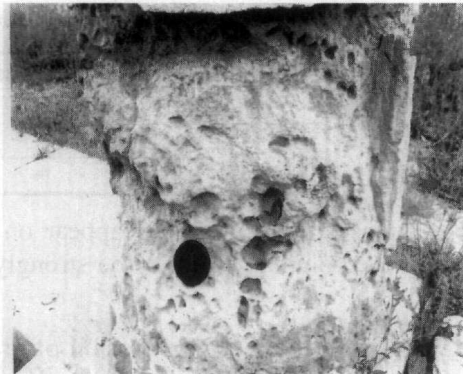
Figure 13 - Severe decay of bottom column piece constructed of type III sandstone and shape alteration

Calcareous crust was also observed on the column pieces, which were in contact to the capital, constructed of white Penteli marble, (Figs 13, 14).

Rock properties controlling the effects of acid rainwater or/and pore water include mineralogical composition and permeability. The later is again controlled by porosity, more particularly by pore size distribution. The three sandstone types display mean to high porosity. On this basis they are considered of poor quality for building material. The role of pore size distribution is clearly indicated in the decay patterns of sandstone type III, which displays the most intense decay problems compared to the other two types, while its mineralogical composition is similar to that of type I. With increasing porosity the attacking solution waters are able to penetrate deep into the rock. During dry periods of evaporation the salt solution are drawn by capillary action toward the surface, where precipitation may cause the development of a resistant crust over the deteriorated interior, (Figs 13, 15, 16).

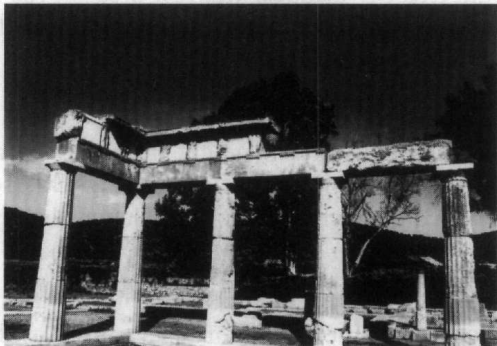
a whitish-grey sandstone found in situ and b: beige (light brown) sandstone cut from the nearby quarry. These two stone materials show different degree of corrosion. The former (Figs 14, 16) displays strong cavity corrosion and colour alteration (calcareous crust), while the latter displays pit and cavity corrosion of a lower degree (Figs 14, 17).

Figure 14 - Different degree of decay on capitals and Calcareous crust development

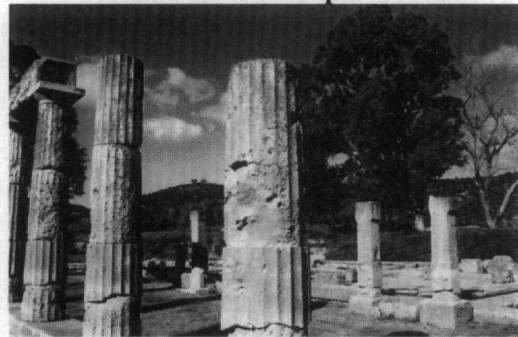
The more intense decay problems appear on the portico columns, (Figs 12, 13, 14, 15). The sandstone of the columns seems to be strongly deteriorated. The different types of decay can be summarized

Figure 15 - Different degree of decay on column pieces

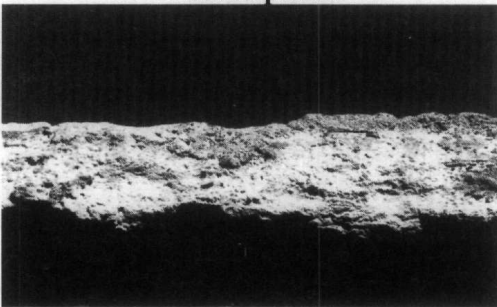
Figure 16 - Capital constructed by lithotype I illustrating high vuggy decay, shape alteration- material loss and crust development

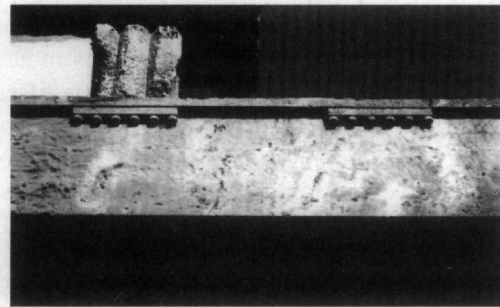
Figure 17 - capital constructed by lithotype II illustrating vuggy decay and color alteration

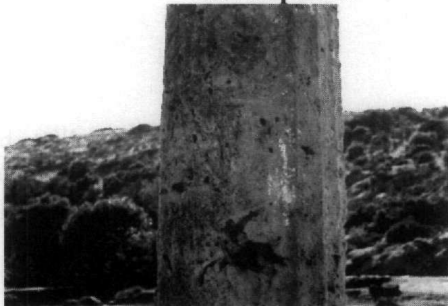
Figure 18 - Intense decay form on sandstone type III

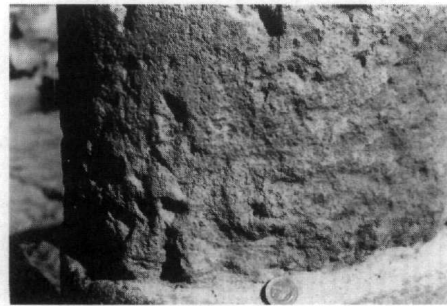
Figure 19 - decay form on sandstone type I

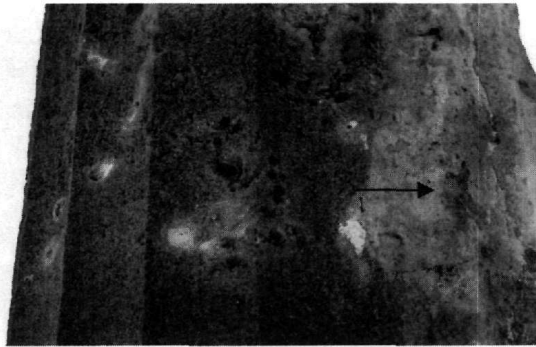
Figure 20 - Cavities and calcareous crust on column piece (arrow)

well as along cracks, (Webley *et al.* 1963, Winnkler 1966). Since the stones have been covered by mud for a substantial period of time and are still influenced by the periodical presence of the water, the development of communities is expected (Michopoulos 2005), (Figs 20, 21) and has considerable impact on stone decay.

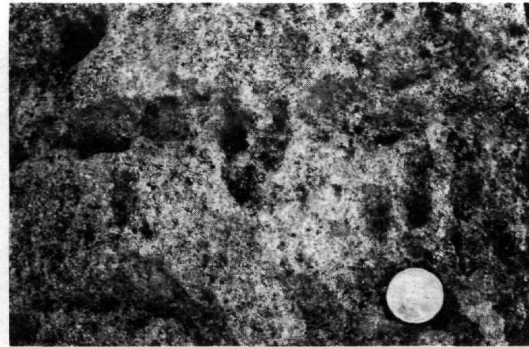
Figure 21 - Development of calcareous crust (white areas)

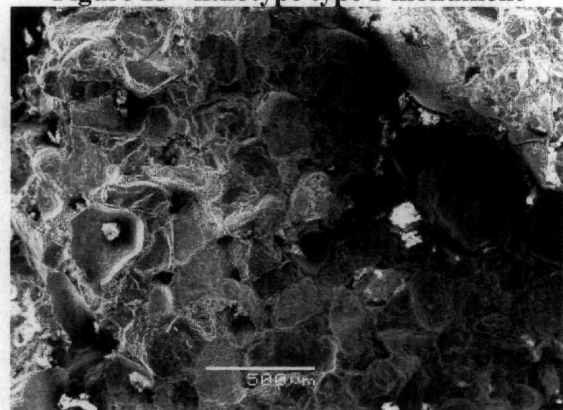
Figure 25 - Litho type III-monument

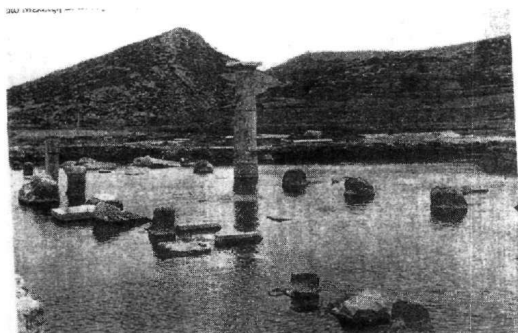
Figure 26 - Brauron monument before the restoration works (photo by Bouras 1967)

Although Erasinos is a small river, it is flooding after strong and intense rainfalls. (Figs 26, 27). Then the waters caring along mineral materials as bed load or in suspension, cover all the area of the monument, (Fig. 16), for considerable period, until the waters withdraw. The water drainage area of Erasinos is large enough including locations as Attica Road, Venizelos airport, Marcopoulo city. Rainwaters and Municipal wastewater treatment from the above areas are driven into the bedload of Erasinos. This might be a possible pollution source for the river waters that reinforce the ion and bio content. Running water picks up ions on its way downstream or loses ions by absorption to clay particles. The flow through stone pores and narrow channels gives the water enough time to reach near equilibrium condition quickly in the presence of calcium carbonate in the stones. The ion content of groundwater is subject to extreme variation depending on both the source rock and the length of travel; groundwater is generally high in Ca, Mg, SO₄, Cl, and Fe. Saline groundwater that usually indicates invasion of corrosive marine water cannot be excluded even in the present since distance from the shore is short and wetlands partly and periodically exist. Soluble salts are considered to be the key-deteriorating factor of building materials in the case of monuments and historic buildings (Arnold 1989). During salt crystallization pressure crystallization occurs within the pores of rocks, and degree of weathering is depends on the degree of salt saturation of the solution and the pore size (Benavente *et al.* 1999).

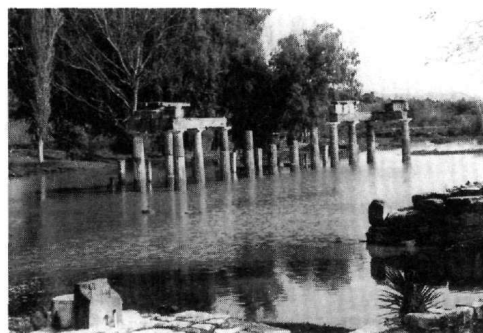
Figure 27 - Brauron monument (26/11/2005) Erasinos flooded after strong rainfalls

Unfortunately flood controls are not sufficient and the phenomenon goes on for centuries, increasing the stone decay by the river or/and seawaters. In addition, the columns side mainly of the new stones, facing toward northeast are affected by marine aerosol and display stronger decay degree due to salt crystallization. The rate of decay is at its greatest when the cycling of the crystallization–hydration cycles is relatively infrequent. It is the length of this ‘drying’ period that apparently has the greatest influence on the rate of decay and could explain the significant difference in the rate of decay between different stone pieces. (Colston *et al.* 2001).
