## FIELD TESTING OF REMOTE SENSOR GAS LEAK DETECTION SYSTEMS FINAL REPORT

# FIELD TESTING OF REMOTE SENSOR GAS LEAK DETECTION SYSTEMS

SwRI® Project No. 18.10485

December 2004

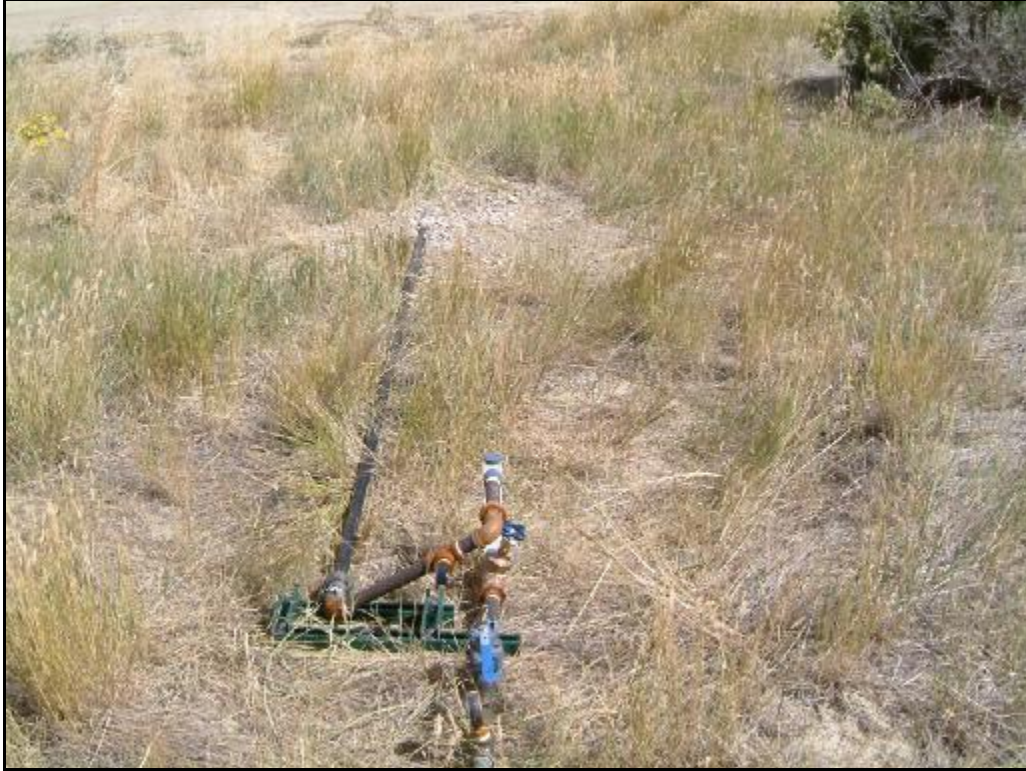
Site 1 – Underground leak outlet is roughly 10 feet from rotometer location (in gravel area).

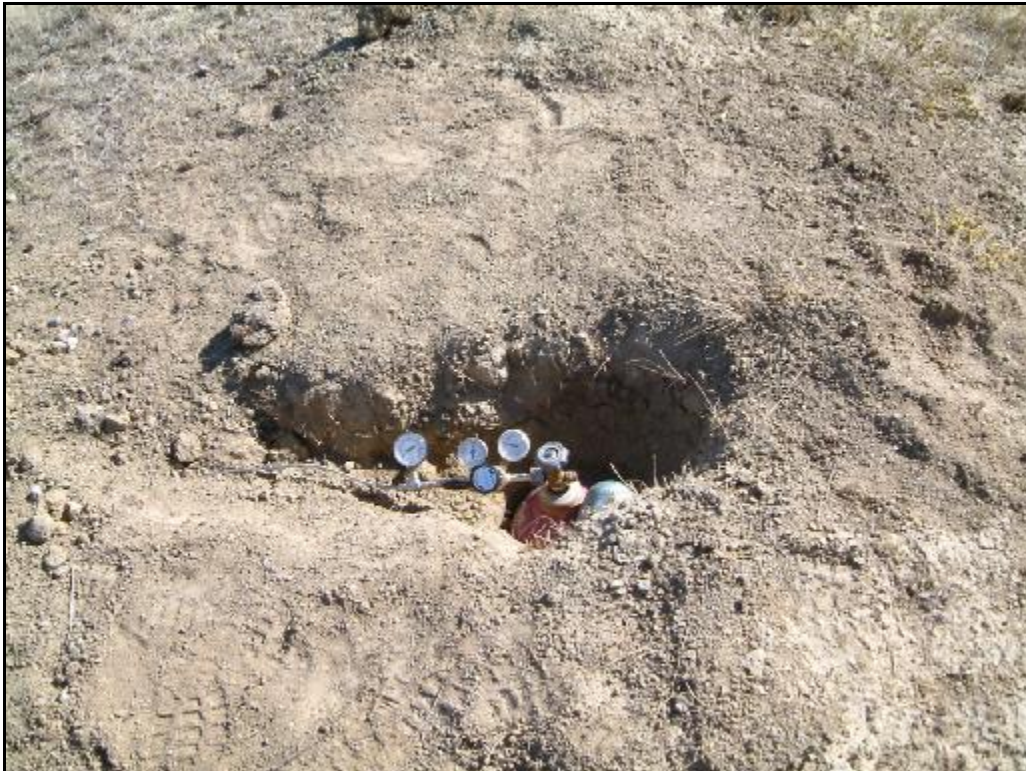
Site 2A – View of bottle and regulator (typical of all bottle fed leaks; 2A through 2E).

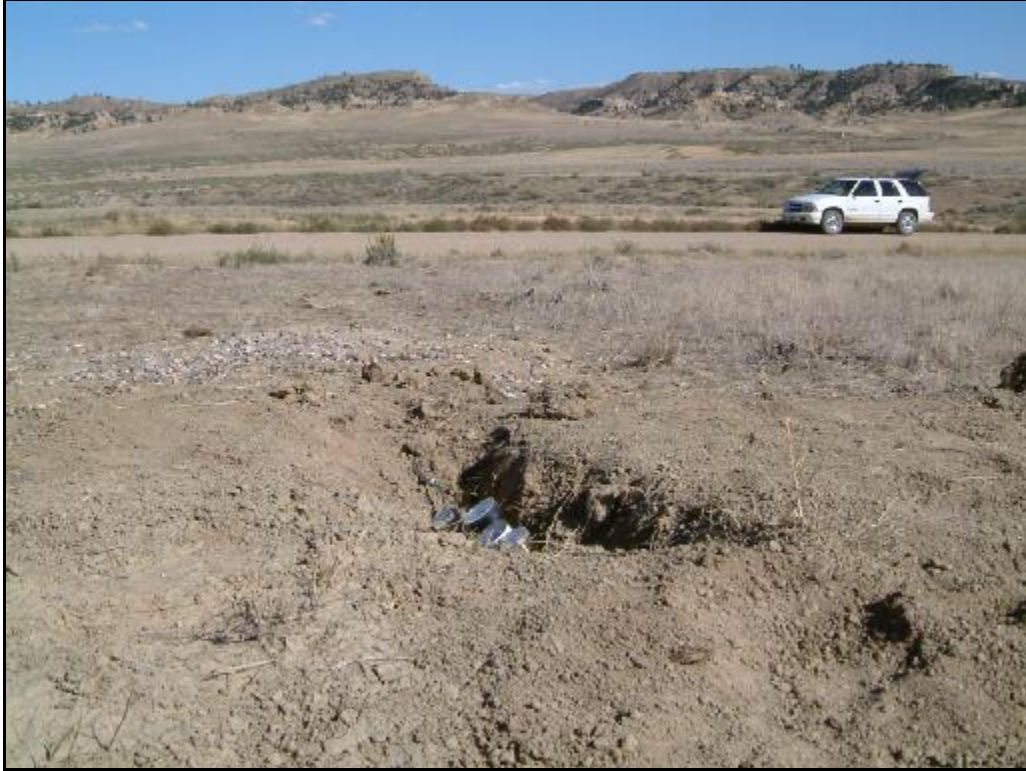
**Site 2A – View from leak site to road. Underground leak located in the gravel area approximately 8 feet from bottle location.**

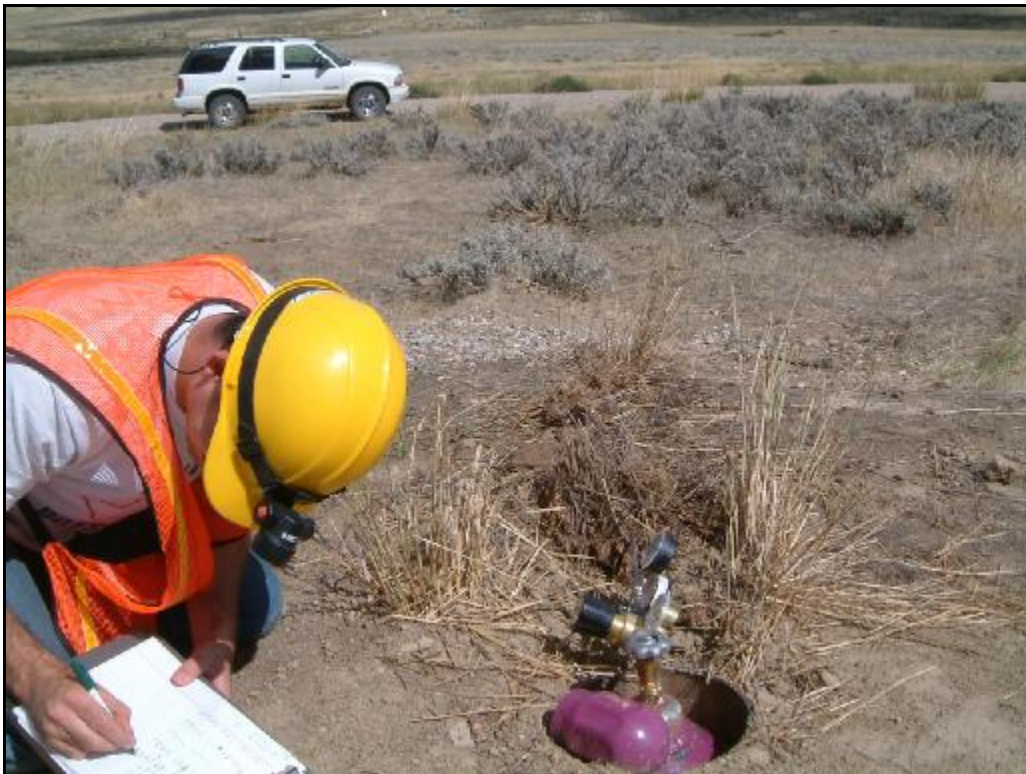
**Site 2B – Underground leak located in the gravel area approximately 8 feet from bottle location.**

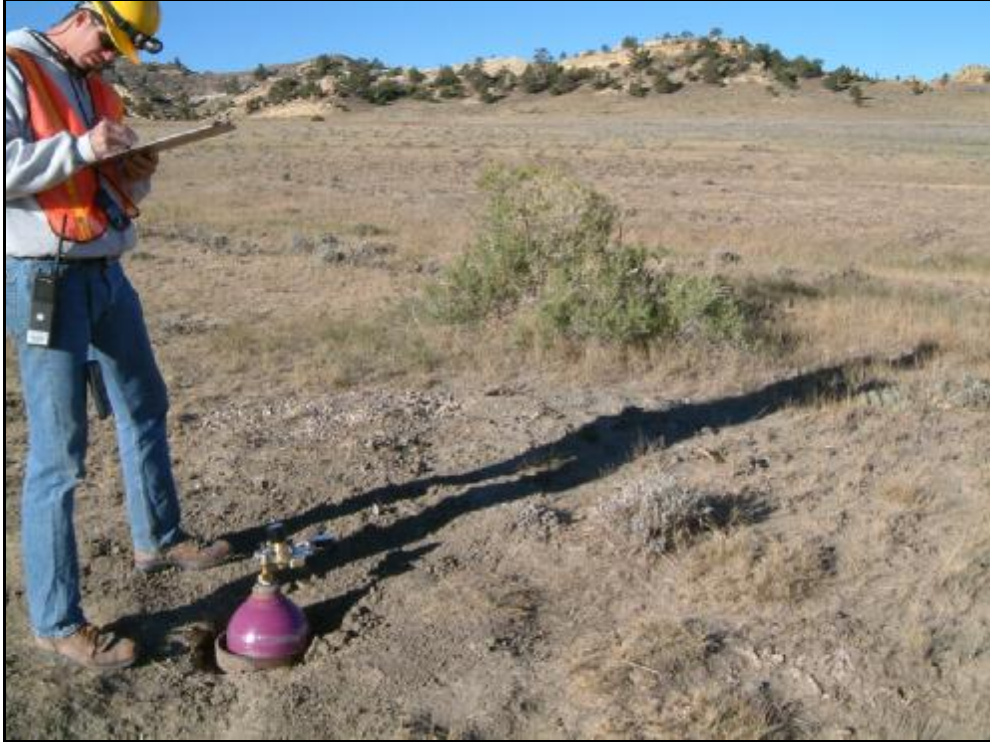
**Site 2C – Underground leak located in gravel area approximately 8 feet from bottle location.**

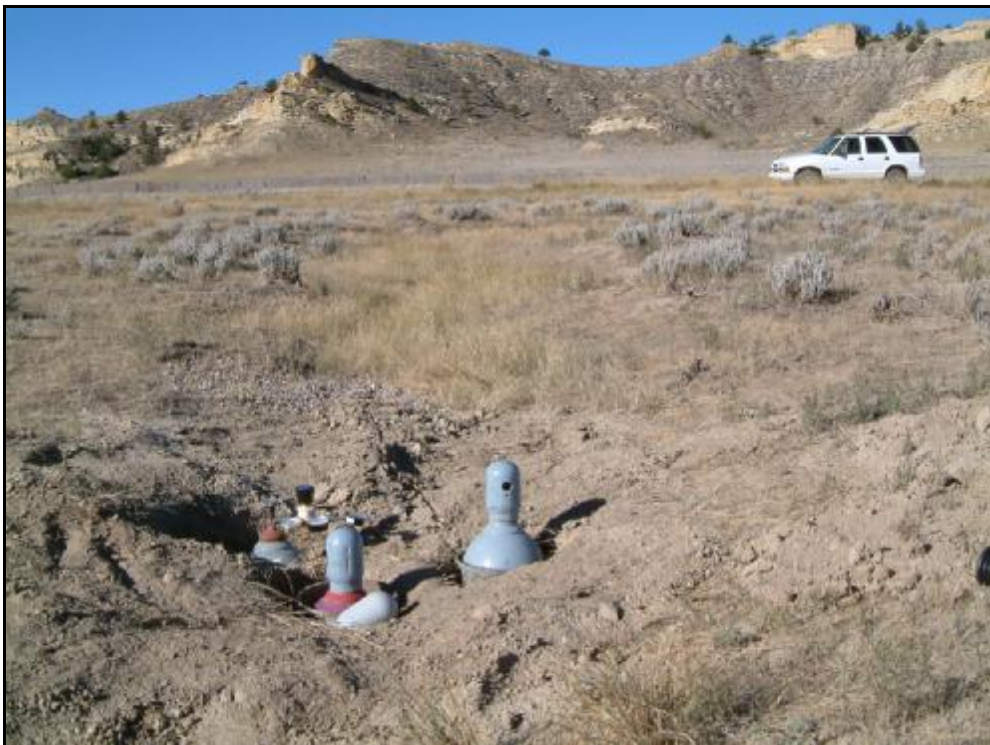
**Site 2D/Site 1F – Three bottles (two with methane only, one with methane/ethane mix). Underground leak located in the gravel area approximately 8 feet from bottle location. Vehicle located on the road.**

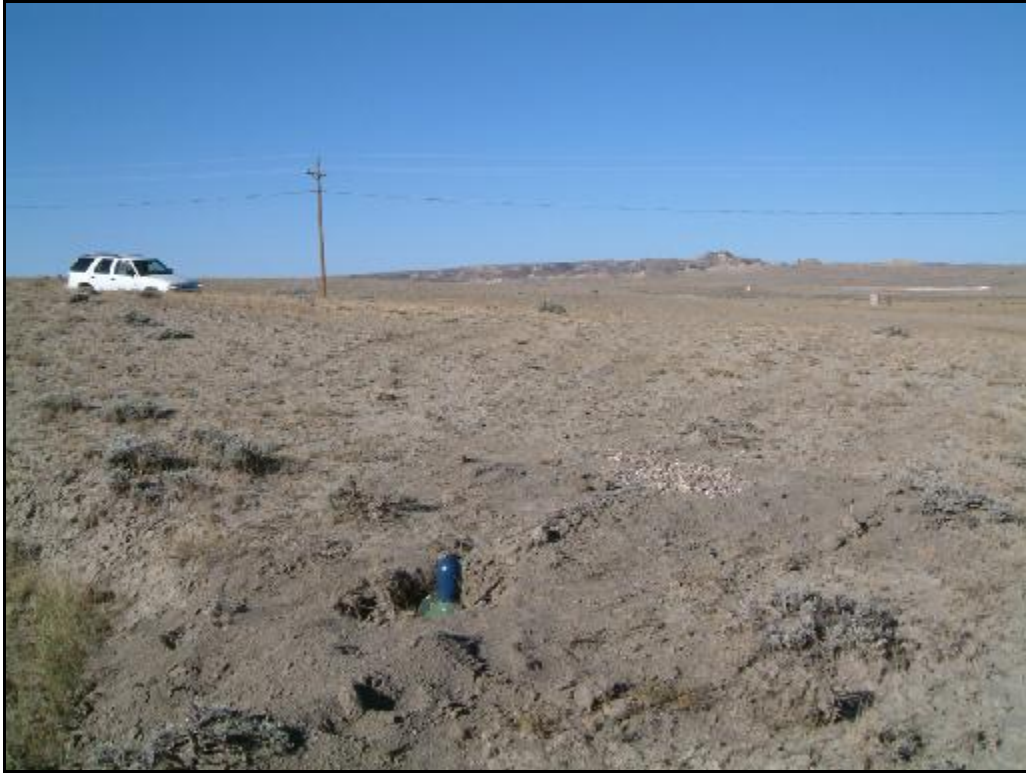
**Site 2E – Underground leak located in the gravel area approximately 8 feet from bottle location.  
Vehicle located on the road.**

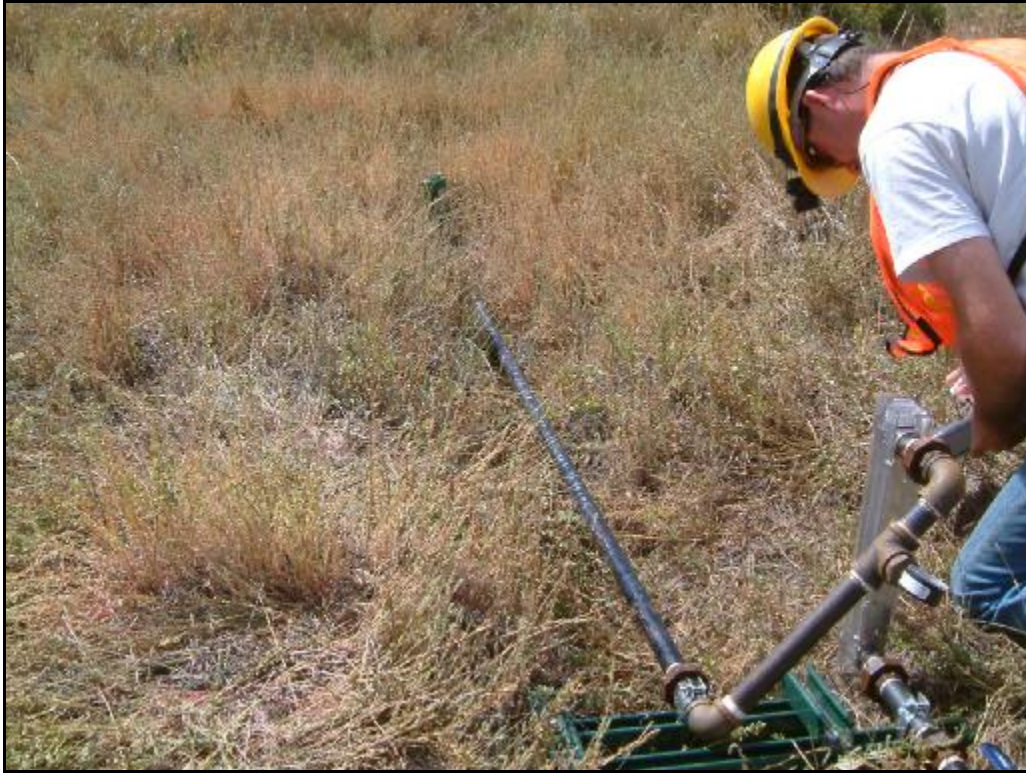
**Site 3 – Aboveground leak at the end of the 10-foot long pipe.**

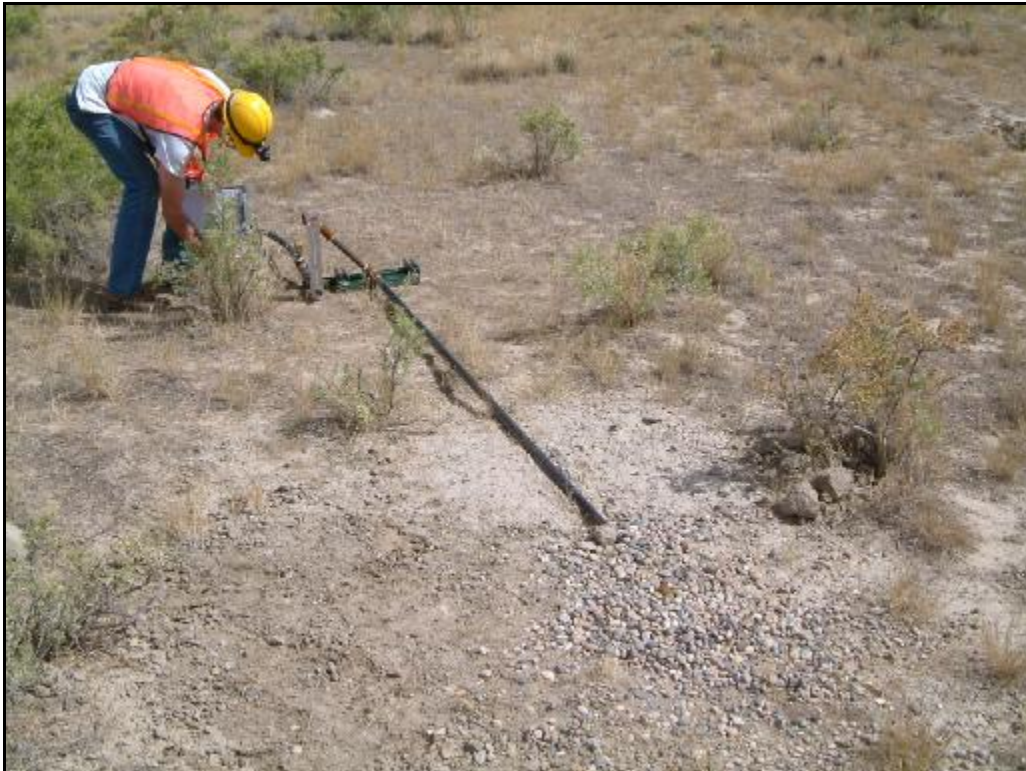
**Site 4 – Underground leak emitting through gravel.**

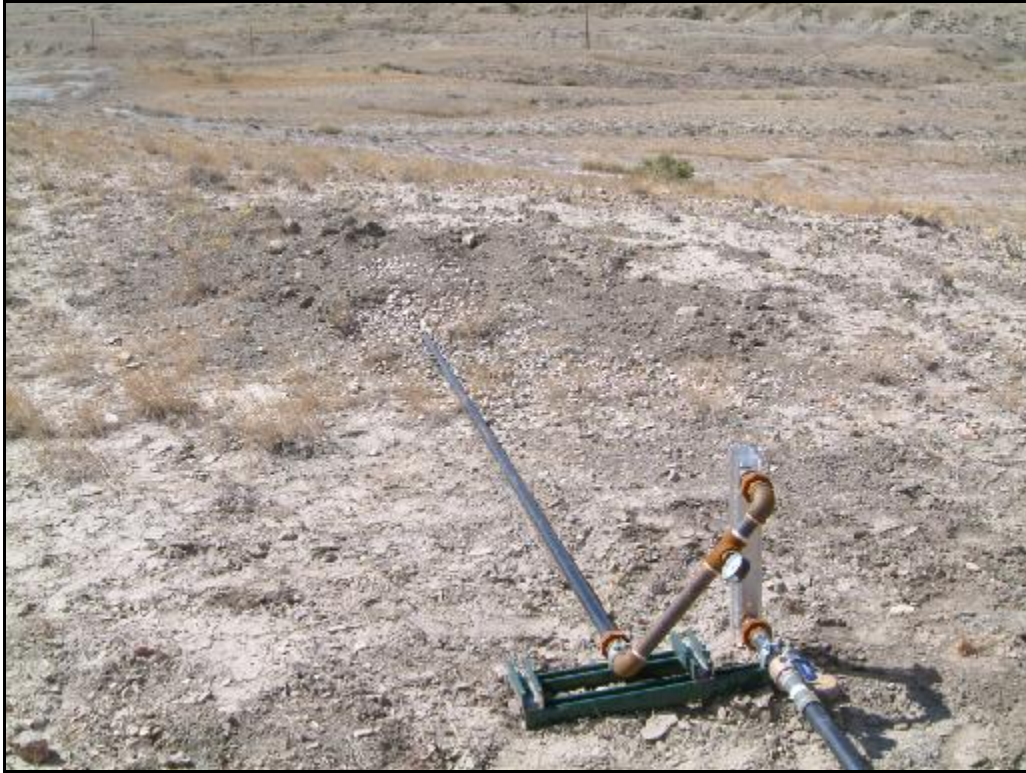
**Site 6 – View at the top of the hill. Underground leak at gravel located approximately 10 feet from the rotometer.**

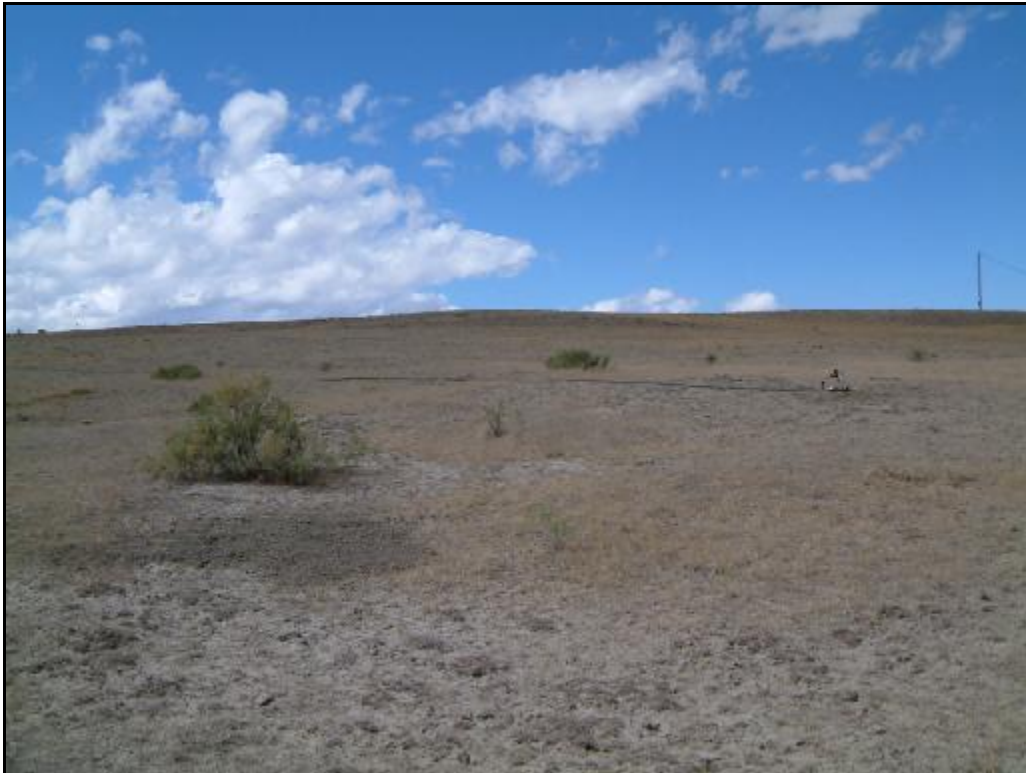
**Site P1 – Underground leak. Directionally drilled such that the leak emits under greasewood bush located approximately 20 feet from rotometer.**

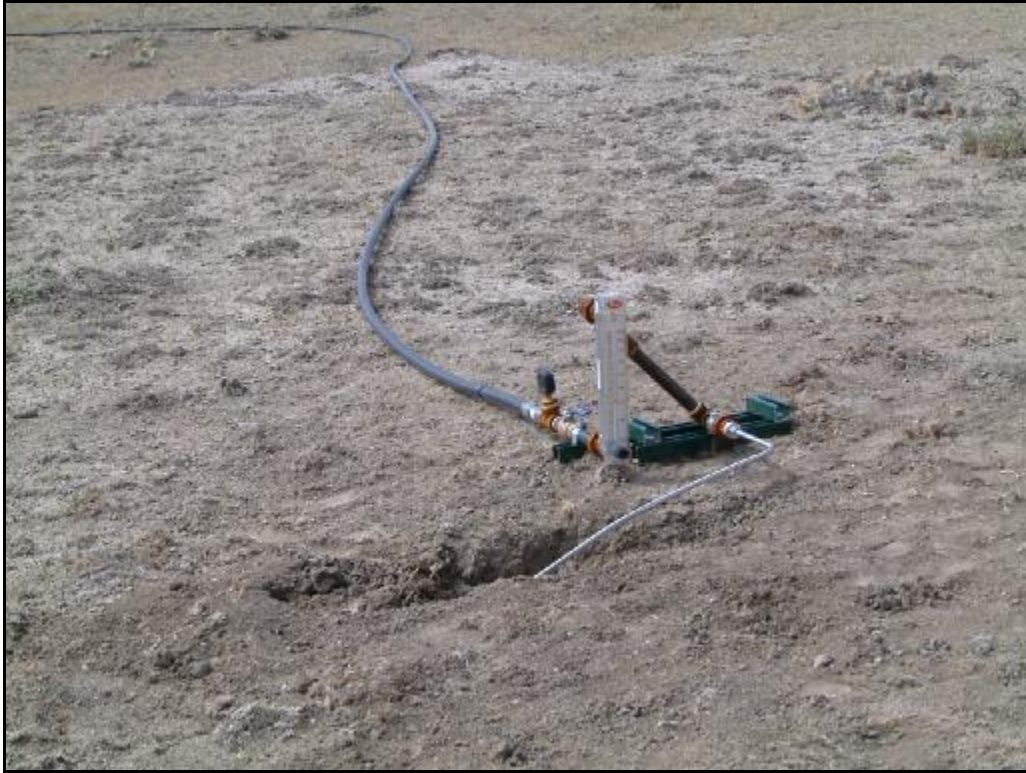
**Site P1 – Detail of tubing entering the ground.**

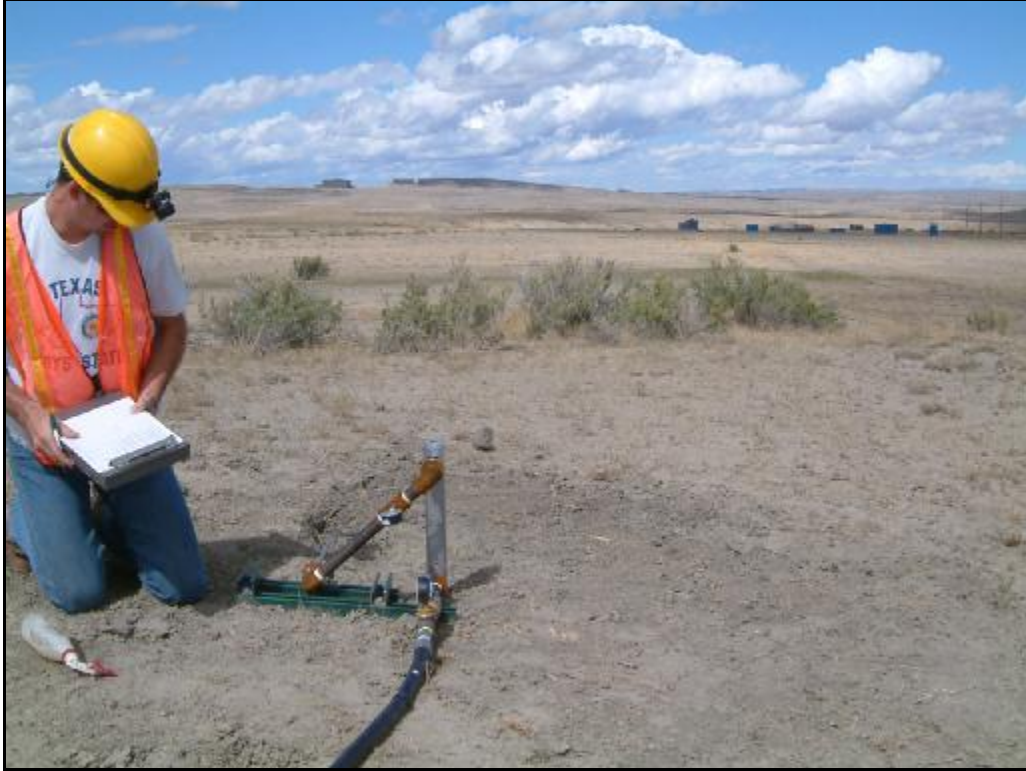
**Site P2 – View of leak site and vegetation. The gas leak emits underground near the middle of the greasewood bushes.**

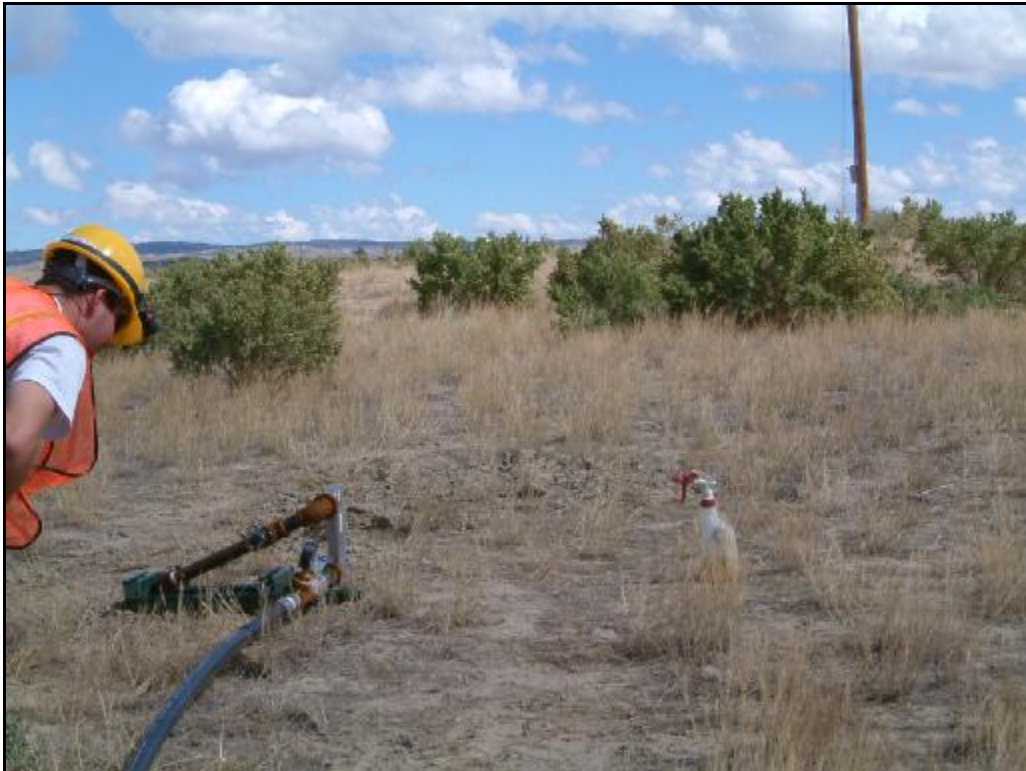
**Site P3 – View of leak site and vegetation. The gas leak emits near the middle of the greasewood bushes.**

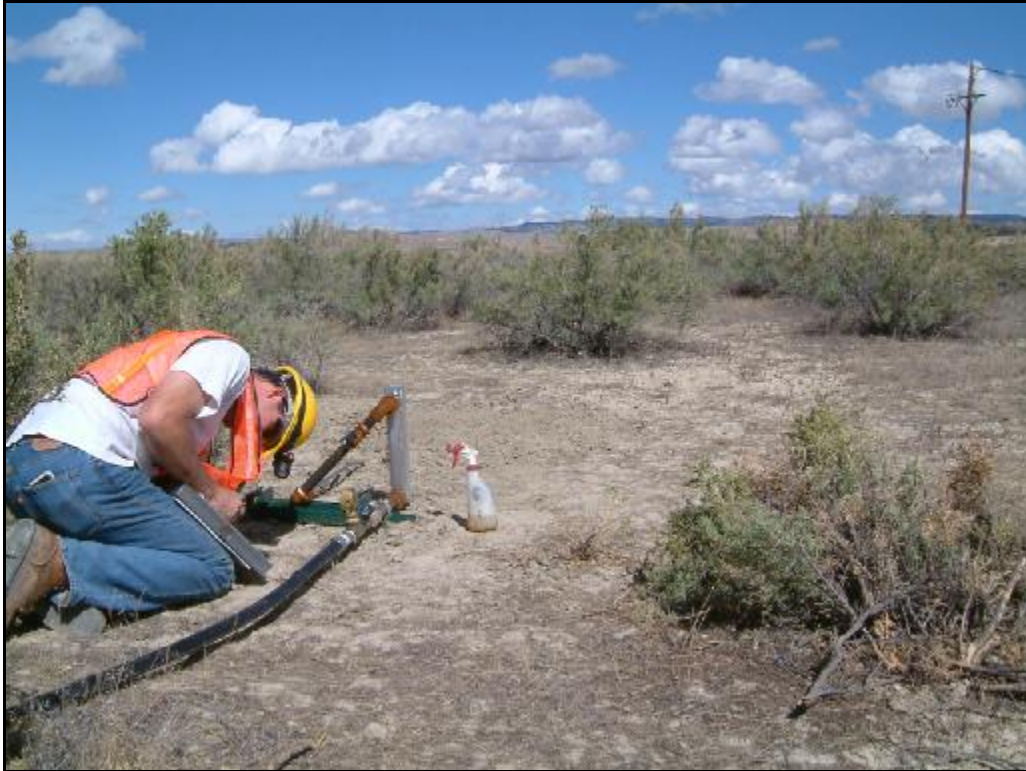
**Site P4– View of leak site and vegetation. The gas leak emits near the middle of the greasewood bushes in the center of the picture.**

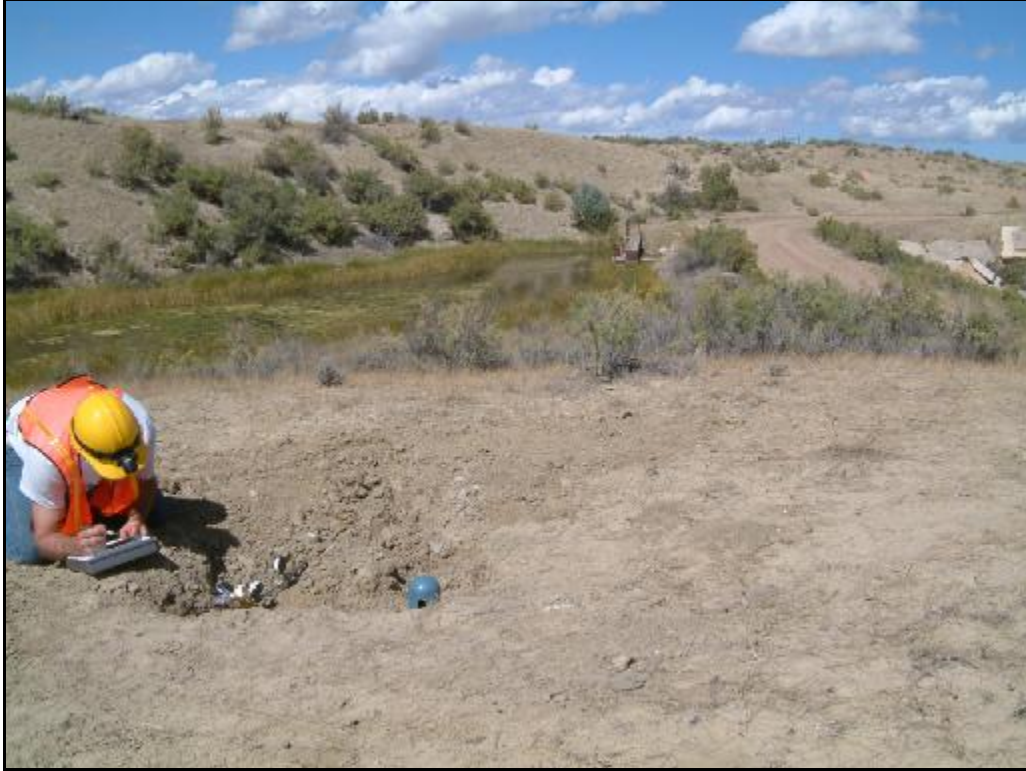
**Site P5 – View of site and vegetation. The leak emits beneath the greasewood bushes in the middle of the picture.**

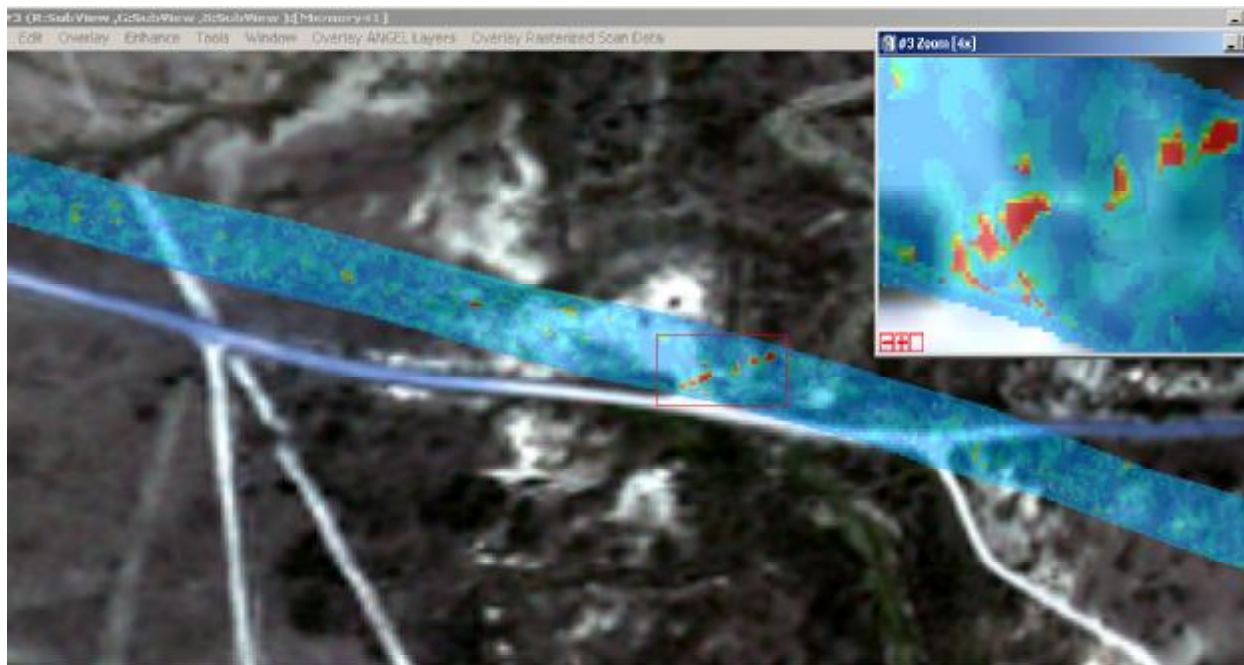
**Figure 1.1.3 Visual Display of Natural Gas Emissions Detected By the ANGEL System on the Afternoon of September 17<sup>th</sup>, 2004 (Calibration Leak)**

natural gas emission is present, the resulting mapping of concentration path lengths may create a visual graphic similar to that which is displayed in Figure 1.1.3. This data can then be interpreted visually or through more algorithms to signify the presence and quantification of a natural gas leak.

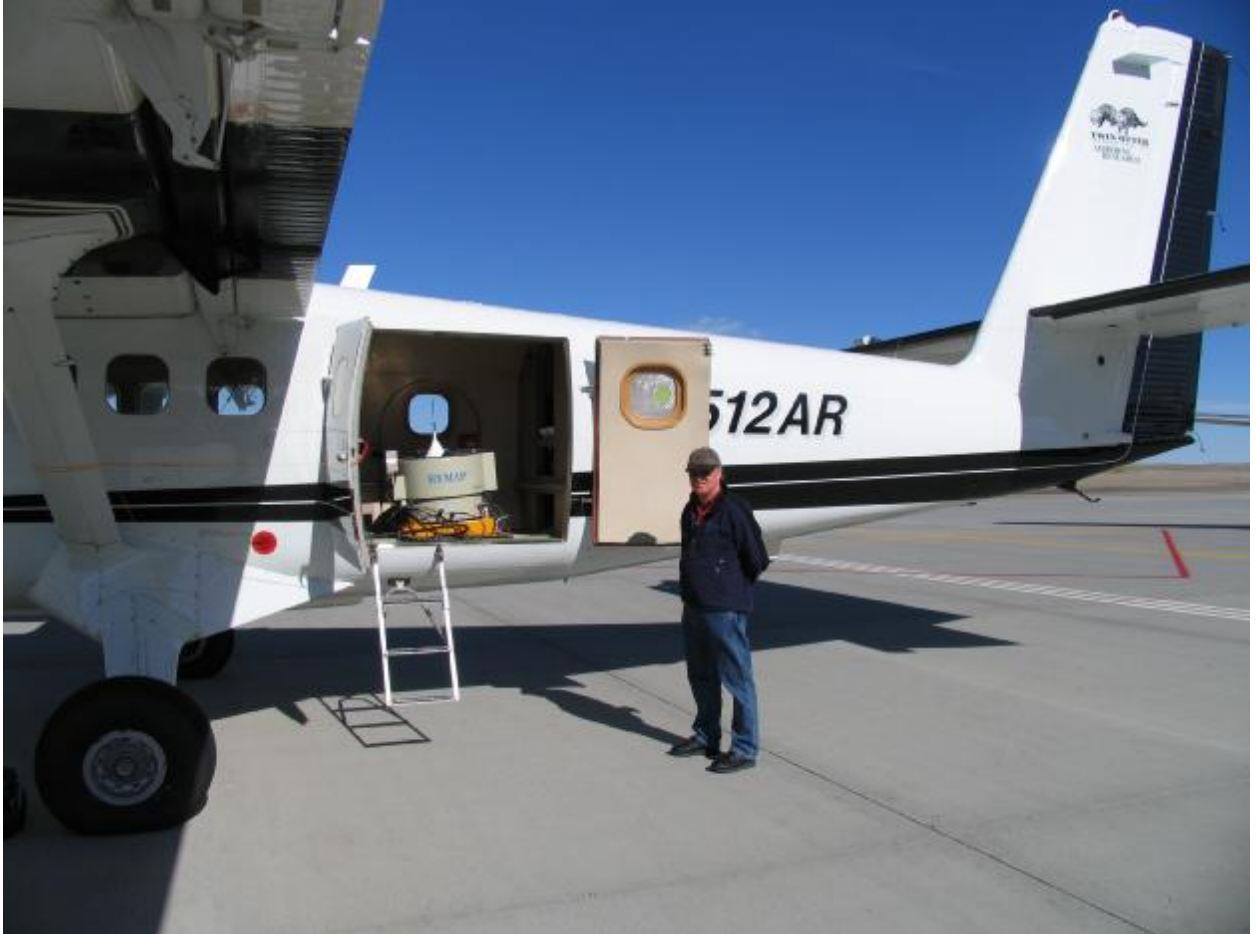
Figure 1 The HyMap sensor is white sitting on the stabilizing platform that is yellow inside the Twin Otter manned aircraft. Mike Hornibrook who is the HyVista operator is shown standing outside side the hatch doors.

The hyperspectral imaging spectrometer is mounted in a Twin Otter aircraft, which has a view hole cut in the bottom of the plane. The sensor is mounted on a stabilizing platform, which contains an inertial measuring unit (IMU). The stabilizing platform maintains the sensor axis angle with respect to the earth below in spite of the motions of the aircraft. The stabilizing platform and sensor combination are mounted over the hole in the bottom of the aircraft. The sensor and the stabilizing platform are controlled by a computer which is rack mounted in the plane near the sensor stabilizing platform combination. The photo in Figure 1 below shows the sensor as white labeled HyMap and the stabilizing platform, which is yellow inside the Twin Otter. The HyVista sensor operator, Mike Hornibrook, is standing at the open hatch doors.

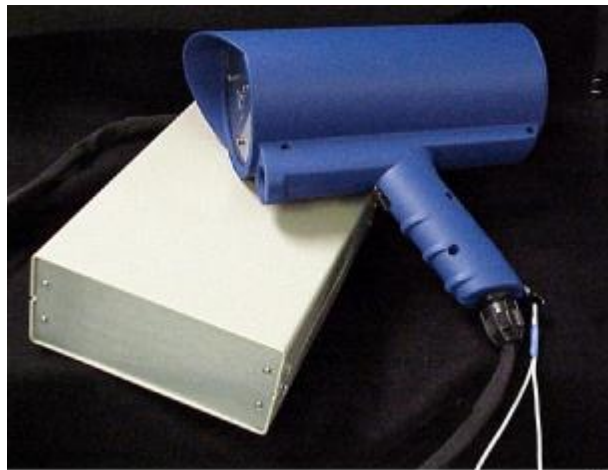
**Figure 1. Remote methane leak detector alpha prototype unit.**

RMLD is a technology previously developed under sponsorship of the PSI and Heath internal funds, US EPA, NYGAS (now NGA), PSE&G, and SoCal for walking survey applications by Local Distribution Companies. The NETL recognized the potential to extend this technology to mobile detection so as to enable its application to transmission pipeline surveys. RMLD participated as a ground-based instrument during the tests at RMOTC. A photograph of the RMLD unit that participated in the RMOTC tests is shown in Figure 1. The control unit is connected to the optical transceiver via a single umbilical.

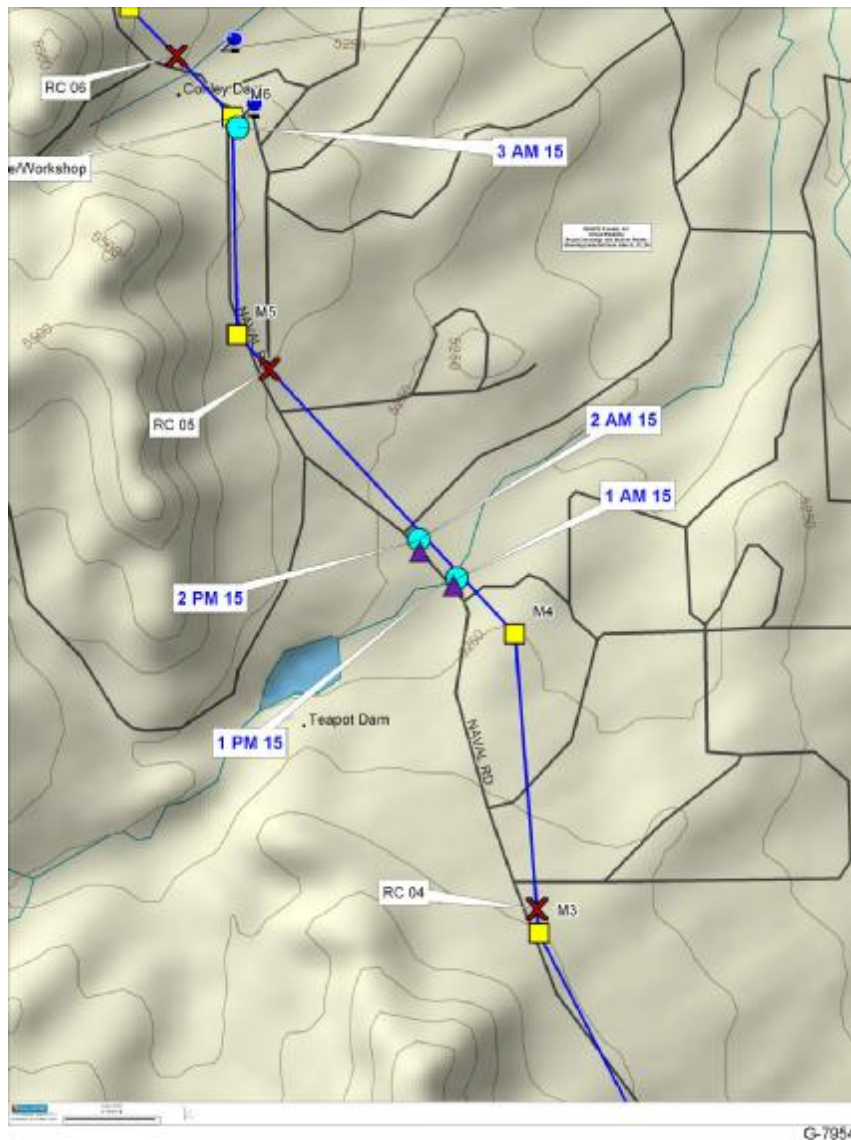
Figure 8. Positions of two adjacent leaks present both Wednesday AM and PM show resolving power.

Again we present in Section 3 the position of the survey vehicle, not the position of the leak origin. We will continue our analysis of the recorded column concentrations to search for small leaks. The RMLD exhibited a good ability to resolve two leaks close together as shown in Figure 8.
