NDOR Research Project Number SPR-PL-1 (038) P530

Long Term Monitoring of a Steel Bridge Constructed Using Phase Construction

National Bridge Research Organization (NaBRO)
(<http://www.NaBRO.unl.edu>)
Department of Civil Engineering
College of Engineering and Technology

July, 2005

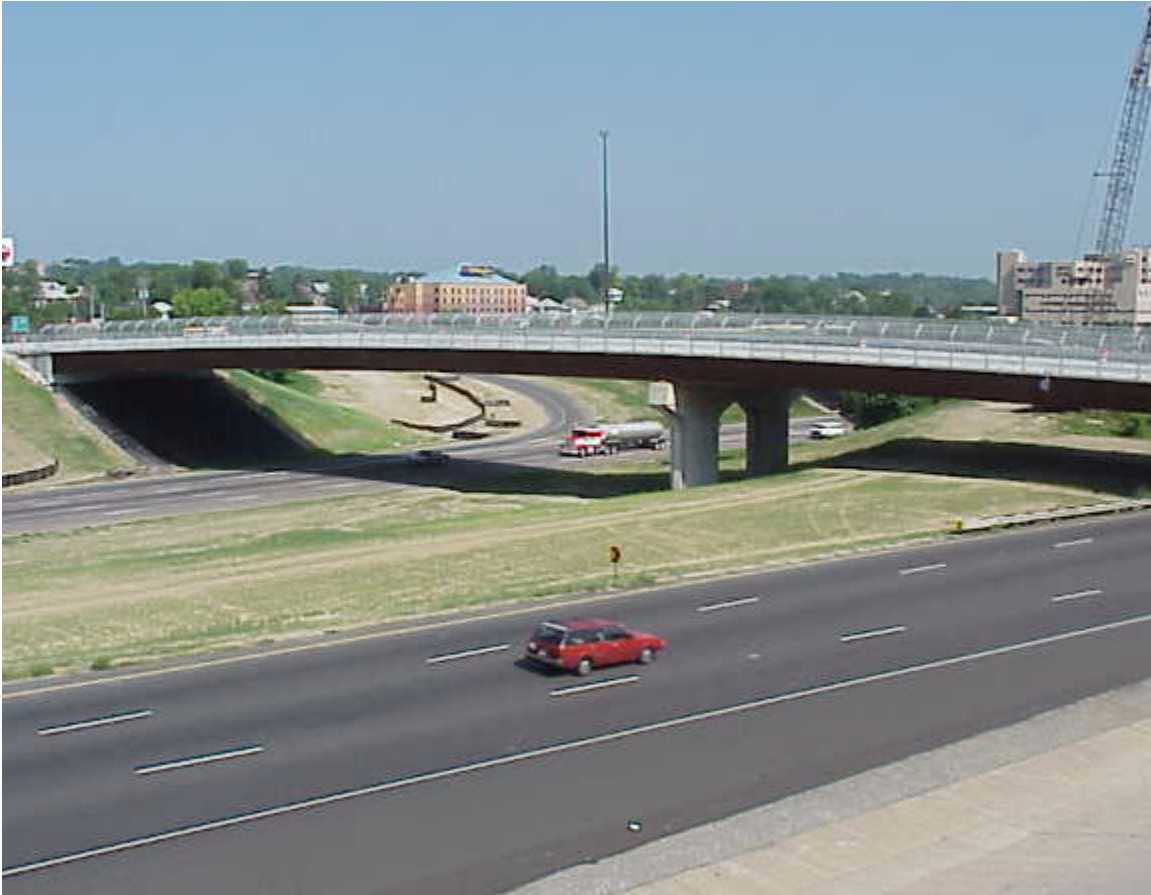
Figure 1-1: Completed structure

This report is the second concerned with the replacement of the Dodge Street Bridge over I-480 in Omaha, Nebraska. The completed structure is shown in Figure 1-1. The replacement of this bridge provided an opportunity to monitor a project built utilizing phased construction. Phased construction, also known as staged construction, allows the replacement of a bridge while maintaining traffic flow. Dodge Street (US Highway 6) is a major arterial and complete closure to traffic during construction was to be avoided. Construction of the bridge occurred in two sequential phases with each phase roughly corresponding to half of the bridge. While one of the halves is being replaced, traffic is permitted to flow in the other one. Later, the two separate phases are joined together by means of a closure pour in order to make the deck of the new bridge transversely continuous. At first, these phases act independently and deflect differently, due to time dependent effects. Instrumentation was installed on the structure prior to

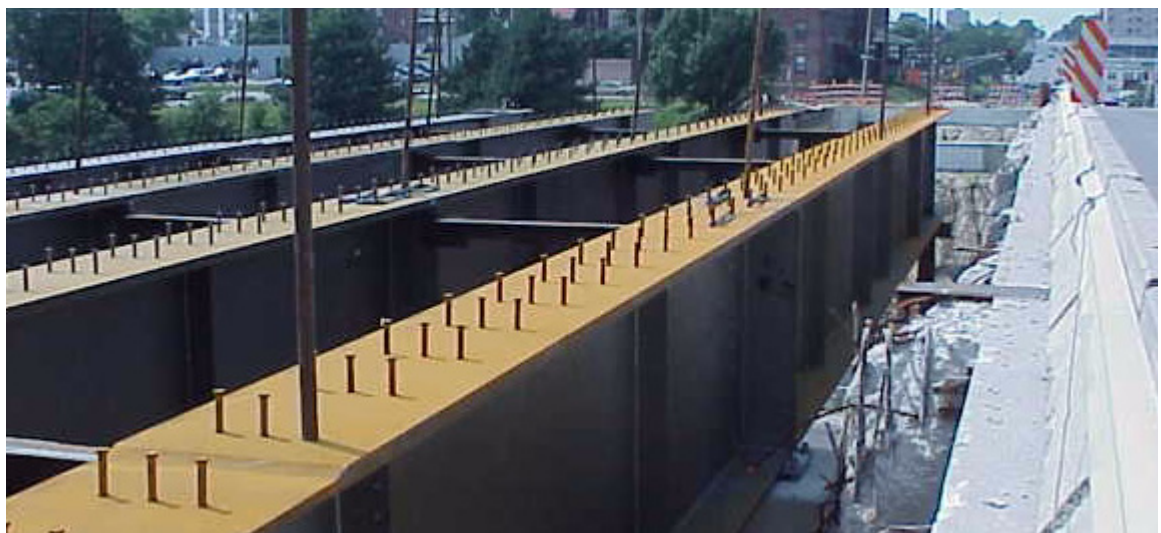
Figure 2-4: Shear Studs on the top flange. Picture is taken looking West. From right to left are Girders E, G, H, and J during erection for Phase I.

Shear studs welded to the top flange will provide composite action with the deck. The shear studs are M7/8 x 5" with three per row spaced 24" between rows. An example of the shear stud placement can be seen in Figure 2-4.

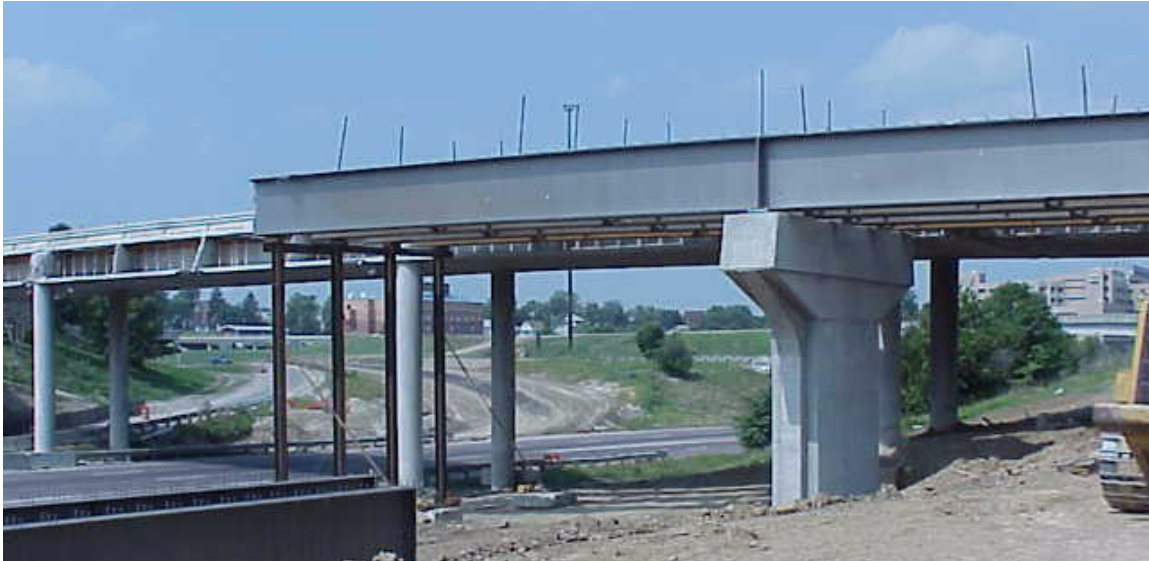
Figure 2-10: Girder sections E3, G3, H3, and J3 placed over the pier

Phase I girders were erected as follows. Sections E3 and G3 were connected by their cross frames while on the ground and placed on the pier. Temporary shoring supported the girders so wind would not blow them off. Next, Sections H3 and J3 were connected on the ground and placed on the pier. While in the air, cross frames between Girders G and H were placed. Now all girder sections over the pier were in place as seen in Figure 2-10. In the

figure Girder J is in forefront. Note the temporary shoring that is supporting the West (left) side.

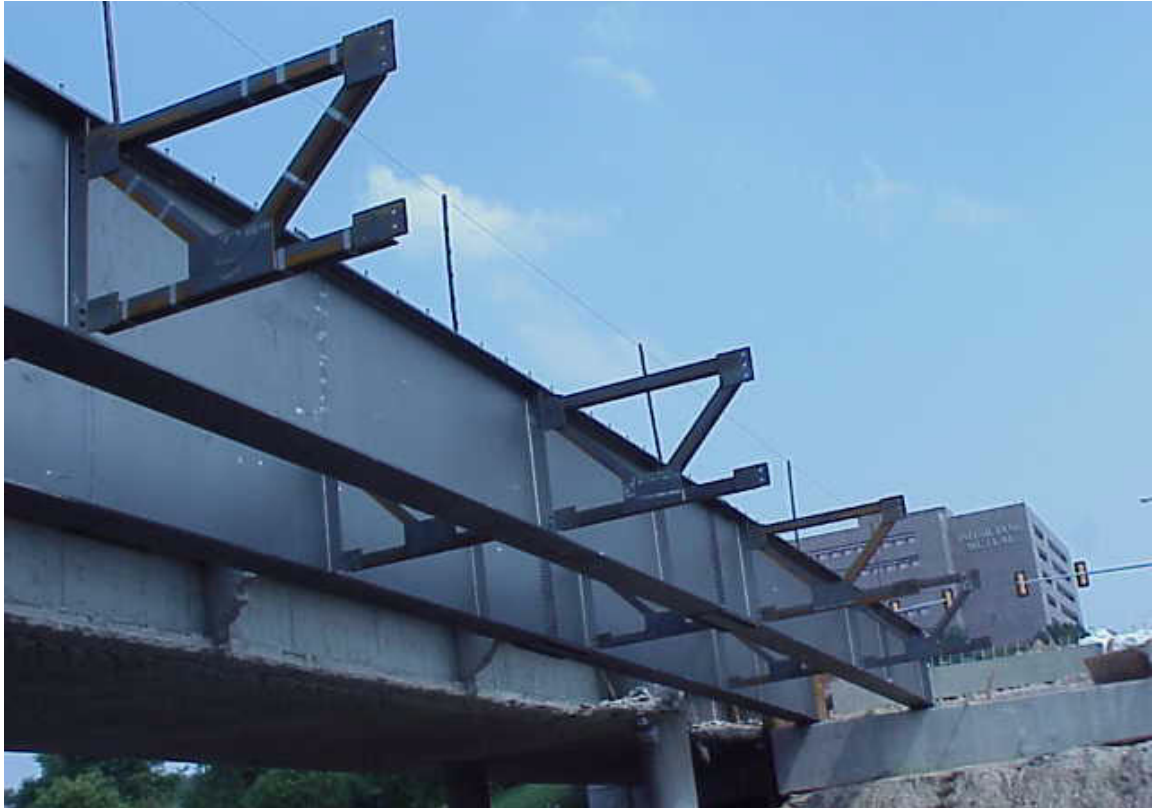
Figure 2-11: Girder sections 4 and 5 of the East span

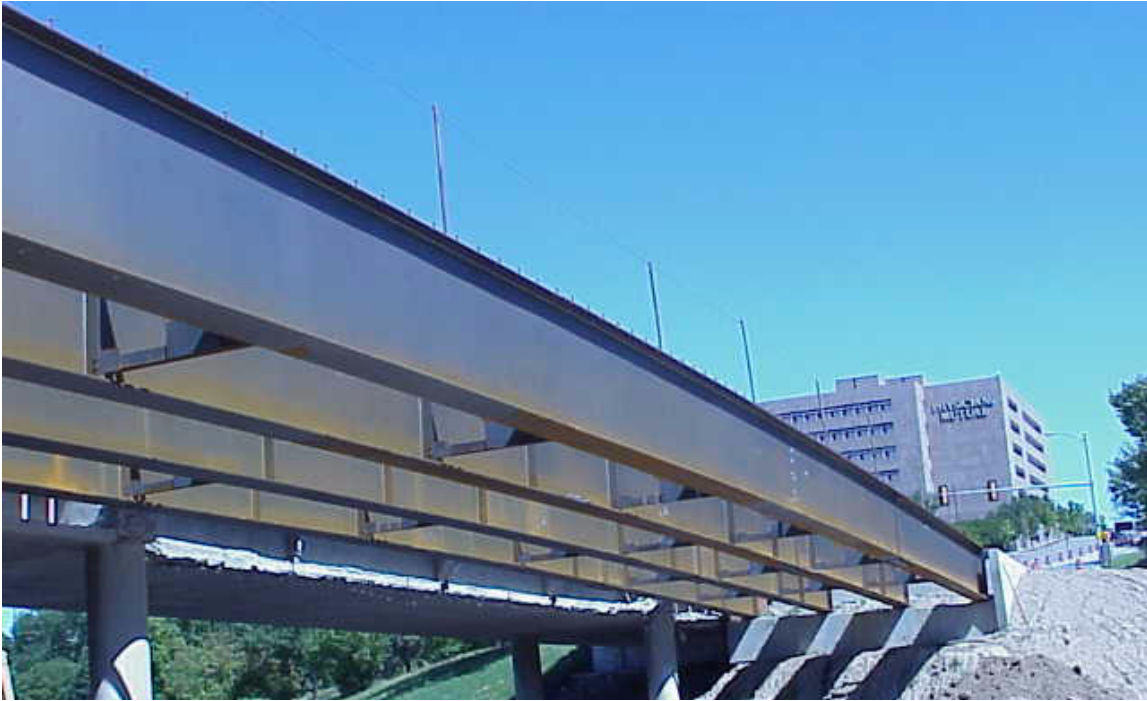
Figure 2-12: All four girders for East span in place.

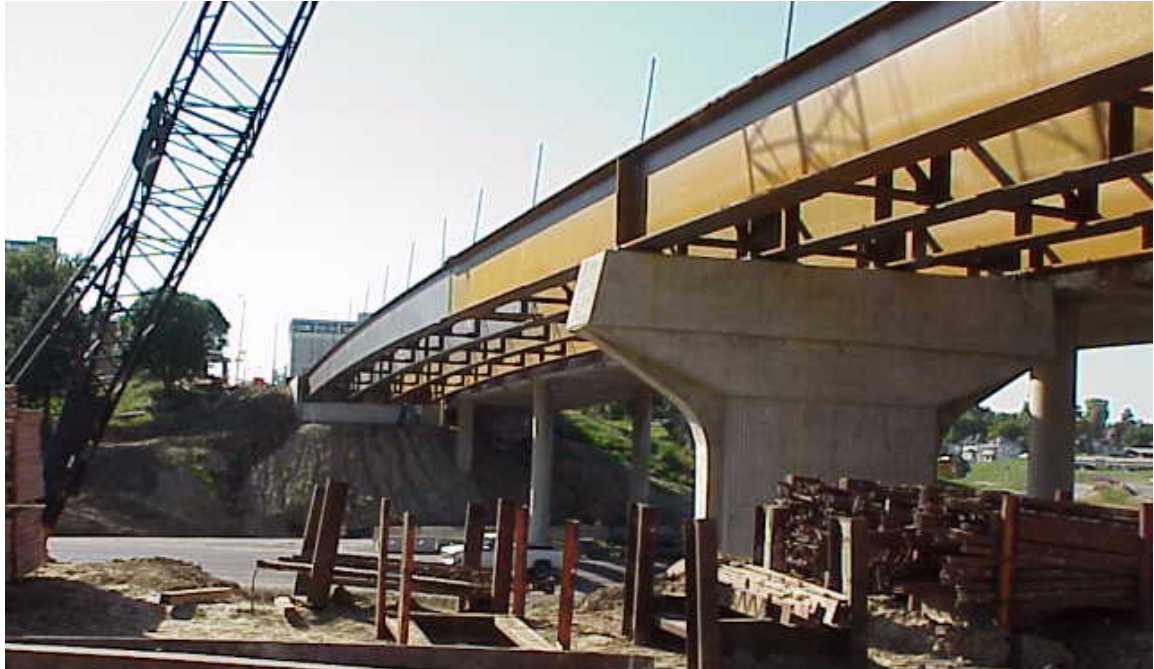
Figure 2-13: West span girders in place

The final girder sections erected for Phase I were those for the West Span. Sections 1 and 2 of Girders E and G were spliced together. The cross frames connecting them were placed along with the cross frames to accept Girder H. This unit was then spliced with girder section 3 in the air and placed on the west abutment girder seats. Girder sections 1 and 2 of Girders H and J were placed in the same way. Figure 2-13 shows the west span girders in place. Note in the figure that the west abutment and the temporary shoring to support section 3 has been removed as it is no longer needed. Girder J

is in forefront. Posts on top of the girders are for the safety of construction workers.

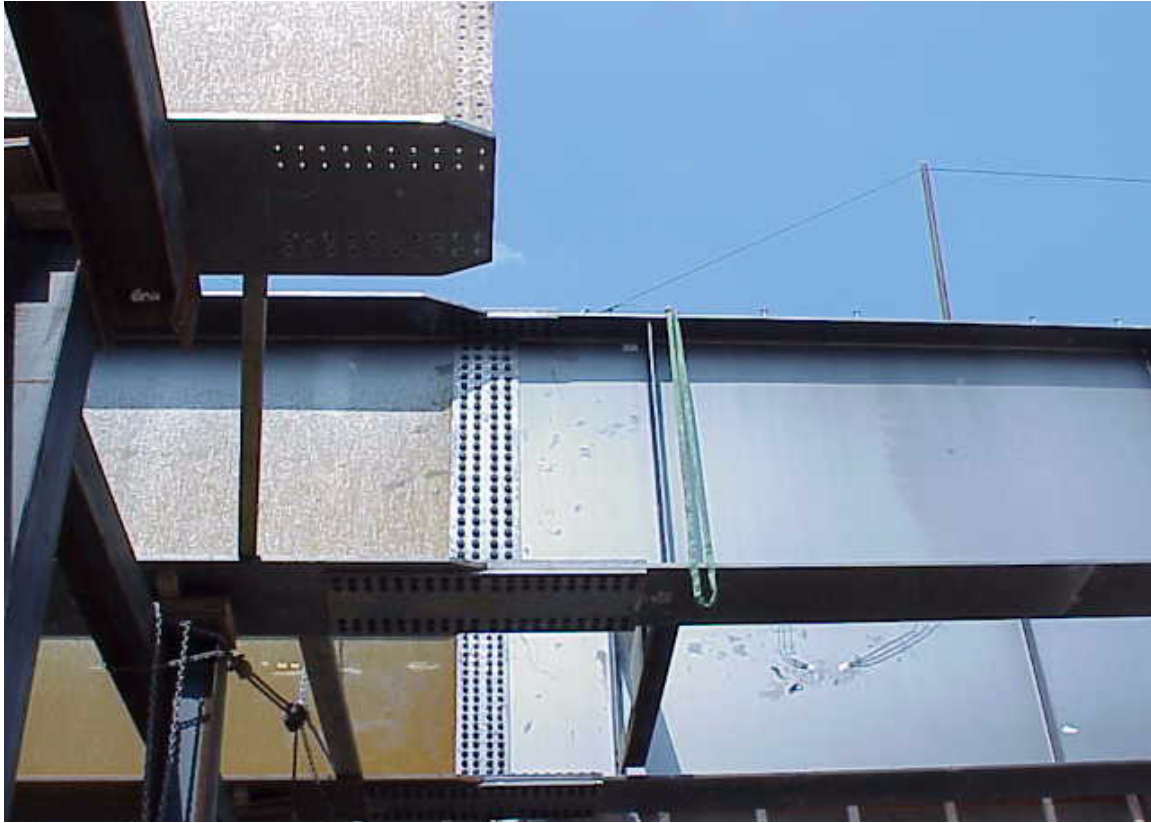
Figure 2-14: Girder splice

plates were 1.0" thick. Filler plates were of appropriate size. A typical splice is shown in Figure 2-14.

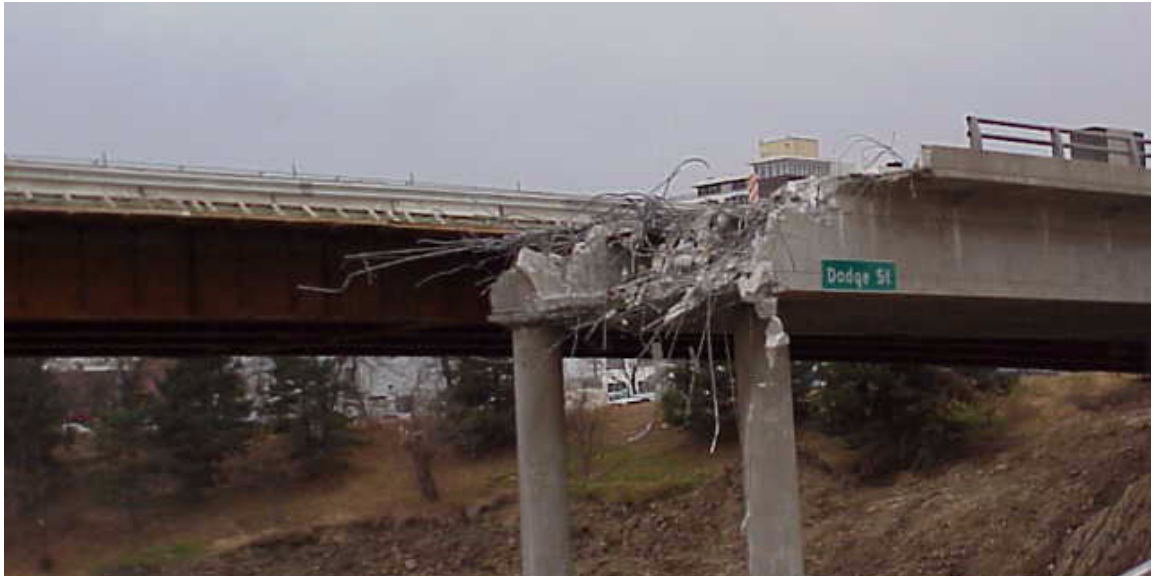
Figure 2-18: Demolition of the Northern half of the existing bridge

On 11/15/99 traffic was switched from the Northern half of the existing bridge to Phase I. Once Phase I was opened to traffic the formwork was removed from all regions except the closure region. After Phase I was carrying the traffic, the remaining half of the existing bridge was demolished as seen in Figure 2-18.

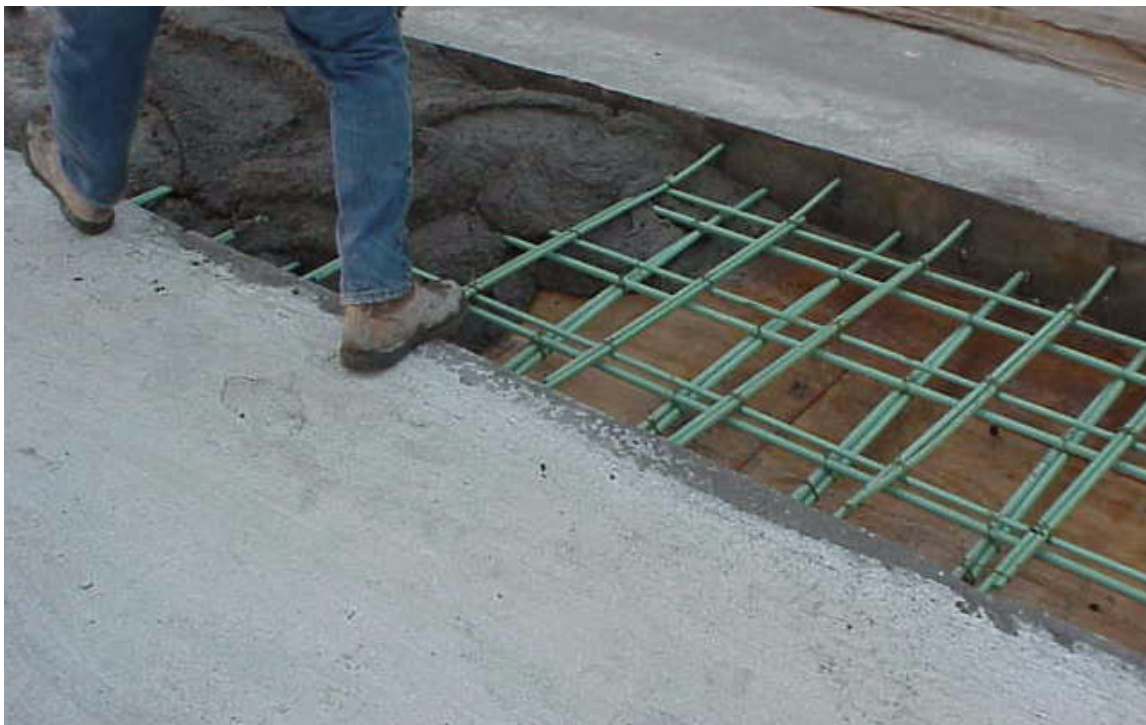
Figure 2-24: Closure pour

Concrete placement began 5:15am on May 6, 2000. Concrete trucks were not allowed on the bridge so concrete was either pumped or carted where it was needed with wheelbarrows. The closure pour was 40" wide and ran the entire bridge length. Pouring started at the East abutment and ended at the West abutment. The depth depended on the amount of differential elevation and was approximately the same as the Phase I and II decks, 7". Figure 2-24 shows the pour as it was being performed. The two decks from Phase I and II are clearly seen in the figure. Note transverse rebar tied together. This rebar consists of extensions of the rebar from the Phase I and II slabs to provide continuity. Longitudinal rebar was placed before the pour commenced. Figure 2-25 indicates the pouring direction.

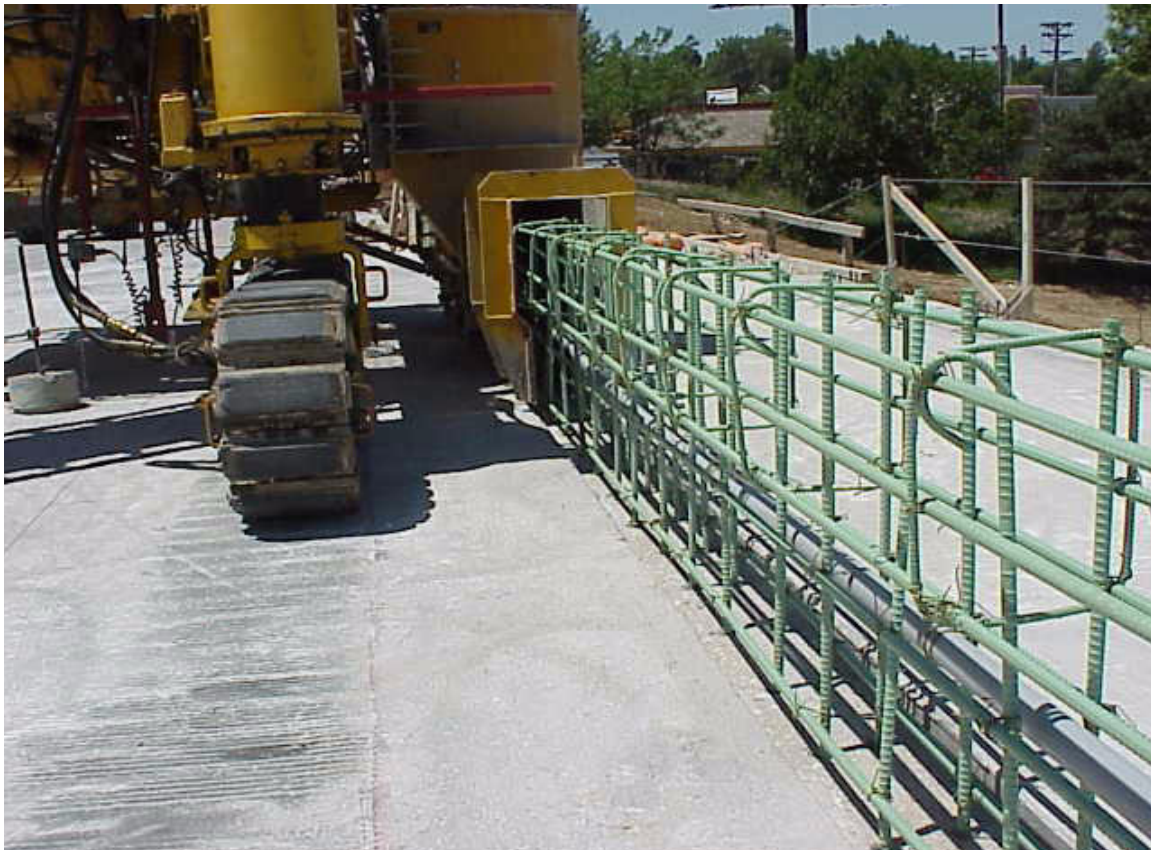
Figure 2-28: Phase II permanent barrier before casting. Note dowels epoxied into deck

With the overlay on Phase II completed and traffic still being carried on Phase I, the permanent barrier on Phase II was placed. After the reinforcing steel was in place, the rail was slip-formed from the West to the East abutment from 2:00pm to 4:30pm on June 2, 2000. The rail was coated with a curing agent and left uncovered. Figure 2-28 shows the machine to slip form the rail and the reinforcing steel in place.

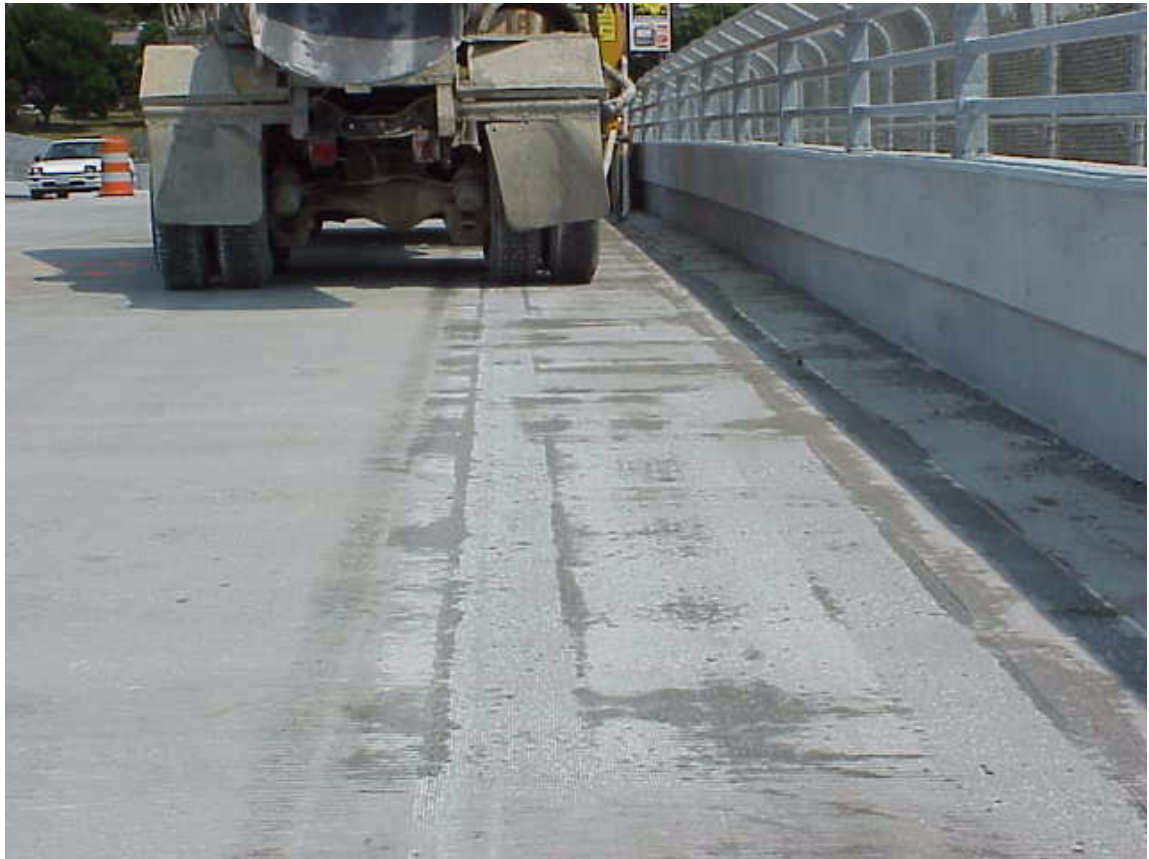
Figure 2-31: Finished permanent barrier. Note truck on bridge is grinding surface.

East abutment as was Phase I. A photo of the finished rail is seen in Figure 2-31.

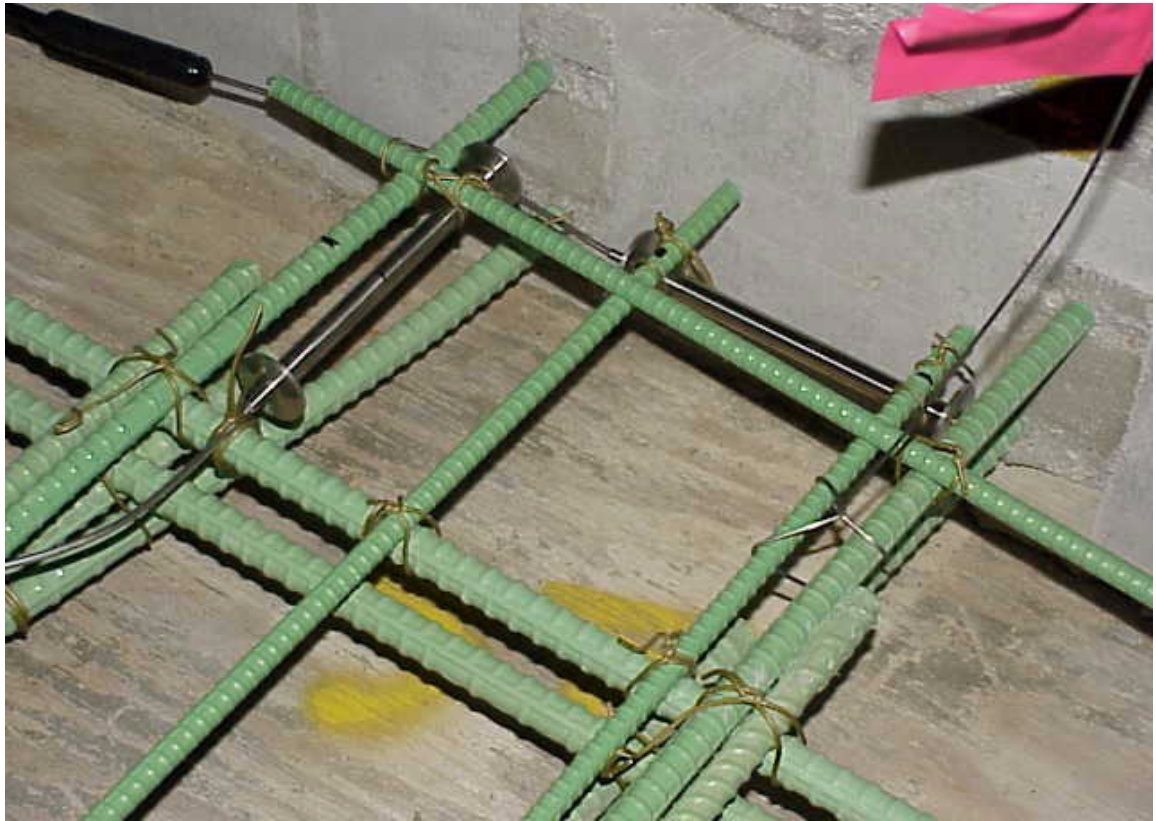
Figure 2-34: Concrete Embedment gage in place. These gages record concrete strain.

The gages are tied to rebar before concrete placement. Figure 2-34 shows two of these gages tied to rebar in the closure region.

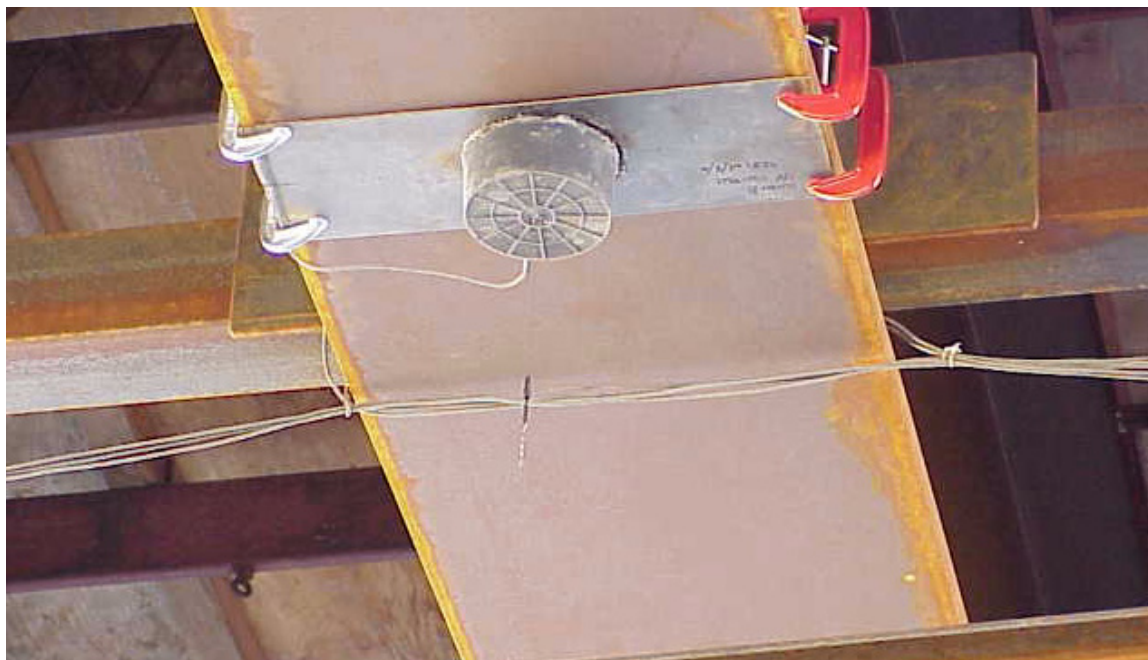
Figure 2-36: Potentiometer connected to the girder and fixed frame.

devices were mounted to a piece of steel and then protected from the environment by constructing a covering over them. Care was taken so the covering would not disturb their normal function. The unit in its protective covering clamped to the bridge girder can be seen in Figure 2-36.

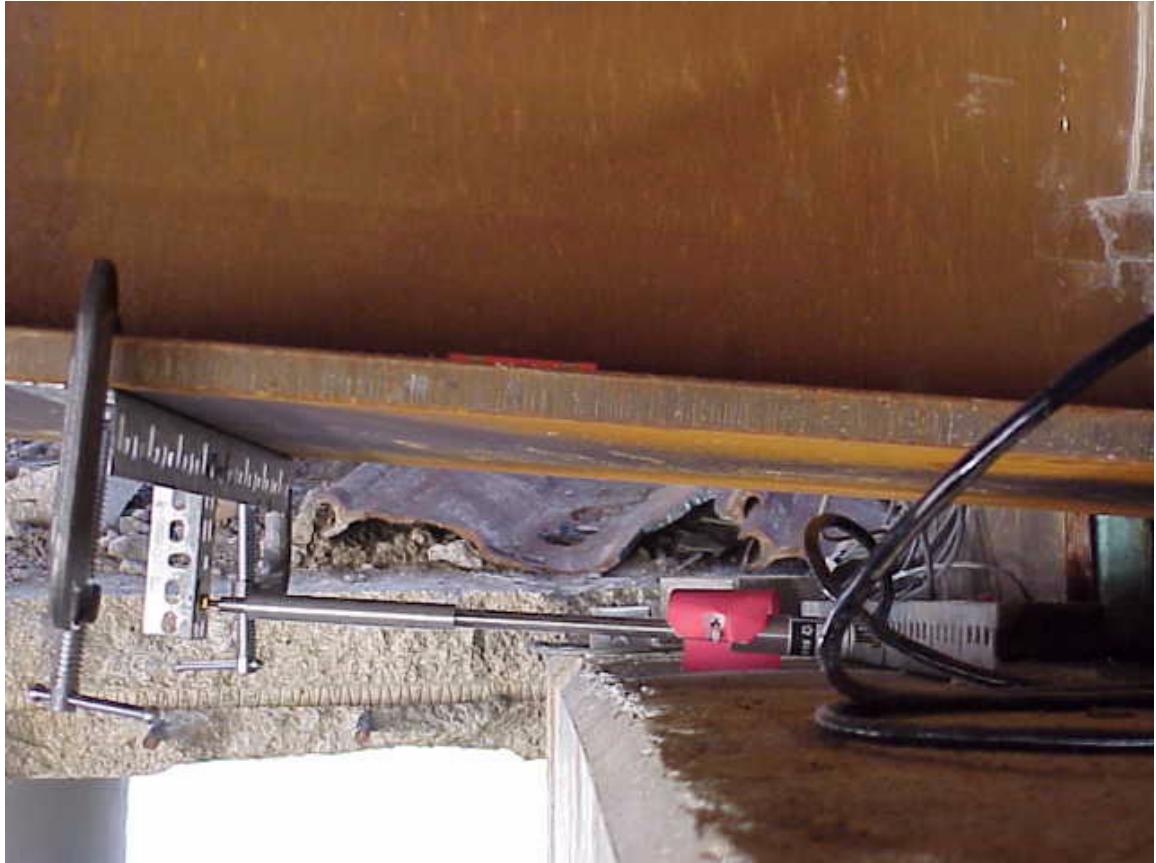
Figure 2-37: Crackmeter connected to girder flange

Longitudinal girder movements were measured at the abutments using VWP Displacement Transducers (crackmeters) produced by Slope Indicator CO. of Bothell, WA. The device is mounted with one end on the girder's bottom flange and the other on a surface that is assumed not to move, the pile cap in this case. The device operates on the same frequency principle as previously mentioned gages but these instruments relate frequency to displacement. As with the other Slope indicator products, local temperature is also recorded. An example of these units during service can be seen in Figure 2-37. In the figure, note the right end connected to the galvanized

angle that has been screwed into pile cap and the left end which is connected to an angle which has been clamped to girder flange.

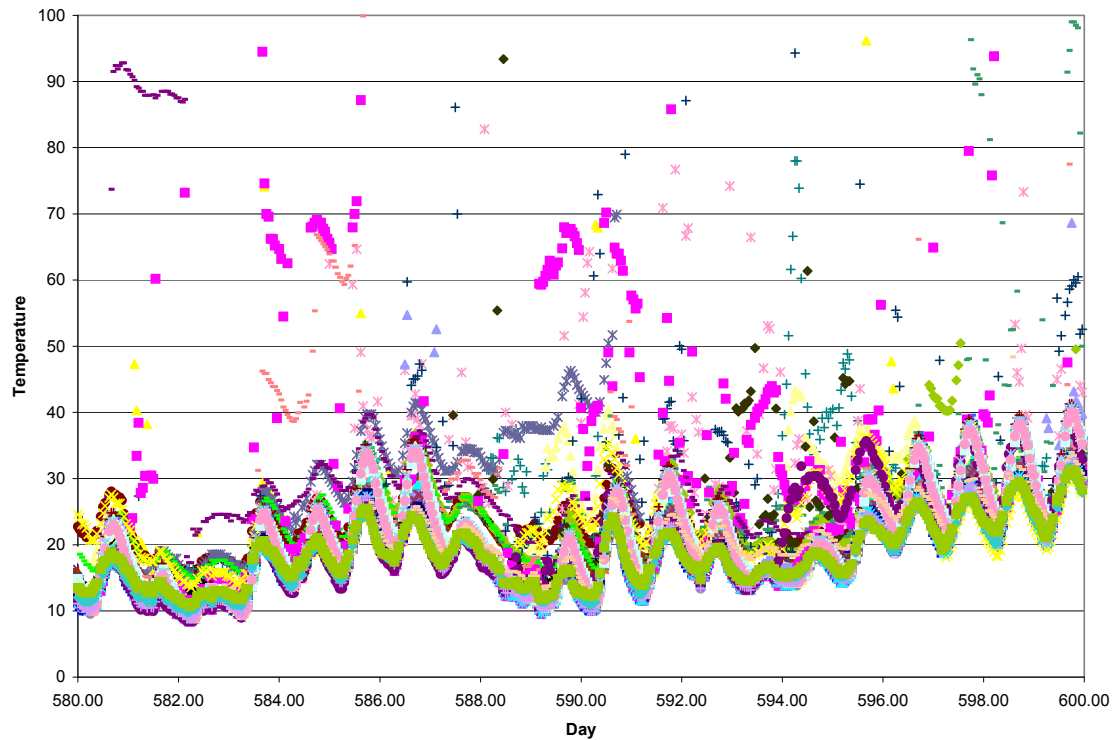
Figure 3-6: Raw Temperature Data

After completion of the second phase there were 75 sensors capable of indicating temperature however the results from each and every gage are not necessarily accurate. Looking at a two week period of time in Figure 3-6 one can see that the temperature data can be quite noisy. This noise can come from a number of sources including but not limited to communication problems, interference, faulty gages, loads and vibration, and moisture in the wiring.

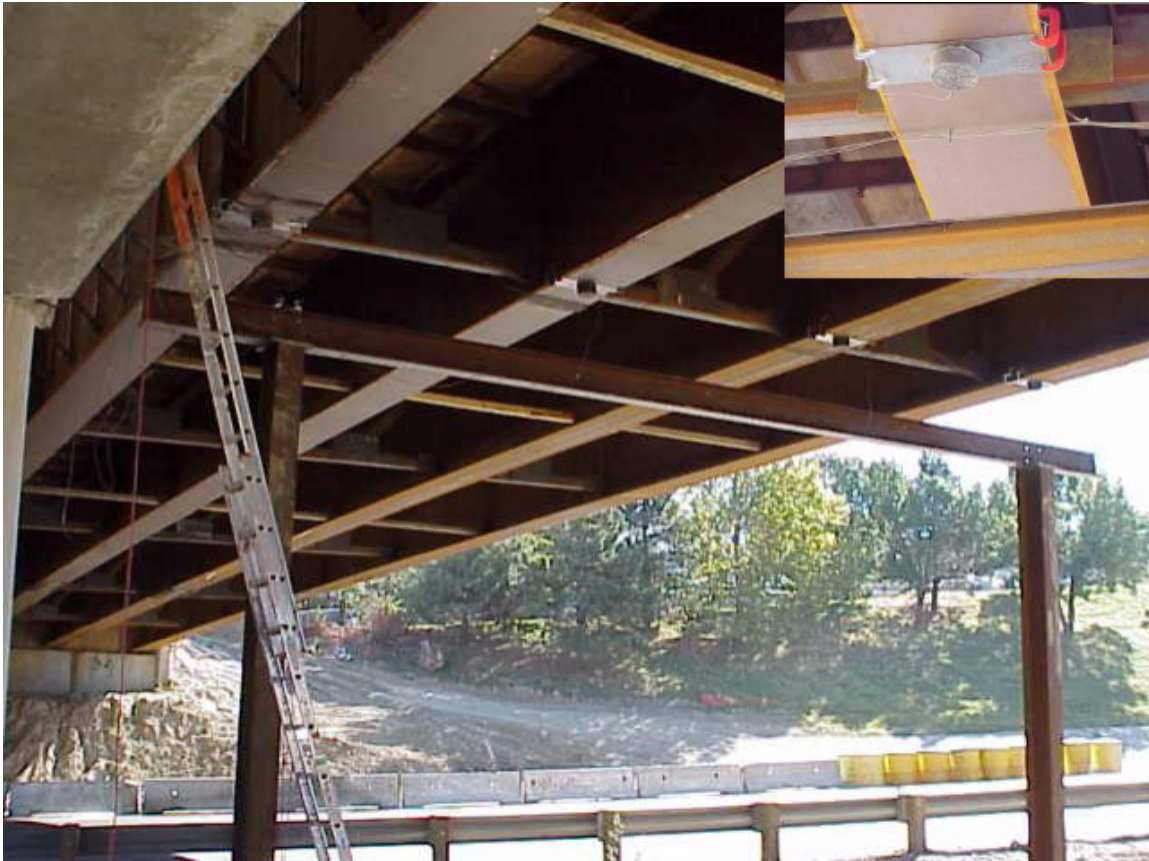
Figure B-15: Test frame used to measure deflection. Note pots mounted on the underside of girders
