Geomorphic and Environmental Change Around a Large, Aging Reservoir: Lake C. W. McConaughy, Western Nebraska, USA

Key Terms: *Reservoir, Shoreline Erosion, Waves, Groundwater*

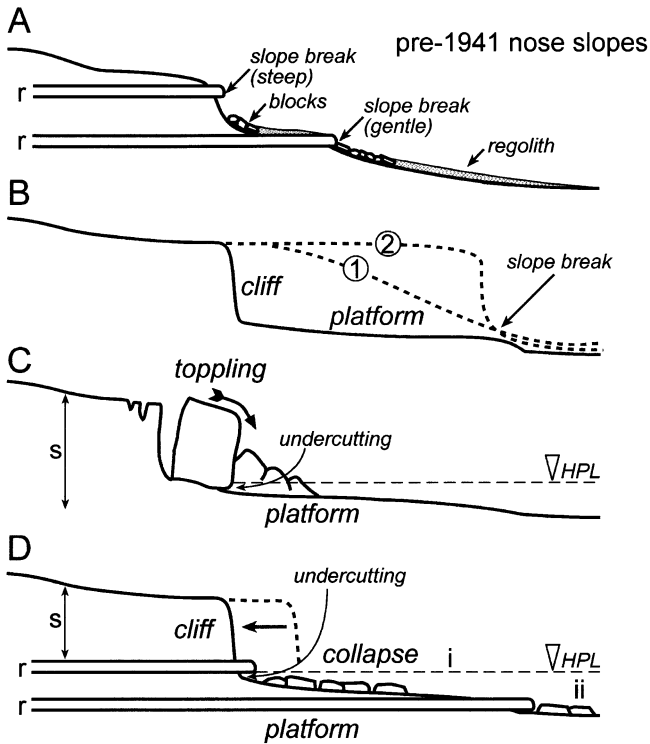
Figure 2. Development of shoreline cliffs and platforms and mechanisms of shoreline retreat at Lake McConaughy. A) Model for pre-1941 configuration of lakeshore nose slopes with preexisting slope breaks forming stepped profiles. Aerial photos from 1938/1939 show that both steeper and shallower slope breaks were present where resistant strata (r) cropped out at the eastern end of the southeastern shore of the lake, although many slopes were smooth and lacked outcrops. Regolith, mostly colluvium and slopewash, possibly with small amounts of loess and/or eolian sand, very likely covered part of stepped slopes, as shown, and all of the smooth slopes. Wave erosion and subsequent mass wasting produced erosional platforms immediately below and in front of pre-1941 slope breaks. B) Post-1941 erosion of platforms by retreat of either (1) a low-angle nose slope, or (2) a preexisting scarp/steep slope break. Aerial photo sequences suggest that both processes took place. C) Toppling of large blocks of soft bedrock (s) and soil after undercutting by wave action at high pool level (HPL), as observed in recent serial visits to the shoreline. D) Undercutting of resistant strata (r) within softer bedrock (s) by wave action at high pool level (HPL), also observed in serial visits to the shoreline. Cliff retreat similar to that shown in B (2) is also interpreted to occur simultaneously.

were sharp, and a scarp with a flat, platform-like slope segment below it already existed (Figures 2 and 9–12). As the lake was filled in the decade following 1941, pool level slowly rose to the most prominent break in slope and was locked in at that particular geomorphic level. Two responses are likely to have resulted in such cases: a pre-existing steep slope break actually became the lakeward margin of a modern-day platform (Figures 9–12, Case 2), or a steep slope break migrated landward by wave erosion as lake level rose to form a platform (Figures 9–12, Case 3). Many nose slopes, however, were smoother and were likely to have been mantled by colluvium and slopewash; partially covered by thin loess or eolian sand (for which there is indirect evidence in 1938/1939 aerial photographs; Figures 10 and 11); or simply had not yet been eroded to produce scarps. During this first attainment of maximum pool level, however, waves along the prograding shoreline stripped regolith and soft bedrock from nose slopes and eroded landward, in some cases stepwise along horizontal planes determined by the position of resistant strata. Any existing flat slope segments atop resistant strata were readily recruited as erosion surfaces. As the lake’s level rose, inundation eventually destroyed the protective covering of sod on drowned slopes, and wave erosion continued behind the advancing shoreline as it moved landward until the former hill slope was below maximum wave base. Eroded sediment from nose slopes was rapidly moved by waves into the lees of nose slopes to produce pocket beaches and filled bays that had been produced from the valleys of small ephemeral streams draining into the North Platte Valley (aerial photographs indicated that this process was well under way by 1952). Therefore, total shoreline recession since 1941 cannot be used to

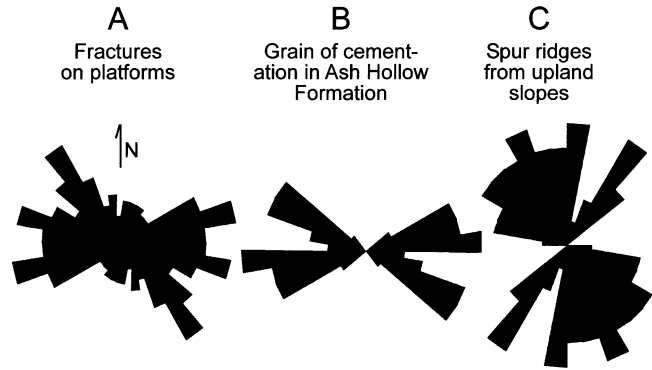
Figure 3. Rose diagrams showing orientations of features measured in the field (A, B) and on maps (C). A) Preferred NW-SE, WNW-ESE, and WSW-ENE orientations of fractures measured on erosional platforms. B) Preferred WNW-ESE and WSW-ENE orientations of grain of cementation (i.e., rod-like cemented masses) in Ash Hollow Formation exposures around shore of Lake McConaughy. C) Orientation of spur ridges from upland slopes along the southeastern shore of the lake, which terminate as lakeshore headlands and are eroding landward. Note similarity between orientations in (A) and (B).

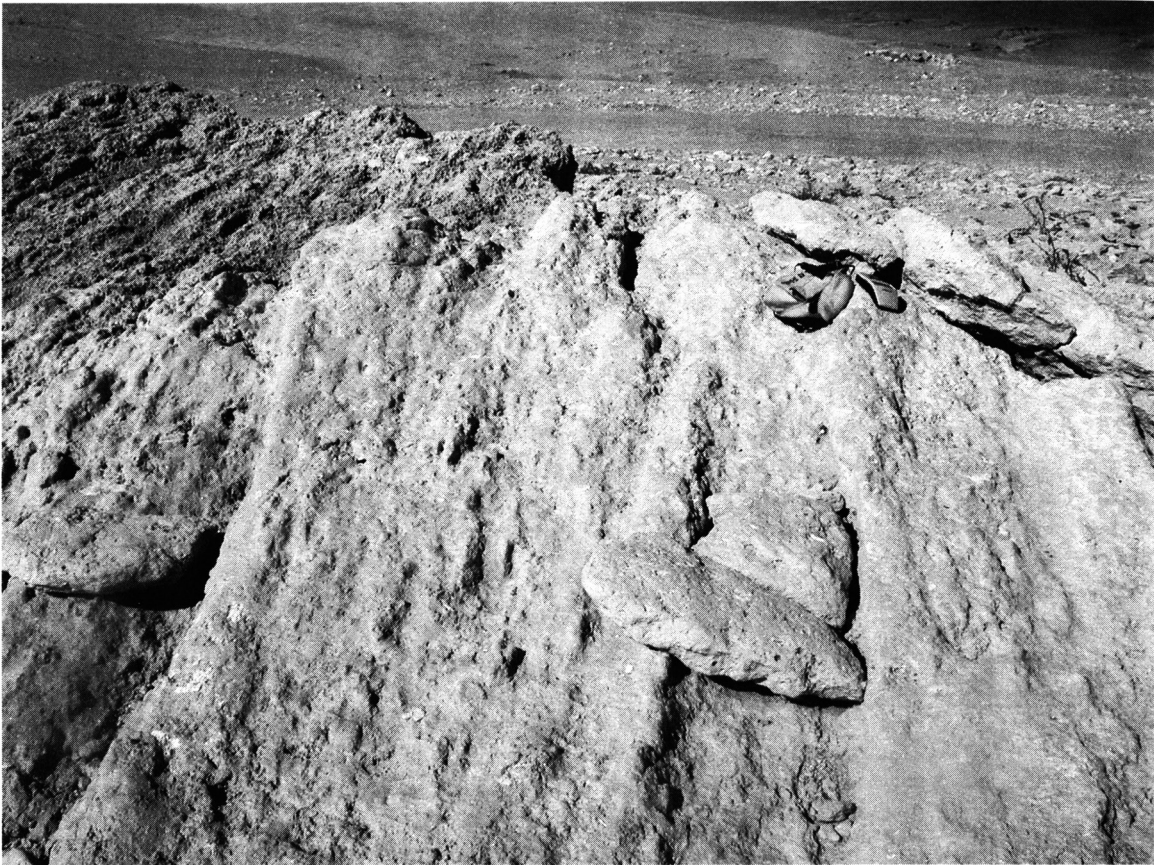
Figure 4. Pronounced grain of cementation (rod-like masses) in Ash Hollow Formation along shore of Lake McConaughy. Preferred orientation of cementation is shown in Figure 3B. Field of view in foreground is about 3 m wide.

Both sandstone and siltstone strata in the Ash Hollow Formation show a conspicuous preferred direction of differential weathering, which we refer to hereafter as cementation grain (Figure 3B). With the exposure and differential erosion of many of these strata along the lake's shore, a pronounced pattern of elongate, low, rounded, WNW-ESE- and ENE-WSW-trending ridges becomes visible in bedding-plane view. These ridges are 10–50 cm wide and several meters long (Figures 3B and 4). These ridges are the upper surfaces of irregular, rod-

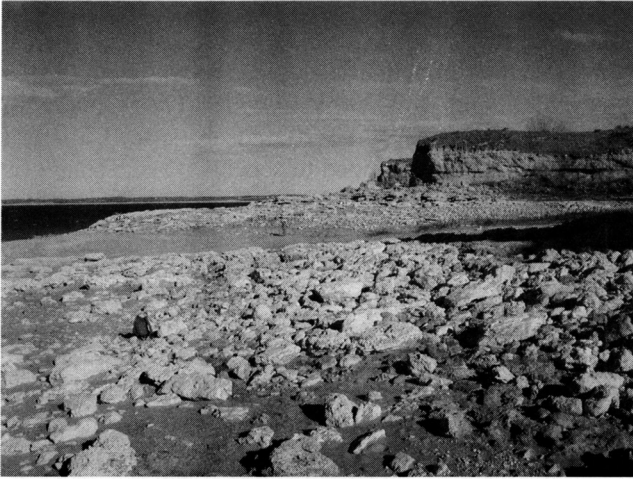
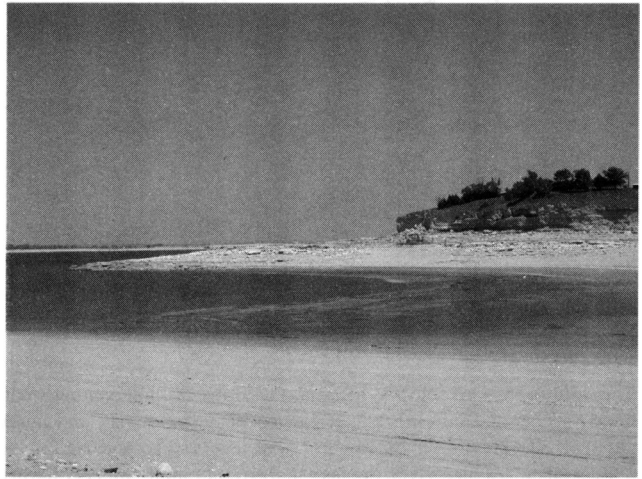
Figure 5. Erosional bedrock platforms on southeastern shore of Lake McConaughy. A) A well-developed platform 113 m in length, and an associated retreating cliff about 10 m high, on the east side of Ogallala Beach (see Figure 10); paving of large blocks (foreground) covers the next platform to the west. Note the pocket beach between adjacent platforms. B) Platform, about 50 m in length, and cliff immediately northeast of the corner of sections 4, 5, 8, and 9, T.14N., R.38W., looking east-northeastward (see Figure 12); note single-story dwelling (right) atop spur ridge from which cliff has been eroded. Several dozen private residences have property lines that abut lakeshore; at least four residences have recent construction work designed to compensate for or slow beach erosion.

The most prominent geomorphic features exposed by low lake levels during 1999–2003 are bedrock platforms extending lakeward from headlands on the shore (Figure 5). Other lake-related landforms can also be observed. The geomorphic features on the southeastern shore are listed below, in approximate order of prominence.

1. Platforms (Figures 5A, 5B, and 6) are nearly flat to gently lakeward-sloping (1° – 10°) bedrock surfaces that extend from vertical cliffs outward into the lake. Platforms appear on the nose slopes of spurs extending from upland ridges, which are now headlands

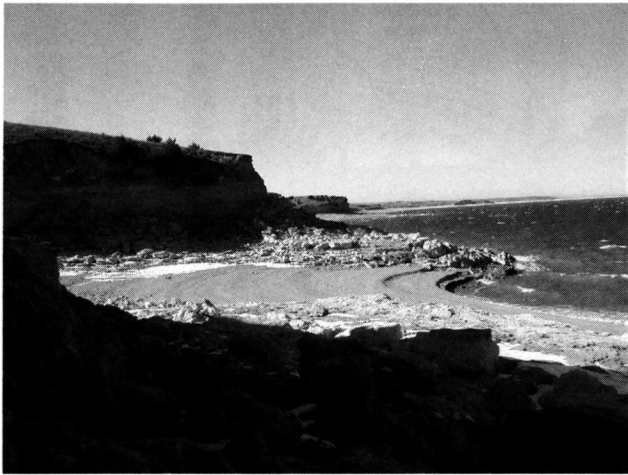
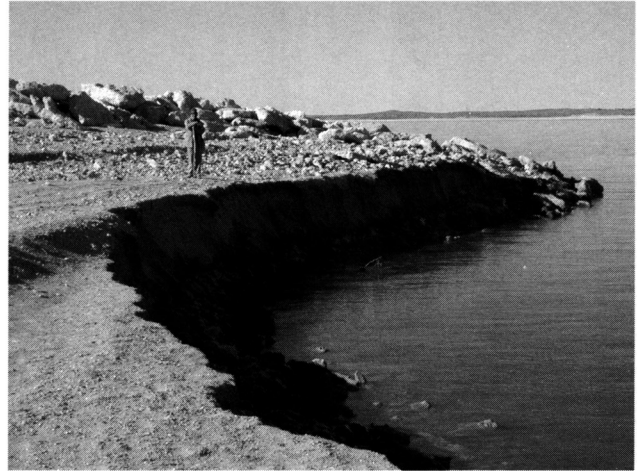
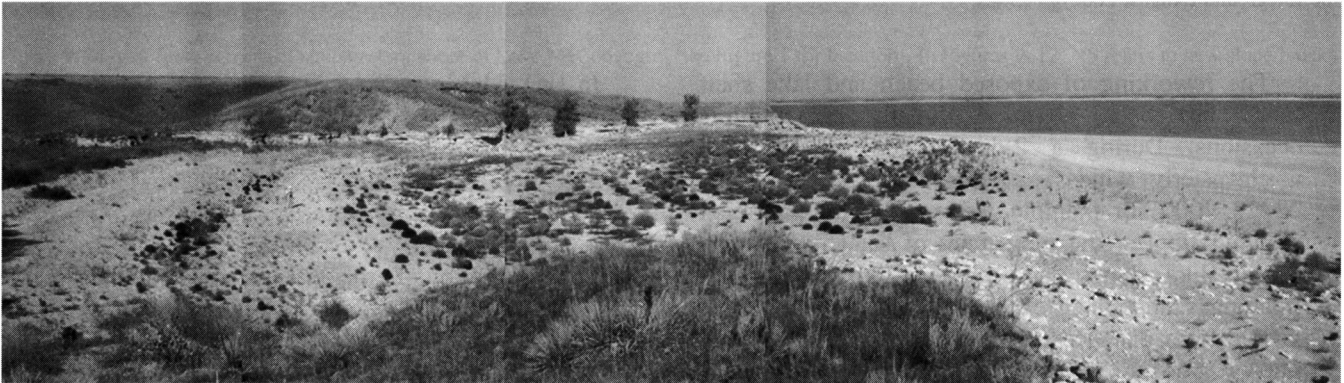
Figure 7. Pocket beaches and related features. A) Pocket beach between two eroded platforms, looking westward. Three successive beach erosion scarps, representing progressive levels of reservoir drawdown, are visible. Note short erosional platform and cliff in background, which trend into a steep blocky shoreline to the left (south-southeast). B) Close-up of actively eroding pocket beach scarp in (A), photographed in November 2000. R. F. D., Jr., is 1.7 m tall. C) Beach ridges, partially delineated by rows of vegetation, in the bay infilling with sand, W $\frac{1}{2}$, NW $\frac{1}{4}$ of section 7, T.14N., R.38W., and E $\frac{1}{2}$ NE $\frac{1}{4}$, section 12, T.14N., R.39W., looking westward (see Figure 10). Field of view is roughly 200 m wide. At least 20 beach ridges, representing successive lake levels, are visible (September 2001).

Beach erosion scarps (Figure 7A, 7B) as high as 1.5 m are ubiquitous near the shoreline. These scarps were observed in the process of formation during serial visits throughout the extreme drawdown period of 1999–2003, and there is no evidence that they existed prior to that time. Shore-parallel crown cracks were repeatedly noted within 2 m landward from a given scarp. Two modes of failure were witnessed directly on time scales of hours to a few days: (1) undercutting of scarp toes by waves, causing collapse of slabs of wet beach sediments; and (2) slumping of the scarp edge as groundwater seeped downslope out of pocket beach sediments—in effect, small-scale groundwater sapping.

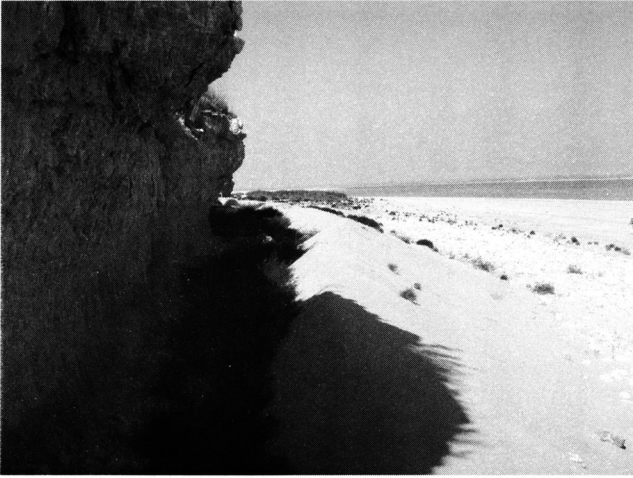
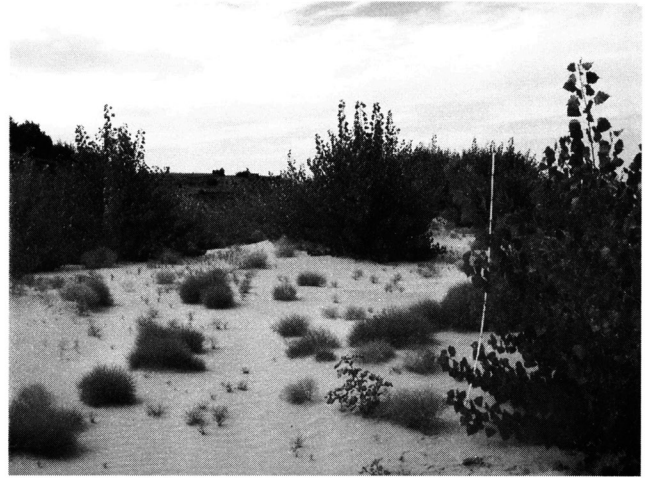
Figure 8. Dunes along the southeastern shore of Lake McConaughy. A) Linear dune approximately 3 m high forming along the cliff containing contact between the Brule Formation (below) and Ash Hollow Formation (above) in S $\frac{1}{2}$ NE $\frac{1}{4}$ SW $\frac{1}{4}$, section 2, T.14N., R.39W. (September 2001). B) Wind-rippled, coppice-like dunes forming among sparse cottonwoods (*Populus deltoides*) along exposed beach nearby; a 2-m measuring rod is in the foreground (August 2002).

6. Dunes (Figure 8) have formed near the western end of the southeastern shore and westward onto the southwestern shore, where the shoreline is smoother and where extensive low-angle sandy surfaces are relatively unbroken by platforms and block aprons. Direct observation by one of the authors (R.F.D., Jr.) and interviews with local residents indicate that these dunes did not exist on formerly submerged surfaces prior to recent, sustained falls in pool level. These new dunes are not covered by vegetation and were observed in the process of growth and migration during the period 1999–2003, as sand was blown from adjacent, exposed beaches and lake shelf. Late Pleistocene or Holocene

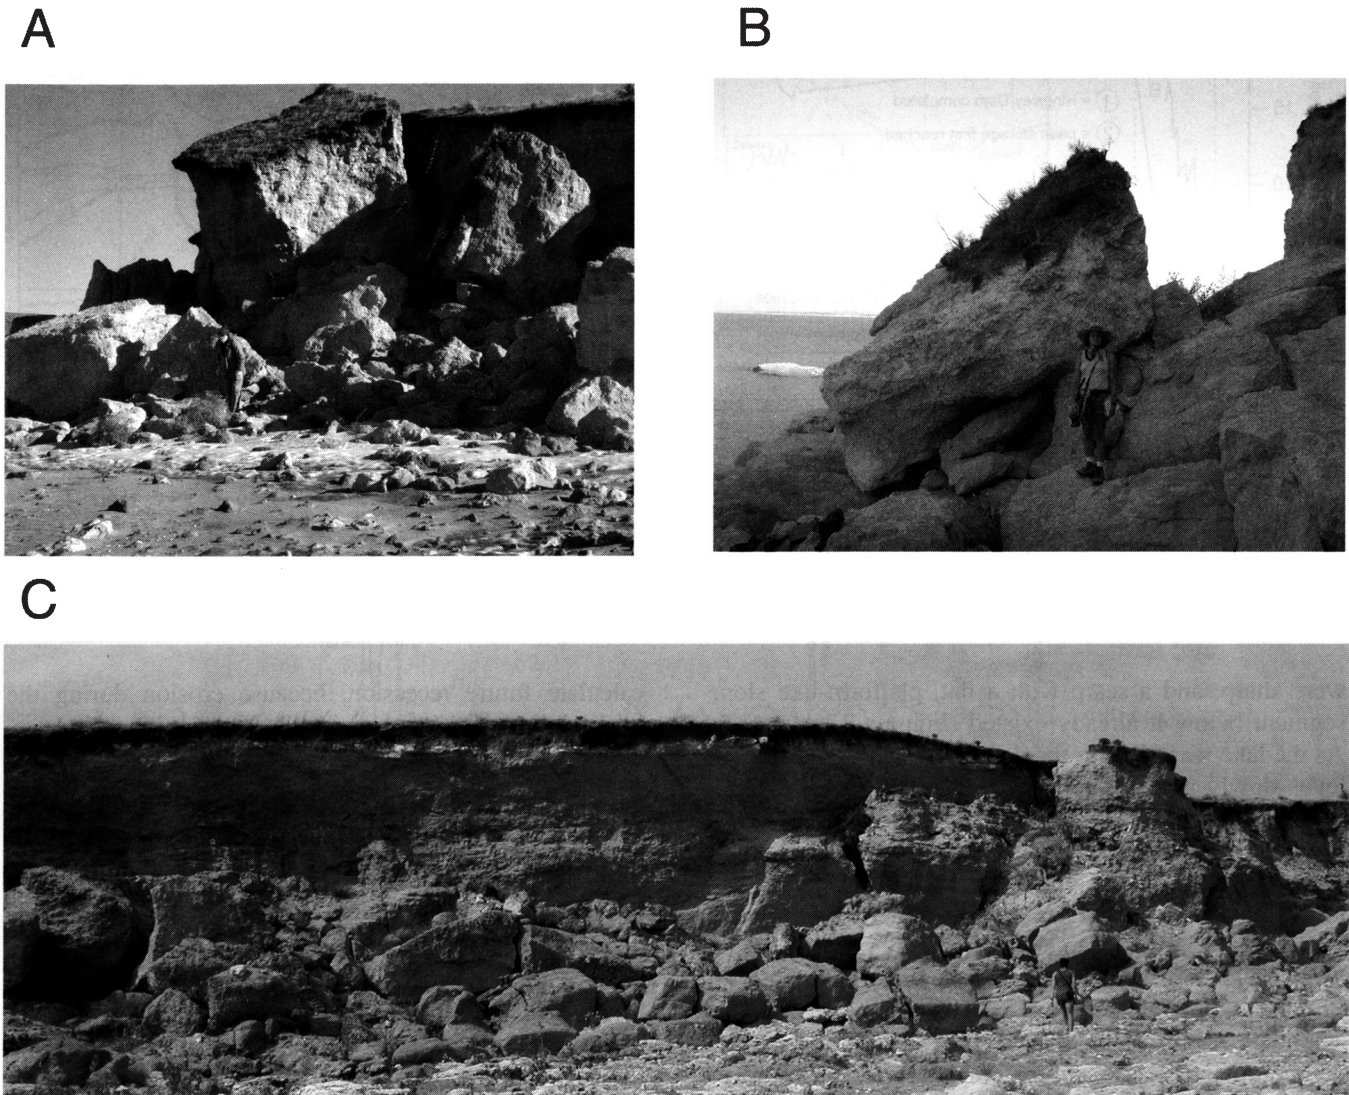
Figure 13. Recent topples of large undercut blocks along southeastern shore of Lake McConaughy. A) Large blocks of soft Ash Hollow Formation strata and soil, with intact turf cover, on cliff face at landward terminus of large erosional platform in S $\frac{1}{2}$, SW $\frac{1}{4}$ NE $\frac{1}{4}$ NW $\frac{1}{4}$, section 8, T.14N., R.38W. (November 2000; see Figure 10). R. F. D., Jr., is 1.7 m tall. B) Large, undercut block of partially cemented Ash Hollow formation, lying atop previously eroded blocks in SW $\frac{1}{4}$ NW $\frac{1}{4}$ SW $\frac{1}{4}$ SW $\frac{1}{4}$, section 3, T.14N., R.38W. (see Figure 12); Jamie Taylor is 1.55 m tall (August 2002). C) Very large toppled blocks of soft Ash Hollow Formation eroding from WNW-ESE trending headland in S $\frac{1}{2}$ NE $\frac{1}{4}$ NW $\frac{1}{4}$ NE $\frac{1}{4}$ and S $\frac{1}{2}$ NW $\frac{1}{4}$ NE $\frac{1}{4}$, section 12, T.14N., R.39W. (see Figure 10); Jamie Taylor (right foreground) is 1.55 m tall (August 2002). Prominence of mass wasting here probably resulted from coincident orientation of cementation grain and fractures (see Figure 3A and 3B).

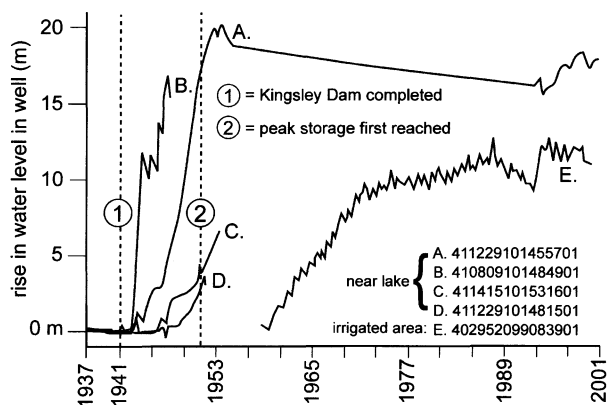
Figure 14. A–D) Hydrographs of selected monitored wells showing rising water tables around Lake McConaughy during attainment of maximum pool level (1941–1951) and thereafter (see Figure 1 for locations). E) Well in irrigated area of Kearney County showing rise in water table in vicinity of canal (see Figure 16A). Well numbers correspond to Nebraska Department of Natural Resources monitoring wells database.

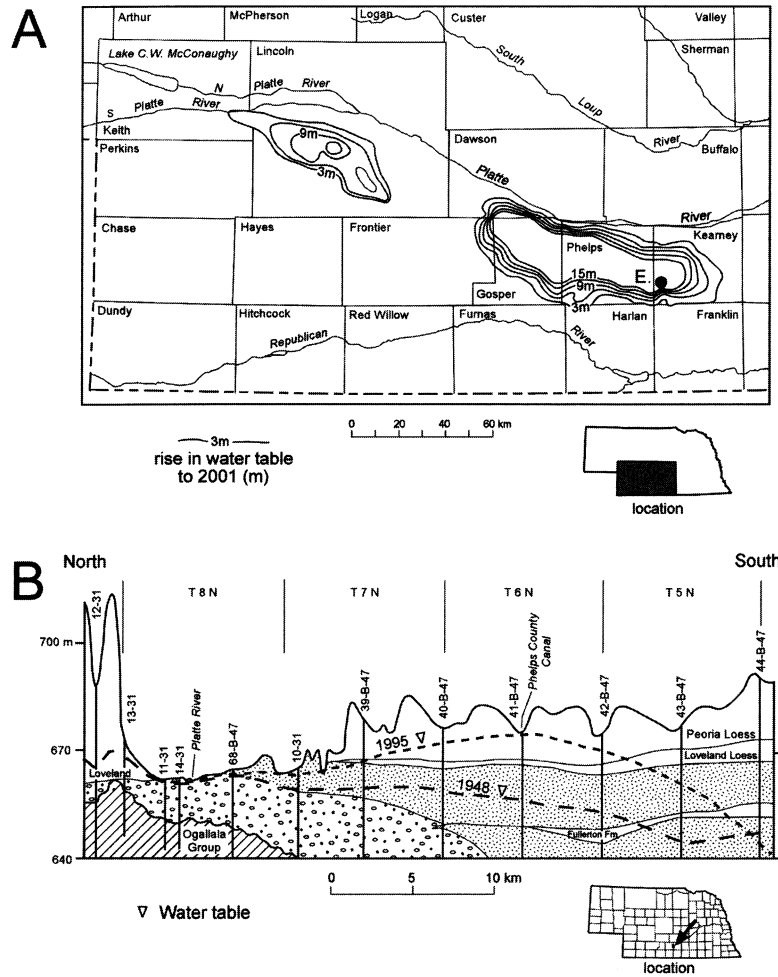
Figure 16. Disjunct hydrogeologic changes associated with Lake McConaughy. A) Historical rise in the water table of the irrigation system of which Lake McConaughy is the key element (Conservation and Survey Division, 2002); point labeled “E” is a well for which hydrograph is shown in Figure 14E. B) Rising water tables alongside an irrigation canal in the same system during period 1948–1995 (Summerside, 2003).

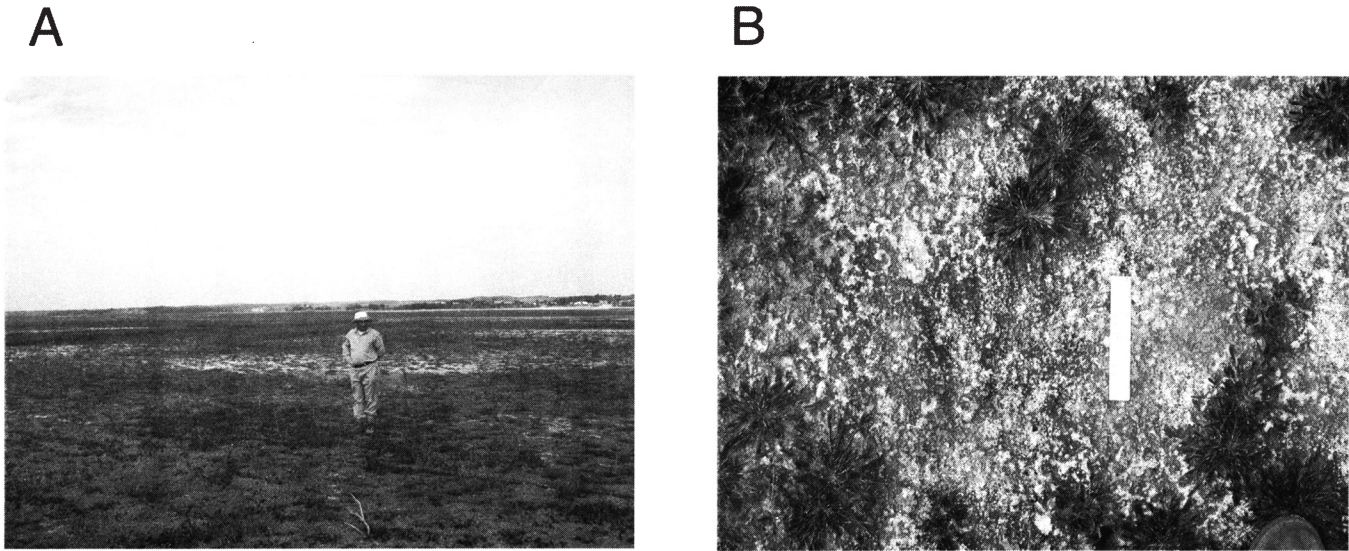
Figure 17. Surface salt accumulation, in essence anthropogenic salt flats, on exposed floor of Lake McConaughy (September 2001). A) Patchy efflorescences of thenardite (Na_2SO_4) and patches of flat sedge (*Cyperus erythrorhizos*), looking northward. B) Close-up of ground surface in the same area featuring fluffy masses of thenardite underlain by gleyed soil horizons showing evidence for sulfate reduction (see Figure 18). Scale is 15 cm long. Horizons of microbial sulfate reduction appear just below the exposure surface as long as the soil remains moist (Figure 16). Efflorescences are produced by evaporation after capillary wicking during dry episodes between rainfall events.

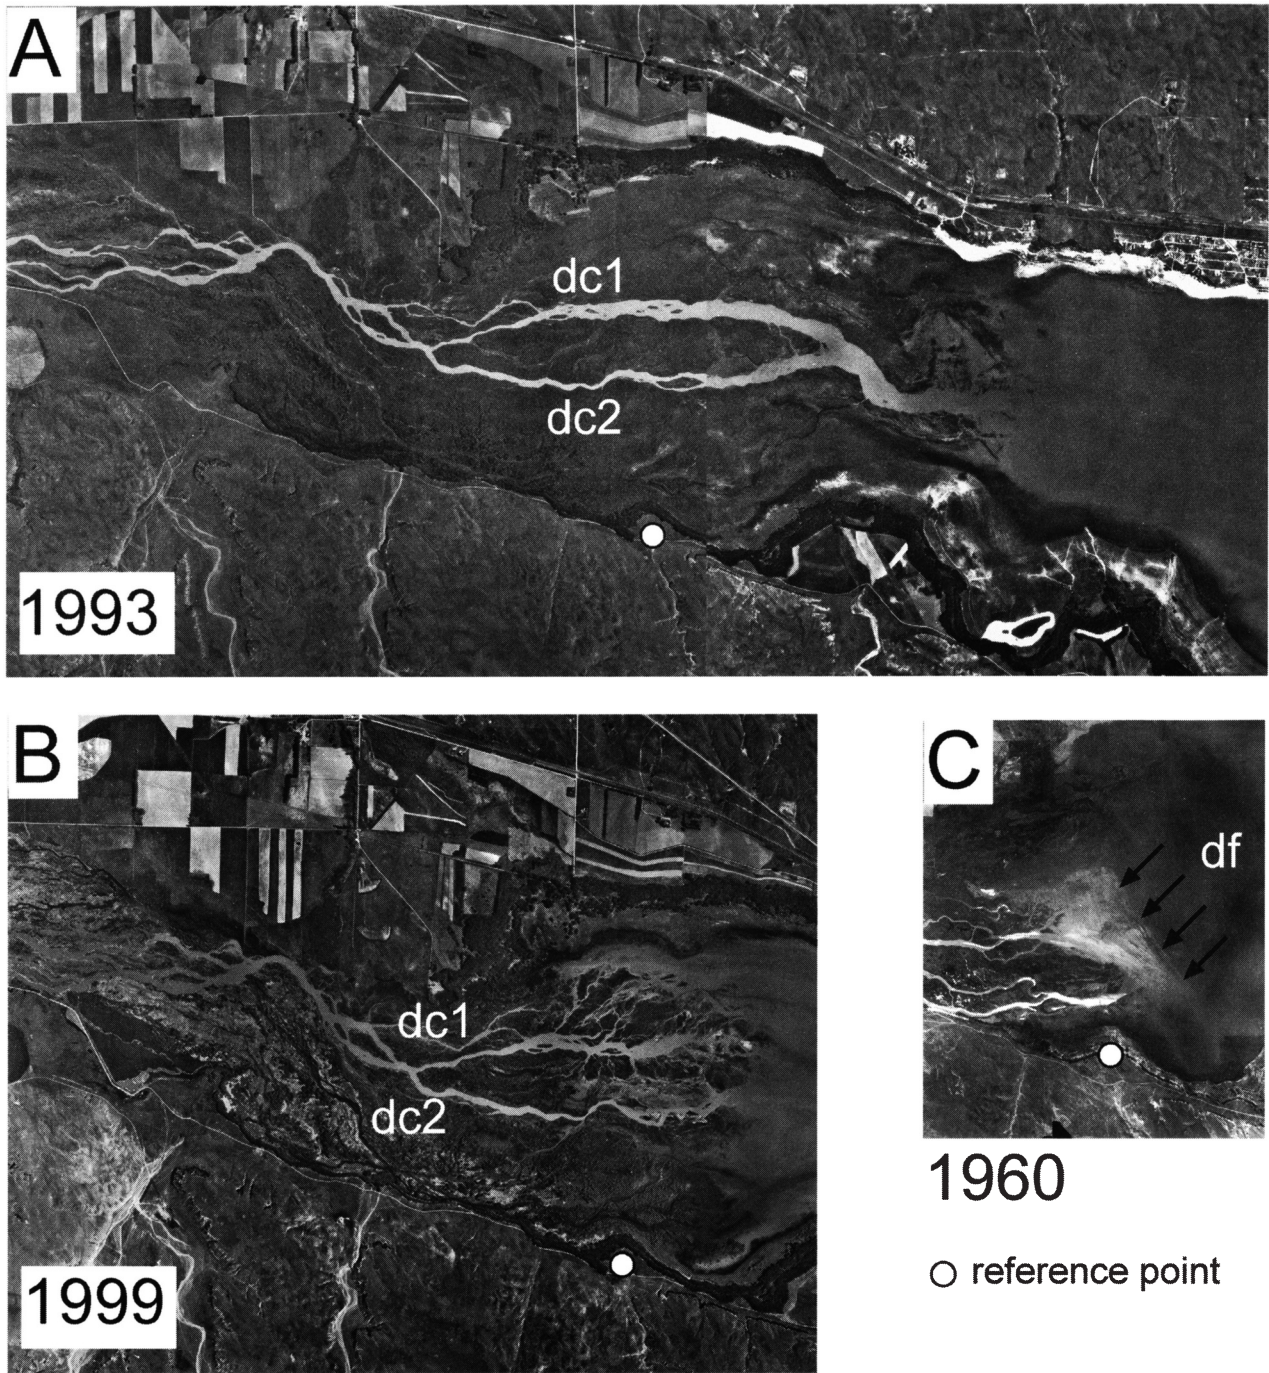
Figure 19. North Platte River delta at Lake McConaughy in 1993 (A), 1999 (B), and 1960 (C). Note the dramatic differences in the appearance of delta 1993 and 1999 due to management procedures: lake level was lower at the time of the 1993 photo, although 1993 had high annual rainfall, but lake level was higher in 1999, a lower-rainfall year. Distributary channels (dc1, dc2) are indicated. Vegetation on stabilized islands immediately upstream of the delta is sparser in 1999, leaving areas of bare sand (B), whereas delta and upstream islands are fully vegetated in 1993 (A). In the 1960 photo (C), the delta front (df) can be clearly seen; wind-driven waves appear to be diverting flow from North Platte southward, and sand is being deposited in shallow water at the delta front.

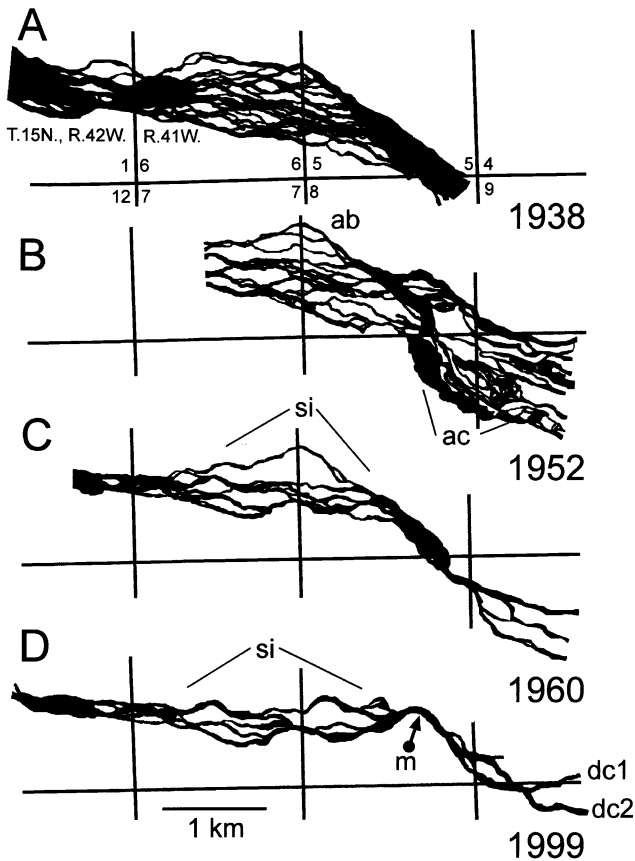
Figure 20. Changes in channel configurations immediately upstream of the North Platte River delta at Lake McConaughy, with an overlay of land section grid; flow is from left (west) to right into the lake. Aerial imagery coverage in 1938 (A) and 1952 (B) is incomplete, but partially overlaps 1999 digital orthophoto quadrangle (D). A) Channel pattern in 1938, immediately before construction of Kingsley Dam and the subsequent elevation in local base level. Note the wide, braided stretch with many braid bars between narrower, shallow stretches on either side in the original air photo. B) Channel pattern in 1952, with Lake McConaughy having reached peak storage for the first time. Note amalgamated bars (ab), which are generally larger than those present in 1938, and accessory channels (ac) that cross-link larger distributary channels downstream. River is approximately as wide as in 1938, but fewer channels are active. C) Channel pattern on June 18, 1960; relatively stabilized islands (si) have formed from bars and the number of channels has decreased markedly since 1952. D) Channel pattern in 1999. Note large, yet fewer, stabilized islands (si), fewer channels, and two delta distributary channels (dc1, dc2); channel has also migrated northward (m) at one point since 1960.

had decreased markedly and stable islands had formed from amalgamated bars (Figure 20C: si). By the 1990s, channel width had fallen to 180 m or less in unbraided stretches and 450 m in braided stretches (Figures 19A, 19B, and 20D). At that time, five or fewer channels were present in the braided stretches, and the number of bars had decreased dramatically, and stable islands had taken their places (Figure 20D: si). Only two distributary channels (Figure 20D, dc1 and dc2) feed the delta today.

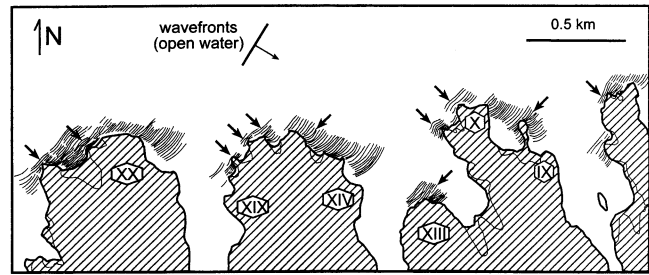
Figure 21. Interaction of waves produced by northwesterly winds with the headlands on the southeastern shore of Lake McConaughy. Arrows indicate sites of slight refraction of wave fronts around projecting parts of the headlands on the northwest-facing flanks. Fine lines within headlands represent margins of pocket beaches or other accretionary sandy shoreline exposed at what appears to be near-maximum pool level. From an aerial photograph GS-VCOP 1-48 (University of Nebraska—Lincoln Conservation and Survey Division files), taken on November 15, 1970. Reference points (Roman numerals) are as in Figures 10 and 11; see also Figure 1 for reference.
