# Comprehensive Evaluation of Fracture Critical Bridges

Sponsored By  
**Nebraska Department of Roads**

February, 2014

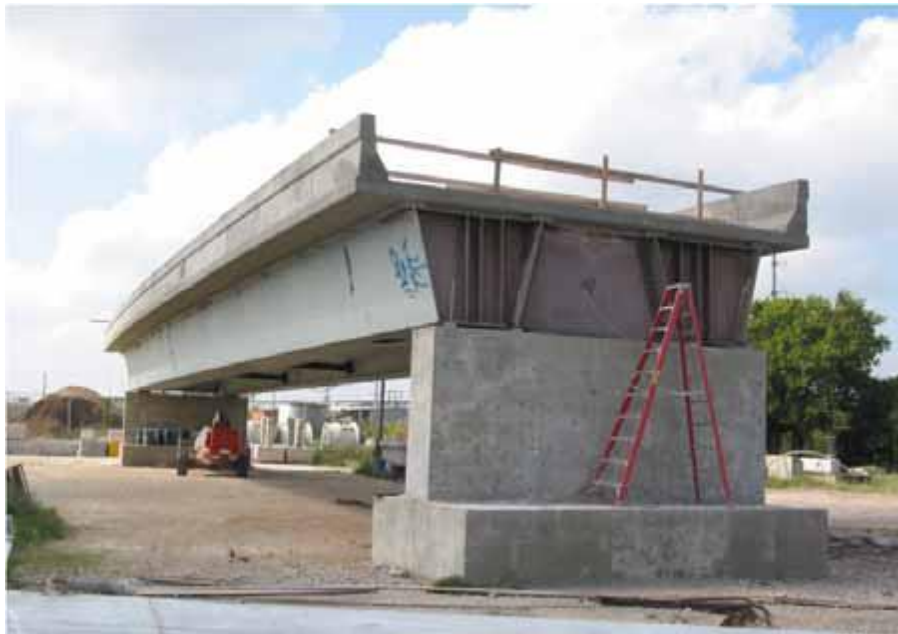
**Figure 1-1. FSEL Twin Box-Girder Bridge [Source: FHWA Report No.: FHWA/TX-10/9-5498-1]**

The full scale bridge test of this research project revealed the intrinsic redundant behavior of twin box girder bridges, despite the test was conducted in the worst case scenario from the redundancy point of view. The tested bridge was a simple-span one and therefore it had no redundancy due to continuity of its superstructure. In addition, all external diaphragms of this bridge were removed. Besides, the railings of the bridge were constructed with expansion joints. This limits the effectiveness of the contribution of the railing to the load carrying capacity of the bridge. And finally the bridge had a horizontal curvature and the fractured girder was the outside girder which has the maximum internal forces. Therefore, it is observed that the situation of a real-life bridge cannot be worse than this bridge from redundancy standpoint. Figure 1-1 shows a picture of this test bridge before conducting the tests.

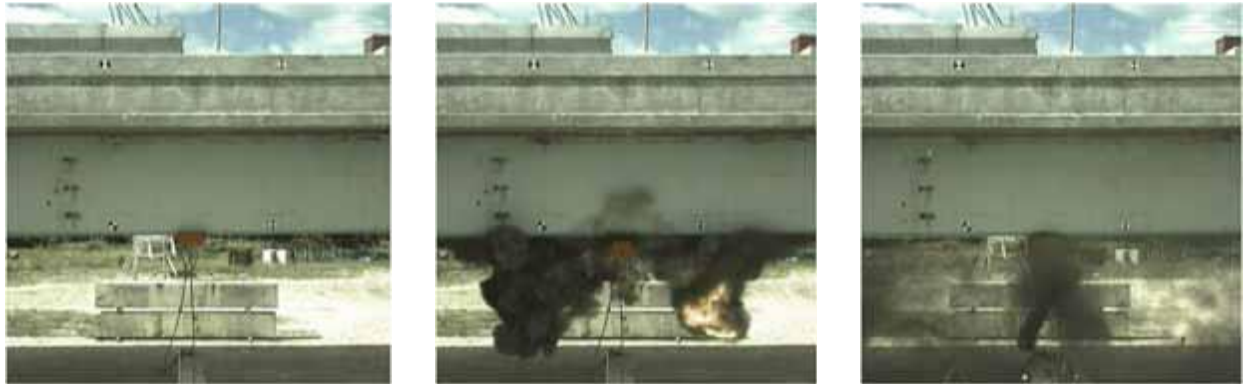
**Figure 1-2. FSEL First Bridge Fracture Test [Source: FHWA Report No.: FHWA/TX-10/9-5498-1]**

Three different tests have been done on this bridge. In the first test, the bottom flange of the exterior girder was rapidly cut by an explosive to simulate a sudden fracture while an equivalent HS-20 load was positioned above the fractured girder and in the worst possible location. Figure 1-2 illustrates the bridge during the explosion and Figure 1-3 shows the bottom flange cut after the explosion. The response of the bridge during and after this test was satisfactory and its maximum deflection was less than one inch.

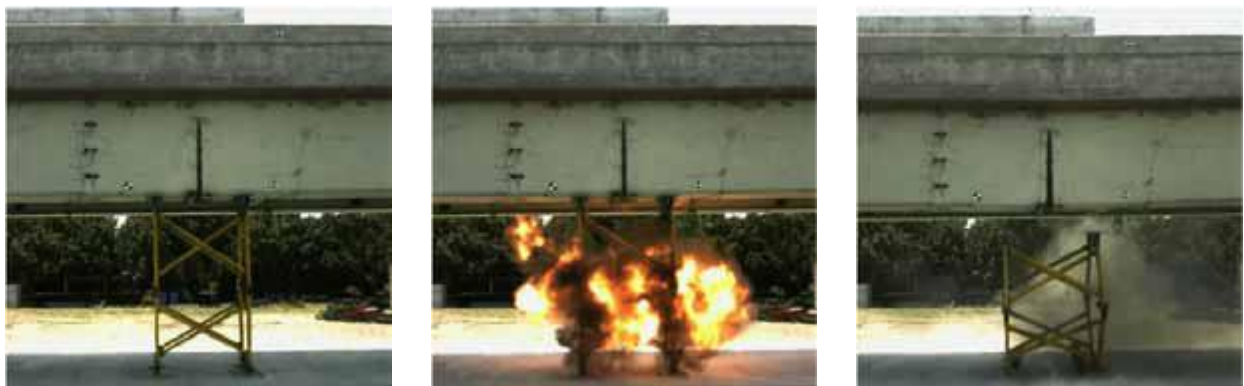
**Figure 1-4. FSEL Second Bridge Fracture Test [Source: FHWA Report No.: FHWA/TX-10/9-5498-1]**

In the second test, the bridge was supported by means of a scissor jack while about 83% of the webs of the cracked girder were cut manually and then the scissor jack was removed suddenly using an explosive acting on the jack. This way the sudden nature of the crack was simulated. Figure 1-4 shows the supporting scissor jack before, during and after the explosion. Again, the bridge showed a well performance with a maximum deflection of seven inches.

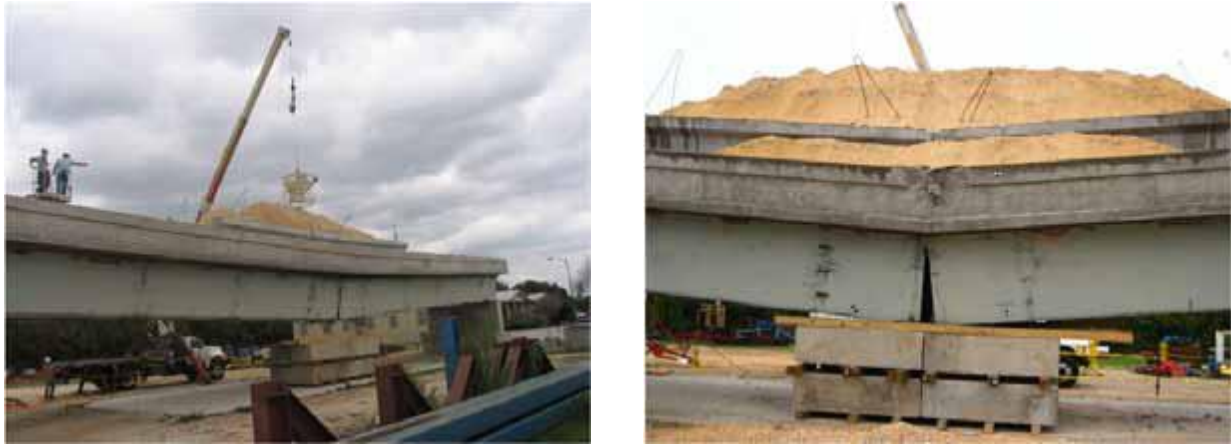
**Figure 1-5. FSEL Third Bridge Fracture Test [Source: FHWA Report No.: FHWA/TX-10/9-5498-1]**

loads. In this test, the bridge carried 363 kips of load which, considering the extent of the damage, was a remarkable capacity. Figure 1-5 shows the incremental loading of the bridge and also the bridge in its collapsed mode.

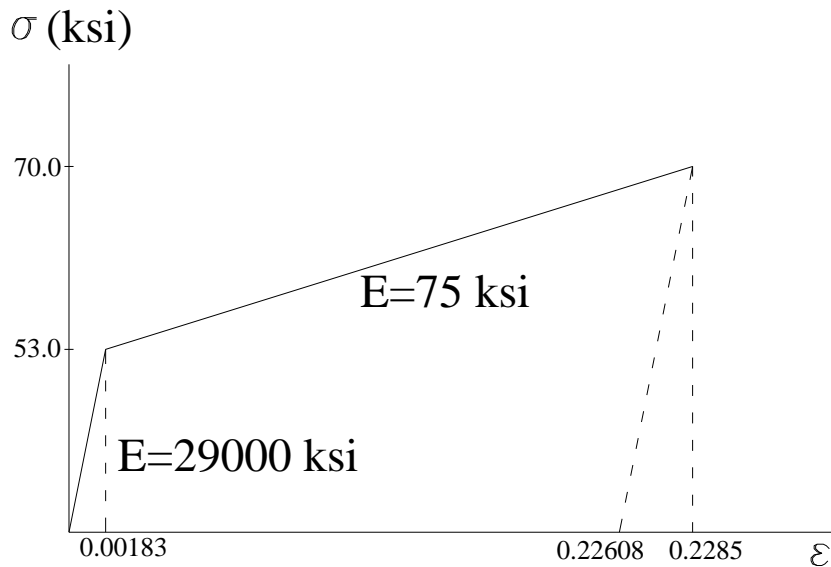
**Figure 3-4. Stress-Strain relationship of Steel Components**

The steel components (girders, floor beams and angles) have a bilinear stress-strain behavior with a Young's modulus of 29000 ksi for stresses up to 53 ksi and a Young's modulus of 75 ksi for stresses between 53 ksi and 70 ksi. This material ruptures at the stress level of 70 ksi. The unit weight of steel is 490 lb/ft<sup>3</sup> and its Poisson's ratio is 0.3. Figure 3-10 shows the stress-strain relationship for the steel material. The considered timber material for deck has a Young's modulus of 1500 ksi, a unit weight of 50 lb/ft<sup>3</sup> and a Poisson's ratio of 0.2.

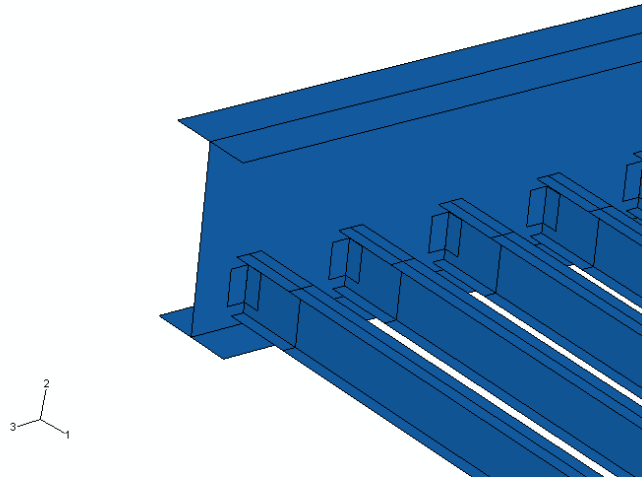
**Figure 3-5. Typical Floor Beam to Girder Connection**

In the models, the floor beams are connected to the girders by means of angles to provide flexibility similar to the actual connections. Figure 3-5 illustrates the typical floor beam to girder connection.

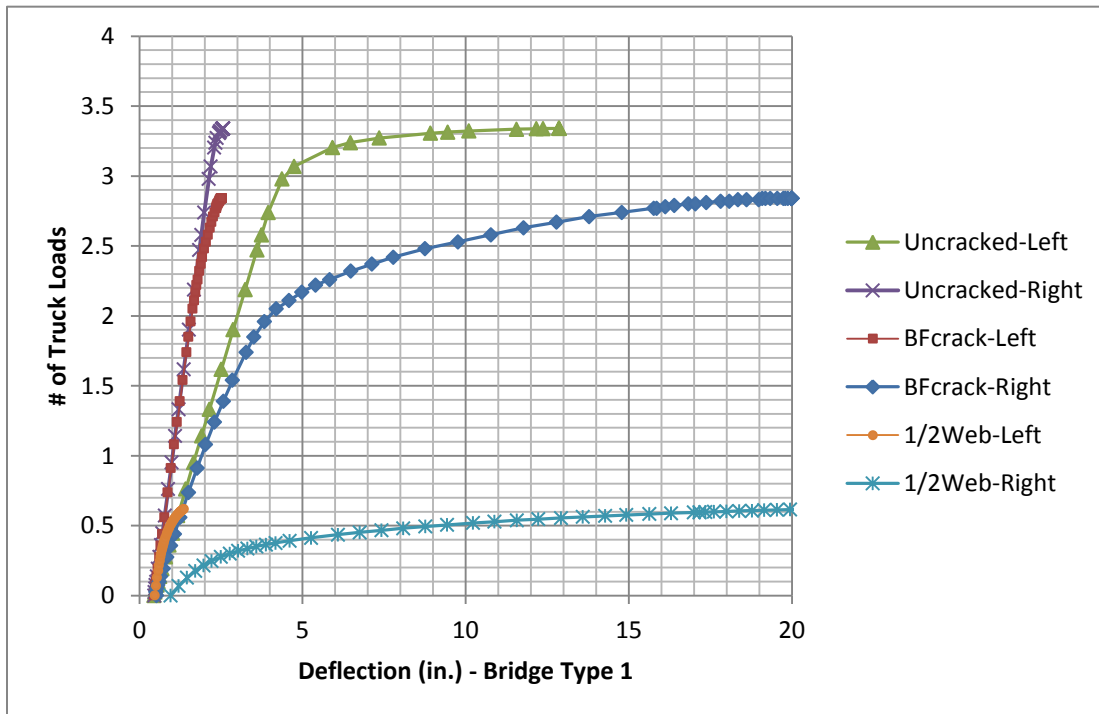
Figure 3-8. Two-girder Bridge Type 1 and its Load-Deflection Curve

Figure 3-8 shows the two-girder bridge Type 1 and its load deflection curves. The bridge was analyzed in its uncracked mode and also the two cracking patterns described earlier. The load capacity of the bridge is denoted by the number of the HS-20 trucks that the bridge could carry. The uncracked bridge was able to carry about 3.35 times HS-20 loads in its uncracked state. When it had the bottom flange of one of the girders cracked, the load decreased to about 2.85 trucks. And when the bridge was modeled with half the depth of one of its girders cracked, the load capacity of the bridge dropped to approximately 0.6 times the weight of a HS-20 truck. The deflections of both cracked and uncracked girders of the bridges are shown in Figure 3-8.

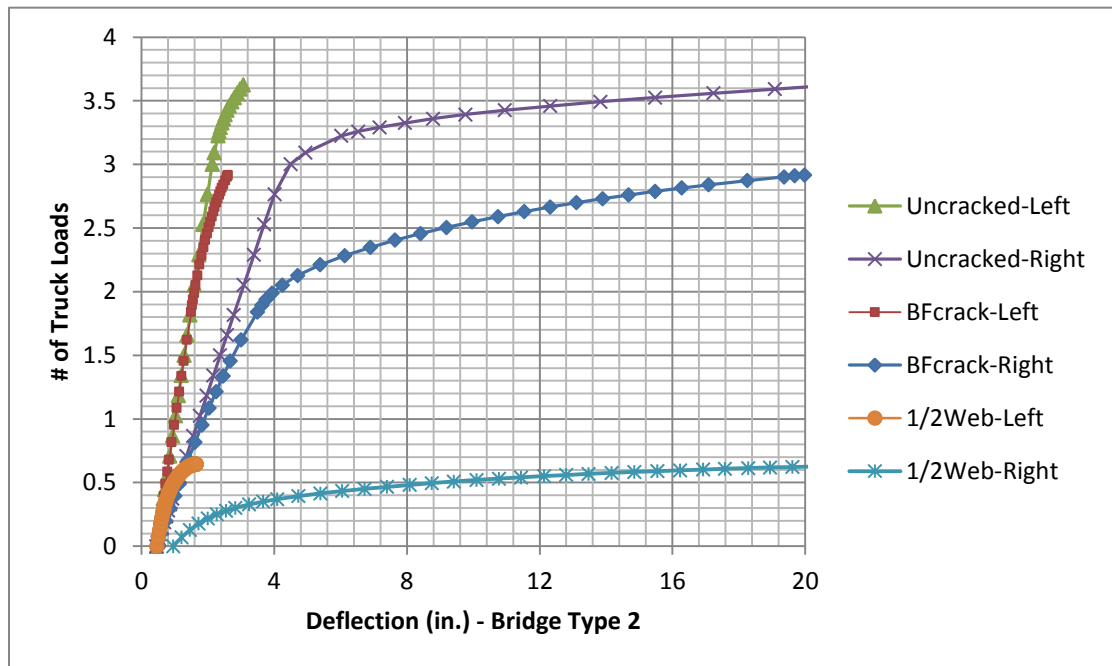
Figure 3-9. Two-girder Bridge Type 2 and its Load-Deflection Curve

The two-girder bridge Type 2 and its load deflection curves are illustrated in Figure 3-9. The bridge was analyzed in its uncracked mode and also the two described cracking patterns. The uncracked bridge was able to carry about 3.60 times HS-20 loads in its uncracked state. When it had the bottom flange of one of the girders cracked, the load reduced to about 2.90 times of HS-20 truck load. When the bridge had one half of the depth of one of its girders cracked, the load capacity of the bridge dropped to approximately 0.60 times of HS-20 load. The deflections of both cracked and uncracked girders of the bridges are shown in Figure 3-9.

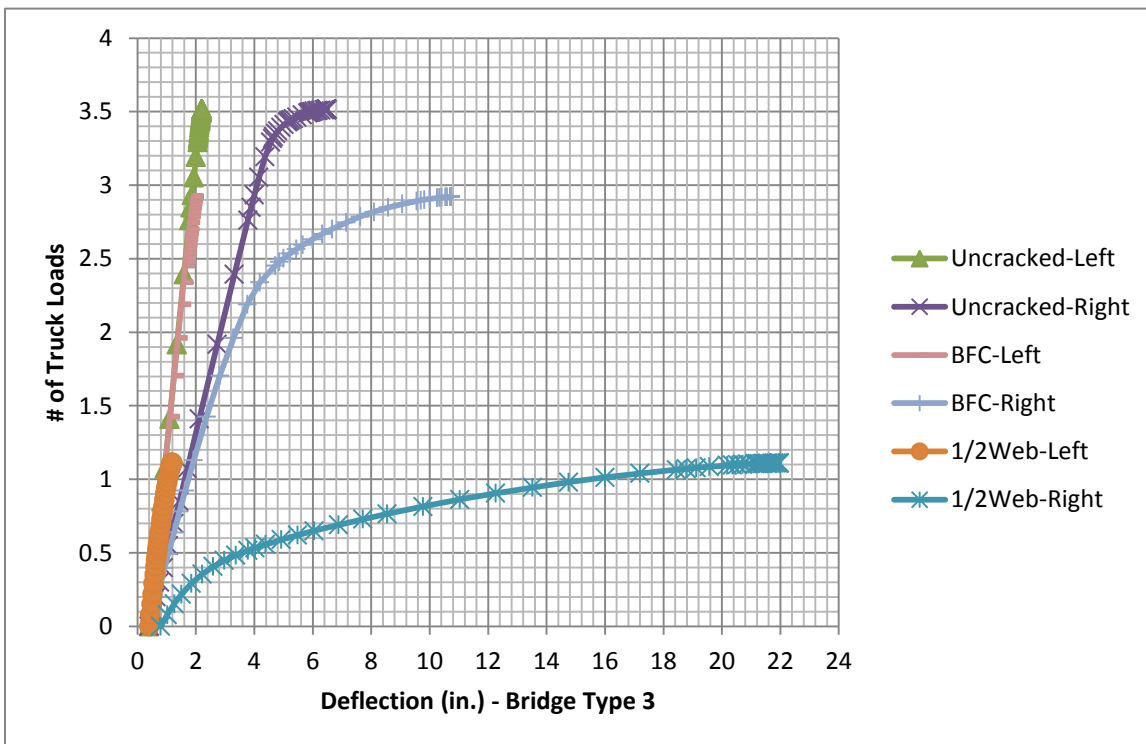
**Figure 3-10. Two-girder Bridge Type 3 and its Load-Deflection Curve**

Figure 3-10 displays the two-girder bridge Type 3 and its load deflection curves. The bridge was analyzed in its uncracked mode and also the two cracking patterns. The uncracked bridge was able to carry about 3.5 times of HS-20 load in its uncracked mode. When the bottom flange of one of the girders was cracked, the load decreased to about 2.9 trucks load. And when the bridge was modeled with half depth of one of its girders cracked, the capacity of the bridge reduced to approximately 1.1 times of the weight of HS-20 truck. The deflections of both cracked and uncracked girders of the bridges are shown in Figure 3-10.

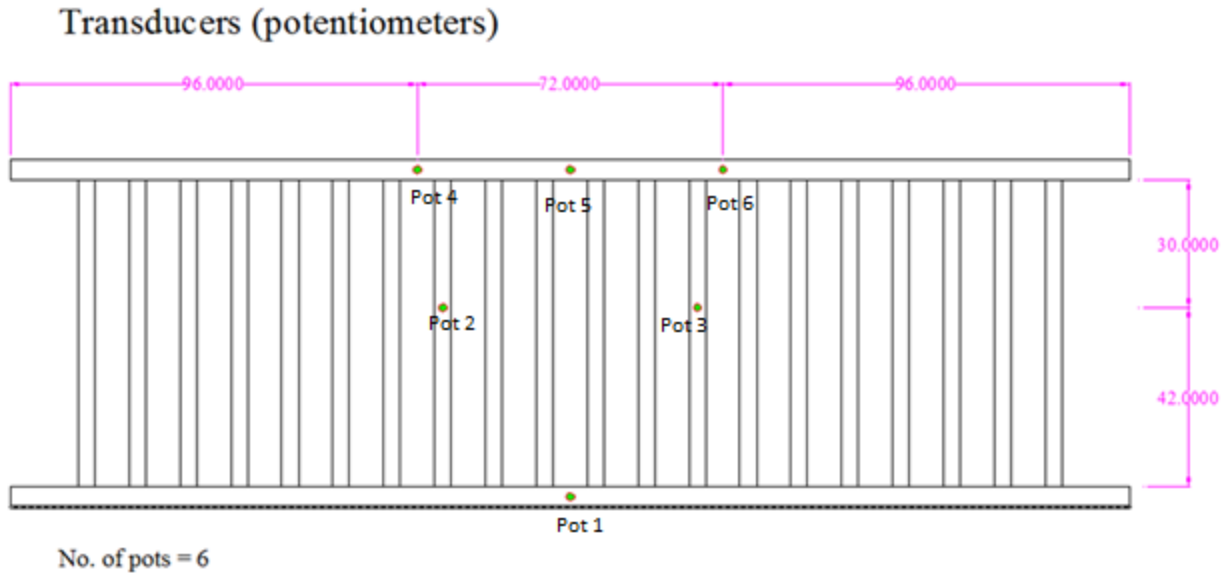
**Figure 4-14. Location of Potentiometers.**

For the first part of the test, which was the lateral torsional buckling capacity evaluation of the bridge, six potentiometers were provided; the positions of which are shown in Figure 4-14. The girder away from the loading points (Girder B) had one potentiometer located at its mid-span. The other girder has three potentiometers, one at each quarter point along the length of the girder. Two other potentiometers were located 30 inches away from the end of the two floor beams beside the loading rods.

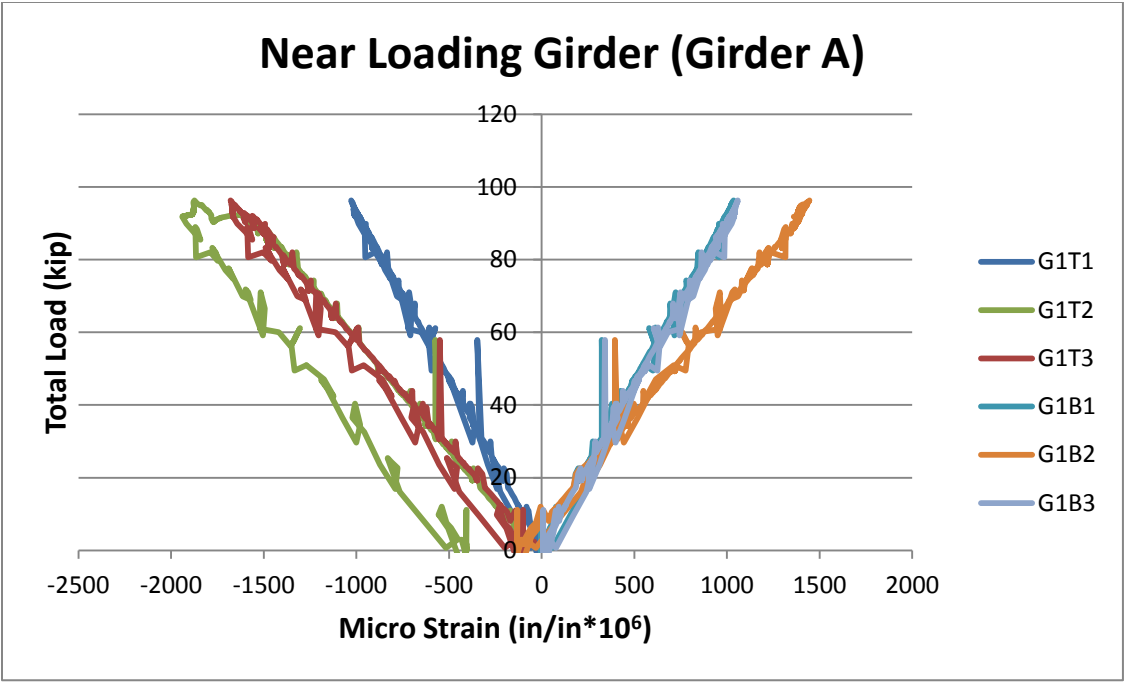
Figure 4-16. Main Girder Strains (με) vs. Applied Load (kip)- Partial LTB Test

The data obtained from strain gages are divided into two groups. The first group consists of the strain gages attached to floor beams, angles and the girder away from point of loading (Girder B). These strain gages showed values of strain between  $-1113 \text{ me}$  and  $+1228 \text{ me}$  which were less than the yielding strain of  $1700 \text{ me}$  for Grade50 steel material. The results from this group of gages followed from linear elastic predictions and were not shown. The more important data were acquired from strain gages of the main girder close to loading (Girder A). As shown in Figure 4-16, the strains in bottom flange of the girder at quarter length sections, named G1B1 and G1B3 showed positive values less than  $1058 \text{ me}$ . These tensile strains were less than the yielding strain of the steel material and restored to zero after unloading the test bridge. The strain gage of the bottom flange at mid-span section, G1B2, and strain gage of the quarter length of top flange, G1T1, showed similar but opposite responses with maximum values of  $+1444 \text{ me}$  and  $-1028 \text{ me}$ , respectively. However, the two strain gages attached to top flange of the girder at mid-span section had larger values of strain. The one attached to the inside edge of the top flange, G1T3, had a strain of  $+1678 \text{ me}$  which was at the yielding threshold and the other one, G1T2, located at the outer edge of the top flange, had a strain of  $+1941 \text{ me}$  which is greater than the yielding strain. It was observed in Figure 4-16 that the strains from these gages did not restore to zero after unloading the bridge.

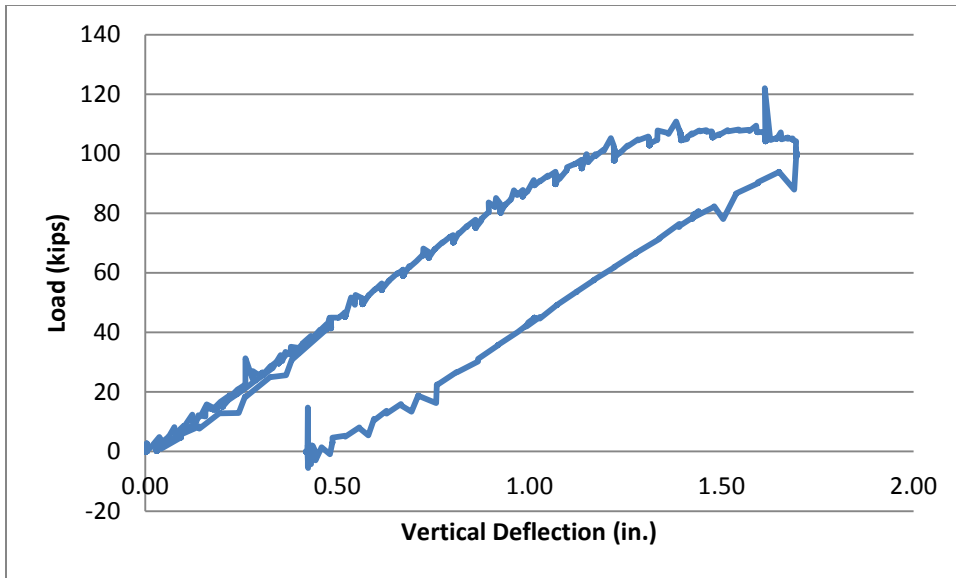
**Figure 4-47. Load vs. Vertical Deflection at Mid-span of Loaded Girder**

Figure 4-47 illustrates the applied load versus the vertical deflection of the girder closer to the loading (Girder A) at mid-span. It is observed that a maximum load of 106 kips was carried by the bridge with a maximum vertical displacement of 1.7 inches. It is also observed that the girder experienced a plastic vertical deformation of about 0.45 inch at the mid-span of the loaded girder.

In the second model, a bridge with a built-up girder was used to provide a taller specimen. This provided the maximum ratio found in practice for the height of the girder to height of the floor beams. In this experiment, the ratio was approximately 4.0. There were a total of five tests performed in on the second model. In the first test, the uncracked bridge system carried a maximum load of 106 kips with a maximum vertical displacement of 1.7 inches. After unloading, the girder closer to the loading point (Girder A) experienced a permanent vertical deformation of approximately 0.45 inch at mid-span.

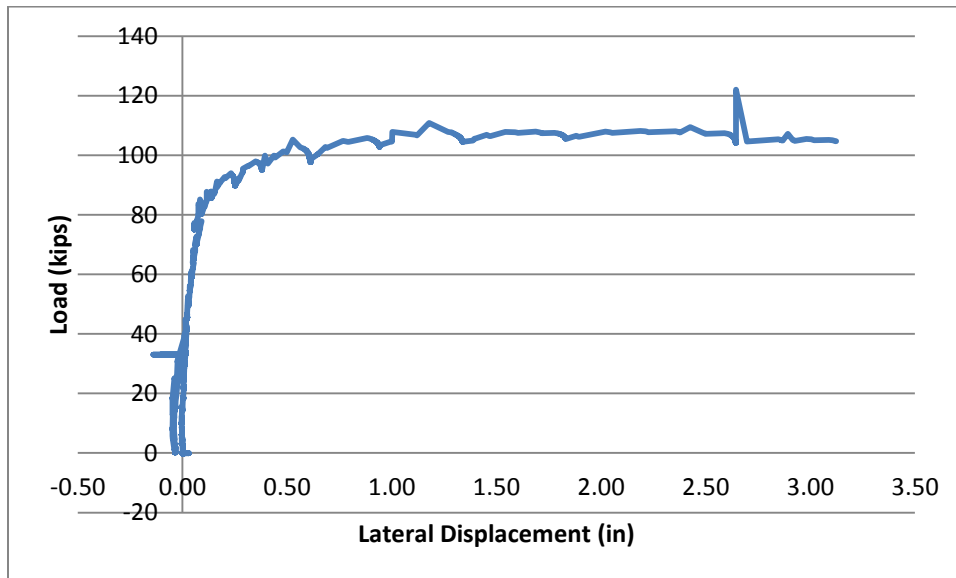
**Figure 4-48. Load vs. Lateral Displacement of Flanges Loaded Girder at Mid-span**

Load versus lateral displacement at mid span of the top flange of the girder near the loading is illustrated in Figure 4-48. Until 80 kip of applied load, lateral displacement of the top flange of the loaded girder was minimal. After that 80 kips of applied load, the lateral displacement increased drastically with a small increase in load.
