Streambed Adjustment and Channel Widening in Eastern Nebraska

Water-Resources Investigations Report 03-4003

By David L. Rus, Benjamin J. Dietsch, U.S. Geological Survey, *and* Andrew Simon, National Sedimentation Laboratory

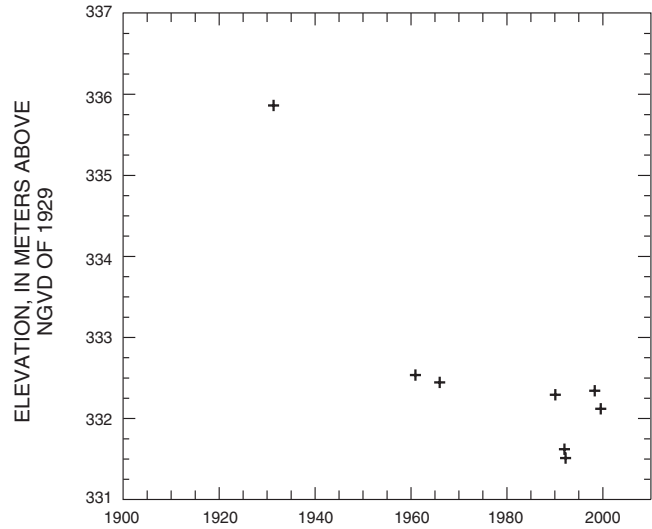
Figure 7. Streambed-elevation changes at Elk Creek at US20 (MRT-8).

Nine of the 23 Missouri River Tributary Basins sites showed degradation responses greater than 1 m (table 6). Site MRT-8 showed the largest amount of change, with 3.7 m of degradation between 1931 and

1999, and most of the change had occurred by 1960 (fig. 7). The streambed materials were coarser in the northeastern basins of Bow, Aowa, and Elk Creeks than in the rest of the basins studied (table 6).

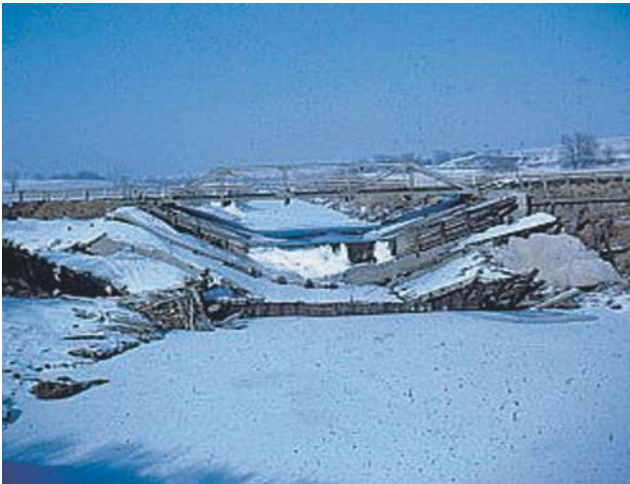
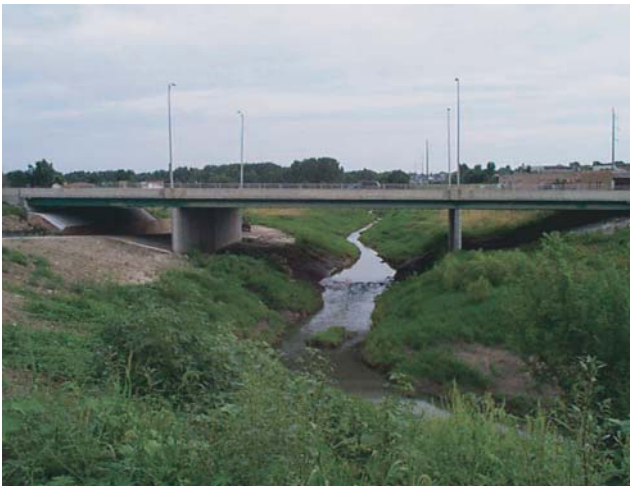
Figure 9. Looking upstream at W Papillion Cr at US275 (PC-3).

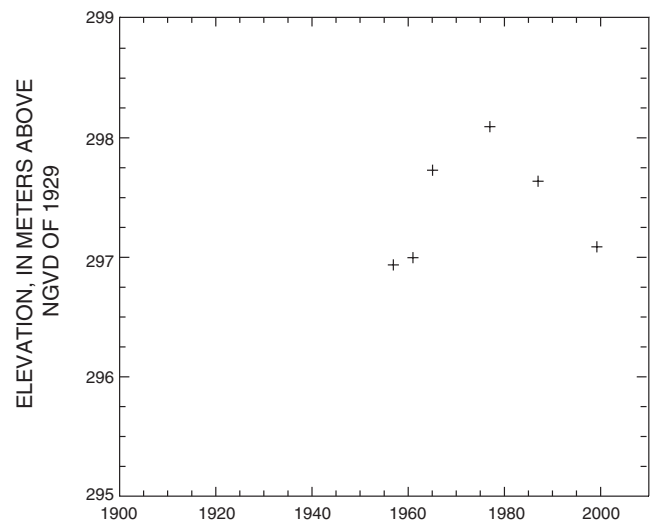
Figure 10. Streambed-elevation changes at W Papillion Cr at 66th Street (PC-H).

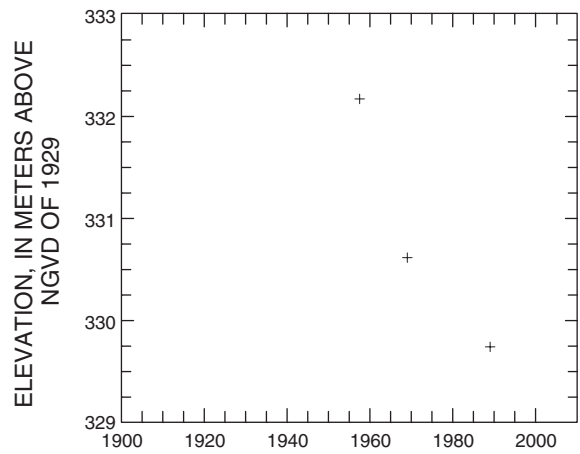
Figure 11. Streambed-elevation changes at Wehrspann Cr at N370 (PC-F).

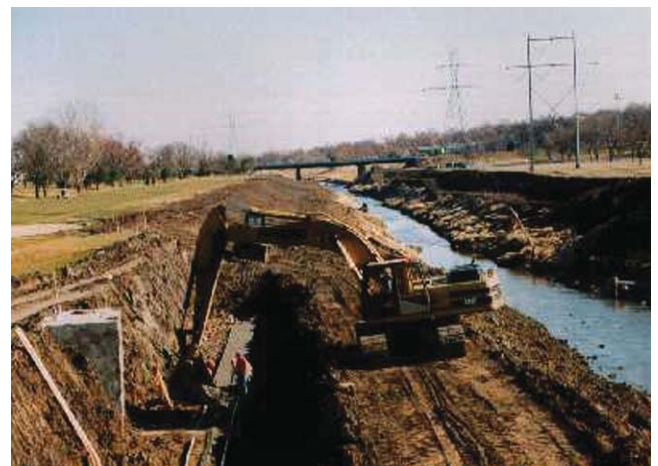
Figure 12. Channel and levee construction, Big Papillion Creek (photograph from the Papio-Missouri River Natural Resources District).

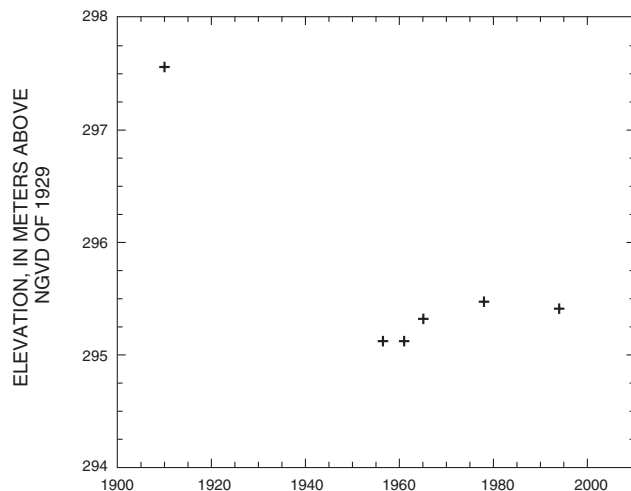
Figure 13. Streambed-elevation changes at Big Papillion Cr at Cornhusker Rd (PC-M).

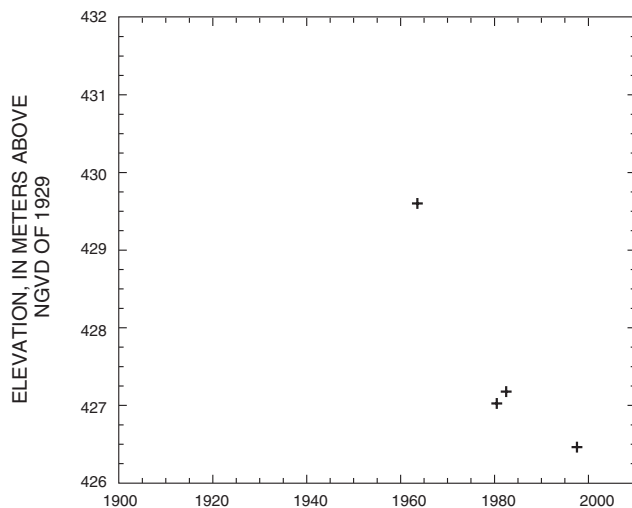
Figure 15. Streambed-elevation changes at Skull Creek at Butler County road (PRT-5).

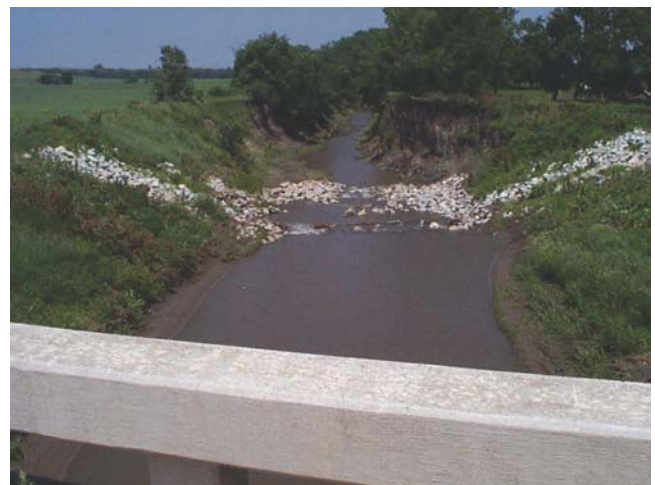
Figure 16. Looking downstream at grade-control structure on Skull Creek at PRT-5.

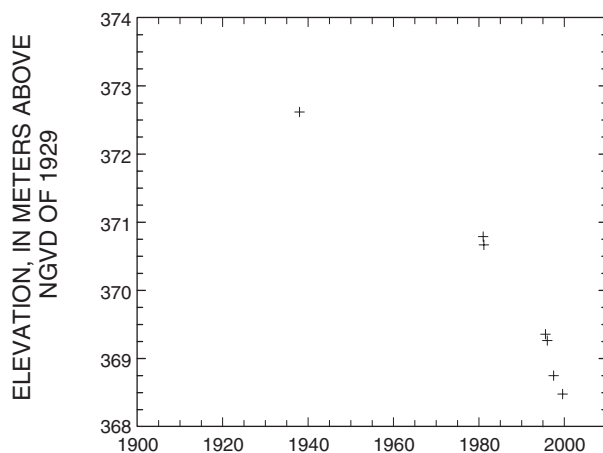
Figure 17. Streambed-elevation changes at Otoe Cr at US77 (PRT-7).

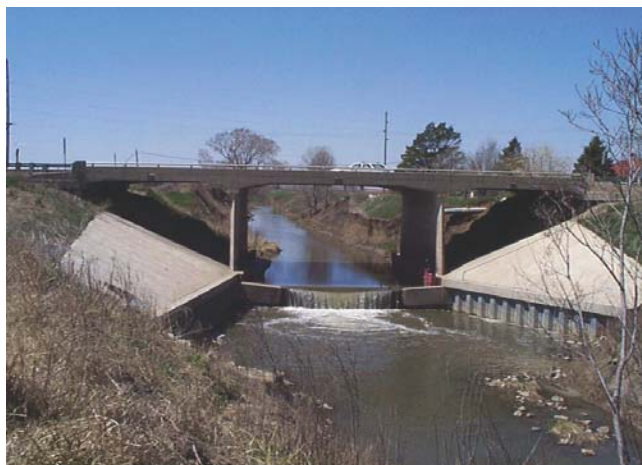
Figure 19. Drop structure at S Logan Cr at N15 (ER-12).

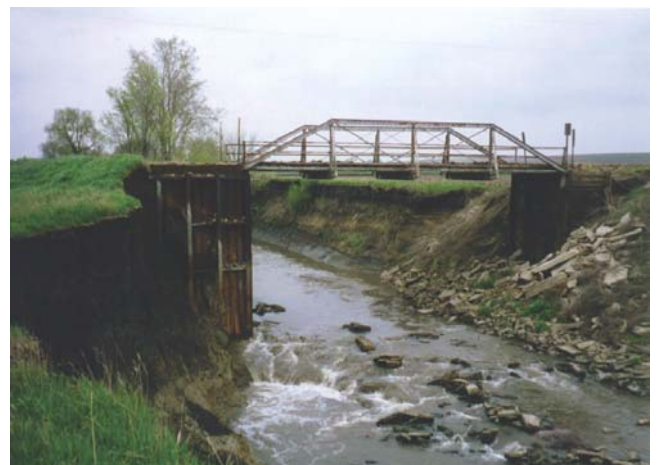
Figure 20. Knickpoint on East Fork Maple Creek located at SW1/4 sec. 26, T. 19 N., R. 4 E.

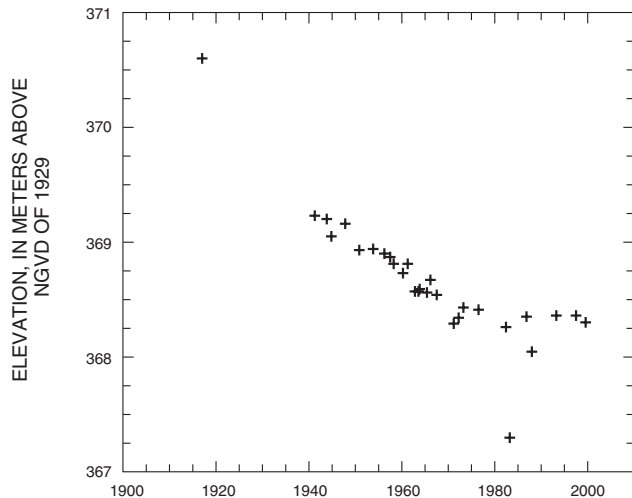
Figure 21. Streambed-elevation changes at Logan Cr at Dodge County Road 22 (ER-15).

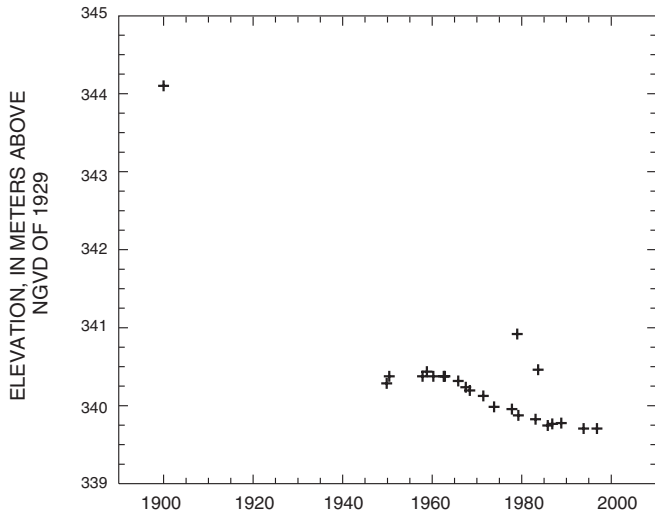
Figure 23. Streambed-elevation changes at Salt Cr at N 27th St, Lincoln (SC-13).

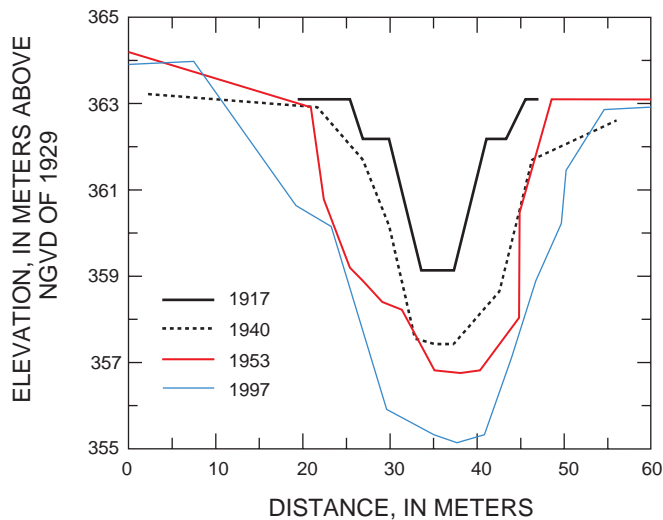
Figure 24. Stream channel response at Middle Cr at US6 (SC-7) following 1917 straightening.

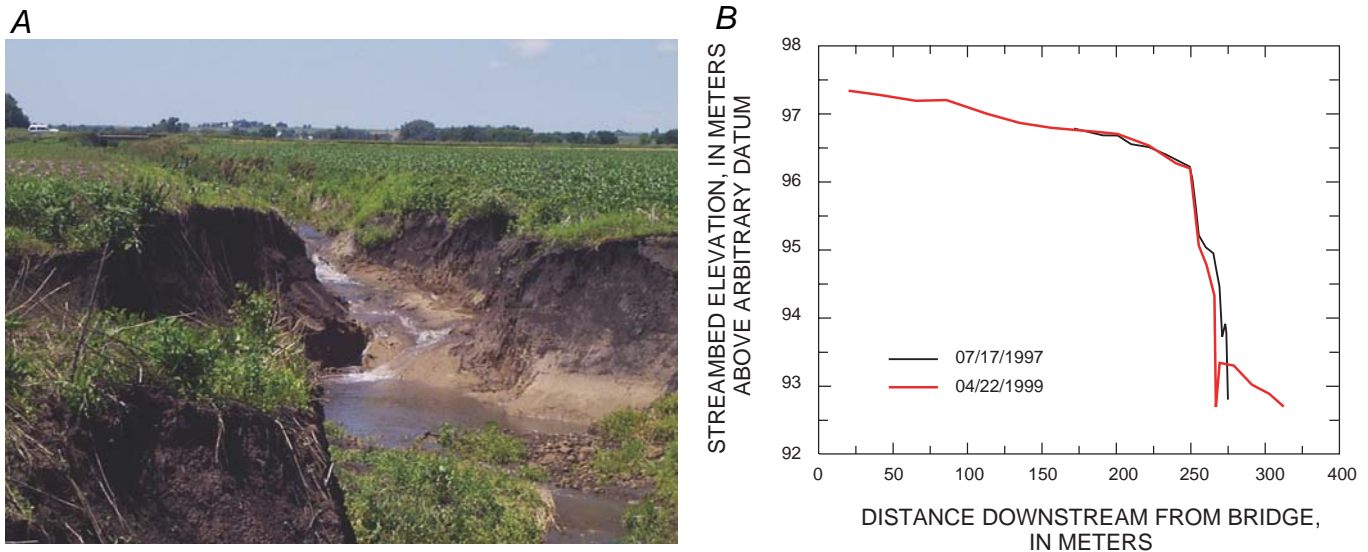
Figure 25. (A) Photograph of knickpoint and (B) streambed profile observed at Sand Cr Tributary at Saunders County Road 24 (SC-31).

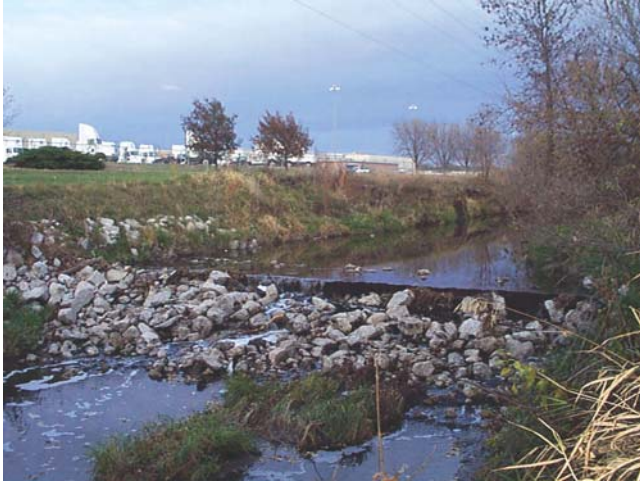
Figure 26. Grade-control structure on Beal Slough upstream from Link 55W (SC-H).

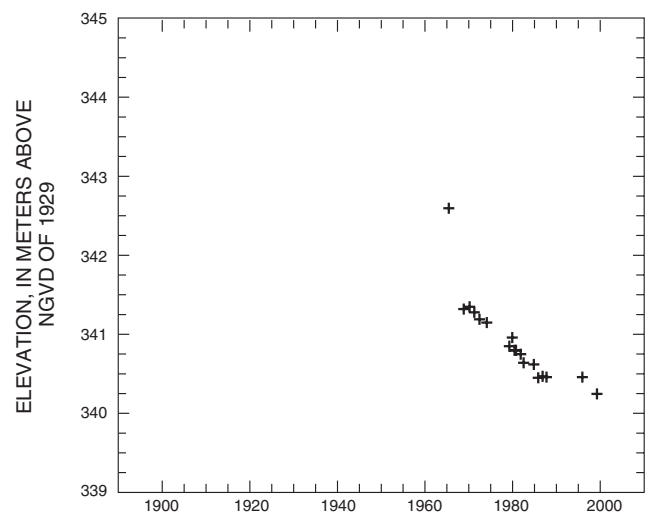
Figure 27. Streambed-elevation changes at Little Salt Cr at Arbor Road (SC-21).

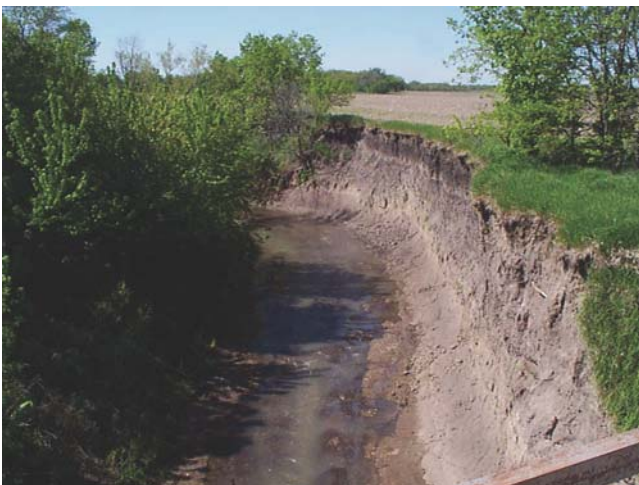
Figure 29. Channel incision observed in 1998 on Spring Creek about 3.5 kilometers upstream from LNR-11.

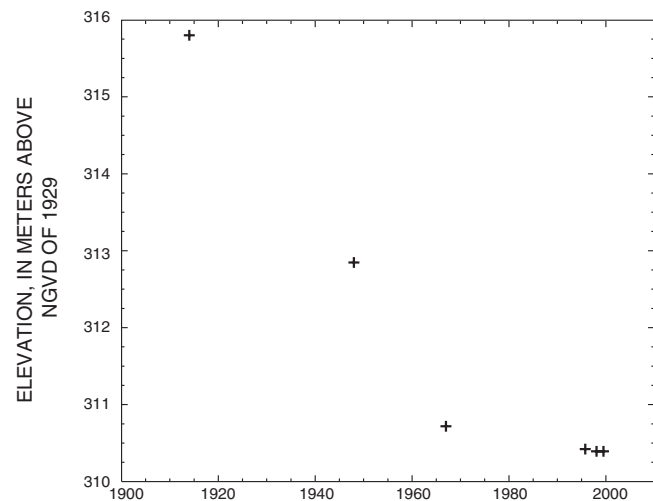
Figure 30. Streambed-elevation changes at S Fk Little Nemaha River at N50 (LNR-8).

Two of the three sites in the South Fork Little Nemaha River subbasin (LNR-8 and LNR-9) showed a response probably caused by the straightening in the subbasin between 1947 and 1953 (fig. 30; table 15). The third site, LNR-7, which is in the upper reaches of the subbasin, seems presently to be aggrading in response to the original channelization. This would indicate that a knickpoint created by the extension of the work may still be migrating upstream through the subbasin and is located between sites LNR-7 and LNR-8. Sites in the Muddy Creek subbasin had the most streambed degradation of any of the sites in the basin, with 6.0 m of change at LNR-B and 5.4 m of change at LNR-6 (table 15).

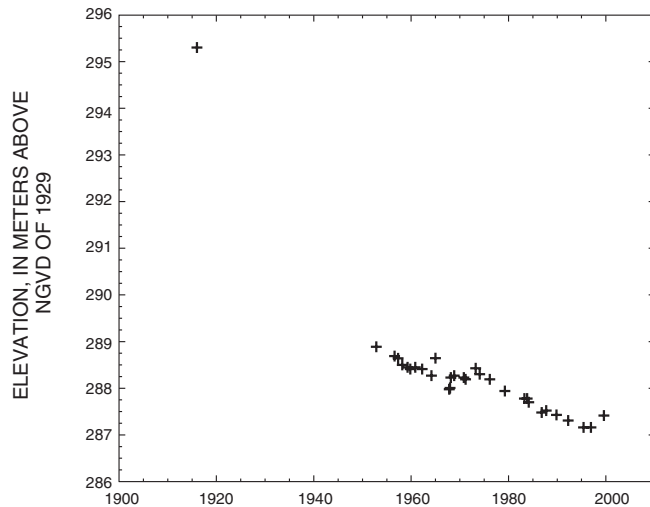
Figure 32. Streambed-elevation changes at N Fk Big Nemaha R at N105 (BNR-9).

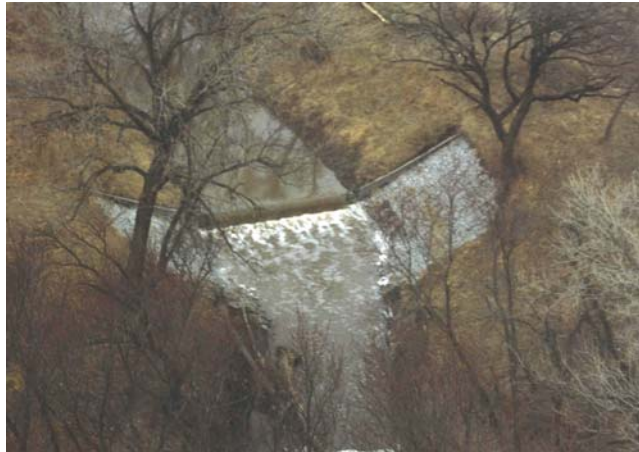
Figure 34. Grade-control structure on Big Indian Creek between Gage County Road (BBR-11) and US77 (BBR-12).

Of the six sites on tributaries that have been straightened, only BBR-12 showed any streambed degradation greater than 1 meter (table 18). This may be a result of grade-control structures, but also might be the result of insufficient data at the other sites. Bedrock currently is exposed at site BBR-12, which has effectively halted any further degradation.
