Development of a Temporary Concrete Barrier To Permanent Concrete Median Barrier Approach Transition

*Midwest States Regional Pooled Fund Research Program
Fiscal Year 2005-2006 (Year 16)
Research Project Number SRP-03(017)
NDOR Sponsoring Agency Codes RFPF-06-07 and RFPF-06-09*

MIDWEST ROADSIDE SAFETY FACILITY

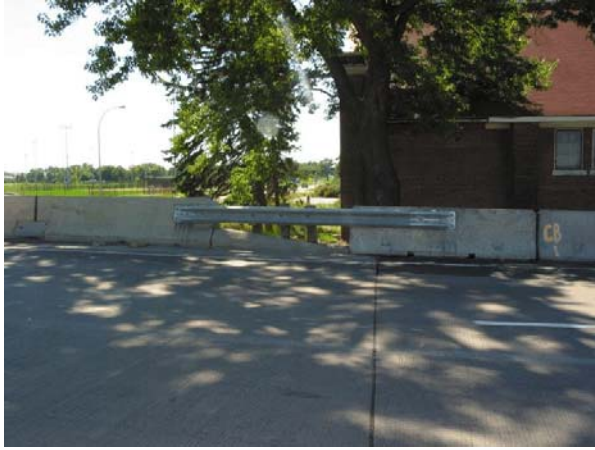
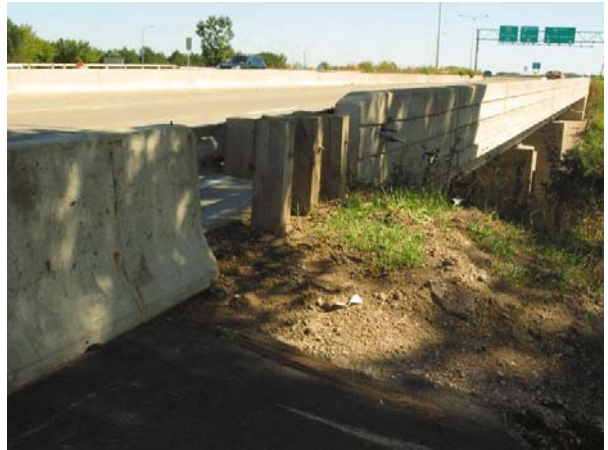
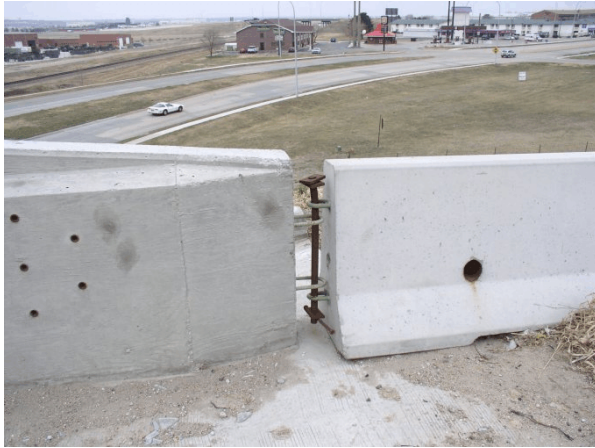
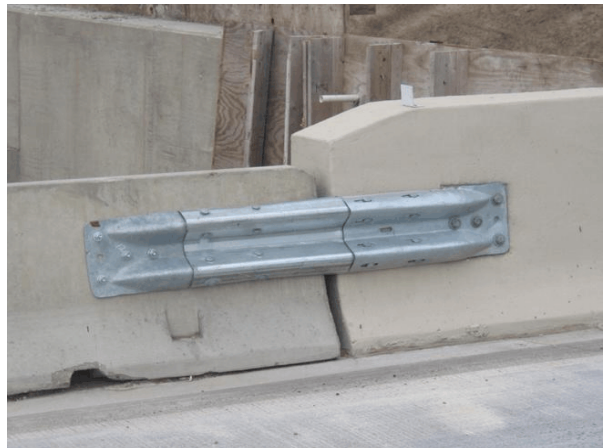
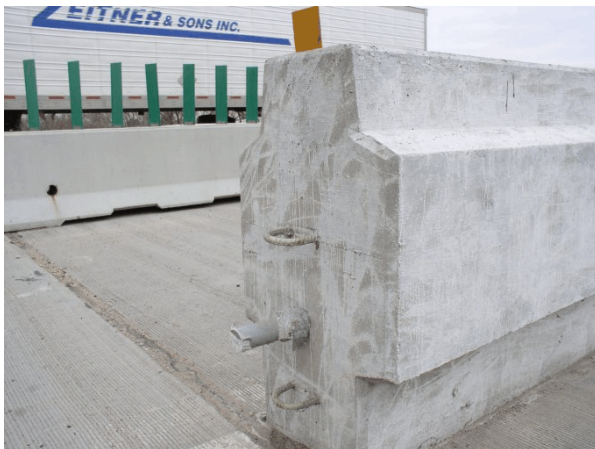
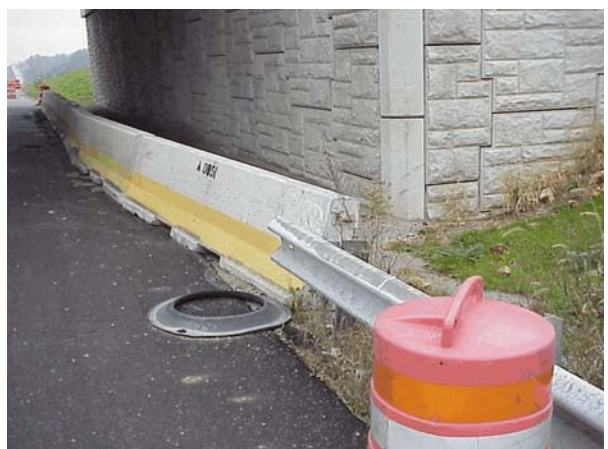
Figure 1. Temporary Concrete Barrier Transition Types

In practice, temporary concrete barriers must be connected and transitioned to many types of barriers, as shown in Figure 1. Sometimes the temporary concrete barriers are connected to similarly shaped permanent concrete barriers while at other times, they must be connected to vertical concrete barriers, tubular steel bridge railings, W-beam guardrail, thrie-beam guardrail, and open concrete bridge railings. Unfortunately, there has been little effort devoted to this issue and only the transition between safety shaped concrete barriers and temporary concrete barriers has been designed (1). Thus, there is a need to identify the temporary barrier transition situations that the Pooled Fund states need.

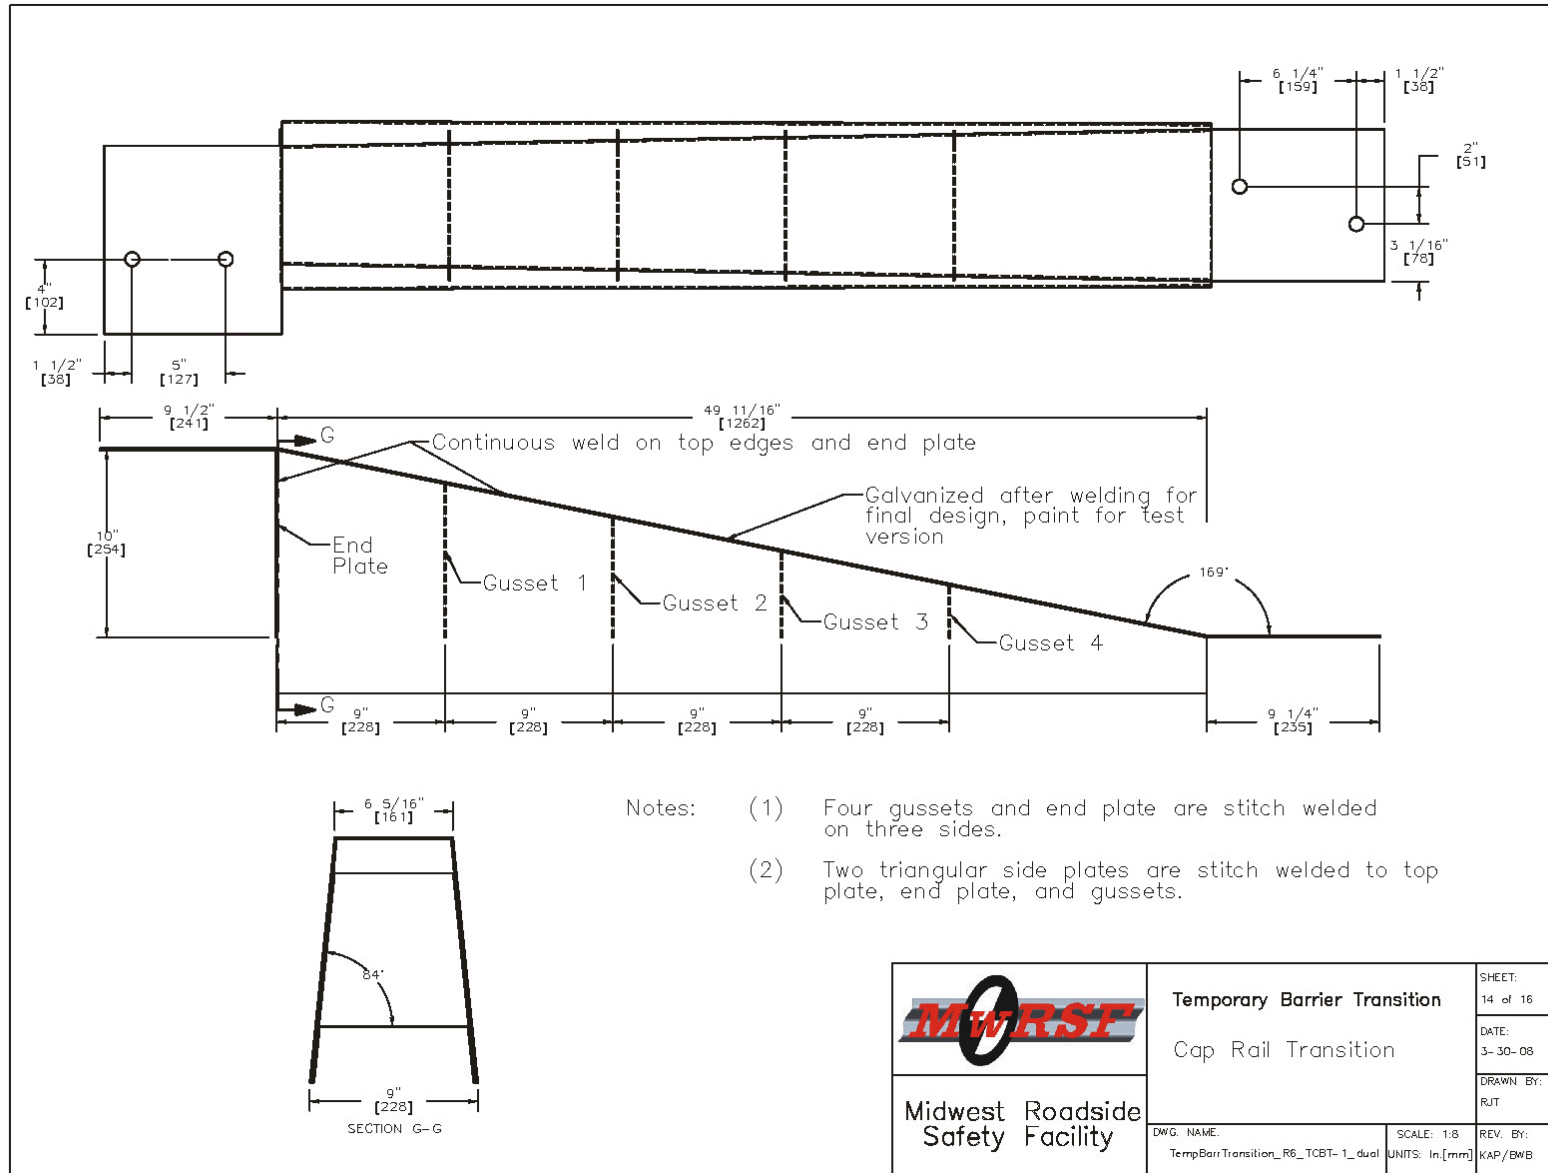
Figure 17. Cap Rail Transition Details, Test Nos. TCBT-1 and TCBT-2

In order to reduce the potential vehicle snag at the joint between the pinned barriers and the rigid parapet, a transition cap and nested thrie beam sections were added. The nested 12-gauge thrie beam sections were bolted across both sides of the barrier at the joint between the pinned barrier and the rigid parapet. It should be noted that 10-gauge thrie beam can be substituted for the nested 12-gauge in actual installations if desired. The thrie beam was bolted to the barriers using five $\frac{3}{4}$ -in. (19-mm) diameter x 6-in. (152-mm) long, Power Fasteners Wedge-Bolt Anchors at each end of the beam, as shown in Figure 16. In addition, the middle of the thrie section was attached to the pinned barrier with two $\frac{3}{4}$ -in (19-mm) diameter Grade 5 bolts and $\frac{3}{4}$ -in (19-mm) diameter RedHead Multi-Set II Drop-in Anchors. A wooden spacer block was used to offset the thrie beam from the concrete barrier on the back side of the installation. The two bolts on the front face were 1 $\frac{3}{4}$ in. (44 mm) long, while the two on the back face were 5 $\frac{1}{2}$ in. (140 mm) long. The 12-gauge ASTM A36 steel cap was 6 $\frac{1}{16}$ in. (154 mm) and 8 $\frac{1}{8}$ in. (206 mm) wide at the top and bottom, respectively, with a height of 10 in. (254 mm). Four 12-gauge ASTM A36 gussets were stitch welded on three sides inside the cap. The cap details are shown in Figures 17 through 19.

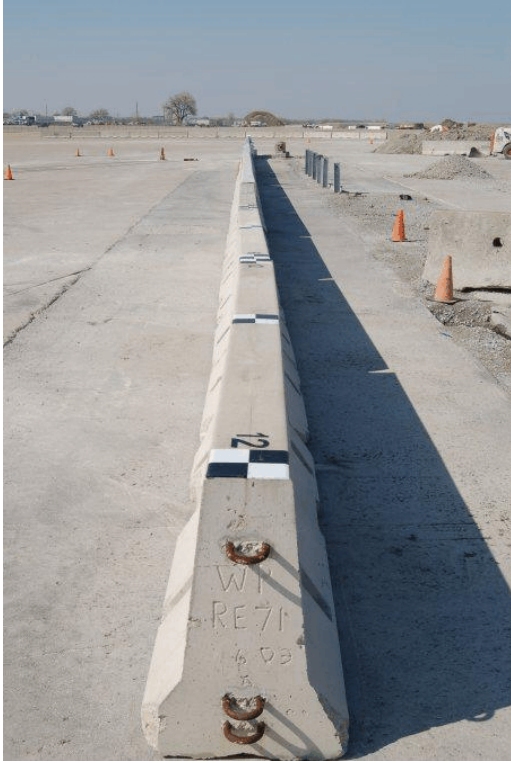
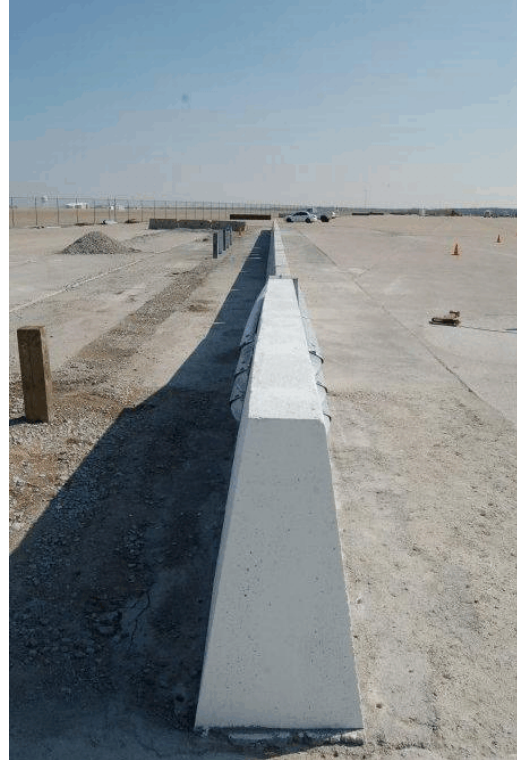
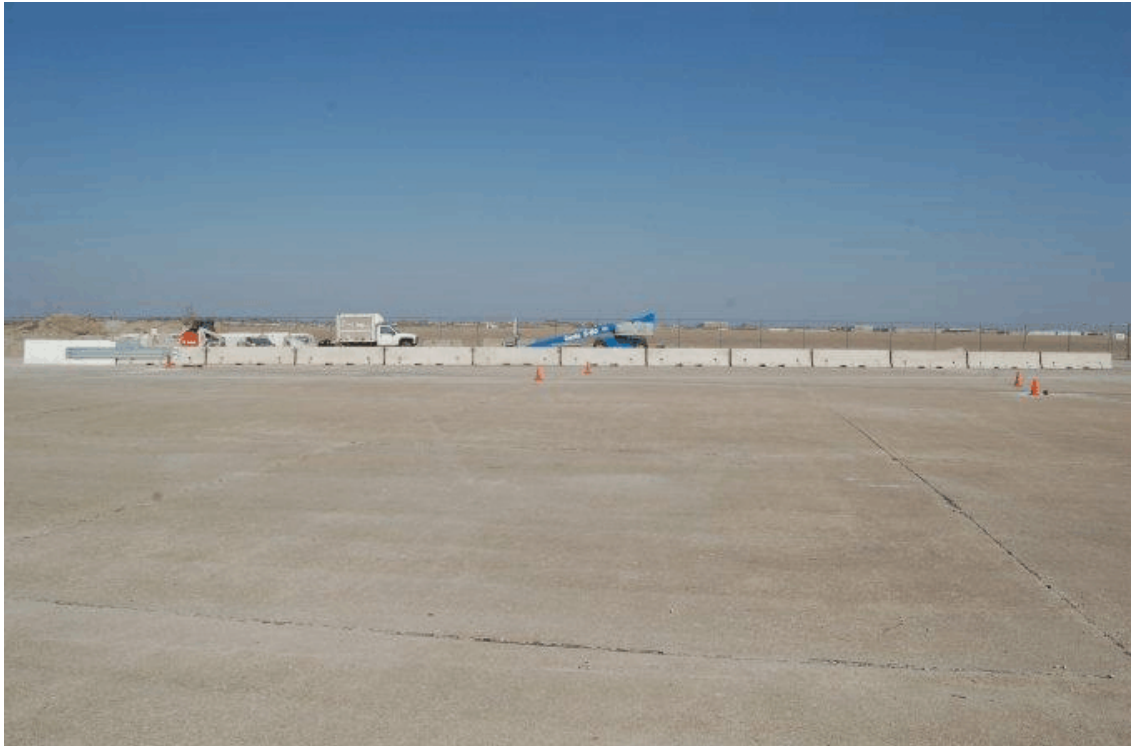
Figure 21. Temporary Concrete Barrier to Permanent Concrete Barrier Transition, Test No. TCBT-1 and TCBT-2

The 166-ft 10-in. (50.9-m) long test installation details for a transition from temporary concrete barriers to a permanent concrete barrier are shown in Figures 4 through 20. The test installation consisted of a rigid parapet, four transition barriers, eight free-standing barriers on the upstream end, and a transition cap. The transition and free-standing barriers were installed on a 3-in. (76-mm) thick asphalt pad. Photographs of the test installation are shown in Figures 21 through 23.

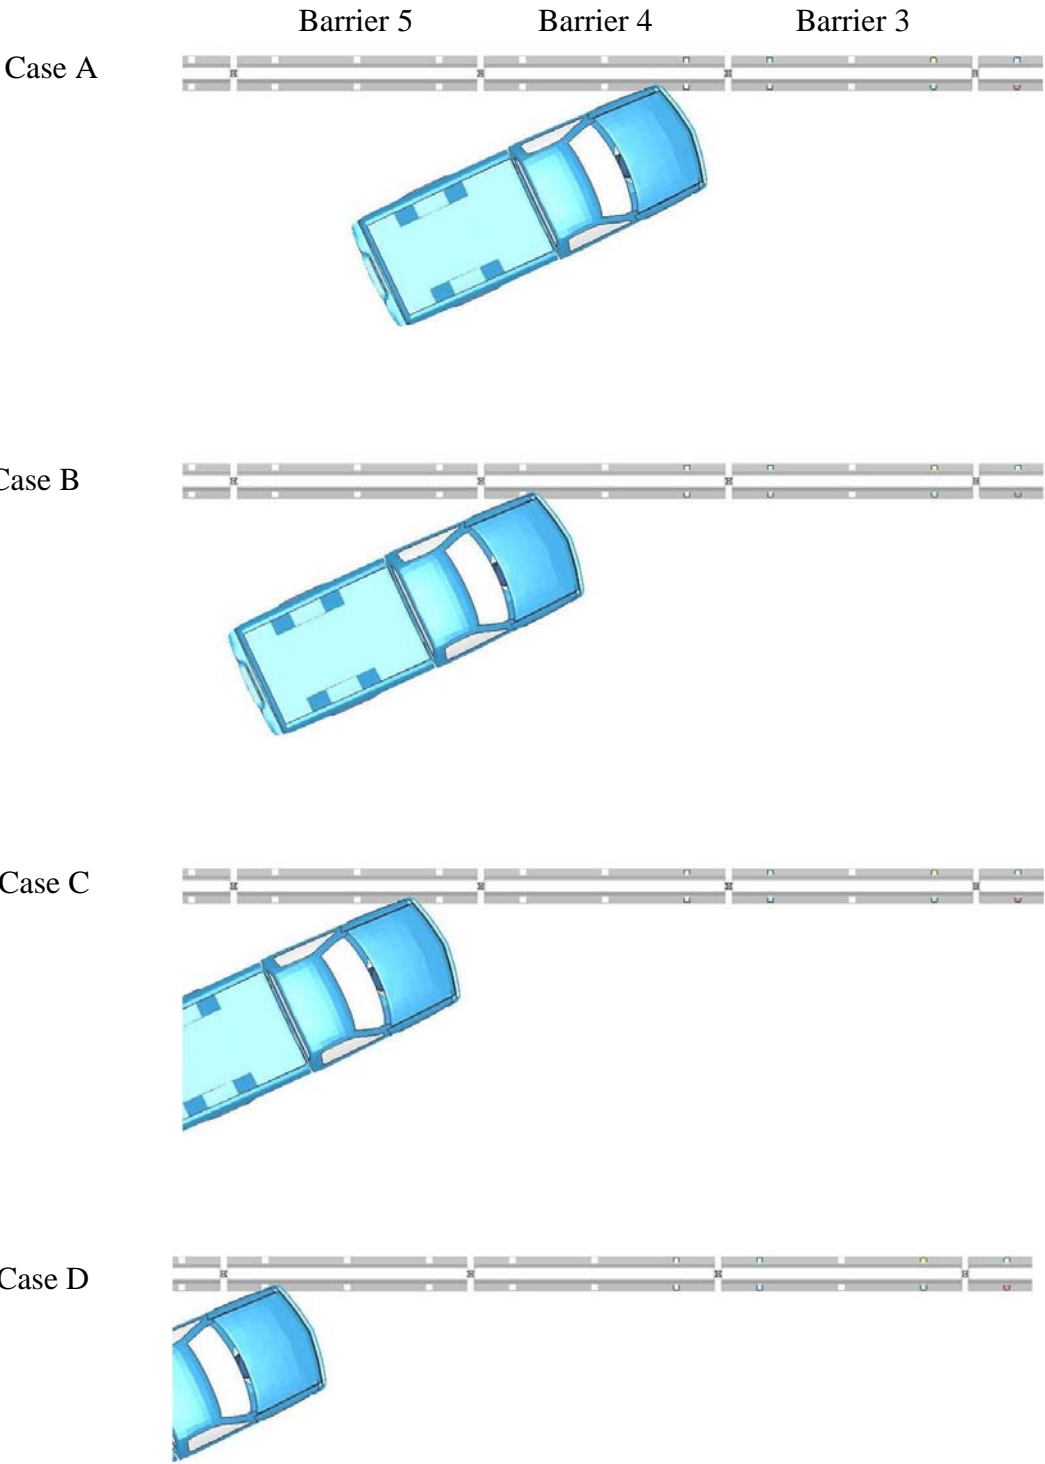
Figure 24. TCB Transition CIP-2000P 100 km/h at 25 degree-Impact Location-Test TCBT-2

Case A exhibited relatively limited barrier motion and although the vehicle exhibited the most pitch, that motion did not cause any significant indication of the vehicle becoming unstable and thus Case A was ruled out for the CIP. Impacts downstream of Case A were expected to produce even lower barrier motions due to the increased constrain on the barriers in the transition. Case D appeared to have the smoothest redirection of the vehicle and was thus ruled out for the CIP. Cases B and C demonstrated somewhat similar behavior, but researchers concluded that Case C had higher

barrier motions overall and slightly more vehicle roll than Case B. Thus, Case C was chosen as the CIP for test TCBT-2.

It should be noted that the CIP for the downstream CIP adjacent to permanent barrier was chosen as 4.3 ft (1.3 m) upstream of the permanent barrier. This value is based on guidance for CIP values for rigid barriers and temporary concrete barriers provided in Table 2.6 in MASH. It represents the distance upstream of a post or joint in a rigid barrier that has increased potential for vehicle snag. Due to the high stiffness of the anchored temporary concrete barrier sections adjacent to the permanent barrier, it was believed that this CIP location would be sufficient to determine the potential for snag on the rigid median barrier.

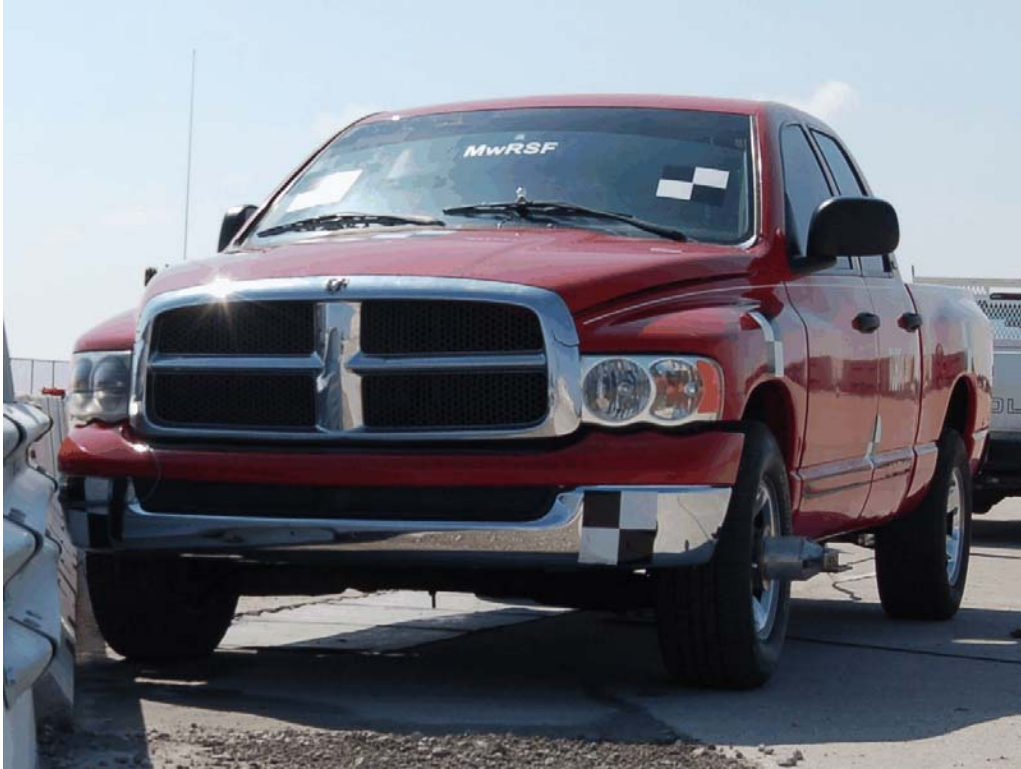
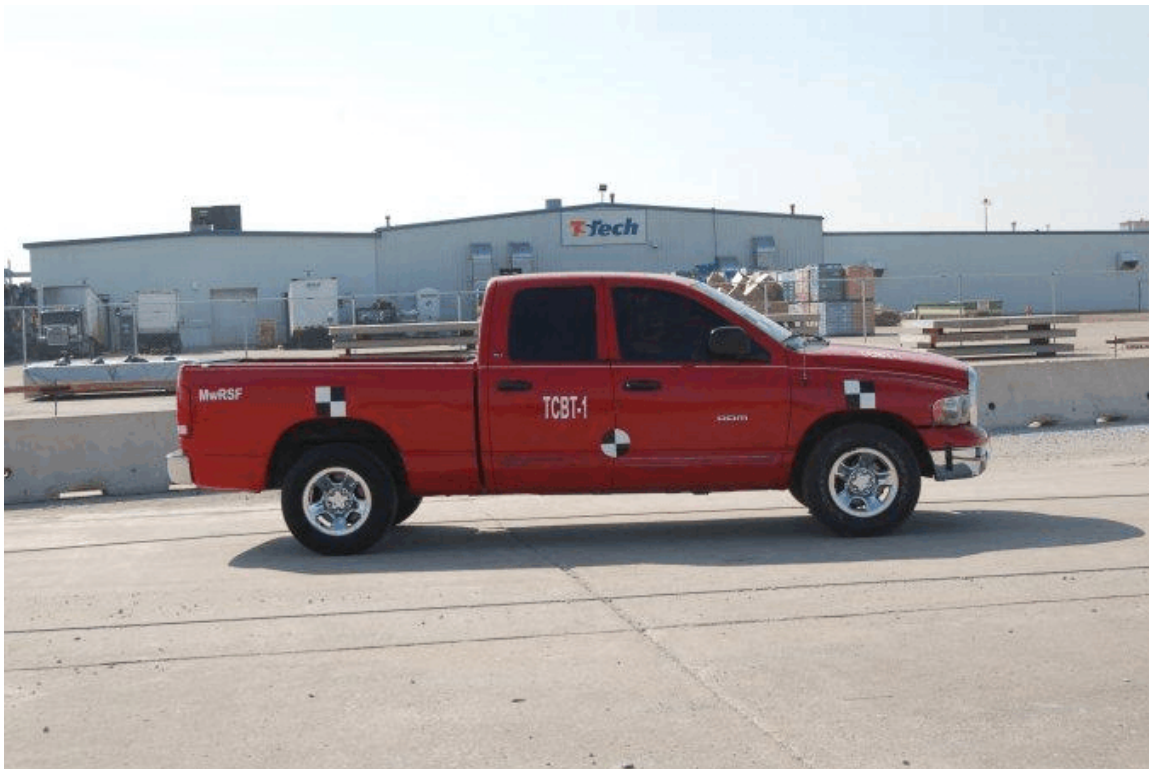
Figure 29. Test Vehicle, Test No. TCBT-1

For test no. TCBT-1, a 2002 Dodge Ram 1500 Quad Cab pickup truck was used as the test vehicle. The test inertial and gross static weights were 5,006 lb (2,271 kg) and 5,175 lb (2,347 kg), respectively. The test vehicle is shown in Figure 29, and vehicle dimension are shown in Figure 30.

Date:	<u>4/4/2008</u>	Test Number:	<u>TCBT-1</u>	Model:	<u>Ram 1500 Q.C.</u>
Make:	<u>Dodge</u>	Vehicle I.D.#:	<u>ID7HA1DM225681989</u>		
Tire Size:	<u>265/70 R17</u>	Year:	<u>2002</u>	Odometer:	<u>110519</u>

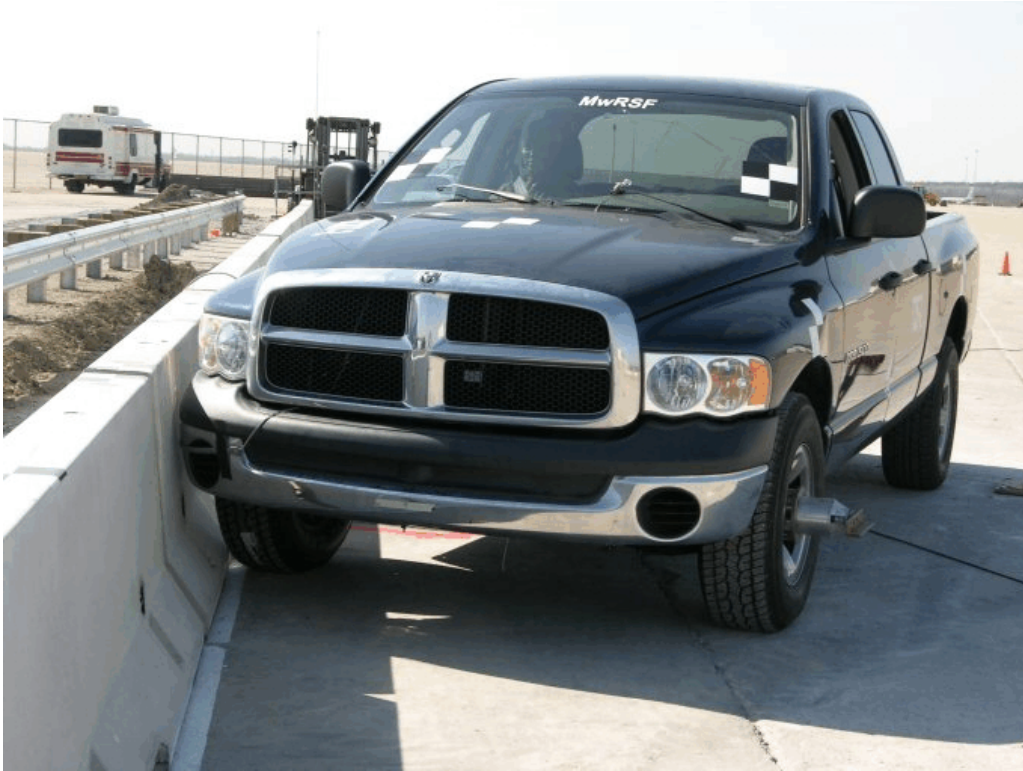
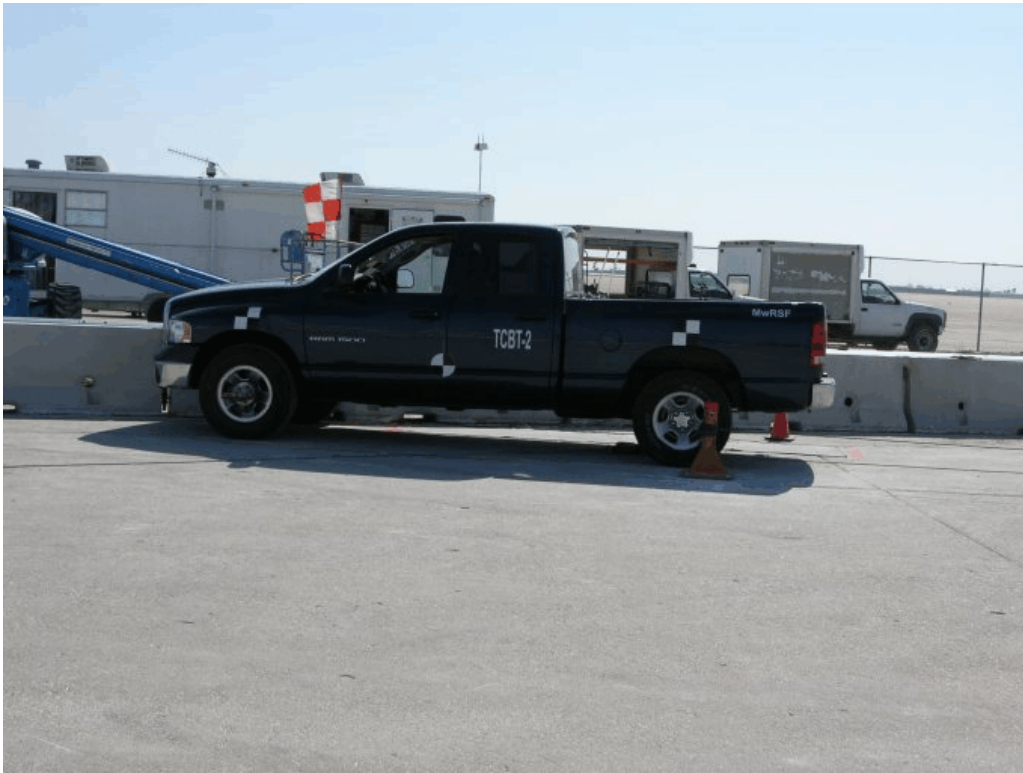
Figure 31. Test Vehicle, Test No. TCBT-2

For test no. TCBT-2, a 2003 Dodge Ram 1500 Quad Cab pickup was used as the test vehicle. The test inertial and gross static weights were 4,990 lb (2,263 kg) and 5,160 lb (2,341 kg), respectively. The test vehicle is shown in Figure 31, and vehicle dimensions are shown in Figure 32.

Date: 4/23/2008 Test Number: TCBT-2 Model: Ram 1500 Q.C.
 Make: Dodge Vehicle I.D.#: 1D7HA18K73J619050
 Tire Size: 265/70 R17 Year: 2003 Odometer: 58889

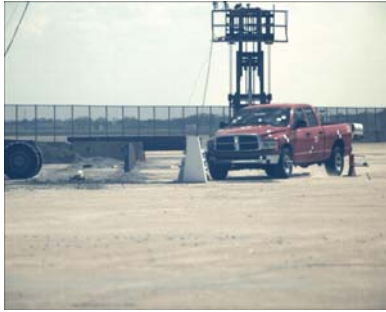
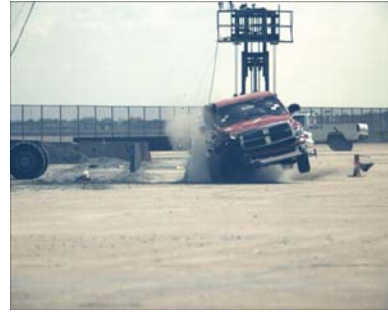
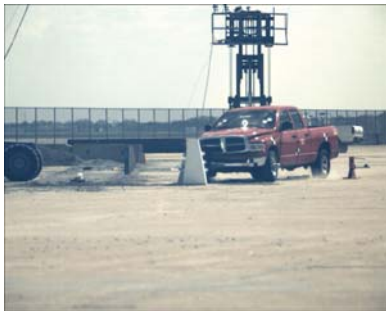
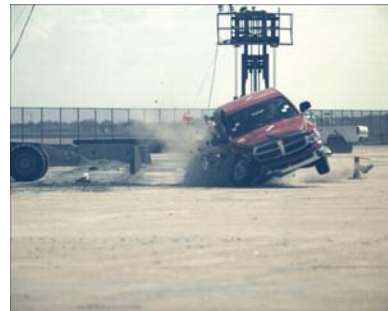
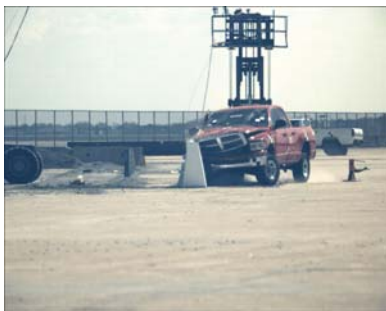
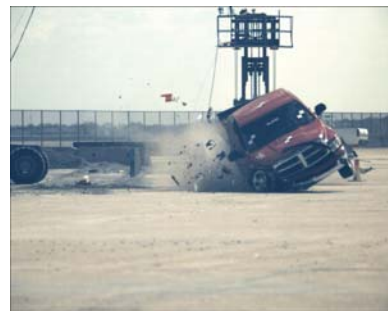
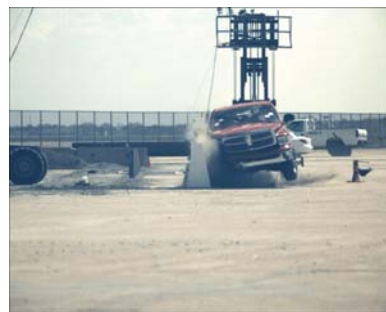
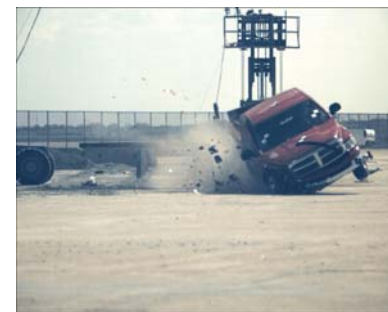
Figure 38. Additional Sequential Photographs, Test No. TCBT-1

The 5,175-lb (2,347-kg) pickup truck, with the dummy placed in the right-front seat, impacted the temporary concrete barrier to permanent barrier transition, at a speed of 62.5 mph (100.6 km/h) and at an angle of 24.7 degrees. Test no. TCBT-1 was performed to evaluate the transition directly adjacent to the permanent median barrier. A summary of the test results and sequential photographs are shown in Figure ?. Additional sequential photographs are shown in Figures 38 through 41. Documentary photographs of the crash test are shown in Figure 42.

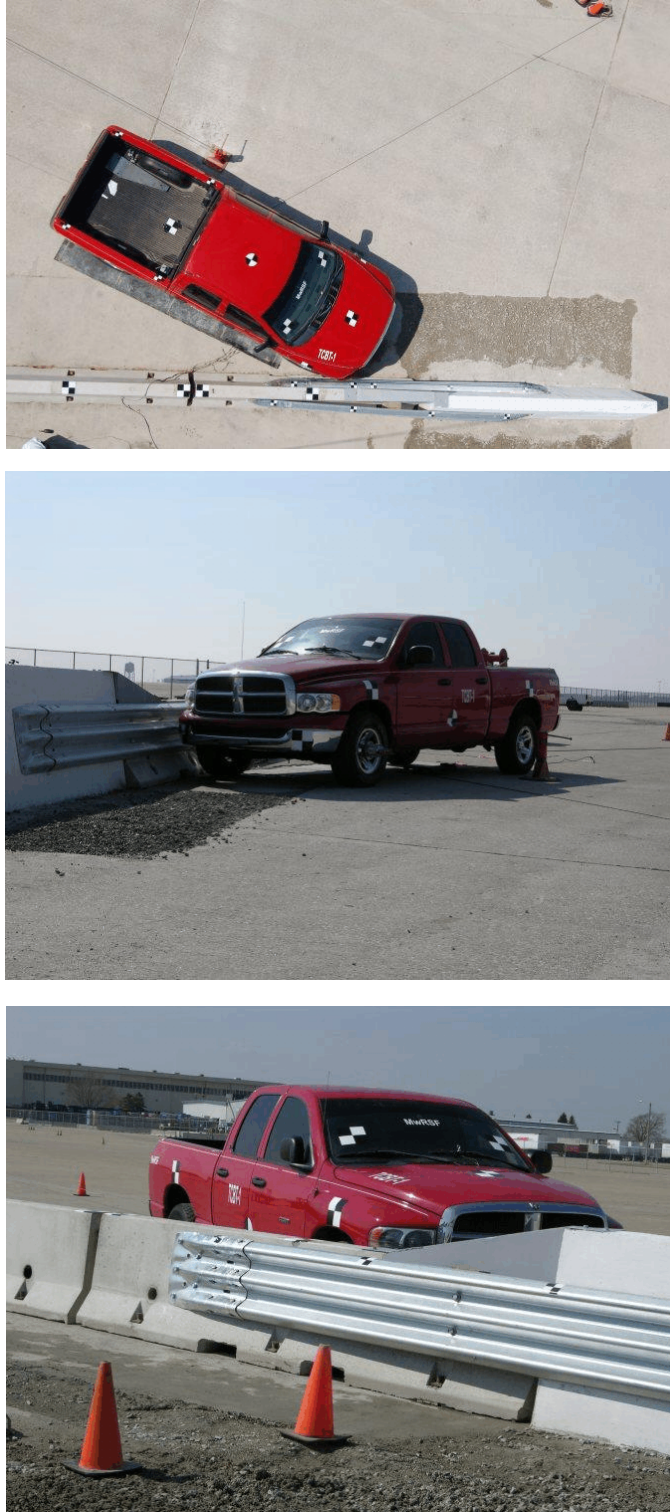
Figure 43. Impact Location, Test No. TCBT-1

Initial vehicle impact was to occur 51 ⁵/₈ in. (1,311 mm) upstream from the upstream end of the permanent barrier, as shown in Figure 43. Actual vehicle impact occurred 56 ³/₈ in. (1,432 mm) upstream from the upstream end of the permanent barrier. Table 5 contains a sequential description

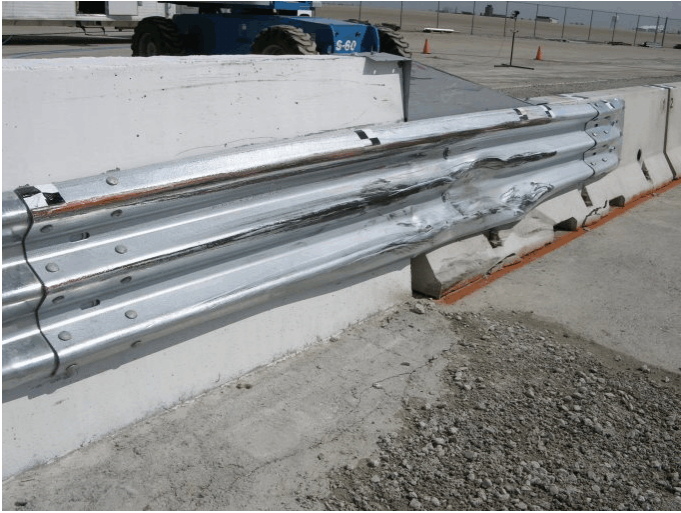
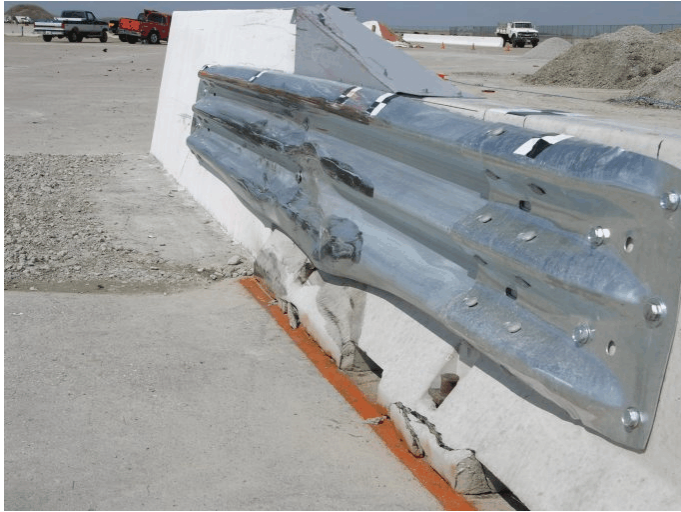
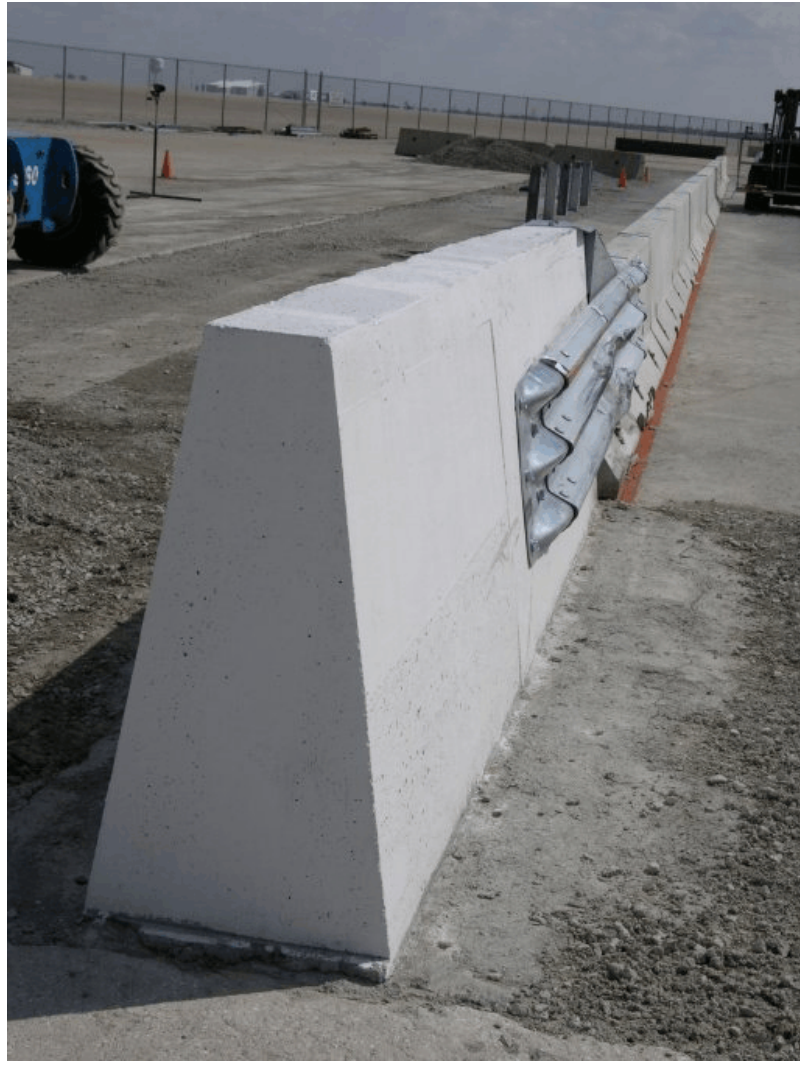
Figure 45. System Damage, Test No. TCBT-1

Damage to the system was moderate, as shown in Figures 45 through 50. Barrier damage consisted of scrapes and contact marks on temporary concrete barriers, permanent barrier, and the thrie beam section, cracking of temporary barrier sections, and deformed thrie beam. The length of the vehicle contact along the transition was approximately 14 ft - 1 ⅝ in. (4.3 m), which spanned

The thrie beam transition encountered deformation, flattening, and minor tears. Flattening and deformation of the thrie beam rail occurred from 4 in. (102 mm) downstream from impact to 60 in. (1,524 mm) downstream from impact. A 2 $\frac{1}{4}$ in. (57 mm) tear in the nested thrie beam rail on the traffic-side was found 34 in. (864 mm) downstream from impact which was caused by the truck dragging across the midspan. The thrie beam rail on the non-impact side underwent slight bending at the center of the beam. The transition cap was deformed and a slight twist on top of the cap down on the traffic-side. The concrete permanent barrier had minor contact marks above and downstream of the transition.

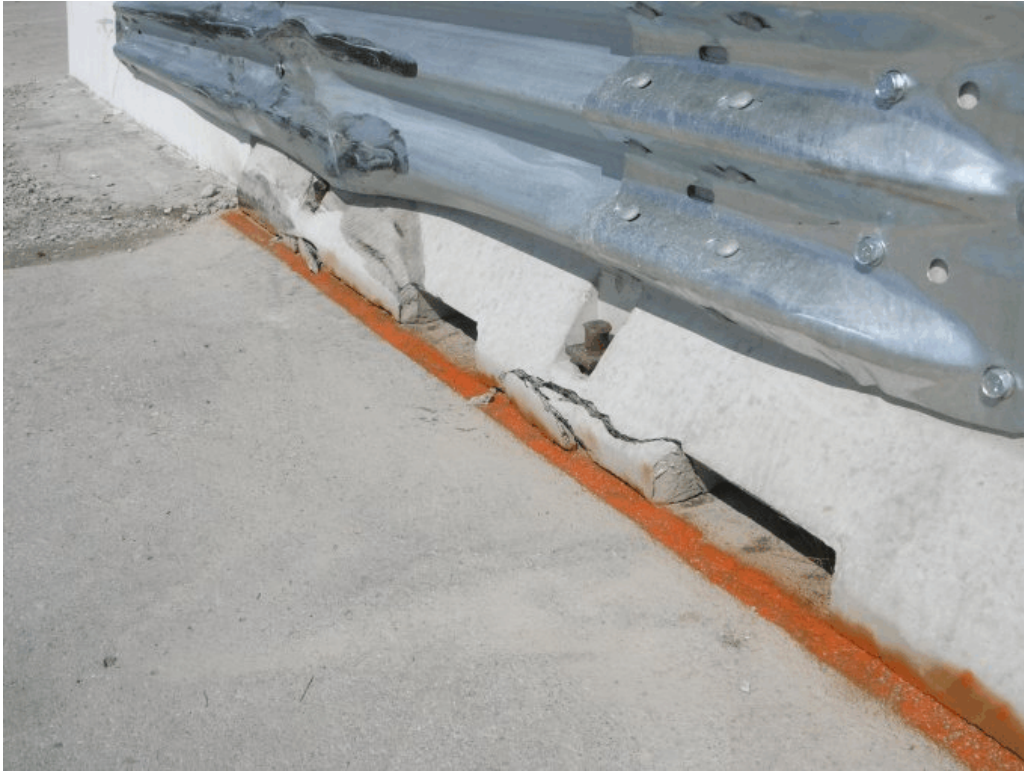
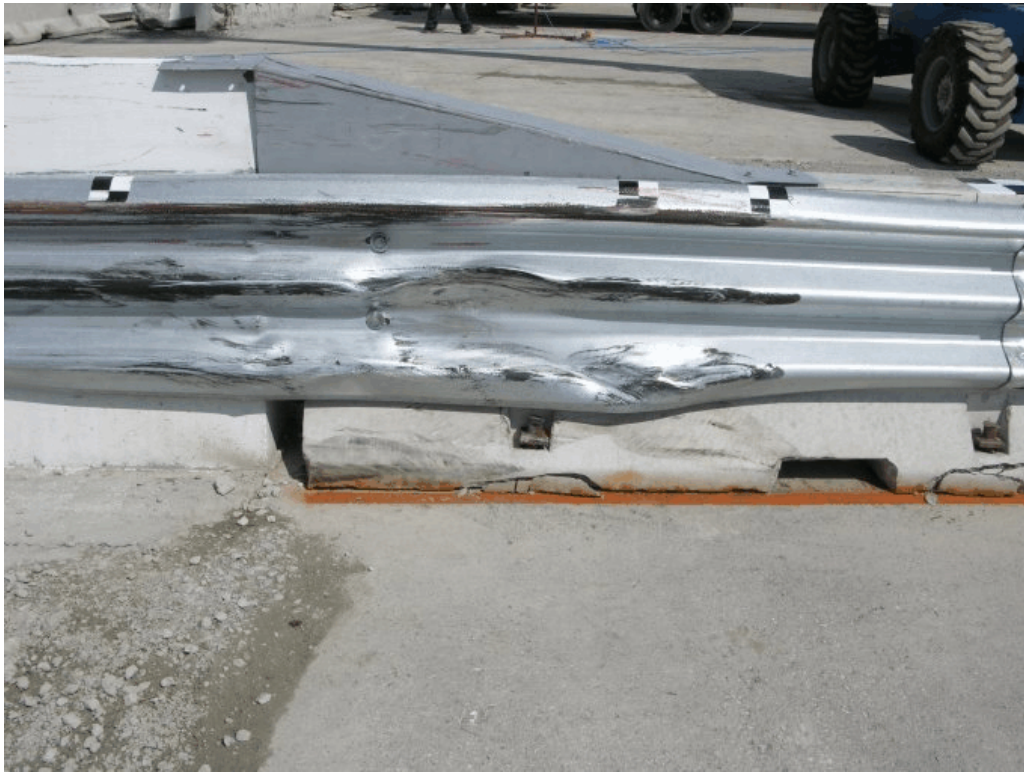
Figure 46. System Damage, Test No. TCBT-1

The permanent set of the barrier system is shown in Figure 46. The maximum lateral permanent set barrier deflection was $\frac{1}{4}$ in. (6 mm) at the downstream end of barrier no. 1. The maximum lateral dynamic barrier deflection was 2.6 in. (67 mm) on middle of the non-impact-side of the thrie beam, as determined from highspeed digital video analysis. The working width of the system was found to be 24 $\frac{7}{8}$ in. (632 mm).

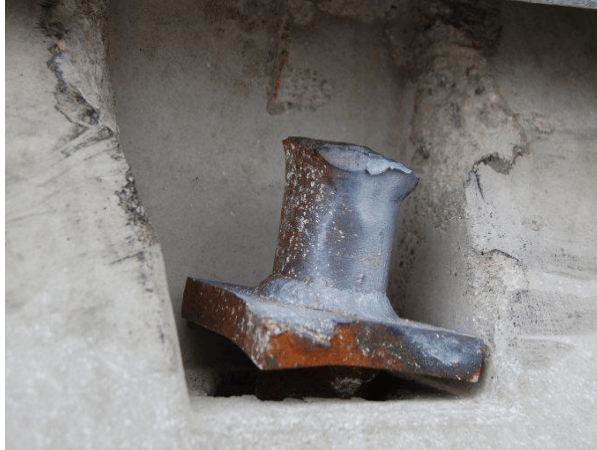
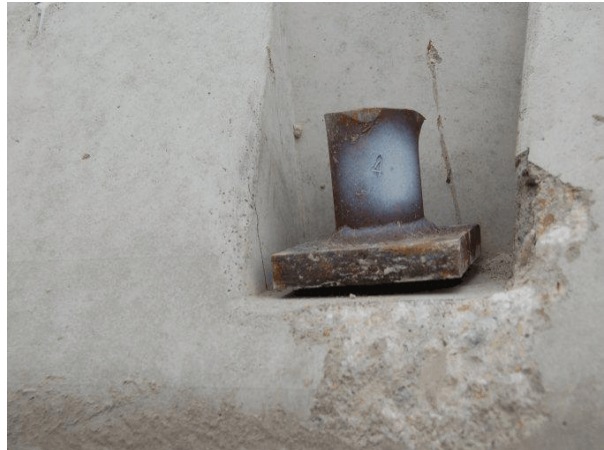
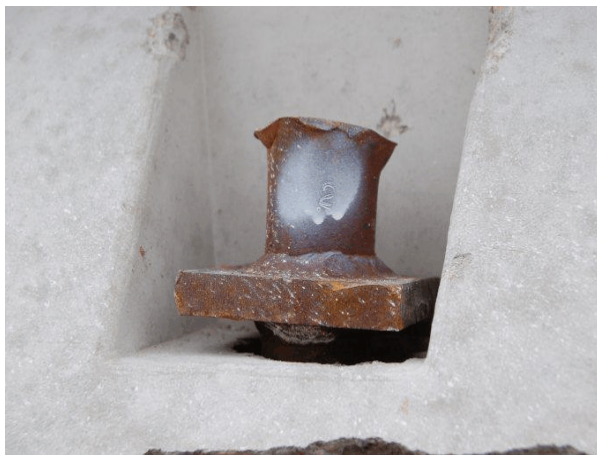
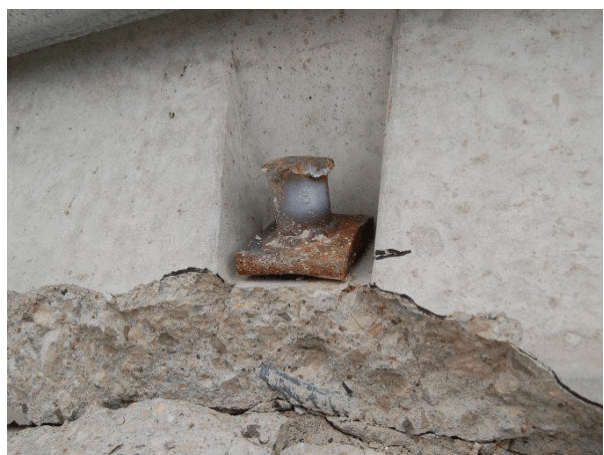
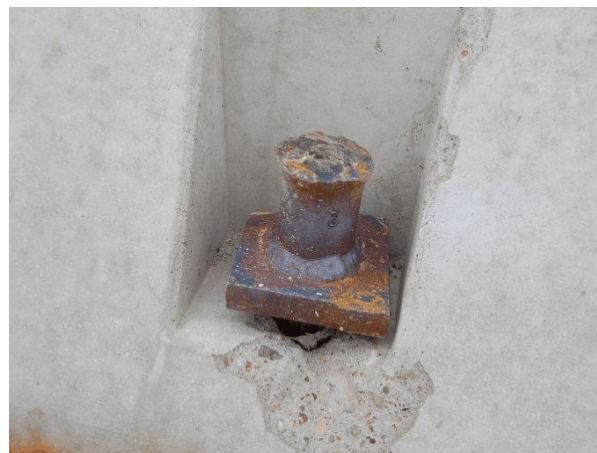
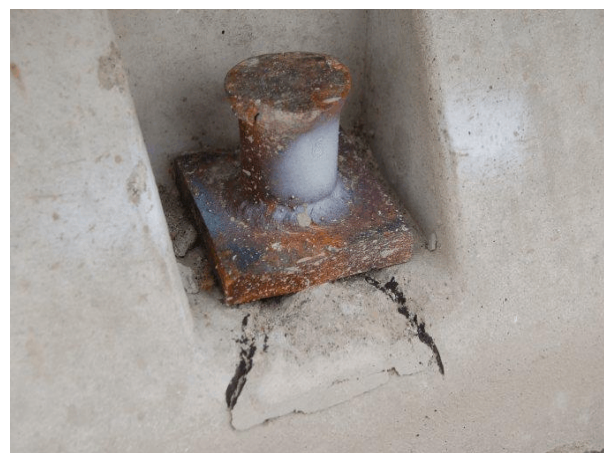
Figure 48. Asphalt Pin Damage, Test No. TCBT-1

Barrier No. 1 Traffic Side Downstream

Barrier No. 1 Non-Traffic Side Downstream

Barrier No. 1 Traffic Side Midspan

Barrier No. 1 Non-Traffic Side Midspan

Barrier No. 1 Traffic Side Upstream

Barrier No. 1 Non-Traffic Side Upstream

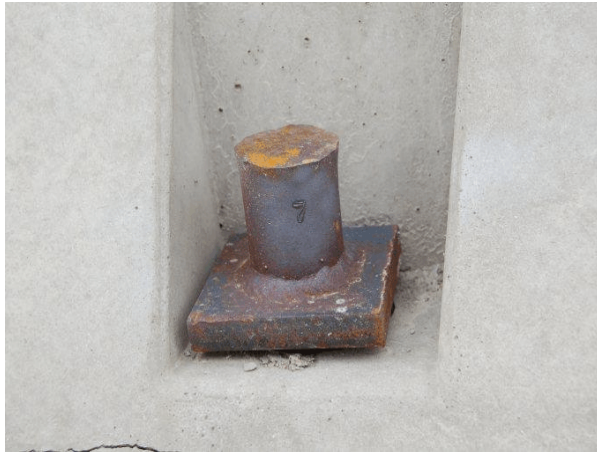
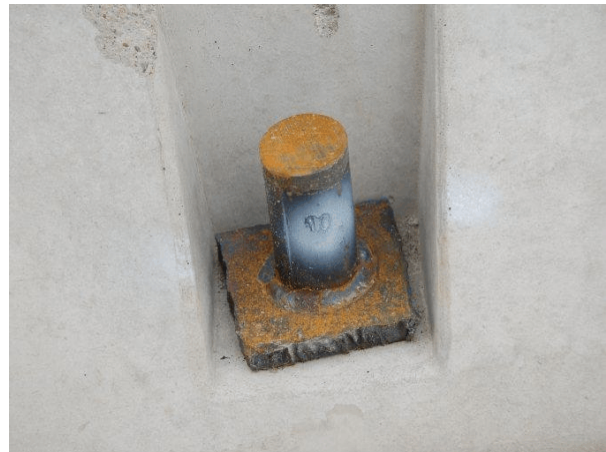
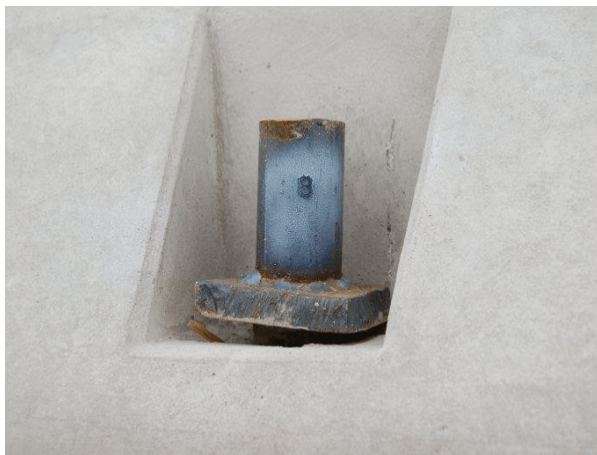
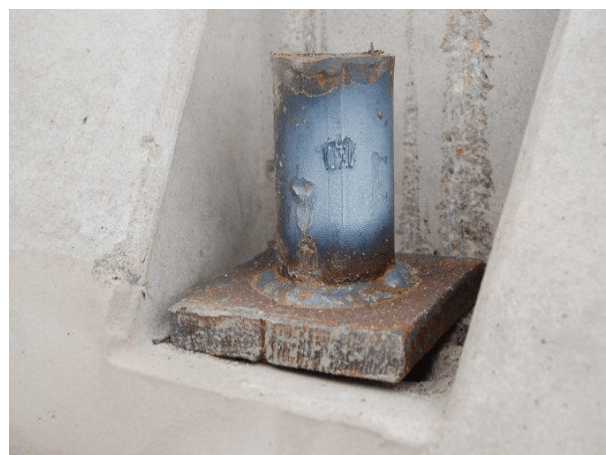
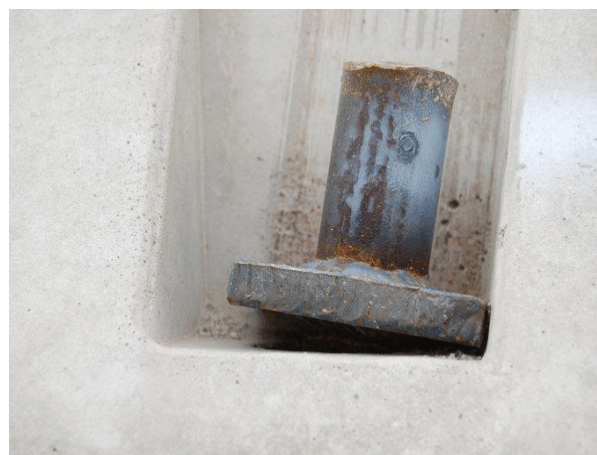
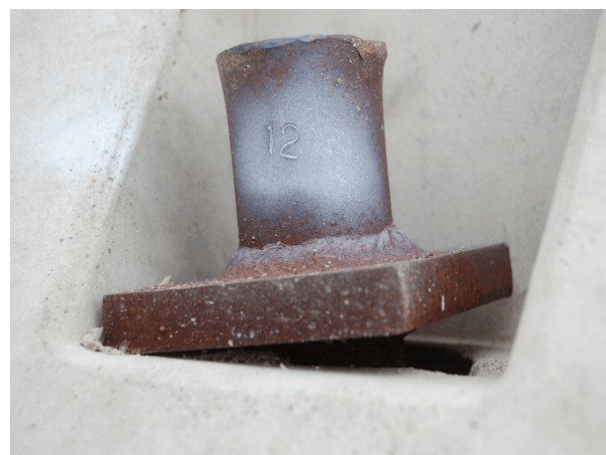
Figure 49. Asphalt Pin Damage, Test No. TCBT-1

Barrier No. 2 Traffic Side Downstream

Barrier No. 2 Non-Traffic Side Downstream

Barrier No. 2 Traffic Side Midspan

Barrier No. 2 Non-Traffic Side Midspan

Barrier No. 2 Traffic Side Upstream

Barrier No. 2 Non-Traffic Side Upstream

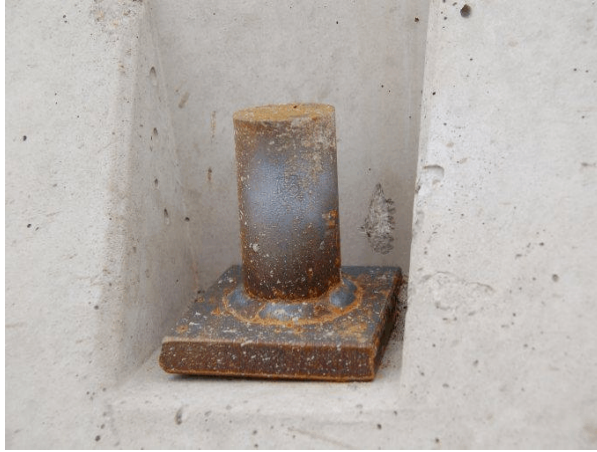
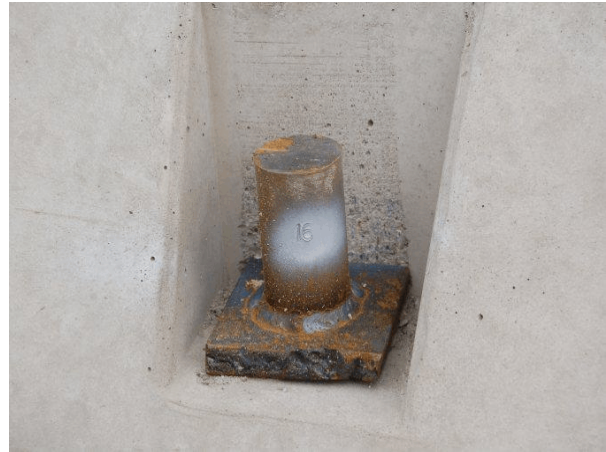
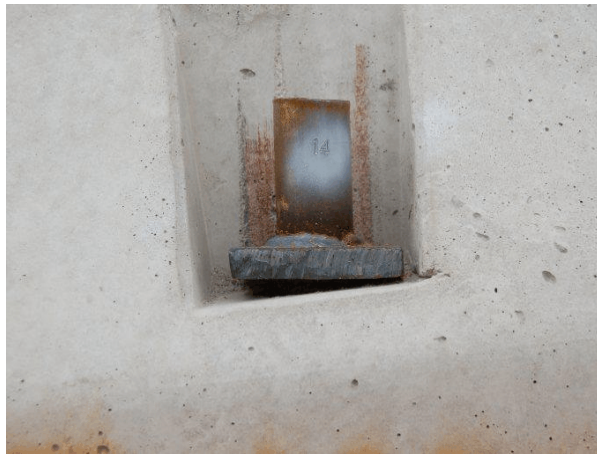
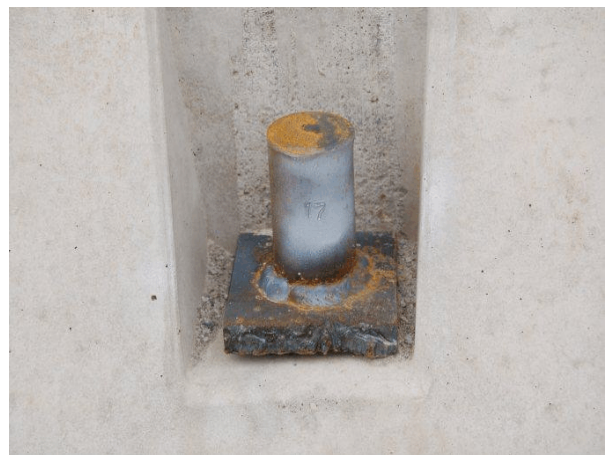
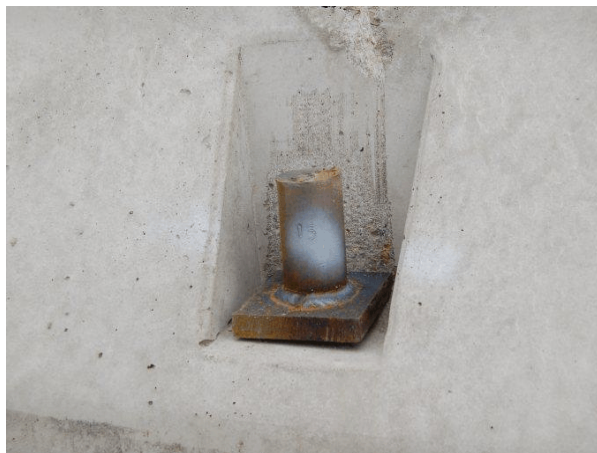
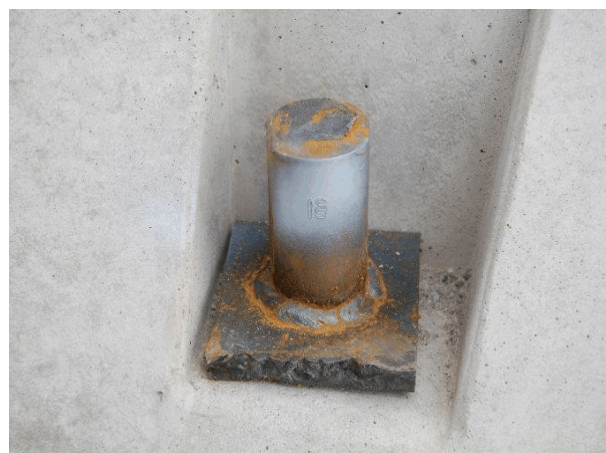
Figure 50. Asphalt Pin Damage, Test No. TCBT-1

Barrier No. 3 Traffic Side Downstream

Barrier No. 3 Non-Traffic Side Upstream

Barrier No. 3 Traffic Side Upstream

Barrier No. 4 Traffic Side Downstream

Barrier No. 3 Non-Traffic Side Downstream

Barrier No. 4 Non-Traffic Side Downstream
