Development of a Temporary Concrete Barrier To Permanent Concrete Median Barrier Approach Transition

*Midwest States Regional Pooled Fund Research Program
Fiscal Year 2005-2006 (Year 16)
Research Project Number SRP-03(017)
NDOR Sponsoring Agency Codes RFPF-06-07 and RFPF-06-09*

MIDWEST ROADSIDE SAFETY FACILITY

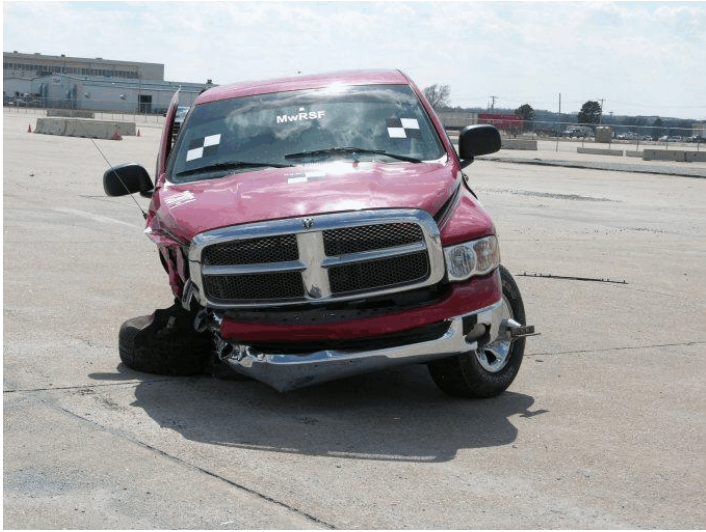
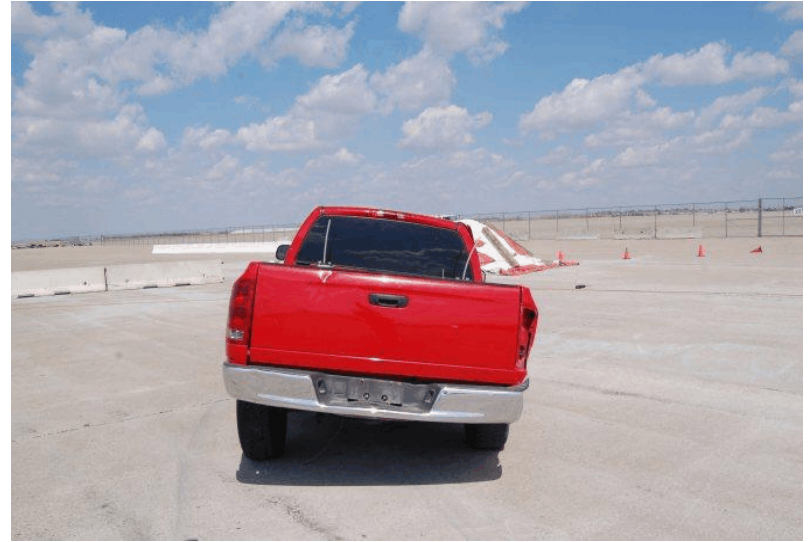
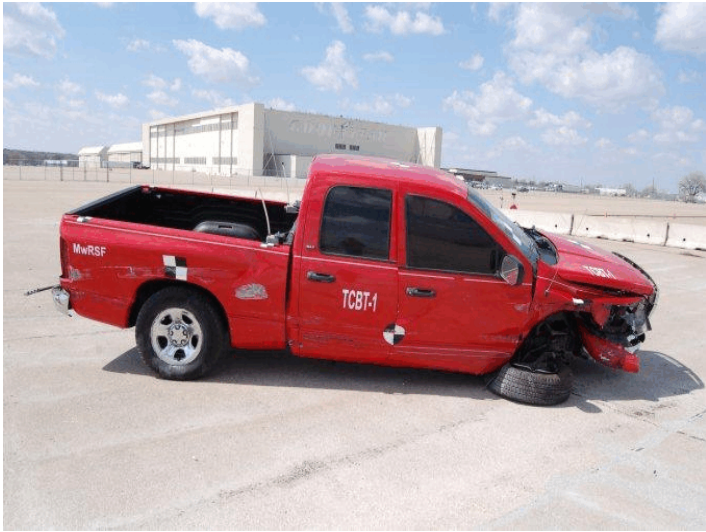
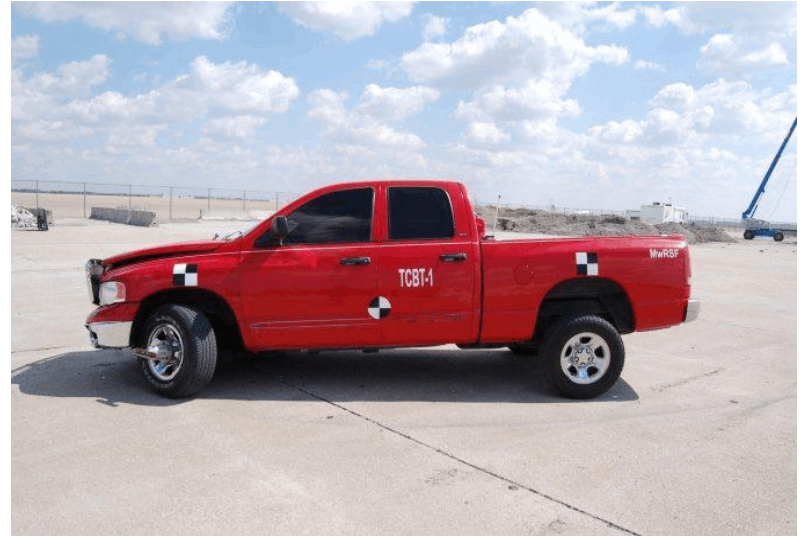
Figure 51. Vehicle Damage, Test No. TCBT-1

Vehicle damage was moderate, as shown in the Figures 51 through 54. Occupant compartment deformations to the right side of the floorboard were judged insufficient to cause serious injury to the vehicle occupants, as shown in Figure 54. Maximum longitudinal deflections of 6 in. (152 mm) were located near the front-center of the right-side floor pan. Maximum lateral deflections of 2 ¾ in. (70 mm) were located at the front-right of the right-side floor pan. Maximum vertical deflections of 5 ¼ in. (133 mm) were located near the front-center of the right-side floor pan. Complete occupant compartment deformations and the corresponding locations are provided in Appendix E.

Damage was concentrated on the right-front corner of the vehicle. The front bumper bent approximately 90 degrees 13 in. (330 mm) from the right side with the end in the wheel well area. The right-front corner was deformed inward toward the engine compartment. The right-front corner of the hood was deformed. The right-front wheel well is covered in black tire marks. The right-front upper and lower control arms were severely damaged. Scrapes and contact marks were found along the entire right side of the vehicle. Major sheet metal deformations were found above the right-side wheel well and along the lower portion of the right-side doors, not allowing the right side doors to open. The right side door buckled outward from the inside causing a 5-7 in. (127-178 mm) gap along the top frame of the door and a 1-6 in. (25-152 mm) gap along the side of the door. The right-rear bumper was deformed inward and flattened flush with rear quarter panel. Contact marks were found on the right-rear hubcap. The right-side taillight housing was dislodged. The right-front tire was cut severely about 6-8 in. (152-203 mm) and detached from the vehicle, except for the being attached only by the brake line. All other tires remained attached. Spider-web cracking was found on the

bottom, left, and right sides of the windshield. No other window damage occurred. The roof and the left side of the vehicle remained undamaged.

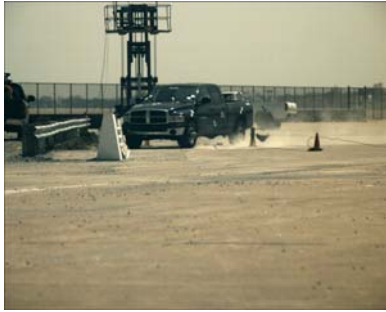
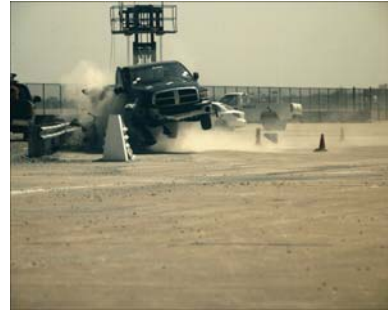
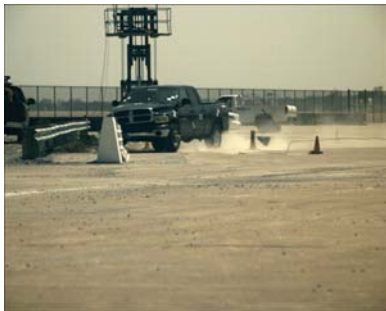
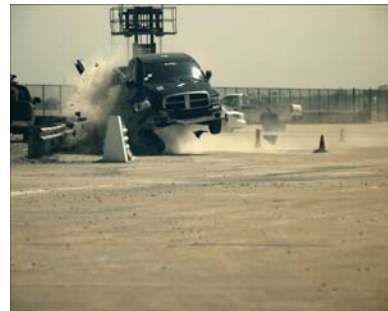
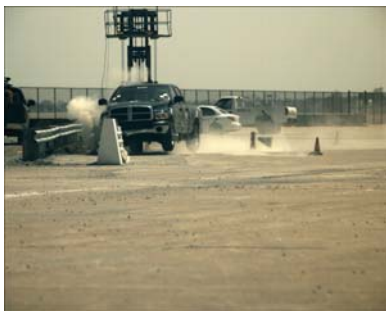
Figure 55. Summary of Test Results and Sequential Photographs, Test No. TCBT-2

0.052	cracks formed at the base on the traffic-side of barrier no. 4
0.062	barrier no. 3 began to deflect
0.068	the right-front tire exploded
0.088	barrier no. 4 cracked near its middle on top and traffic-side

0.252	the front of the vehicle lost contact with the barrier and the right-front tire disengaged from the vehicle
0.268	the right taillight contacted barrier no. 4 and fractured

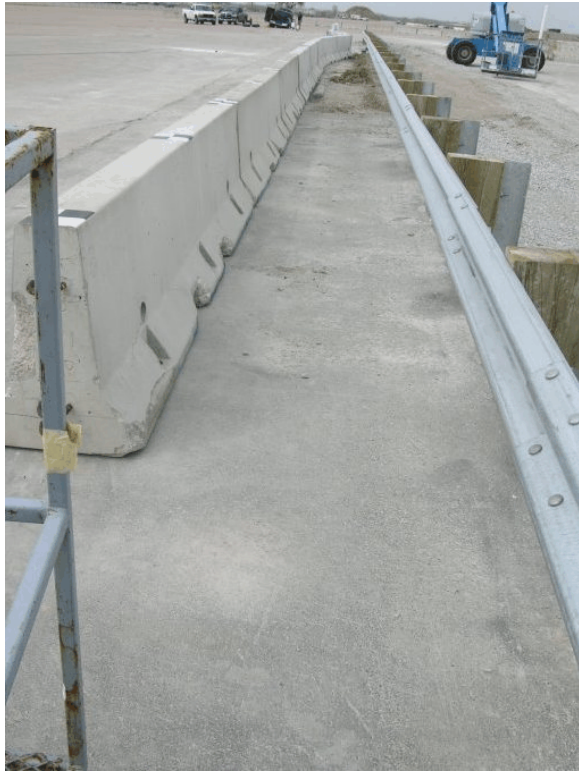
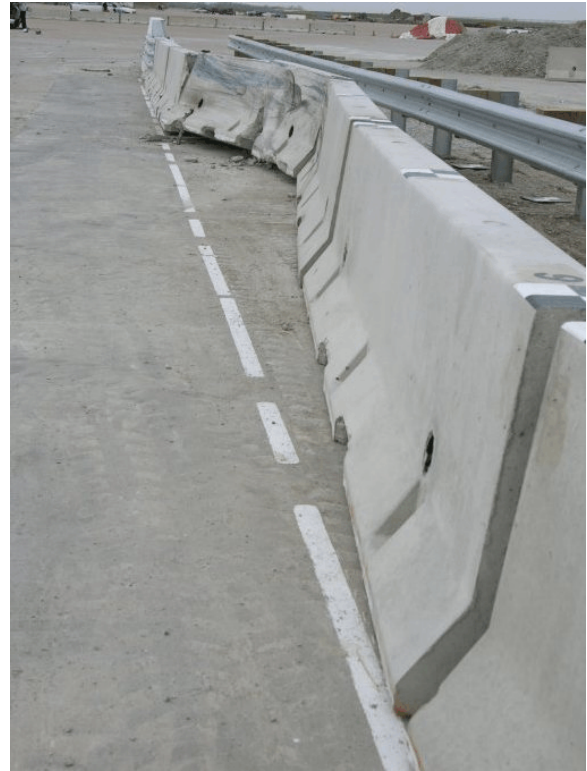
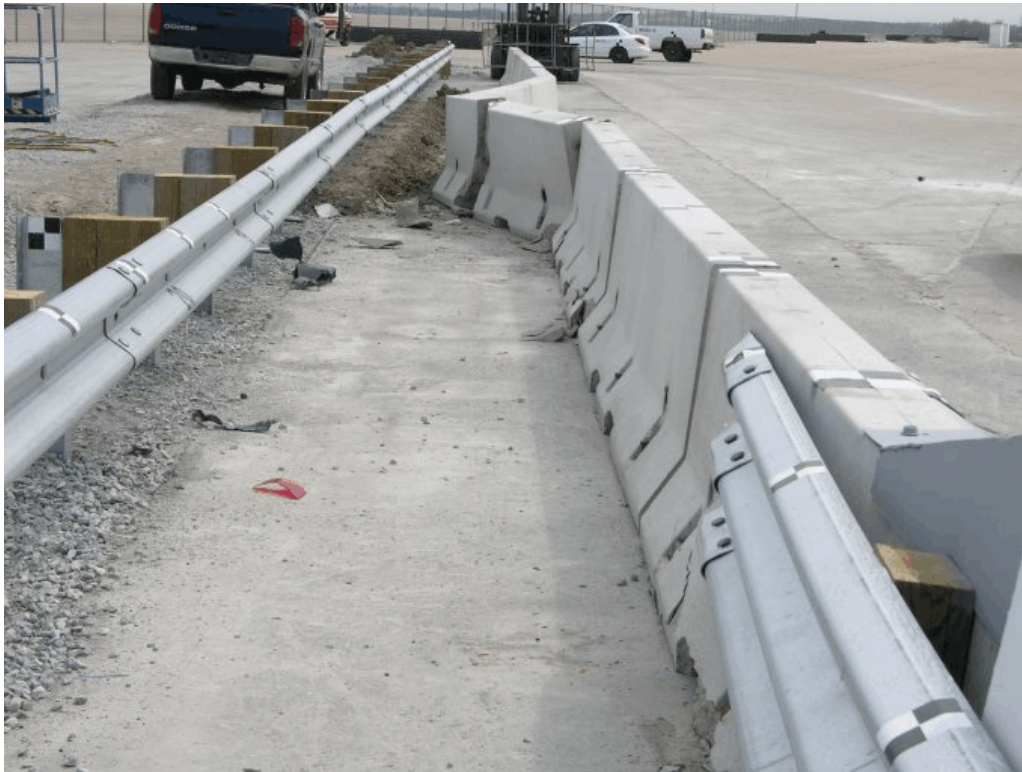
Figure 62. System Damage, Test No. TCBT-2

Damage to the system was moderate, as shown in Figures 62 through 64. Barrier damage consisted of scrapes, contact marks, and concrete spalling on temporary concrete barriers and asphalt pin deflections, cracking of temporary barrier sections, and fractured temporary barriers. The length of the vehicle contact along the transition was approximately 17 ft - 1 ½ in. (5.2 m), which spanned from 41 ¼ in. upstream of the downstream end of barrier no. 5 to 8 in. (203 mm) downstream from the upstream end of barrier no. 3.

The permanent set of the barrier system is shown in Figure 62. The maximum lateral permanent set barrier deflection was 34 in. (864 mm) at the downstream end of barrier no. 5, as measured in the field. It should be noted that the barrier segments upstream of impact had permanent set longitudinal deflections between 5 in. and 6 in. (127 mm and 152 mm) downstream. The maximum lateral dynamic barrier deflection was 34 in. (864 mm) at the upstream end of barrier no. 5, as determined from highspeed digital video analysis. The working width of the system was found to be 55.8 in. (1,117 mm).

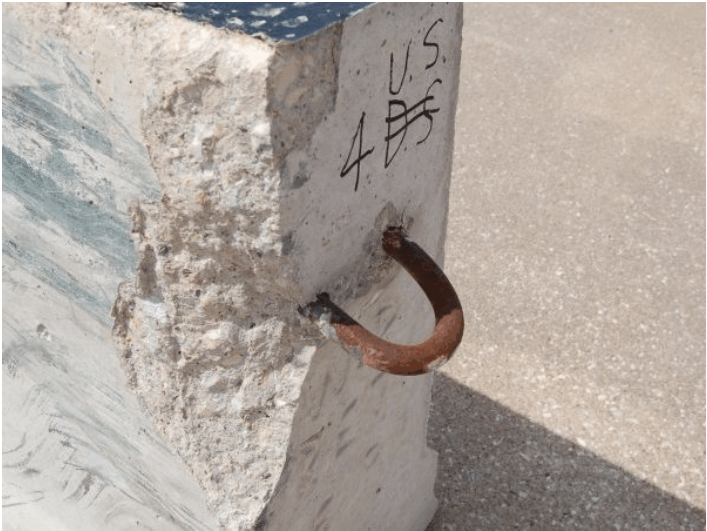
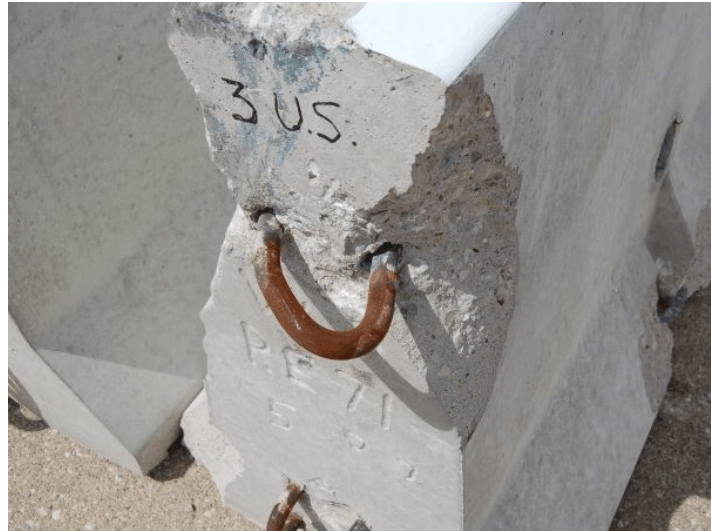
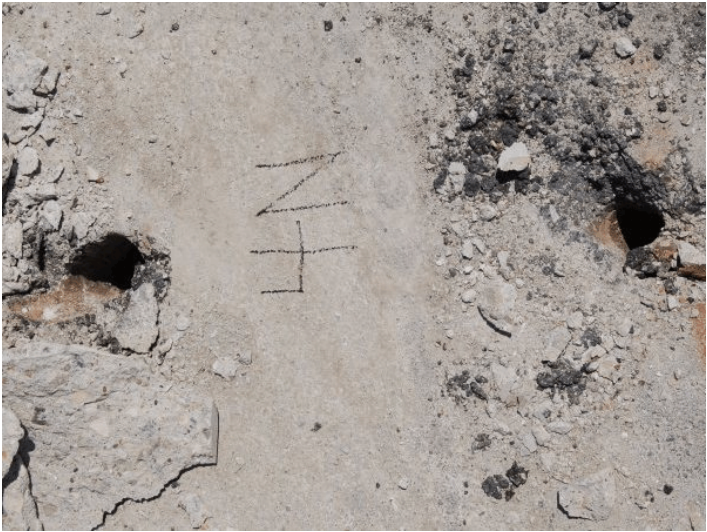
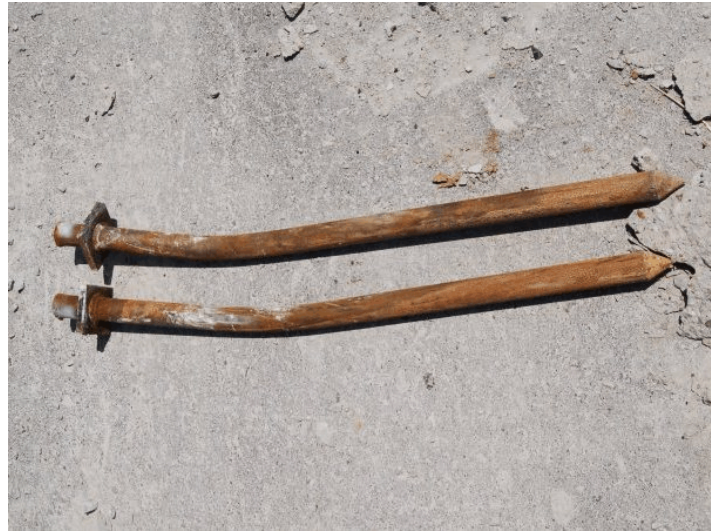
Figure 64. System Damage, Test No. TCBT-2

Tire marks, scrapes, and cracking of the concrete were visible on barrier segment nos. 3 through 5. The traffic-side of barrier no. 5 had concrete spalling on the upstream end of the barrier. Concrete spalling occurred around the rear upstream asphalt pin of barrier no. 3 which was 19 in. (483 mm) long by 7 in. (178 mm) high. Concrete spalling also occurred around the rear downstream asphalt pin of barrier no. 3 which began at the downstream end and continued for 44 in. (1,118 mm). The top of barrier no. 3 on the upstream end had significant contact marks. Barrier no. 4 rolled toward the back of the system exposing the upstream end of barrier no. 3 to the truck. Barrier no. 4 was cracked in half and rebar was fractured at the midsection. Concrete spalling was found on the backside of barrier no. 4 beginning at the lower downstream end and continued 32 in. (813 mm) along the bottom of the barrier. The traffic-side of barrier no. 5 had tire and minor contact marks on the downstream end.

Deformation to several concrete temporary barrier loop joints and connection pins were noted in the impact region. The bottom loop on the downstream end of barrier no. 5 deformed ½ in. (13 mm) toward the traffic-side of the system. The top loop on the upstream end of barrier no. 4 deformed ¼ in. (6 mm) toward the traffic-side of the system. The bottom loop on the downstream

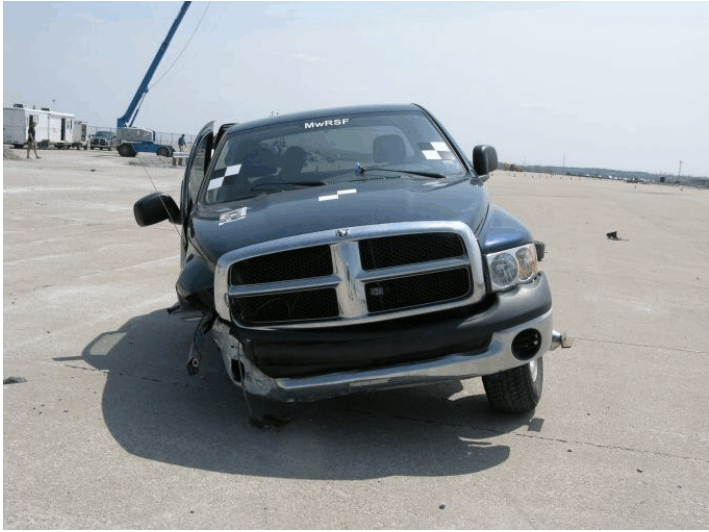
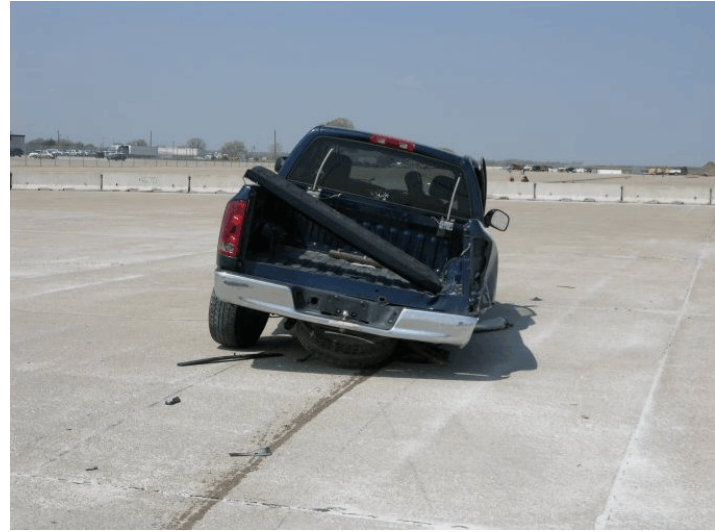
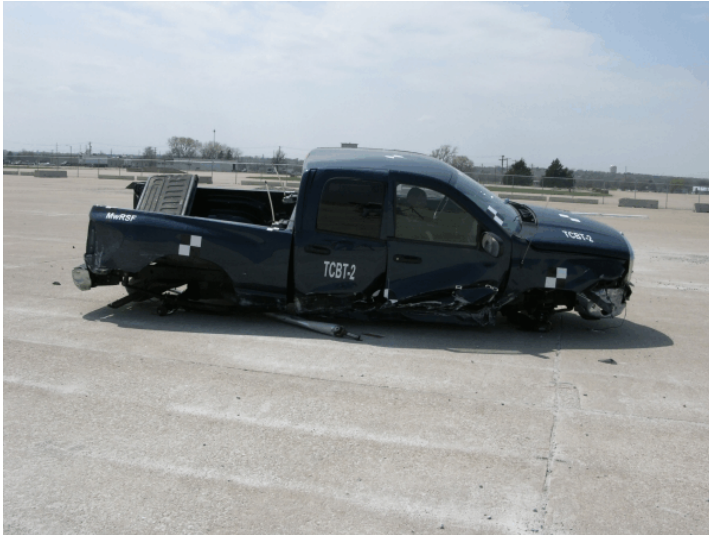
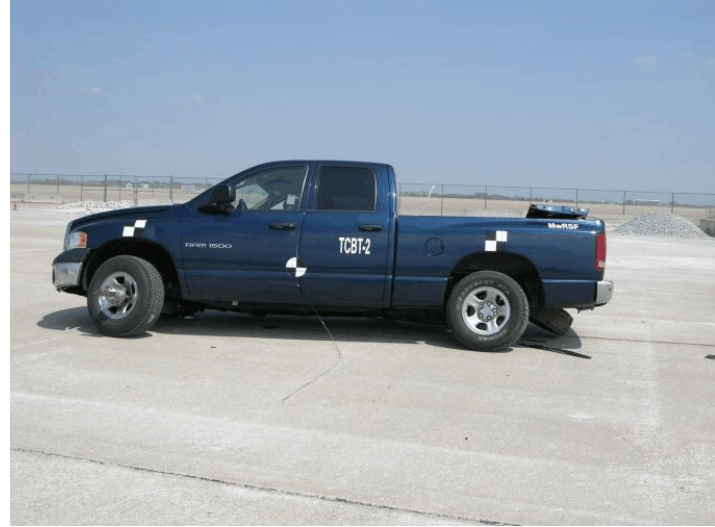
Figure 65. Vehicle Damage, Test No. TCBT-2

Vehicle damage was moderate, as shown in the Figures 65 through 68. Occupant compartment deformations to the right side of the floorboard were judged insufficient to cause serious injury to the vehicle occupants, as shown in Figure 68. Maximum longitudinal deflections of 2 in. (51 mm) was located front center of the right-side floor pan. Maximum lateral deflections of 1 ¾ in. (44 mm) was located at the front center of the right-side floor pan. Maximum vertical deflections of 2 ½ in. (64 mm) was located front right of the right-side floor pan. Complete occupant compartment deformations and the corresponding locations are provided in Appendix E.

Damage was concentrated on the right-front corner of the vehicle. The right-front corner was deformed inward toward the engine compartment. The right side of the front bumper wrapped around truck frame at 90 degrees. The right-front headlight housing disengaged from the vehicle. The right-front fender damaged along entire length and folded down and inward. The right-front wheel assembly disengaged from upper and lower control arms. Heavy contact mark were found along the frame and gussets from right-front wheel coming off. Contact marks spanned the entire right side of the vehicle which was centered just above the wheel wells. Heavy damage was found on the right-front door. The lower hinges of the right-front door were pulled away from the door. A triangular section measuring 6 in. (152 mm) by 10 in. (254 mm) was ripped open on the lower front corner of the right-rear door. The lower half B pillar was deformed on the right-rear door. Glass was wedged out of the right-rear door but was not broken. The drive shaft was disengaged. Heavy damage was observed on the bottom of the right-rear door. Glass popped out of the left-rear door but was not broken. The right-rear wheel was disengaged from the vehicle. The spare tire and tail gate were disengaged from the vehicle. The rear bumper deformed and was not in contact with

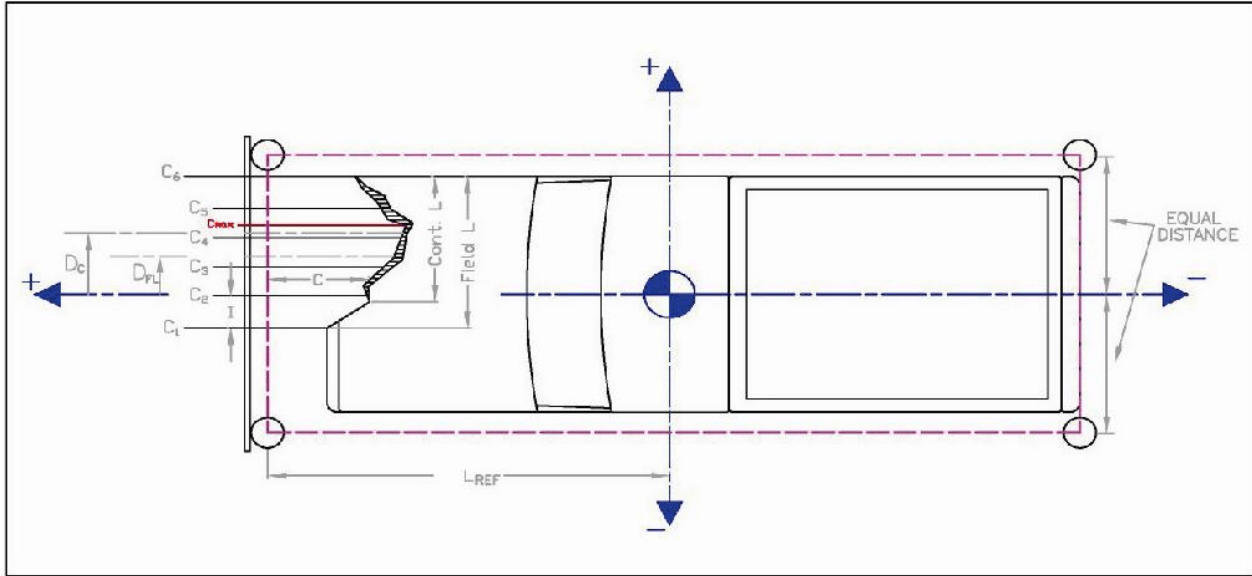
Figure E-6. Exterior Vehicle Crush (NASS) - Front, Test TCBT-1

in.	(mm)
Distance from C.G. to reference line - L_{REF} :	110.25	(2800)
Width of contact and induced crush - Field L:	39	(991)
Crush measurement spacing interval ($L/5$) - I:	7.8	(198)
Distance from center of vehicle to center of Field L - D_{FL} :	19.5	(495)
Width of Contact Damage:	16	(406)
Distance from center of vehicle to center of contact damage - D_C :	31	(787)

Crush Measurement		Lateral Location		Original Profile Measurement		Dist. Between Ref. Lines		Actual Crush	
	in.	(mm)	in.	(mm)	in.	(mm)	in.	(mm)	in.	(mm)
C ₁	3.75	(95)	0	(0)	10.25	(260)	-4.5	(-114)	-2	(-51)
C ₂	4	(102)	7.8	(198)	10.4844	(266)			-1.9844	(-50)
C ₃	7	(178)	15.6	(396)	11.6563	(296)			-0.1563	(-4)
C ₄	20.5	(521)	23.4	(594)	13.3906	(340)			11.6094	(295)
C ₅	NA	#####	31.2	(792)	16.8125	(427)			#####	#####
C ₆	NA	#####	39	(991)	29	(737)			#####	#####
C _{MAX}	20.5	(521)	23.4	(594)	13.3906	(340)			11.6094	(295)

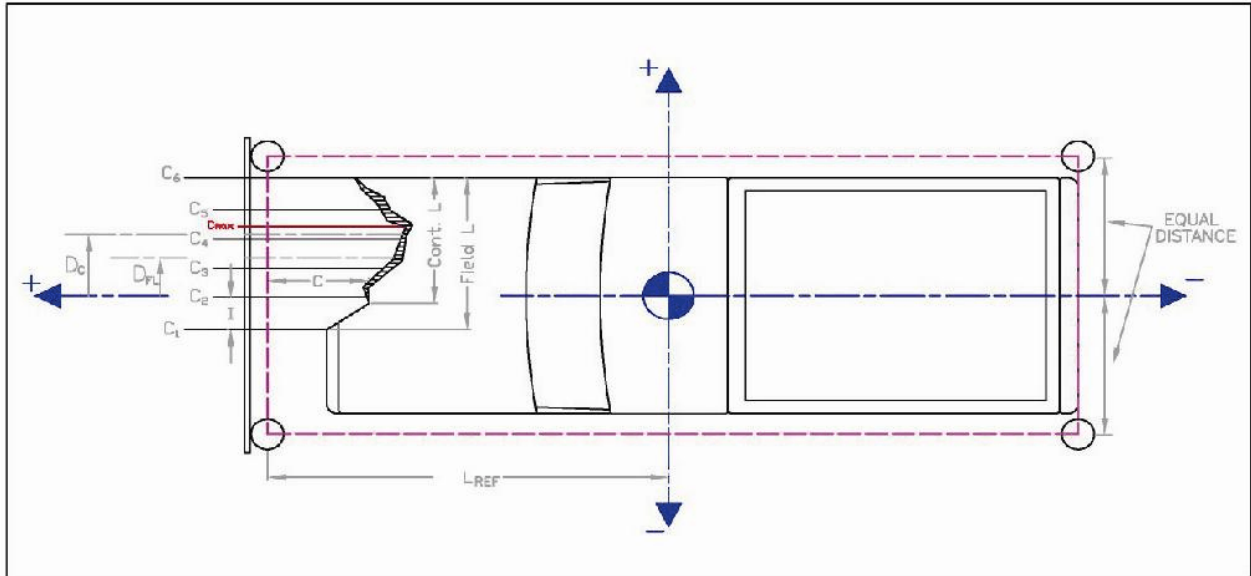
in.	(mm)
Distance from C.G. to reference line - L_{REF} :	109	(2769)
Width of contact and induced crush - Field L:	23.5	(597)
Crush measurement spacing interval ($L/5$) - I:	4.7	(119)
Distance from center of vehicle to center of Field L - D_{FL} :	27.25	(692)
Width of Contact Damage:	23.5	(597)
Distance from center of vehicle to center of contact damage - D_c :	27.25	(692)

Crush Measurement		Lateral Location		Original Profile Measurement		Dist. Between Ref. Lines		Actual Crush	
	in.	(mm)	in.	(mm)	in.	(mm)	in.	(mm)	in.	(mm)
C ₁	8.5	(216)	15.5	(394)	11.6563	(296)	-5	(-127)	1.84375	(47)
C ₂	11.5	(292)	20.2	(513)	12.5	(318)			4	(102)
C ₃	23	(584)	24.9	(632)	13.9531	(354)			14.0469	(357)
C ₄	29.75	(756)	29.6	(752)	15.9063	(404)			18.8438	(479)
C ₅	NA	#####	34.3	(871)	19.5938	(498)			#####	#####
C ₆	NA	#####	39	(991)	29	(737)			#####	#####
C _{MAX}	29.75	(756)	29.6	(752)	15.9063	(404)			18.8438	(479)
