Termination and Anchorage of Temporary Concrete Barriers

TERMINATION AND ANCHORAGE OF TEMPORARY CONCRETE BARRIERS

MwRSF Research Report No. TRP-03-209-09

October 29, 2009

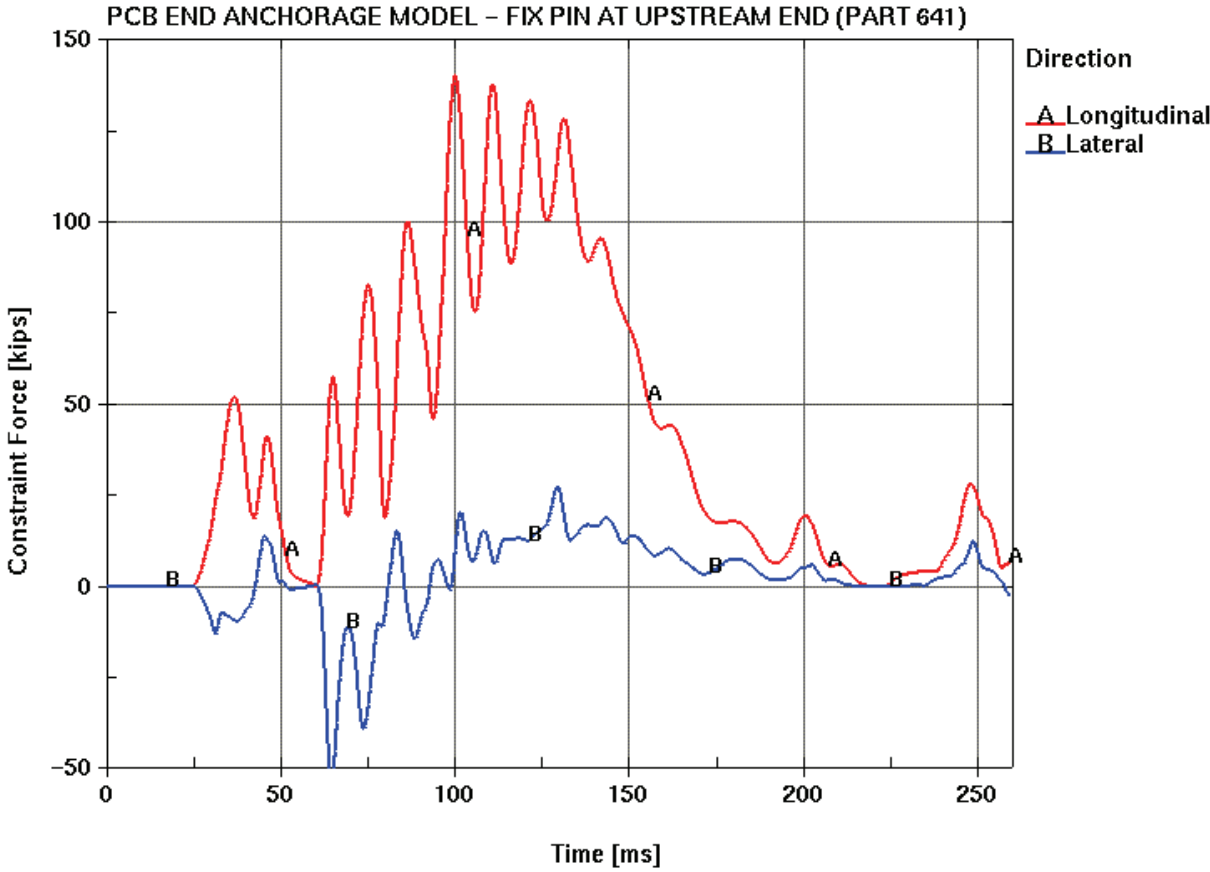
Figure 1. Case 1 – Pinned-End Constraint Loads

Initially, the design loads were determined for a free-standing barrier system with the first upstream barrier constrained with a simple pinned-end condition at the end connection pin (i.e., rotation allowed about the vertical axis of the end pin only and no translation of the pin allowed). This “ideal” case was used to provide an understanding of the loads imparted to an anchor system where translation was not allowed as well as an indication of the vehicle and barrier performance. As expected, the 2000P vehicle was smoothly redirected by the barrier system, but at the cost of relatively high loads to the end constraint, as shown in Figure 1 and Figure 2. Longitudinal barrier loads were measured at approximately 140 kips (623 kN). As mentioned previously in the discussion of the design criteria, a rigid connection tends to create higher anchor loads. Thus, some deflection of the end anchor was desired to reduce these loads to manageable levels.

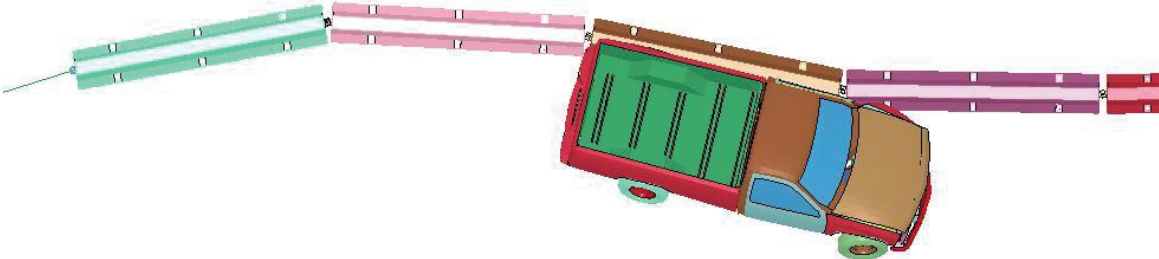
Figure 5. Case 3 – 3-D Spring Constraint Simulation

The third simulated end condition switched the end constraint to a 3-D spring with one end fixed upstream of the barrier at the ground line and the other end attached to the barrier half-way between the end loop bars. The redefined end constraint better represented the type of ground to barrier connection that would be used in the final design and added a vertical constraint to barrier rotation not previously applied. In addition, the 3-D spring was defined with higher capacity than the previous spring in order to reduce barrier deflections. The new spring was defined with an initial slope that rose to 80 kips (356 kN) over 10 in. (254 mm), then held constant at 80 kips (356 kN) for another 10 in. (254 mm), and finally released or failed after 20 in. (508 mm) of total deflection. The spring was placed vertically half-way between loops at the mid-height of the barrier. This end condition helped to improve the barrier deflections and did not demonstrate barrier motions that would cause concern for vehicle stability, as shown in Figure 5.

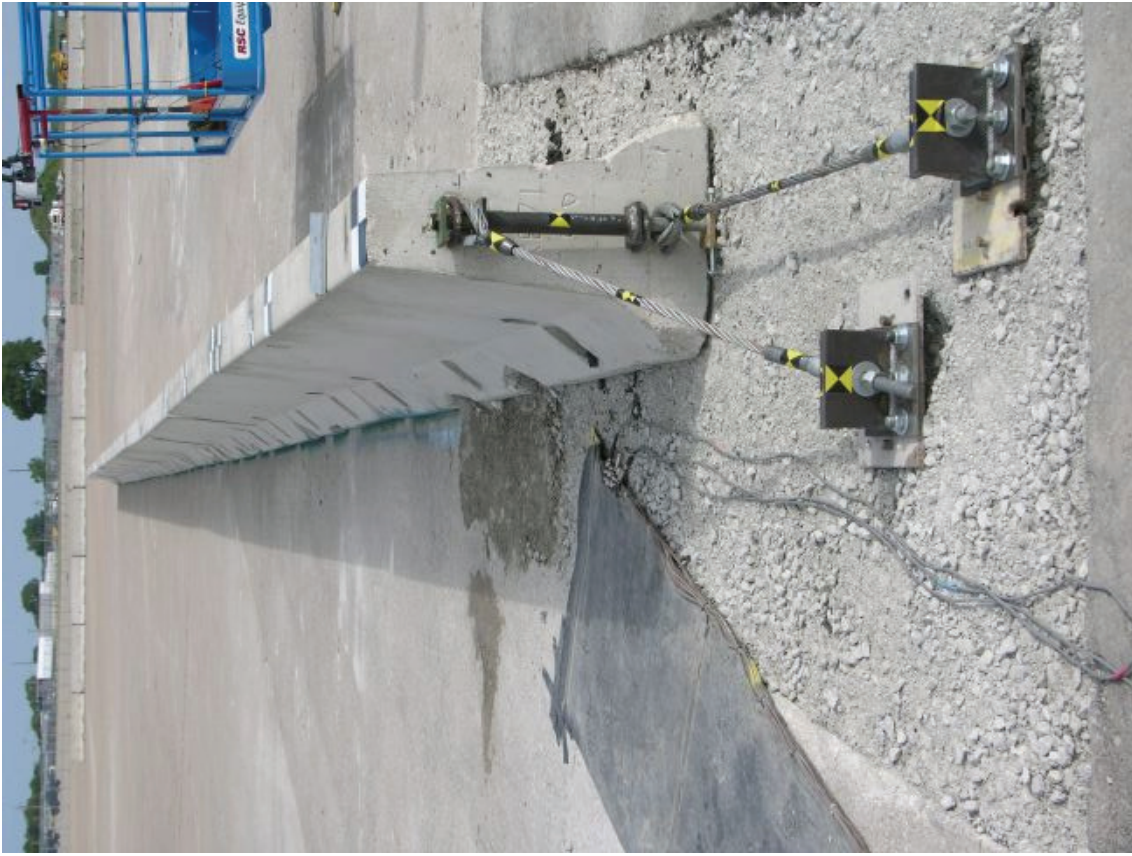
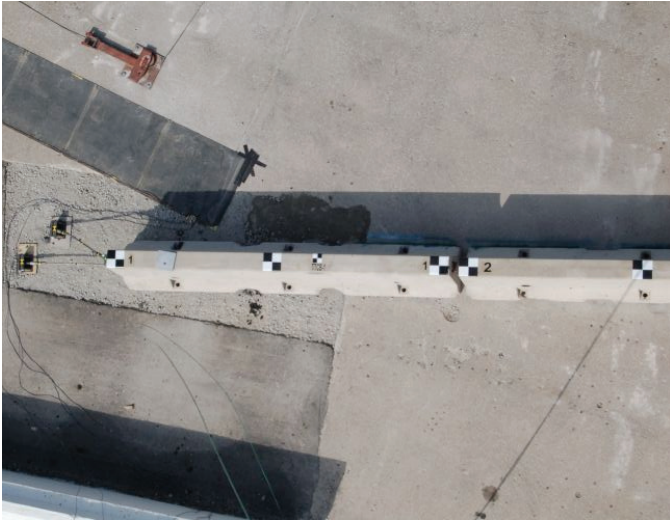
Figure 20. Barrier System Test Installation, Test No. TTCB-1

The 156.5-ft (47.7-m) long test installation, as shown in Figure 8, consisted of two major components: (1) twelve segments of 32-in. (813-mm) tall F-shape, temporary concrete barrier installed on a concrete surface and (2) an anchorage system composed of two $\frac{3}{4}$ -in. (19-mm) diameter wire cables and two anchor post assemblies. Design details are shown in Figure 8 through Figure 19. The corresponding metric-unit drawings are shown in Appendix A. Photographs of the test installation are shown in Figures 20 and 21.

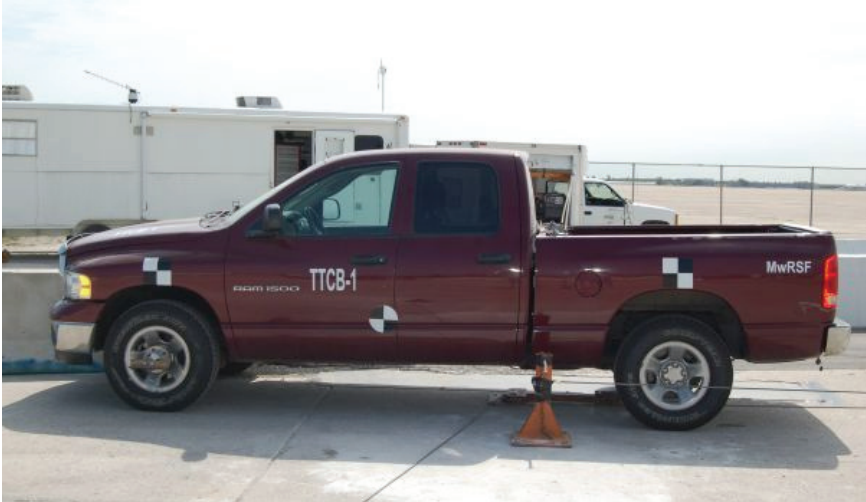
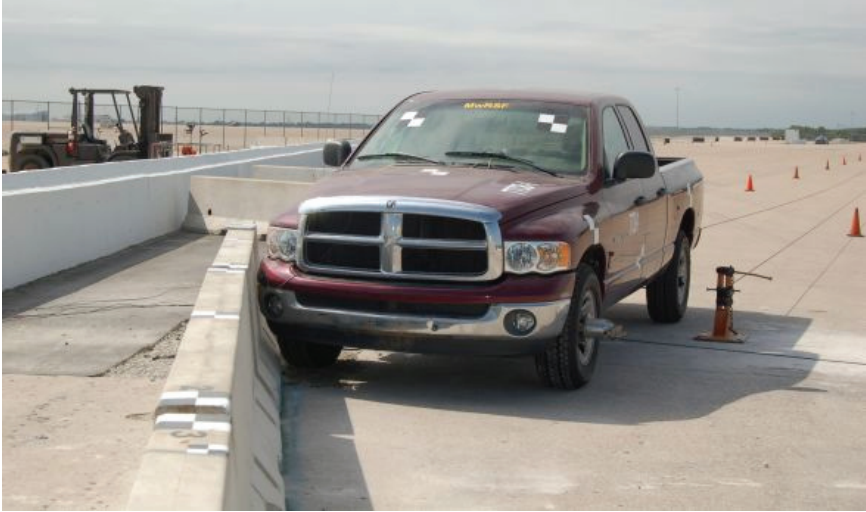
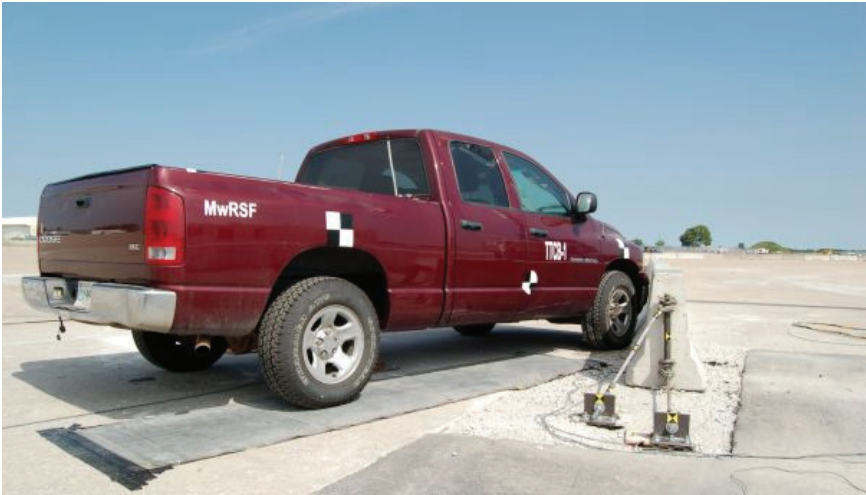
Figure 22. Test Vehicle, Test No. TTCB-1

For test no. TTCB-1, a 2003 Dodge Ram 1500 Quad Cab pickup truck was used as the test vehicle. The test inertial and gross static weights were both 4,991 lbs (2,264 kg). The test vehicle is shown in Figure 22, and vehicle dimensions are shown in Figure 23.

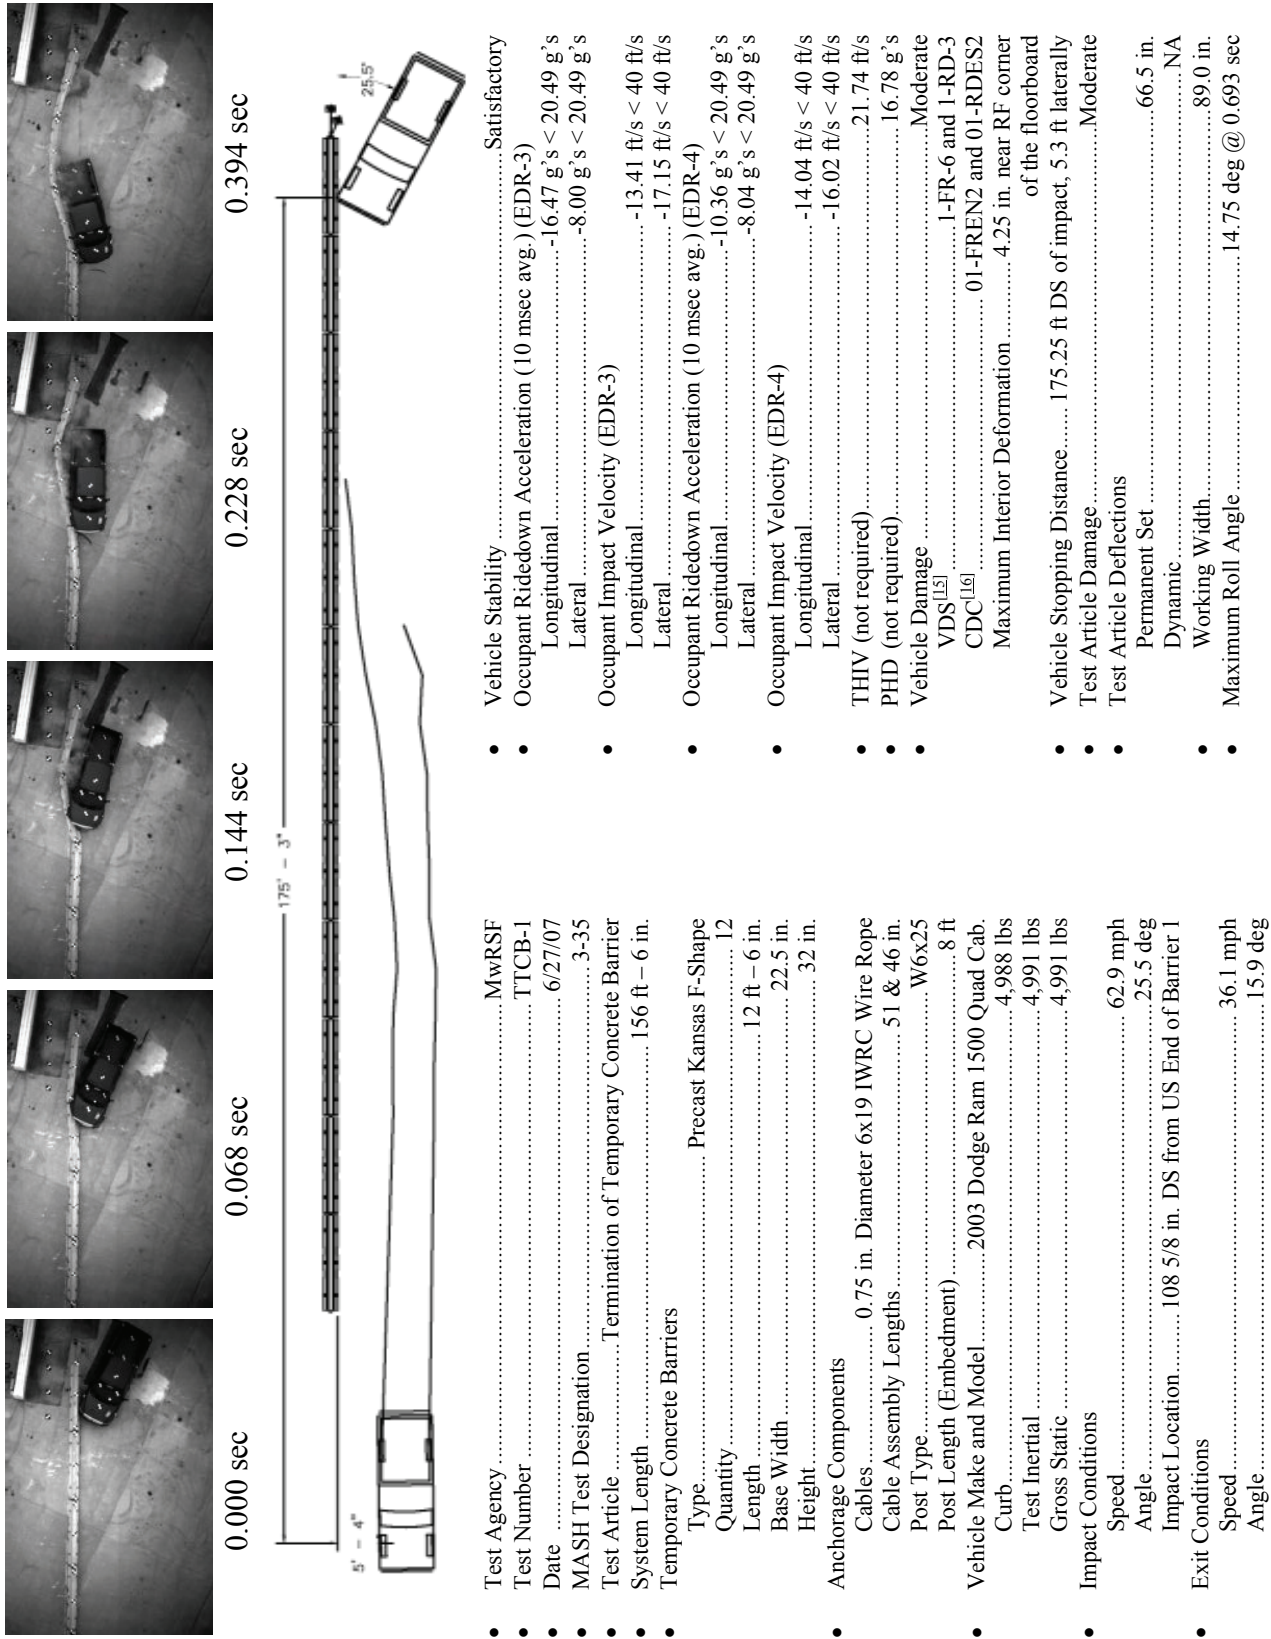
Figure 26. Summary of Test Results and Sequential Photographs, Test No. TTCB-1

The analysis of the test results for test no. TTCB-1 showed that the temporary concrete barrier termination and anchorage system adequately contained and redirected the vehicle. There were no detached elements nor fragments which showed potential for penetrating the occupant compartment nor presented undue hazard to other traffic. The deformation of, or intrusion into, the occupant compartment was minimal and did not pose a threat to cause serious injury. The test vehicle did not penetrate nor ride over the barrier and remained upright during and after the collision. Vehicle roll, pitch, and yaw angular displacements were noted, as shown in Appendix E, and were deemed acceptable because they did not adversely influence occupant risk safety criteria nor cause rollover. After impact, the vehicle exited the barrier at an angle of 15.9 degrees and did not intrude into adjacent traffic lanes. Therefore, test no. TTCB-1, conducted on a termination and anchorage system for temporary concrete barrier, was determined to be acceptable according to the TL-3 safety performance criteria found in the MASH using test designation no. 3-35.

• Anchorage Components		Lateral	-4.88 m/s < 12.2 m/s
Cables	19 mm Diameter 6x19 IWRC Wire Rope	• THIV (not required)	6.63 m/s
Cable Assembly Lengths	2195 & 1168 mm	• PHD (not required)	16.78 g's
Post Type	W152x37.2	• Vehicle Damage	Moderate
Post Length (Embedment)	2.44 m	VDS ^[15]	1-FR-6 and 1-RD-3
Vehicle Make and Model	2003 Dodge Ram 1500 Quad Cab	CDC ^[16]	01-FREN2 and 01-RDES2
Curb	2,263 kg	Maximum Interior Deformation	108 mm near RF corner of the floorboard
Test Inertial	2,264 kg	• Vehicle Stopping Distance	53.4 m DS of impact, 1.6 m Laterally
Gross Static	2,264 kg	• Test Article Damage	Minimal

• Impact Conditions		• Test Article Deflections	
Speed	101.3 km/h	Permanent Set	1,689 mm
Angle	25.5 deg	Dynamic	NA
Impact Location	2.76 m DS from US End of Barrier 1	Working Width	2,261 mm

• Exit Conditions		• Maximum Roll Angle	14.75 deg @ 0.693 sec
Speed	58.1 km/h		
Angle	15.9 deg

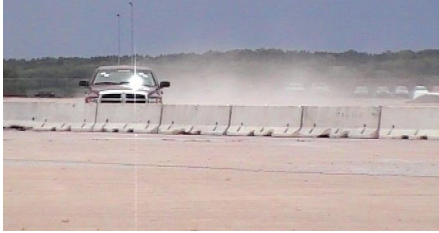
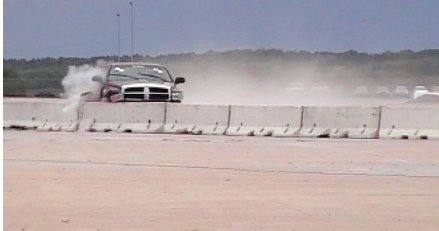
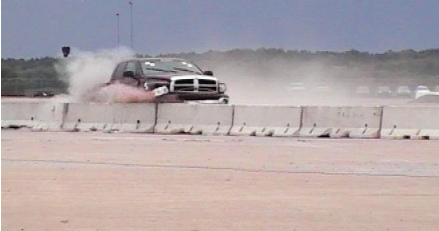
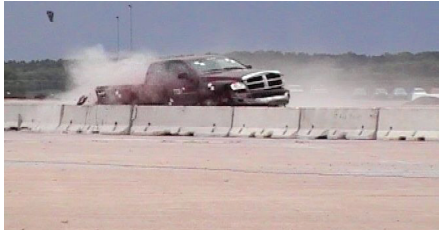
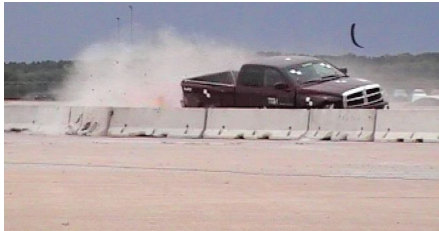
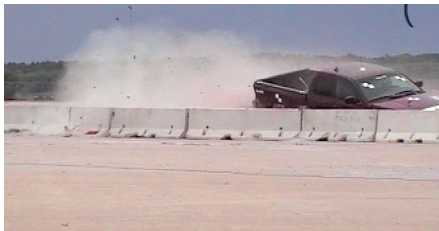
Figure 28. Additional Sequential Photographs, Test No. TTCB-1

The 4,991-lb (2,264-kg) pickup truck impacted the anchored temporary barrier system at a speed of 62.9 mph (101.2 km/h) and at an angle of 25.5 degrees. A summary of the test results and sequential photographs are shown in Figure 26. The summary of the test results and sequential photographs in metric units are shown in Appendix C. Additional sequential photographs are shown in Figures 27 through 29. Documentary photographs of the crash test are shown in Figure 30.

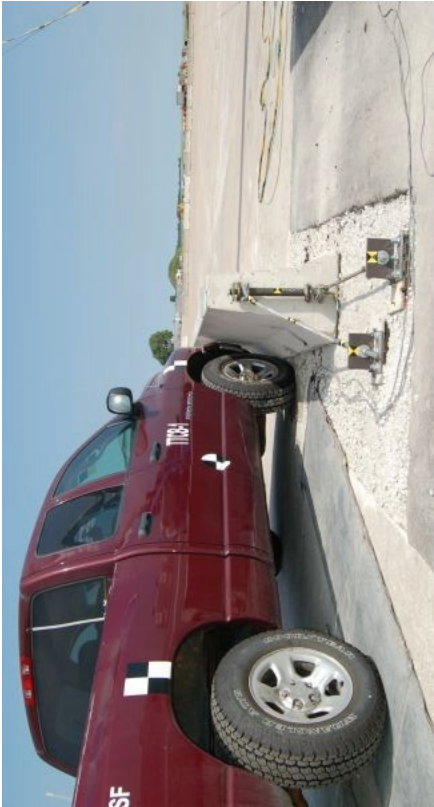
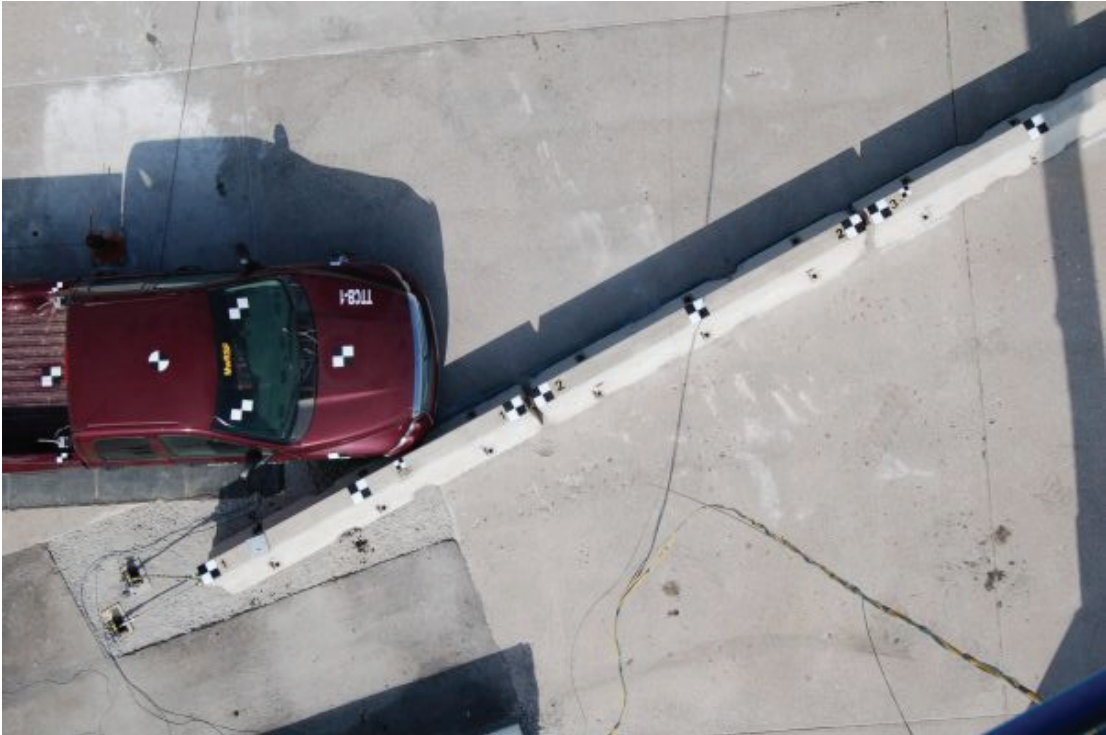
Figure 31. Impact Location, Test No. TTCB-1

Initial vehicle impact was to occur 98 3/8 in. (2,499 mm) downstream of the upstream end of barrier no. 1, as shown in Figure 31. The actual point of impact was 10 1/4 in. (260 mm) downstream of the targeted impact. At 0.014 sec after impact, the right-front quarter panel was deformed and began to override the front face of the barrier. At 0.018 sec, barrier no. 1 began to move backward and rotate clockwise (CW) about the anchor. At 0.020 sec, the right-front tire

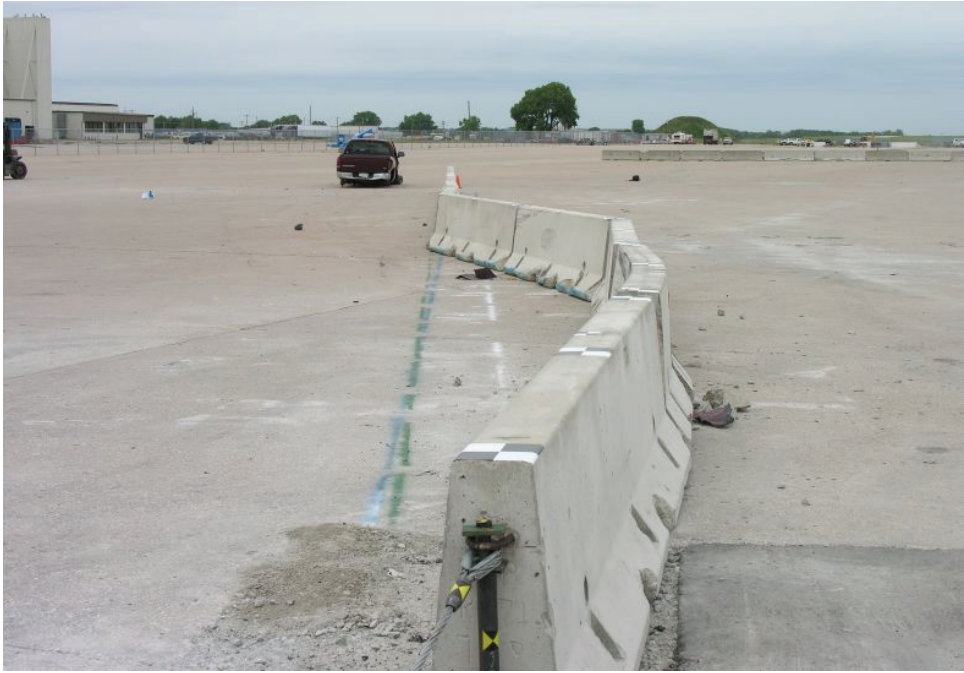
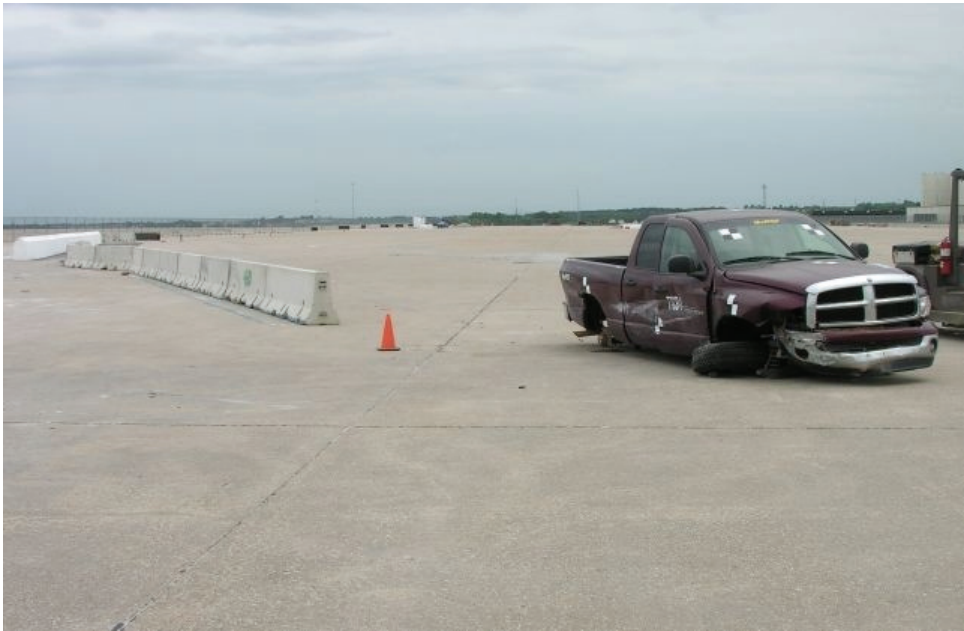
Figure 32. Vehicle Final Position and Trajectory Marks, Test No. TTCB-1

ground, and the vehicle began to yaw CW. At 0.756 sec, the front bumper impacted the ground, and at 0.810 sec, the vehicle lost contact with the barrier system at 36.1 mph (58.1 km/h) and an angle of 15.9 degrees. At 0.994 sec, the rear tires impacted the ground, and the right-rear tire detached from the vehicle. At 1.000 sec, the barrier system had stopped deflecting as the pickup truck continued to move downstream and yaw CW until it eventually came to a stop 175 ft – 3 in. (53.42 m) downstream of impact and 5 ft – 4 in. (1.63 m) in front of the barrier system. The trajectory and final position of the vehicle are shown in Figure 32.

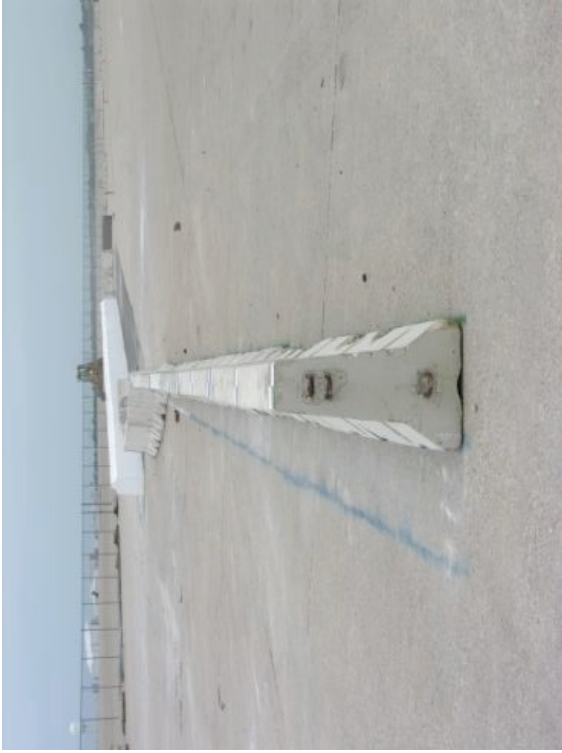
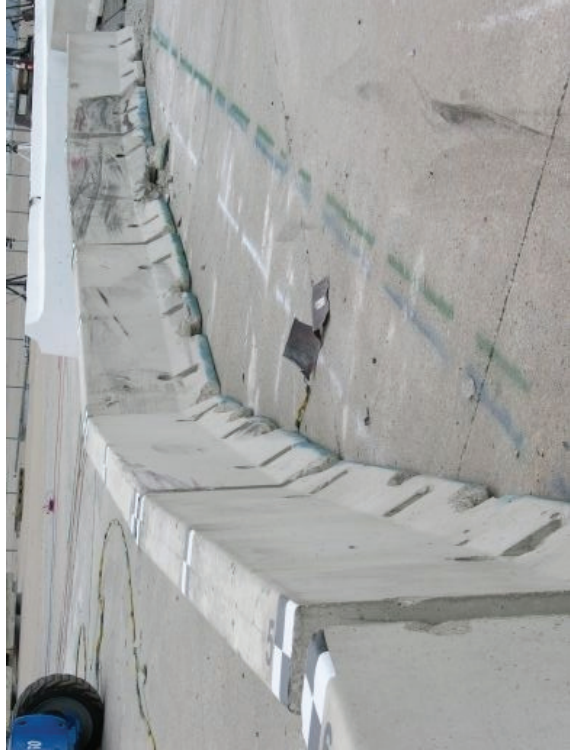
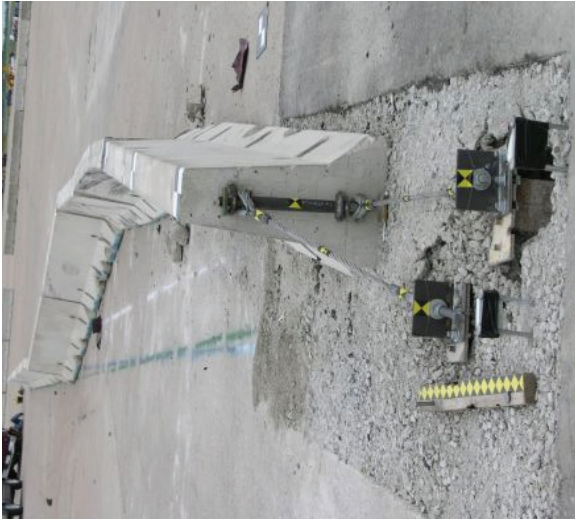
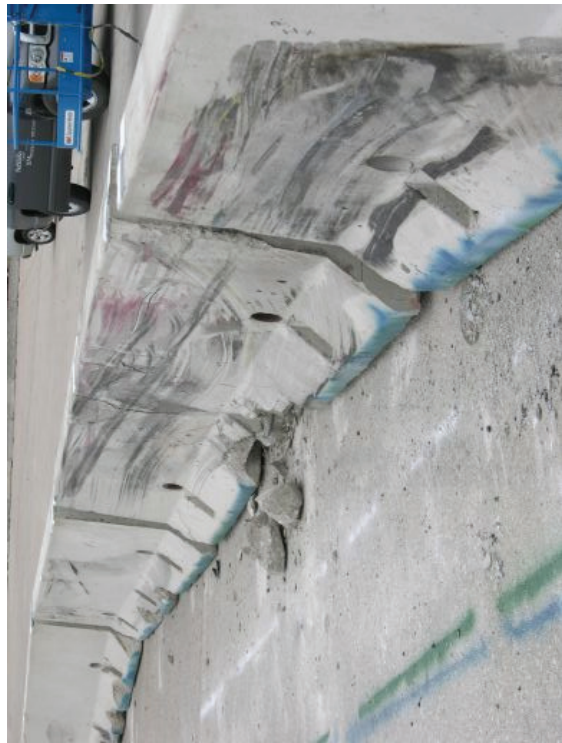
Figure 33. System Damage, Test No. TTCB-1

Damage to the barrier system was moderate, as shown in Figures 33 through 39. Tire marks were found on barrier no. 1 beginning 95 7/8 in. (2,435 mm) downstream of the upstream end of barrier no. 1 and continued to the downstream end of barrier no. 2. Contact marks from the body of the pickup truck began 108 5/8 in. (2,759 mm) downstream of the upstream end of barrier no. 1 and continued through barrier no. 2. Both the tire and vehicle body marks are shown in Figures 34 and 35. Spalling was found on the barrier edges at the joint between barrier nos. 1 and 2.

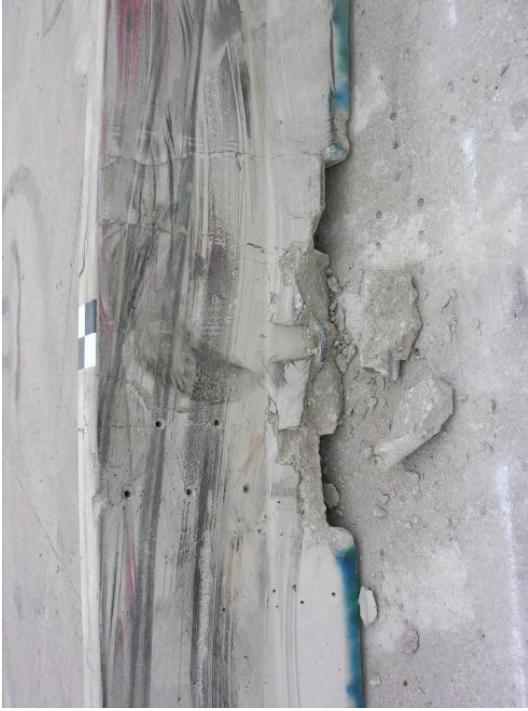
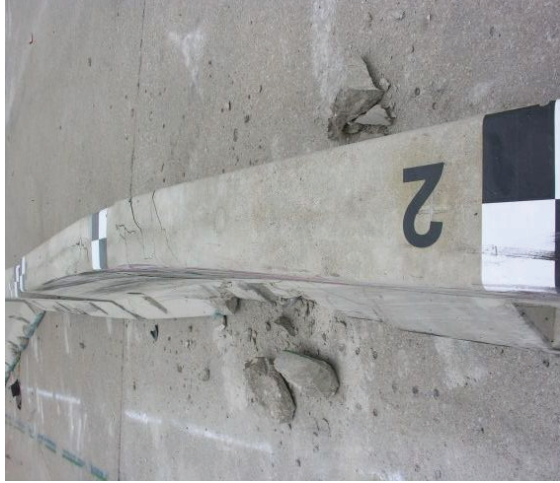
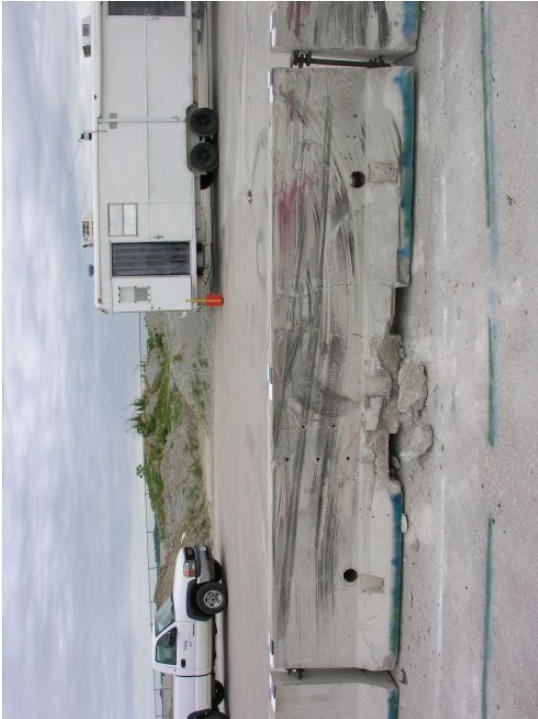
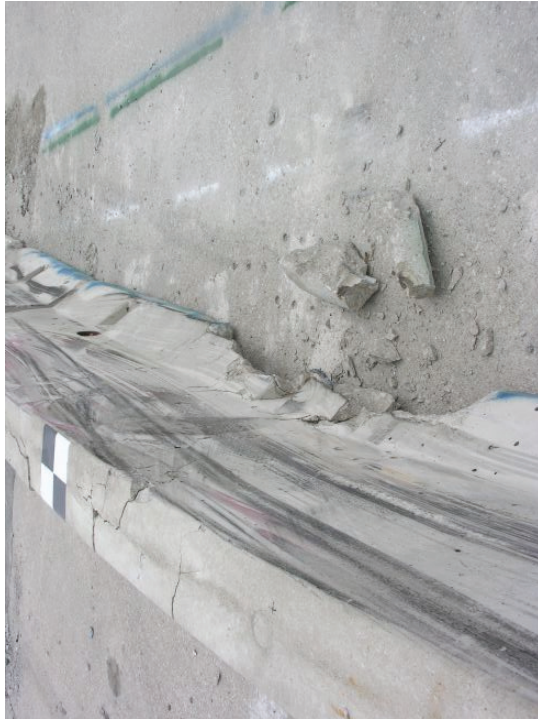
Figure 35. System Damage - Barrier No. 2, Test No. TTCB-1

The most extensive barrier damage occurred to barrier no. 2, as shown in Figures 35 and 36. Cracks were found through the entire cross section of the barrier spanning the middle 60 in. (1,524 mm) of barrier no. 2. These cracks were typically hairline cracks on the front surface of the barrier, but opened up larger gaps on the back surface. The front-side of barrier no. 2 had two 12-in. wide x 6-in. tall x 4-in. deep (305-mm x 152-mm x 102-mm) concrete pieces break away from the toe near the center of the barrier. Barrier no. 2 was permanently bowed such that the center of the barrier was 3.125 in. (79 mm) off line. Spalling and gouging was found in various areas on the front face of the barrier.

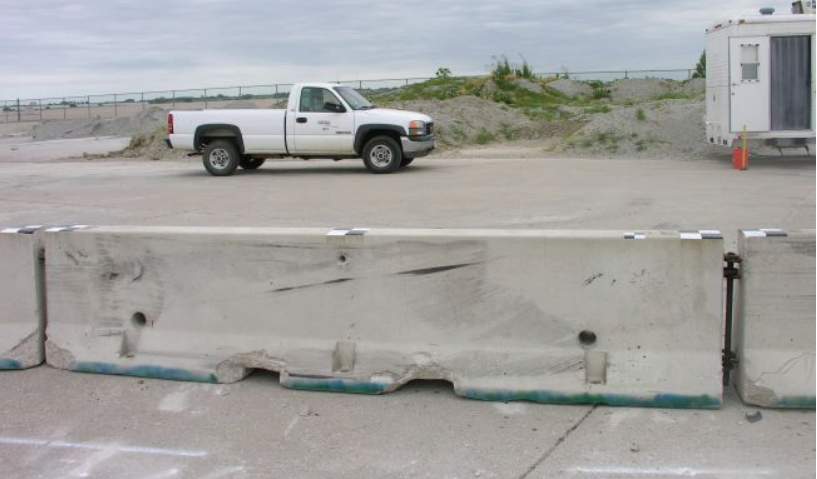
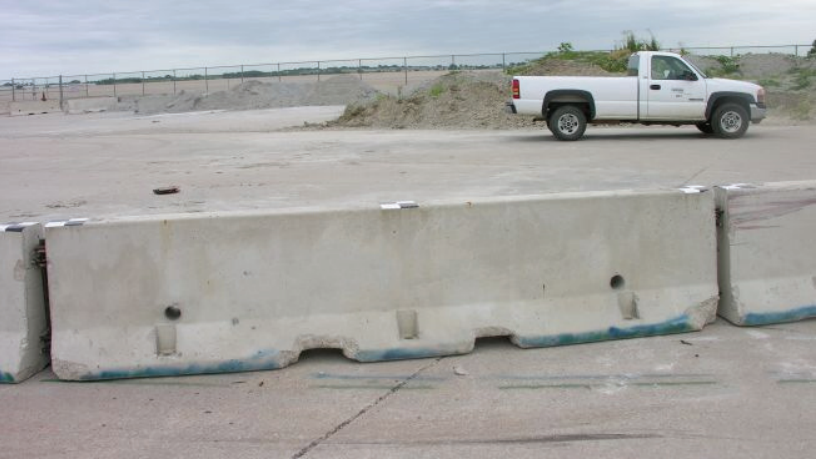
Figure 37. System Damage - Barrier Nos. 3-5, Test No. TTCB-1

Spalling was also found at the edges of the joint between barrier nos. 2 and 3. Barrier no. 3 contained tire marks beginning 20 in. (508 mm) from the upstream end and continued down the length of the barrier, as shown in Figure 37. A maximum permanent set deflection of 66.5 in. (1,689 mm) was measured at the downstream end of barrier no. 3. No dynamic deflection measurement was available because the barriers were still in motion and the end of the available high-speed video footage taken from the overhead view. Various tire and vehicle body contact marks were found from the middle of barrier no. 4 to the upstream side of barrier no. 5. The remaining barriers remained undamaged.

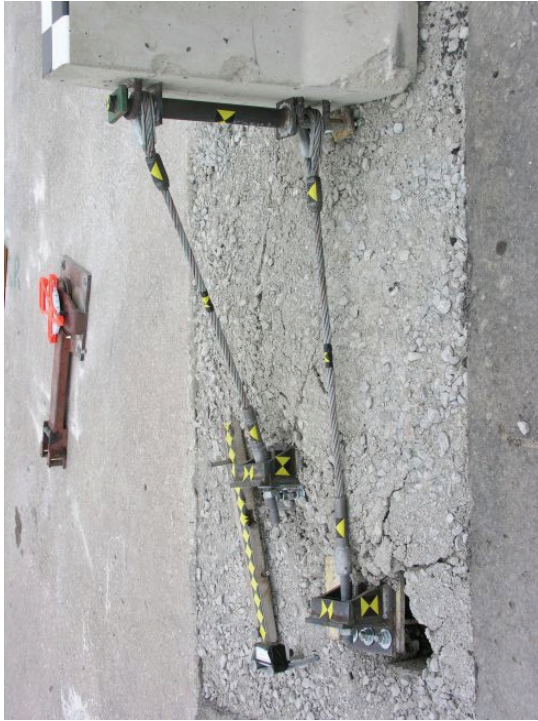
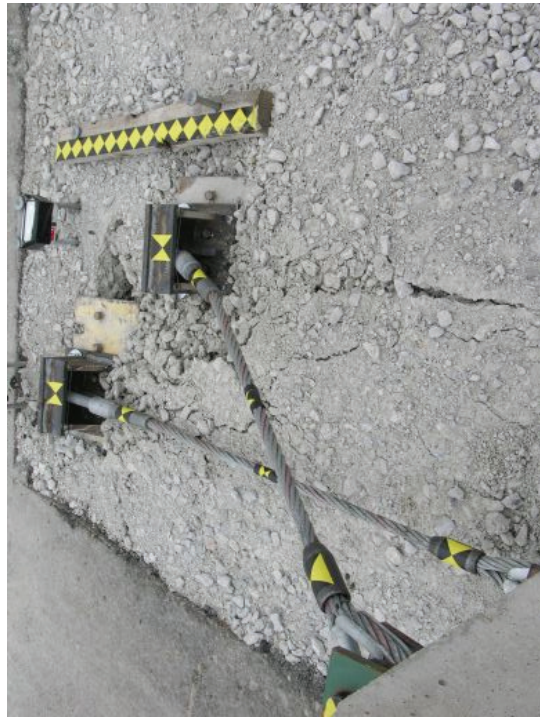
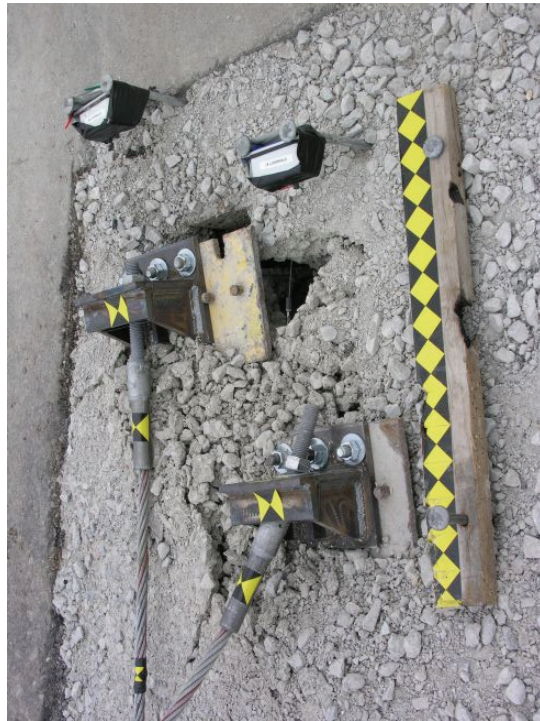
Figure 38. Anchorage Displacement, Test No. TTCB-1

The soil downstream of the anchor plates was bulged upward and cracked at the ground surface, as shown in Figure 38. A soil gap of 4.75 in. (121 mm) was located on the upstream side of the anchor post in line with the system, as shown in Figure 39. The offset anchor was twisted slightly toward the system. Analysis of the data from the string potentiometer mounted on the anchors showed maximum dynamic anchor deflections of 5.28 in. (134 mm) for the offset anchorage and 6.19 in. (157 mm) for the in-line anchorage. String potentiometer data is located in Appendix F. No visible damage to the anchor cables or cable brackets was observed.

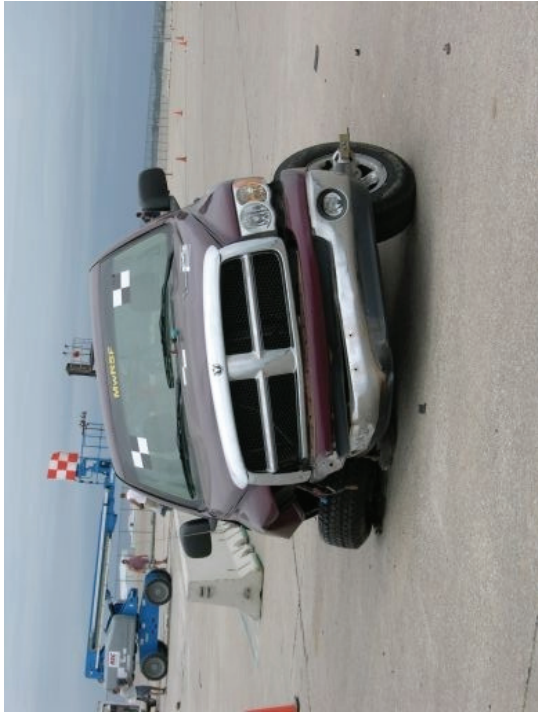
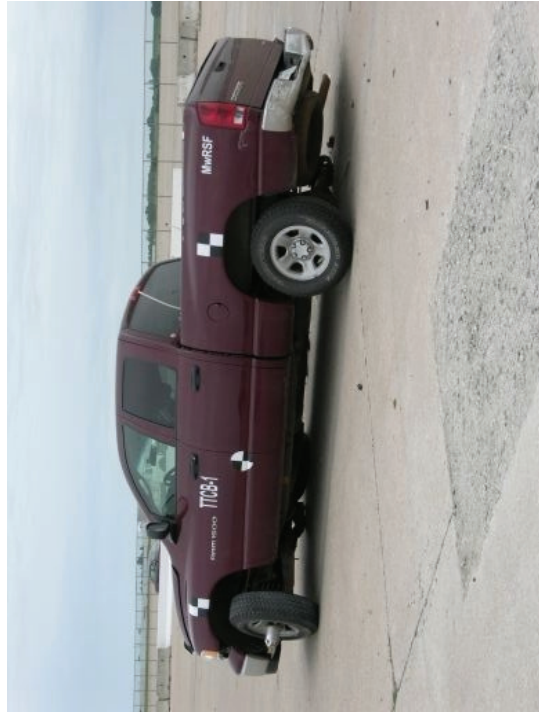
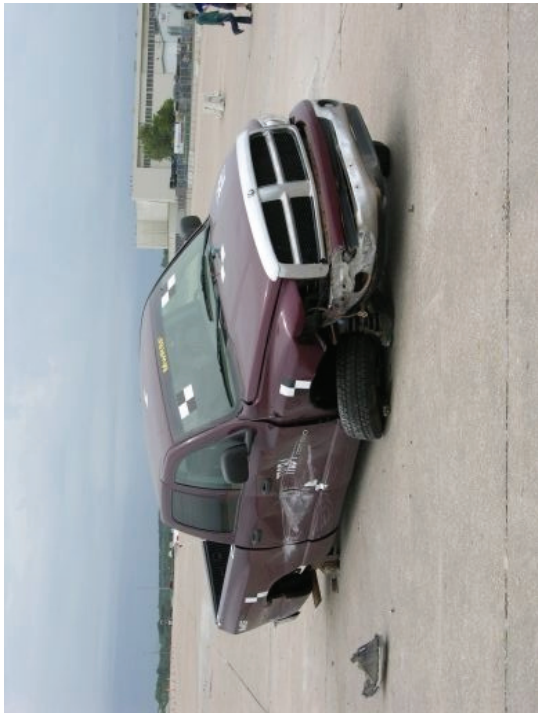
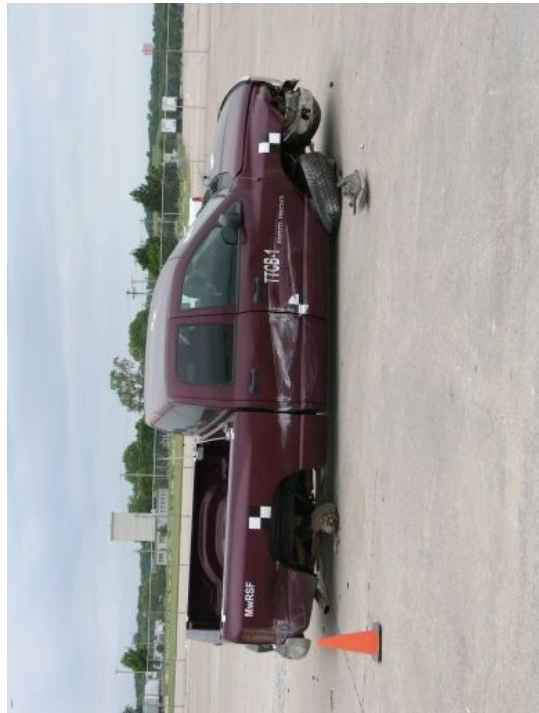
Figure 40. Vehicle Damage, Test No. TTCB-1

The damage to the vehicle was moderate, as shown in Figures 40 through 45. The most extensive damage was concentrated at the right-front corner of the pickup truck where the quarter panel was crushed inward. The right side of the front bumper was also crushed in toward the engine compartment, and the right side of the grill was torn apart, as shown in Figure 41. Also, the entire front bumper was shifted downward approximately 2.5 in. (64 mm). The right-front tire was detached from the pickup truck and was resting flat underneath the right-side occupant compartment. The right-front control arm was fractured, and the tie rod had broken off,

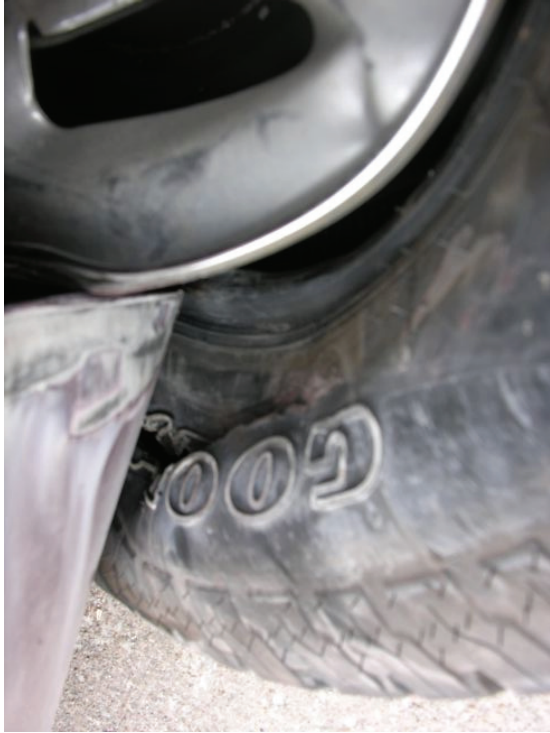
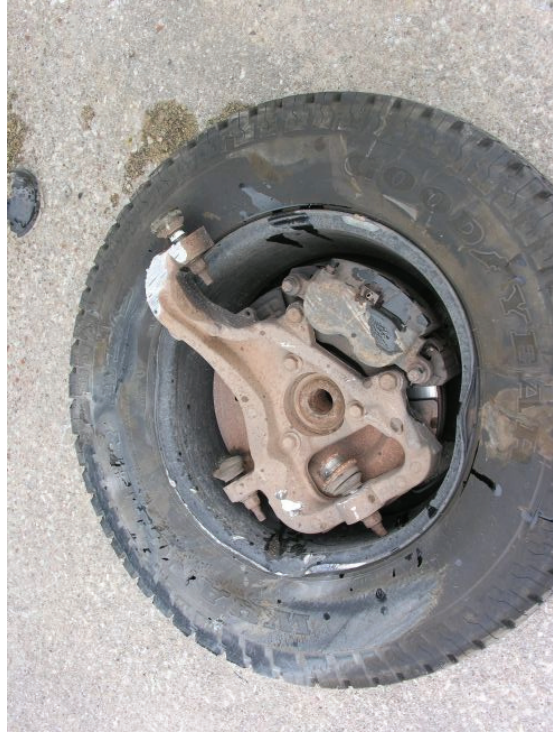
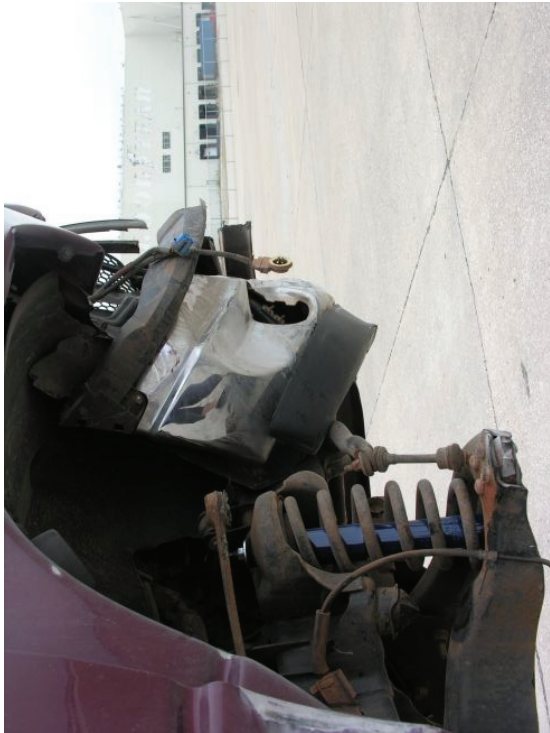
Figure 42. Vehicle Right-Front Wheel Assembly Damage, Test No. TTCB-1

as shown in Figure 42. Also, the right-front tire was deflated and received multiple tears in the rubber and deformations to the rim.

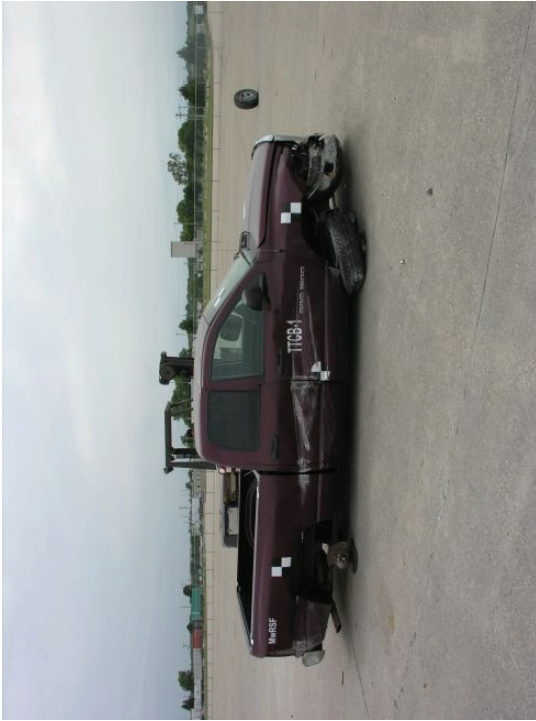
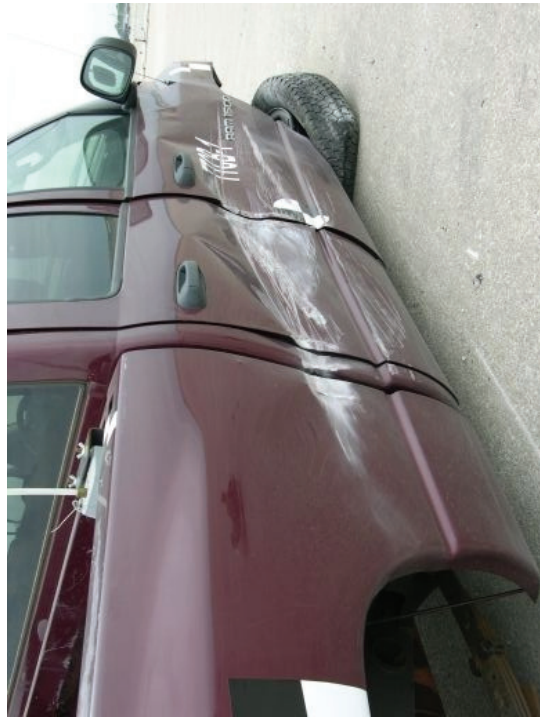
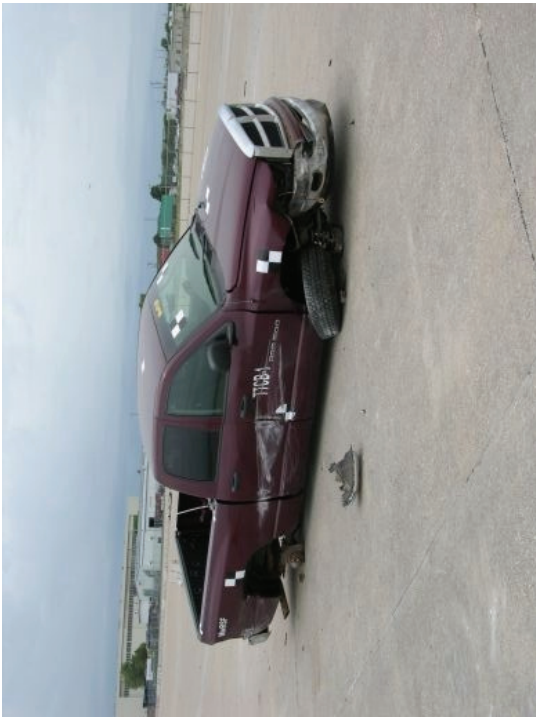
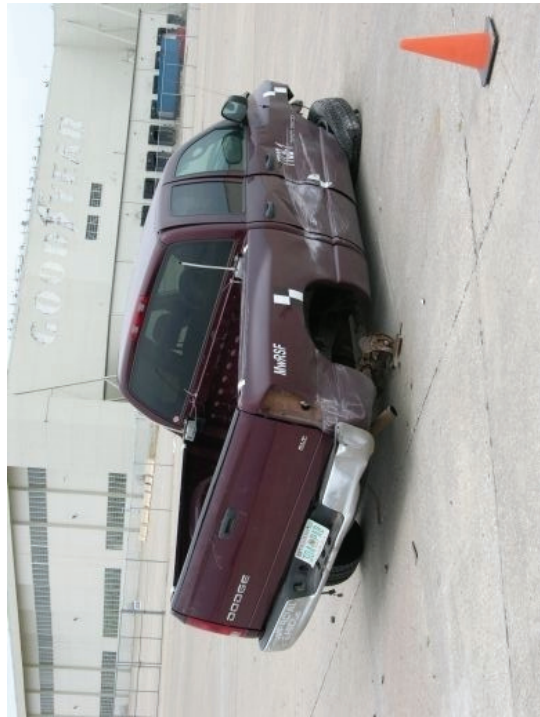
Figure 43. Damage to Right Side of Vehicle, Test No. TTCB-1

The right side of the pickup truck received multiple scratches, gouges, and dents, as shown in Figure 43. The scratches and gouges spanned from the right-front door to the right-rear corner of the vehicle. The right-side doors were dented inward approximately 2 in. (51 mm).
