Termination and Anchorage of Temporary Concrete Barriers

TERMINATION AND ANCHORAGE OF TEMPORARY CONCRETE BARRIERS

MwRSF Research Report No. TRP-03-209-09

October 29, 2009

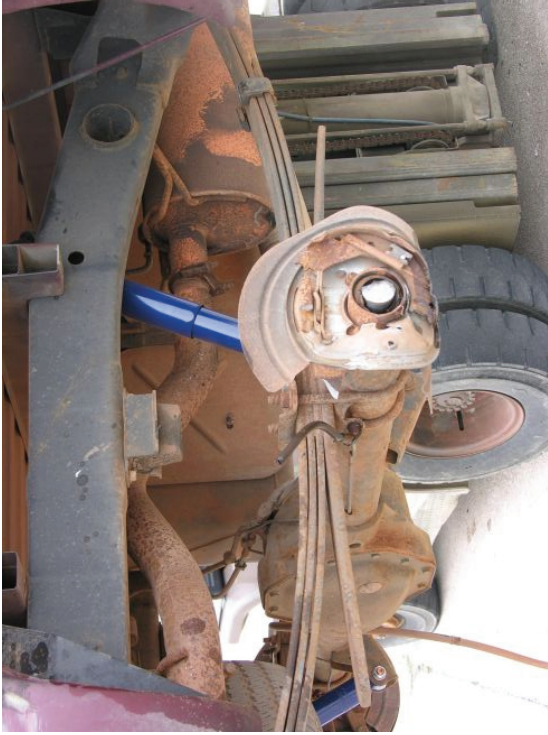
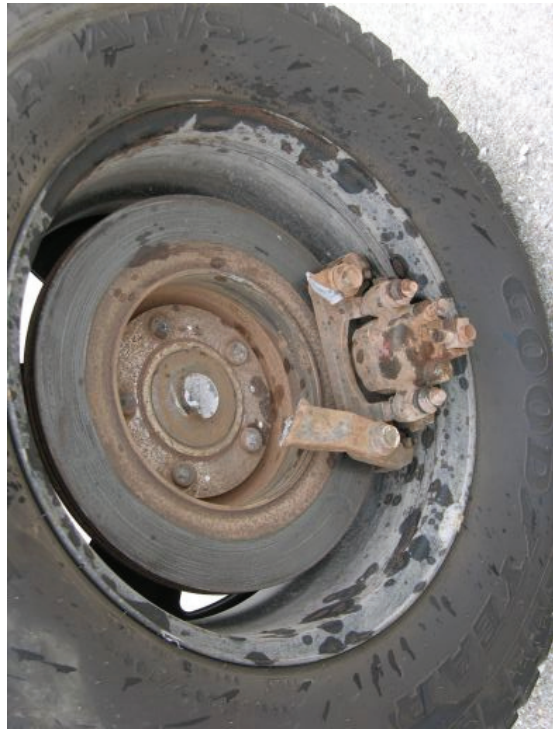
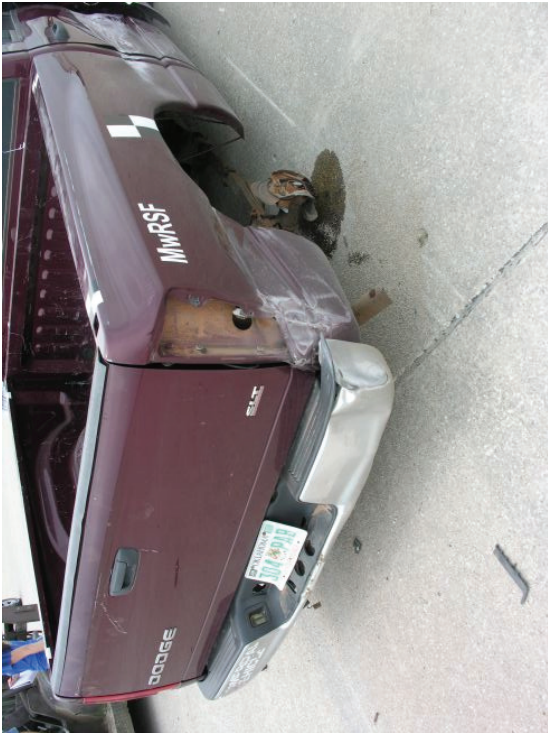
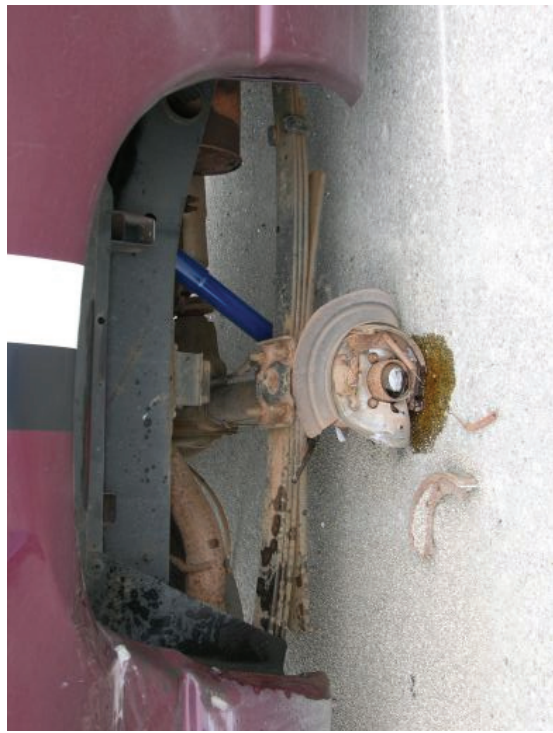
Figure 44. Vehicle Right-Rear Wheel Damage, Test No. TTCB-1

The right-rear tire was also detached from the pickup truck and came to rest approximately 40 ft (12.2 m) to the left of the vehicle. The right-rear disc brake was deformed and fractured, and the brake line was snapped, as shown in Figure 44. The right tail light was detached, and the rear bumper was bowed inward and shifted down.

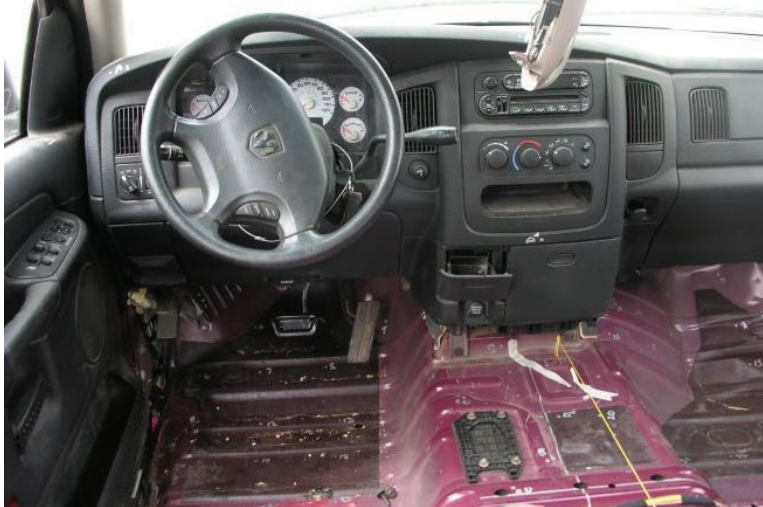
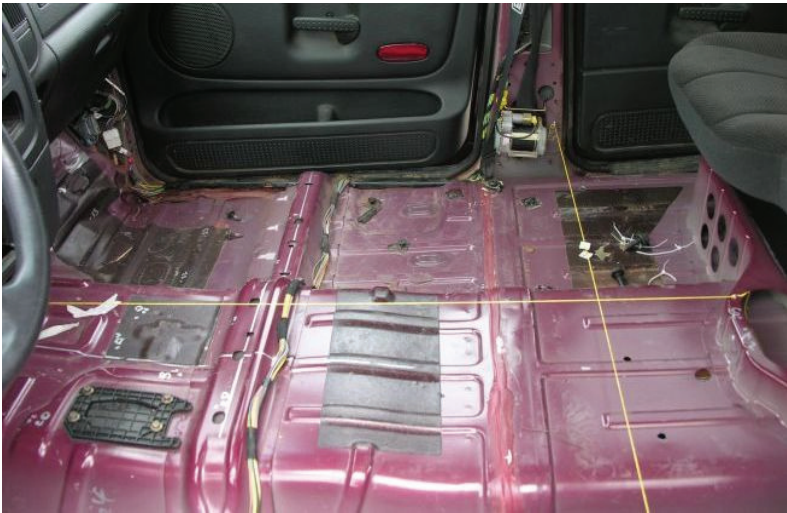
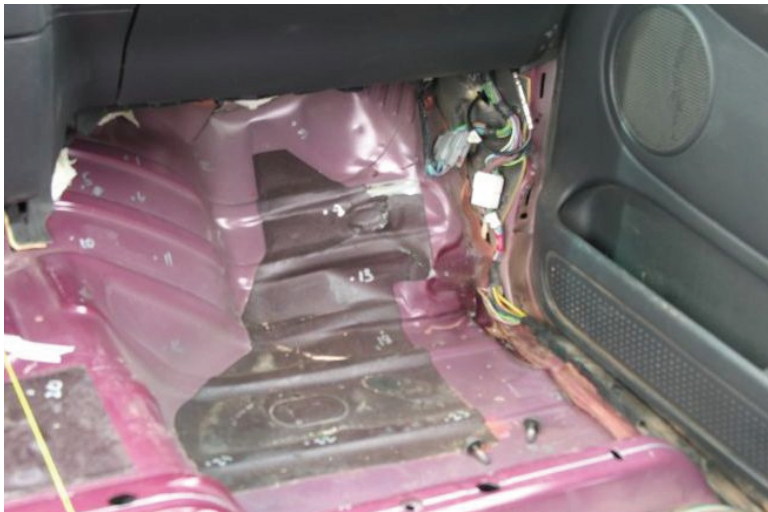
Figure 45. Vehicle Damage, Occupant Compartment, Test No. TTCB-1

Occupant compartment deformations to the right front of the floorboard, as shown in Figure 45, were judged insufficient to cause serious injury to the vehicle occupants. A maximum longitudinal deformation of 4 in. (102 mm) was located along the right side of the floorboard. A maximum lateral deformation of 3 in. (76 mm) was located at the front of the right-side floorboard. A maximum vertical deformation of 4.25 in. (108 mm) was located near the right-front corner of the floorboard. Deformations were recorded from two separate locations before and after the test. Complete occupant compartment deformations and the corresponding locations are provided in Appendix D.

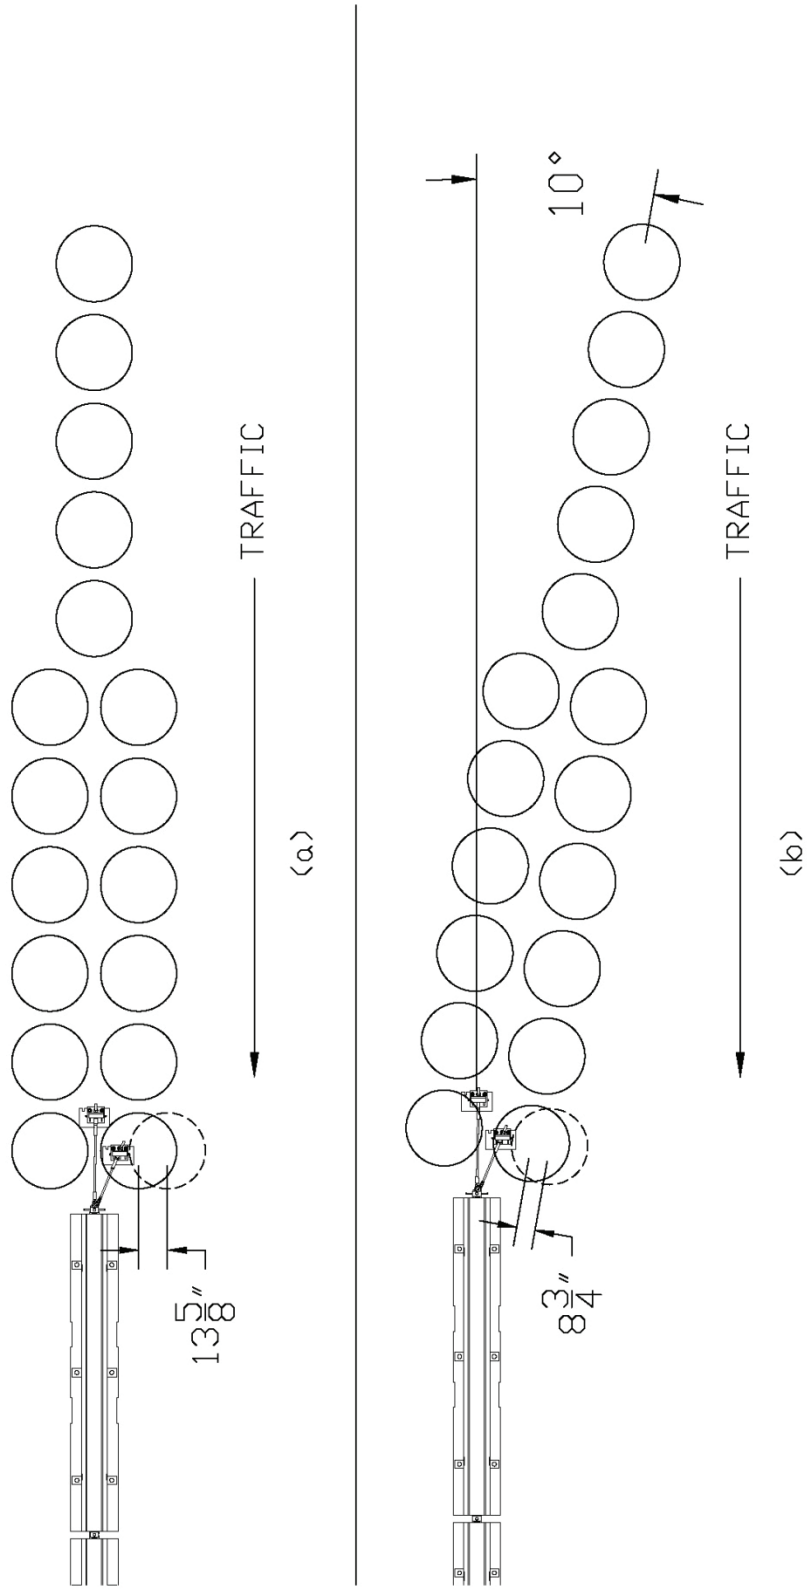
Figure 58. Schematic of Sand Barrel Array for Termination and Anchorage System

As mentioned previously, the termination and anchorage system was designed such that the upstream barrier end would be shielded with either inertial sand barrel crash cushions or be placed outside the clear zone by flaring the end segments of the temporary barrier system. When using sand barrel crash cushions, the anchors posts are positioned to allow for the sand barrels to be placed adjacent to the anchors with only minor deviation from the standard sand barrel array, as shown in Figure 58. It should be noted that no variation of anchor spacing allowed for a perfect placement of the sand barrels at the end of the temporary barriers. For sand barrel arrays oriented parallel to the roadway and barrier system, the chosen anchor layout allowed for the sand barrels to be placed with only a 13.625-in. (346-mm) shift of one barrel on the traffic side of the array. For sand barrel arrays rotated to the 10 degree maximum recommended angle with respect to the roadway, the maximum deviation of the end barrel on the traffic side of the array was only 8.75 in. (222 mm). These minor variations in the placement of a single barrel are not

expected to adversely affect the safety performance of the sand barrel crash cushion. When the termination and anchorage system is installed on temporary barriers that have been flared to place the end barriers outside of the clear zone, appropriate flare rates guidelines should be used, such as those found in the AASHTO Roadside Design Guide [17].
