Midwest Guardrail System (MGS) Placed Adjacent to a 1V:2H Fill Slope with 6-ft Posts

*Midwest States Regional Pooled Fund Research Program
Fiscal Year 2013 (Year 24)
Research Project Number TPF-5(193) Supplemental #68
NDOR Sponsoring Agency Code RFPF-14-MGS-8*

MIDWEST GUARDRAIL SYSTEM (MGS) WITH 6-FT POSTS PLACED ADJACENT TO A 1V:2H FILL SLOPE

MIDWEST ROADSIDE SAFETY FACILITY

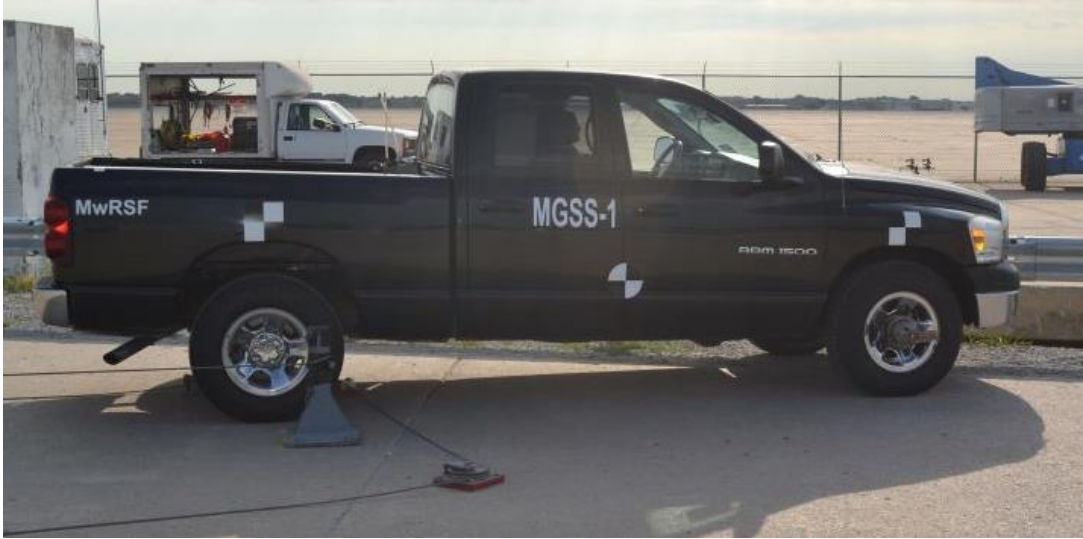
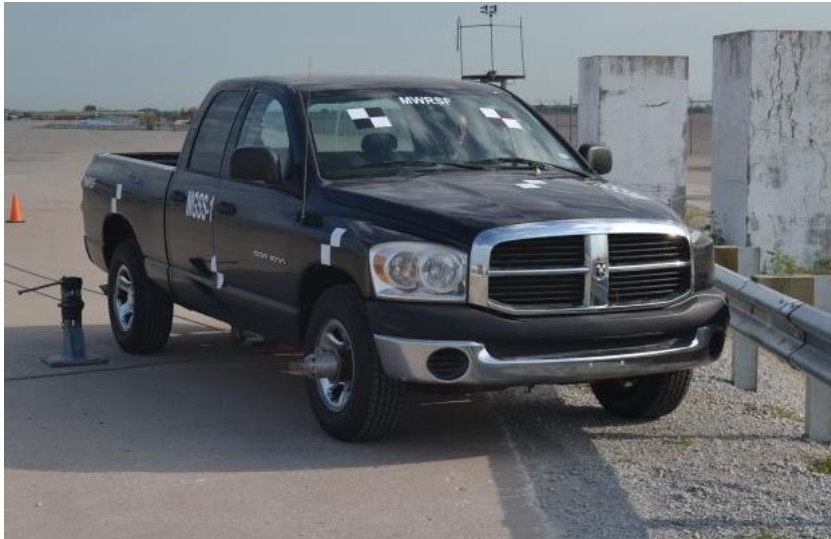
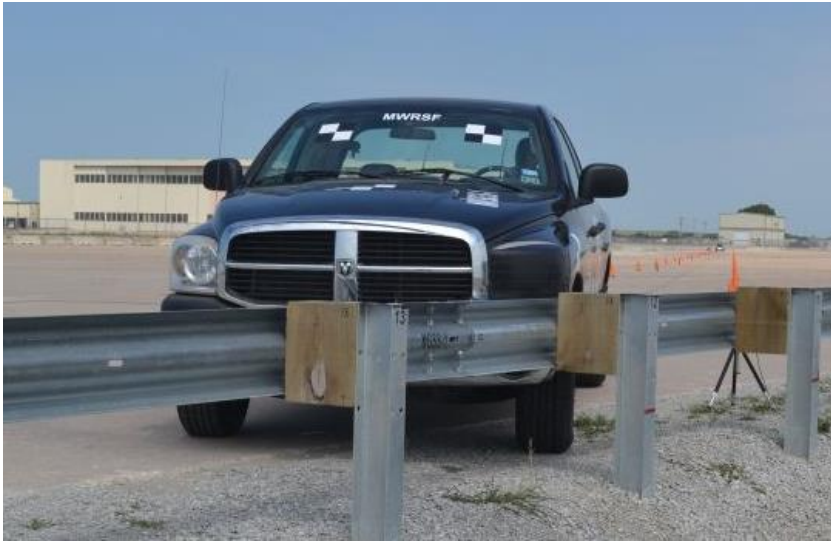
Figure 15. Test Vehicle, Test No. MGSS-1

For test no. MGSS-1, a 2007 Dodge Ram 1500 pickup truck was used as the test vehicle. The curb, test inertial, and gross static vehicle weights were 5,024 lb (2,279 kg), 4,992 lb (2,264 kg), and 5,158 lb (2,340 kg), respectively. The test vehicle is shown in Figure 15, and vehicle dimensions are shown in Figure 16.

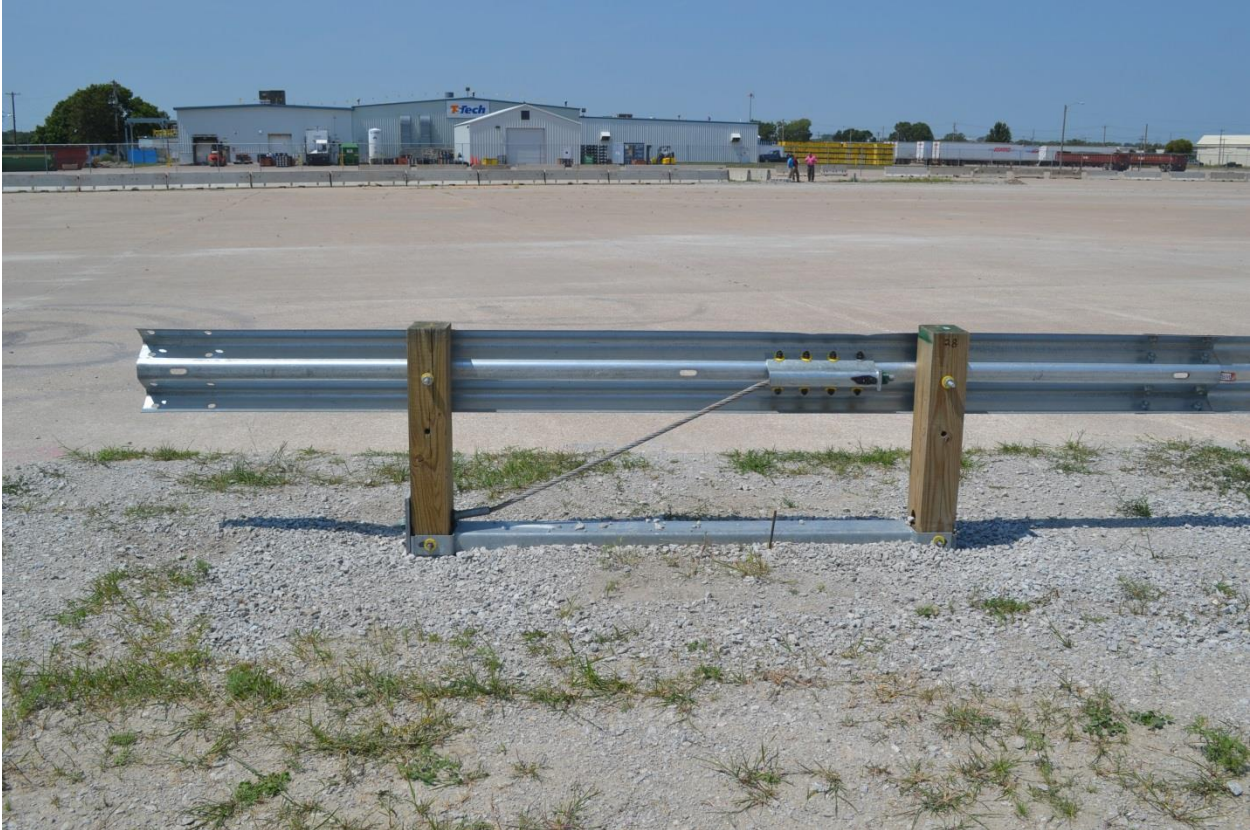
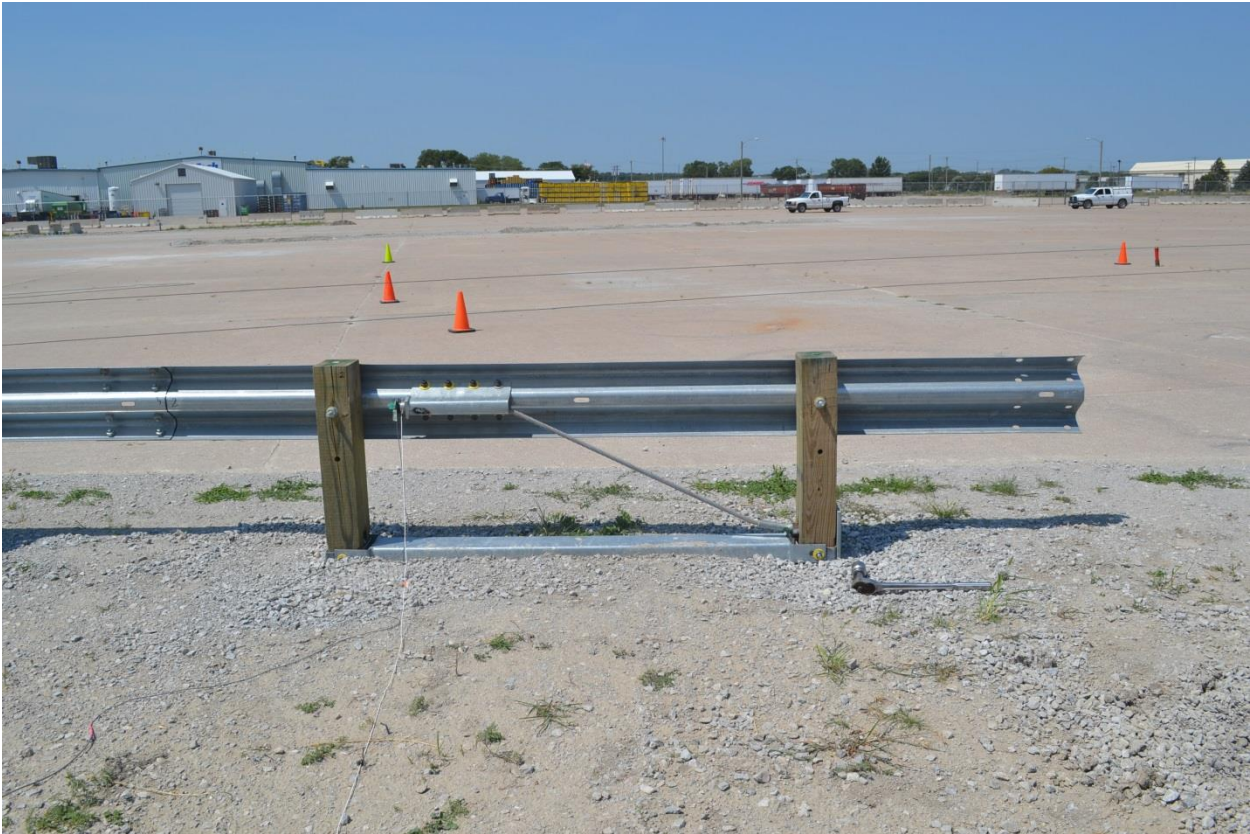
Figure 18. Load Cell Placement, Test No. MGSS-1

Load cells, shown in Figure 18, were installed in the upstream anchor cable for test no. MGSS-1. The load cells were Transducer Techniques model nos. PCB 1-1376 and 261278 with a load range up to 80 kips (356 kN). During testing, output voltage signals were sent from the transducers to a National Instruments PCI-6071E data acquisition board, acquired with LabView software, and stored on a personal computer at a sample rate of 10,000 Hz.

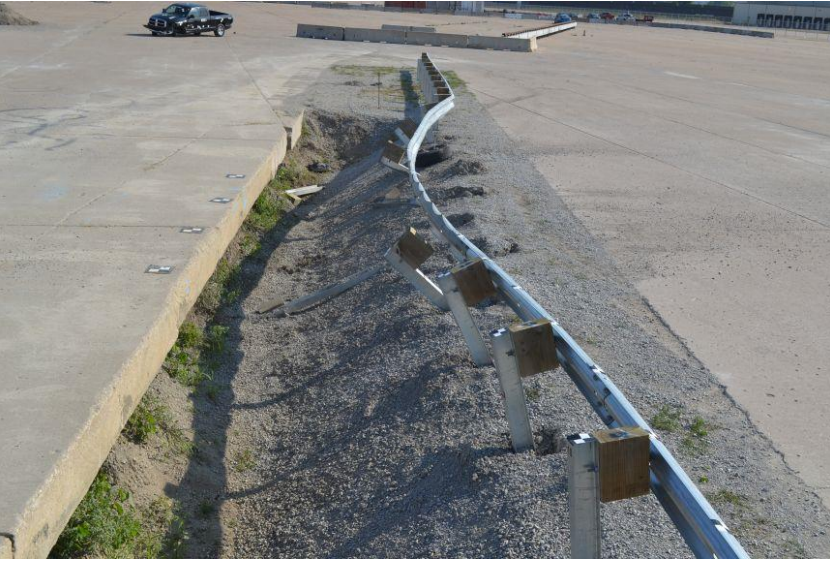
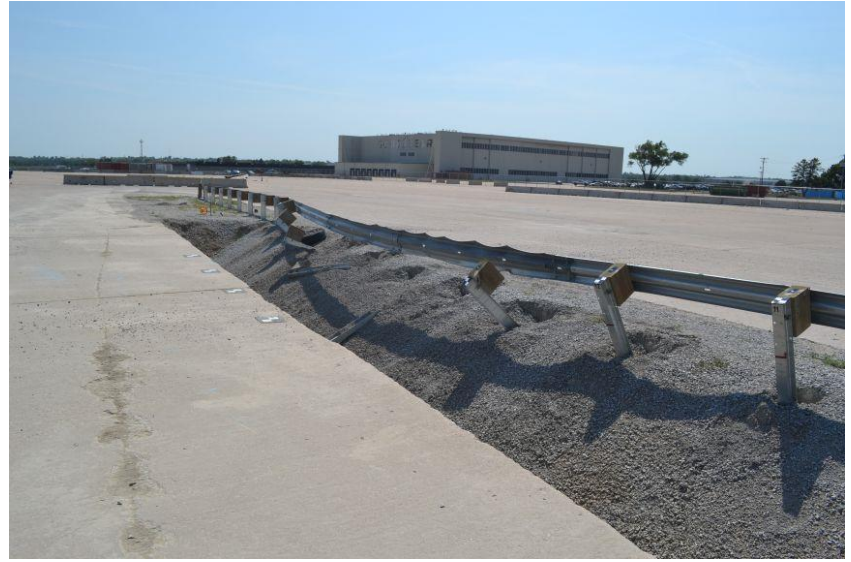
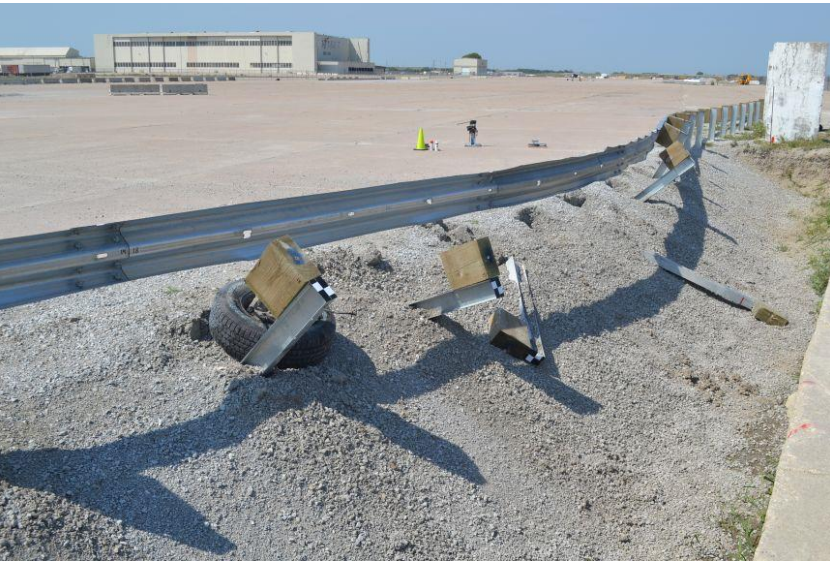
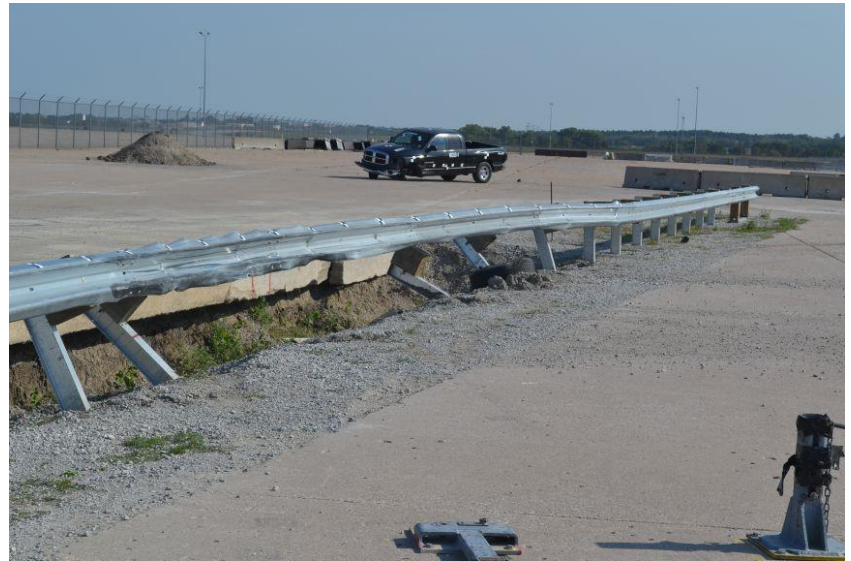
Figure 27. System Damage, Test No. MGSS-1

Damage to the barrier was moderate, as shown in Figures 27 through 31. Barrier damage consisted of deformed W-beam rail, disengaged W-beam rail from the posts, and post rotation out of the soil. The length of vehicle contact along the barrier was approximately 49 ft – 6 in. (15.1 m), which spanned from 8¼ in. (210 mm) downstream from the centerline of post no. 12 through 2½ in. (64 mm) downstream from the centerline of post no. 20.

The W-beam rail deformed between post nos. 12 through 21. Contact marks were found on the guardrail between post nos. 12 and 21. An 8-in. (203-mm) tear occurred vertically from the end anchorage rail bolt hole at post no. 1. Post no. 2 split vertically through the bolt hole.

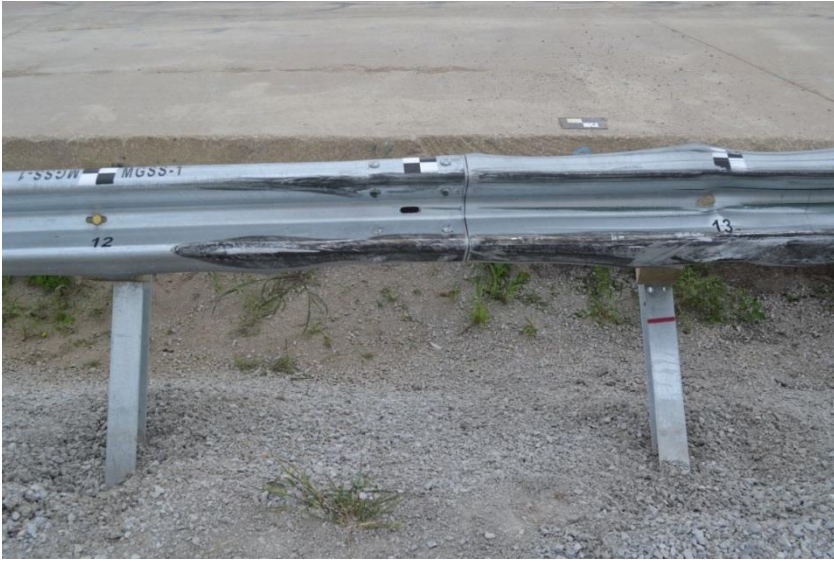
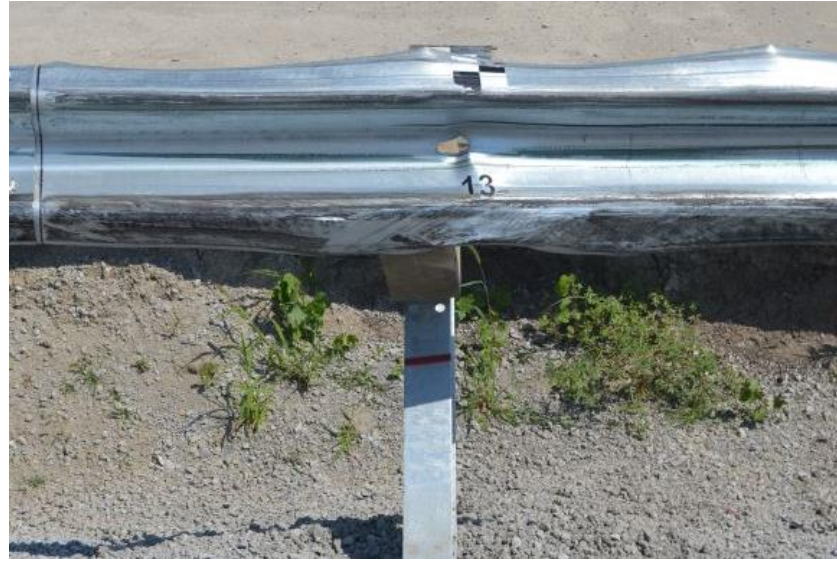
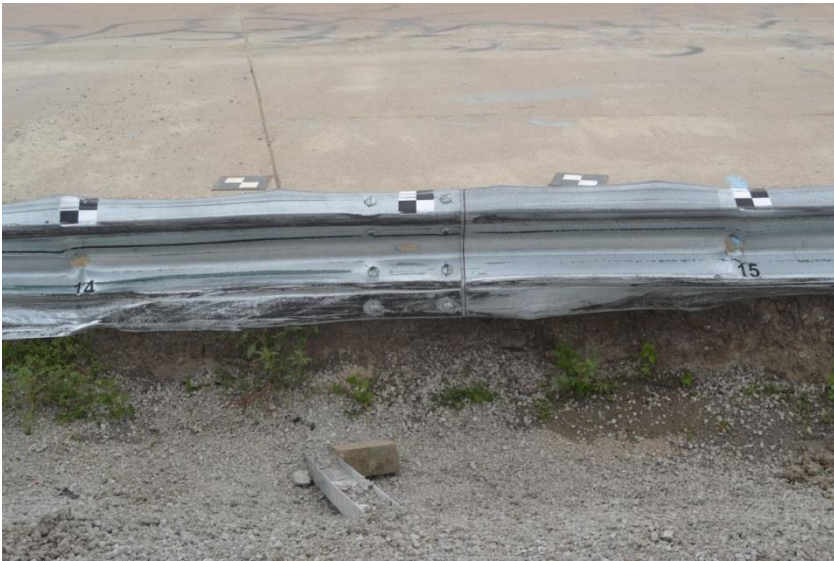
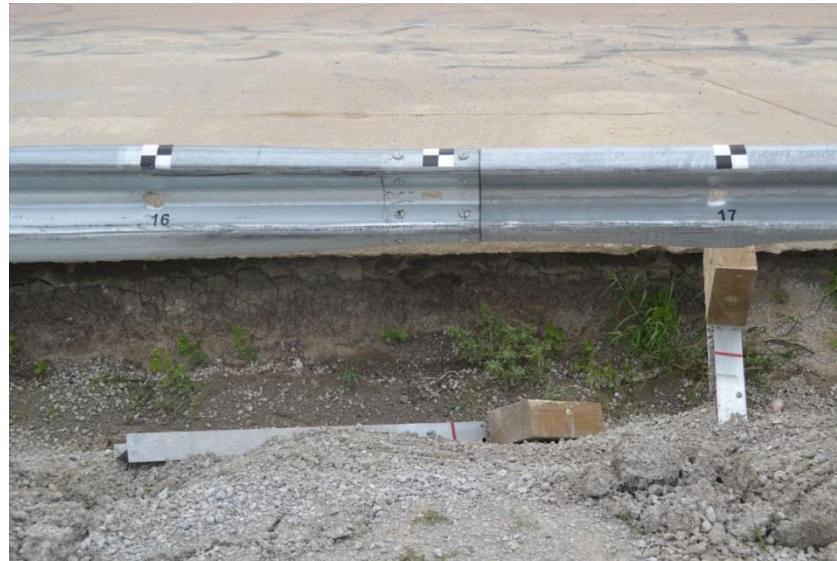
Figure 28. System Damage Between Post Nos. 12 and 17, Test No. MGSS-1

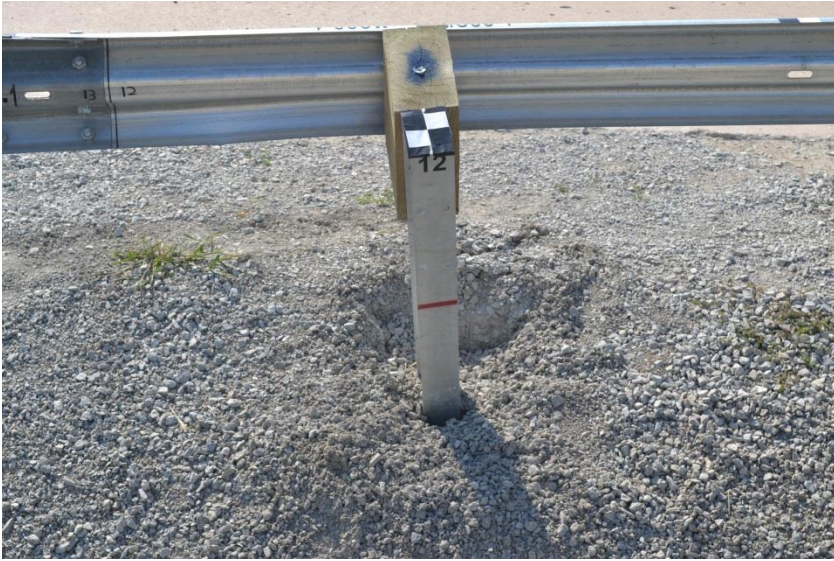
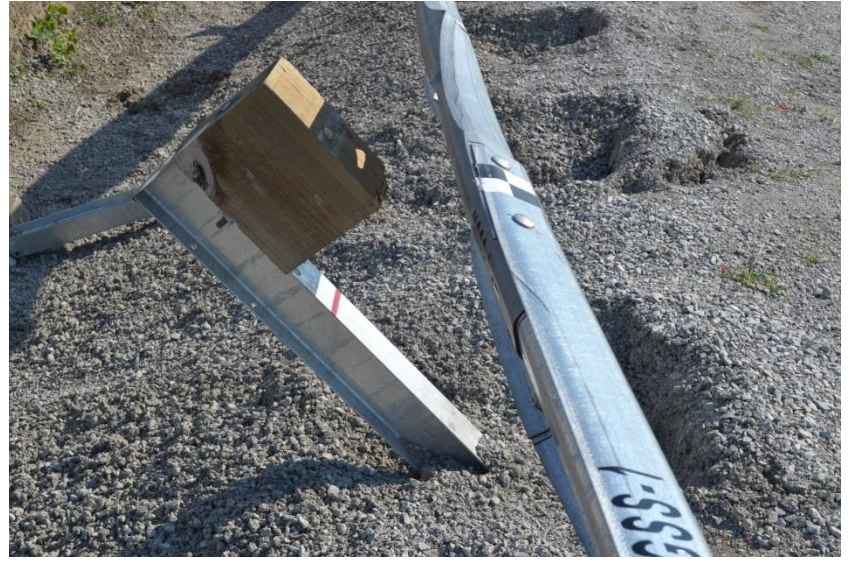
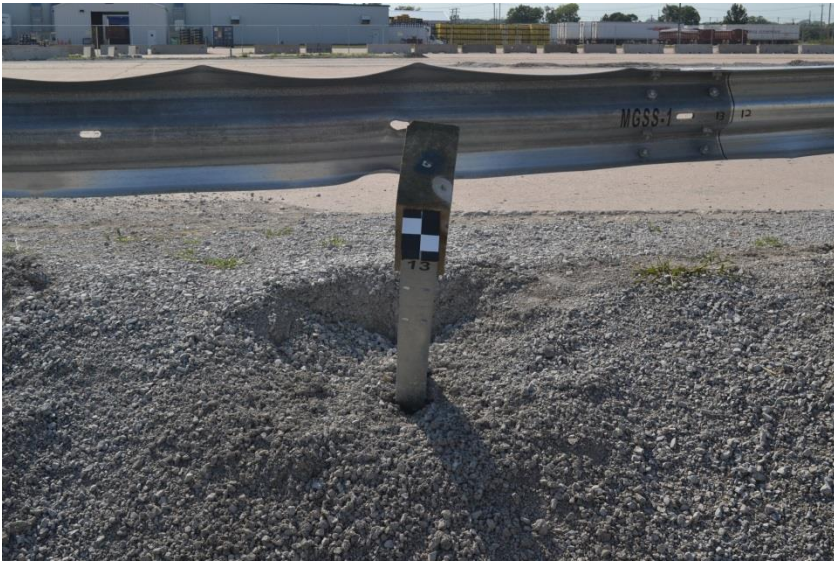
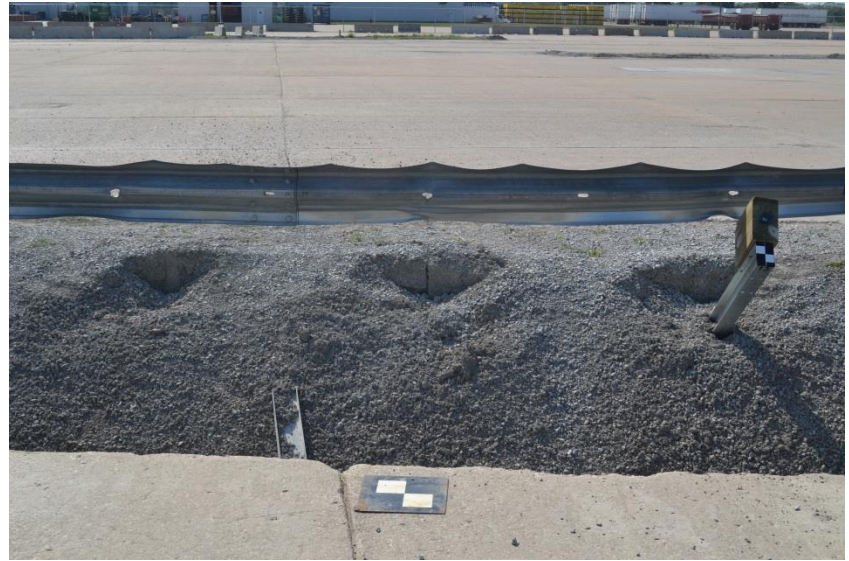
Figure 29. Post Damage Between Post Nos. 12 and 15, Test No. MGSS-1

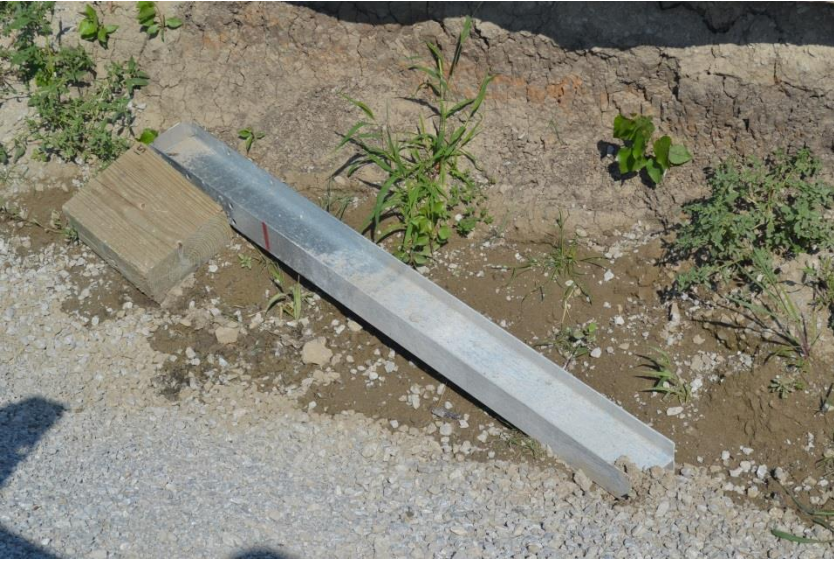
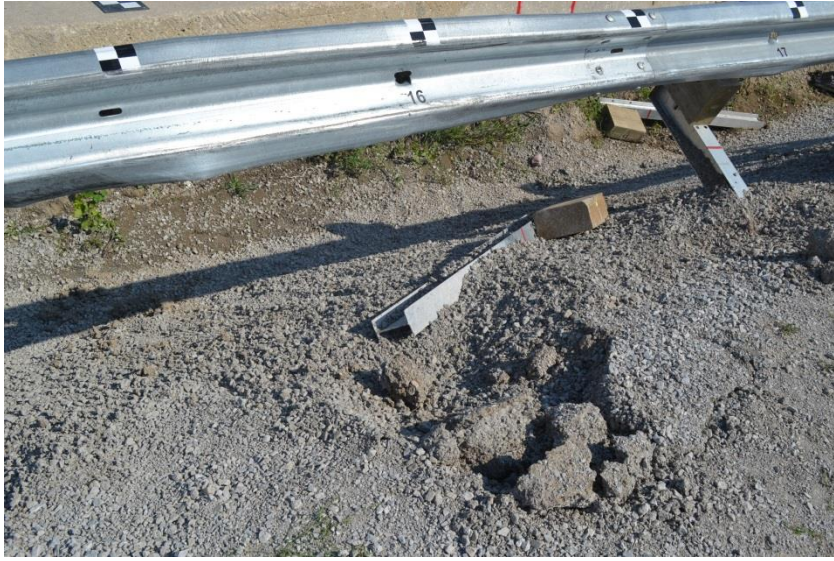
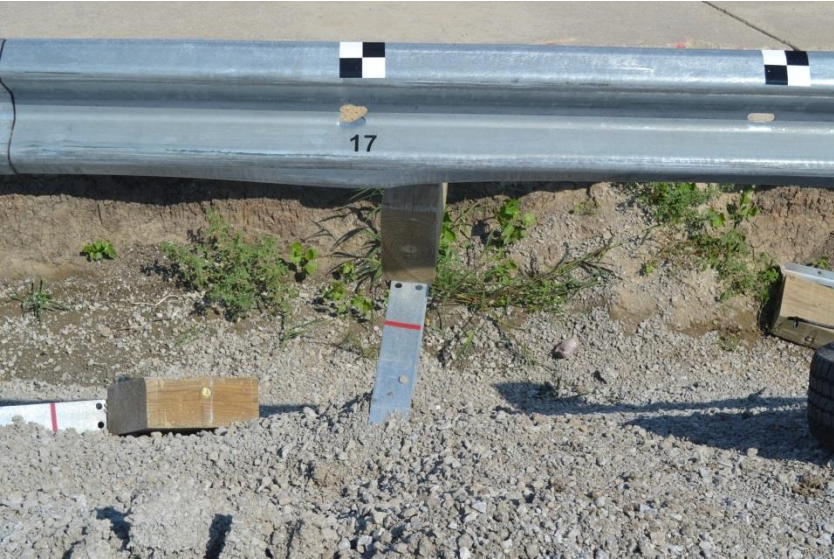
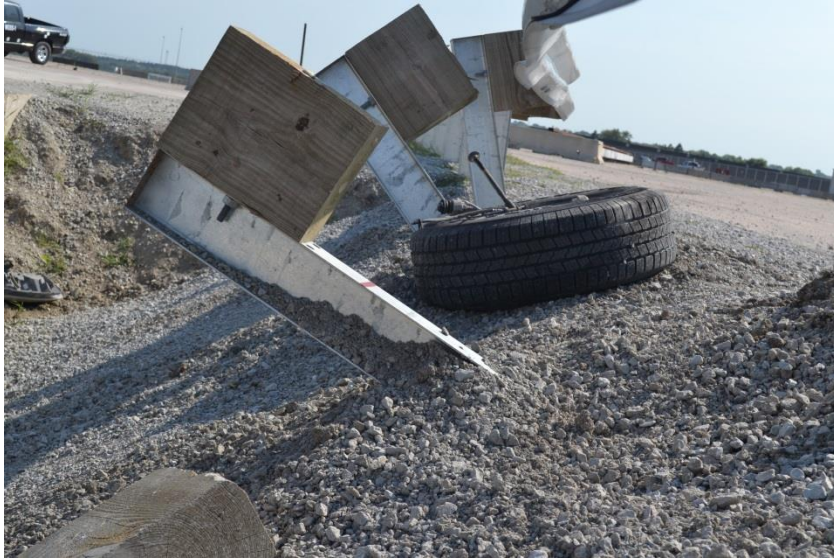
Figure 30. Post Damage Between Post Nos. 15 and 18, Test No. MGSS-1

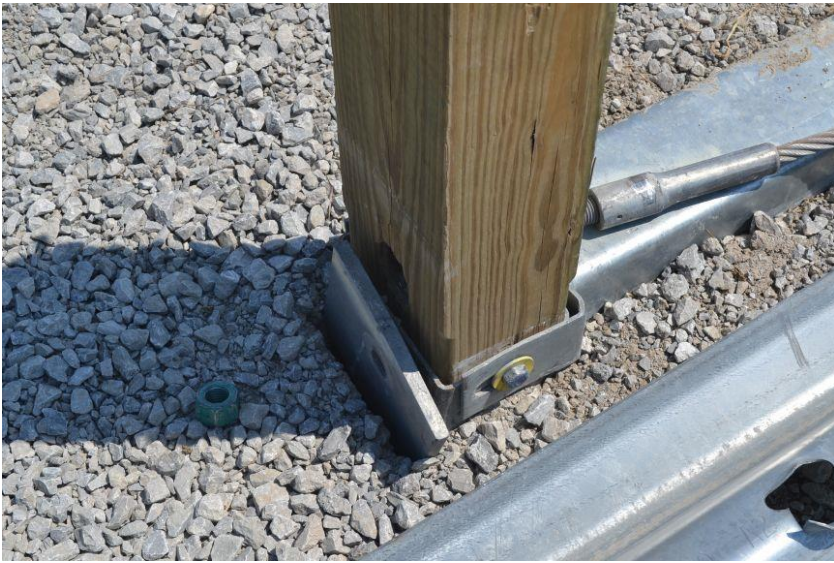
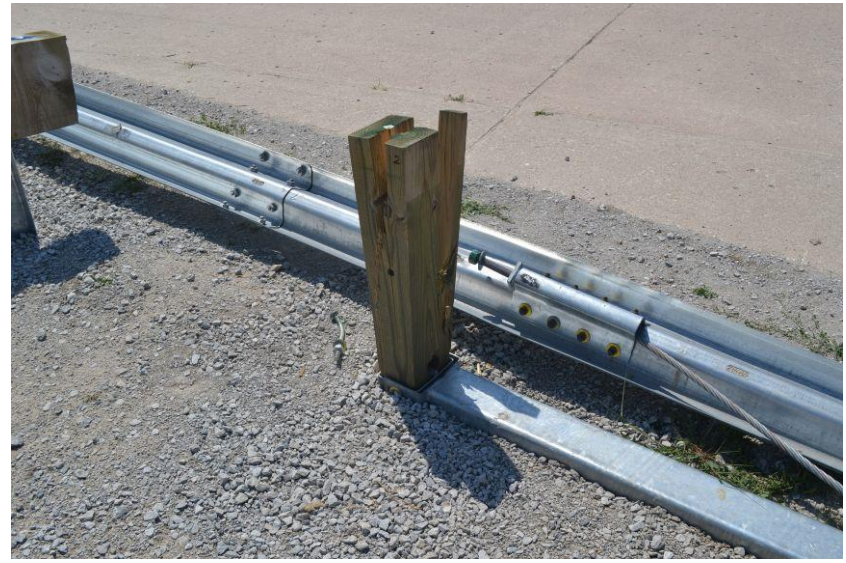
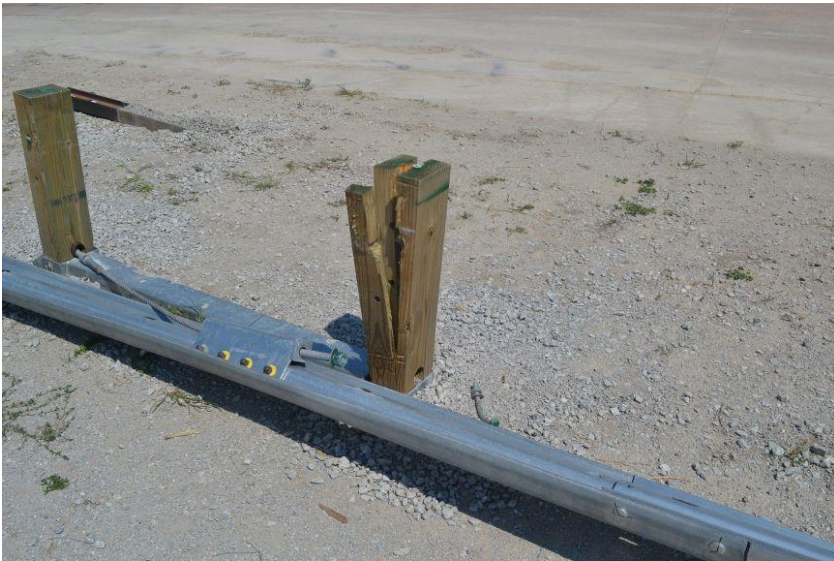
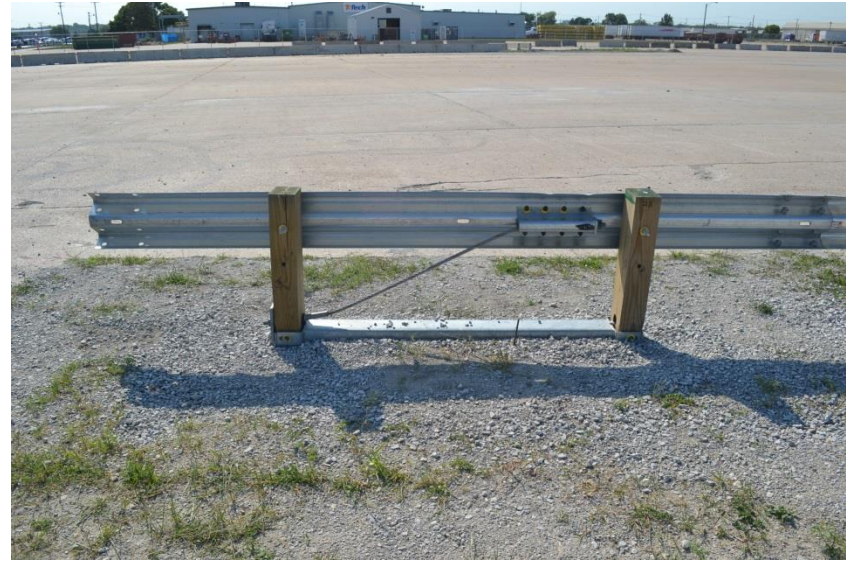
Figure 31. Upstream and Downstream Anchor Damage, Test No. MGSS-1

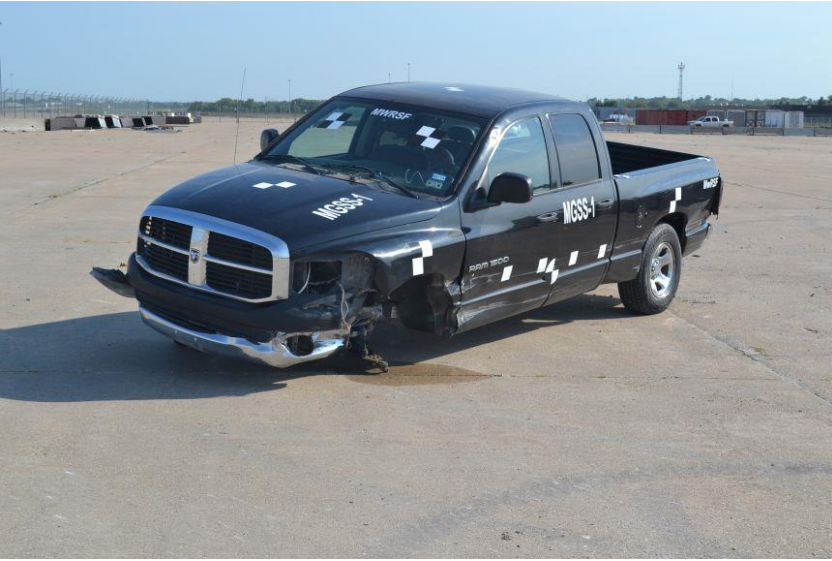
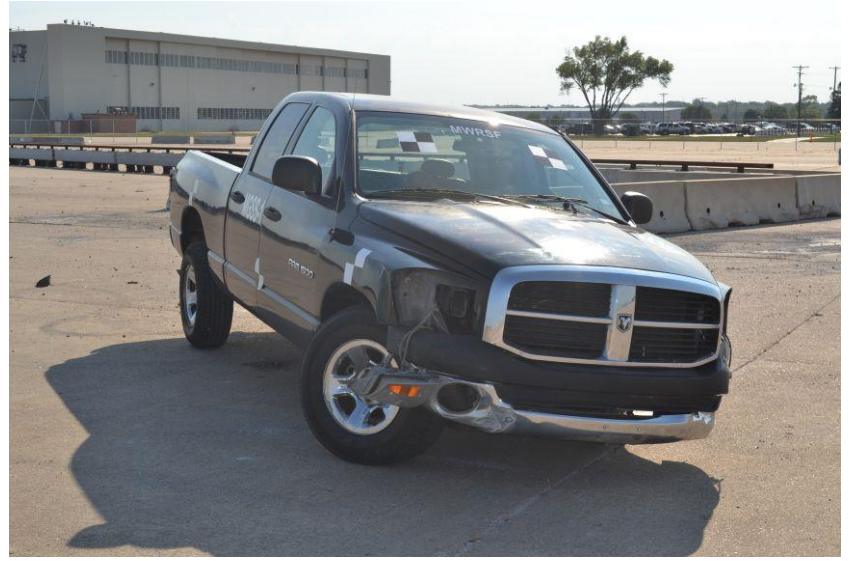
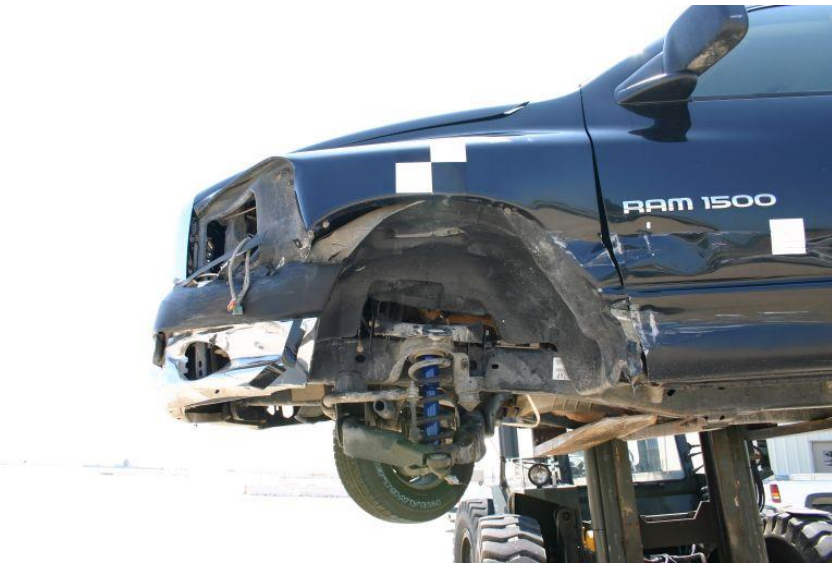
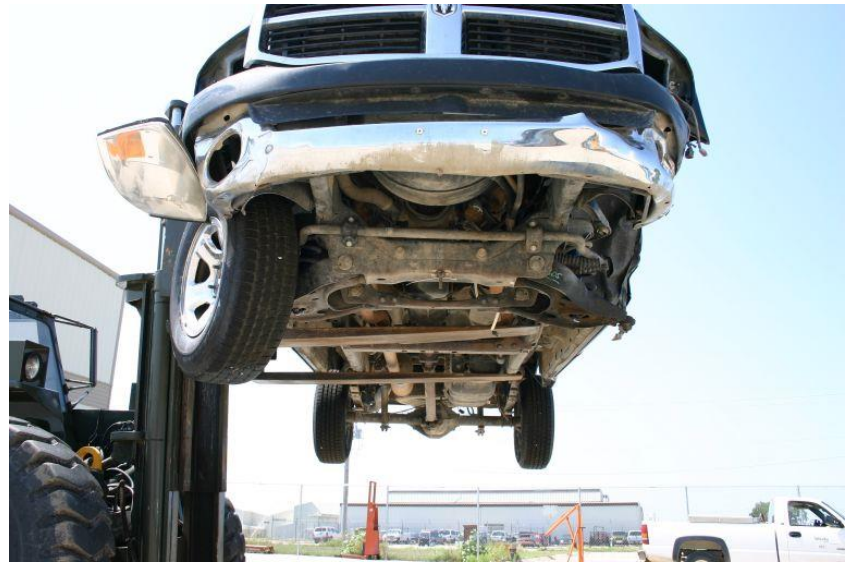
Figure 32. Vehicle Damage, Test No. MGSS-1

The damage to the vehicle was minor, as shown in Figure 32. The maximum occupant compartment deformations are listed in Table 5 along with the deformation limits established in MASH for various areas of the occupant compartment. Note that none of the MASH established deformation limits were violated. Complete occupant compartment and vehicle deformations and the corresponding locations are provided in Appendix D.

The majority of the damage was concentrated on the left-front corner and left side of the vehicle. Contact marks were found along the entire length of the left side of the vehicle and from the right-front bumper to the right-front wheel well. Dents were found on the front bumper and fenders and kinks were found on the bottom of the left-front fender. The left and right headlights disengaged. The left-front wheel assembly disengaged from the control arms and the lower portion of the spindle cracked. Tears 2 in. (51 mm) in length and contact marks were found on the left-front wheel extending from the rim, and contact marks appeared along the outer wall of the tire. Tearing occurred on the back of the left-front wheel well. A 1½-in. (38-mm) deep dent was found on the left-front fender at the back of the wheel. A ¾-in. (19-mm) separation formed between the roof and the left-front door. A small dent was found 14 in. (356 mm) from the bottom of the C-pillar. Denting appeared along the entire length of the left quarter panel. The left taillight partially disengaged, and a 1-in. (25-mm) deep dent was found on the left side of the rear bumper.

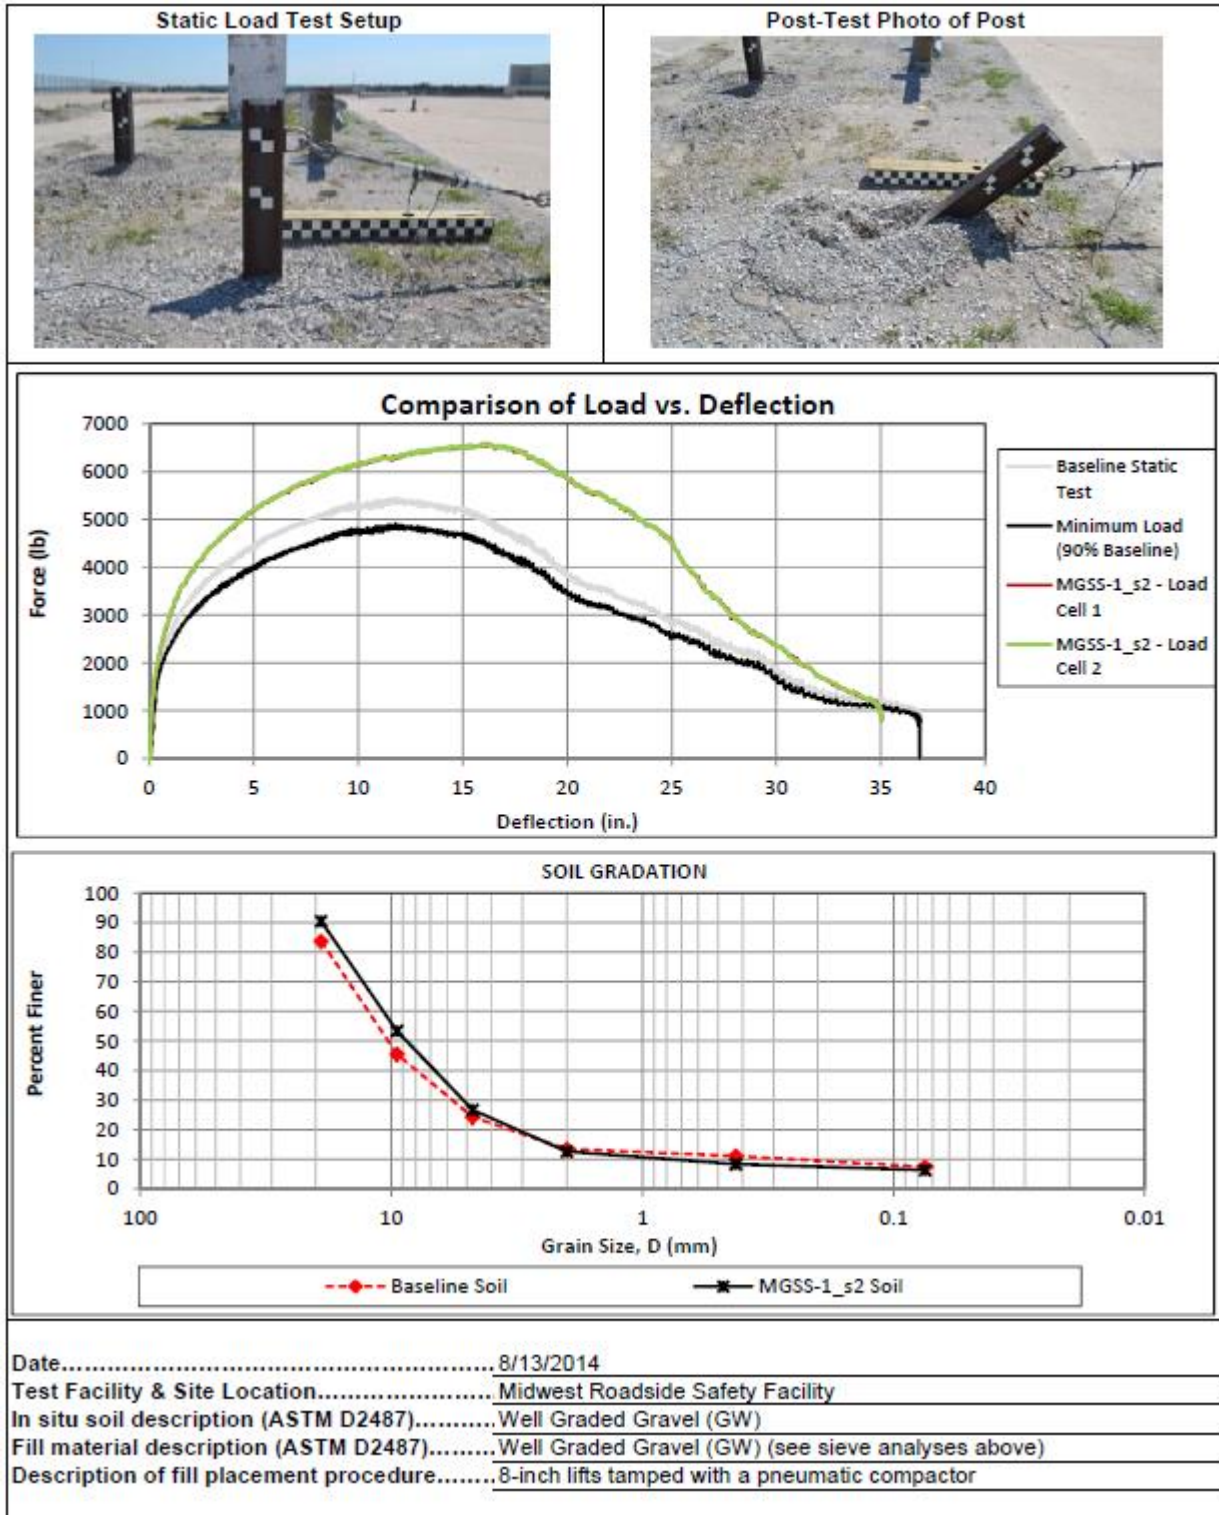
Figure C-2. Static Soil Test S2, Test No. MGSS-1

Before full-scale crash test no. MGSS-1 was conducted, the strength of the foundation soil was evaluated with a static test, as described in MASH. The static test results, as shown in Appendix C, demonstrated a soil resistance above the baseline test limits. Thus, the soil provided adequate strength, and full-scale crash testing could be conducted on the barrier system.

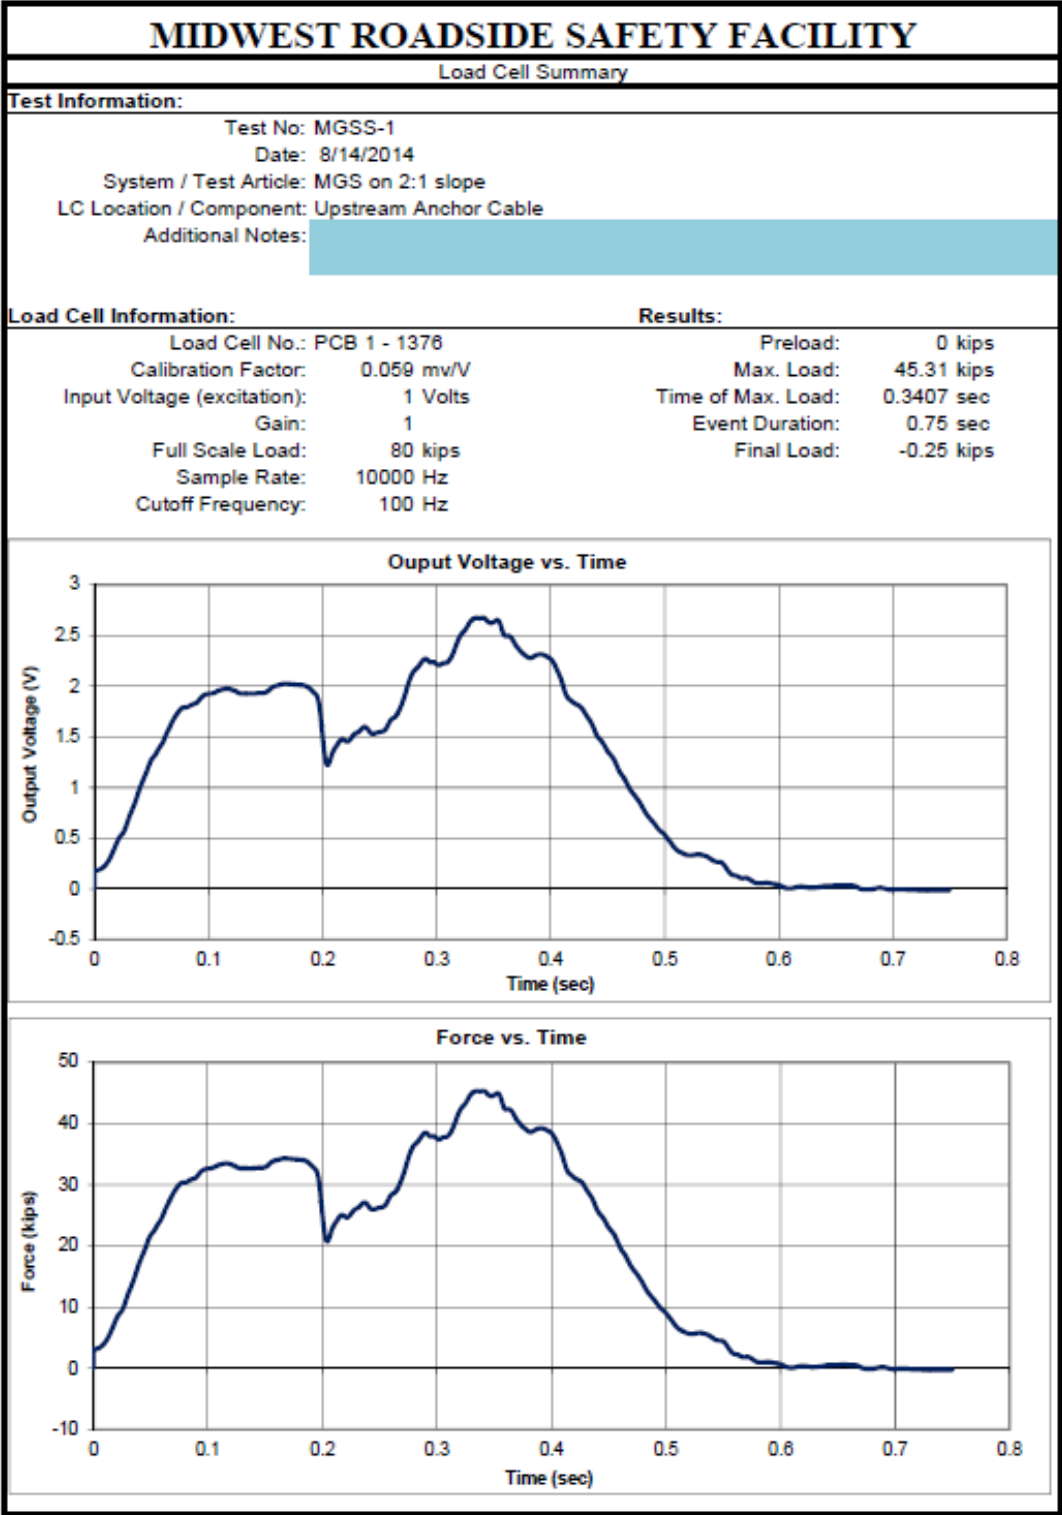
Figure F-1. Upstream Load Cell Data, Test No. MGSS-1
