MASH TL-4 Design and Evaluation of A Restorable Energy-Absorbing Concrete Barrier

Transportation Research Board
95th Annual Meeting
January 10-14, 2016
Washington, D.C.

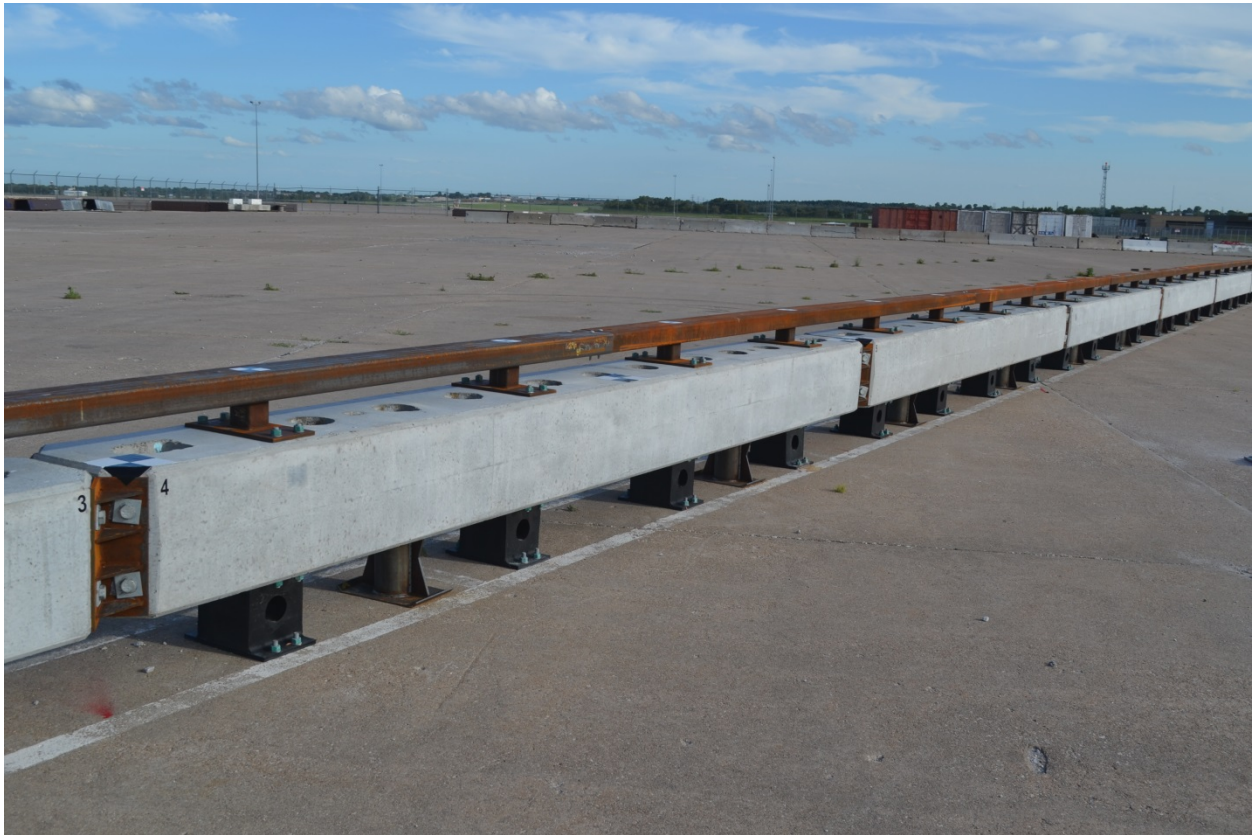
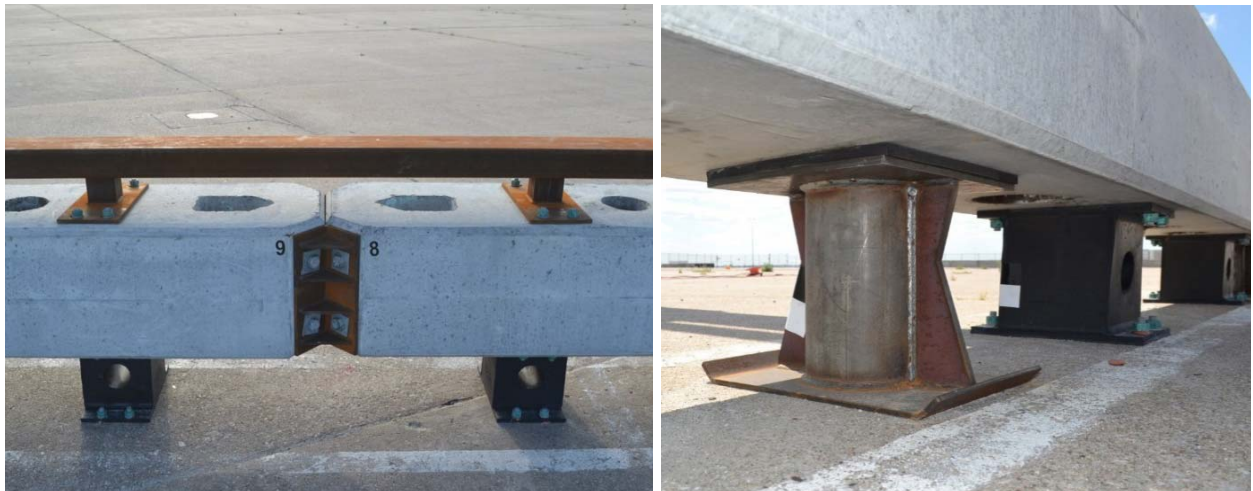
FIGURE 1 View of initial concept with elastomer posts and metal skins (4,14).

29 Photographs of the design selected for further evaluation via computer simulation and full-scale
30 crash testing is shown in FIGURE 1 (4,14).

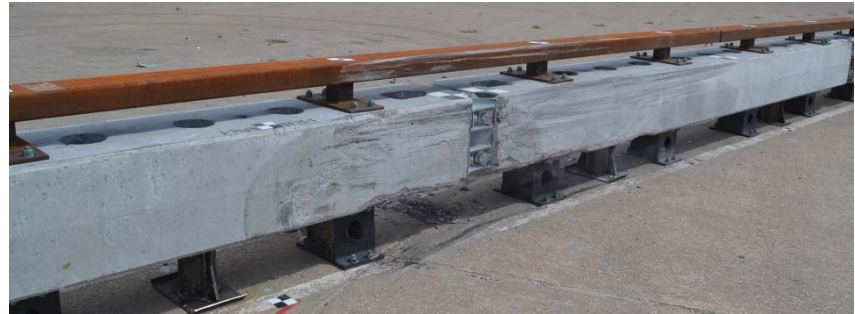
(b) System Damage

FIGURE 3 System and vehicle damage in test SFH-1, (a) sequential photos, (b) system damage, (c) joint at barriers 5 and 6, (d) post contact, and (e) vehicle damage.

28 Barrier damage consisted of contact marks, concrete spalling and gouges, and hairline
29 concrete cracks. The length of vehicle contact along the barrier was approximately 15 ft – $\frac{1}{4}$ in.
30 The front faces of barriers 5 and 6 were gouged from wheel contact. The joints between barriers
31 5 and 6 maintained strength during and after impact, but upon removal of the joints, several
32 concrete pieces between the splice bolts on the frontside of the beams had fractured off up to the
33 reinforcement. The first two posts downstream from the splice between barriers 5 and 6 had
34 contact marks along the front face and part of the upstream face. Permanent set was
35 approximately $\frac{7}{8}$ in. The working width of the system was found to be 33.5 in.

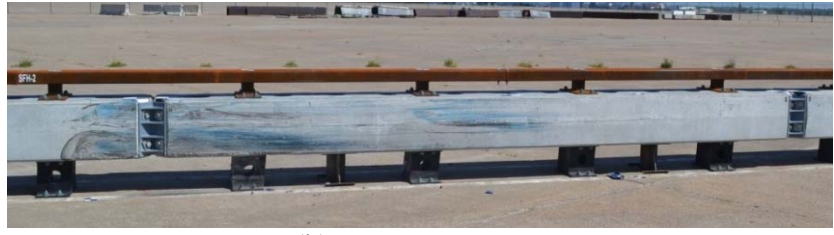
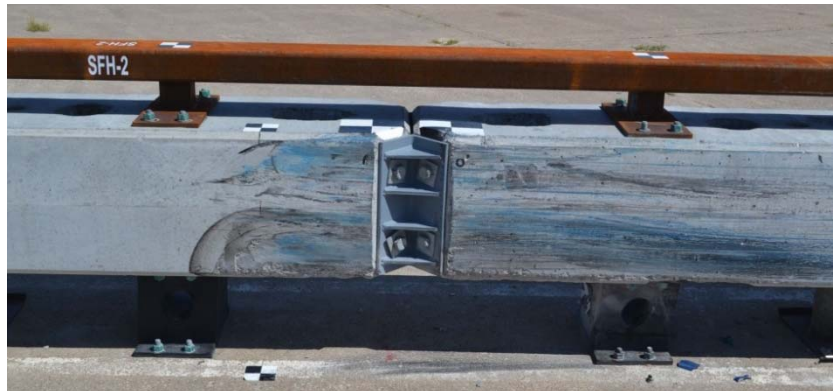
FIGURE 5 System and vehicle damage in test SFH-2, (a) sequential photos, (b) system damage, (c) system damage, (d) post damage, and (e) vehicle damage.

12 Barrier damage consisted of gouging and contact marks on the front face of concrete
13 beams 7 and 8 and cuts in the elastomer posts. The length of the vehicle contact along the barrier
14 was approximately 12 ft – 7 in. The first post downstream from the joint between barriers 7 and
15 8 had a 3½-in. wide x 7-in. tall contact mark on the upstream face and was cut along the length
16 of the front face 3 in. above the groundline that had a maximum depth of ½ in. due to contact
17 with the vehicle's rim. The second post downstream from the joint between barriers 7 and 8 was
18 cut along the length of the front face located 4 in. above the groundline that had a maximum
19 depth of 2 in. The upstream corner of the front face had contact marks 5¼ in. wide x 7 in. tall.
20 The vehicle re-contacted the system after exiting the system initially.

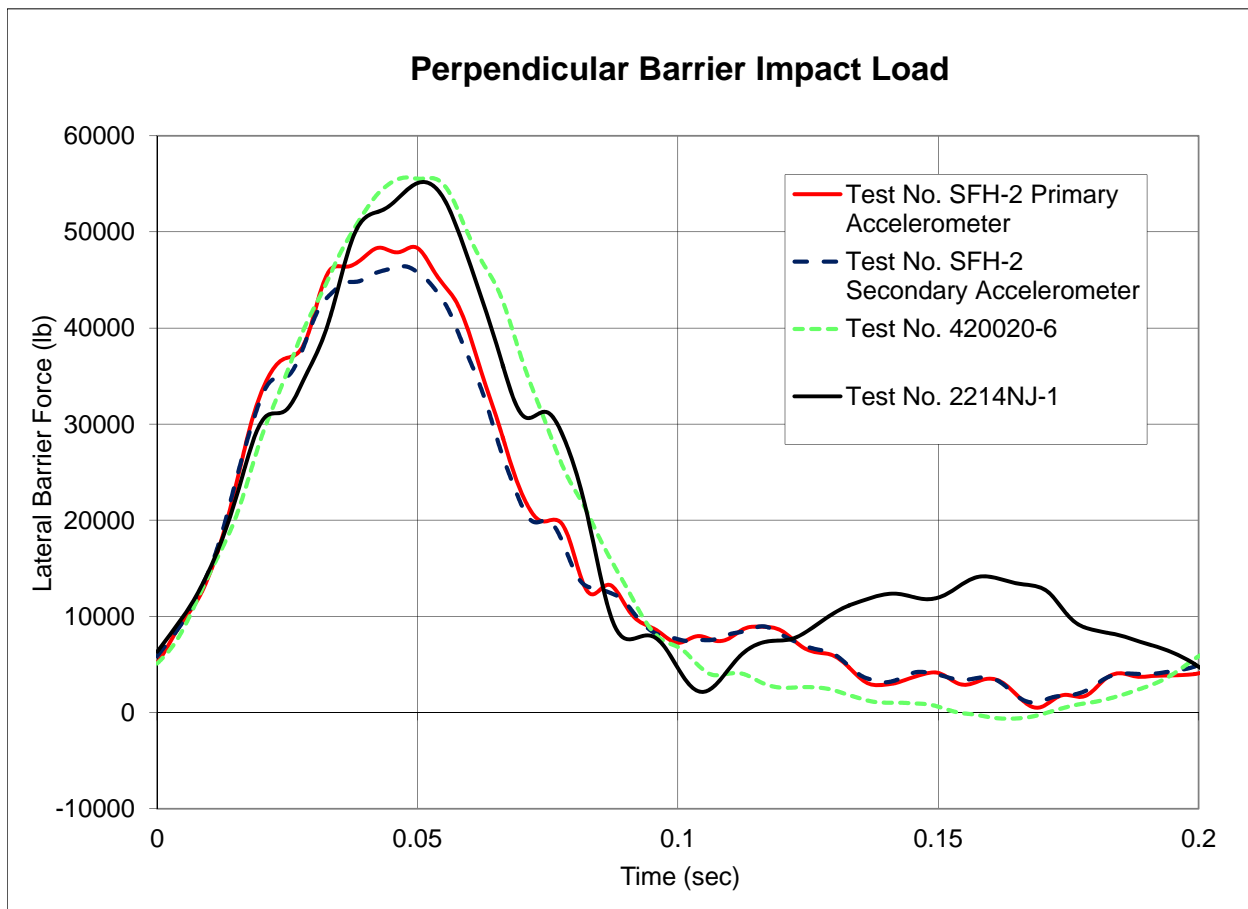
FIGURE 6 Test Comparison of 1100C vehicle impacts.

40 The test comparison matrix and the force comparison plots for the 1100C vehicle are
41 shown in FIGURE 6. The lateral peak barrier forces were reduced 15 percent and 16 percent
42 when compared to tests 420020-6 and 2214NJ-1, respectively. The MASH-recommended CFC
43 180 10-ms average peak lateral acceleration increased 23 percent when compared to test 420020-
44 6 and decreased 21 percent when compared to test 2214NJ-1. The peak lateral acceleration may
45 have been lower in the steel median gate; since, it had lower inertia, may have deformed more,
46 and may have distributed load more efficiently than concrete. Additionally, the energy-absorbing

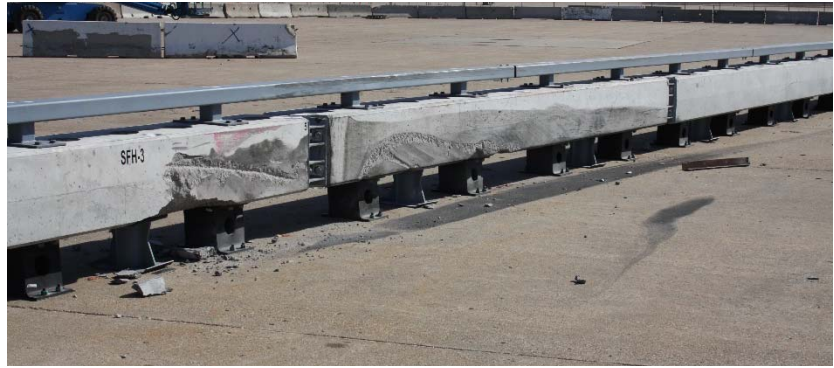
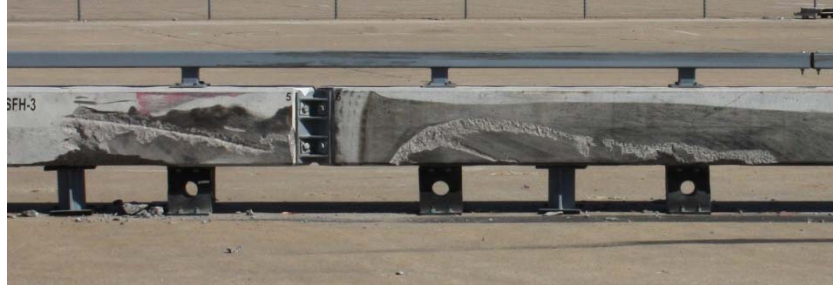
FIGURE 7 System and vehicle damage in test SFH-3, (a) sequential photos, (b) system damage, (c) system damage, (d) barriers 6 and 7 damage, and (e) vehicle damage.

14 Barrier damage consisted of contact marks and gouging on the front face of the concrete
15 beams, cracking and spalling at the joint connections, contact marks along the top of the concrete
16 beams and along the upper tube assembly, and contact marks on the elastomer posts. The length
17 of the vehicle contact along the barrier was approximately 59 ft – 3 in. The front faces and
18 bottom edges of barriers 5 and 6 were gouged from wheel contact with the system. The first post
19 upstream from the joint between barriers 5 and 6 had a ¼-in. deep x 1-in. diameter semicircular
20 cut on the front face from contact with the left-front tire lug nuts. The top of barriers 6, 7, and 8
21 were gouged from contact with the underside of the cargo box. The joints between barriers 4 and
22 5 through barriers 8 and 9 maintained strength during and after impact, but upon removal of the
23 joints, several concrete pieces on the lower half of the beams had fractured off up to the

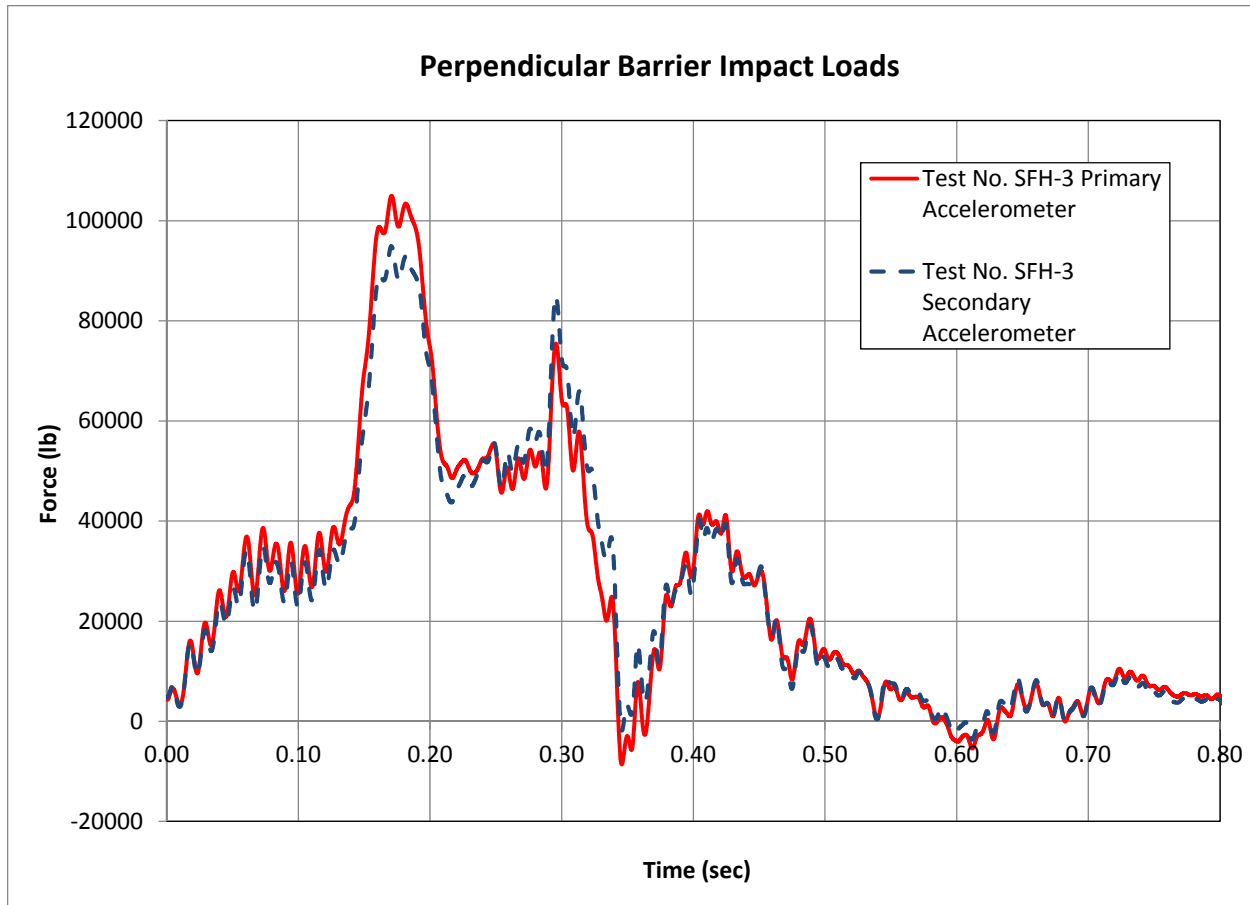
1
2 **FIGURE 8 Perpendicular barrier forces in test SFH-3.**

37 While it was not a design criteria to reduce lateral accelerations for the single-unit truck,
38 MASH test designation 4-12 crash tests with rigid concrete barriers were desired to compare
39 barrier forces. However, test data was not available to compare barrier forces. The vehicular
40 loading applied to the barrier system in test SFH-3 was calculated the same as previously. From
41 the data analysis, the perpendicular impact force was determined, as shown in FIGURE 8. The
42 maximum perpendicular, or lateral, load imparted to the barrier was 105 kips and 95 kips, as
43 determined by the primary and secondary accelerometers, respectively.

1 The barrier also adequately contained and redirected the MASH TL-4 single-unit truck.
2 The structural capacity was sufficient to sustain the maximum perpendicular load of 105 kips
3 with only minimal damage to the system.
