Evaluation of the Environmental Impacts of Bridge Deck Runoff

Report SPR-P1(12) M315

Final Report
26-1121-4008-001

Evaluation of the Environmental Impacts of Bridge Deck Runoff – Preliminary Draft

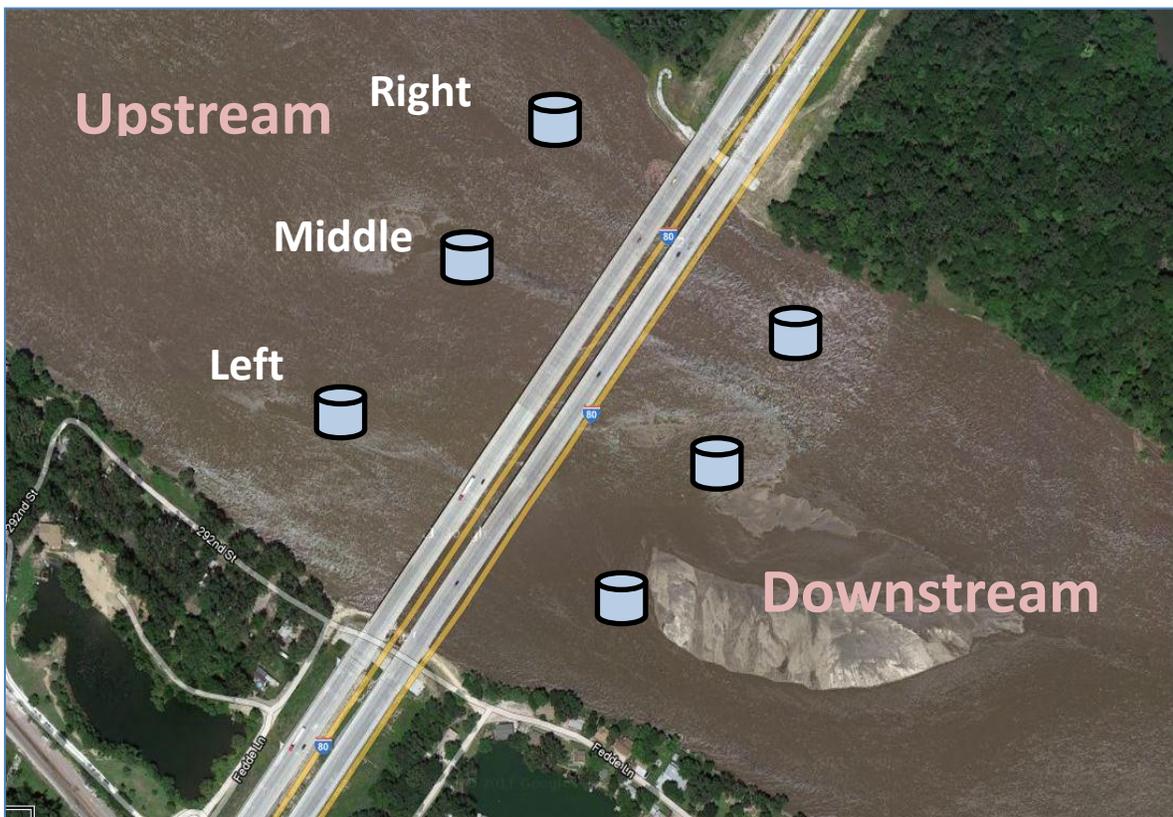
Figure 2.2 Dry weather sampling sites at the I-80 over the Platte River bridge

Dry weather in-stream samples were collected at the I-80 bridge over the Platte river site and the Highway 77 bridge over Rock Creek just south of Ceresco site. Samples were collected by facing a bottle lengthwise with its opening facing downstream, submerging it in the water at half of the stream depth. At both sites, three grab samples were collected upstream and three were collected downstream of the bridge. Aerial views of each bridge are shown in figures 2.2 and 2.3, respectively.

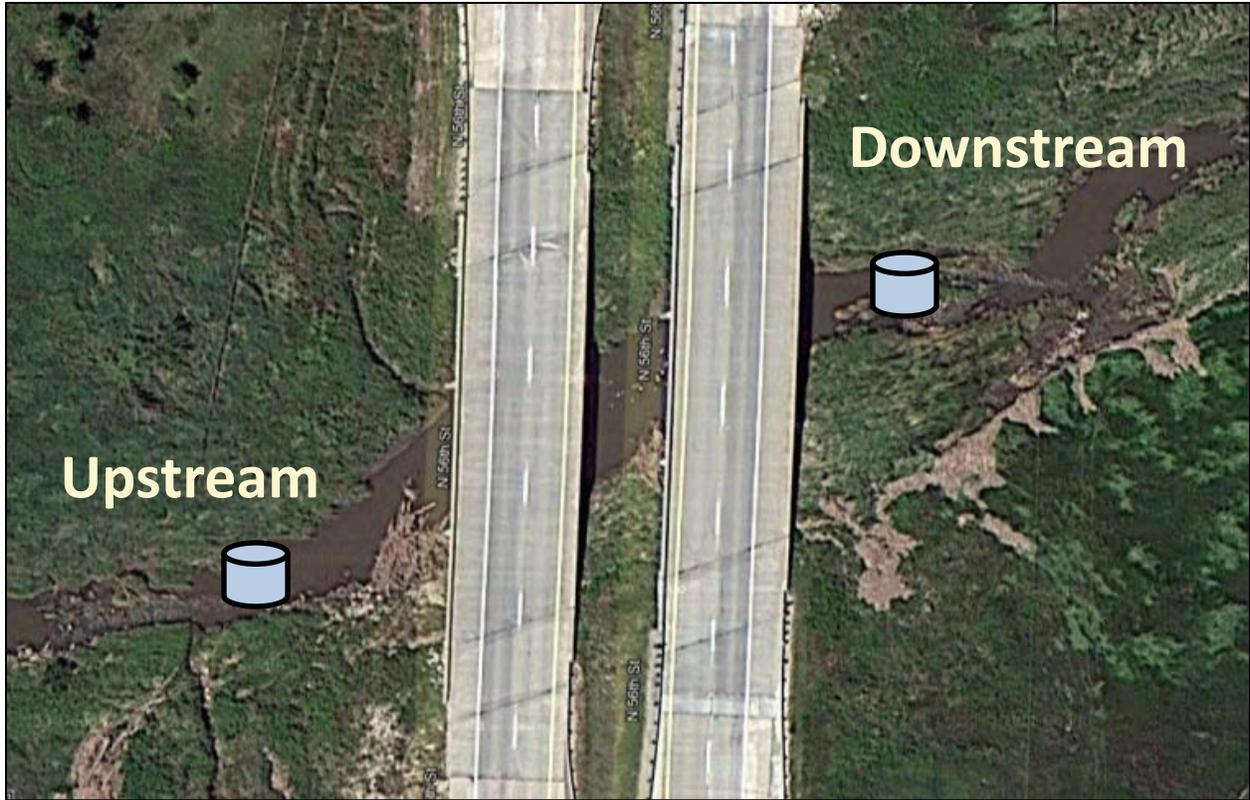
Figure 2.3 Dry weather sampling sites at the Highway 77 over Rock Creek bridge

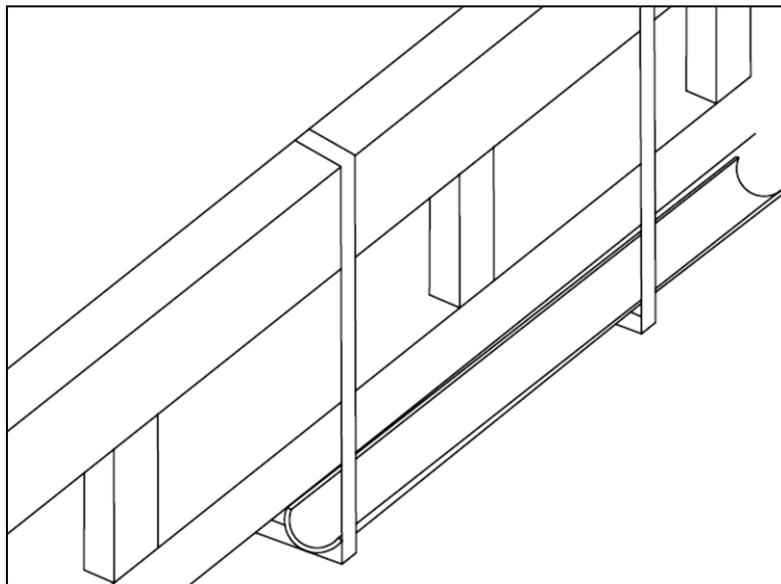
Figure 2.4 Perspective drawing of bridge gutter system

during the wet season. Lourdes Mena, a U.S. Fish and Wildlife Service (USFWS) contaminants biologist, was also consulted during this decision. She concluded this was an acceptable sampling method for a preliminary study. Figures 2.5, 2.6, and 2.7 show pictures of the bridge gutter system installed at some of the bridge sites.

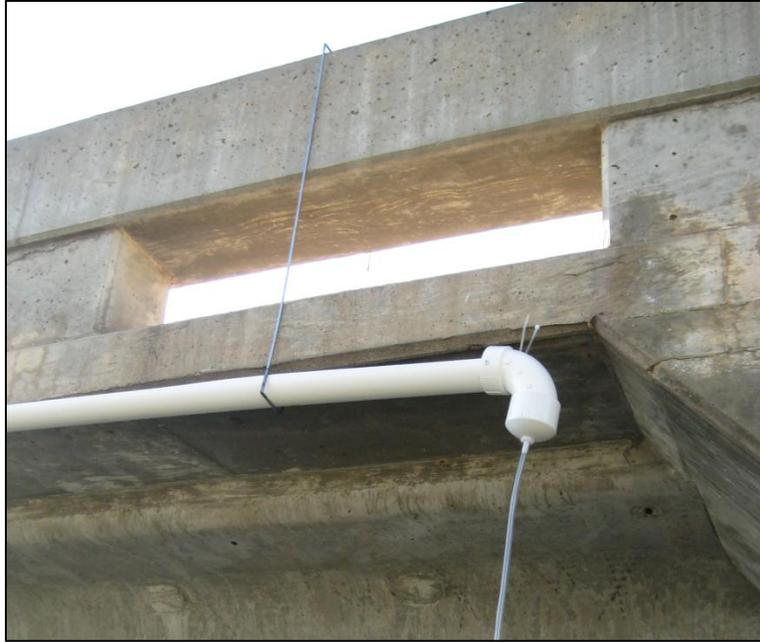
Figure 2.5 Bridge gutter installed at Highway 64 over the Platte River near Leshara, NE

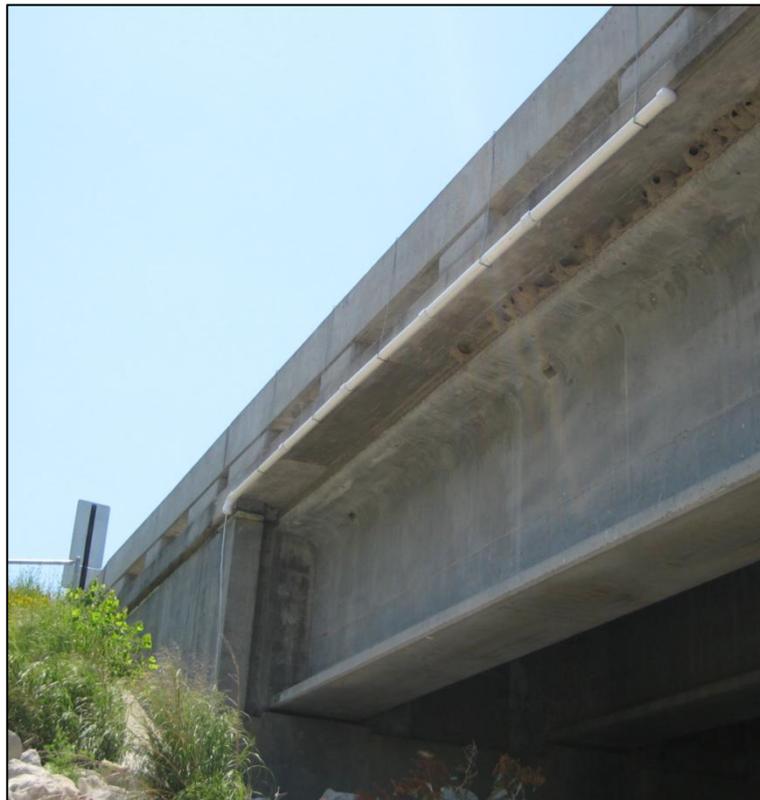
Figure 2.6 Bridge gutter installed at I-80 over Platte River site

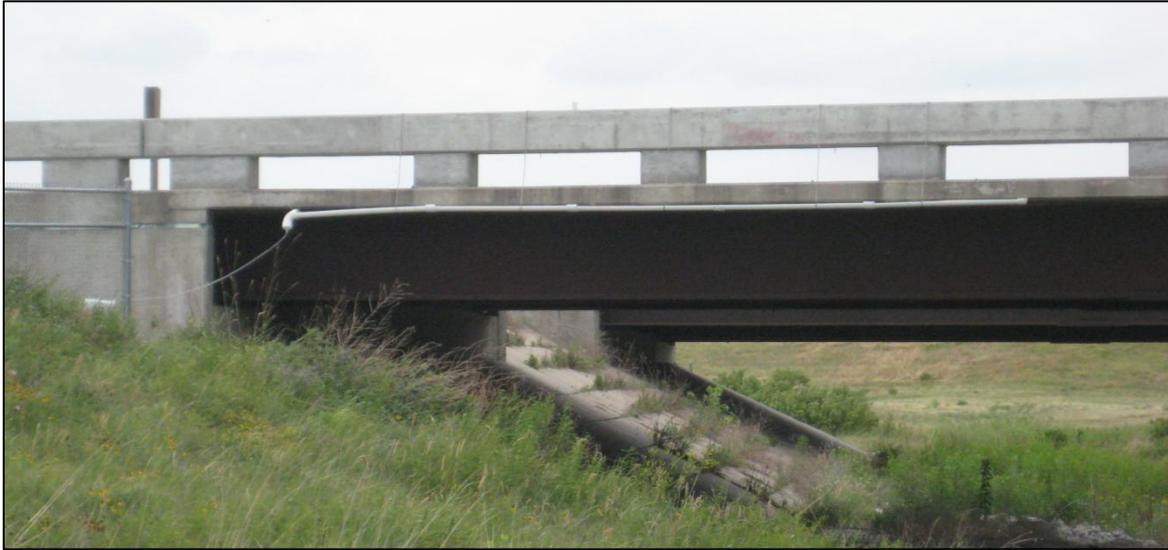
Figure 2.7 Bridge gutter installed at I-80 over Little Salt Creek site near 27th Street exit in Lincoln, NE

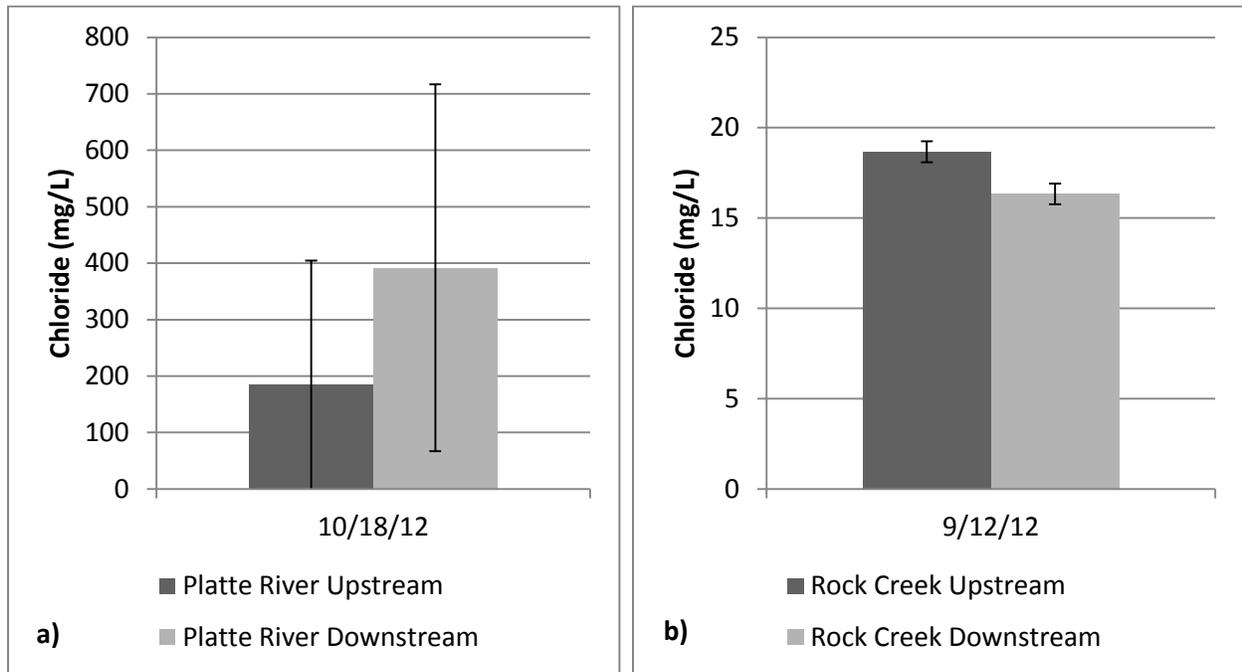
Note differences in the magnitudes of the y-axes.

Figure 3.1 Comparison of upstream and downstream chloride values a) Platte River b) Rock Creek

The following figures show a comparison of upstream and downstream values at the I-80 over the Platte River bridge and Highway 77 over Rock Creek bridge locations. Some constituents were not detected and were not graphed in this section, including BTEX compounds, arsenic, cadmium, chromium, copper, hexane extractable materials, nickel, and zinc. See section 2.4 for the analyses and limits, and the appendix for the raw data tables.

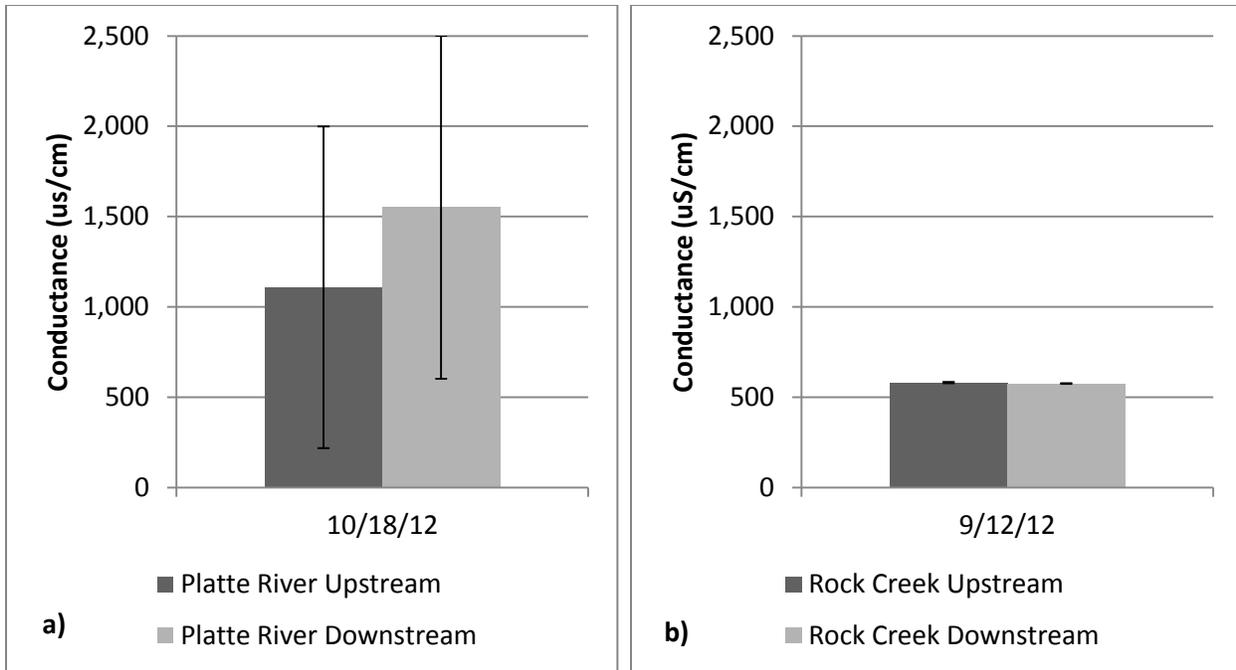
Figure 3.2 Comparison of upstream and downstream conductance a) Platte River b) Rock Creek

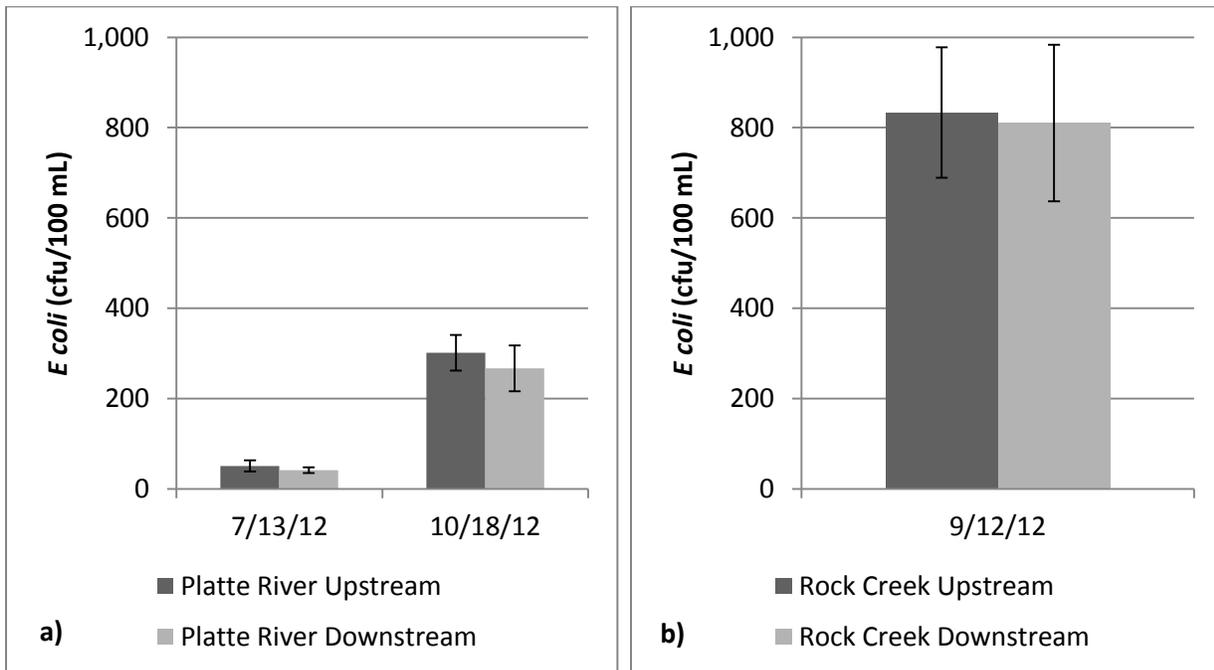
Figure 3.3 Comparison of upstream and downstream *E. coli* values a) Platte River b) Rock Creek

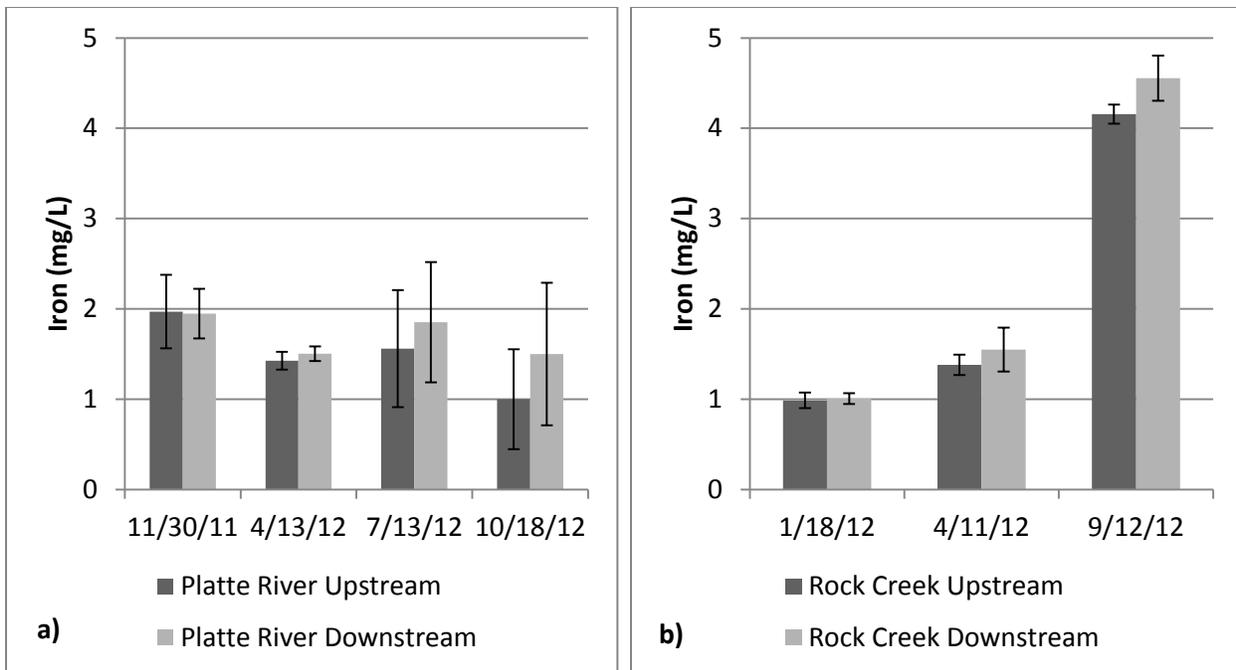
Figure 3.4 Comparison of upstream and downstream iron values a) Platte River b) Rock Creek

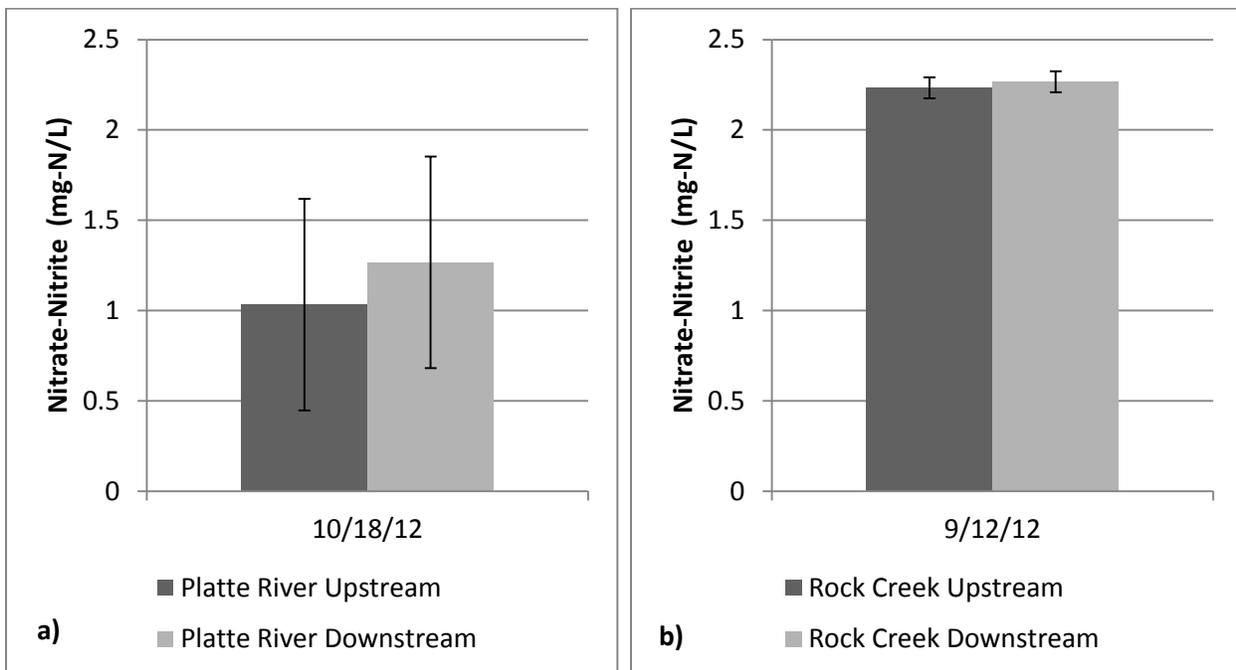
Figure 3.5 Comparison of upstream and downstream nitrate-nitrite values a) Platte River b) Rock Creek

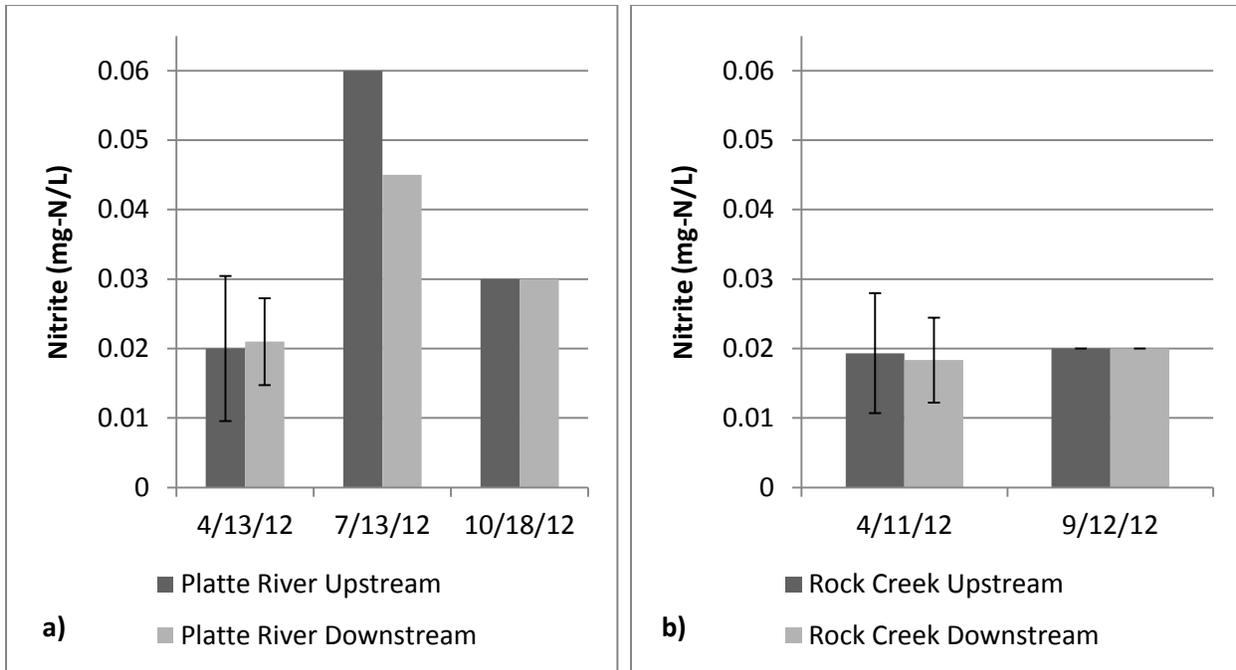
Figure 3.6 Comparison of upstream and downstream nitrite values a) Platte River b) Rock Creek

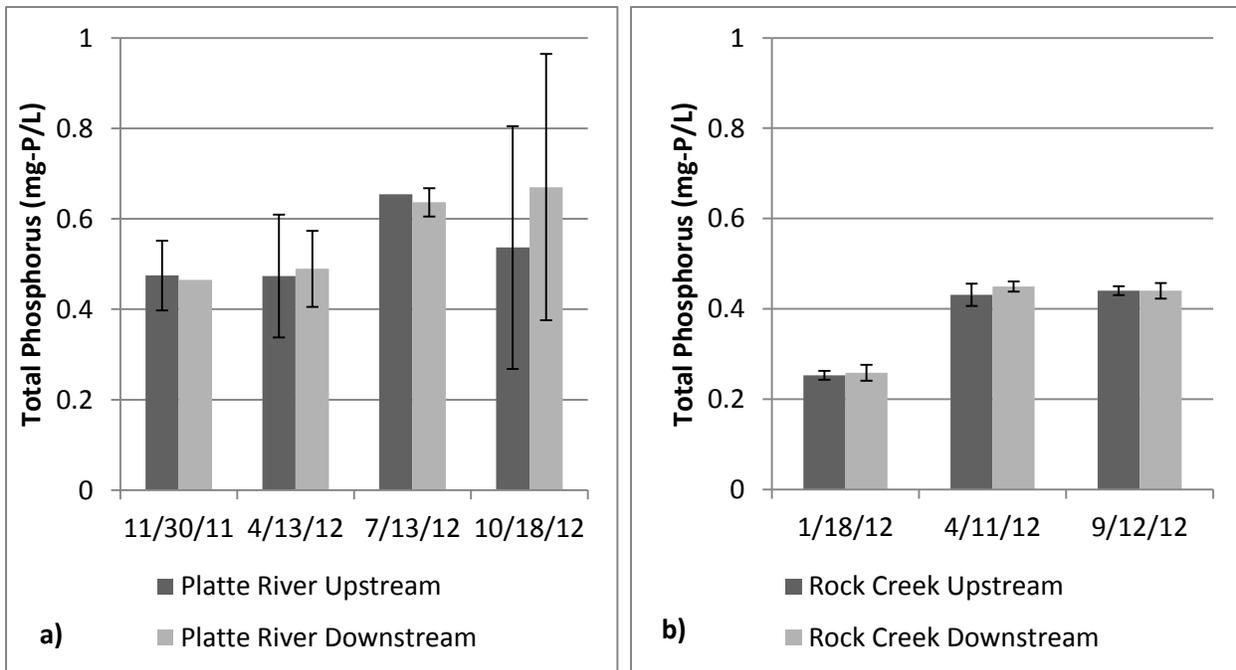
Figure 3.7 Comparison of upstream and downstream total phosphorus values a) Platte River b) Rock Creek

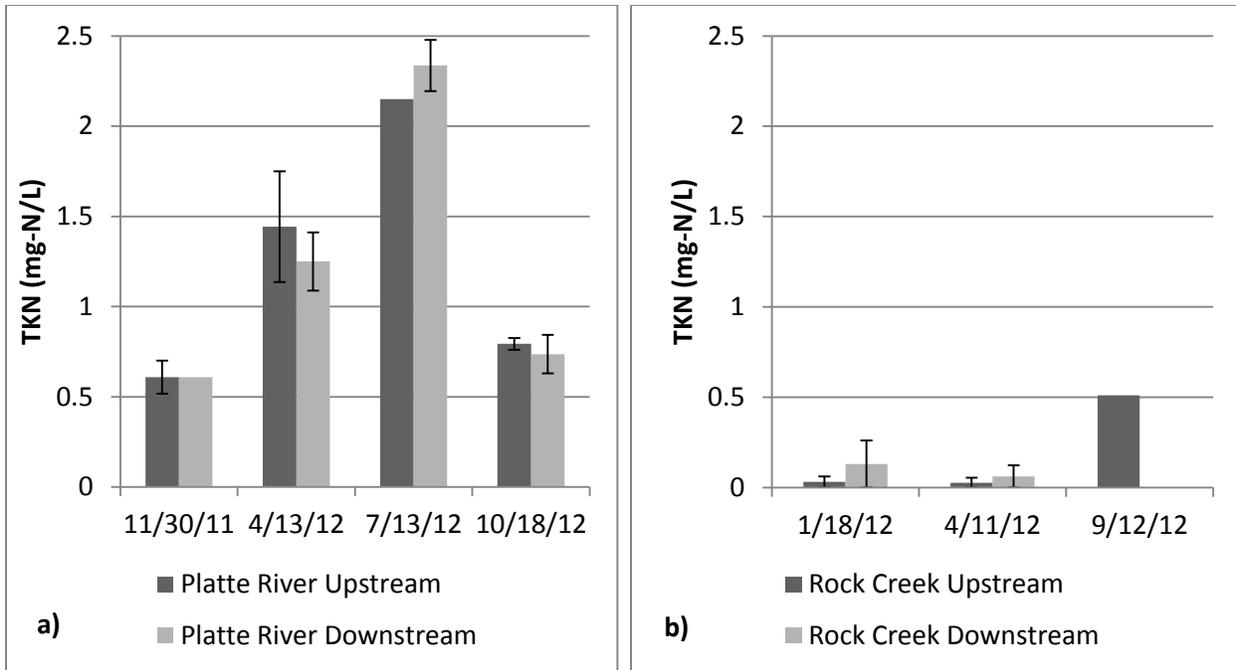
Note the differences in magnitudes of the y-axes. Also note that only one sample had TKN detected upstream in Rock Creek on 9/12/12, and none were detected downstream. This could be due to sampling or analysis error.

Figure 3.8 Comparison of upstream and downstream TKN values a) Platte River b) Rock Creek

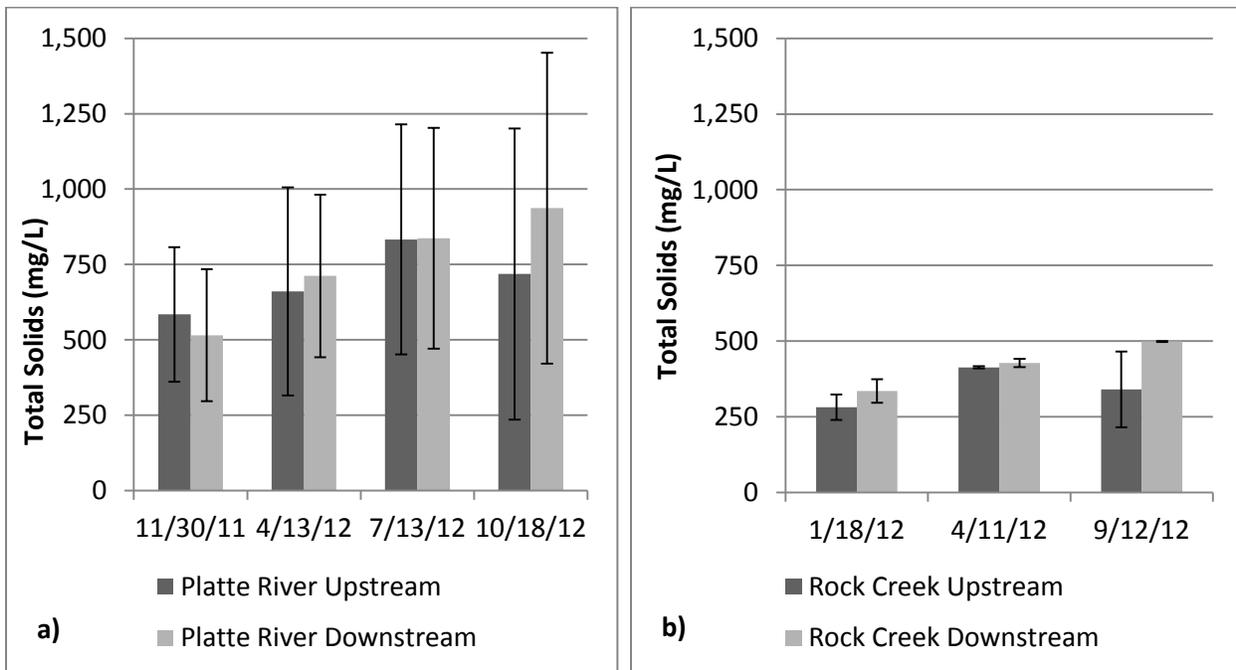
Figure 3.9 Comparison of upstream and downstream total solids values a) Platte River b) Rock Creek

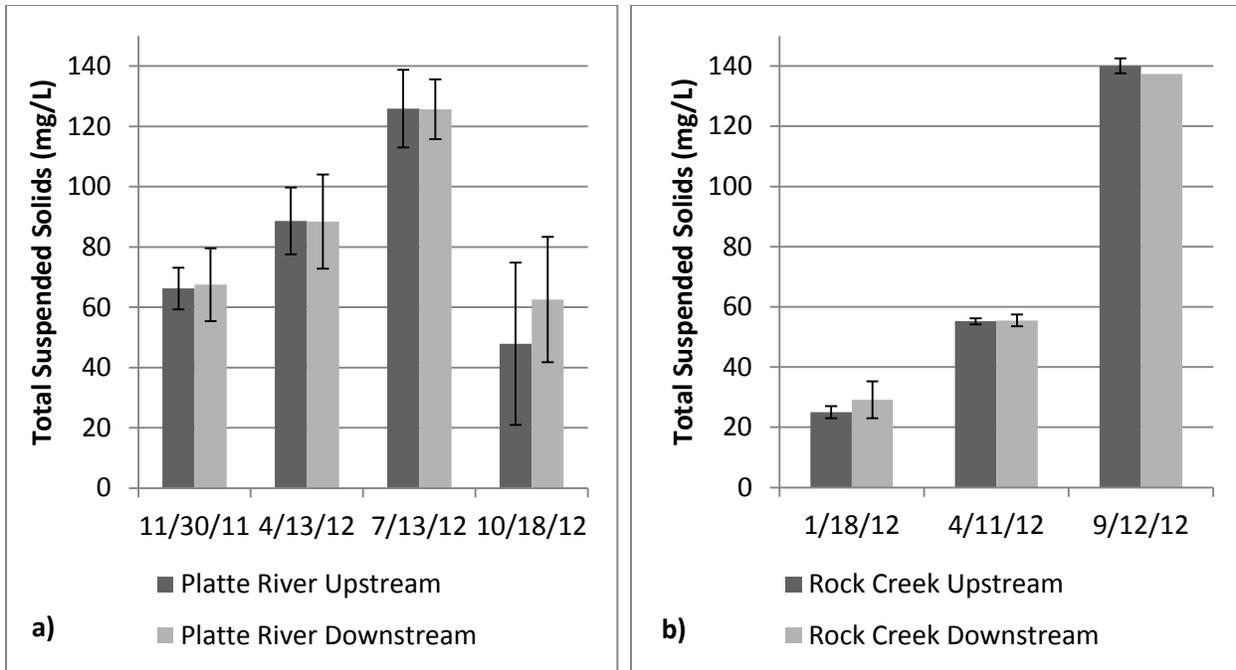
Figure 3.10 Comparison of upstream and downstream total suspended solids values a) Platte River b) Rock Creek

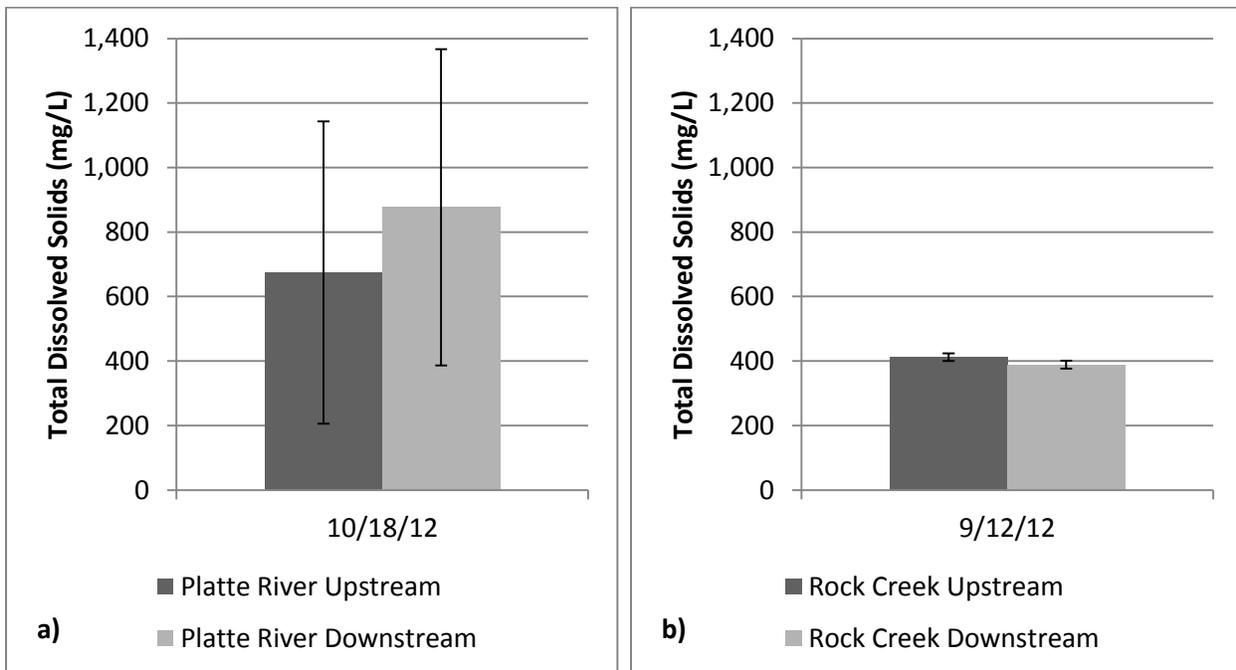
Figure 3.11 Comparison of upstream and downstream total dissolved solids values a) Platte River b) Rock Creek

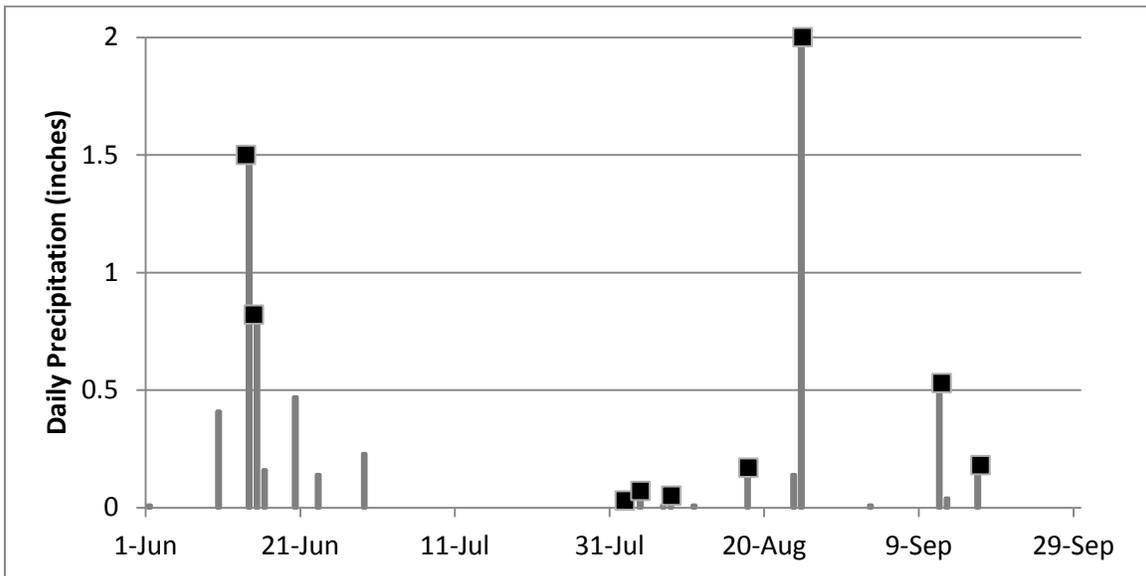
Figure 3.12 Rainfall for the Highway 64 bridge over the Platte River taken from a Valley, NE weather station

The following figures show the amount of rainfall throughout the summer and the corresponding sampled rain events. Weather stations selected were as close to bridge locations as possible, however rain events must still be considered approximate in regards to the exact locations of the bridges. The black square dots on the graph signify the storm events that were sampled.

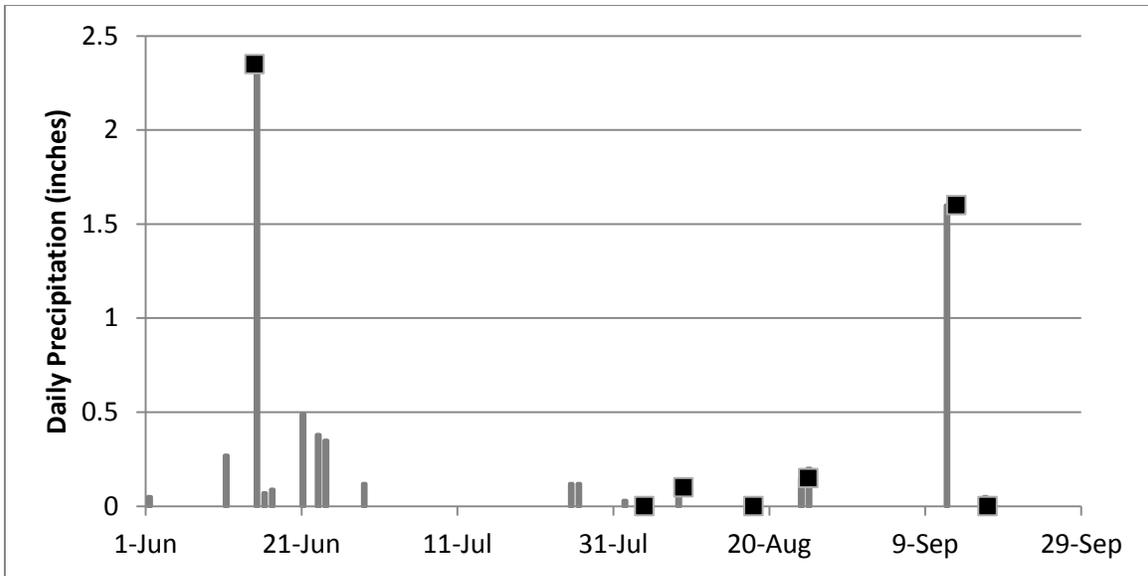
Figure 3.13 Rainfall for the I-80 bridge over the Platte River taken from a nearby Ashland, NE weather station

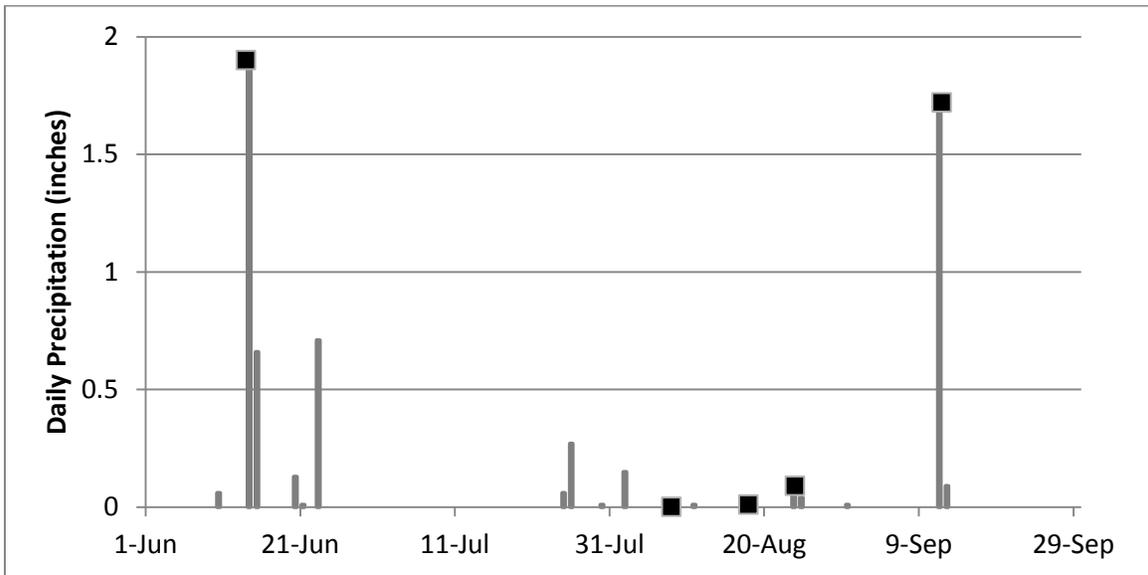
Figure 3.14 Rainfall for the I-80 bridge over the Little Salt Creek taken from a nearby Lincoln, NE weather station

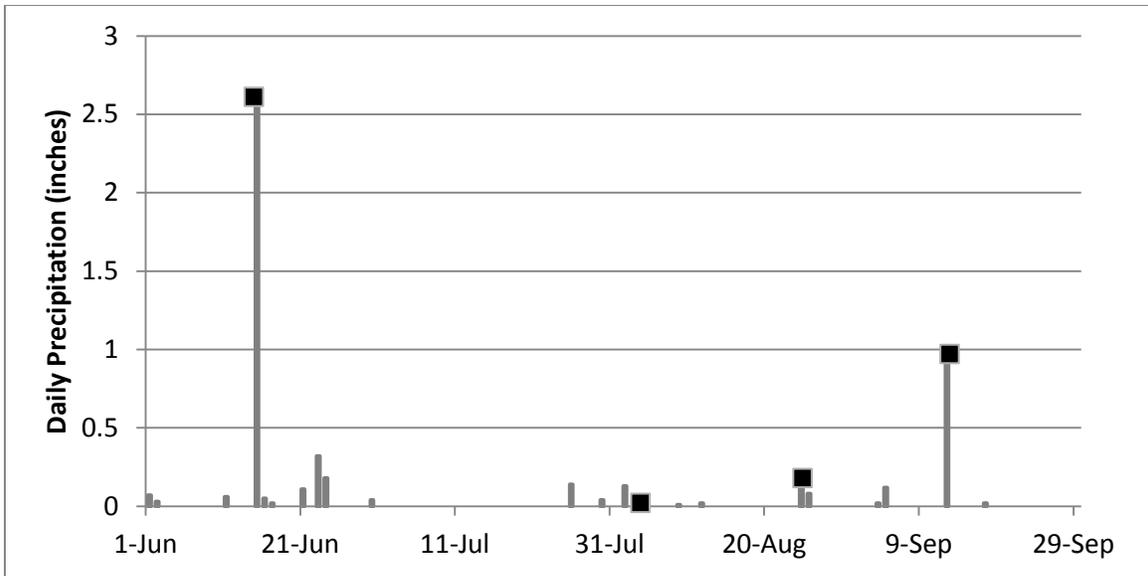
Figure 3.15 Rainfall for the Highway 77 bridge over the Rock Creek taken from a nearby Raymond, NE weather station

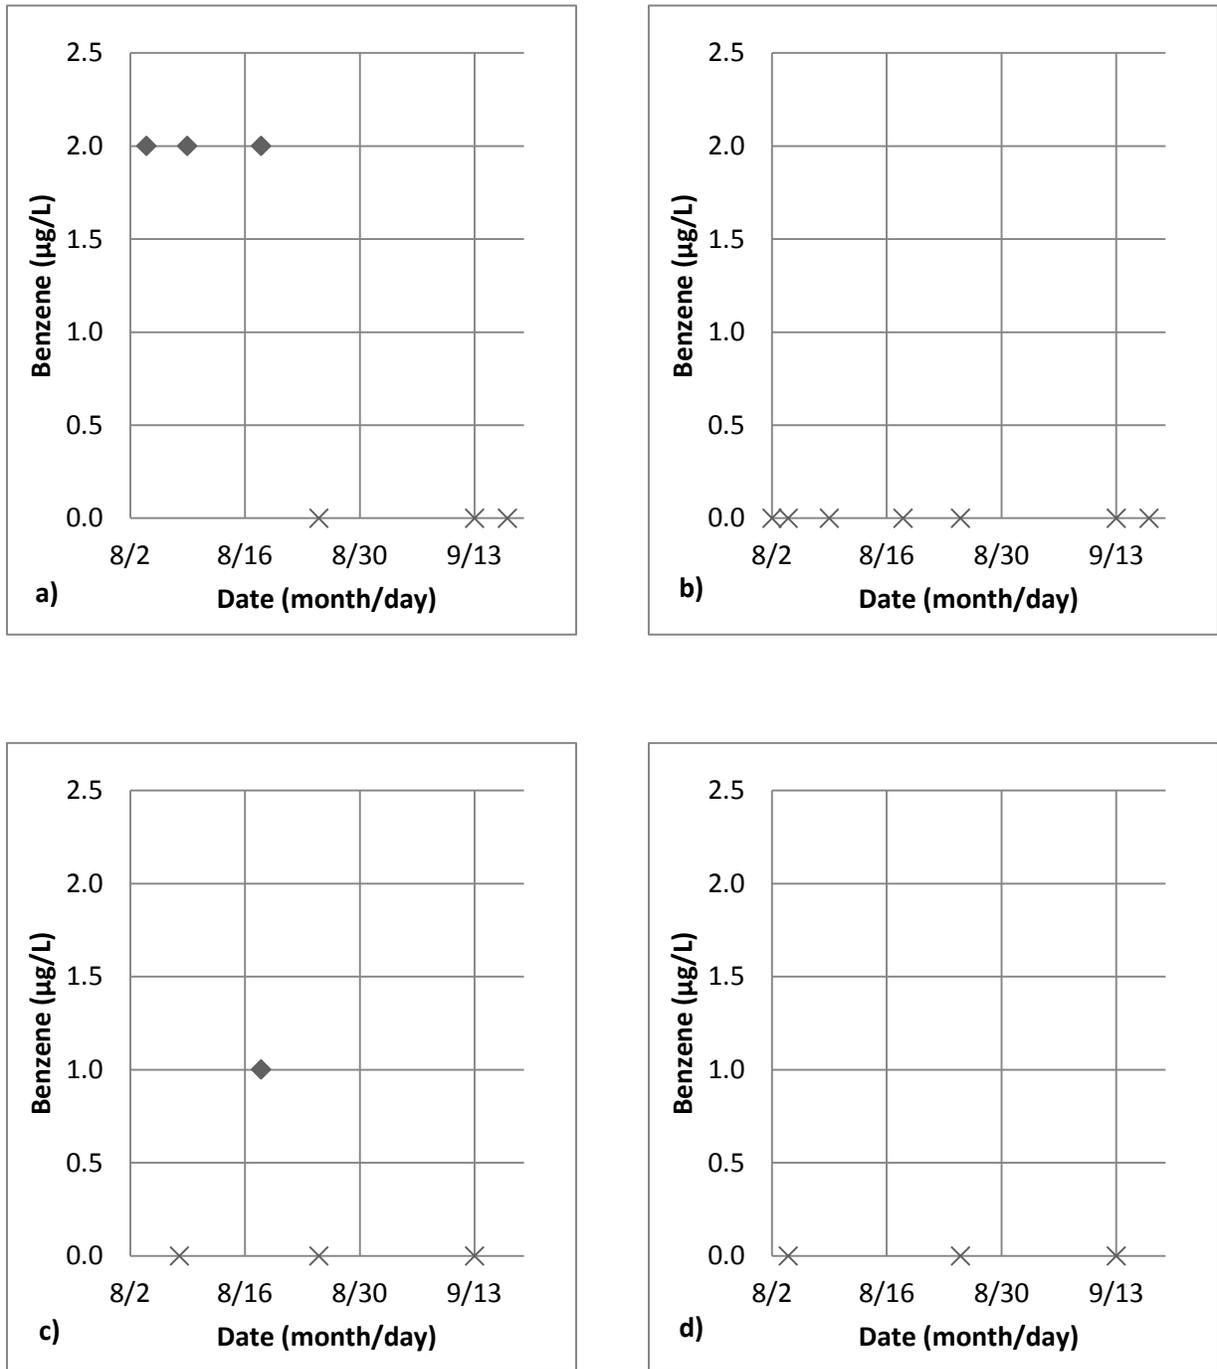
3.2.2.1 Benzene

Figure 3.16 Benzene concentration in runoff from a) I-80 bridge over Platte River b) Highway 64 bridge over Platte River c) I-80 bridge over Little Salt Creek d) Highway 77 bridge over Rock Creek

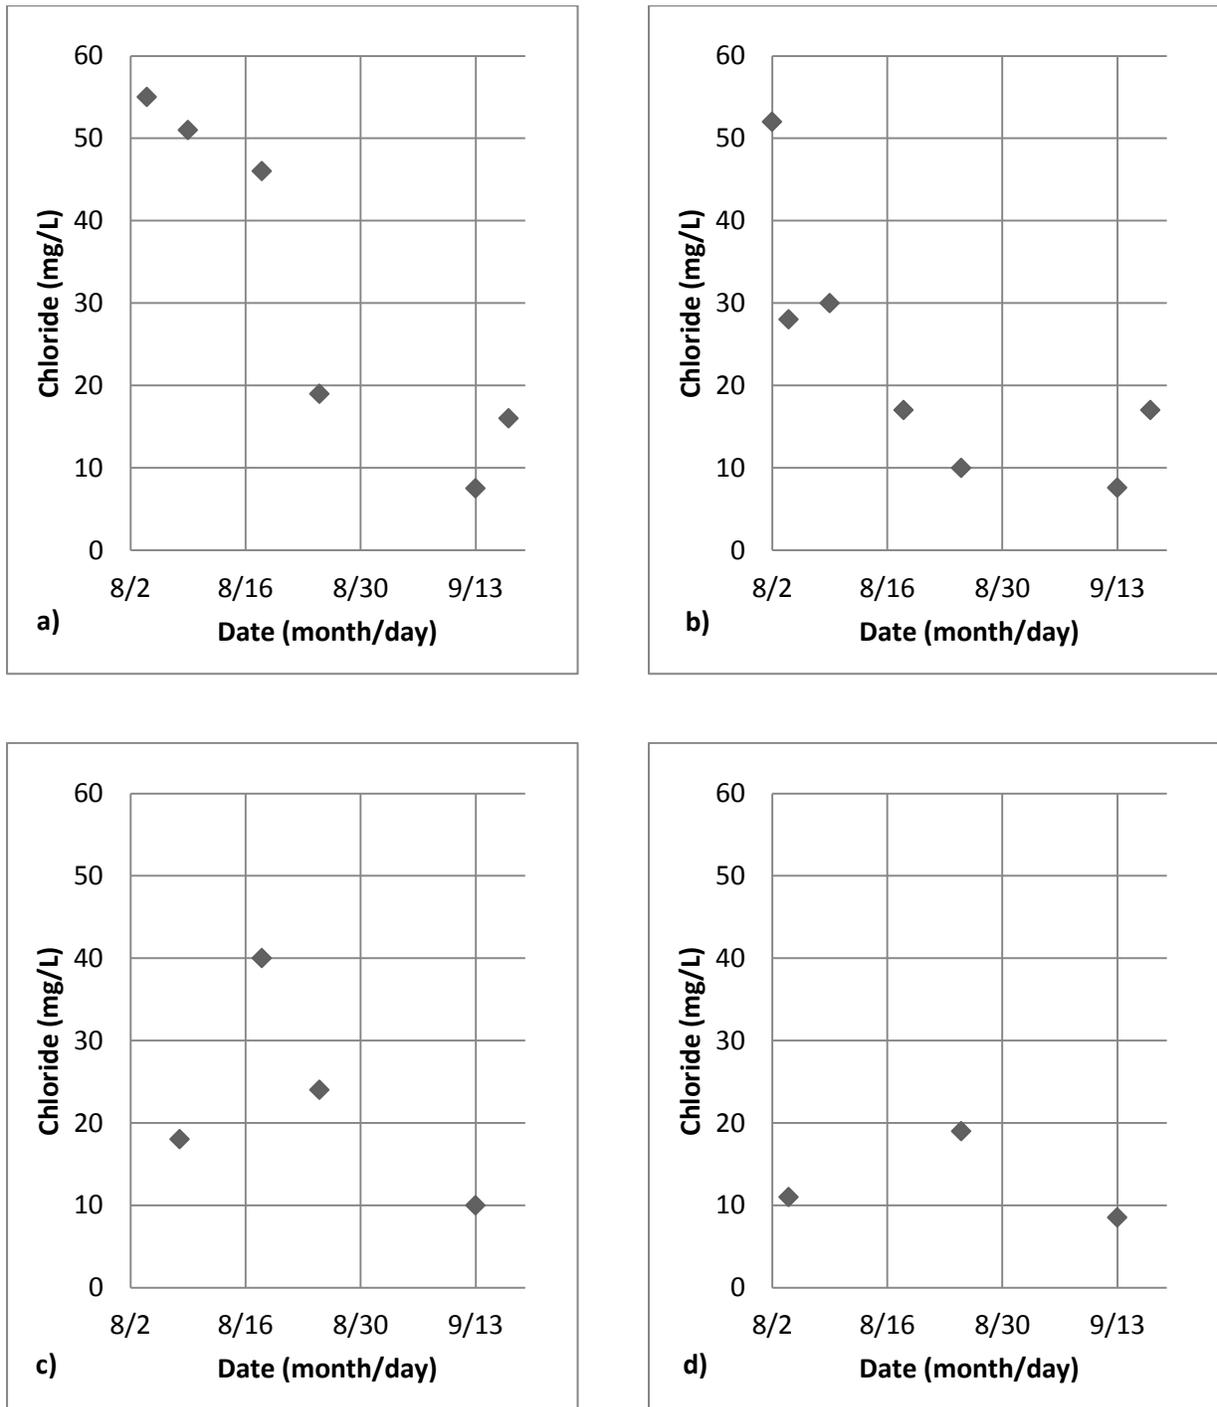
3.2.2.2 Chloride

Figure 3.17 Chloride concentration in Runoff from a) I-80 bridge over Platte River b) Highway 64 bridge over Platte River c) I-80 bridge over Little Salt Creek d) Highway 77 bridge over Rock Creek

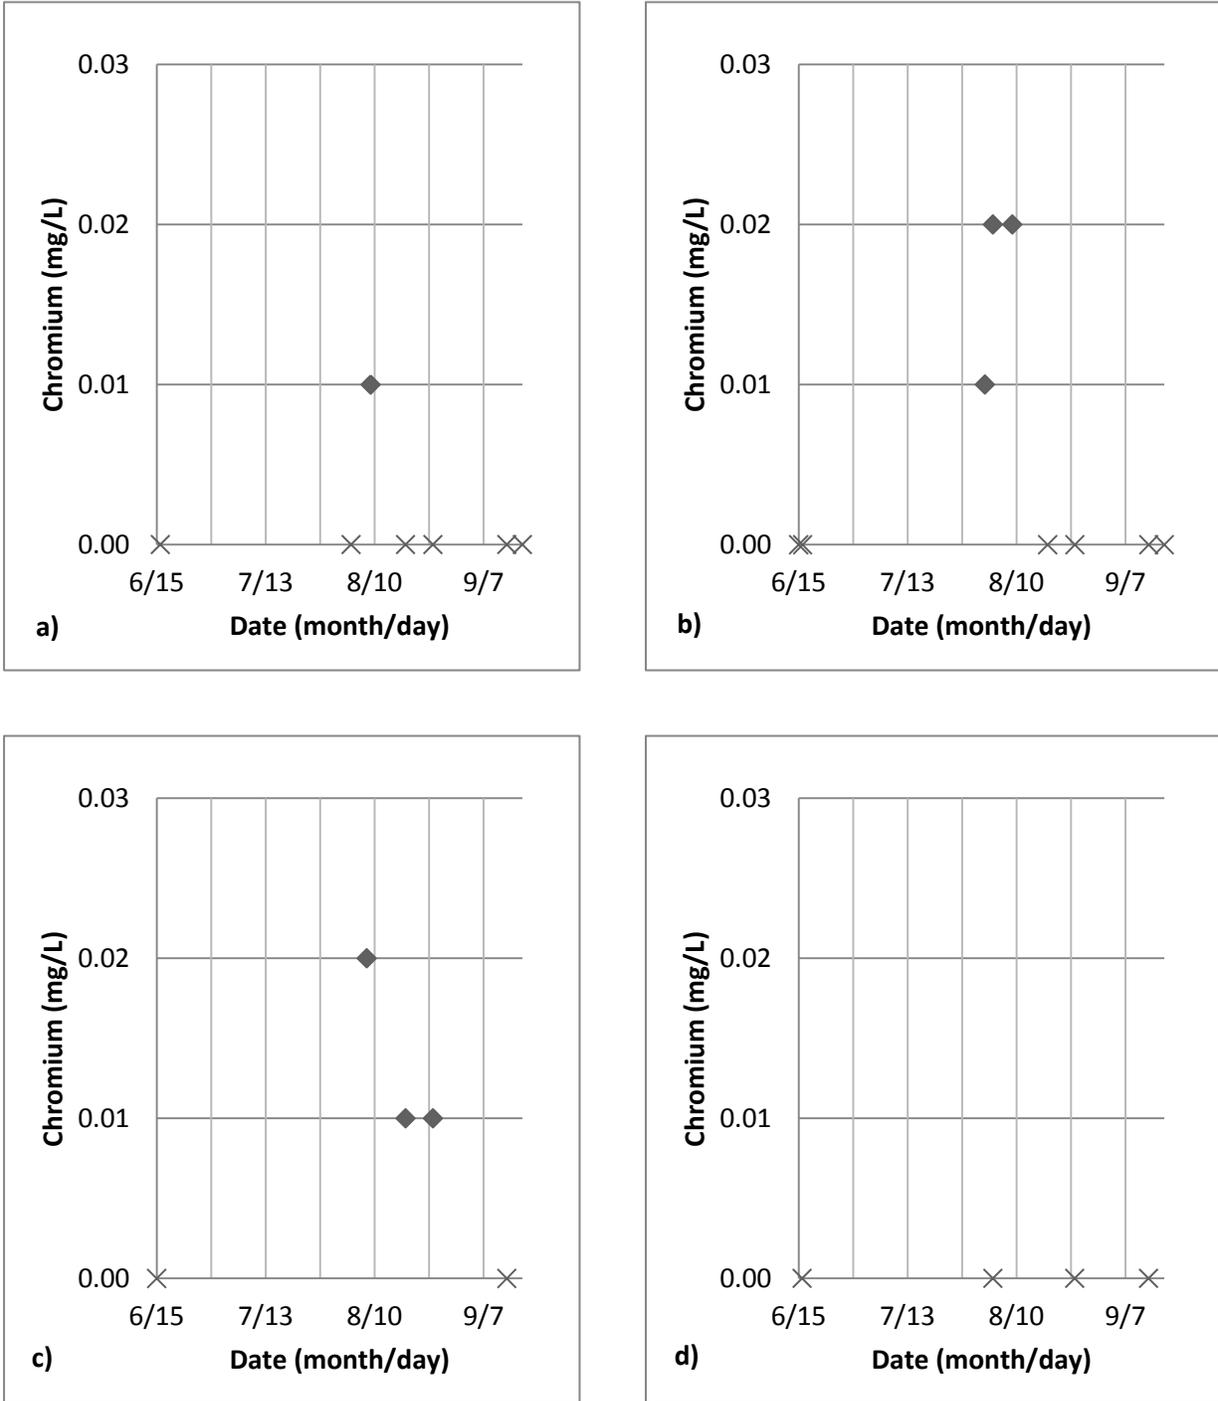
3.2.2.3 Chromium

Figure 3.18 Chromium concentration in runoff from a) I-80 bridge over Platte River b) Highway 64 bridge over Platte River c) I-80 bridge over Little Salt Creek d) Highway 77 bridge over Rock Creek
