Evaluation of the Environmental Impacts of Bridge Deck Runoff

Report SPR-P1(12) M315

Final Report
26-1121-4008-001

Evaluation of the Environmental Impacts of Bridge Deck Runoff – Preliminary Draft

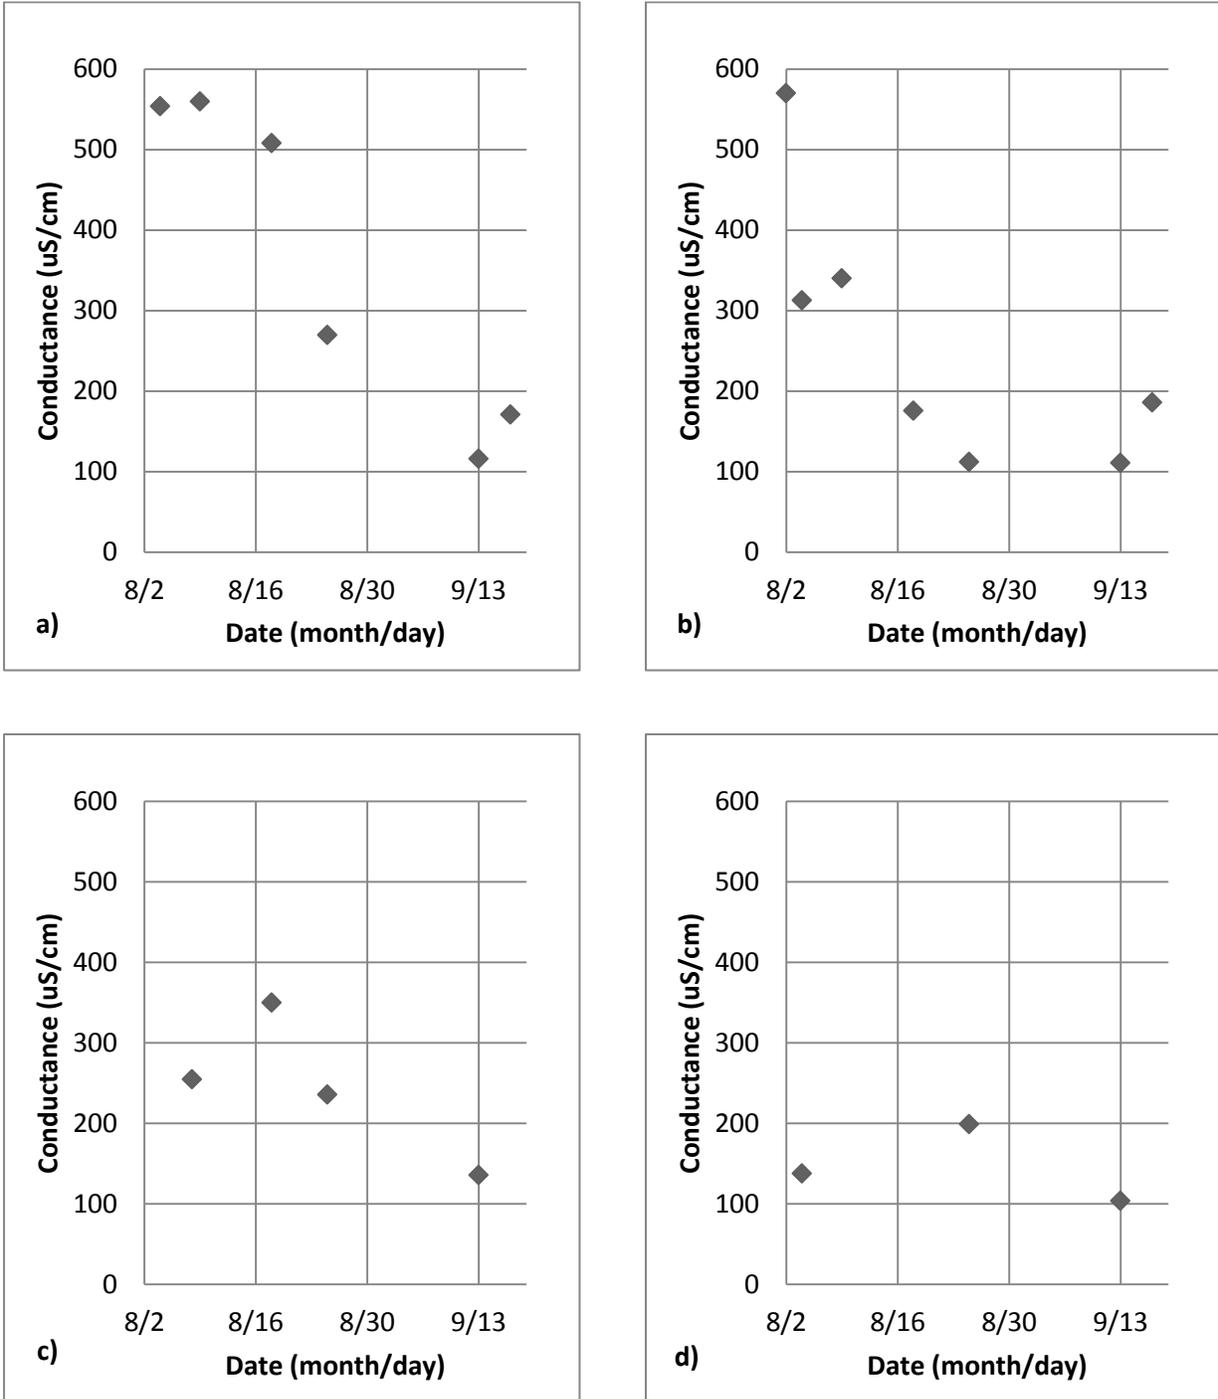
3.2.2.4 Conductance

Figure 3.19 Conductance of runoff from a) I-80 bridge over Platte River b) Highway 64 bridge over Platte River c) I-80 bridge over Little Salt Creek d) Highway 77 bridge over Rock Creek

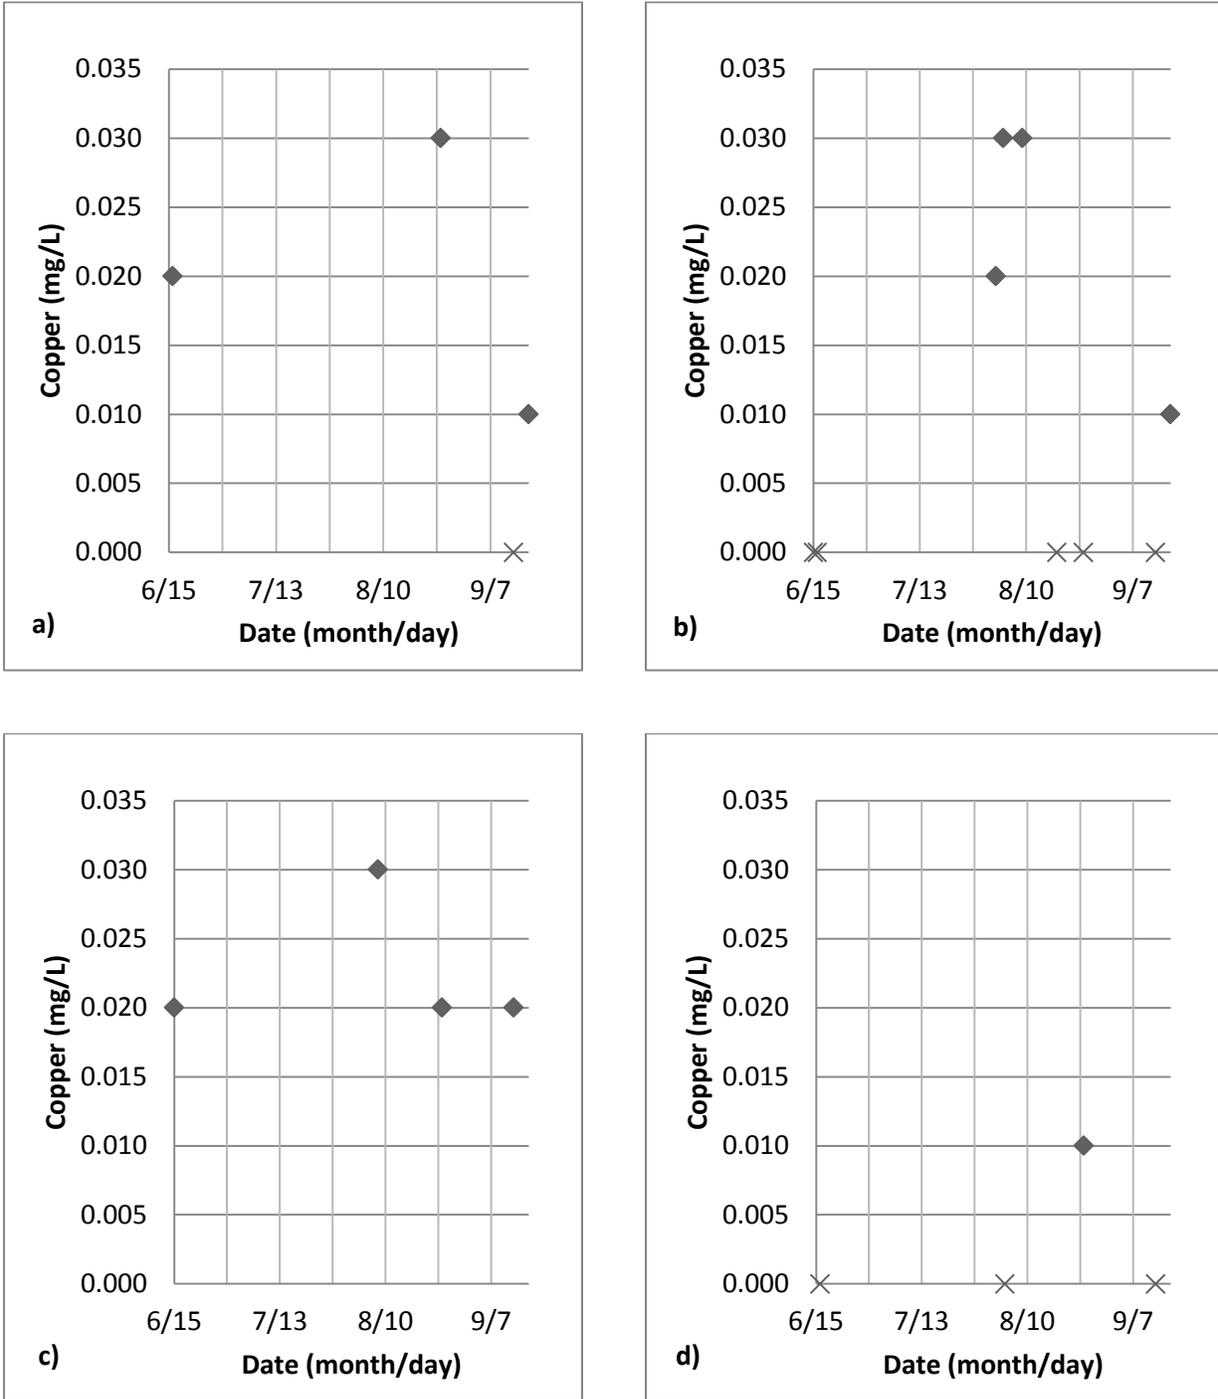
3.2.2.5 Copper

Figure 3.20 Copper concentration in runoff from a) I-80 bridge over Platte River b) Highway 64 bridge over Platte River c) I-80 bridge over Little Salt Creek d) Highway 77 bridge over Rock Creek

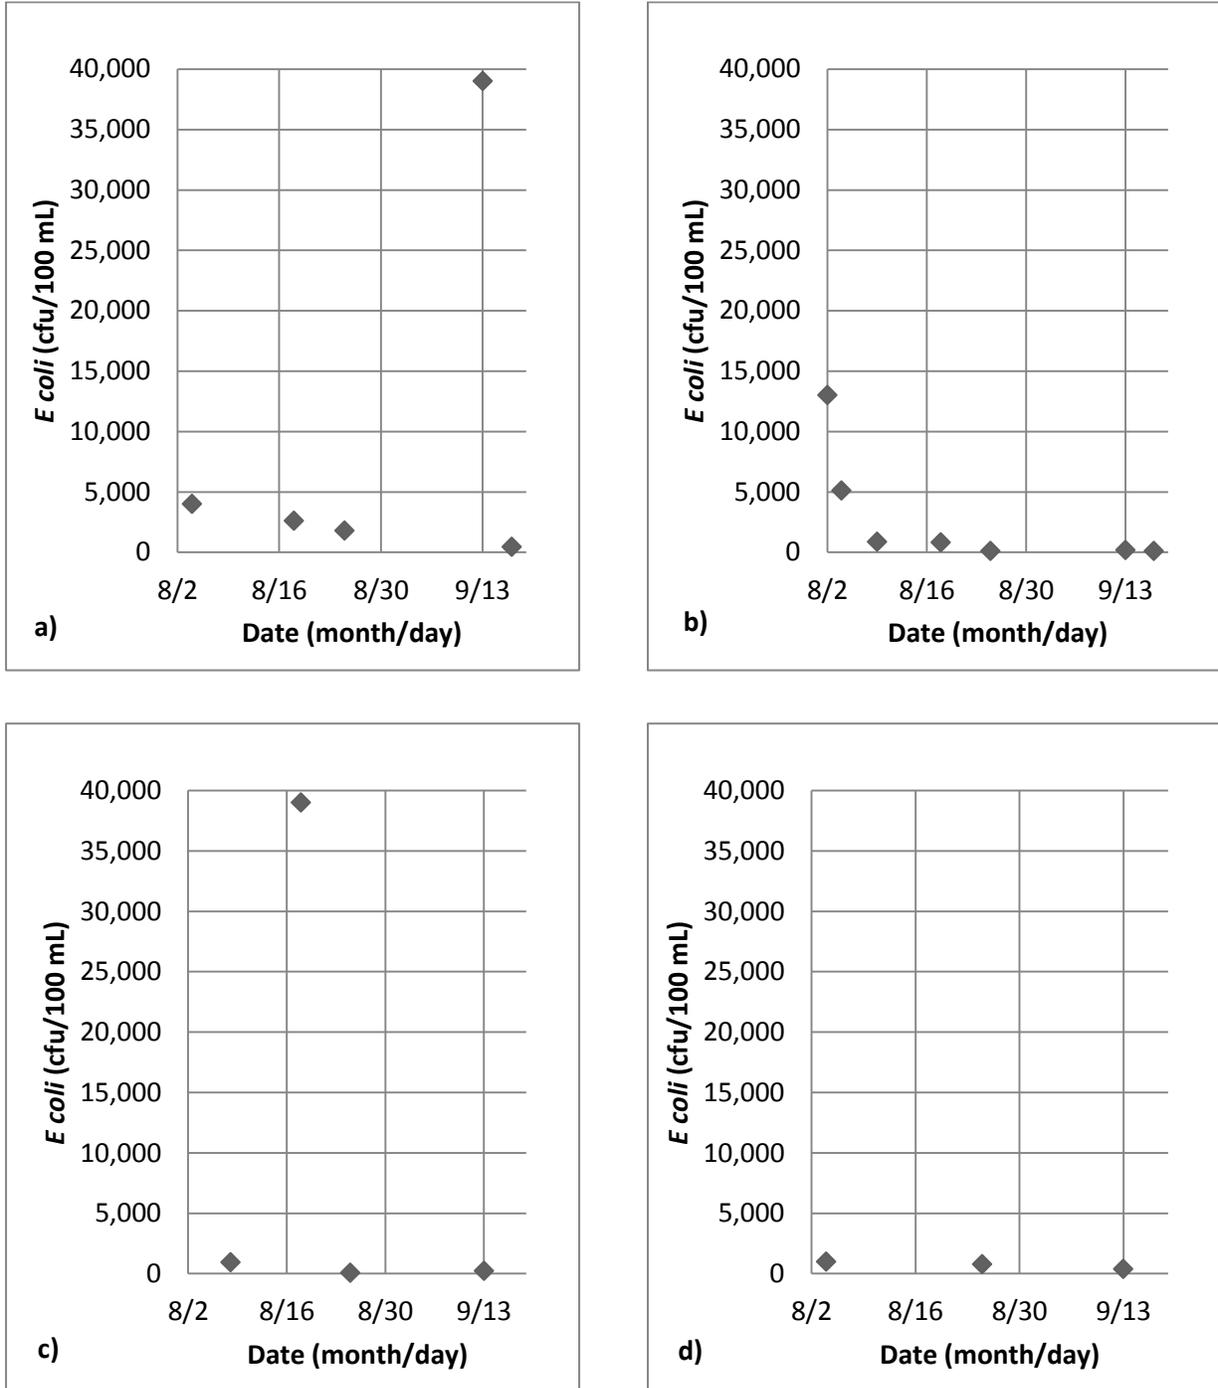
3.2.2.6 *E coli*

Figure 3.21 *E coli* concentration in runoff from a) I-80 bridge over Platte River b) Highway 64 bridge over Platte River c) I-80 bridge over Little Salt Creek d) Highway 77 bridge over Rock Creek

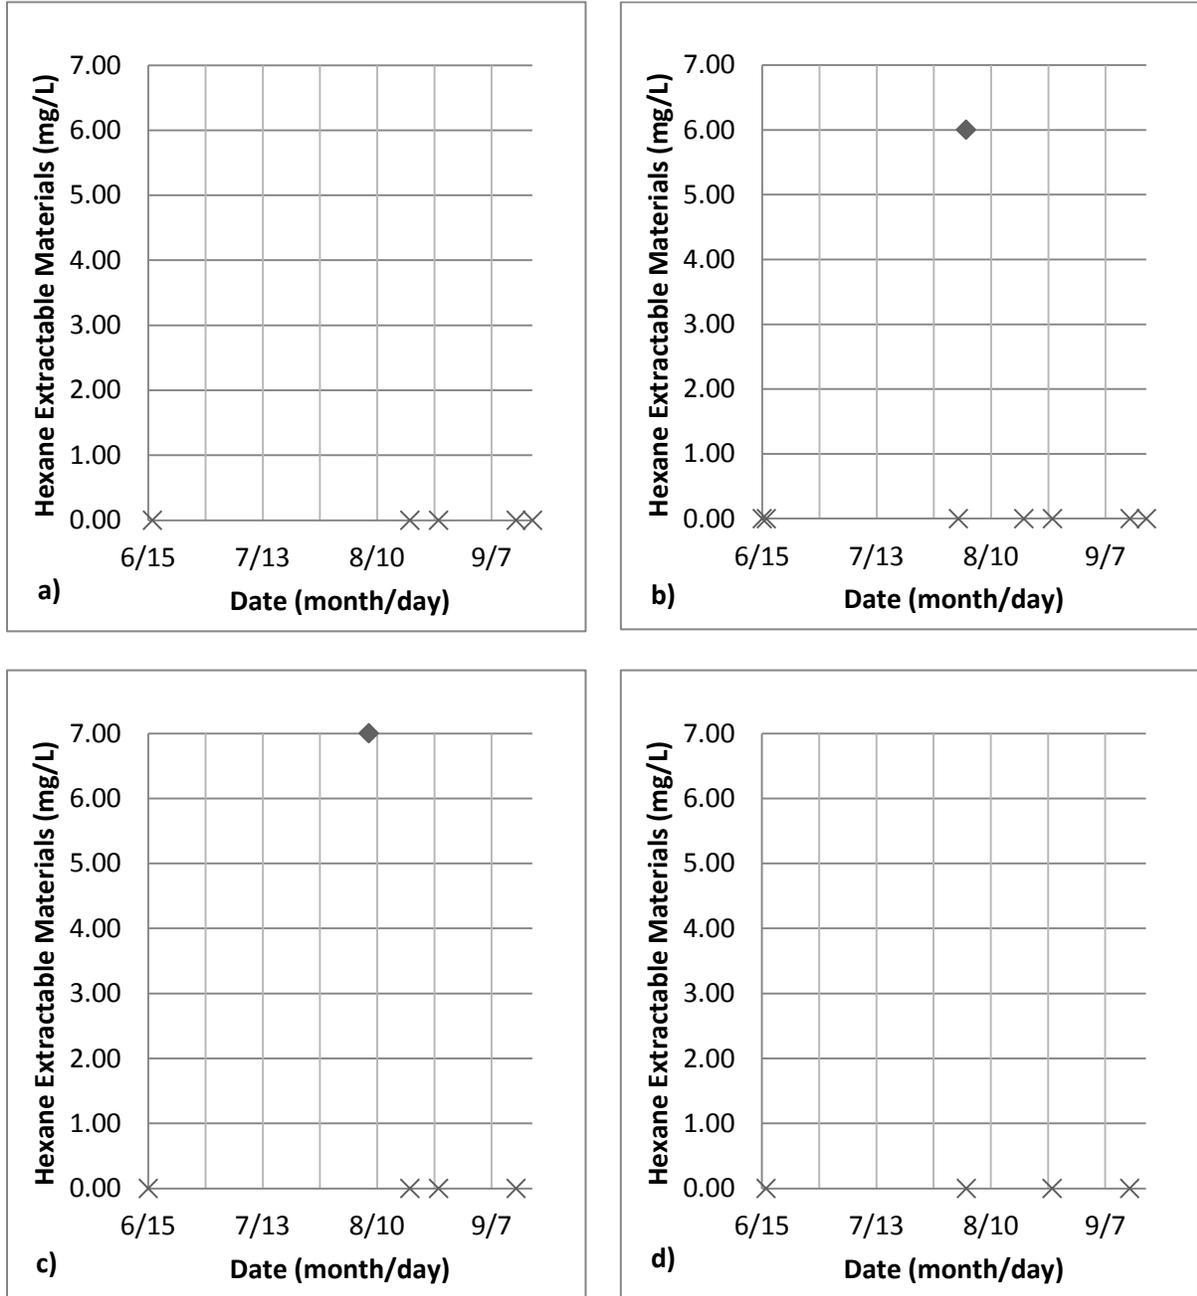
3.2.2.7 HEM

Figure 3.22 Hexane Extractable Materials concentration in runoff from a) I-80 bridge over Platte River b) Highway 64 bridge over Platte River c) I-80 bridge over Little Salt Creek d) Highway 77 bridge over Rock Creek

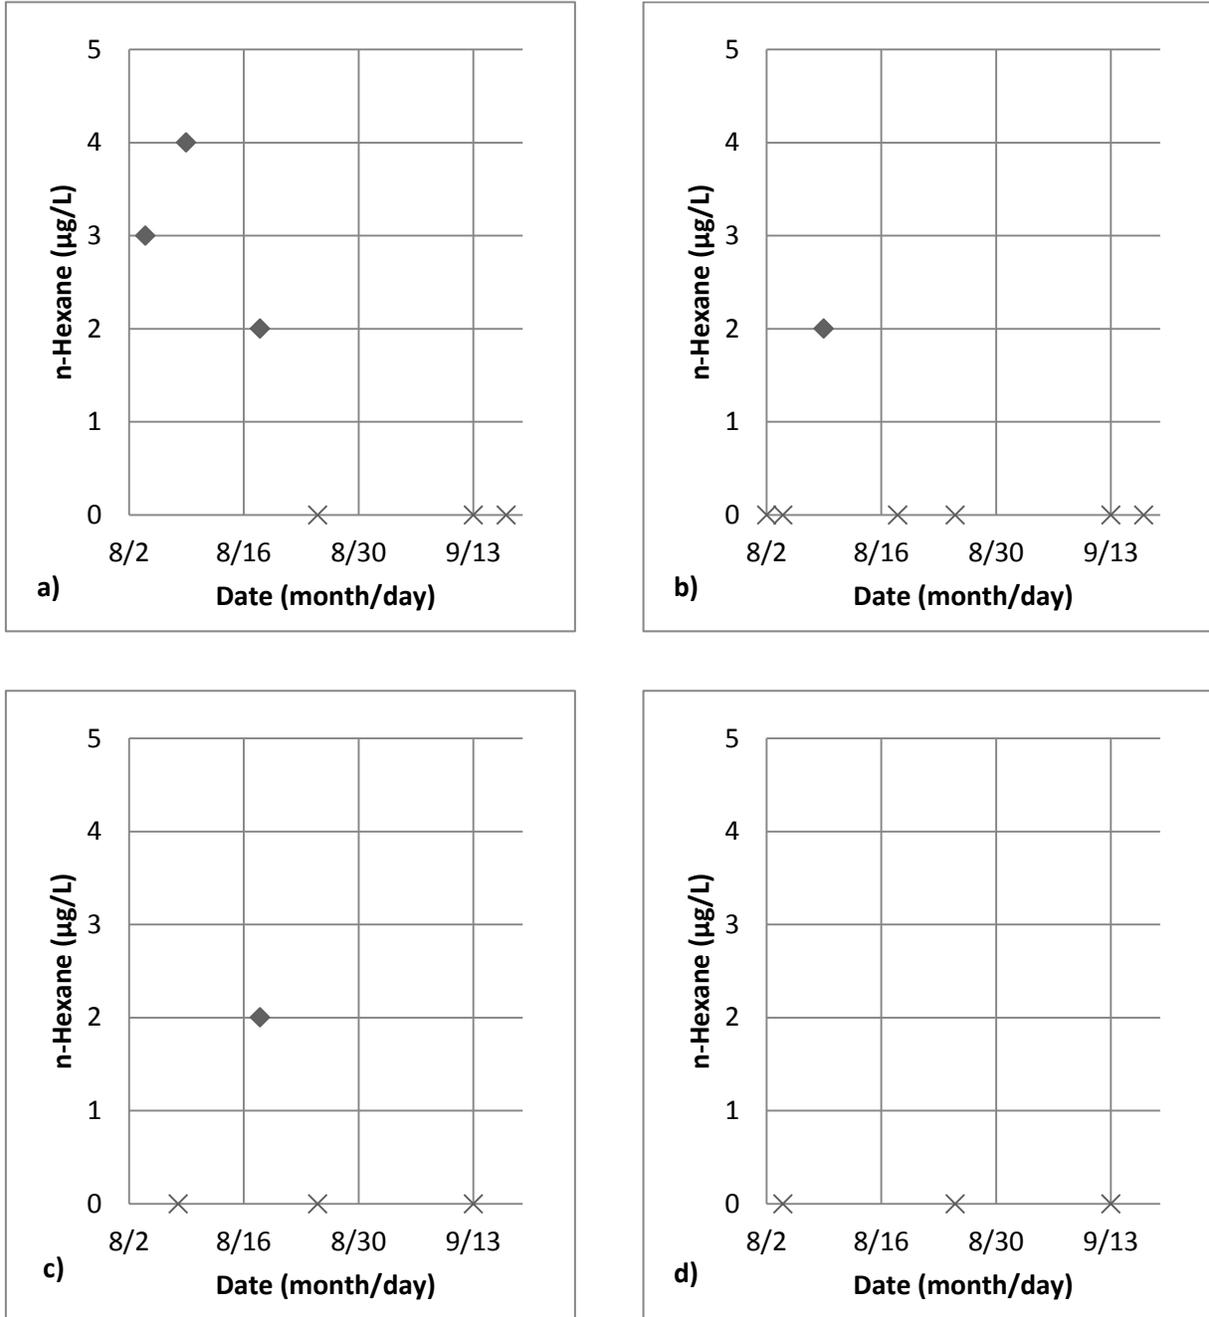
3.2.2.8 n-Hexane

Figure 3.23 n-Hexane concentration in runoff from a) I-80 bridge over Platte River b) Highway 64 bridge over Platte River c) I-80 bridge over Little Salt Creek d) Highway 77 bridge over Rock Creek

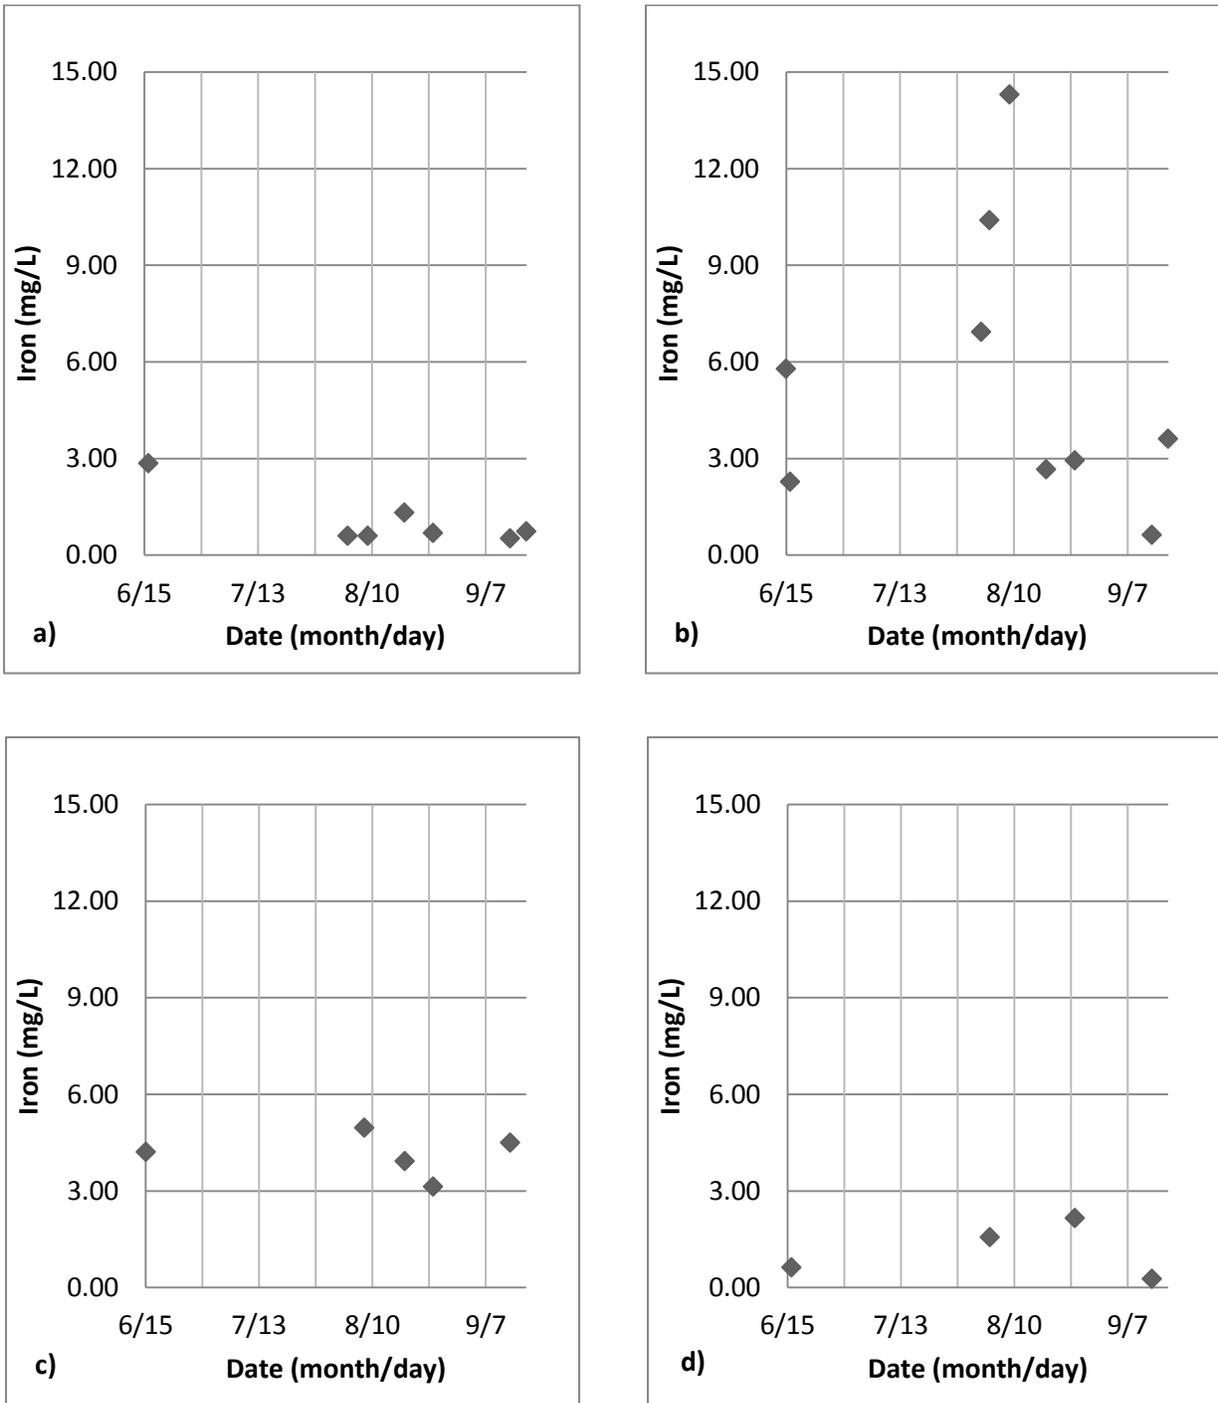
3.2.2.9 Iron

Figure 3.24 Iron concentration in runoff from a) I-80 bridge over Platte River b) Highway 64 bridge over Platte River c) I-80 bridge over Little Salt Creek d) Highway 77 bridge over Rock Creek

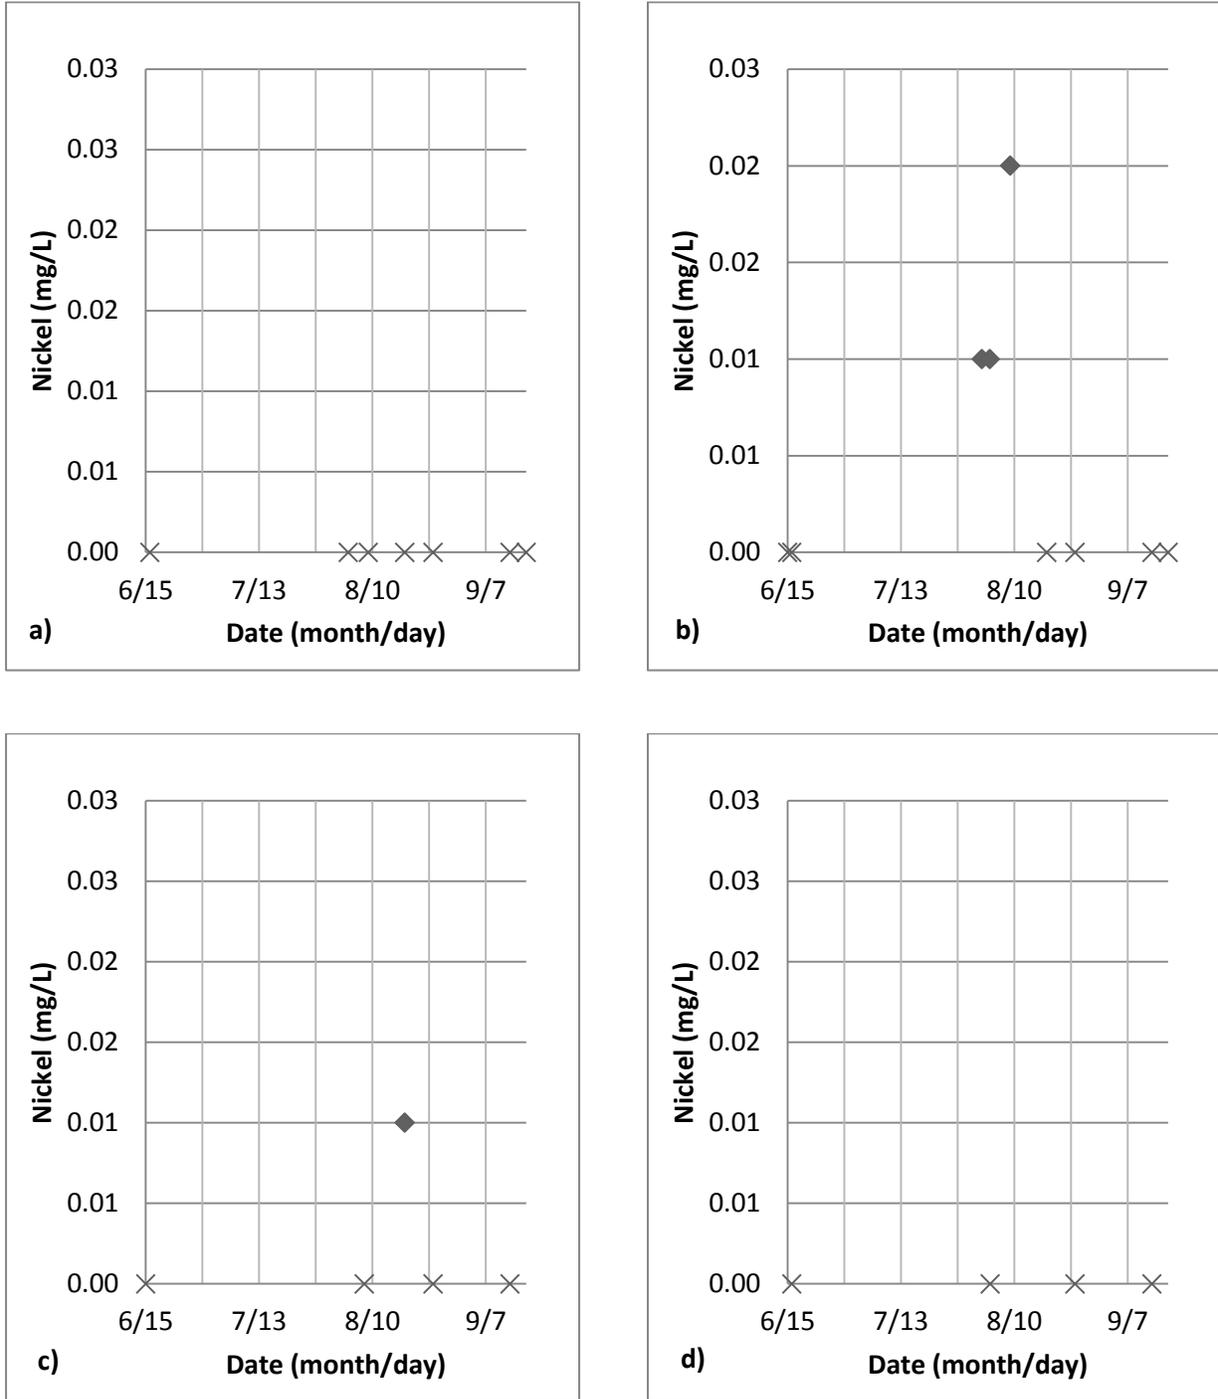
3.2.2.10 Nickel

Figure 3.25 Nickel concentration in runoff from a) I-80 bridge over Platte River b) Highway 64 bridge over Platte River c) I-80 bridge over Little Salt Creek d) Highway 77 bridge over Rock Creek

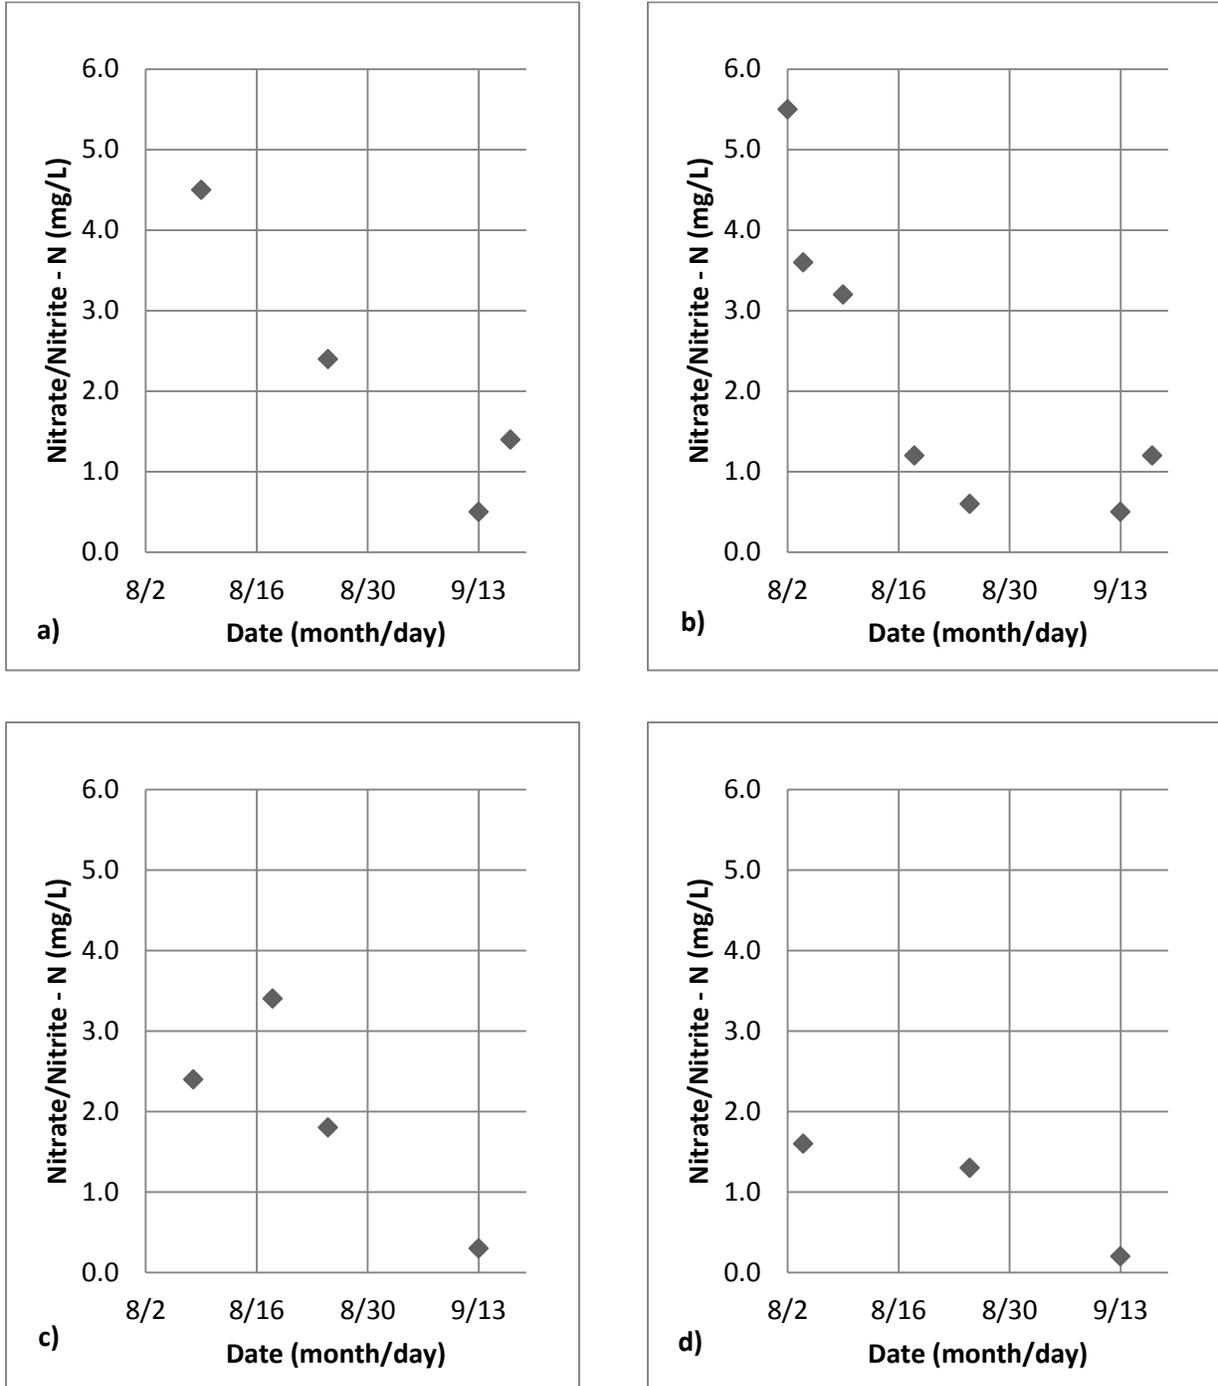
3.2.2.11 Nitrate/Nitrite

Figure 3.26 Nitrate/Nitrite concentration in runoff from a) I-80 bridge over Platte River b) Highway 64 bridge over Platte River c) I-80 bridge over Little Salt Creek d) Highway 77 bridge over Rock Creek

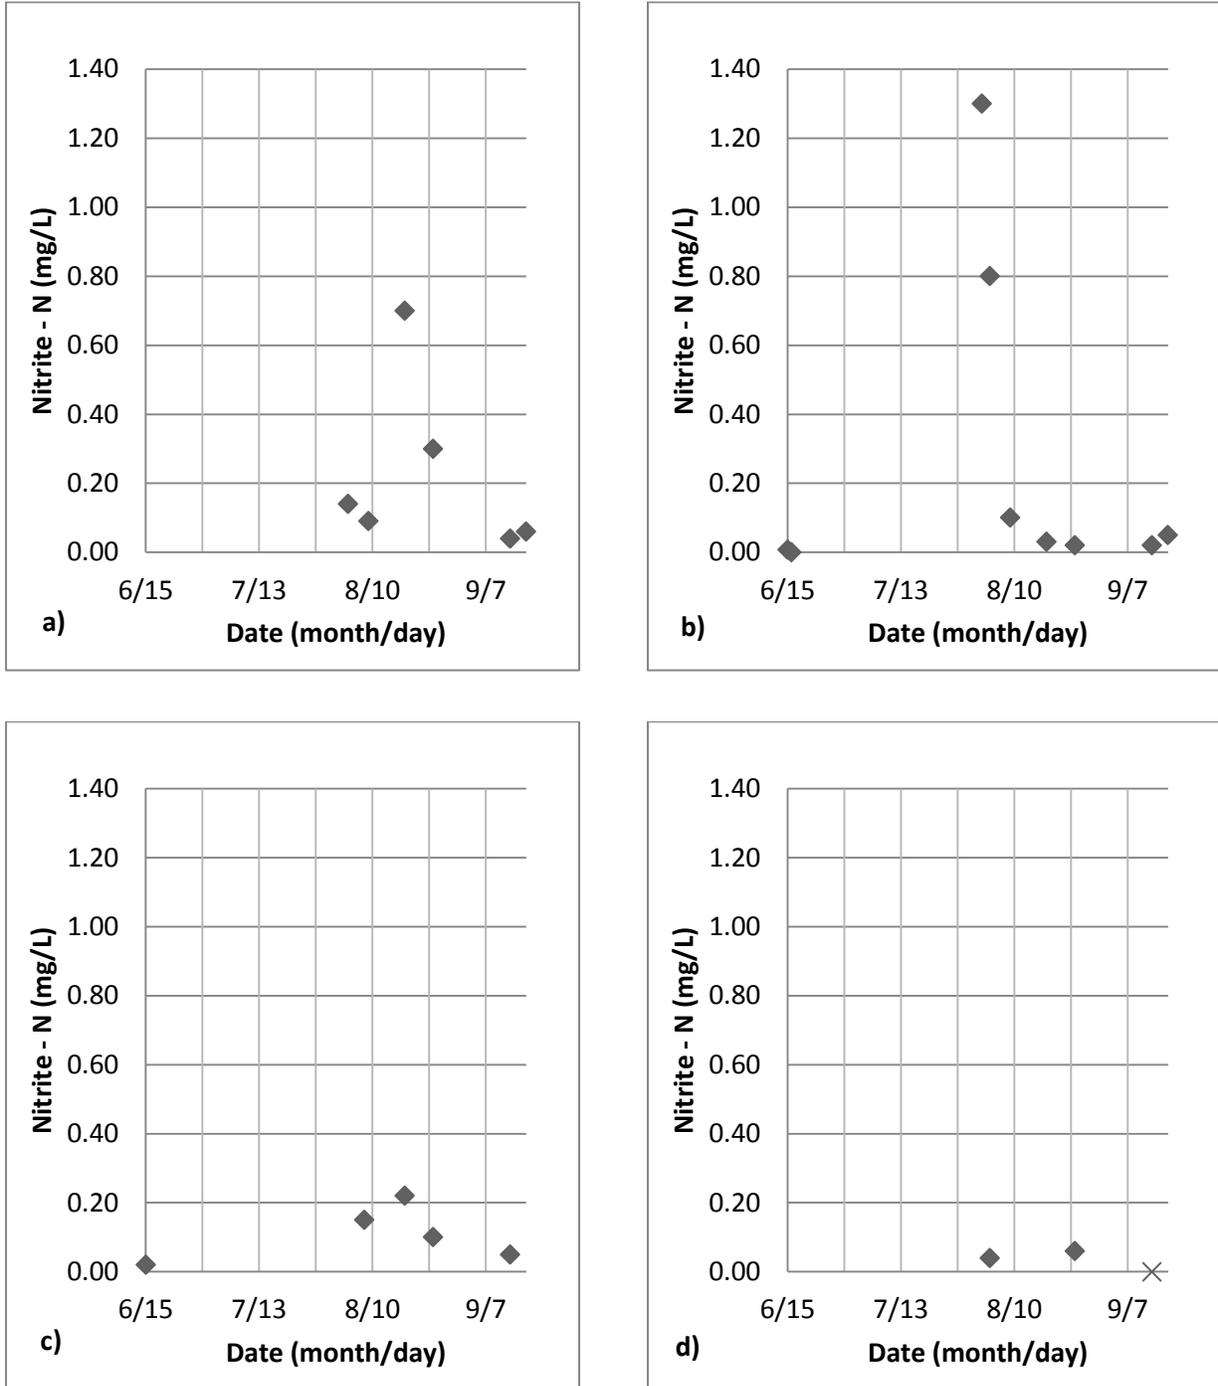
3.2.2.12 Nitrite

Figure 3.27 Nitrite concentration in runoff from a) I-80 bridge over Platte River b) Highway 64 bridge over Platte River c) I-80 bridge over Little Salt Creek d) Highway 77 bridge over Rock Creek

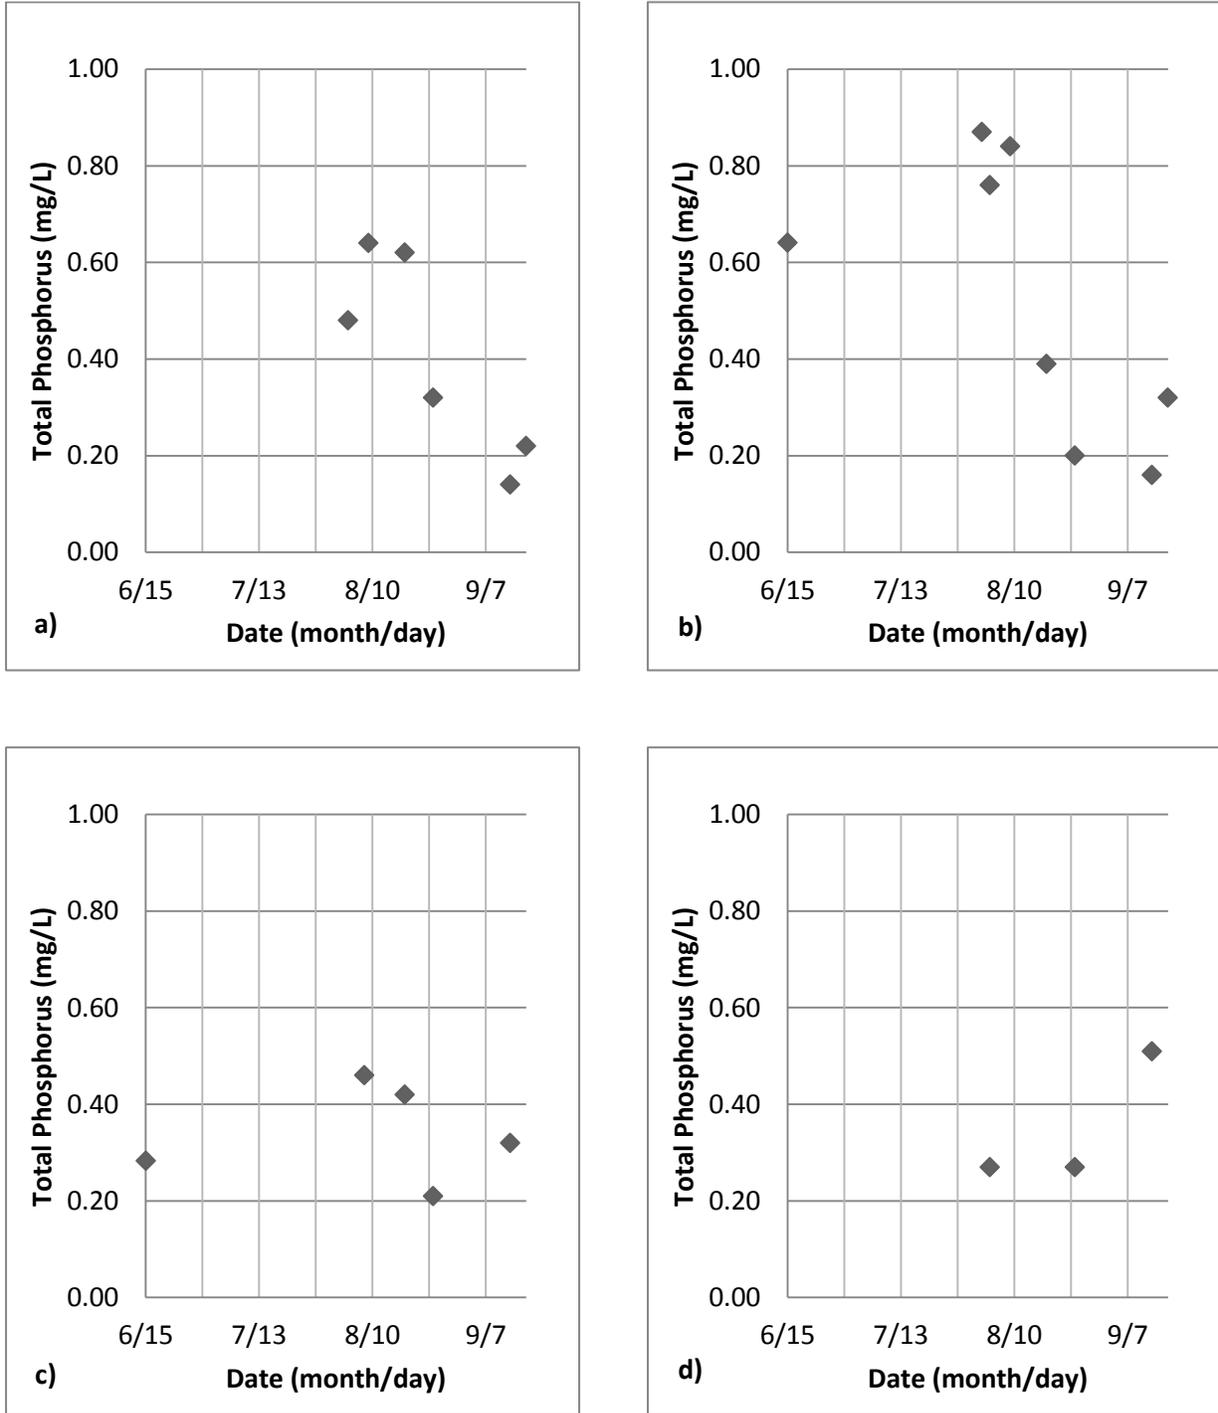
3.2.2.13 TP

Figure 3.28 Total phosphorus concentration in runoff from a) I-80 Bridge over Platte River b) Highway 64 Bridge over Platte River c) I-80 Bridge over Little Salt Creek d) Highway 77 bridge over Rock Creek

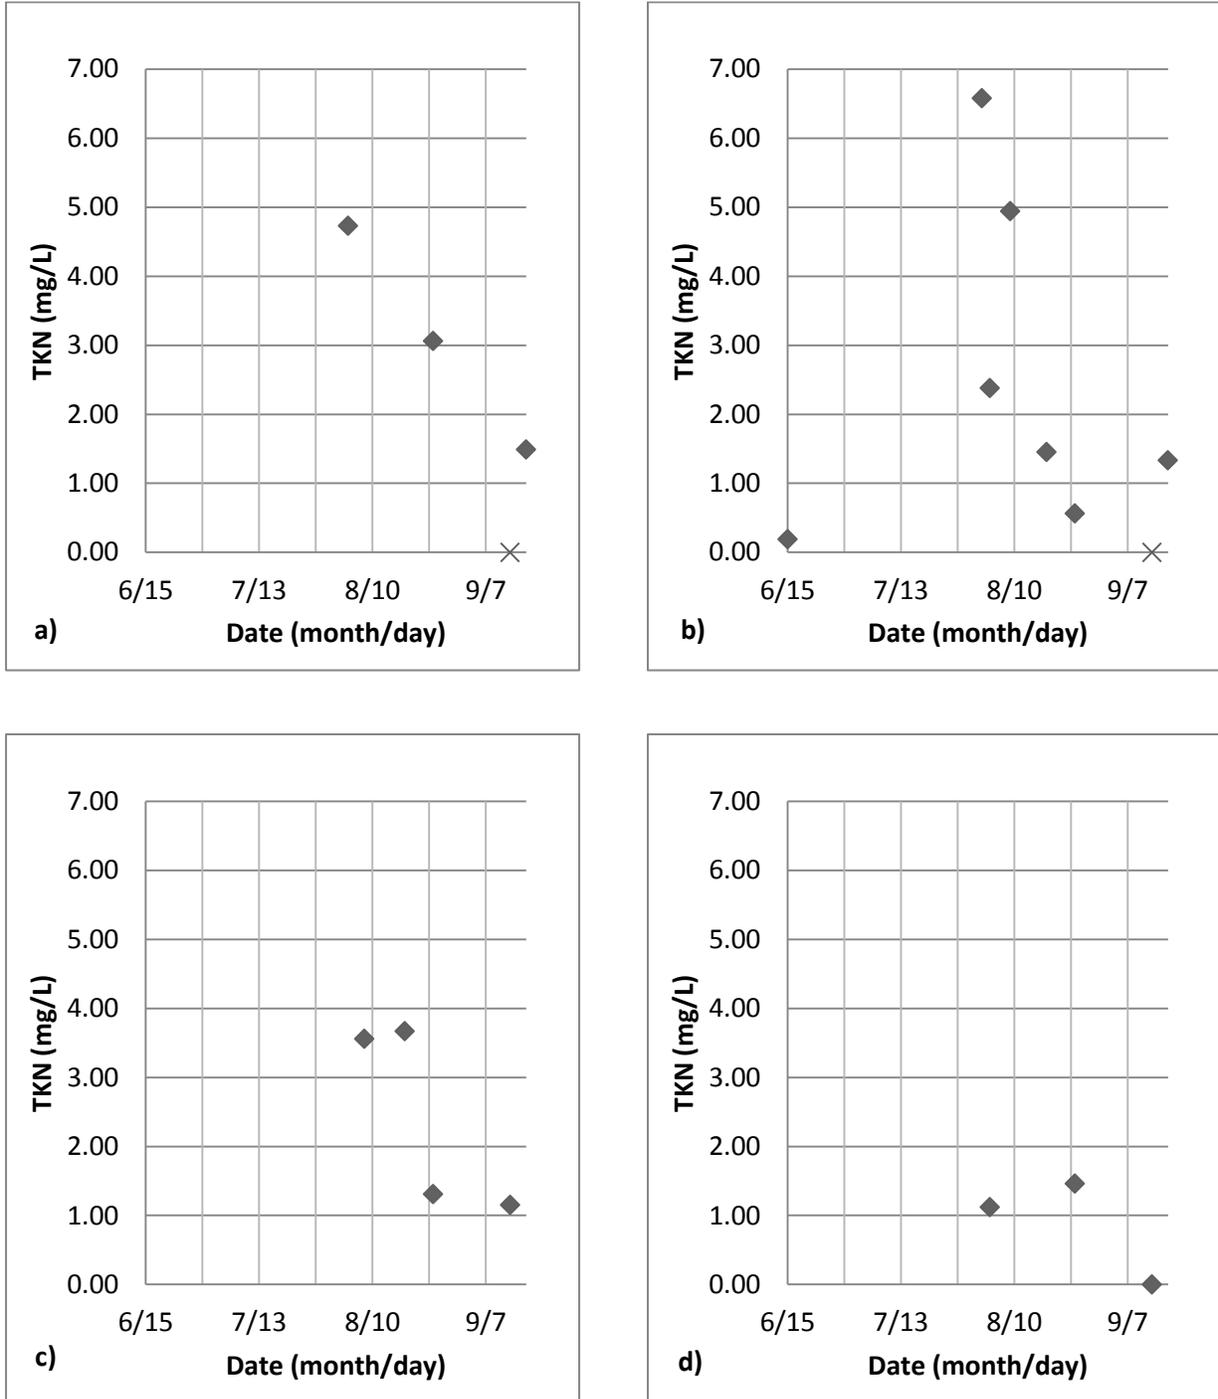
3.2.2.14 TKN

Figure 3.29 TKN concentration in runoff from a) I-80 bridge over Platte River b) Highway 64 bridge over Platte River c) I-80 Bridge over Little Salt Creek d) Highway 77 bridge over Rock Creek

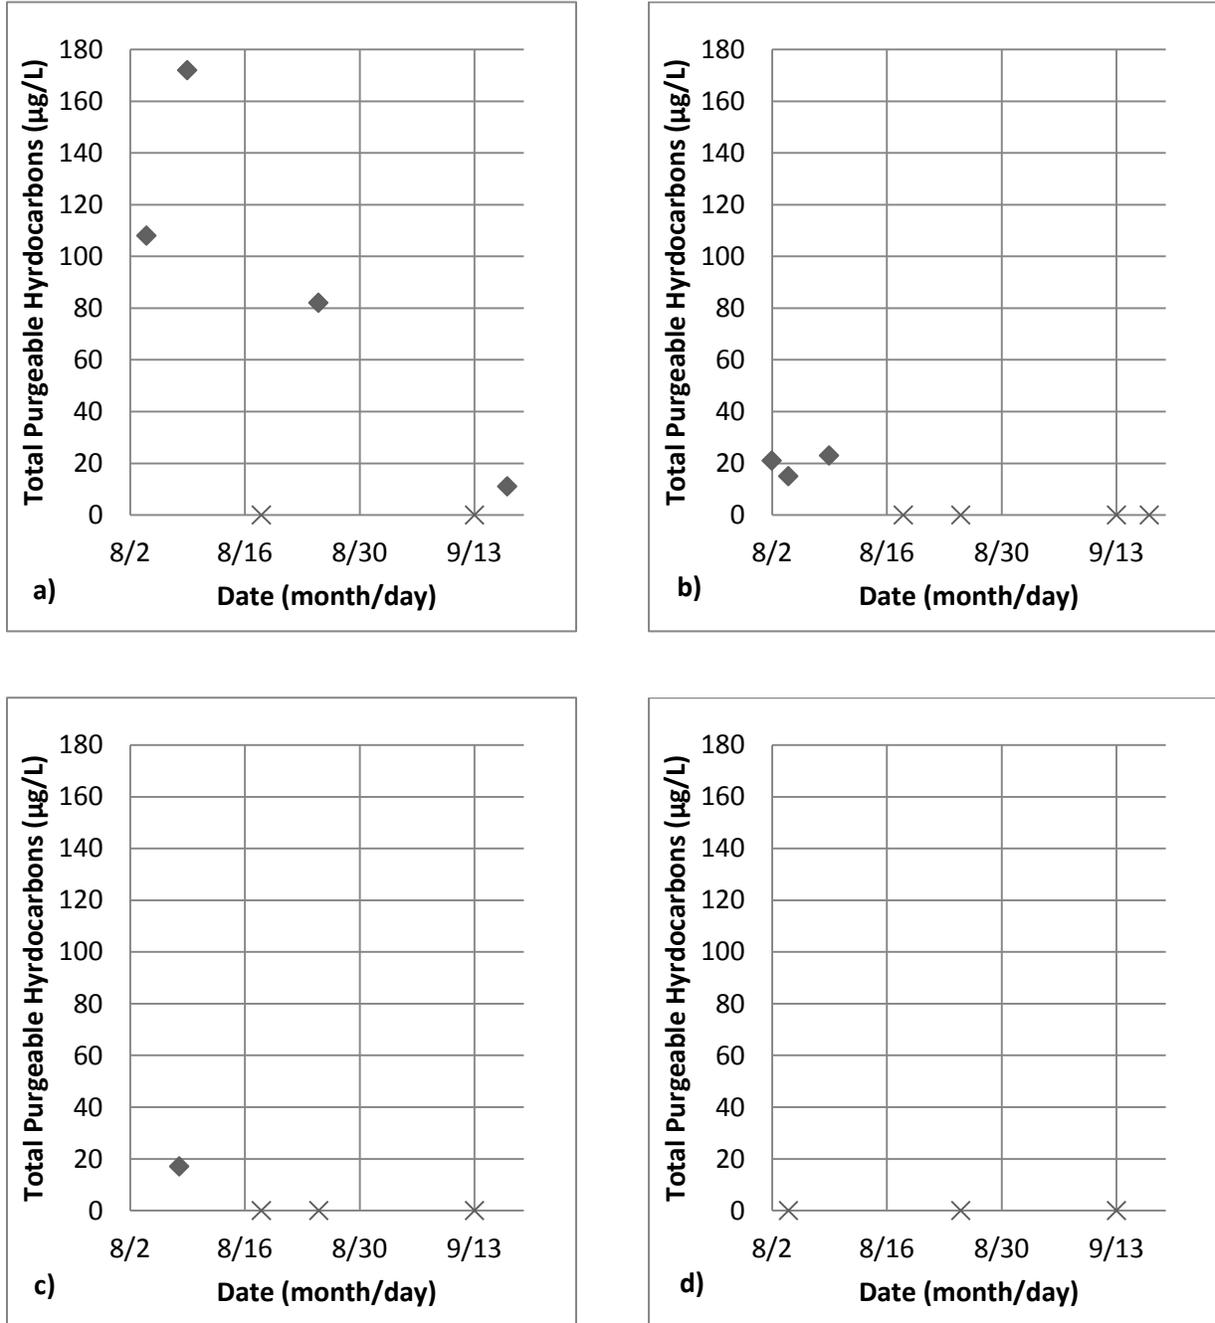
3.2.2.15 Total Purgeable Hydrocarbons

Figure 3.30 Total purgeable hydrocarbons concentration in runoff from a) I-80 Bridge over Platte River b) Highway 64 bridge over Platte River c) I-80 bridge over Little Salt Creek d) Highway 77 bridge over Rock Creek

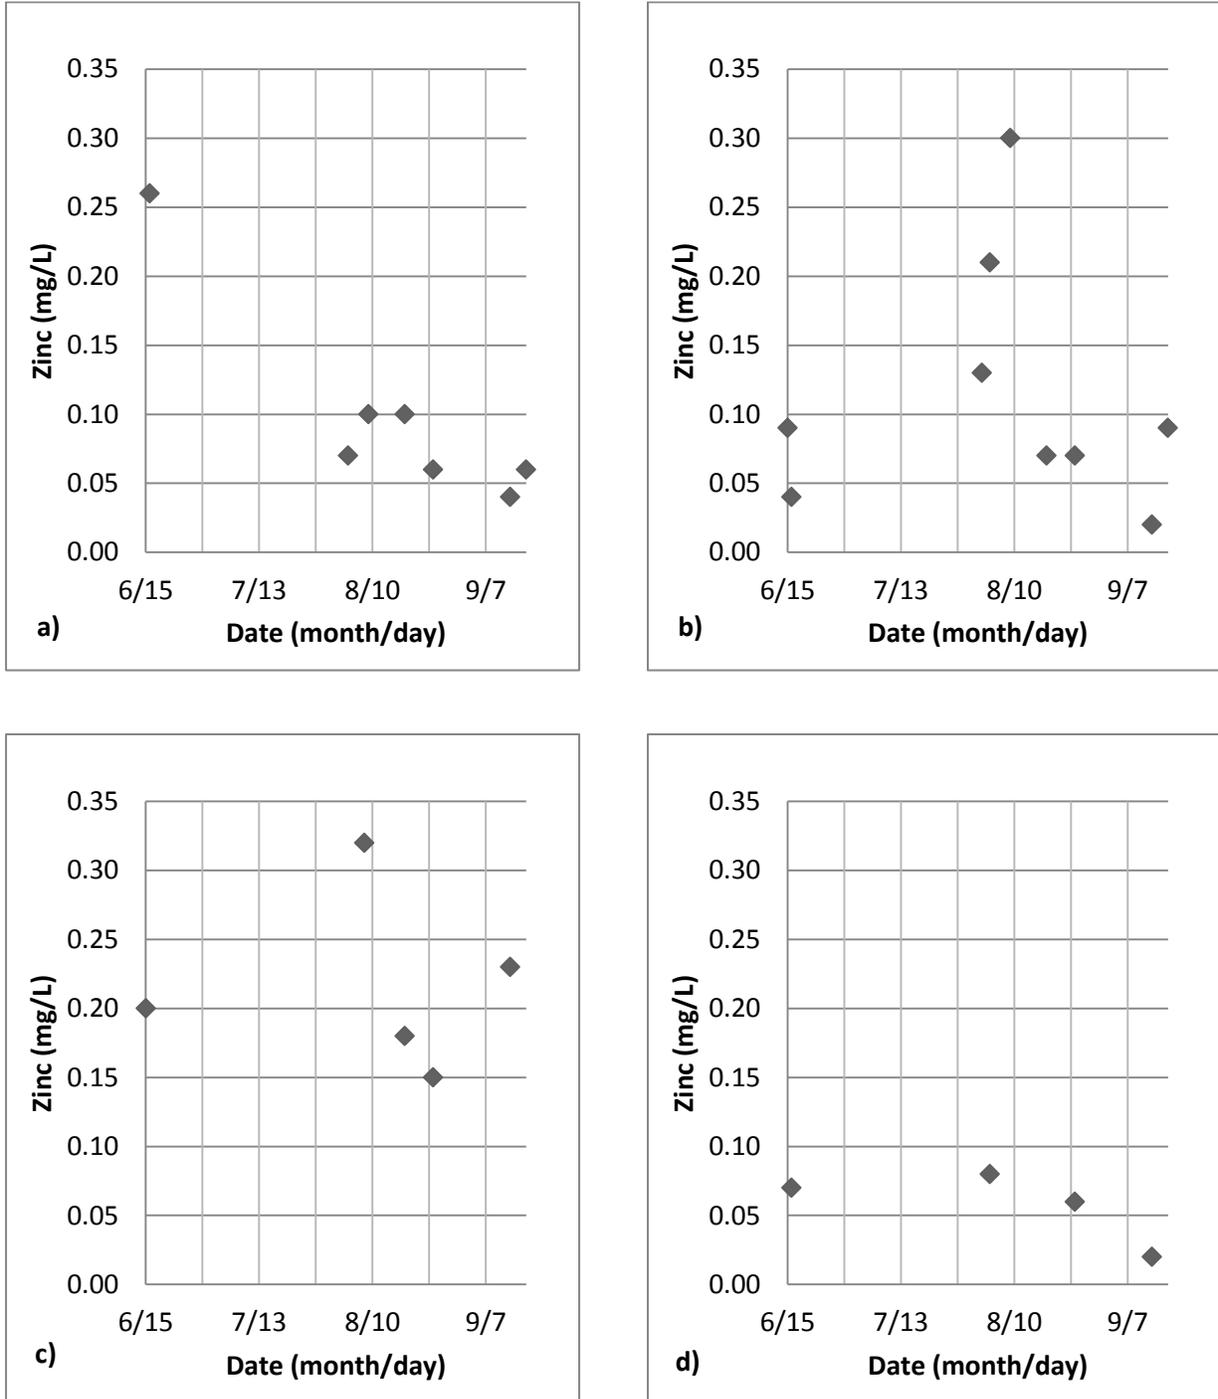
Figure 3.31 Zinc concentration in runoff from a) I-80 bridge over Platte River b) Highway 64 bridge over Platte River c) I-80 bridge over Little Salt Creek d) Highway 77 bridge over Rock Creek
