Evaluation of the Environmental Impacts of Bridge Deck Runoff

Report SPR-P1(12) M315

Final Report
26-1121-4008-001

Evaluation of the Environmental Impacts of Bridge Deck Runoff – Preliminary Draft

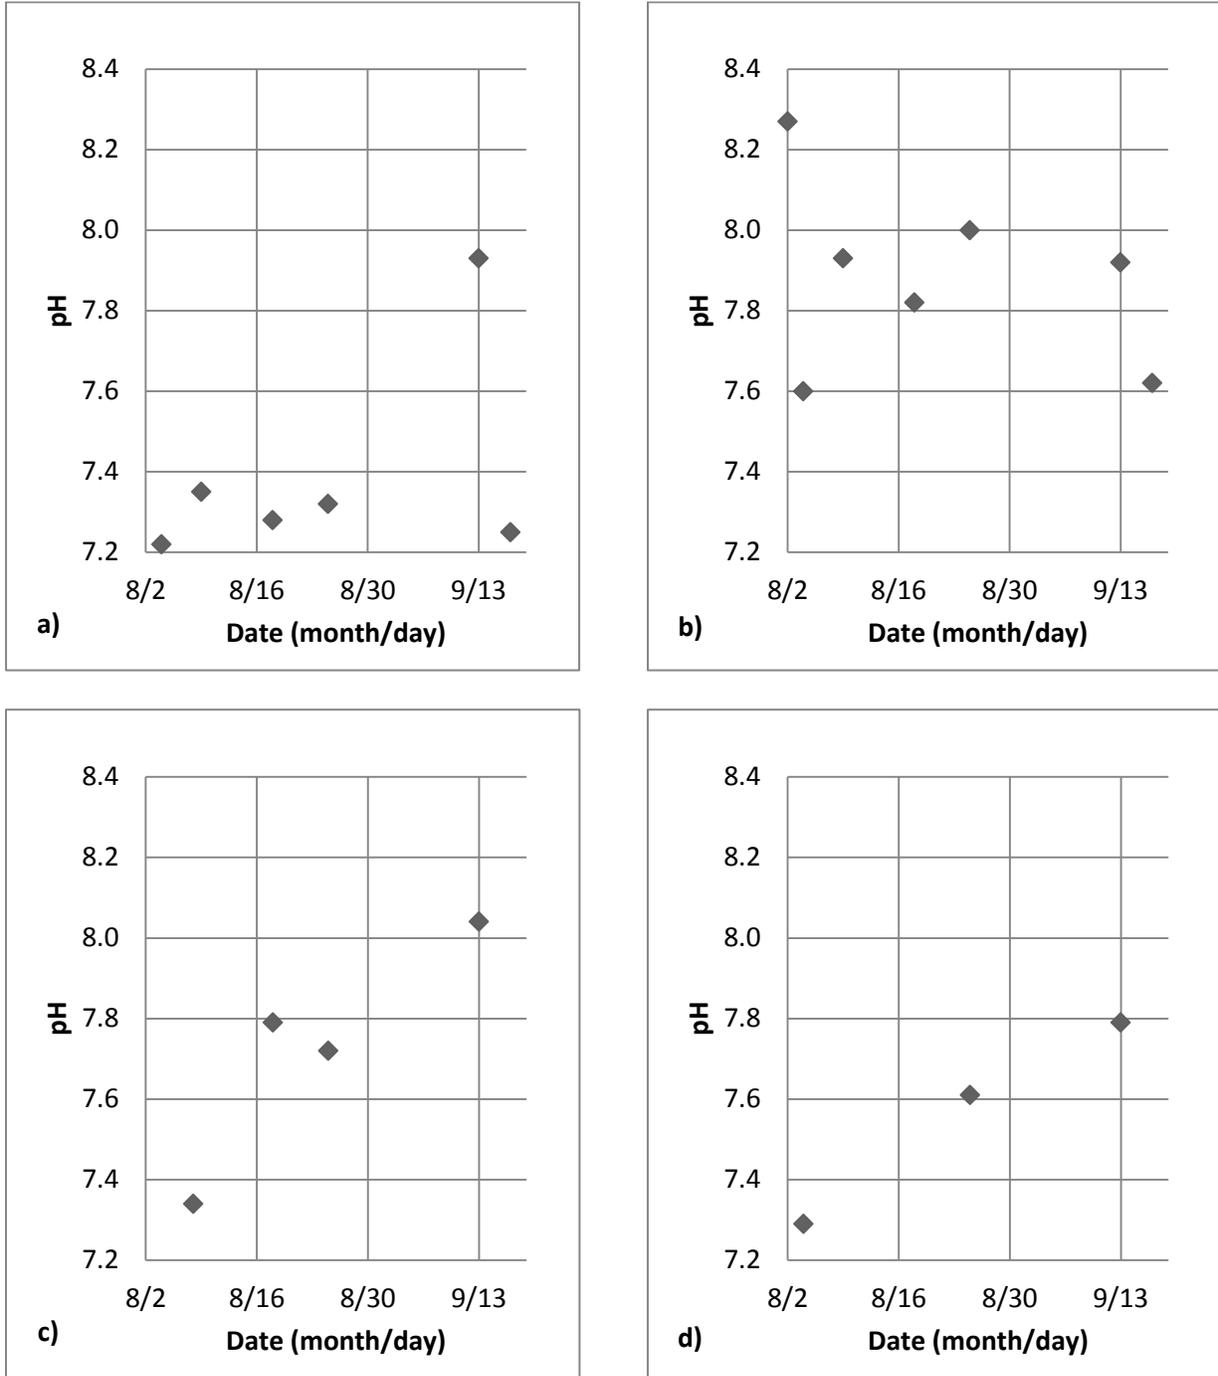
Figure 3.32 pH of Runoff from a) I-80 bridge over Platte River b) Highway 64 Bridge over Platte River c) I-80 bridge over Little Salt Creek d) Highway 77 bridge over Rock Creek

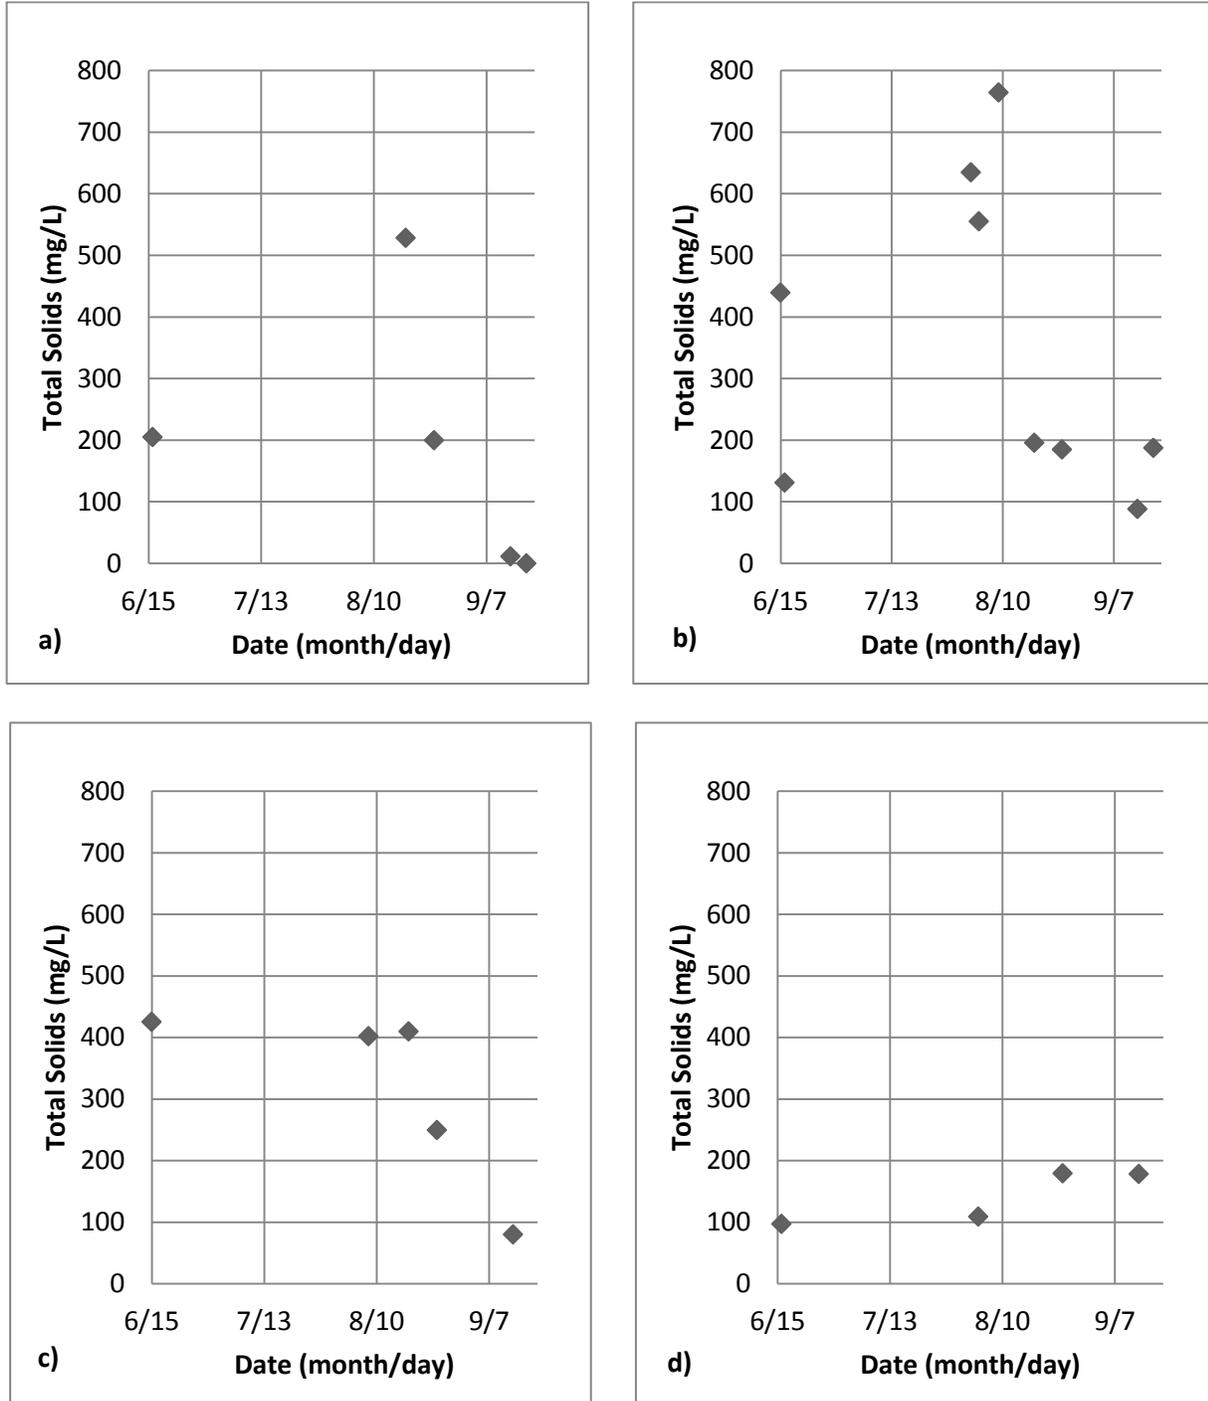
Figure 3.33 Total solids concentration in runoff from a) I-80 bridge over Platte River b) Highway 64 bridge over Platte River c) I-80 bridge over Little Salt Creek d) Highway 77 bridge over Rock Creek

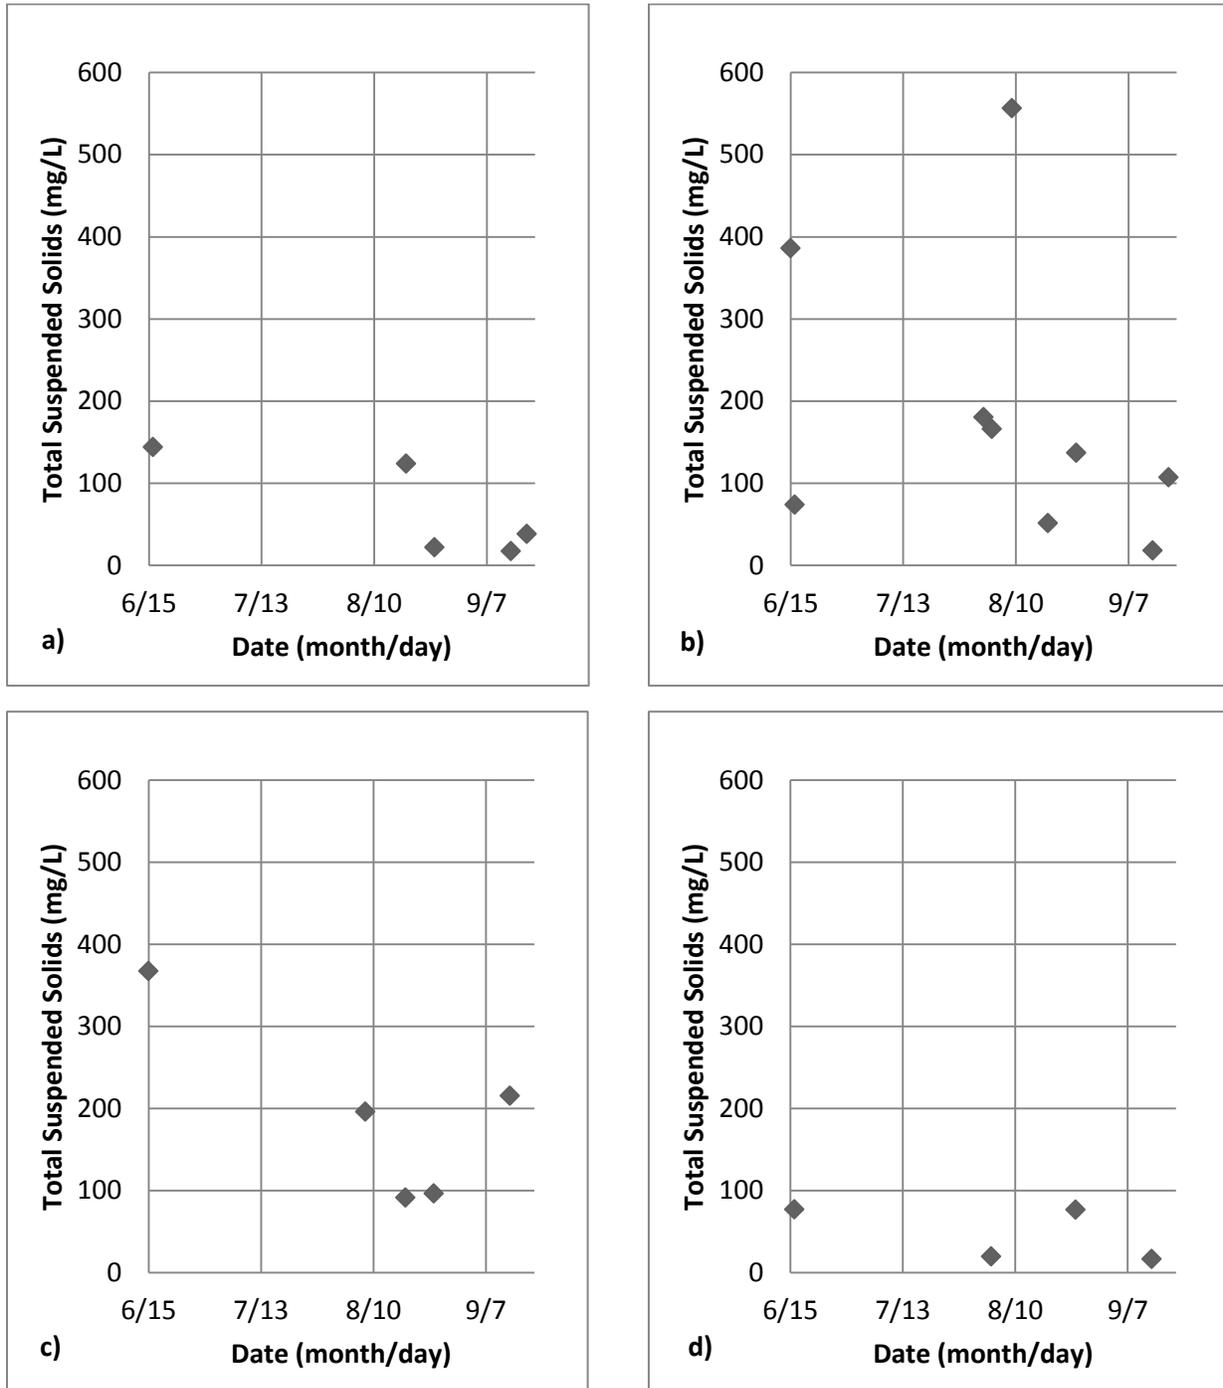
Figure 3.34 TSS concentration in runoff from a) I-80 bridge over Platte River b) Highway 64 bridge over Platte River c) I-80 bridge over Little Salt Creek d) Highway 77 bridge over Rock Creek

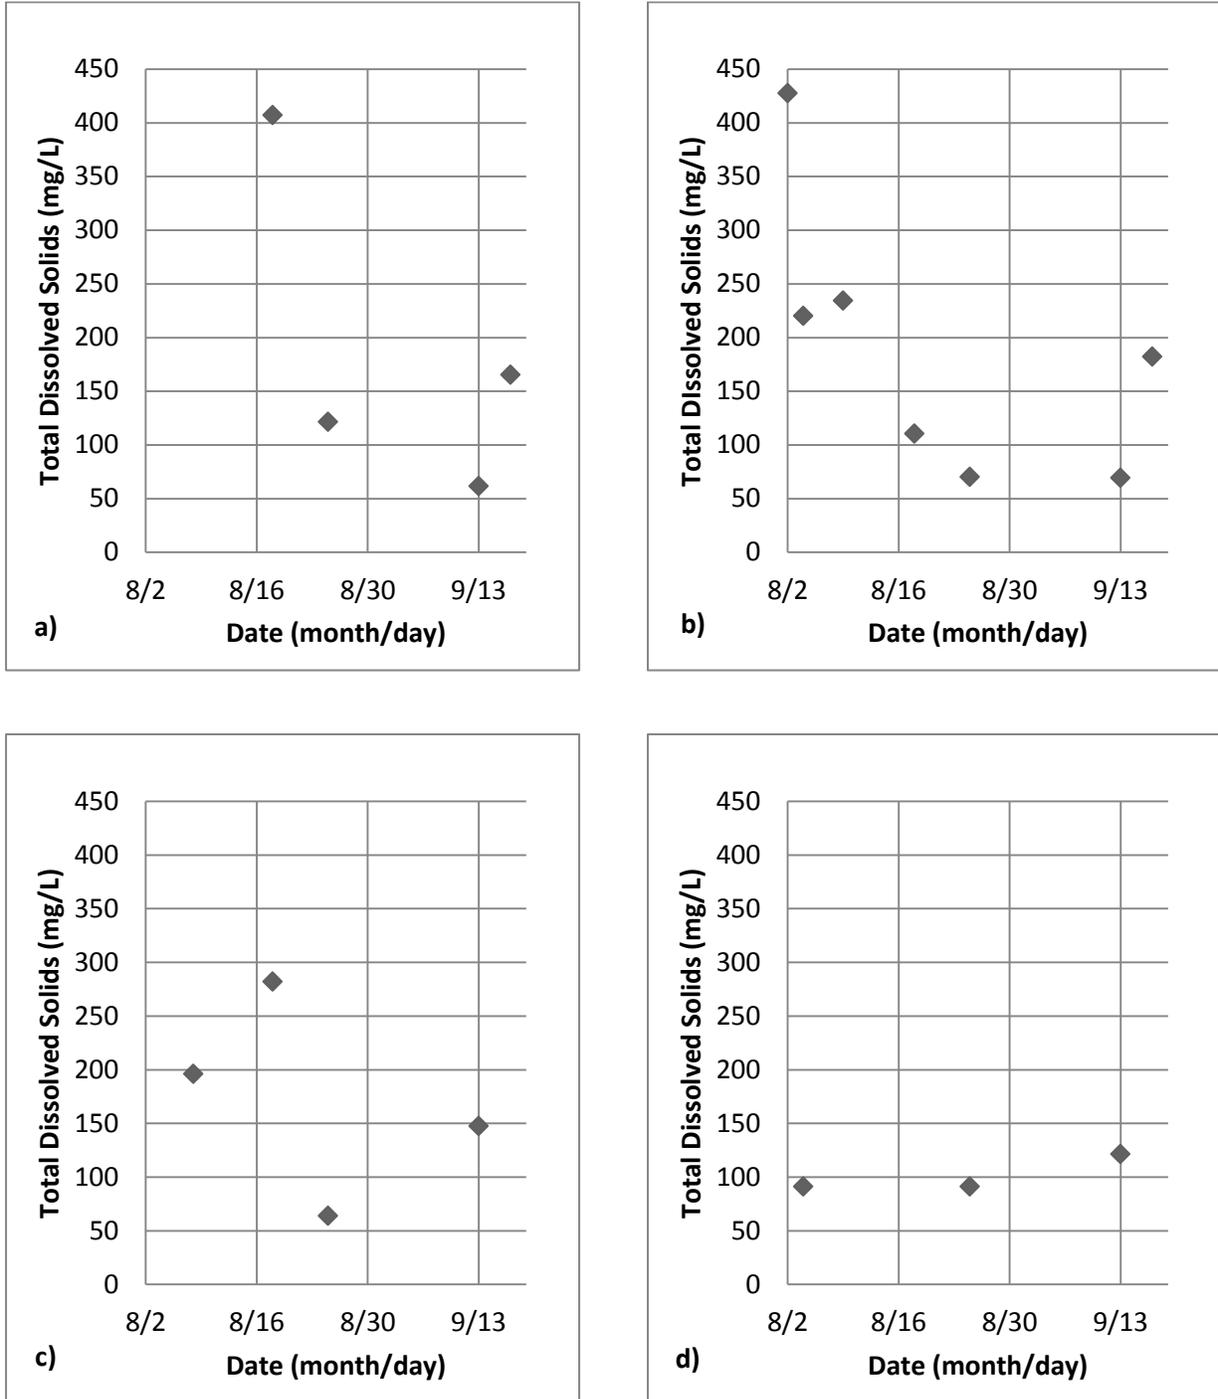
Figure 3.35 TDS concentration in runoff from a) I-80 bridge over Platte River b) Highway 64 bridge over Platte River c) I-80 bridge over Little Salt Creek d) Highway 77 bridge over Rock Creek

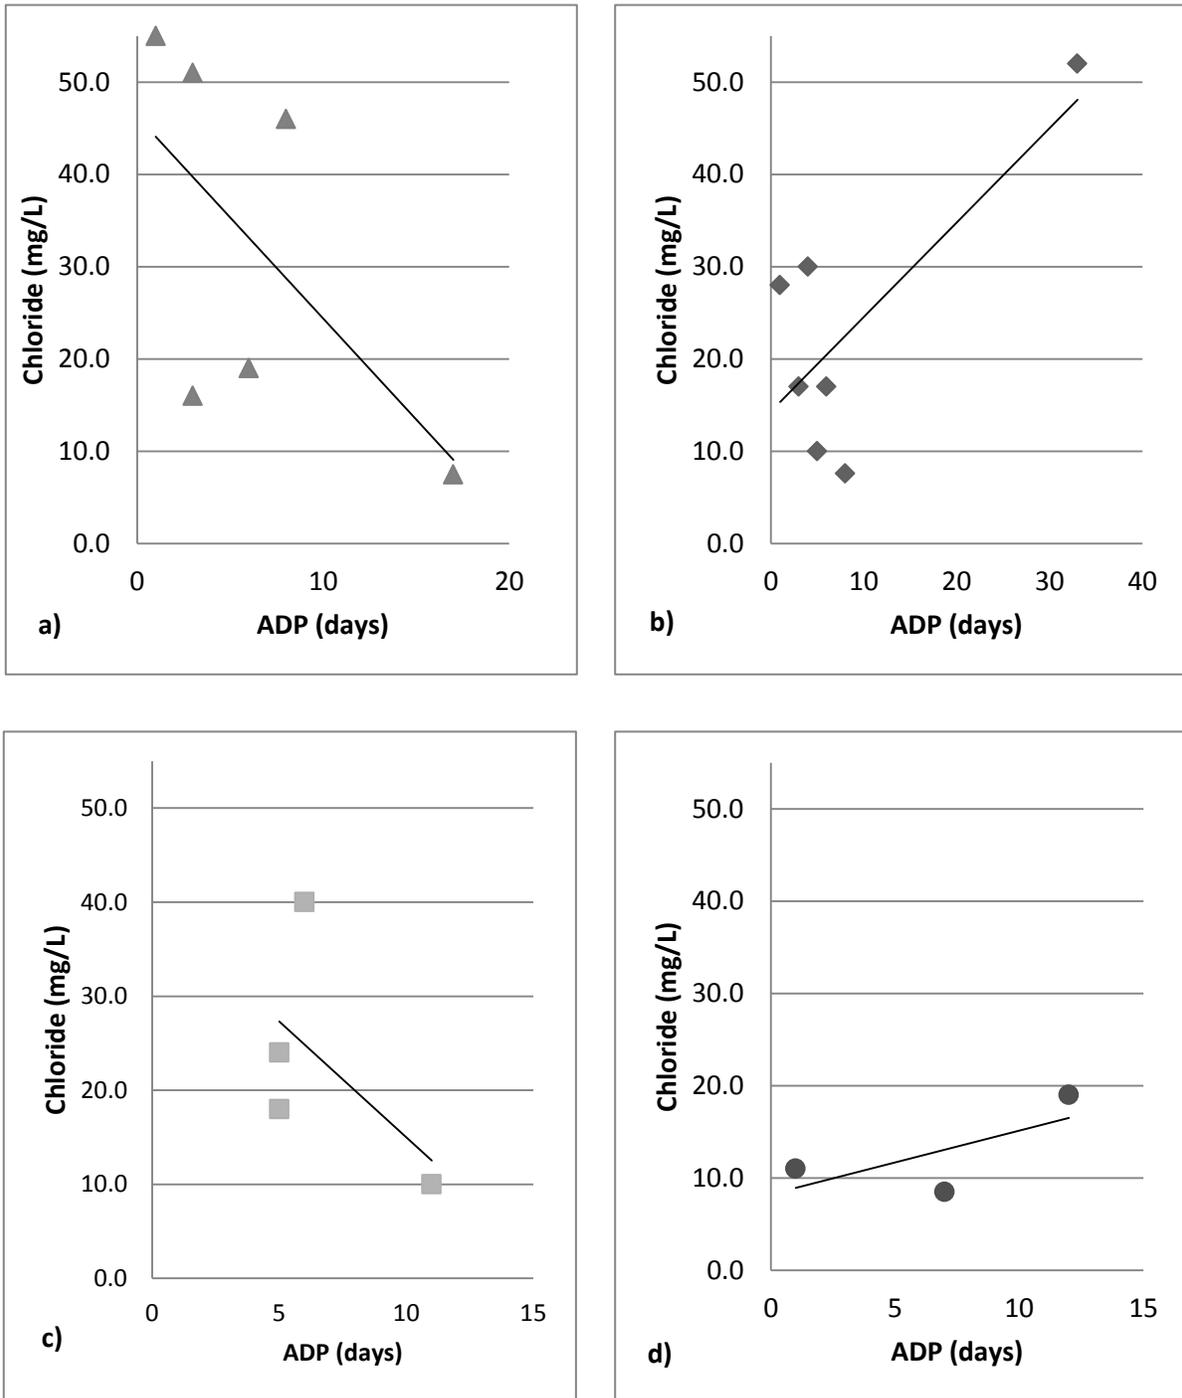
Figure 4.1 Chloride concentration in runoff from a) I-80 bridge over Platte River b) Highway 64 bridge over Platte River c) I-80 bridge over Little Salt Creek d) Highway 77 bridge over Rock Creek

The following figures compare the concentrations of contaminants in the bridge runoff with the ADP in days. Also included in the graphs are trend lines to better represent general increases or decreases in the data. Upon examining the first two graphs, it is difficult to see any correlation between ADP and the concentration of pollutants in bridge runoff. Since this is the case across all types of pollutants (showing similar or no results), only the first few sets of figures are shown in this section. The remaining sets of figures can be found in Appendix B of the current report.

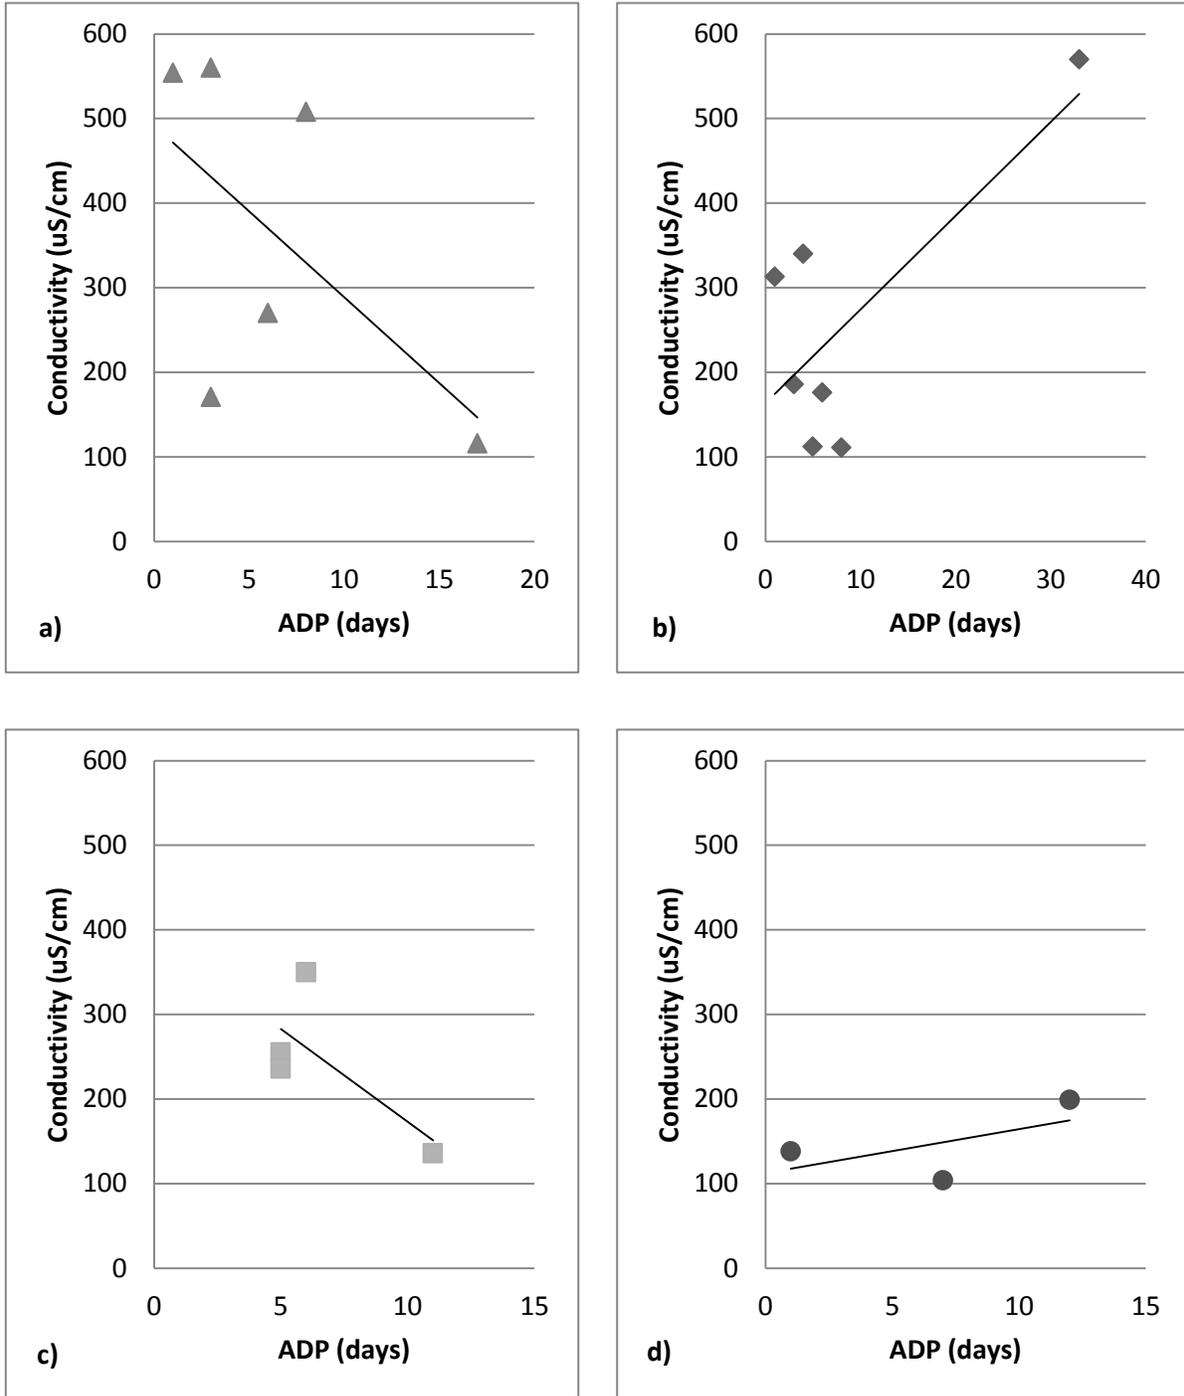
Figure 4.2 Conductivity of Runoff from a) I-80 bridge over Platte River b) Highway 64 bridge over Platte River c) I-80 bridge over Little Salt Creek d) Highway 77 bridge over Rock Creek

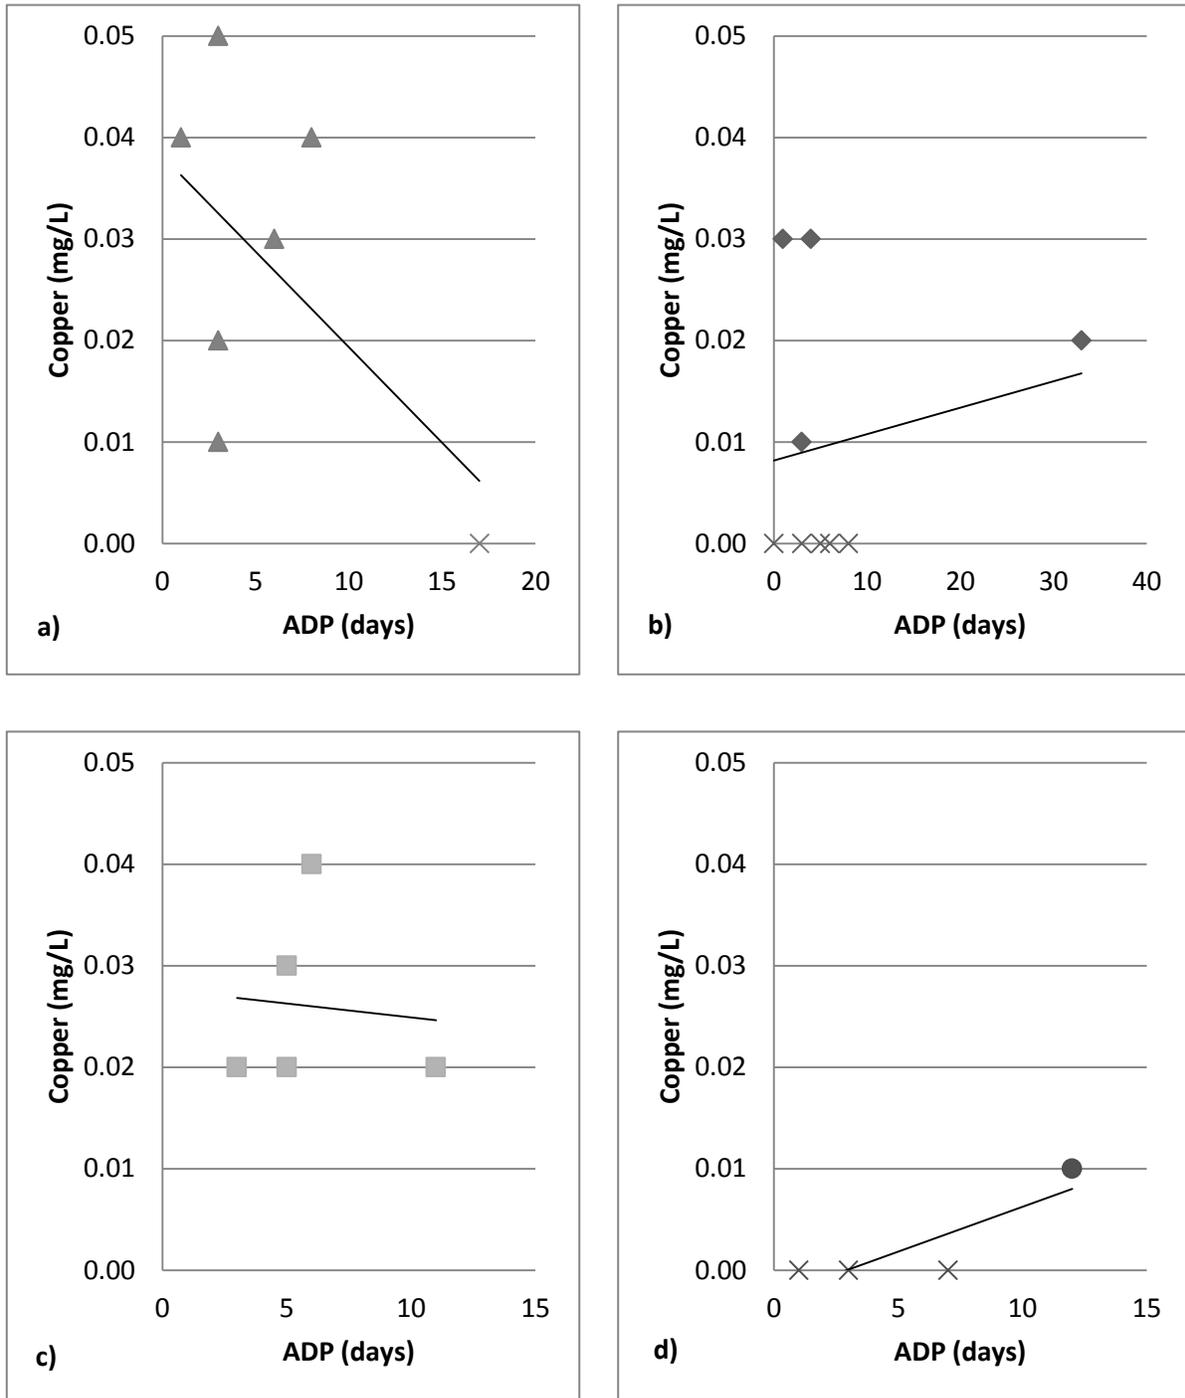
Figure 4.3 Copper concentration in runoff from a) I-80 bridge over Platte River b) Highway 64 bridge over Platte River c) I-80 bridge over Little Salt Creek d) Highway 77 bridge over Rock Creek

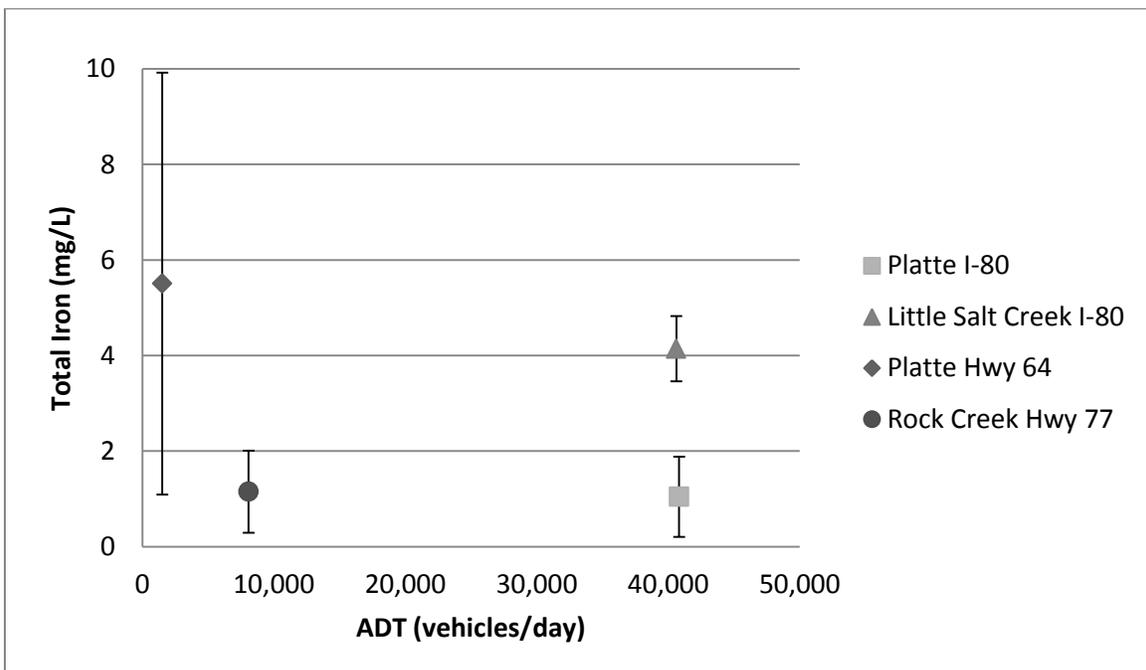
Figure 4.4 Iron concentration of bridge deck runoff versus ADT

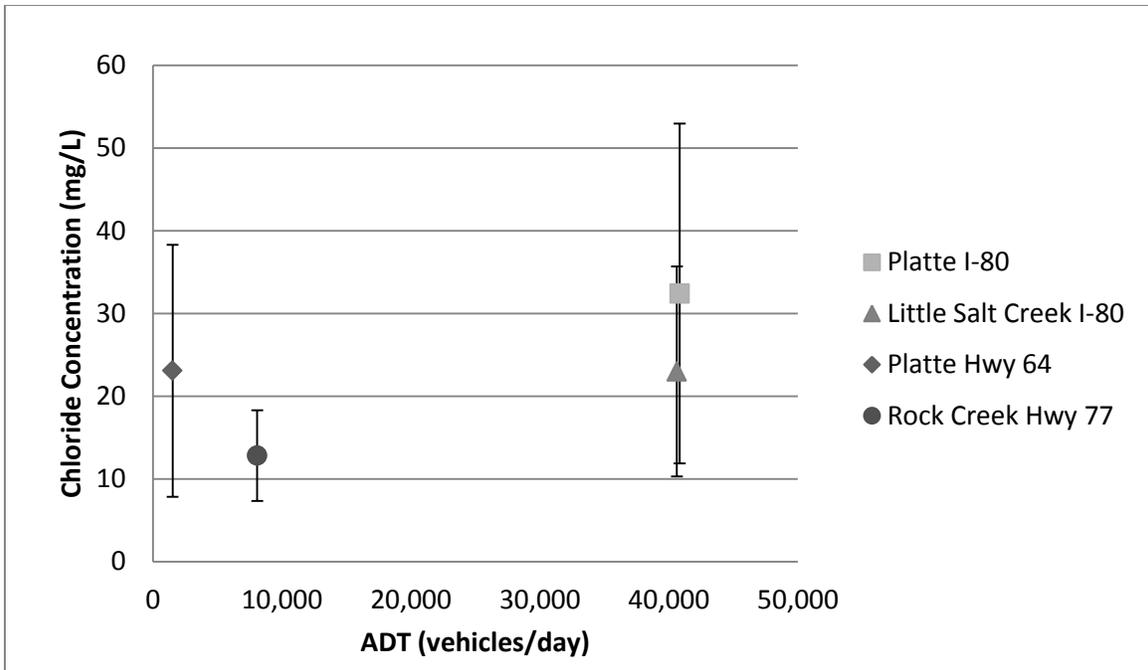
Figure 4.5 Chloride concentration of bridge deck runoff versus ADT

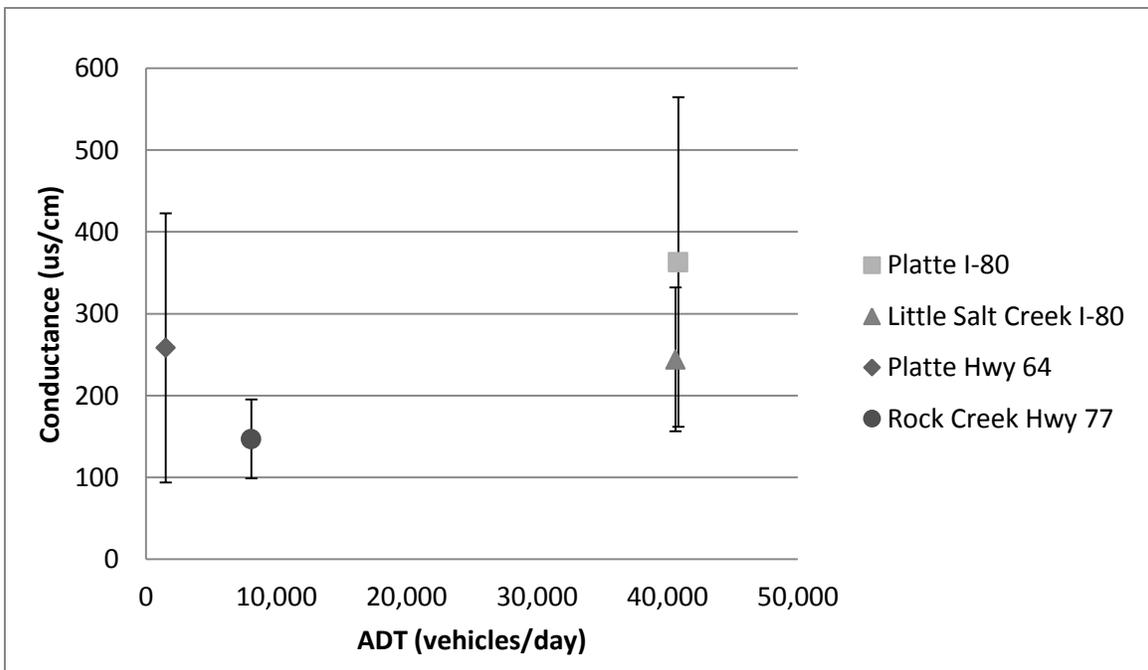
Figure 4.6 Conductance of bridge deck runoff versus ADT

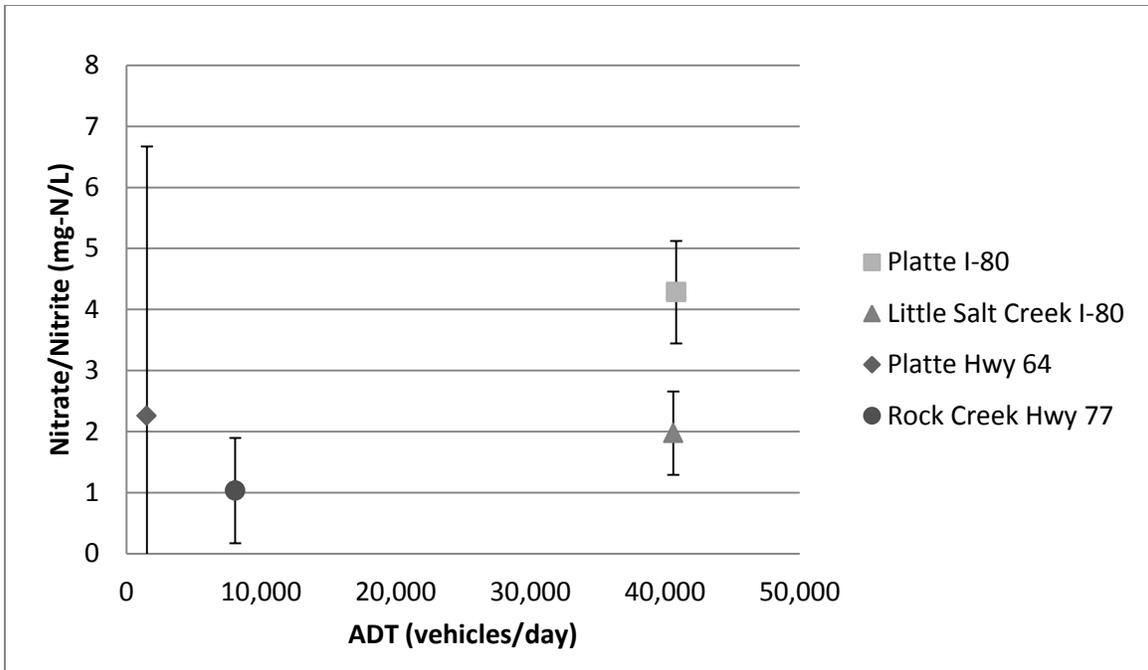
Figure 4.7 Nitrate/Nitrite in bridge deck runoff versus ADT

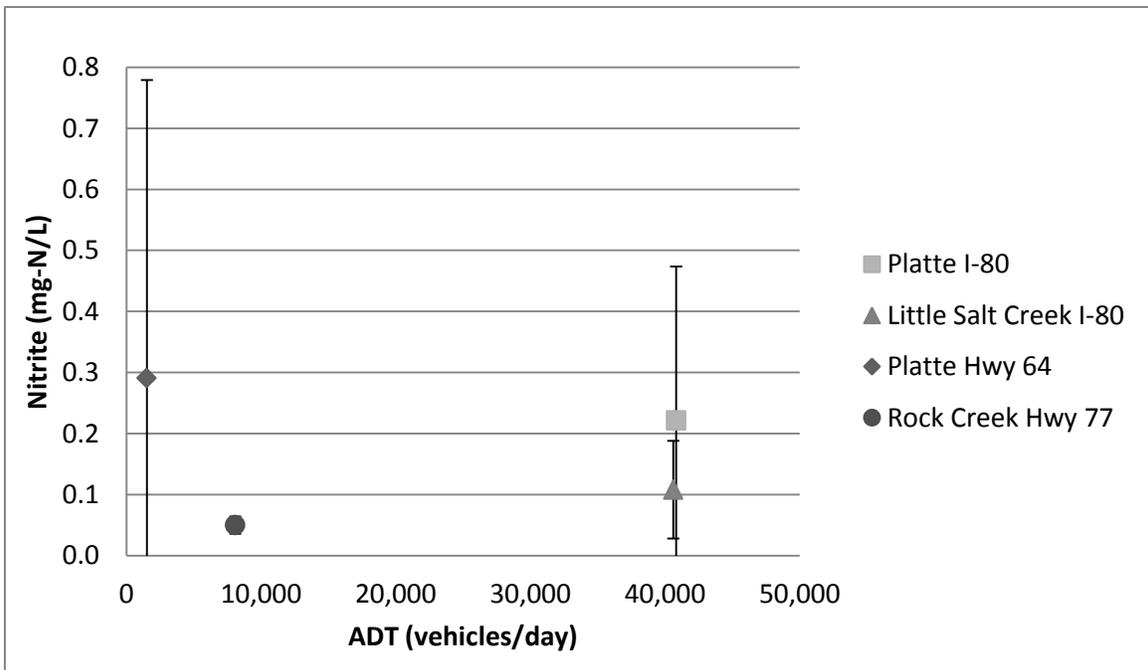
Figure 4.8 Nitrite in bridge deck runoff versus ADT

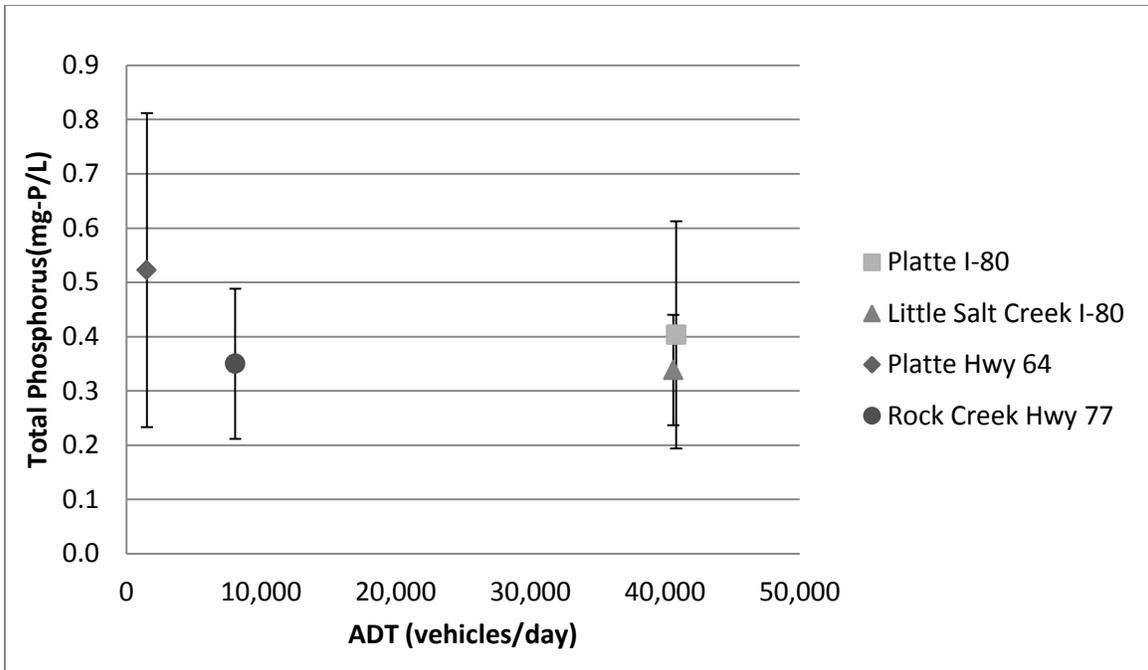
Figure 4.9 TP in bridge deck runoff versus ADT

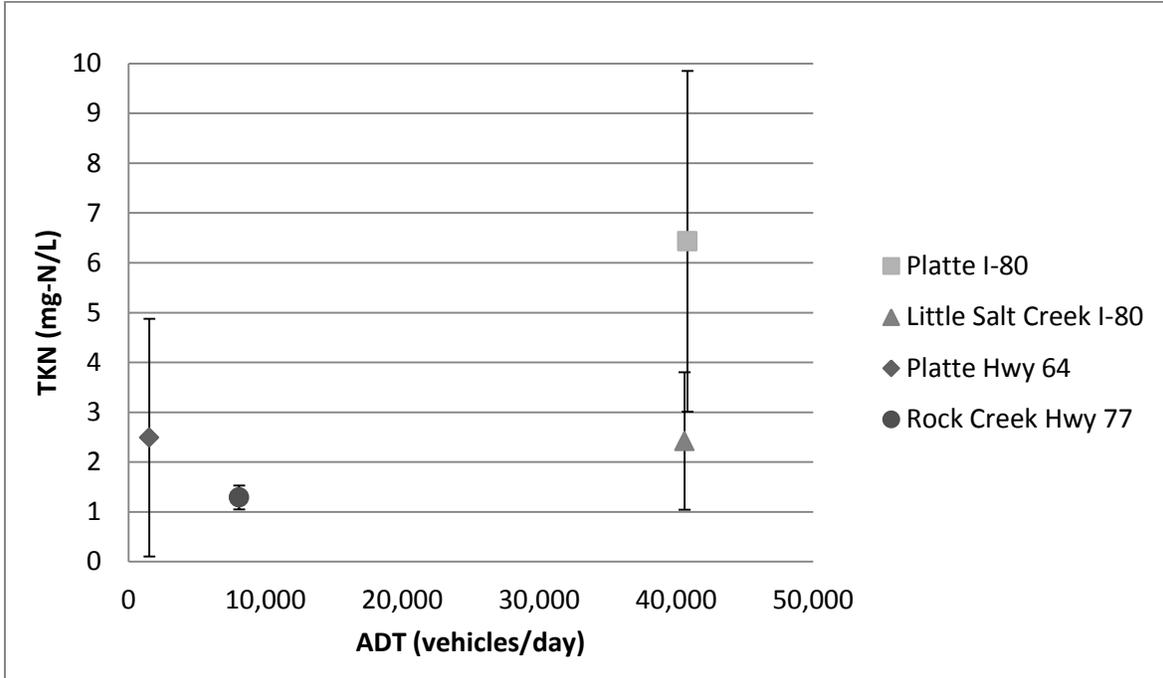
Figure 4.10 TKN in bridge deck runoff versus ADT

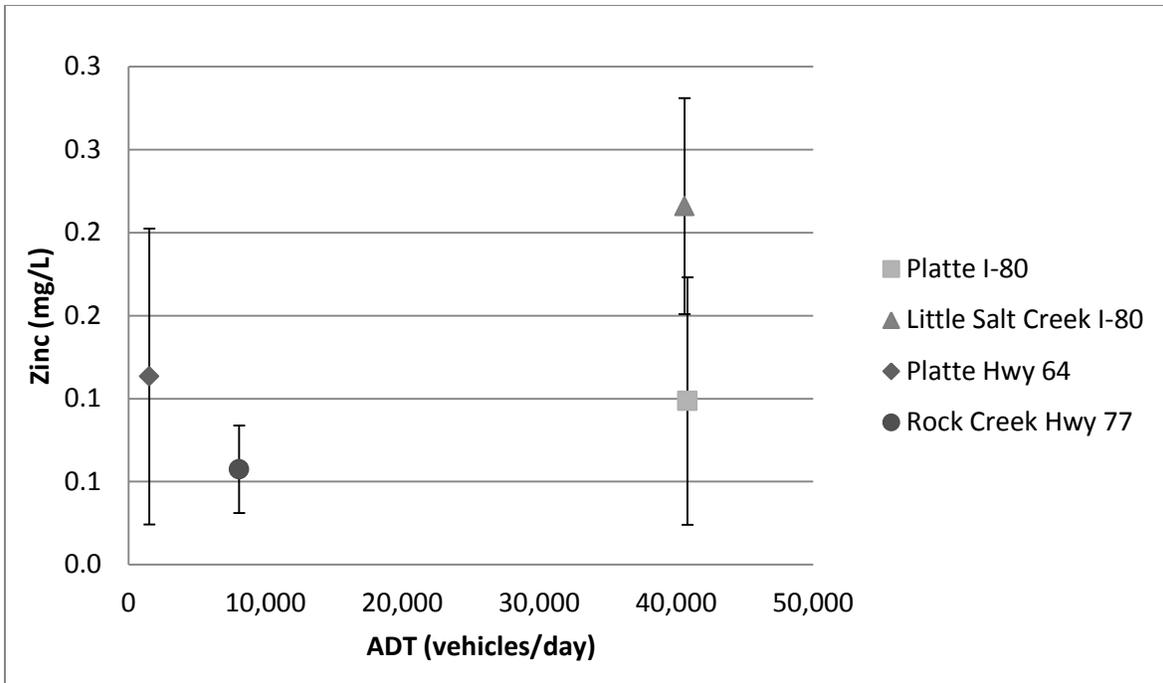
Figure 4.11 Zinc in bridge deck runoff versus ADT

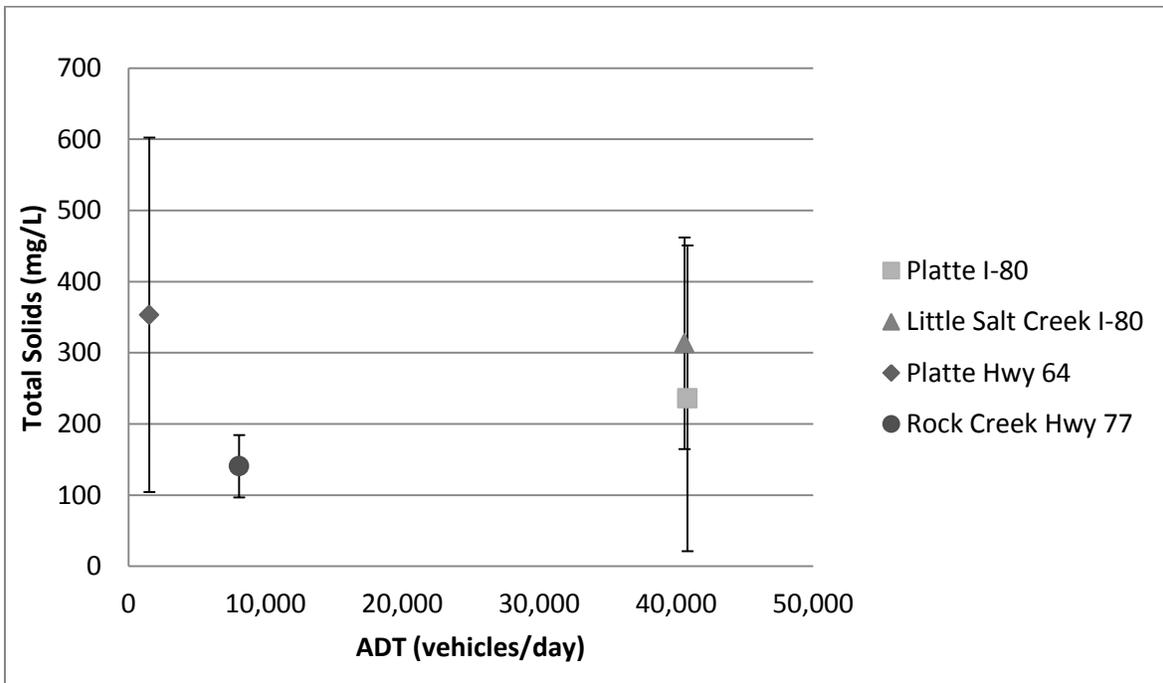
Figure 4.12 Total solids in bridge deck runoff versus ADT

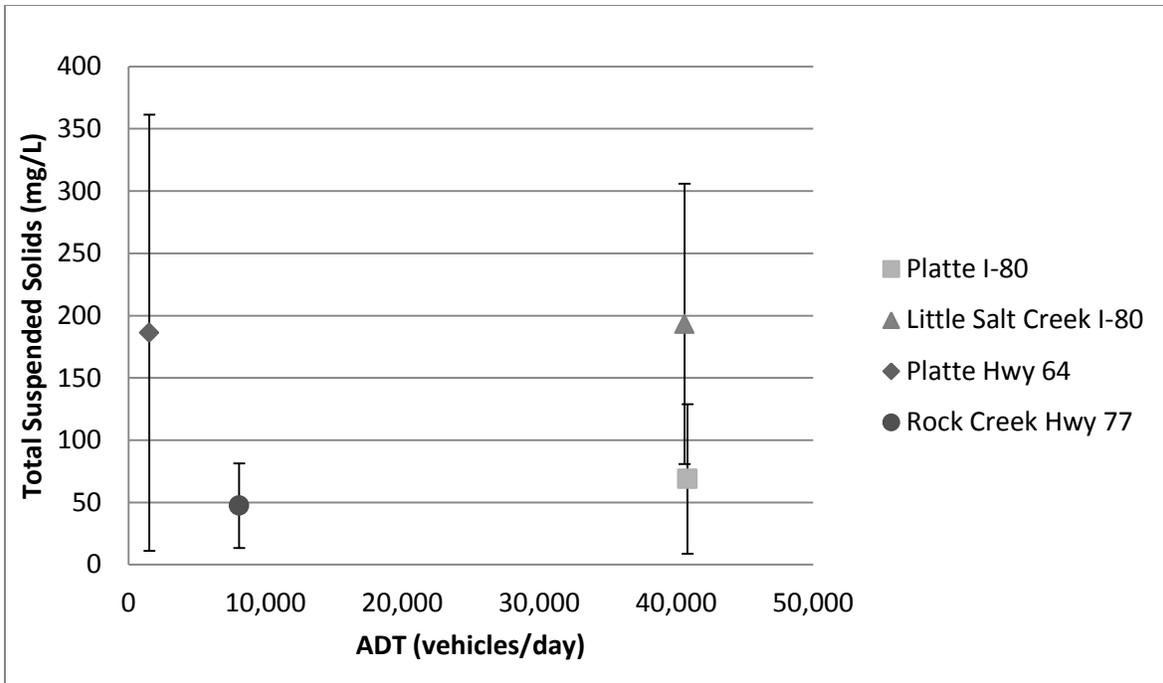
Figure 4.13 TSS in bridge deck runoff versus ADT

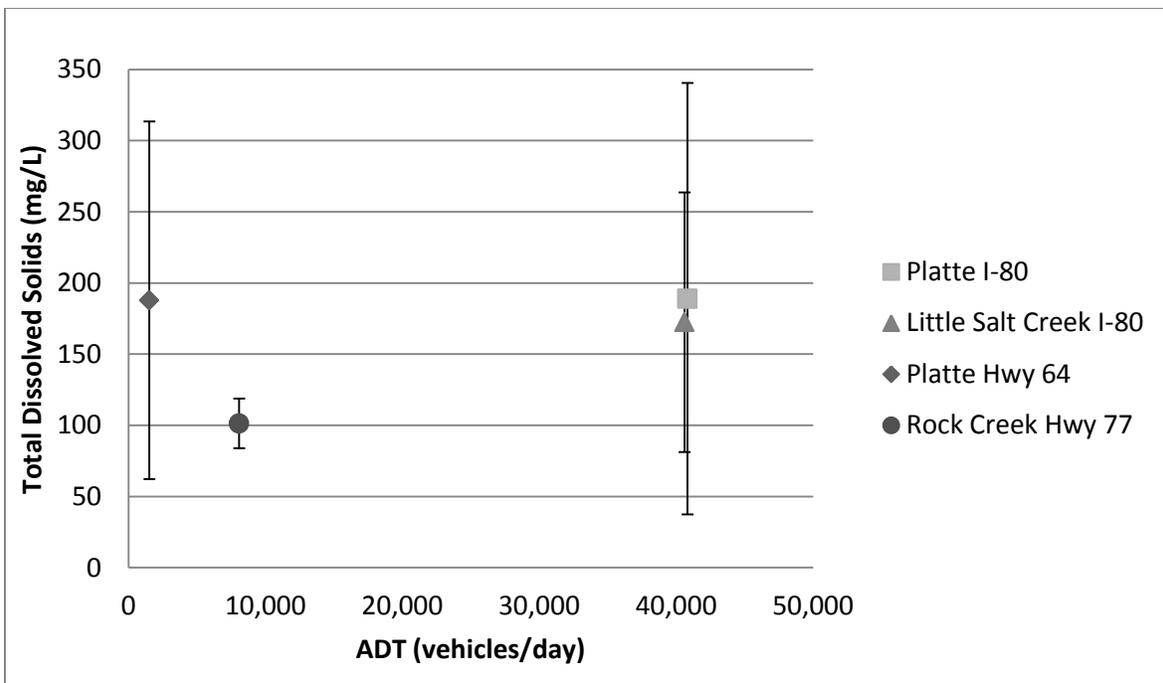
Figure 4.14 TDS in bridge deck runoff versus ADT

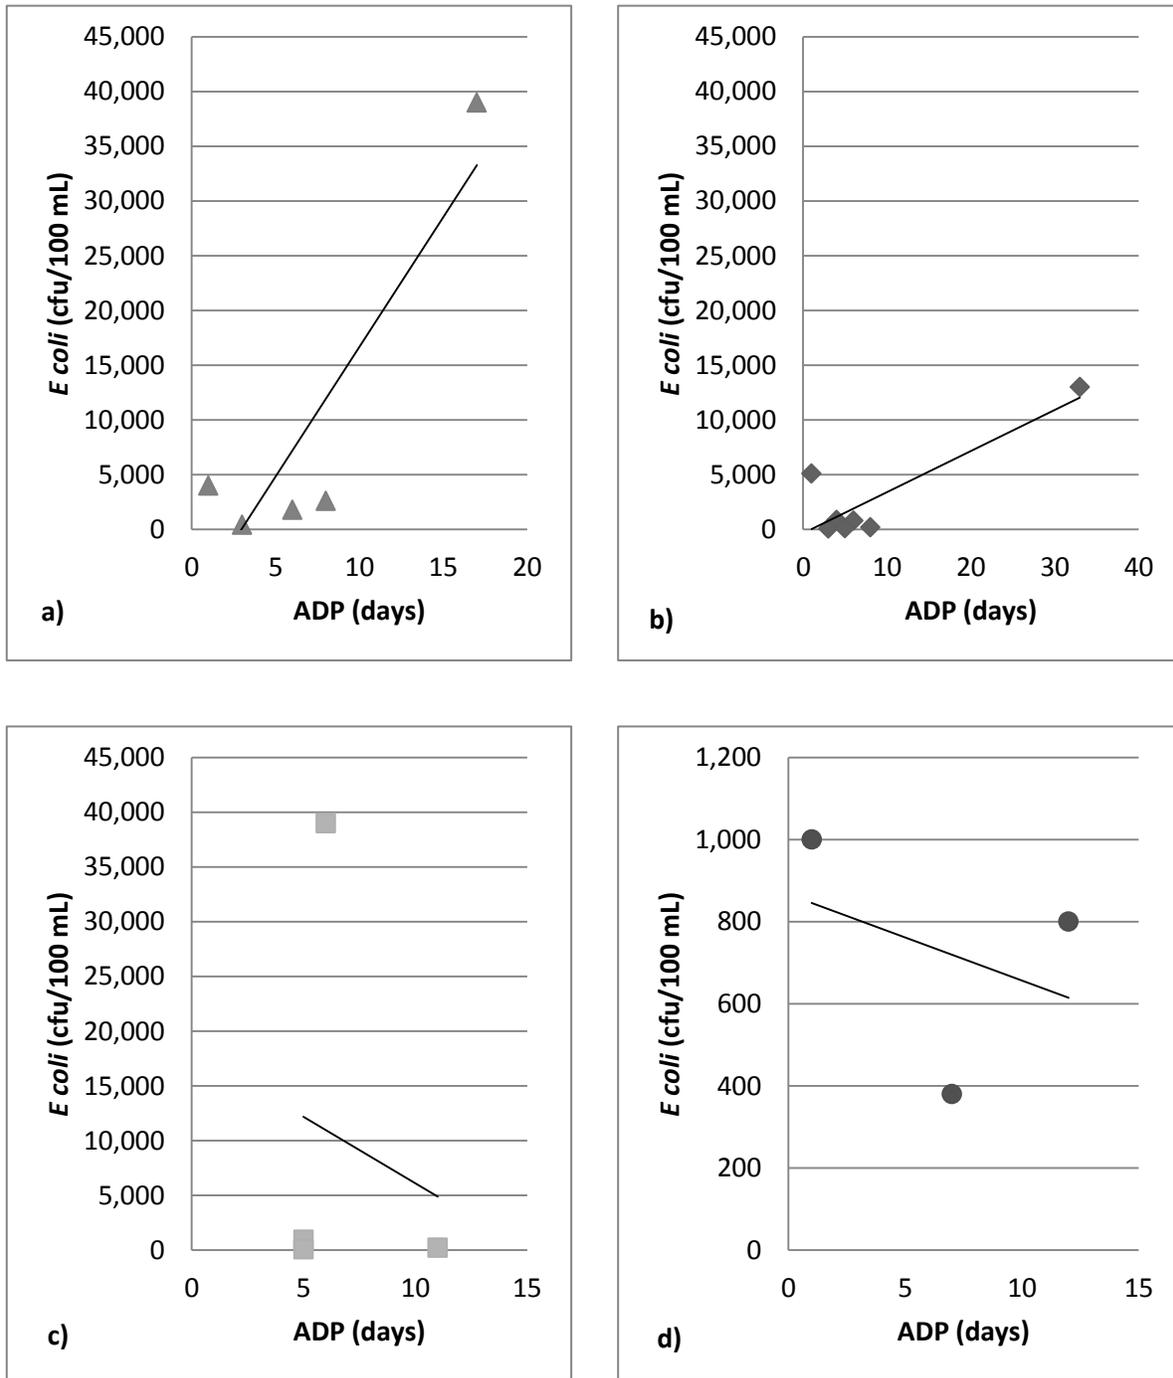
Figure B.1 *E coli* concentration in runoff versus ADP from a) I-80 bridge over Platte River b) Highway 64 bridge over Platte River c) I-80 bridge over Little Salt Creek d) Highway 77 bridge over Rock Creek
