Evaluation of the Environmental Impacts of Bridge Deck Runoff

Report SPR-P1(12) M315

Final Report
26-1121-4008-001

Evaluation of the Environmental Impacts of Bridge Deck Runoff – Preliminary Draft

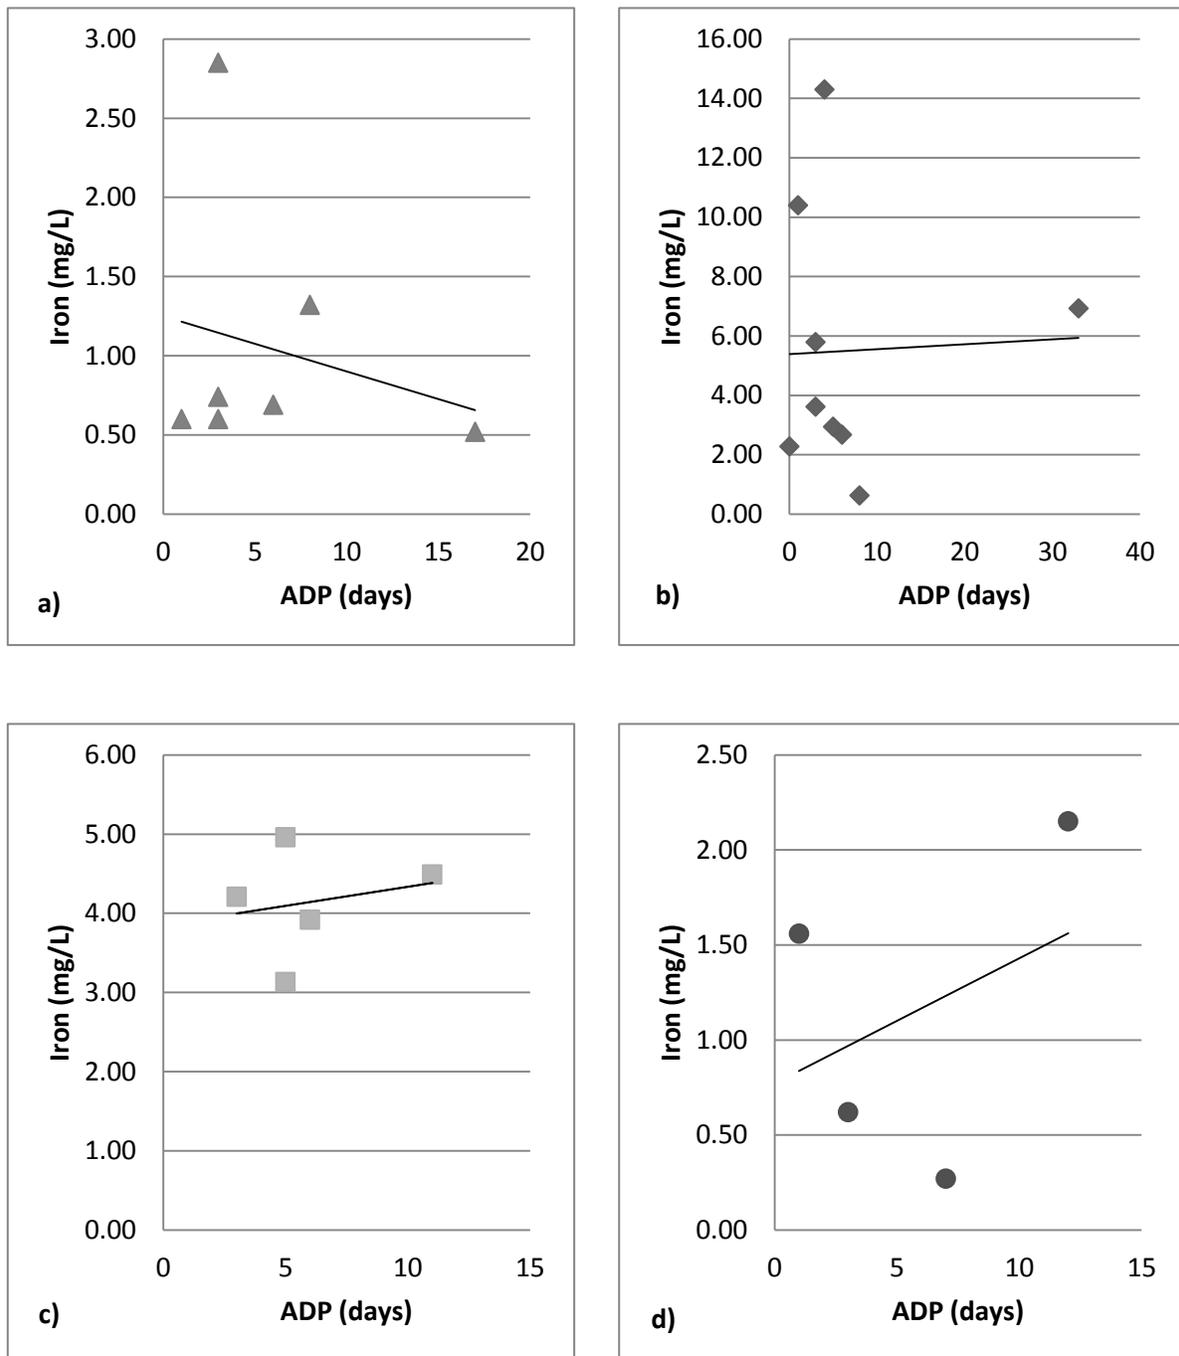
Figure B.2 Iron concentration in runoff versus ADP from a) I-80 bridge over Platte River b) Highway 64 bridge over Platte River c) I-80 bridge over Little Salt Creek d) Highway 77 bridge over Rock Creek

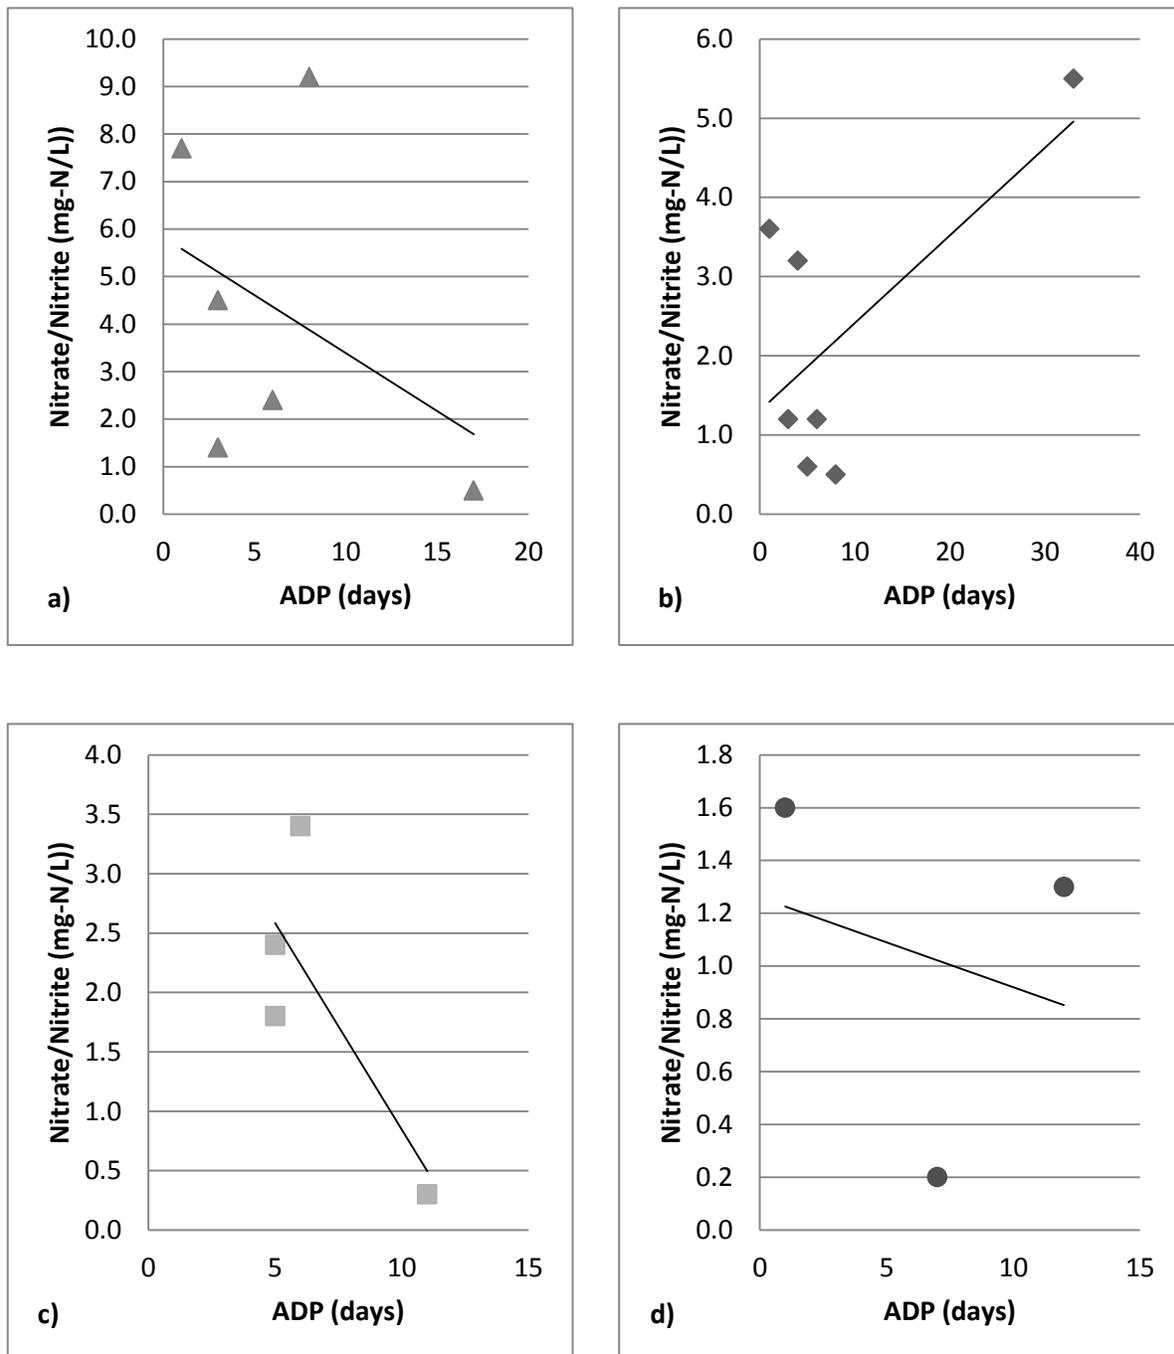
Figure B.3 Nitrate/Nitrite concentration in runoff versus ADP from a) I-80 bridge over Platte River b) Highway 64 bridge over Platte River c) I-80 bridge over Little Salt Creek d) Highway 77 bridge over Rock Creek

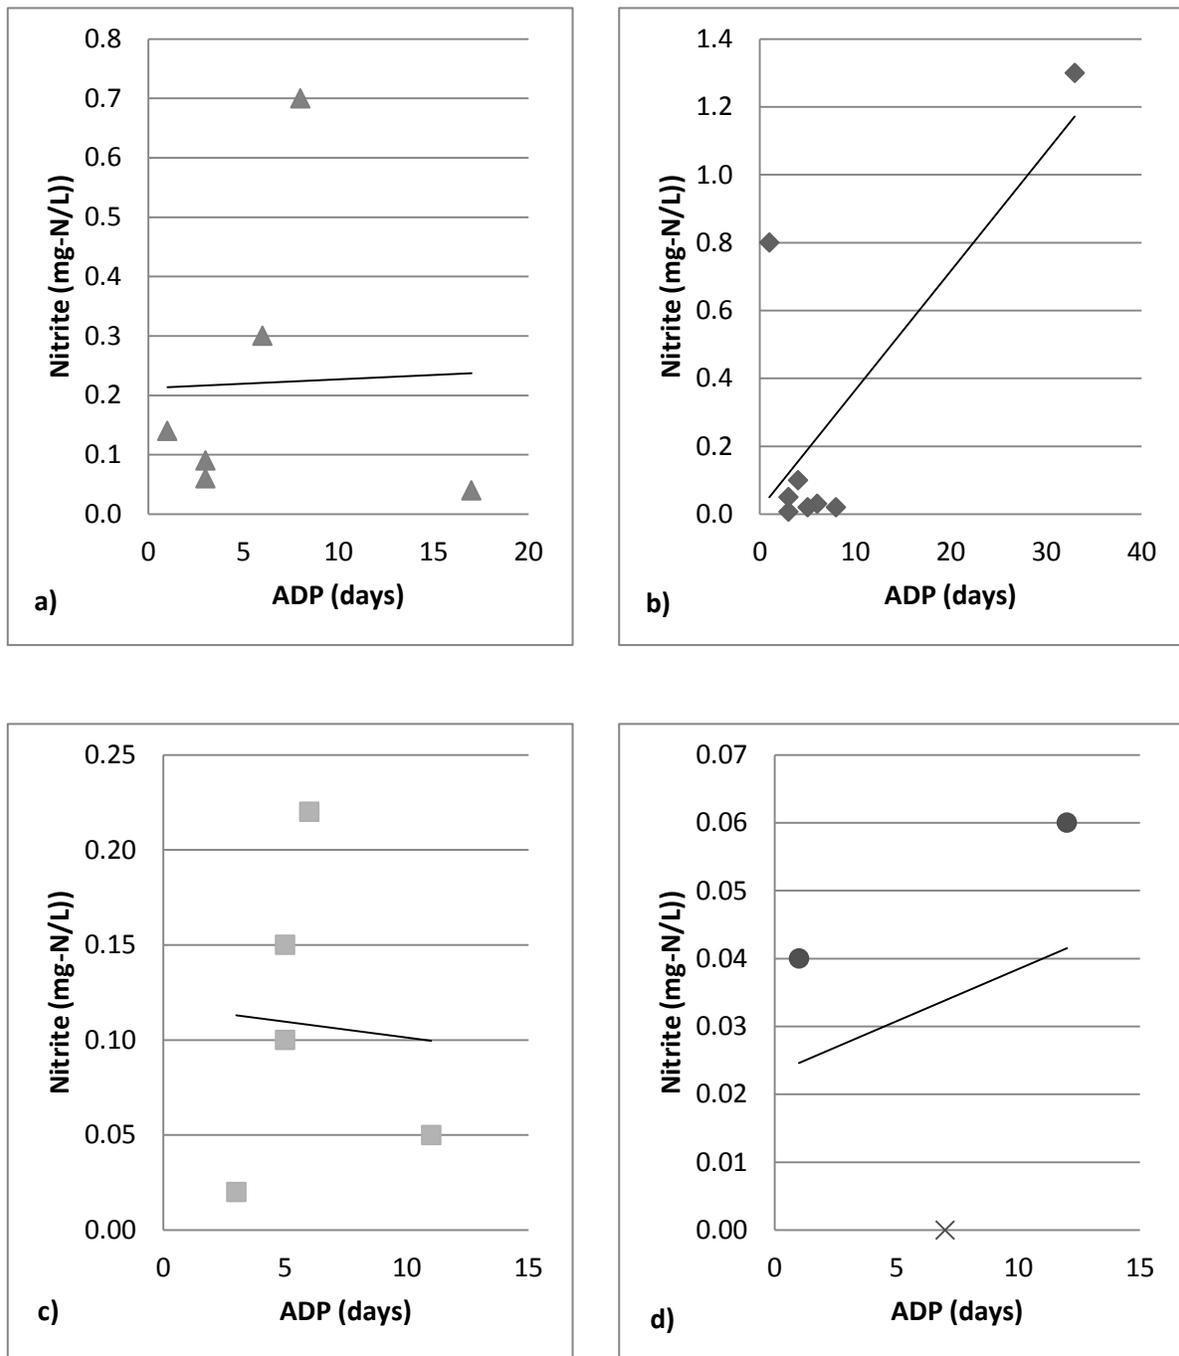
Figure B.4 Nitrite concentration in runoff versus ADP from a) I-80 bridge over Platte River b) Highway 64 bridge over Platte River c) I-80 bridge over Little Salt Creek d) Highway 77 bridge over Rock Creek

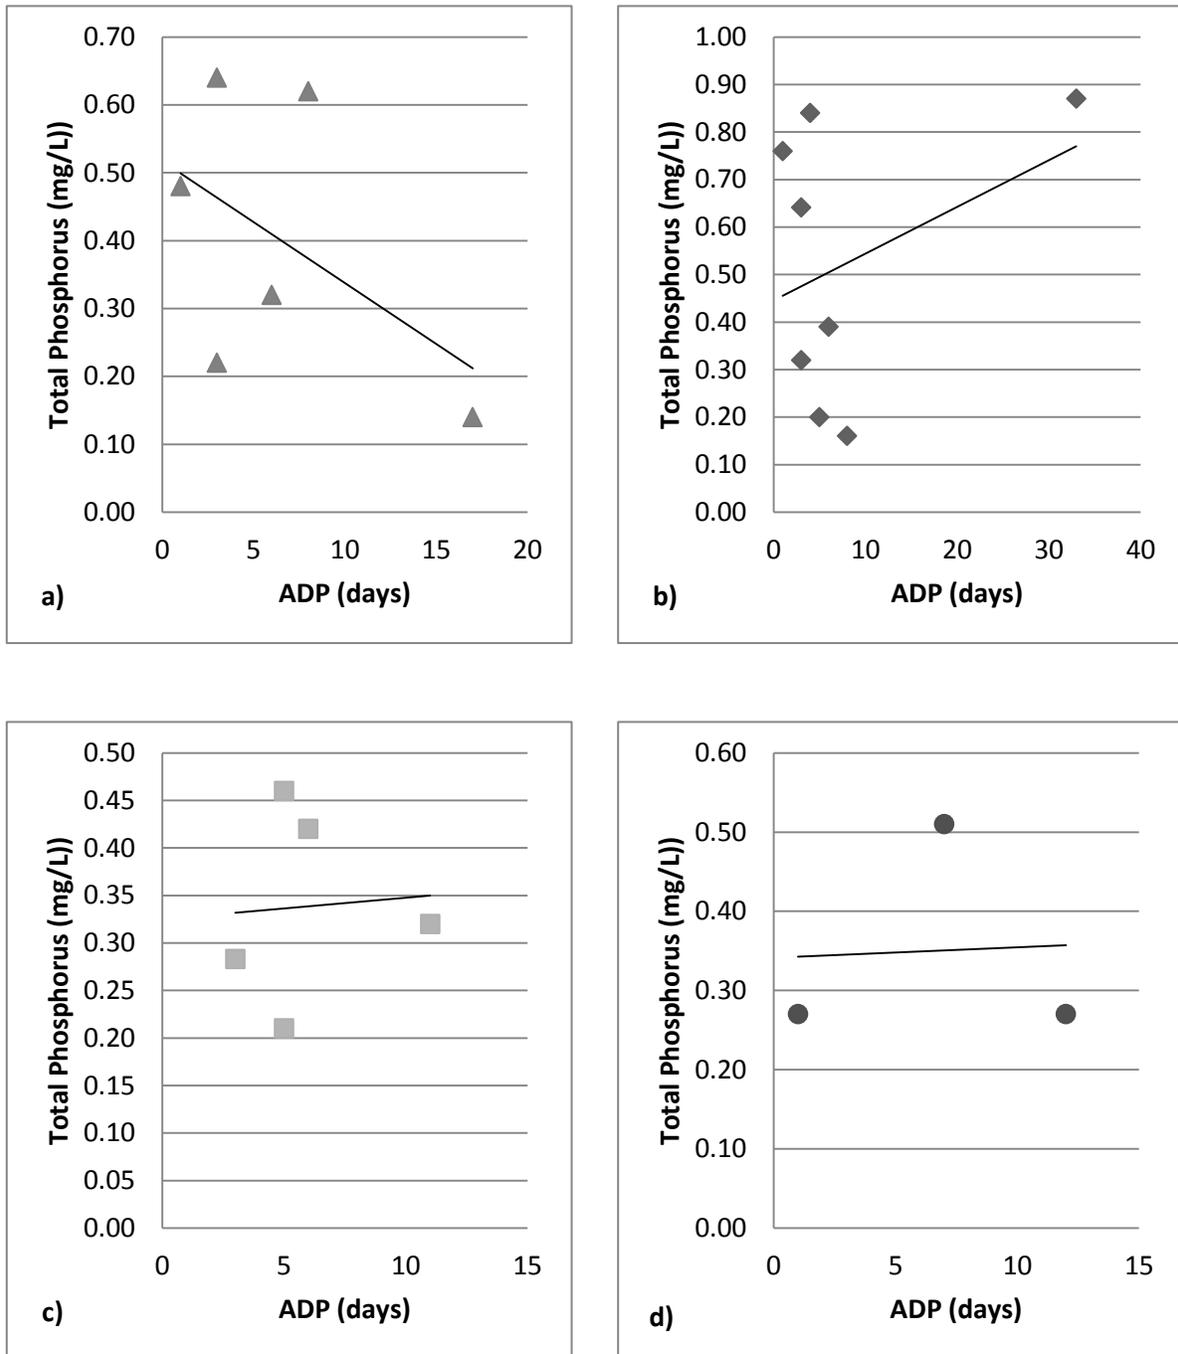
Figure B.5 Total phosphorus concentration in runoff versus ADP from a) I-80 bridge over Platte River b) Highway 64 bridge over Platte River c) I-80 bridge over Little Salt Creek d) Highway 77 bridge over Rock Creek

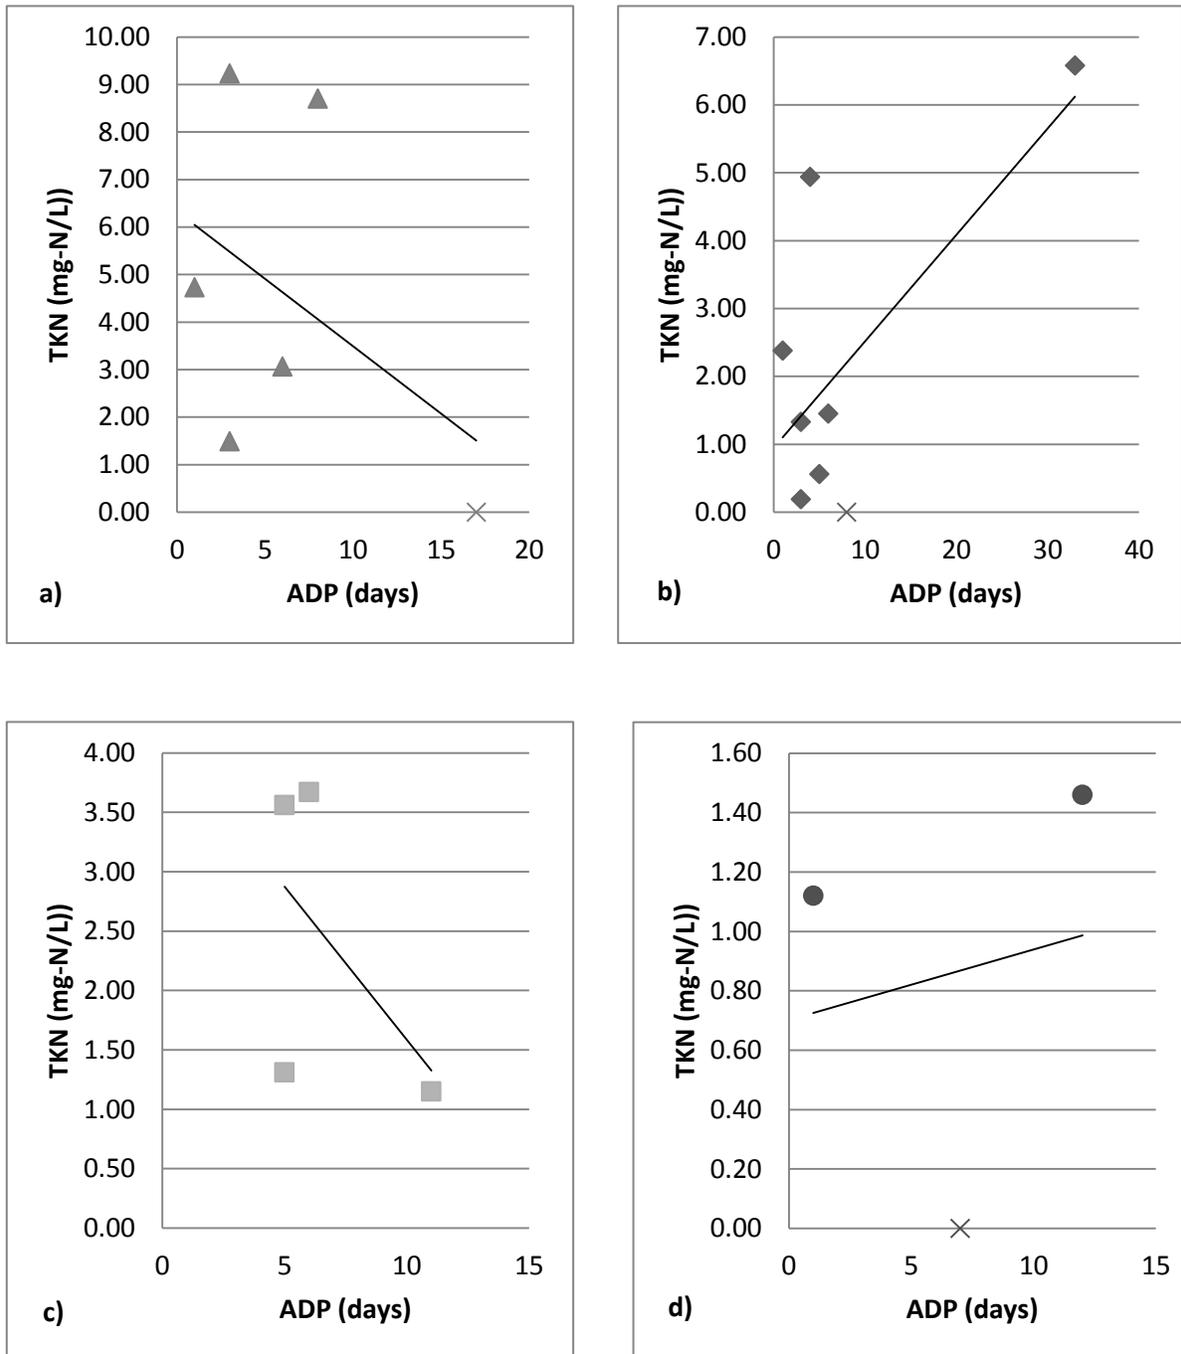
Figure B.6 TKN concentration in runoff versus ADP from a) I-80 bridge over Platte River b) Highway 64 bridge over Platte River c) I-80 bridge over Little Salt Creek d) Highway 77 bridge over Rock Creek

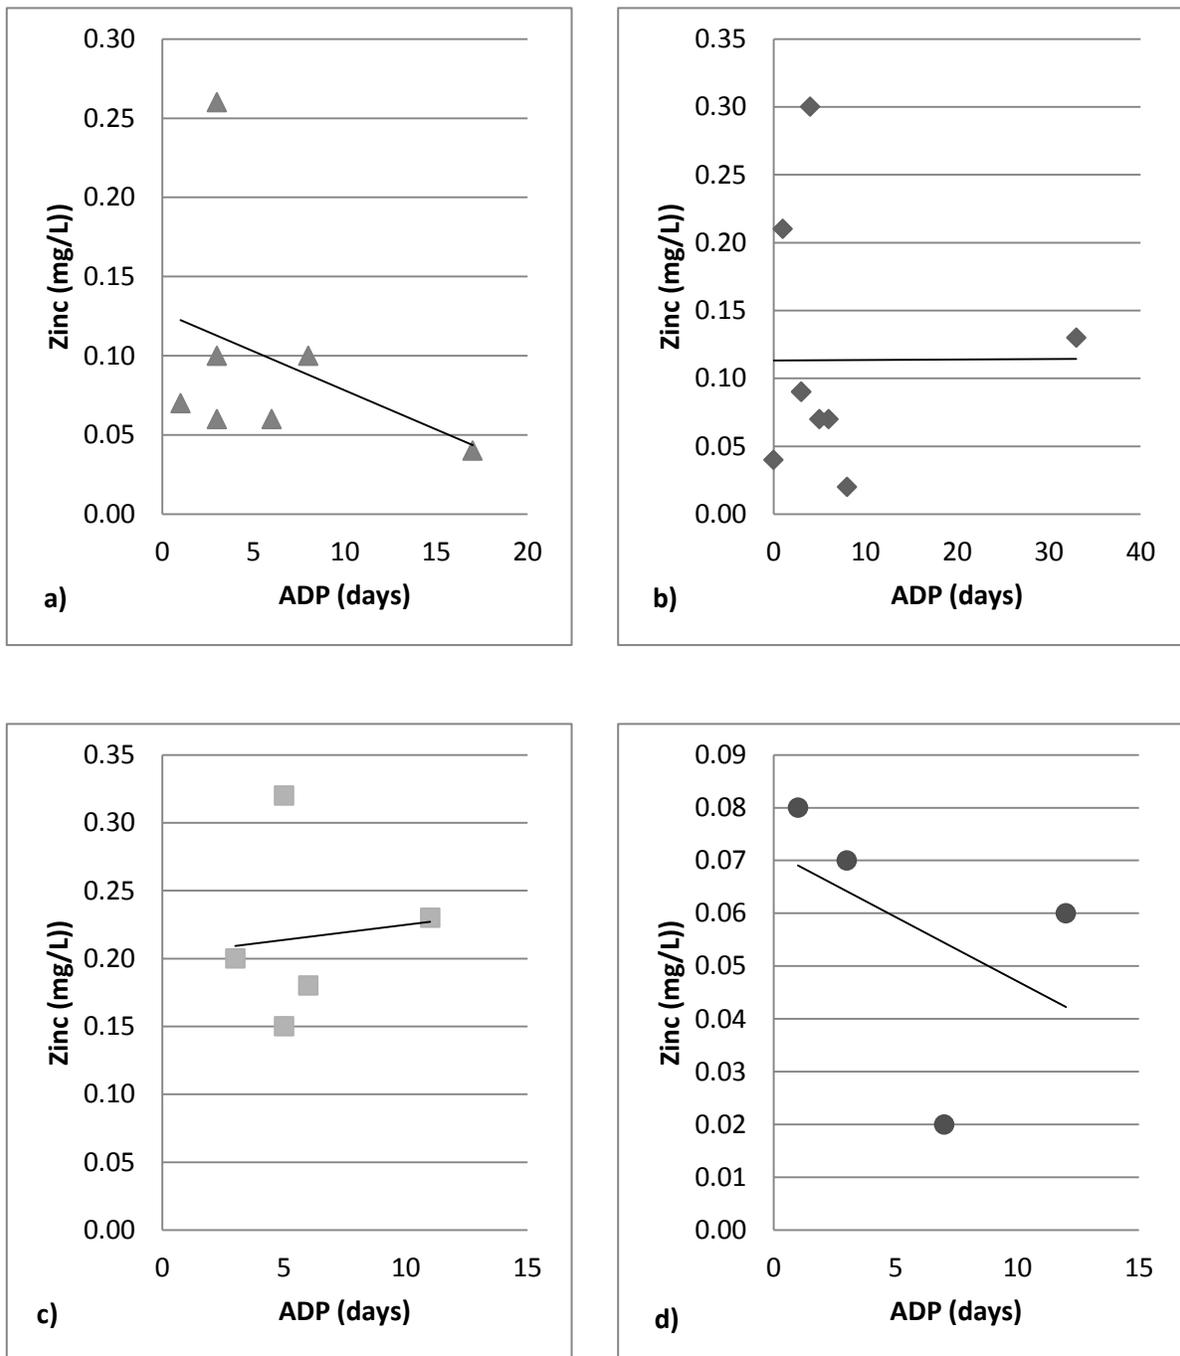
Figure B.7 Zinc concentration in runoff versus ADP from a) I-80 bridge over Platte River b) Highway 64 bridge over Platte River c) I-80 bridge over Little Salt Creek d) Highway 77 bridge over Rock Creek

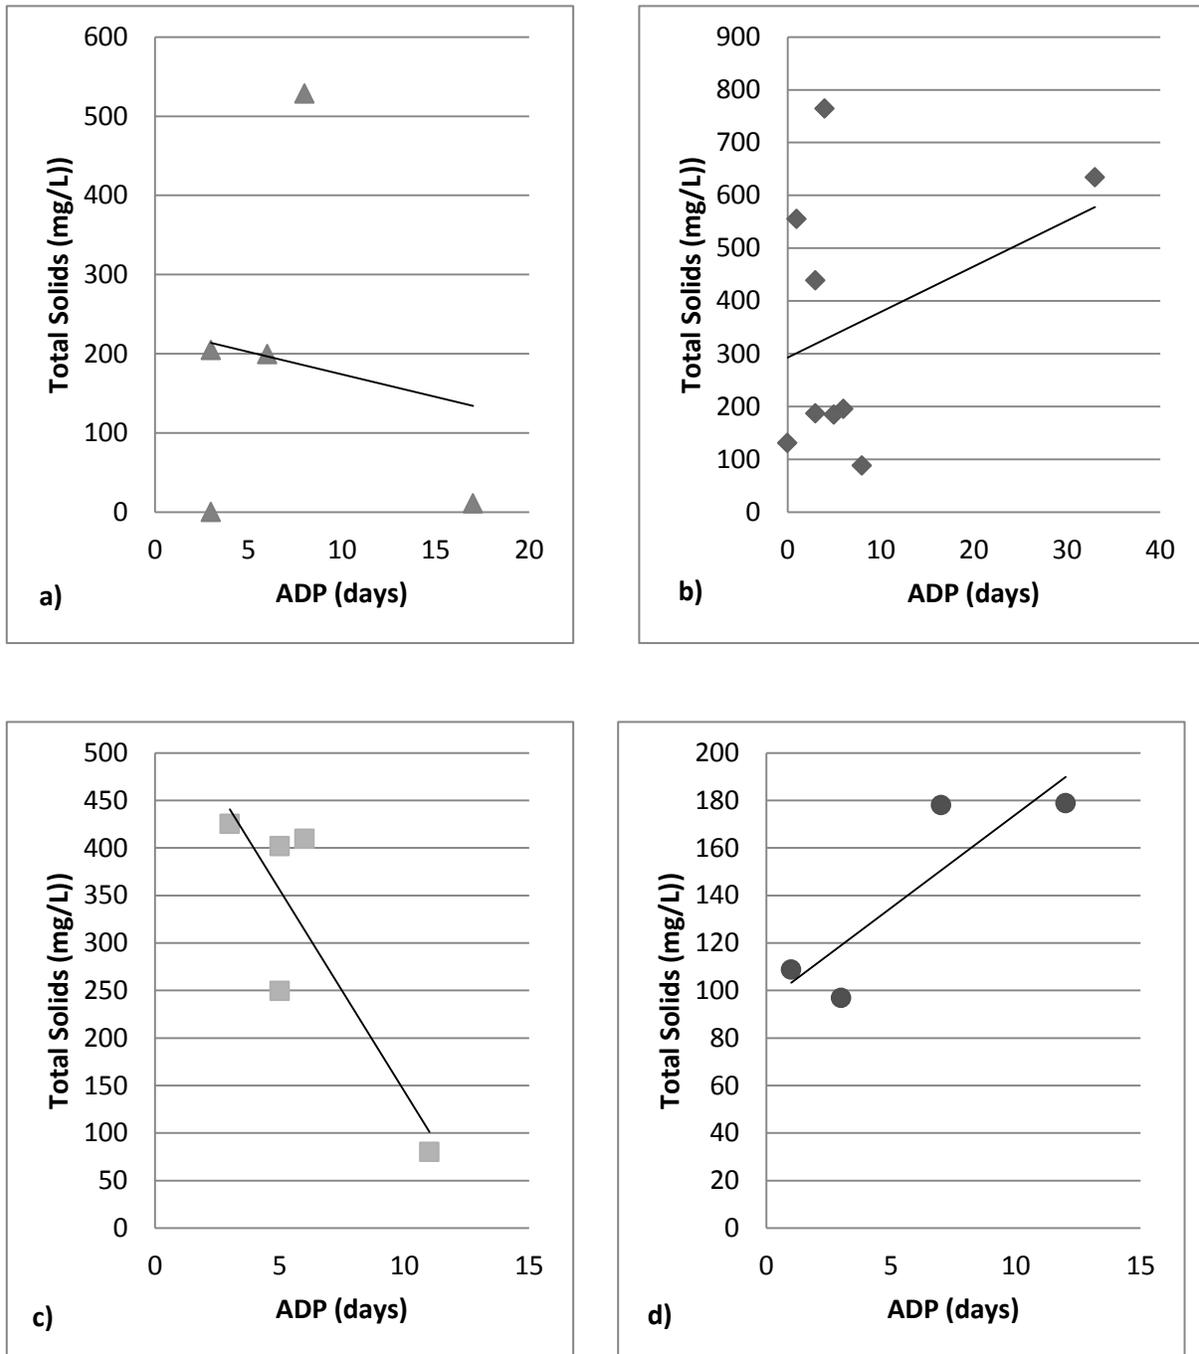
Figure B.8 Total solids concentration in runoff versus ADP from a) I-80 bridge over Platte River b) Highway 64 bridge over Platte River c) I-80 bridge over Little Salt Creek d) Highway 77 bridge over Rock Creek

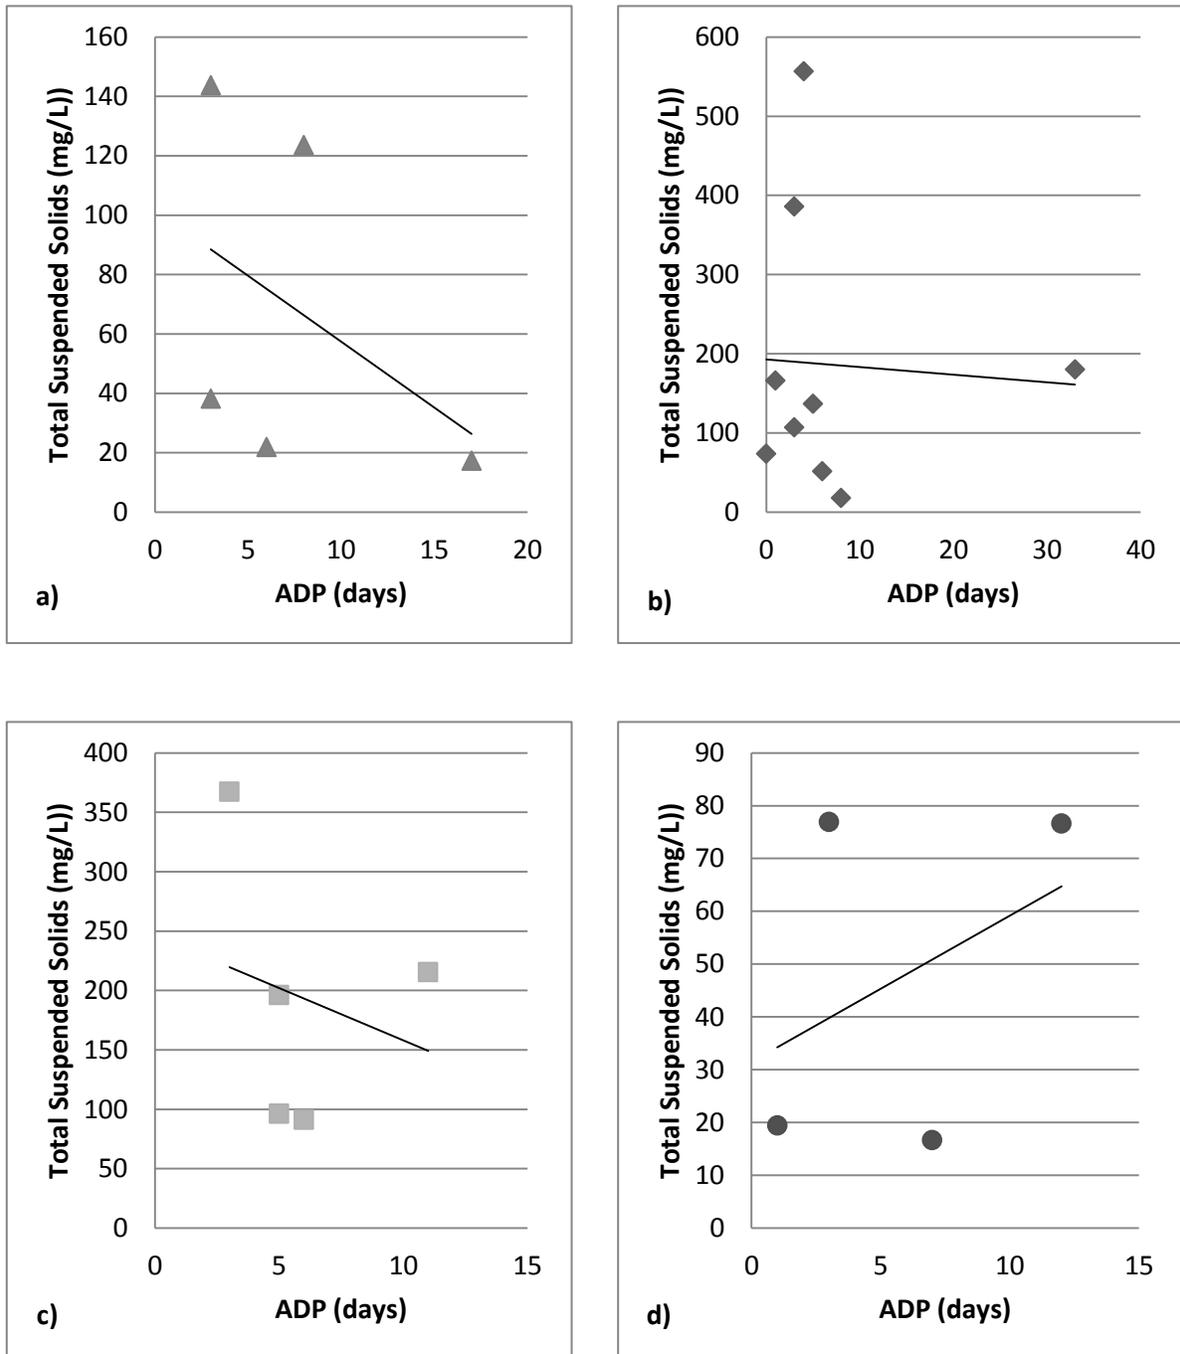
Figure B.9 TSS concentration in runoff versus ADP from a) I-80 bridge over Platte River b) Highway 64 bridge over Platte River c) I-80 bridge over Little Salt Creek d) Highway 77 bridge over Rock Creek

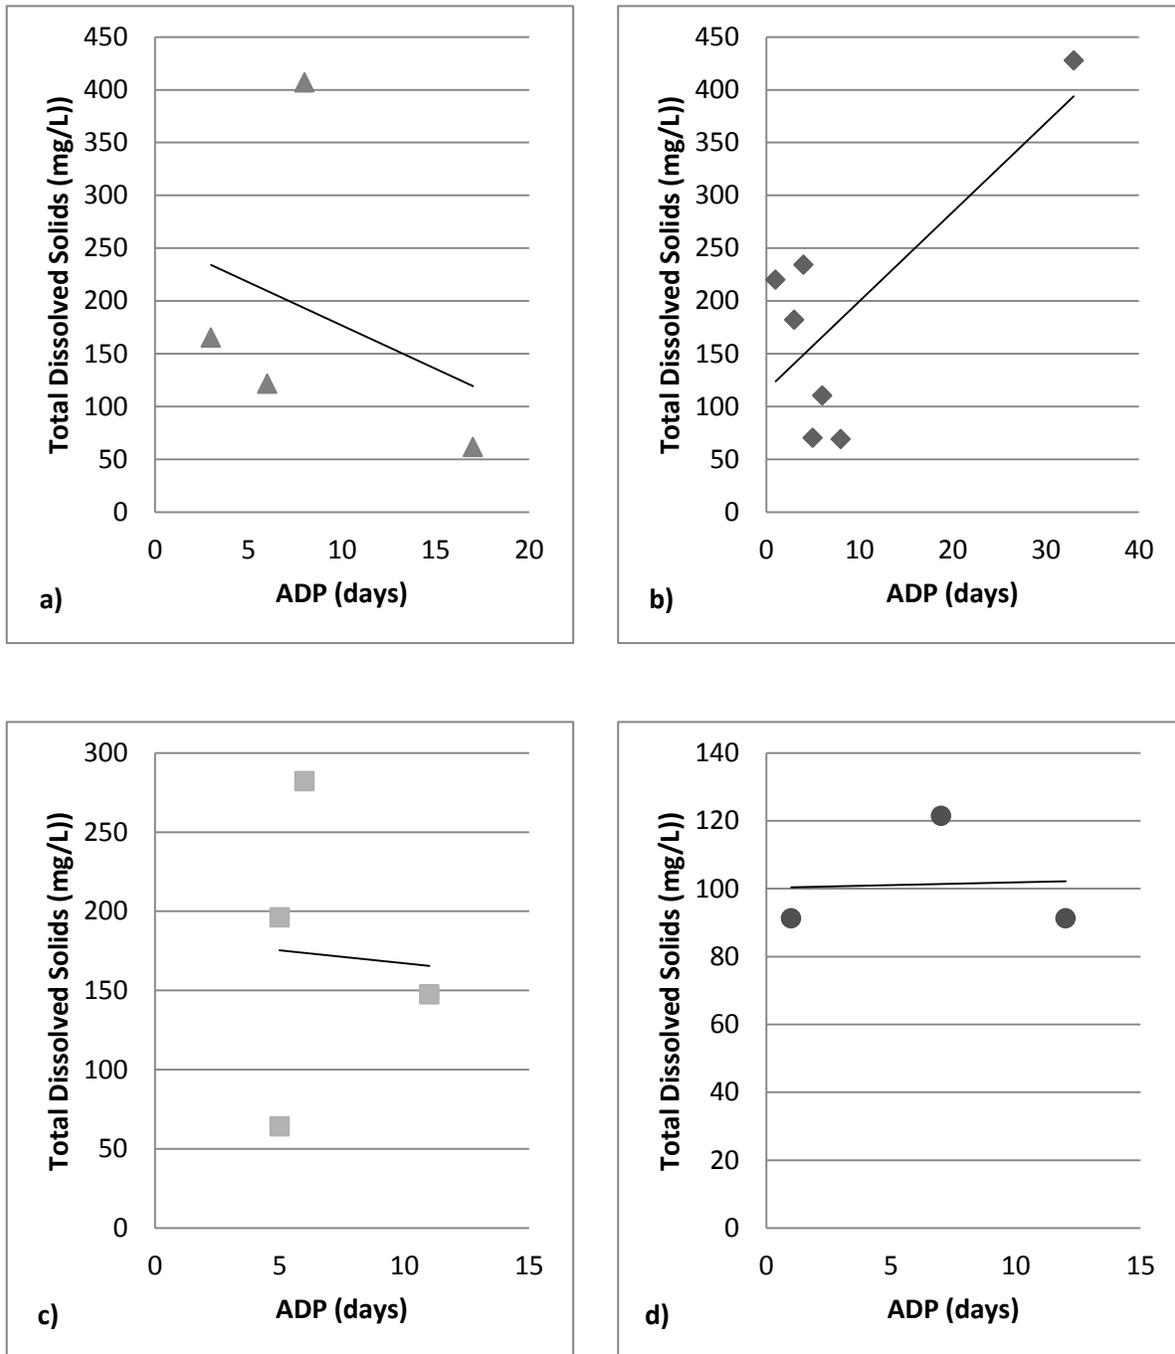
Figure B.10 TDS concentration in runoff versus ADP from a) I-80 bridge over Platte River b) Highway 64 bridge over Platte River c) I-80 bridge over Little Salt Creek d) Highway 77 bridge over Rock Creek
