Quantifying Effectiveness of Streambank Stabilization Practices on Cedar River, Nebraska

Abstract: Excessive sediment is a major pollutant to surface waters worldwide. In some watersheds, streambanks are a significant source of this sediment, leading to the expenditure of billions of dollars in stabilization projects. Although costly streambank stabilization projects have been implemented worldwide, long-term monitoring to quantify their success is lacking. There is a critical need to document the long-term success of streambank restoration projects. The objectives of this research were to (1) quantify streambank retreat before and after the stabilization of 18 streambanks on the Cedar River in North Central Nebraska, USA; (2) assess the impact of a large flood event; and (3) determine the most cost-efficient stabilization practice. The stabilized streambanks included jetties (10), rock-toe protection (1), slope reduction/gravel bank (1), a retaining wall (1), rock vanes (2), and tree revetments (3). Streambank retreat and accumulation were quantified using aerial images from 1993 to 2016. Though streambank retreat has been significant throughout the study period, a breached dam i

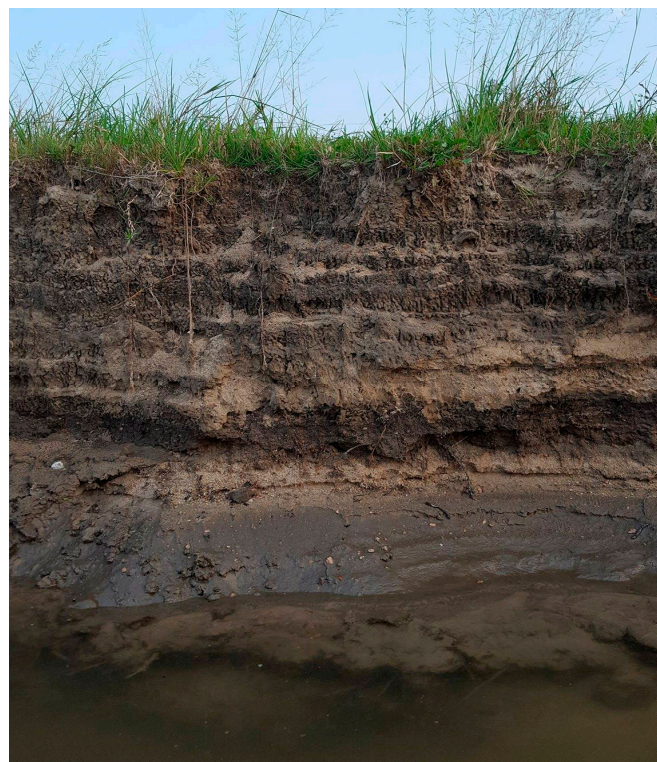
Figure 2. Typical streambank on Cedar River. Note the transition from sandy soil at the top to silty loam in the bottom.

The Cedar River watershed is located in North Central Nebraska (Figure 1). The western half of the 3200 km² watershed is mainly grassland and sand dunes in the Sand Hills, whereas the eastern half is predominantly cropland. Streambank height on the Cedar River averages 2.1 m and ranges from 0.4 to 4.0 m [20]. Streambanks are typified by silty, vegetated low-lying banks or higher banks with a combination of sandy and silty soil (Figure 2).

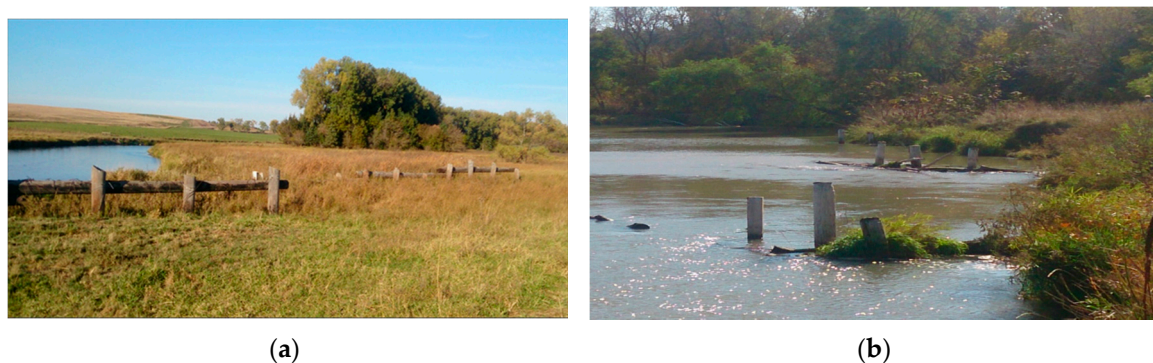
Figure 3. Jetties installed in 1950 at Site 5 (a) and in 2000 at Site 4 (b). Note the sediment that has accumulated over time in front of the jetties installed in 1950.

and should be used if minimal failure of risk is acceptable. The jetty installed in 1950 demonstrates that jetties can endure and be successful for extended periods of time. Our study indicated that structurally designed practices such as retaining walls might be worth the investment only if failure cannot be risked. Because of the ease of installation, affordability, and stability, agricultural producers and others may prefer using jetties.

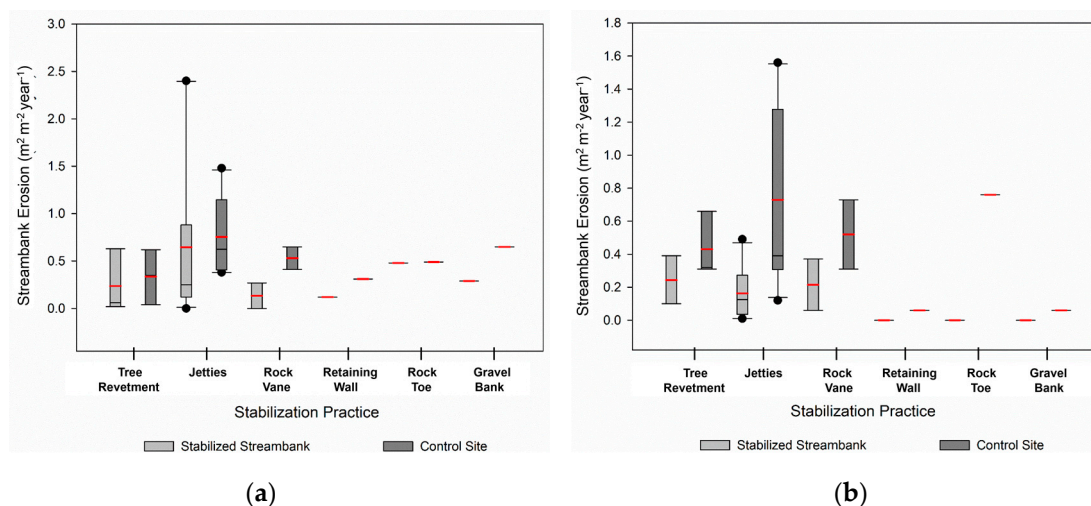
Figure 6. Boxplots illustrating the streambank erosion rates for the pre-stabilization (a) and post-stabilization (b) periods for the stabilized streambanks and control sites. Red lines indicate the mean erosion rates.

To distinguish the impact of varied streamflow between the pre-stabilization and post-stabilization periods, the streambank erosion rate was compared with the 40 control sites (Table 2). Although we intended to identify control sites that mimicked our study sites, the median streambank erosion was significantly greater for the control sites ($0.55 \text{ m}^2 \text{ m}^{-1} \text{ year}^{-1}$) than the stabilized streambanks ($0.22 \text{ m}^2 \text{ m}^{-1} \text{ year}^{-1}$) during the pre-stabilization period with a *p*-value of 0.0042. The average streambank erosion rate pre-stabilization for the stabilized streambanks was $0.45 \text{ m}^2 \text{ m}^{-1} \text{ year}^{-1}$ with a range of $0\text{--}2.4 \text{ m}^2 \text{ m}^{-1} \text{ year}^{-1}$ compared with $0.63 \text{ m}^2 \text{ m}^{-1} \text{ year}^{-1}$ and a range of $0.04\text{--}1.5 \text{ m}^2 \text{ m}^{-1} \text{ year}^{-1}$ for the control sites. The median streambank erosion rate during the post-stabilization period between the stabilized and control streambanks were significantly different (a *p*-value of 0.0002) with median streambank erosion rates of $0.13 \text{ m}^2 \text{ m}^{-1} \text{ year}^{-1}$ and $0.38 \text{ m}^2 \text{ m}^{-1} \text{ year}^{-1}$ for the stabilized and control sites, respectively. The jetties were successful with the median erosion for the stabilized streambanks and controls sites, being $0.13 \text{ m}^2 \text{ m}^{-1} \text{ year}^{-1}$ and $0.39 \text{ m}^2 \text{ m}^{-1} \text{ year}^{-1}$, respectively. The erosion was significantly different with a *p*-value of 0.0036. The more expensive practices (rock toe, retaining wall, and gravel bank) were all successful and completely stabilized the streambanks.

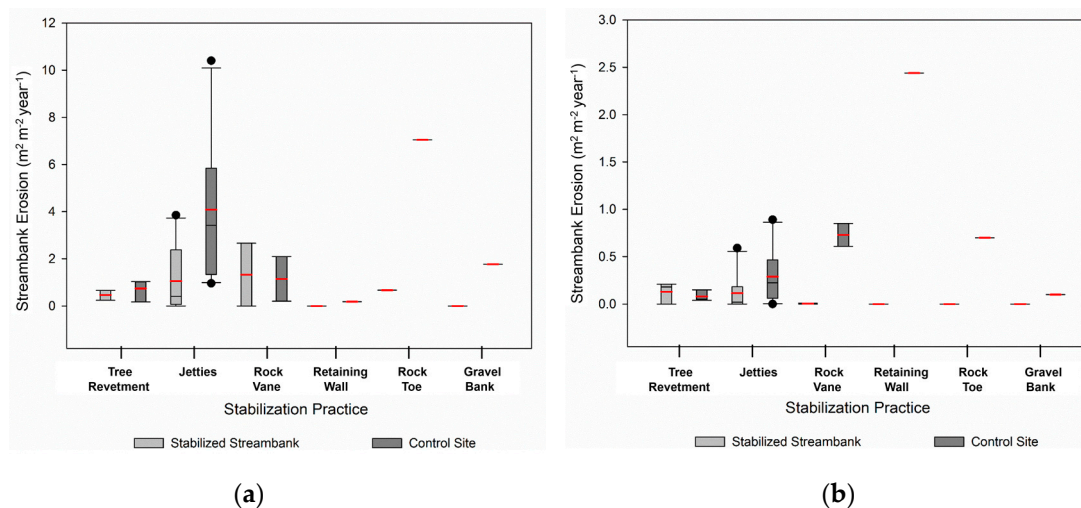
Figure 7. Streambank erosion rate for the flood period (2009–2010) (a) and post-flood period (2010–2016) (b) for the stabilized streambanks and control sites.

The flood in 2010 caused a significant quantity of erosion, especially at the control sites (Figure 7). The average erosion rate during the flood was $0.74 \text{ m}^2 \text{ m}^{-1}$ and $3.1 \text{ m}^2 \text{ m}^{-1}$ for the stabilized streambanks and control sites, respectively. The medians, $0.40 \text{ m}^2 \text{ m}^{-1}$ and $1.93 \text{ m}^2 \text{ m}^{-1}$, were significantly different with a p -value of 0.0013. Four sites downstream of Spalding failed because their structure lost functionality during the flood: Sites 10, 16, and 18, which have jetties, and Site 12, which has a rock vane. Even with some of the jetties failing at Sites 10, 16, and 18 (Figure 3), the average streambank erosion rates for jetties for the stabilized streambanks and the control sites were significantly different (0.007) with a median erosion of $0.41 \text{ m}^2 \text{ m}^{-1}$ and $3.42 \text{ m}^2 \text{ m}^{-1}$, respectively. Minimal erosion occurred at the top of the streambank at Site 9 (rock toe). No erosion occurred
