Experimental Study on a New Type of Transverse Connection for Nebraska County Bridge System

EXPERIMENTAL STUDY ON A NEW TYPE OF TRANSVERSE CONNECTION
FOR NEBRASKA COUNTY BRIDGE SYSTEM

A THESIS

Presented to the Faculty of
The Graduate College at the University of Nebraska
In Partial Fulfillment of Requirements
For the Degree of Master of Science

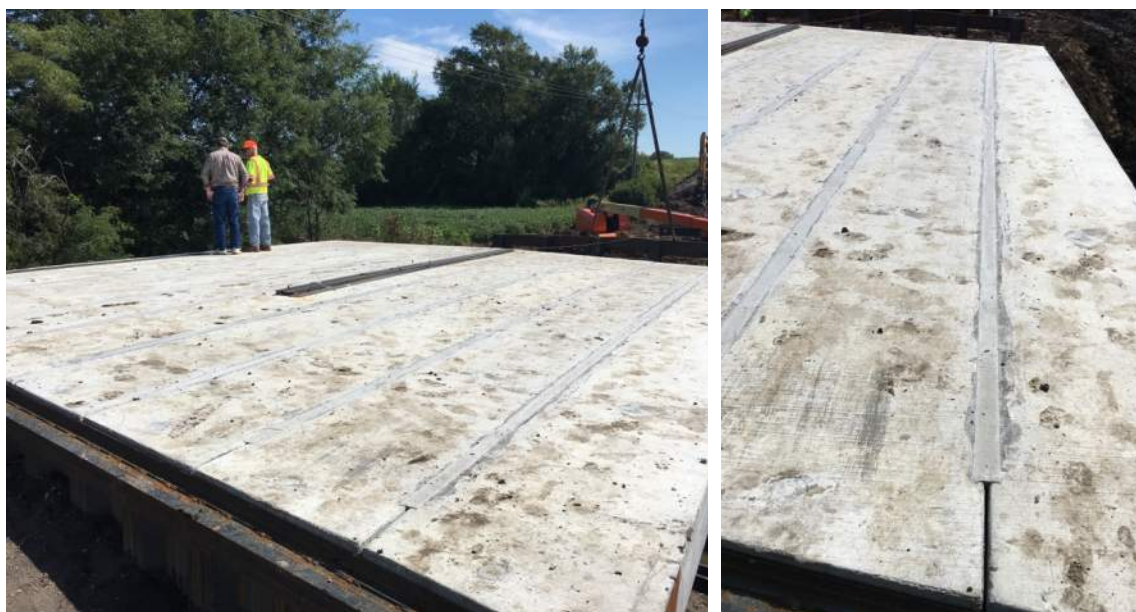
Figure 1.3: Grouts between Longitudinal Shear Keys

The grout between these longitudinal shear keys easily cracks and creates a path for water and chlorides to penetrate through. Even though deicing salt may not be used

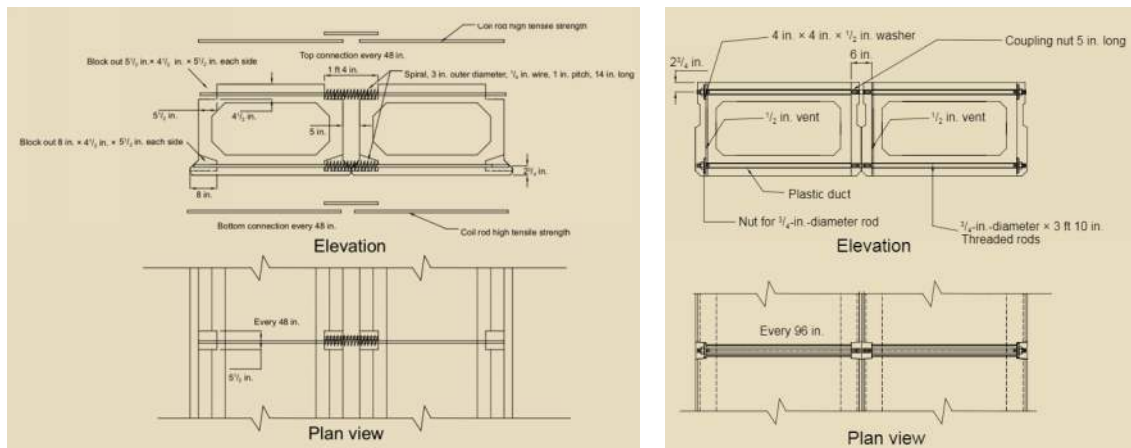
Figure 2.4: Wide-Joint and Narrow-Joint Connection Details Introduced in Nebraska study (retrieved from Hanna et al., 2011)

development length to take place. To reduce the cost of the wide-joint system, the research team recommended using self-consolidating concrete in the shear keys to reduce the time and cost associated with grouting. The narrow-joint system utilized a $\frac{3}{4}$ in. diameter threaded rod at every eight feet with a 5 in. long coupling nut to connect the two pieces at the top and bottom.

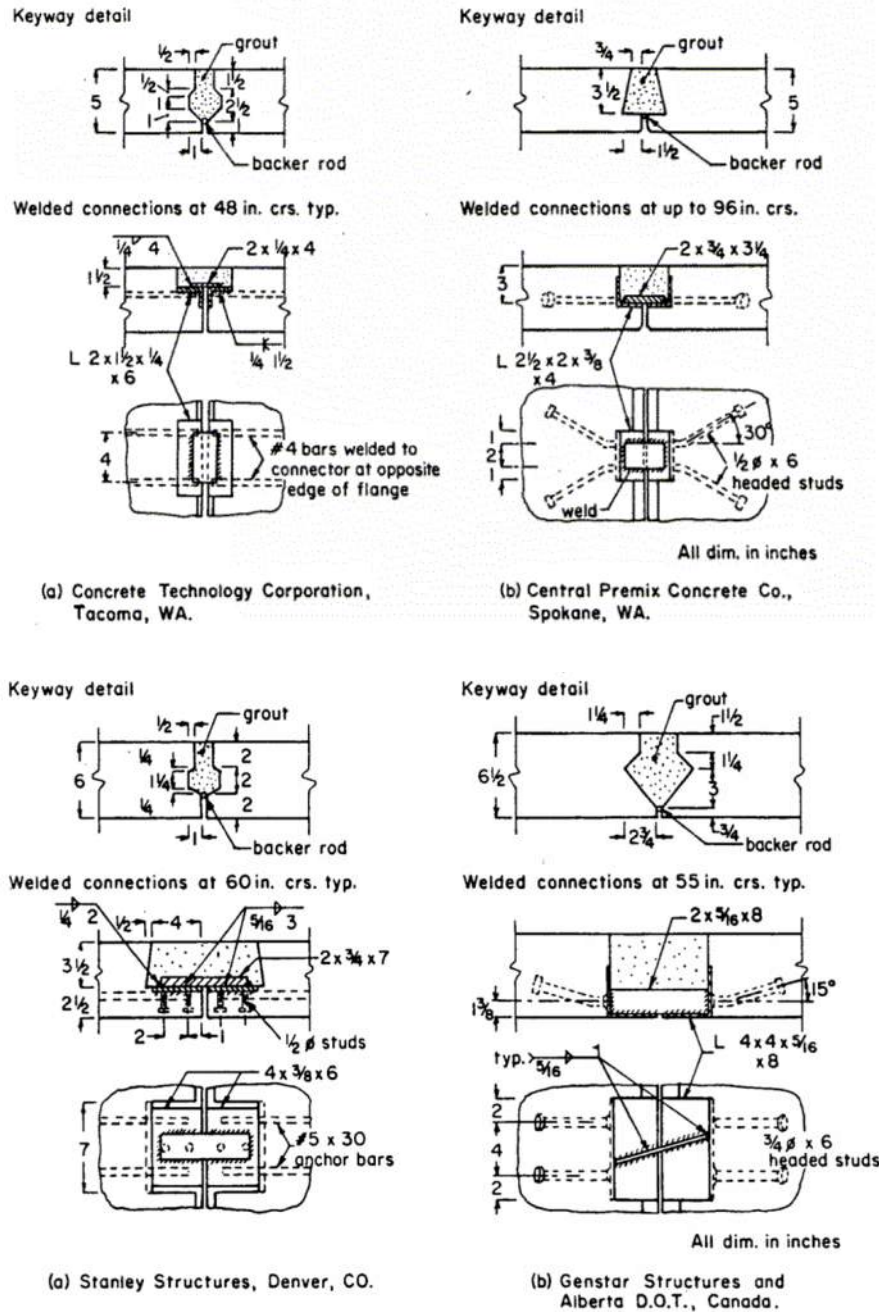
Figure 2.5: Examples of Shear Keyway Details (retrieved from Stanton and Mattock, 1986)

county bridge engineers and precast producers who provided details for the different shear keys they used (Figure 2.5).

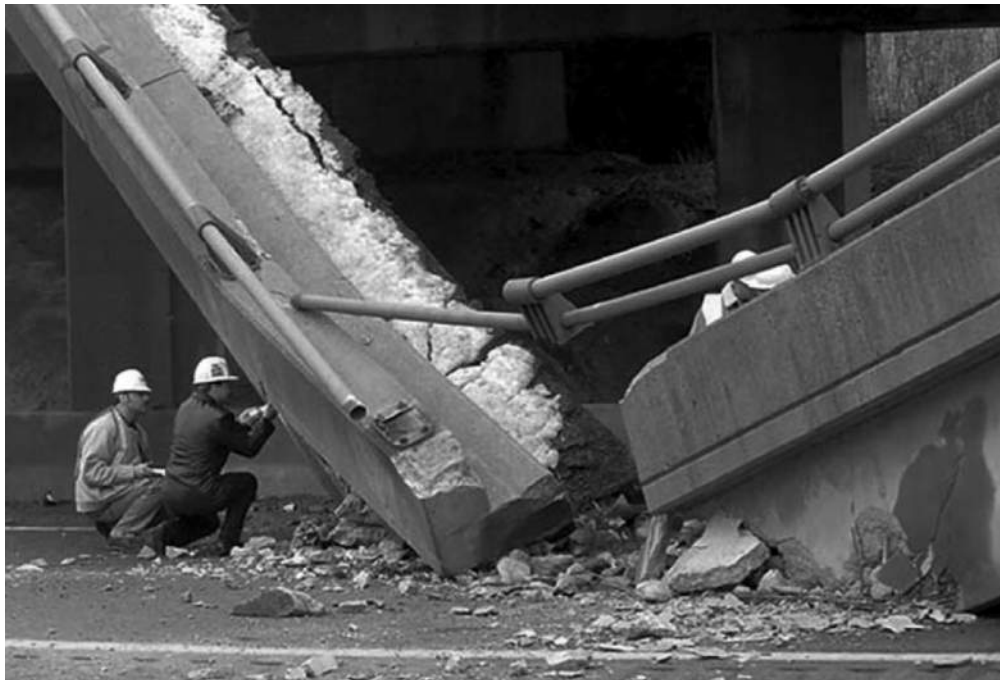
Figure 2.9: Forensic Examination of Noncomposite Adjacent Precast Prestressed Concrete Box Beam Bridge Failure in Pennsylvania (retrieved from Naito et al., 2010)

From this inspection it was noted that an impact may have happened to a specific beam, and that 20 of the 60 strands were broken in that member. The other members were only moderately damaged and the bridge was rated as poor (four on a scale of zero to nine). At this point beam replacement was labeled as a priority. It was later discovered after the collapse through inspection that 39 of the 60 strands were severely damaged through corrosion and it was believed that there was no indication of an impact before the collapse. This bridge had four spans each of which had eight pretensioned box beams with an approximate two-inch bituminous overlay with no water-proofing membrane. The bridge beams were poured and erected in 1960. The clear cover from the strands to the exterior surface for the beam that collapsed ranged from $1 \frac{5}{16}$ inches to $1 \frac{9}{16}$ inches which met the 1953 AASHTO Standard Specifications for Highway Bridges but was less than the minimum cover of 1.5 inches specified by the 1965 AASHTO specifications.

The next item the research team looked into was the shear reinforcement. The shear stirrups were not placed below the bottom layer of prestressing strands and for the ease of construction an L-shape was used and placed between the first and second layer of strands which was common practice at the time the bridge was constructed. It should be noted this is no longer a standard practice. It was also found that many of the top and bottom L-shaped stirrups were not physically lap-spliced in the middle and were separate from each other. Due to this lack of splice contact and also the short development length provided (12 in.), the authors were concerned about the shear capacity for these box girders. An interesting note for this bridge was the way in which the void was formed and the drains that were used. The voids were constructed with the use of cardboard void

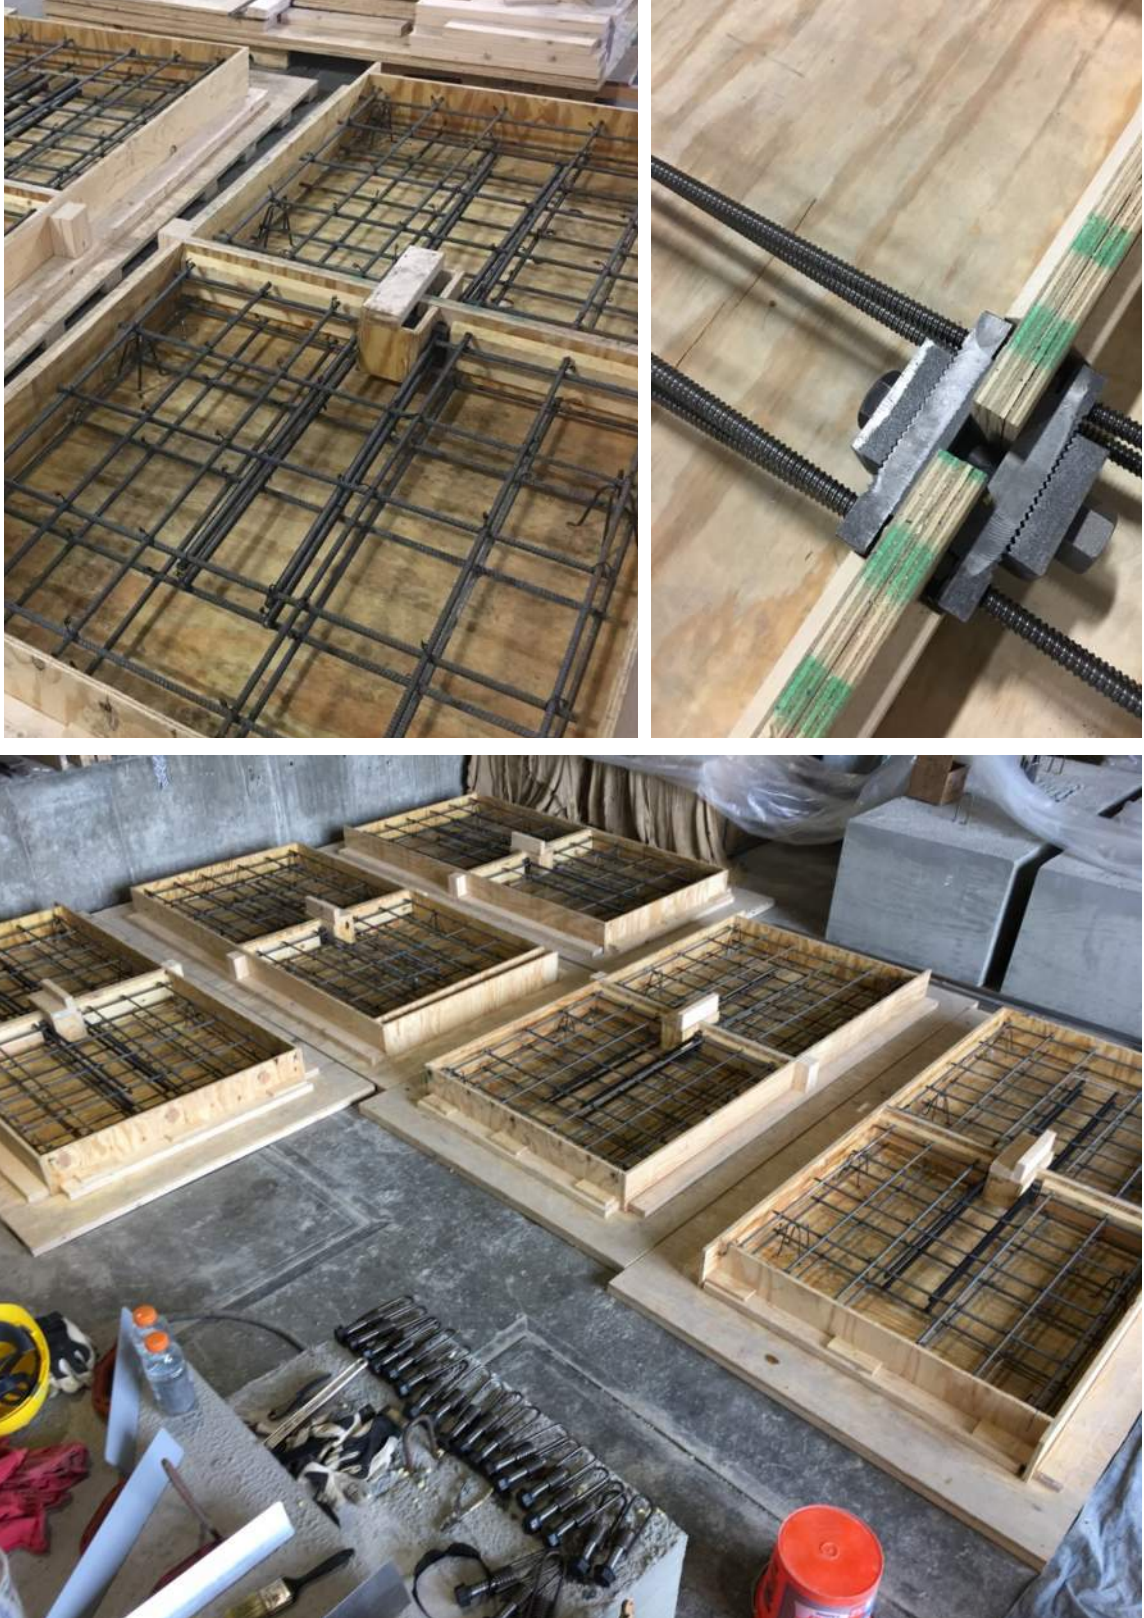
Figure 3.5: Formwork for Mechanical Connection Slab Panels

It should be noted that the block out around the mechanical joint follows the details provided in Figure 3.2. It should also be noted that these block out designs should be redesigned to allow more space for the removal and replacement of the connection bolt. This was learned after the building experience.

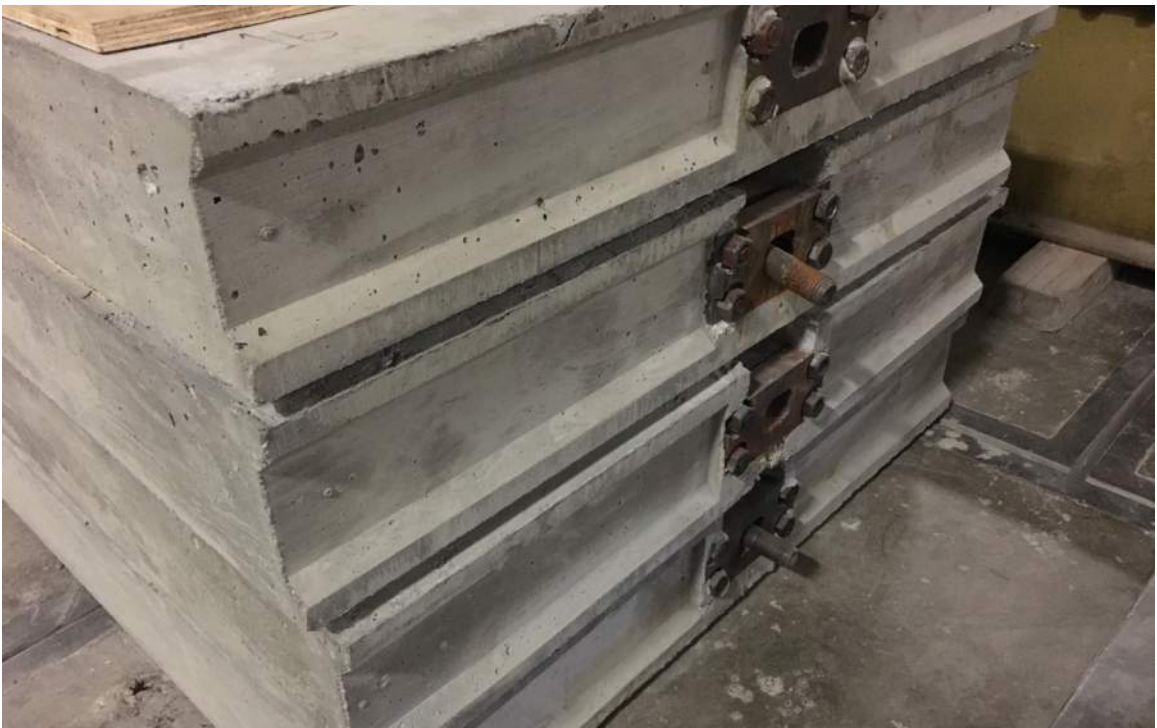
Figure 3.7: Slab Panels with Mechanical Joints

The slabs were then allowed to rest for around two hours before they were covered with burlap, covered with water, and finally had plastic placed over the top. The same covering process was also used for the cylinders to ensure they had similar curing conditions. For the next seven days after the pour the slabs and cylinders were watered at least once every day and twice when needed to insure the burlap remained saturated. The slabs were then removed from the forms after seven days. The test cylinders were also removed from their plastic forms around the same time. Both the slabs and cylinders were stored in the lab until the test date (Figure 3.7).

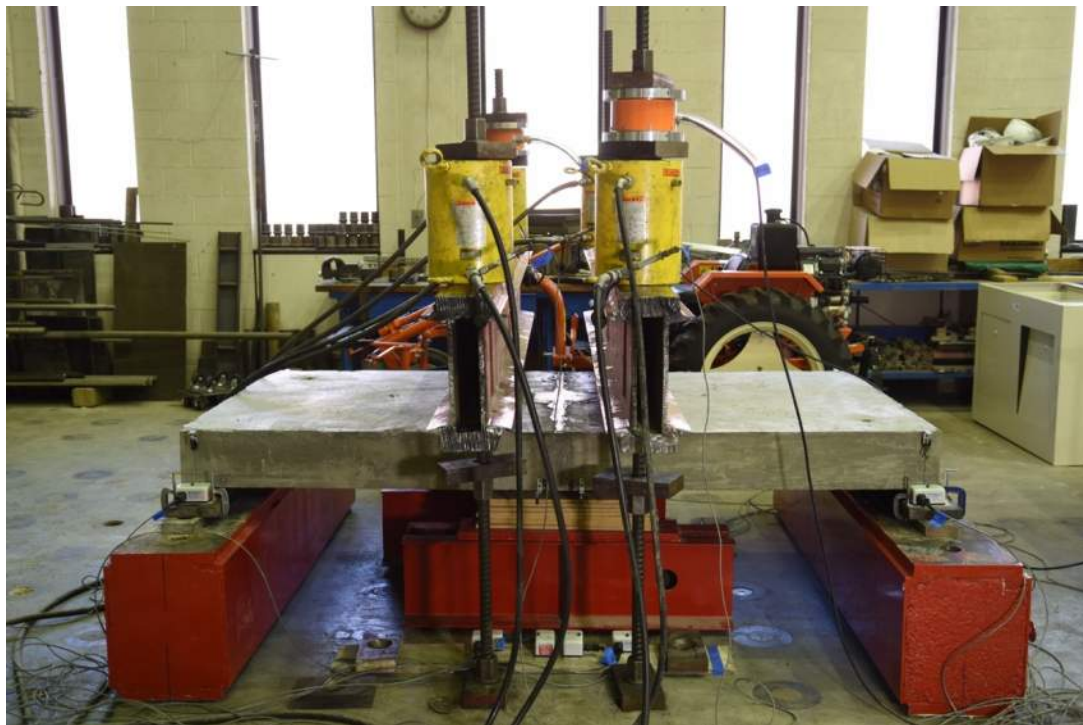
Figure 3.11: Four-point Bending Test Setup (Specimen F-F-1)

This section provides the test results of four-point bending test on the specimen containing fine all-threads on each side (Specimen F-F-1, Figure 3.11). The first crack was observed at the interface between the grout and the specimen as shown in Figure 3.12, which was also within the constant moment region where the moment was the highest.

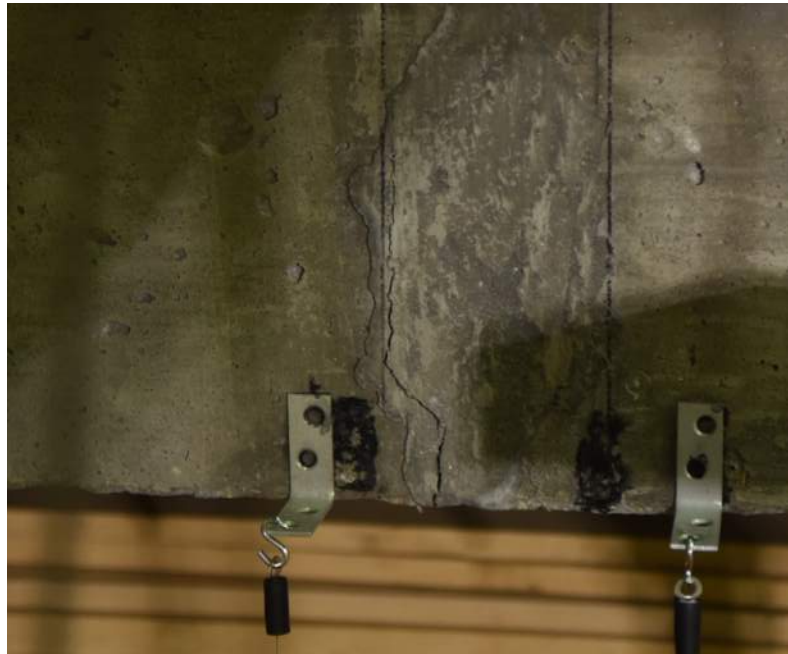
Figure 3.12: Initial Cracking at the Grout Interface (Specimen F-F-1)

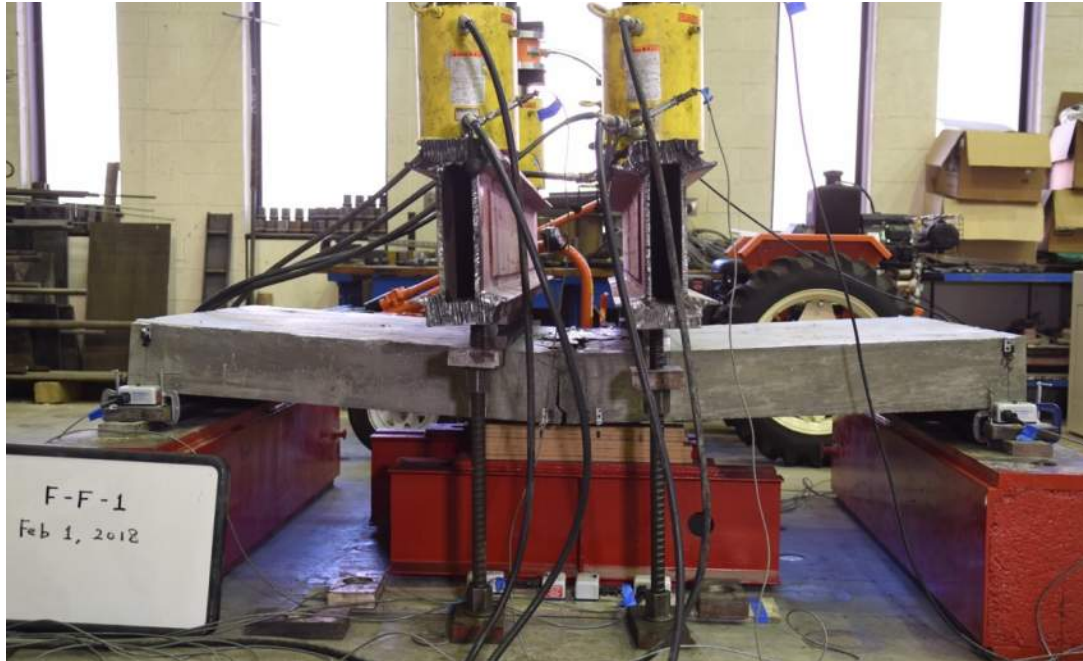
Figure 3.13: Concrete Crushing at Top (Specimen F-F-1)

As more load was applied, the crack at the interface opened up at the bottom allowing rotation and eventually crushed the concrete on the top part of the slab as shown in Figure 3.13, and the grout can be seen eventually pulling away from the concrete on the bottom side at failure from a close-up photo (Figure 3.14). The load-displacement curve for Specimen F-F-1 is shown in Figure 3.15. The maximum load reached was 8.5 kips on one side of the slab (from two hydraulic rams) and the deflection at peak load was 1.6 in. The test was terminated when there was an obvious drop in the load-displacement curve as shown in Figure 3.15 and the slab was not able to take more load but deflection was increasing due to the rotation at the joint. Considering the reading at failure load from the two load cells which were 8.5 kips, the spreader beam weight under the hydraulic ram which was 2 kips, and including the moment caused by the self-weight (4.6 kip-ft), the total experimental joint moment was 37 kip-ft.

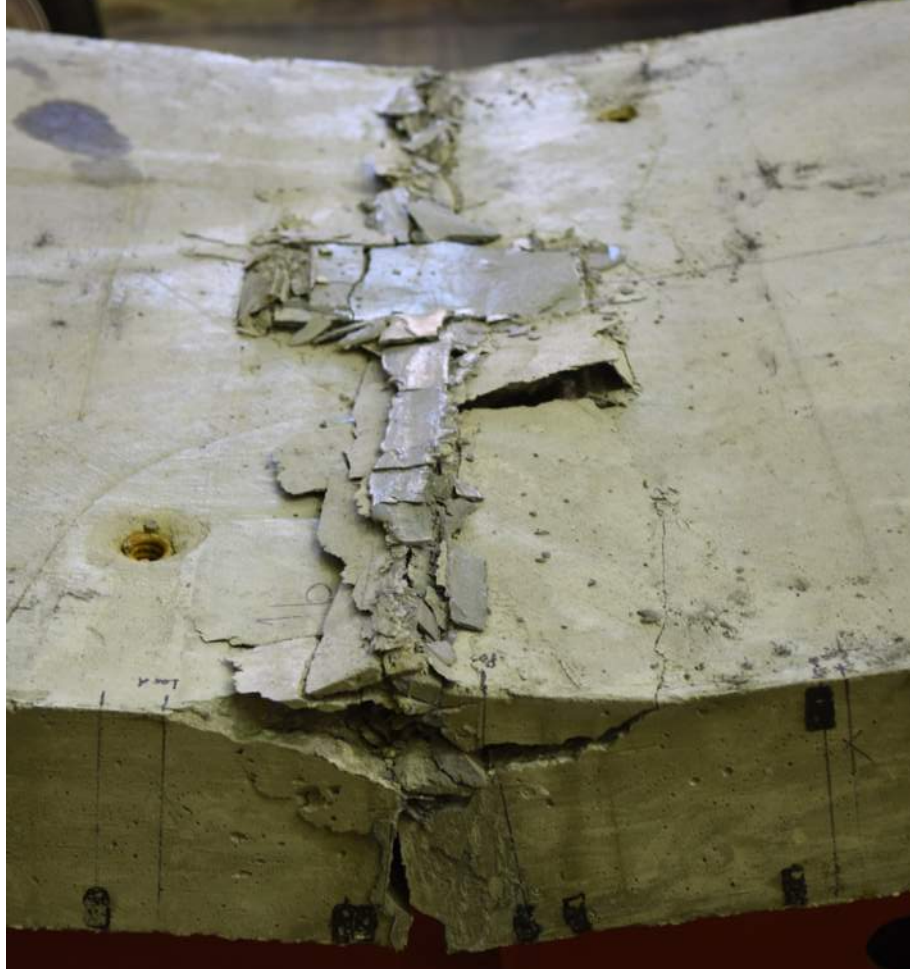
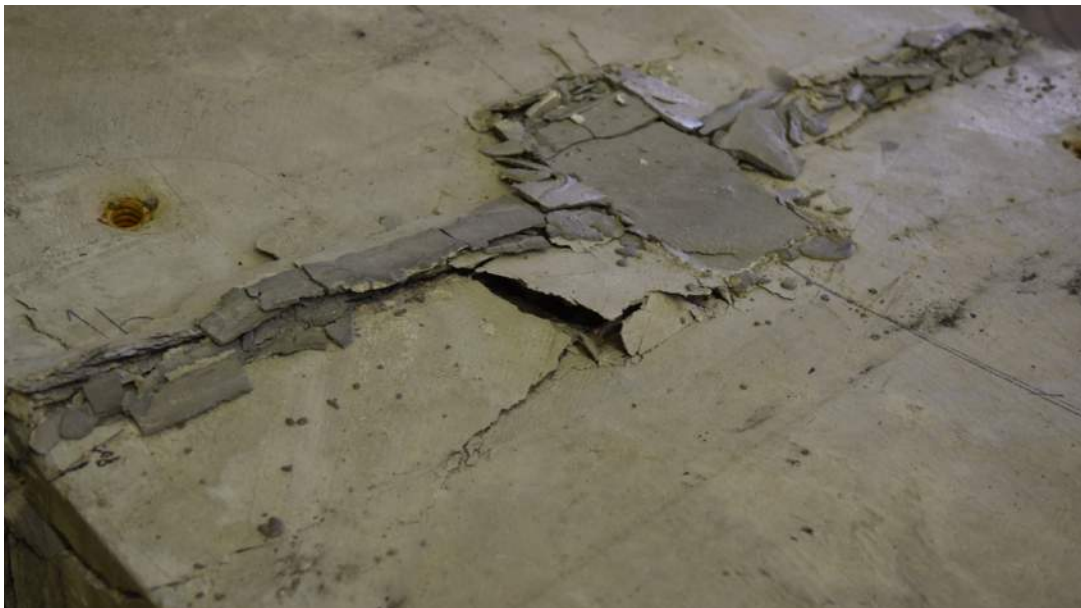
Figure 3.16: Specimen F-F-1 Joint Close-up Photo after Failure

Figure 3.16 shows a close-up photo of the joint taken after the test was complete. Other than the shear crack that initiated at the corner of the joint where the shape changes that propagated through the slab to the loading points and some cracks initiating from the corners of the block out area, no other cracks were observed in the two slabs connected. The grout was taken out after the testing was complete to observe the performance of the mechanical joint after failure. As shown in Figure 3.17, the two slabs were still connected by the ASTM A490 bolt through the mechanical joint. All fine threaded bars were embedded in concrete well.

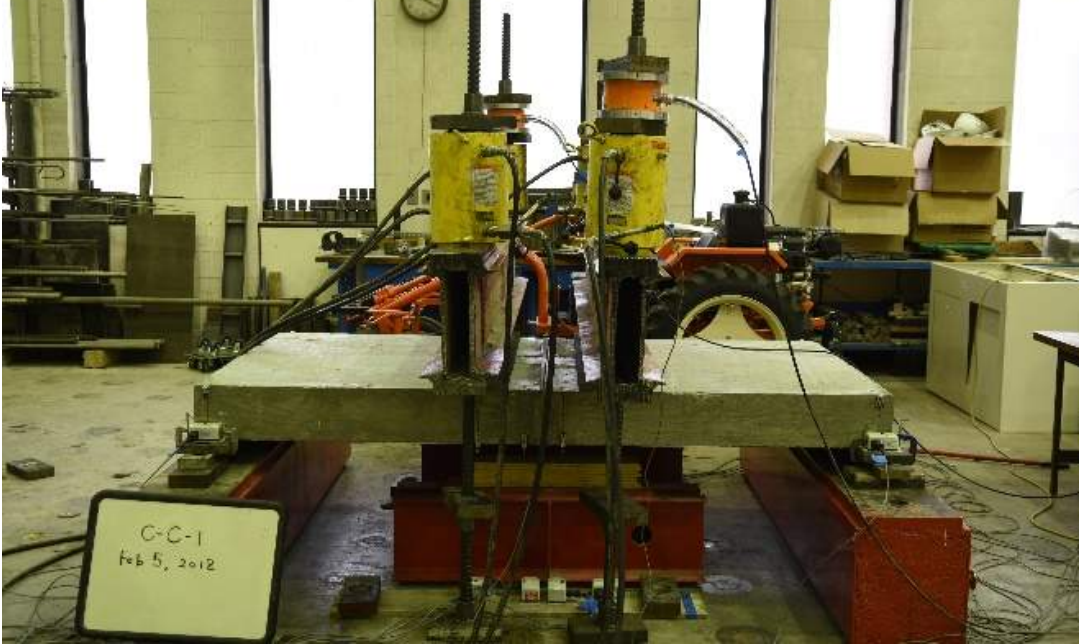
Figure 3.18: Four-point Bending Test Setup (Specimen C-C-1)

This section provides the test results of the four-point bending test on the specimen containing coarse all-threads on each side (Specimen C-C-1, Figure 3.18). The first crack was observed at a similar location as shown in Specimen F-F-1 at the interface between the grout and the specimen in the south side (front). However, on the north side (back), as shown in Figure 3.19, the crack that initiated from bottom started to shear through the grouting. As more load was applied, the crack propagated in an inclined direction towards the loading point as shown in Figure 3.20. The crack at the joint opened up wide allowing the two slabs to rotate until the top of the grout crushed (Figure 3.21). However, the top of the concrete slab did not crush as much as Specimen F-F-1.

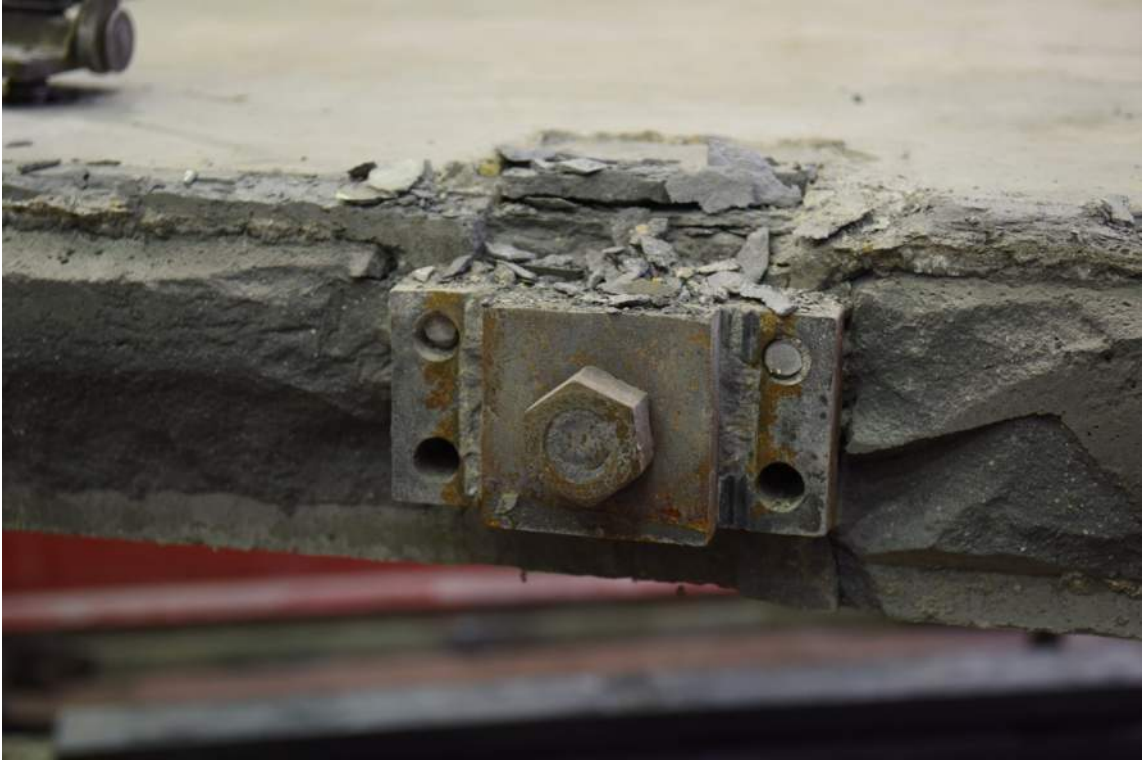
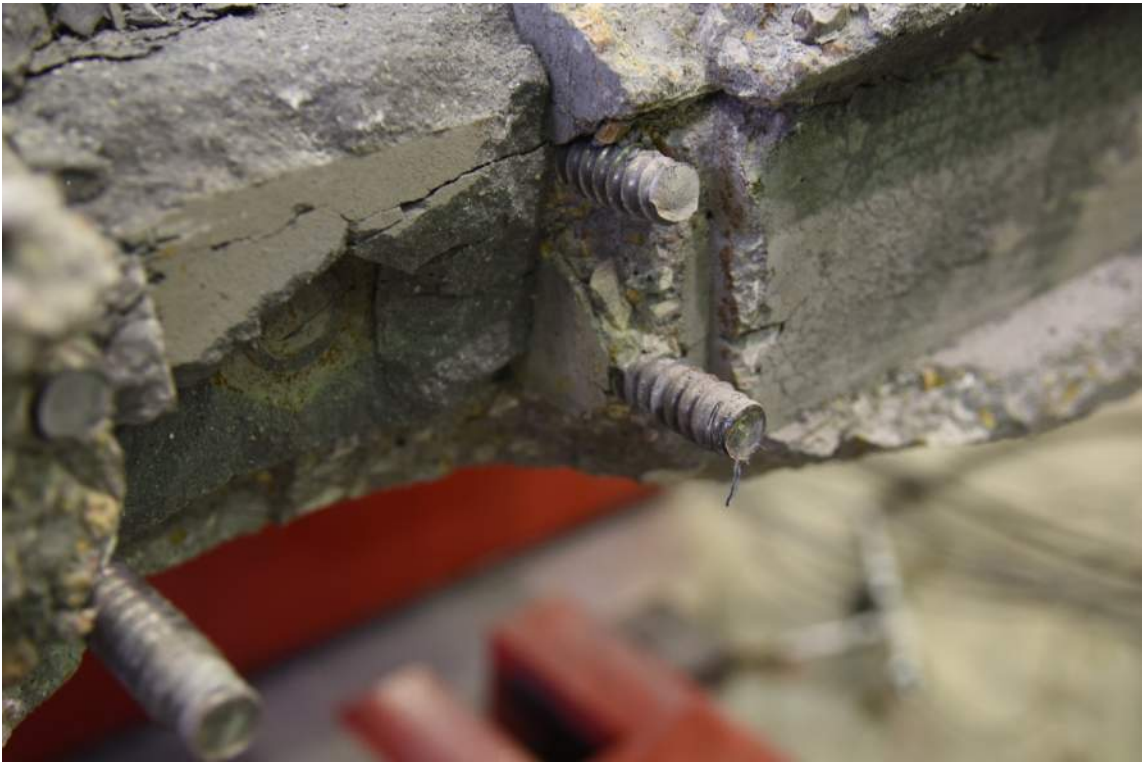
Figure 3.24: Mechanical Joint Shear Failure (Specimen C-C-1)

After the test was complete, all the grout was taken out to check the mechanical connection. The coarse threaded bars were noted to have sheared off as shown in Figure 3.24. This was possibly caused by less bond of the coarse threads compared to the fine threaded bars. If the threaded bars were slipping near failure, there is a possibility that all the moments were taken by these threaded bars before failure, which is the reason Specimen C-C-1 was not able to take more rotation and the load capacity dropped suddenly at a smaller deflection value than Specimen F-F-1.

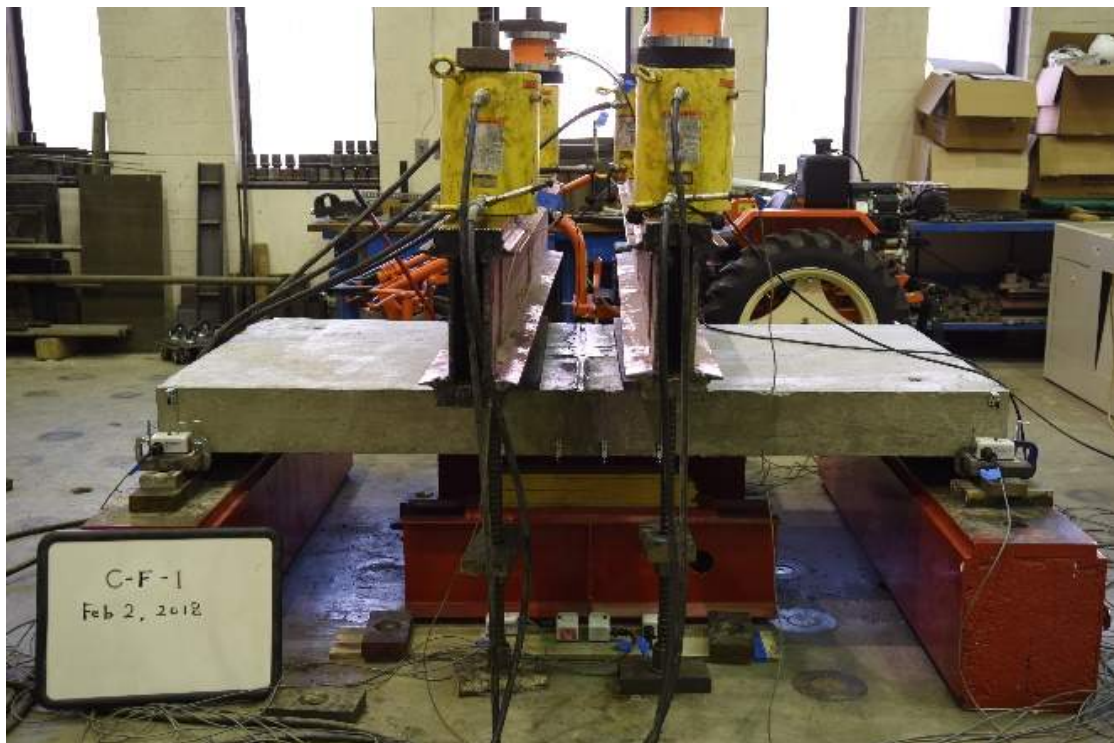
Figure 3.25: Four-point Bending Test Setup (Specimen C-F-1)

This section provides the test results of the four-point bending test that was conducted on the specimen containing fine all-threads on one side and coarse all-threads on the other side (Specimen C-F-1, Figure 3.25). Initial cracking was shown at the interface between the slab and the grouting similar to other specimens as shown in Figure 3.26. This crack shown in the interface opened larger as more load was applied. And, as load increased, the crack at the interface started to propagate in an inclined direction starting from where the shape of the grout shear key changes towards the loading point as shown in Figure 3.27. There was no crack through the grout as shown in the case with Specimen C-C-1. The top of the grouting crushed before failure as shown in Figure 3.28.

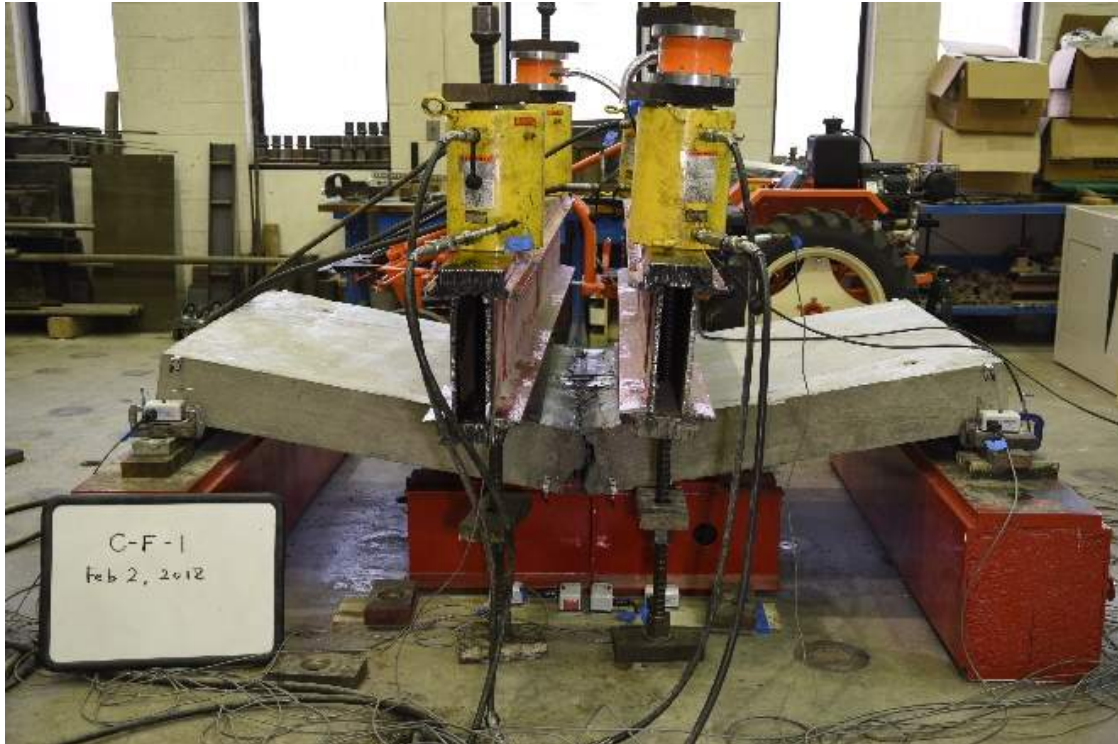
Figure 3.28: Specimen C-F-1 at Failure

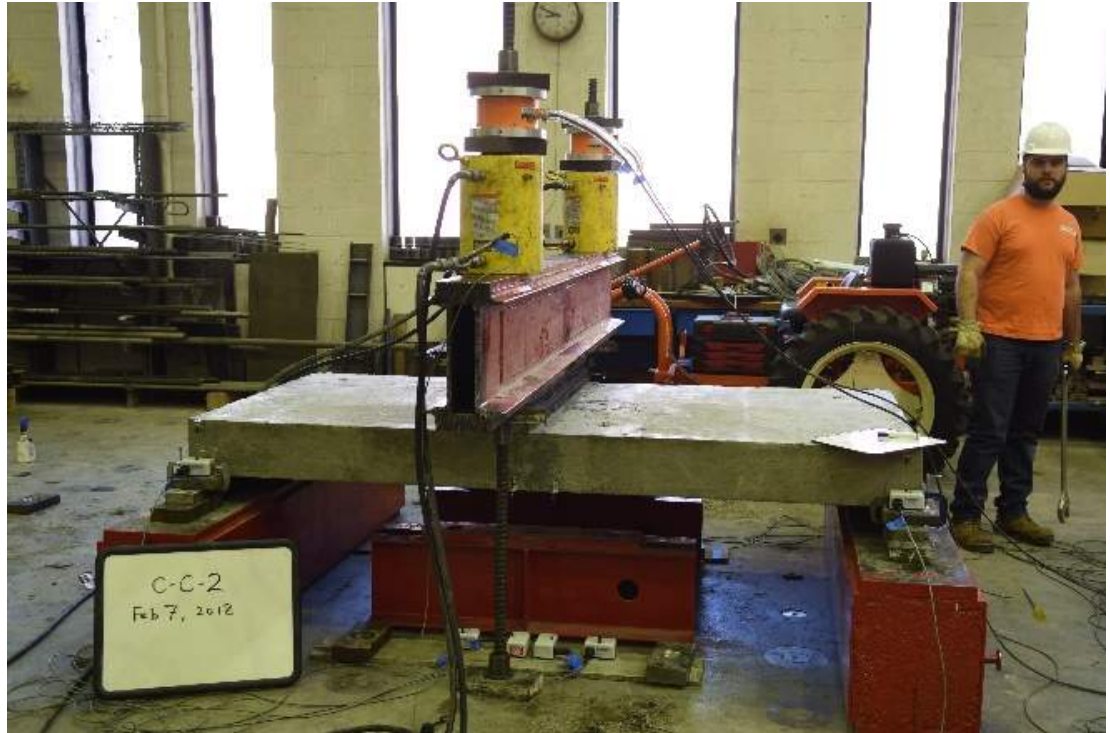
Figure 3.30: Three-point Bending Test Setup (Specimen C-C-2)

This section provides the test results of the three-point bending test that was conducted on the specimen containing coarse all-threads (Specimen C-C-2, Figure 3.30). Initial cracking was seen at the interface between the slab and the grout similar to other specimens as shown in Figure 3.31. This crack shown at the interface opened larger as more load was applied. As load increased, the crack at the interface started to propagate in an inclined direction starting from where the shape of the grout shear key changes towards the loading point as shown in Figure 3.32.

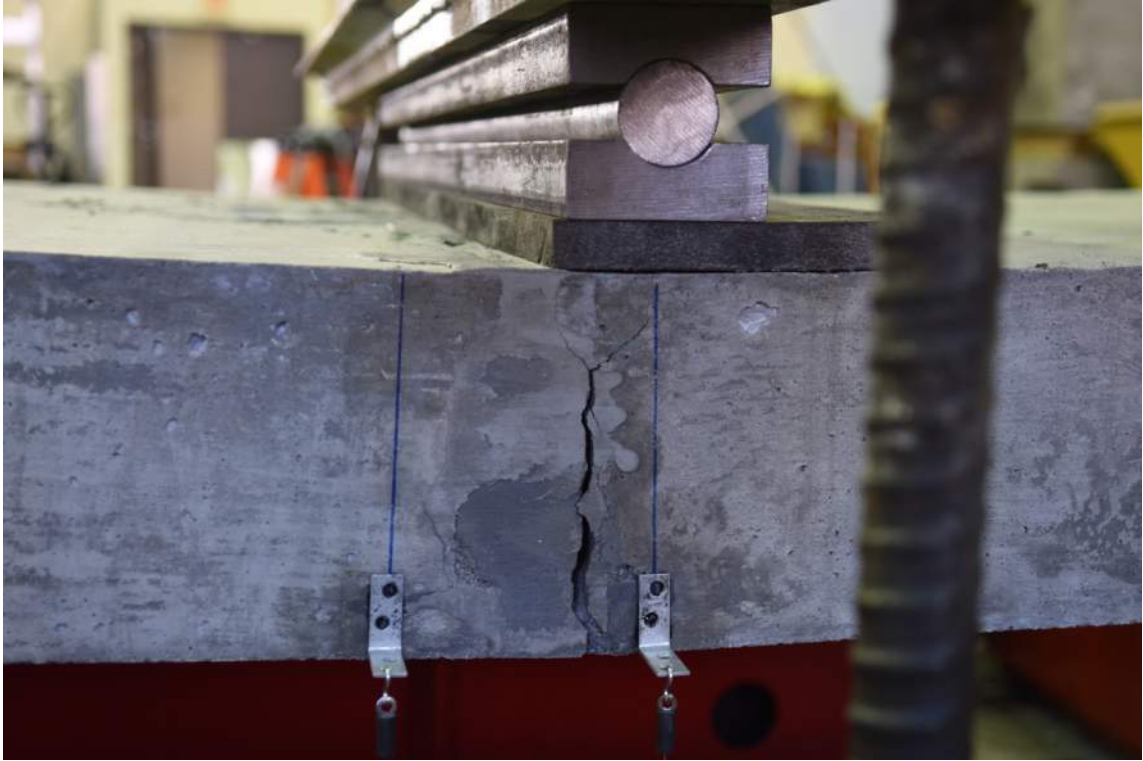
Figure 3.32: Crack Propagation (Specimen C-C-2)

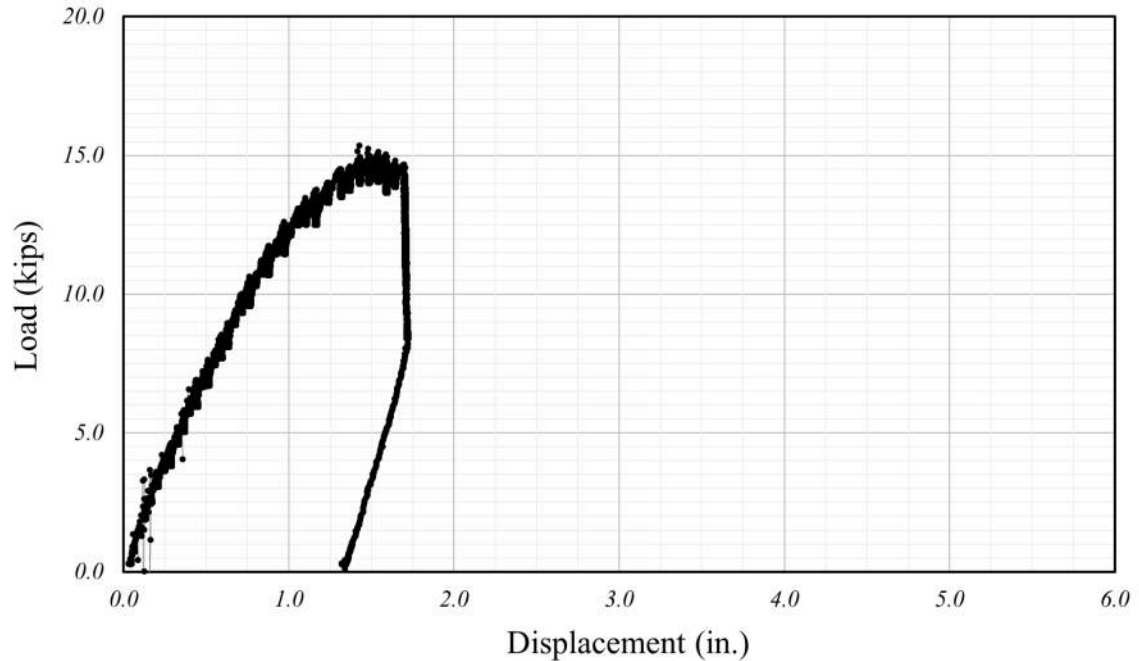
Figure 3.34: Load-Displacement Curve (Specimen C-C-2)

The failure mode was relatively more brittle in this test compared to the identical specimen tested in four-point bending. There was not much crushing seen in the grout or the concrete slab at failure but rather a huge gap at the interface between the shear key and the slab that was loaded as shown in Figure 3.33. The load-displacement curve for Specimen C-C-2 is shown in Figure 3.34. The maximum load reached was 15.4 kips and the deflection at peak load was 1.4 in. Unlike the four-point bending tests, the load dropped suddenly and it was not possible to see further deflection due to rotation (without further load increase). The shear span for this test was rather slender ($a/d = 5.8$) where it is known that the member fails at a disrupt inclined cracking load. The reading at failure load from the two load cells was 15.4 kips and the reaction force at each support would be 7.7 kips. Considering that the spreader beam weight under the hydraulic ram was 2 kips and including the moment caused by self-weight (5.4 kip-ft) of the slab, the total experimental joint moment was 36.9 kip-ft.

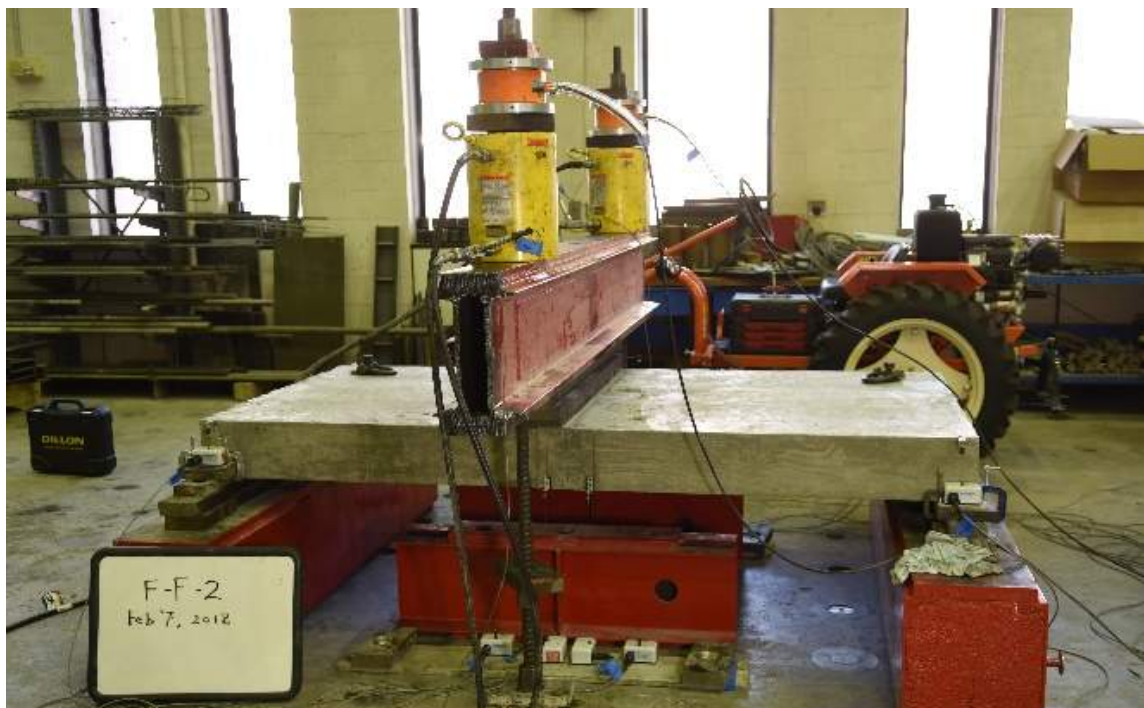
Figure 3.35: Three-point Bending Test Setup (Specimen F-F-2)

This section provides the test results of the three-point bending test that was conducted on the specimen containing fine all-threads (Specimen F-F-2, Figure 3.35). Initial cracking was shown at the interface between the slab and the grout and inside the grout key as shown in Figure 3.36. As load was increased, it is interesting to note that there was an inclined shear crack through the grout as shown in Figure 3.37. This crack was inclining towards the loading point. As additional load was applied, these cracks opened wider and an additional inclined shear crack was observed as shown in Figure 3.38. The close-up photo of the joint taken from the North side of the specimen indicates that the grout key as a whole is about to fall out from the joint before failure (Figure 3.39).

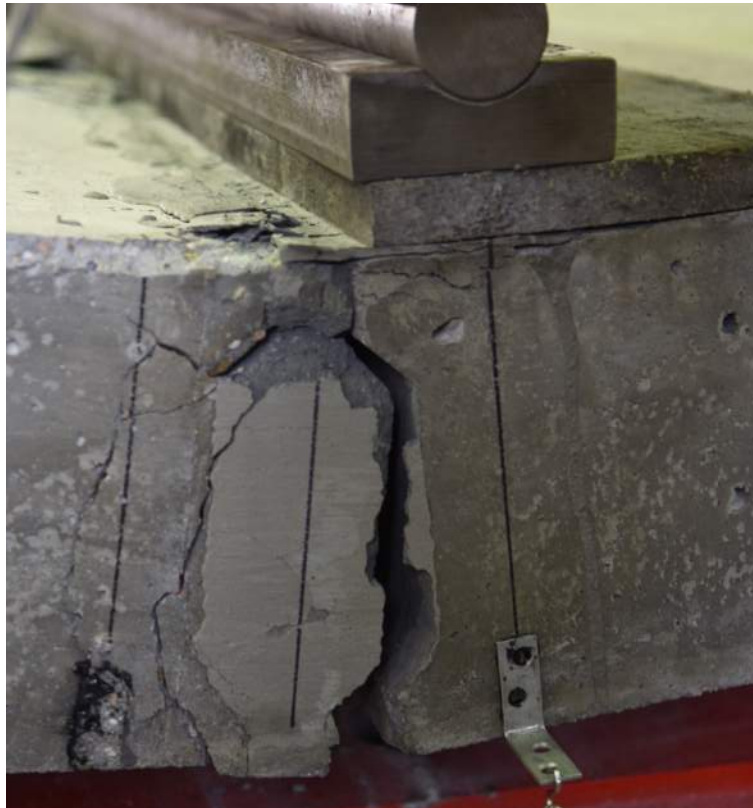
Figure 3.39: Shear Key before Failure (Specimen F-F-2, North view)

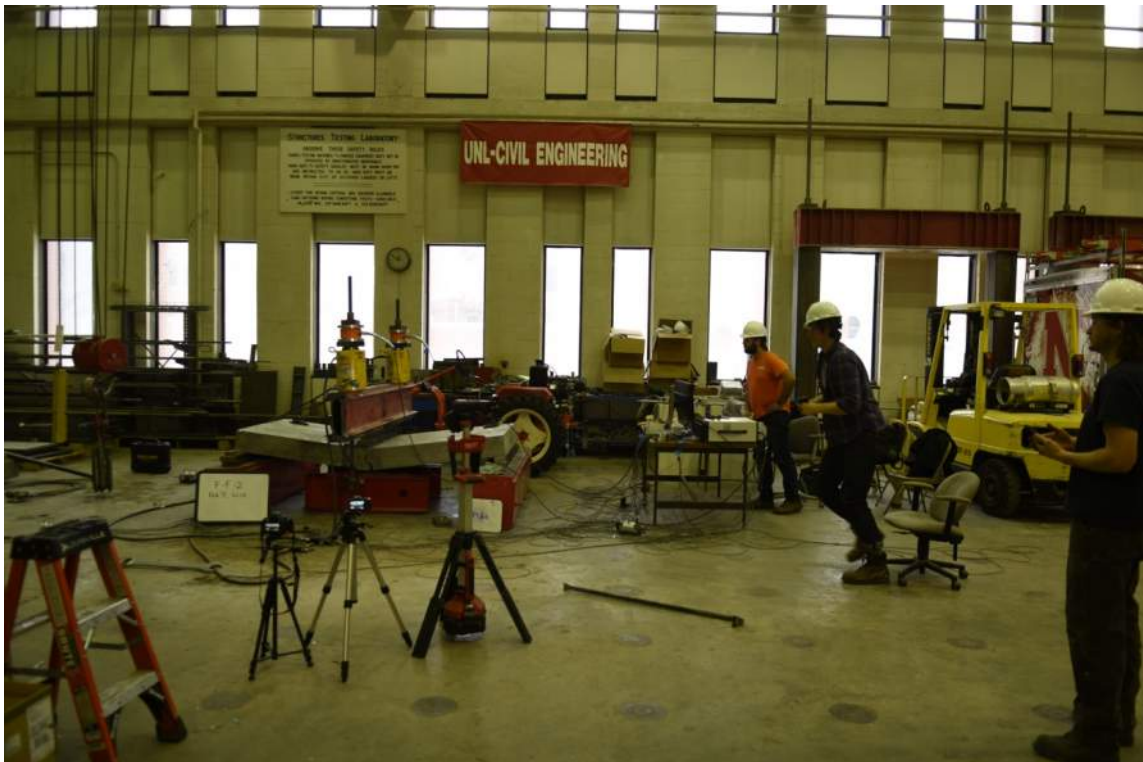
Figure 3.40: Specimen F-F-2 at Failure

The failure mode was similar to Specimen C-C-2 and relatively more brittle compared to the identical specimen tested in four-point bending (Figure 3.40), showing a sudden drop in load. However, the load-displacement curve shown in Figure 3.41 demonstrates that Specimen F-F-2 reached to a higher load and deflected more than what was seen in Specimen C-C-2. The maximum load reached was 18.3 kips and the deflection at peak load was 3.8 in. The reading at failure load from the two load cells were 18.3 kips providing a reaction force at each support of 9.15 kips. Considering that the spreader beam weight under the hydraulic ram was 2 kips and including the moment caused by self-weight (5.4 kip-ft) of the slab, the total experimental joint moment was 42.2 kip-ft.

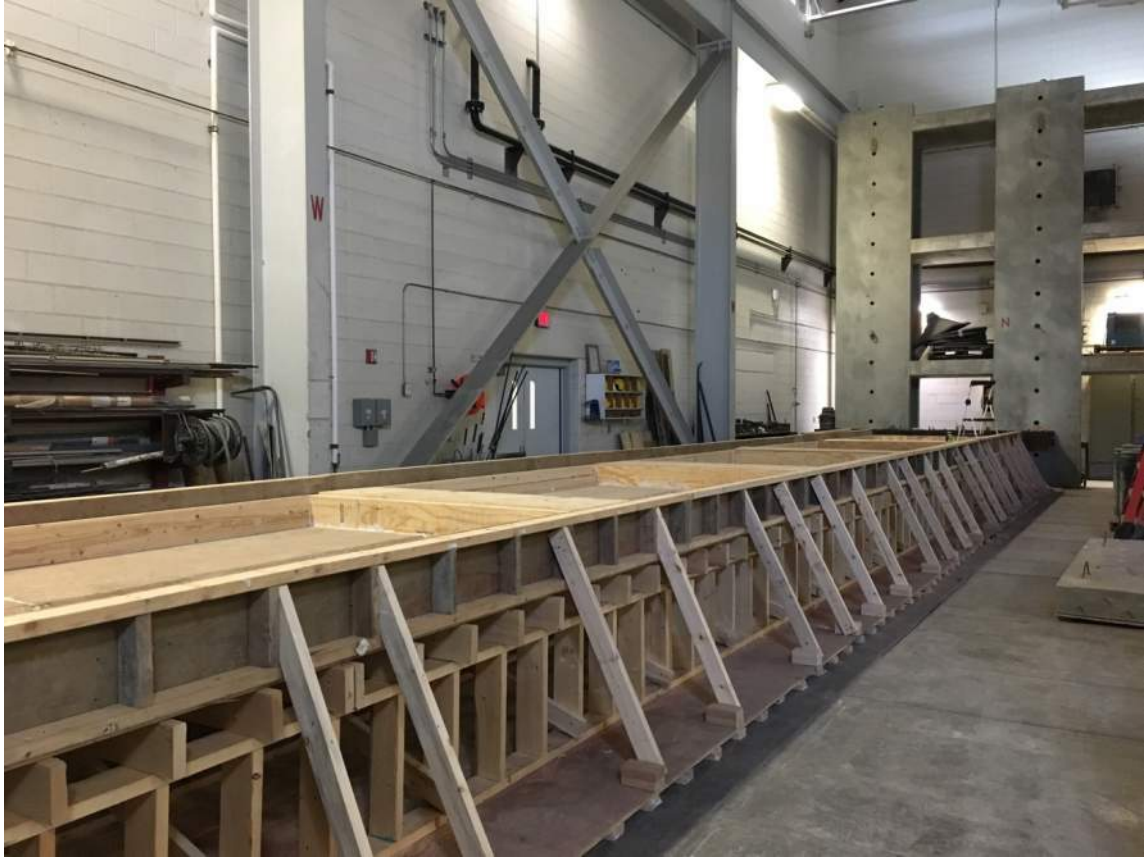
Figure 4.4: Complete Full-Scale Formwork for County Bridge Specimen

A base of 4 by 8 ft (3/4 in. thickness) plywood supported by 2 by 4 in. studs was built to cover a 12 ft by 56 ft lab space. The stem walls were then secured to this base and kickers were used to secure the top of the stem wall. The flange form was then attached to the stem wall form. The side walls were attached to the flange form and the kickers were placed between the platform base and the top of the side wall forms to secure the top as shown in Figure 4.3. Dividers were then installed along the length of the full form to create five 10 ft sections. The complete assembled formwork with diagonal supports is shown in Figure 4.4.
