Experimental Study on a New Type of Transverse Connection for Nebraska County Bridge System

EXPERIMENTAL STUDY ON A NEW TYPE OF TRANSVERSE CONNECTION
FOR NEBRASKA COUNTY BRIDGE SYSTEM

A THESIS

Presented to the Faculty of
The Graduate College at the University of Nebraska
In Partial Fulfillment of Requirements
For the Degree of Master of Science

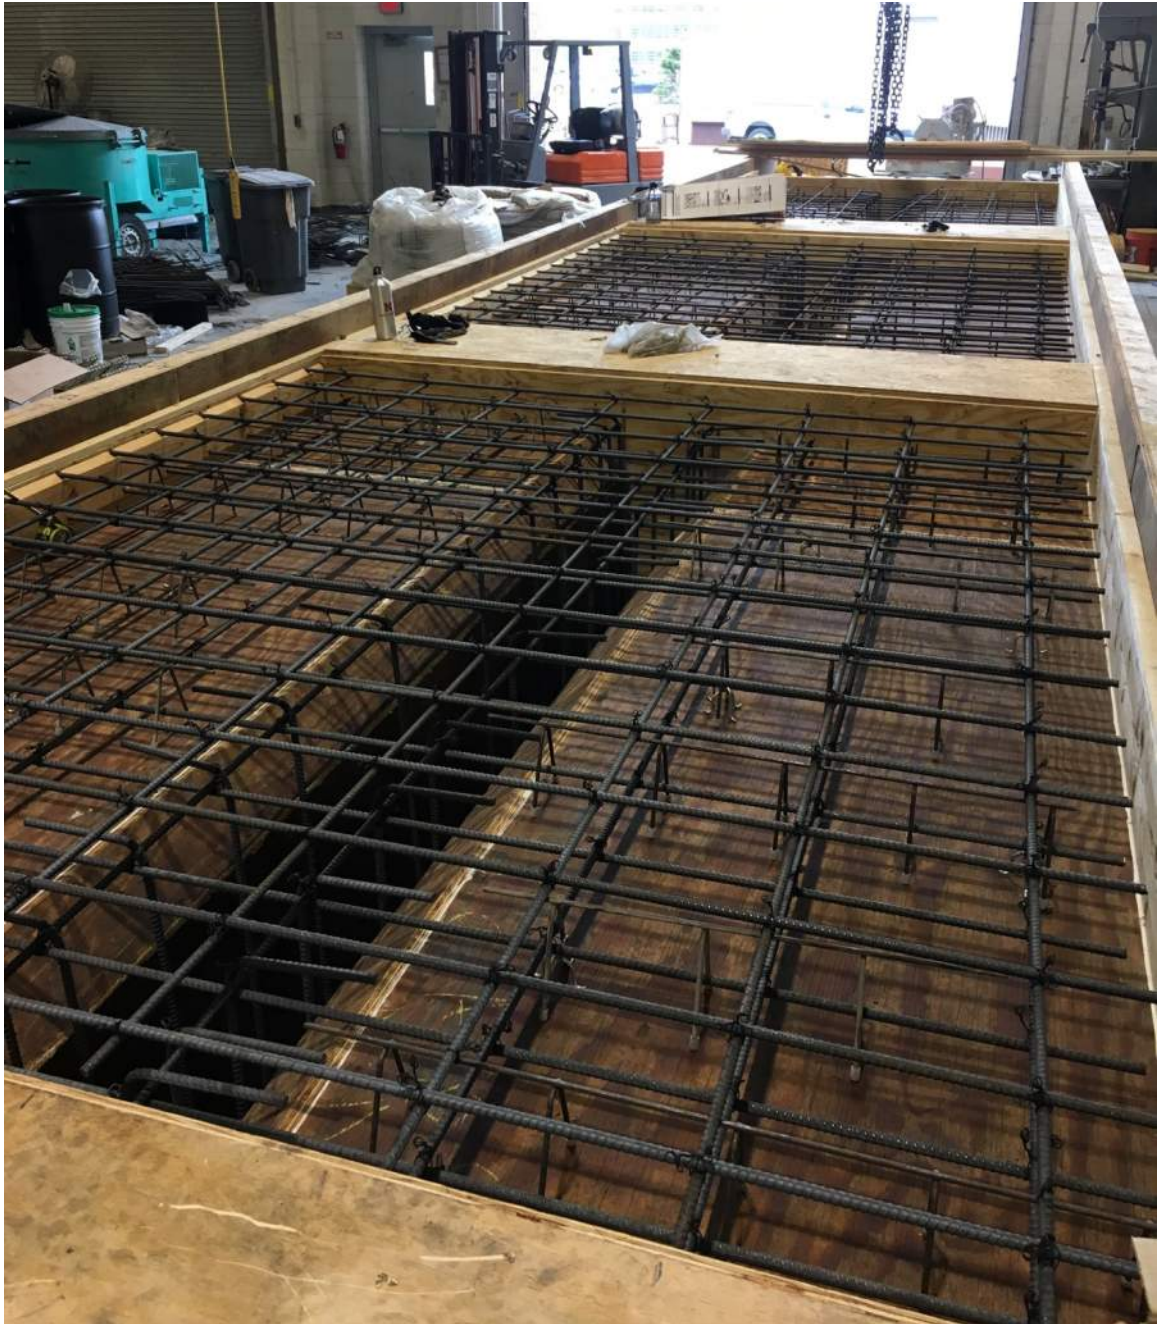
Figure 4.5: Steel Reinforcement Assembly Placed in Formwork

All steel bars for tied by the research team consisting of graduate students and faculty members. No. 11 longitudinal bars which were placed in the stem were built outside the formwork with No. 4 transverse reinforcement tied together. The reinforcement cage was then dropped into the stem using the overhead crane. Top and bottom mat of No. 4 bars were placed as deck reinforcement to finalize the work. Figure 4.5 shows a photo of the assembled steel reinforcement placed inside the entire formwork.

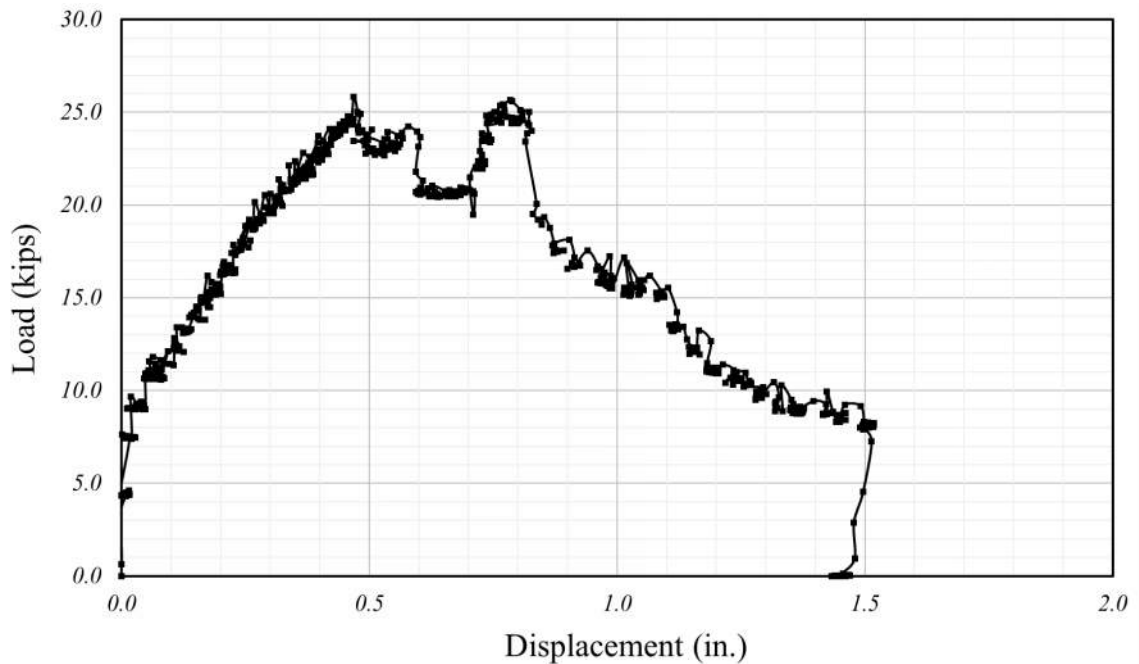
Figure 4.18: Load-Displacement of Specimen F-M
