47<sup>TH</sup> TURBOMACHINERY & 34<sup>TH</sup> PUMP SYMPOSIA  
HOUSTON, TEXAS | SEPTEMBER 17-20, 2018  
GEORGE R. BROWN CONVENTION CENTER

# Troubleshooting of Sub-synchronous Torsional Interaction Phenomena on an Electric Motor-Driven Centrifugal Compressor

*Southwest Research Institute*

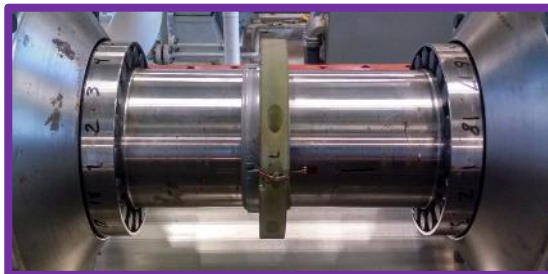
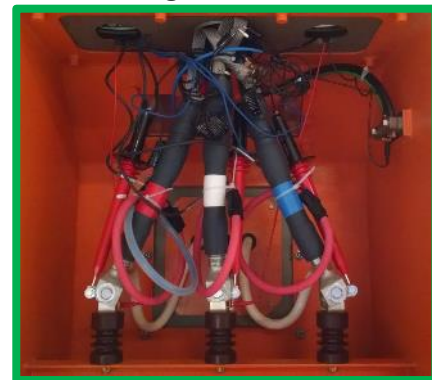
# Instrumentation

Strain ★

Voltage & Current

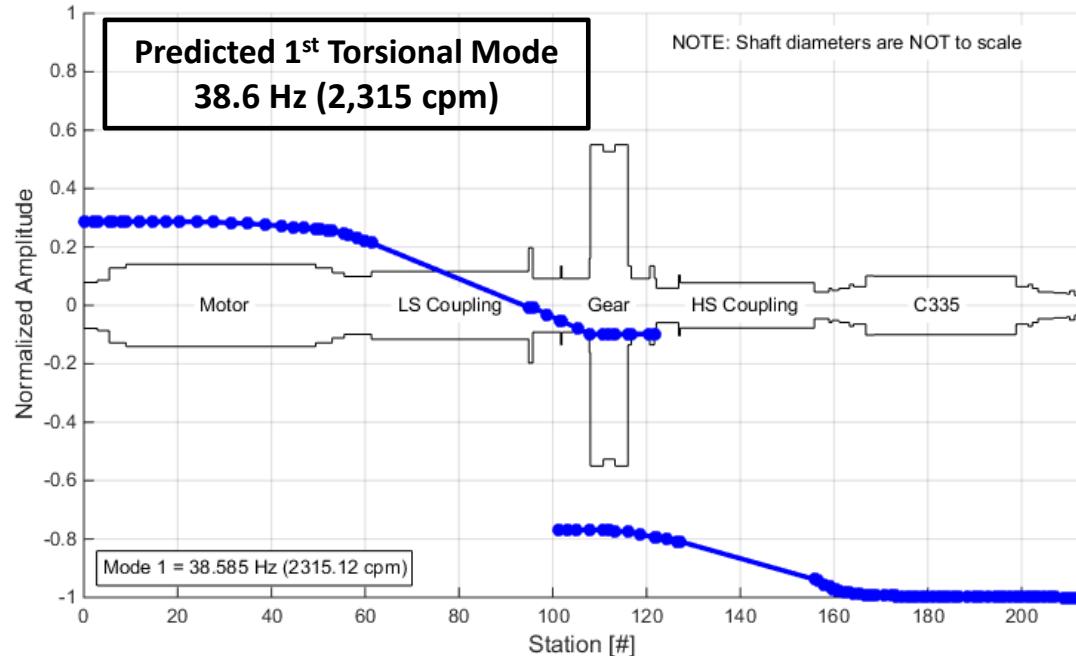
# Torsional Rotordynamic Model

- Campbell diagrams show no interference with 1<sup>st</sup> mode with mechanical 1x and 2x energy orders (next slides)
- VFD non-integer excitation data not provided by VFD manufacturer

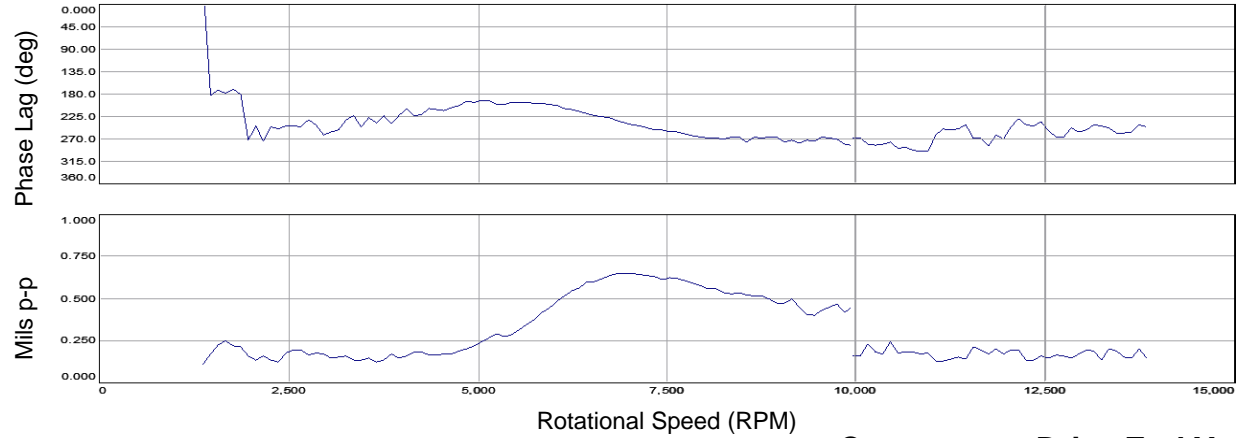
## Compressor Drive End X

Mechanical Check-out:

Open Loop / Air  
Full speed (14k rpm)

Low pressure (P1 = 30 psia)  
Full speed

High pressure (P1 = 600 psia)  
Part speed (9.5krpm)

High pressure  
Full speed  
(OEM present)

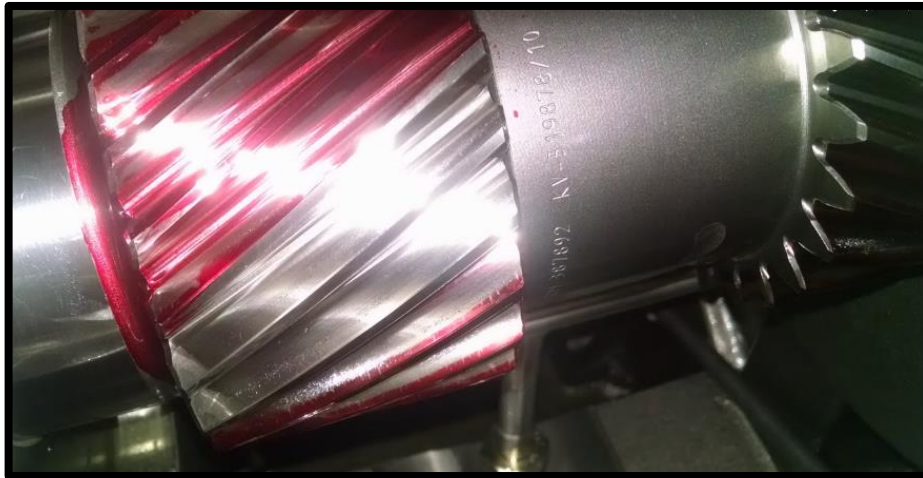
## Additional Observations:

1. **Audible noise** during operation (steady state, accelerations, and decelerations) from gearbox  
*No noise when deceleration occurred via emergency stop on VFD*
2. **Visual wear** on gearbox teeth in post-test inspection

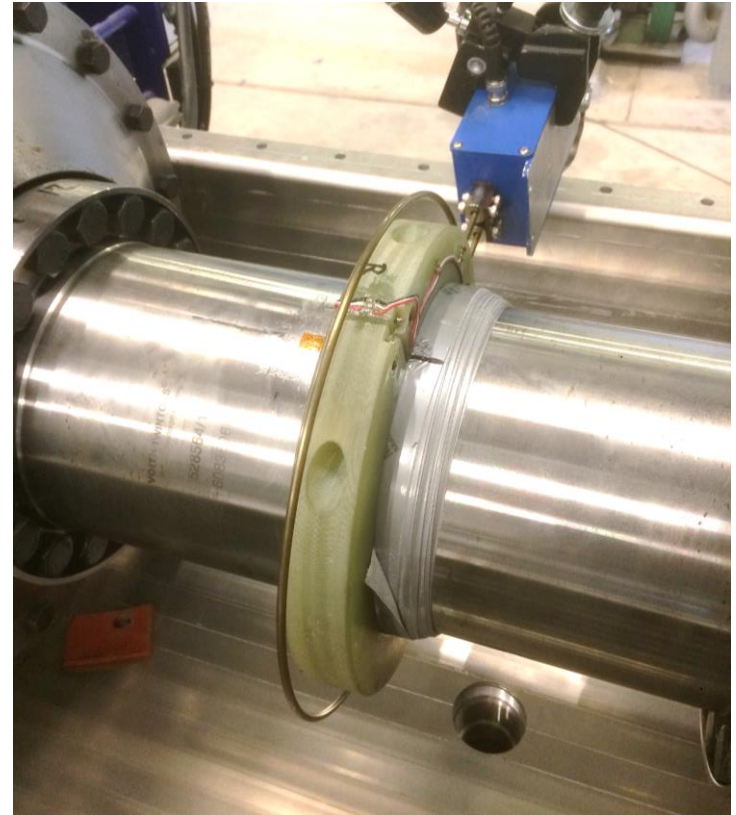
# Low Speed Coupling Measurements

- Measured dynamic torque was applied to the torsional model to determine stress at various critical locations in the machine.
- The stress was plotted on a Goodman diagram to determine if low-cycle fatigue had occurred.
