# ENVIRONMENTAL LEGACY OF 19<sup>th</sup> CENTURY LEAD MINING AND MINERAL PROCESSING AT THE NEWTOWNARDS LEAD MINES

Norman R. Moles, Mark Kelly and Dermot Smyth

**Abstract:** Ireland's largest 19<sup>th</sup> century mining site, the Newtownards Lead Mines at Conlig and Whitespots, County Down, may present significant human and animal health and environmental risks such as exhibited by other abandoned mine sites of similar size. We present information on the distribution of lead enrichment in tailings, spoil, soil and vegetation in the mine sett and adjacent areas, and make outline recommendations for improving site management. The risks are partially mitigated by the absence of smelting on site, the enclosed topography of the ore processing area, and the abundance of carbonate gangue resulting in neutralisation of acid generated during oxidation of the spoil and tailings. Tailings and associated soils in the southern part of the main sett contain remarkably high concentrations of lead. The tailings material has been dispersed by erosion enhanced by motorbike scrambling and similar recreational activities. The site is a Country Park and a designated Area of Special Scientific Inte

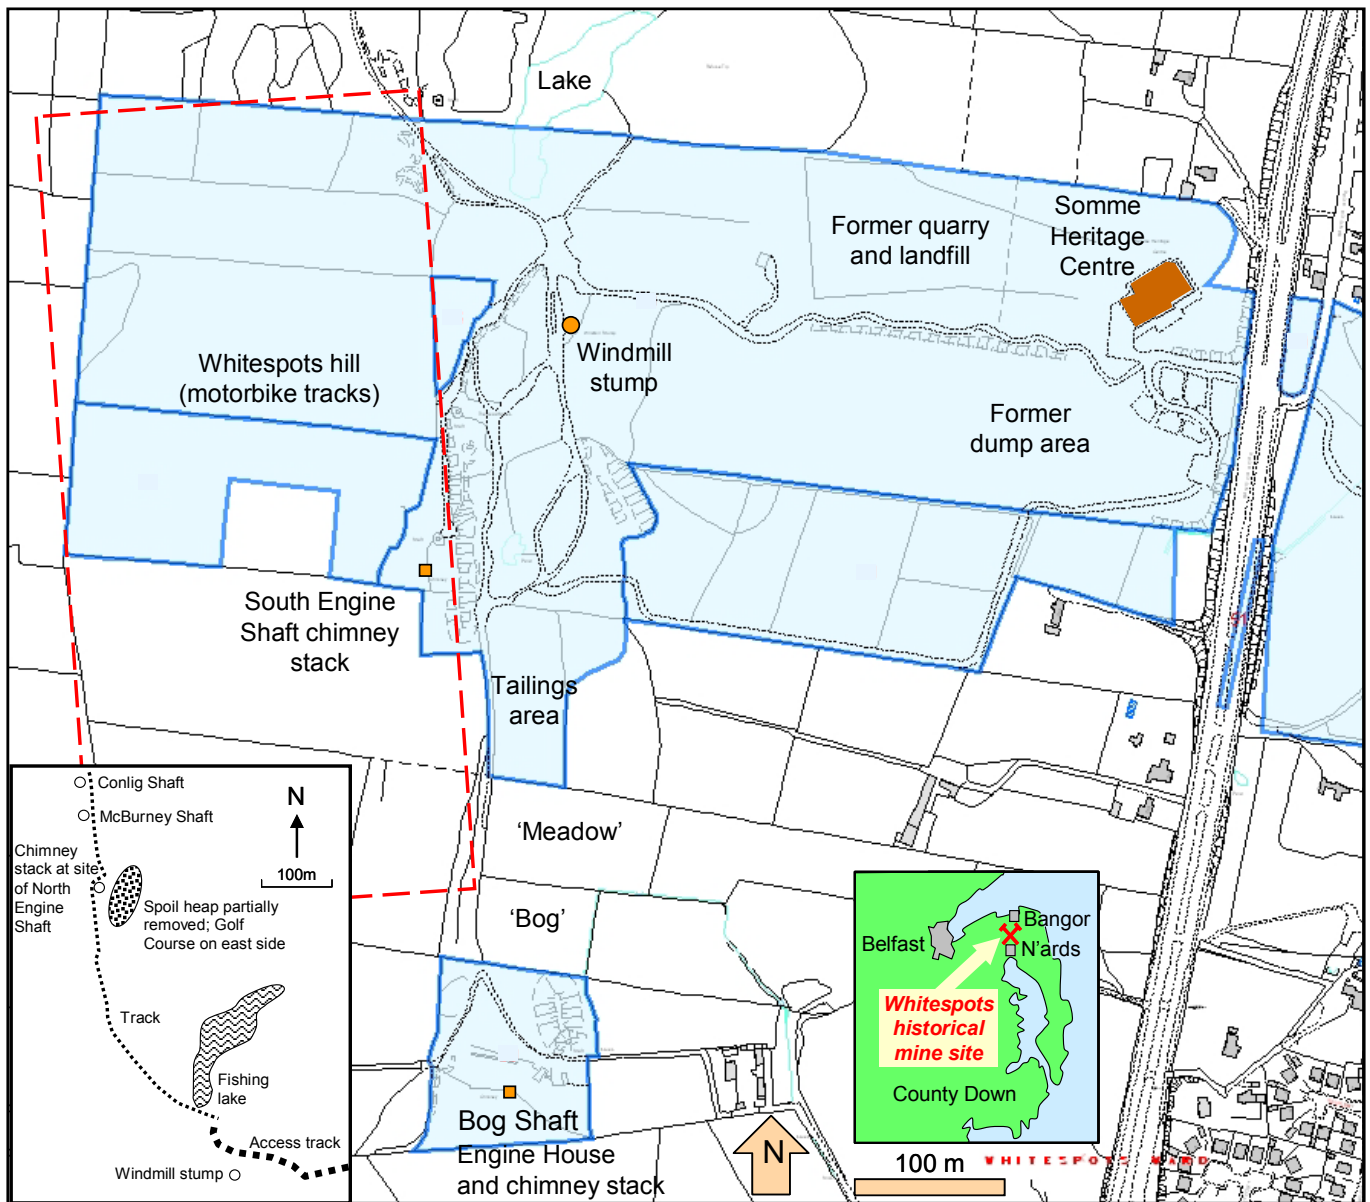
**Fig. 1: Field boundary map of the Whitespots area showing in blue the land owned by Ards and North Down Borough Council. Crown Copyright reserved. Red dashed box indicates the area shown in Fig. 6. On the right of the map is the Newtownards–Bangor road. The mine site is easiest to access from car parks located southeast of the Somme Heritage Centre. Inset maps show the location within eastern Northern Ireland, and a northwestern extension of the main map to show location of the Conlig Lead Mine sett. Base map provided by Ordnance Survey of Northern Ireland: Crown Copyright reserved**

influenced the location of mine infrastructure and ore processing, as well as the current environmental legacy. The northern part of the mineralized structure, the Conlig Mine sett, lies within undulating woodland of the Cladeboye Estate and adjacent greens of the Cladeboye Golf Course. The trace of the concealed mineralized structure is expressed as an elongate depression. This is likely due to a combination of pre-Holocene erosion and dissolution and surface mining and/or subsidence into shallow underground workings. South of the estate boundary, the Whitespots Mine sett lies on an east-facing escarpment on Whitespots Hill (Fig. 1).

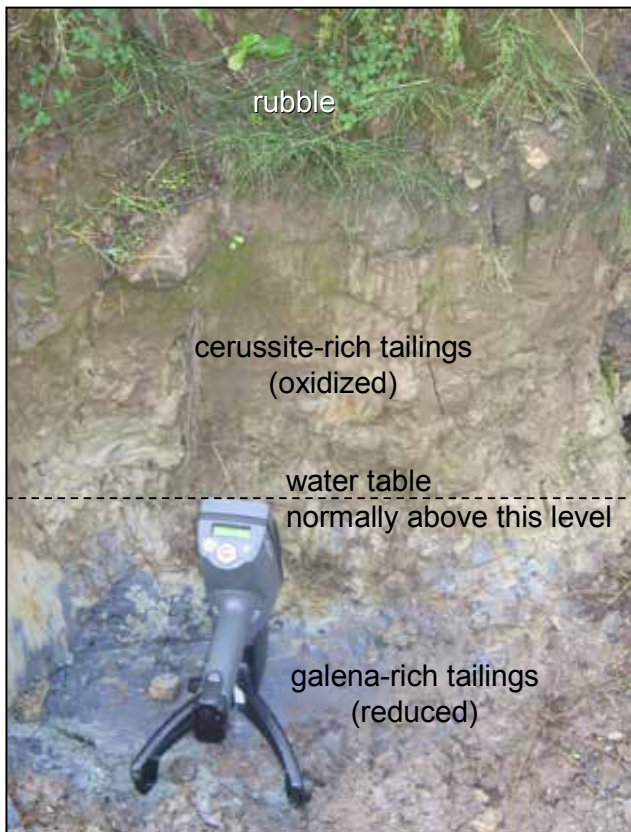
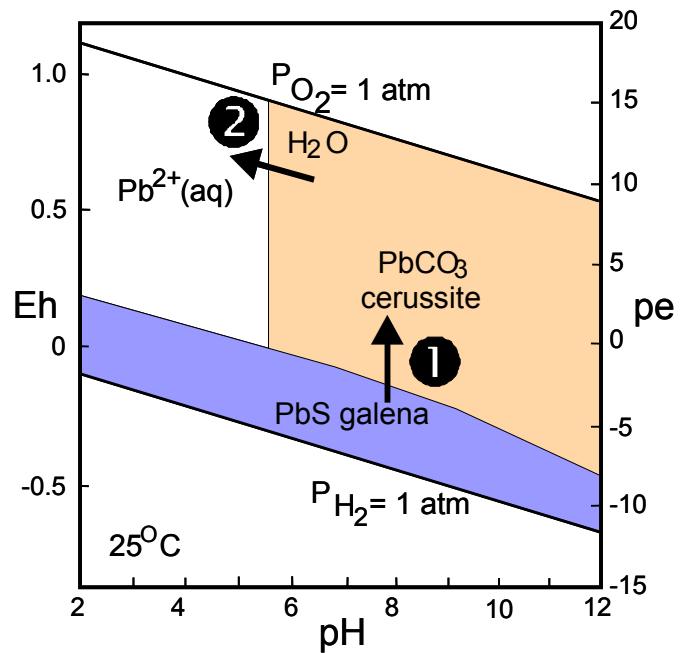
**Fig. 2:** *Left: Vertical section through tailings at the southern edge of the fishing lake (located in the north part of Fig. 1) exposed during a prolonged dry period. An Innov-X alpha PXRF spectrometer is set up for in situ measurement. The lower part of the profile comprises unoxidised tailings that are blue-grey coloured due to finely comminuted galena. The beige-coloured upper part comprises oxidised tailings in which the original galena has been replaced by the lead carbonate cerussite. Right: Simplified acidity-oxidation diagram for Pb compounds, adapted from Drever (1997). ①: oxidation of tailings in presence of excess carbonate forming cerussite. ②: cerussite dissolution due to physical transfer to a lower pH environment such as moderately acidic soil, or a mammal's stomach*

As noted above, in the tailings lead occurs mainly as very fine-grained cerussite (lead carbonate,  $PbCO_3$ ) except where waterlogged conditions have preserved galena (Fig. 2). Cerussite is not present in the primary ore and its origin is attributed to reactions involving the decomposition of fine-grained galena in the presence of oxygen and excess carbonate, and the release of sulphate in solution (Fig. 2). The excess carbonate is provided by calcite and dolomite which are, fortuitously, major constituents of the ore material and therefore abundant in the tailings as shown by X-Ray Diffraction (XRD) analyses. The oxidation-carbonation process probably occurred during the first few decades after filling of the impoundments, during which time large amounts of dissolved sulphate were presumably transported away from the tailings in groundwater and overland flow.

- Ingestion of soil enriched with the principal lead-bearing mineral, cerussite, which is readily soluble in the acid conditions of the stomachs of humans or animals (Fig. 2);
- Consumption of blackberries from bramble plants growing in the vicinity of the tailings;
- Outdoor inhalation of respirable dust, particularly in dry weather when dust is raised by vehicle tyres;
- Indoor inhalation of respirable dust from metal enriched soil/ tailings material that site users may unknowingly transfer to their homes via footwear and clothing, or for example from adherence to the fur of pet dogs.

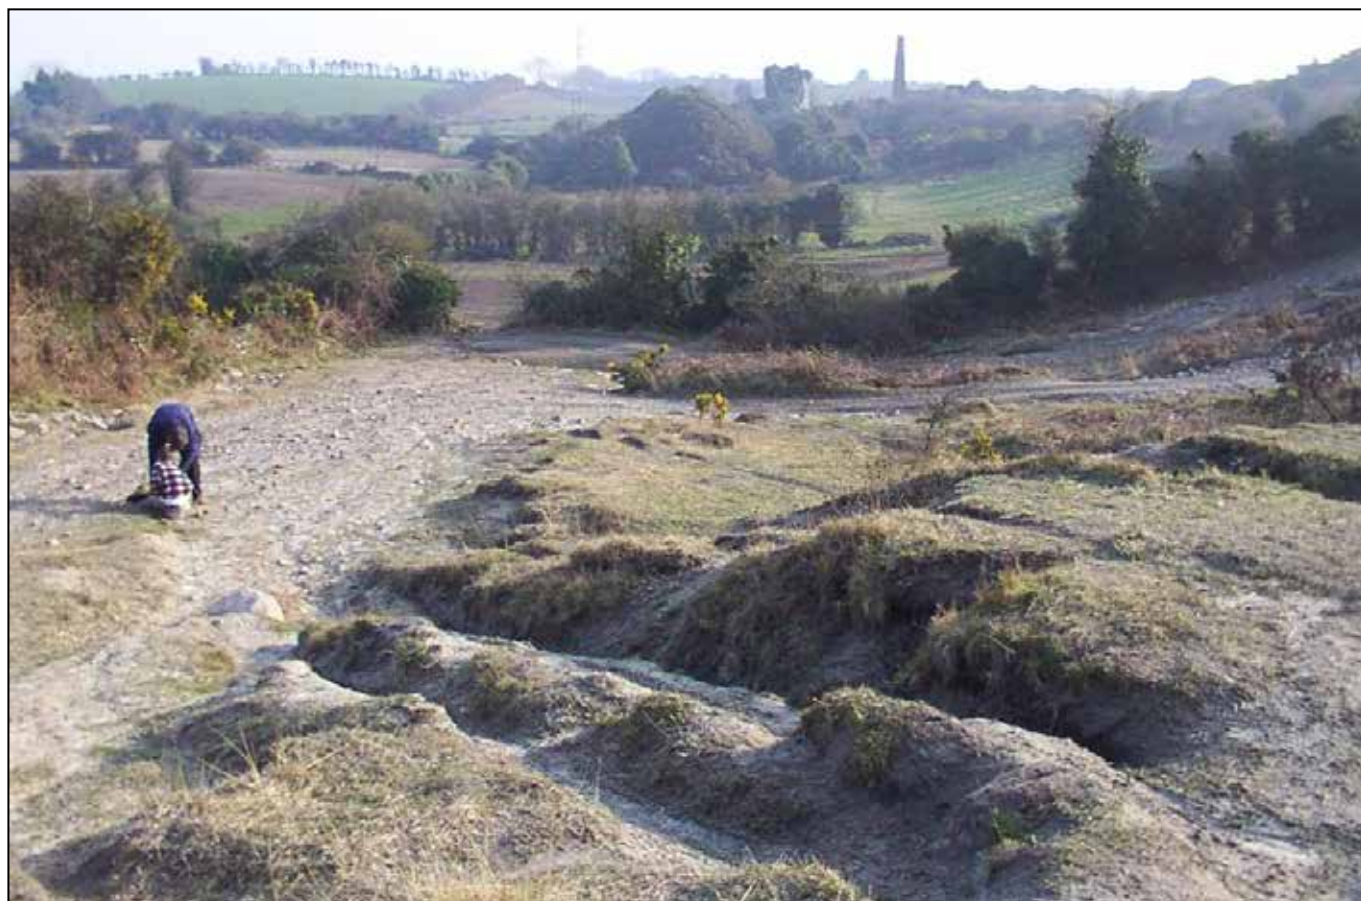
**Fig. 3: Eroded tailings impoundment in the area southeast of the South Engine Shaft chimney stack, looking south with the Bog Shaft engine house, chimney stack and (gorse-covered) spoil heap visible in the distance. During periods of rain, cerussite-rich tailings material is washed downslope through the gap in the hedge into the 'meadow' beyond. The meadow and hedge are the subjects of biogeochemical analyses reported here**

A valley, presently densely vegetated, extends for about 100m southwards from the southern edge of the Whitespots spoil heaps. In its upper (northern) part the valley contains a cluster of deep roughly circular depressions, some 3 m in diameter, which may have been budding pits. Downslope to the south are a series of tailings terraces, their flat tops indicating the original top surface of infilled tailings dams (impoundments). Lines of cobbles transverse to the valley axis are the remains of the impounding walls. The oxidised tailings are characterised by pale-coloured and compact silty material, and where undisturbed are capped by a thin organic-rich soil and vigorous growth of bracken. Tailings material is also stacked against the escarpment on the west side of the valley. In total there were at least four tailings impoundments, now variably eroded (Fig. 3) as will be discussed later.

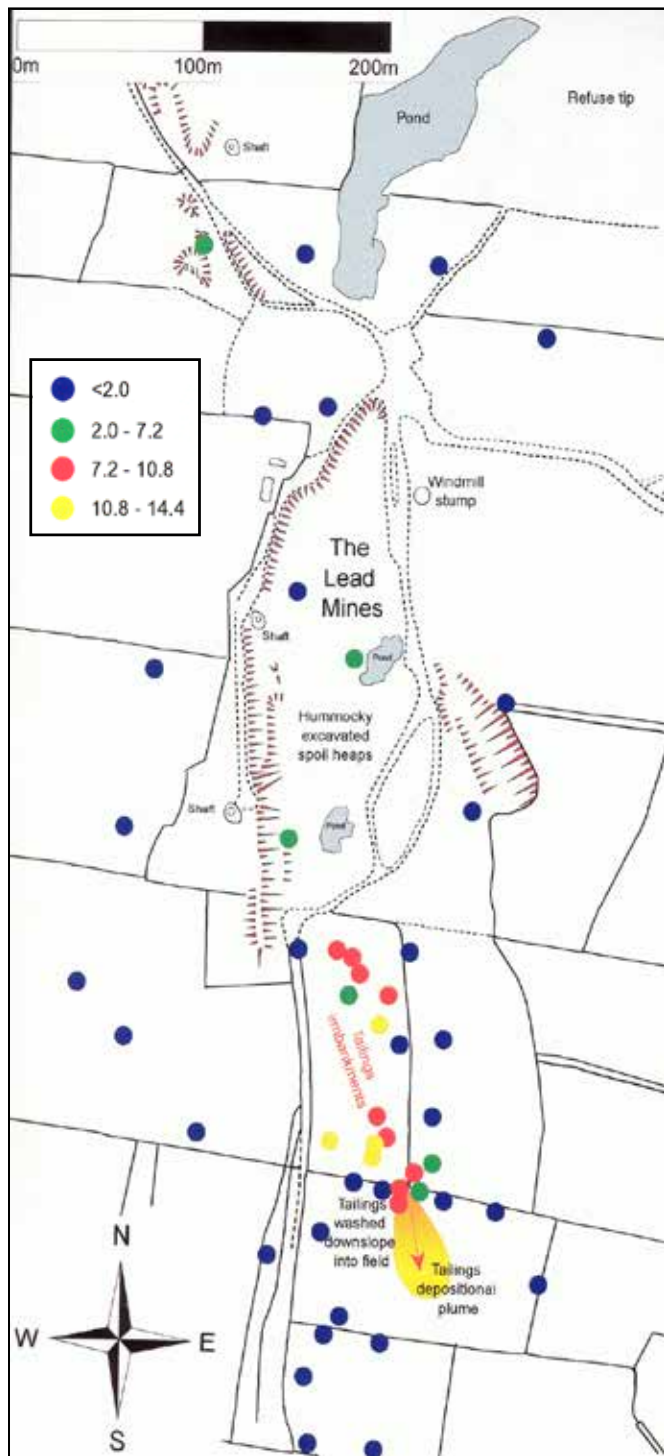
**Fig. 4: Dermot Smyth's map of Pb concentrations (classified into 4 class intervals with values in weight percent) in <2 mm soil or other substrates collected from 53 locations in the Whitespots area**

In the late 1990s as part of a PhD research project at QUB on biogeochemical prospecting methods, Dermot Smyth undertook sampling and analysis of soil and vegetation from throughout the Whitespots Mine site and adjacent area, although this was not reported in his final thesis (Smyth, 2001). Considering the widespread occurrence of bracken (*Pteridium aquilinum*) at the site, Dermot chose this plant as a sampling medium. He collected samples of bracken leaves and associated root-zone soil or other substrate such as tailings from 53 sites across an area of about one third of a square kilometre (Fig. 4). The <2 mm sieved soil and ashed vegetation were analysed at OMAC Laboratories using an Aqua Regia digest and an ICP Emission Spectrometry multi-element method. Lead concentrations ranged from <300 ppm to >1.9 % in 'background' soil and from 8.0 % to 14.4 % in tailings. Bracken ash Pb values ranged up to 0.28 % and showed a weak correlation with substrate Pb values. The soil Pb analysis results are shown in Fig. 4 using four class intervals, the lowest being <2 % Pb which includes most soil and mine spoil samples. Confirming the outcome of Mark Kelly's initial work, Dermot found that relatively high Pb values in soil are confined to the main tailings area and redeposited tailings in the meadow downslope (Fig. 4 inset).

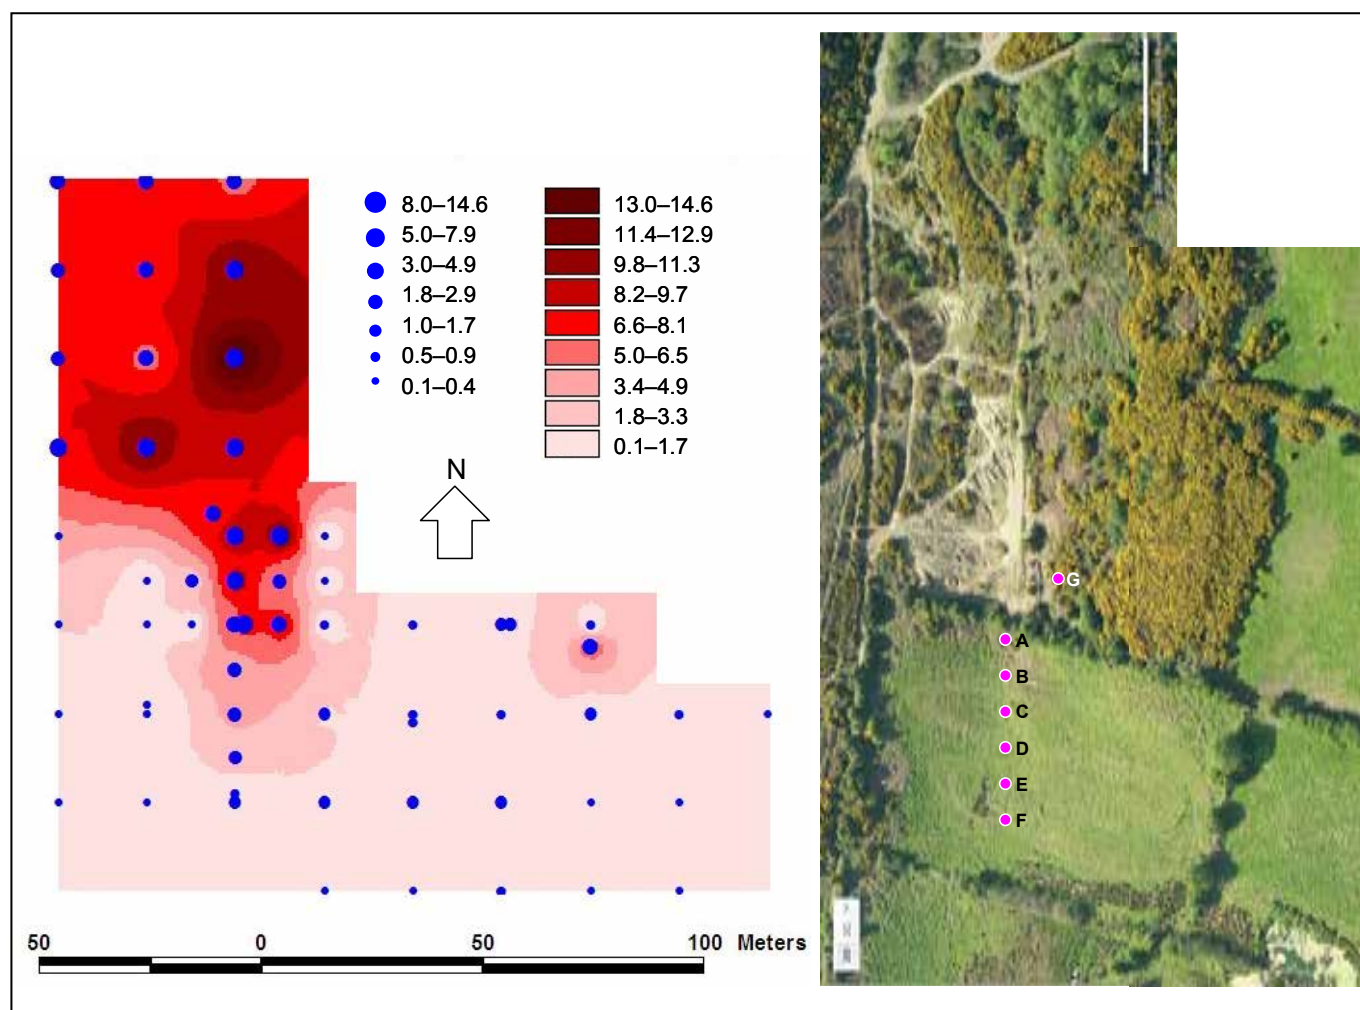
**Fig. 5: Spatial distribution of Pb, determined by in situ PXRF, in topsoil in the tailings area and meadow alongside an aerial photograph of approximately the same area (Microsoft Virtual Earth™, 2006). Data collected by the author. Map produced by Osric Forton using ArcGIS (Moles *et al.*, 2006). Circles labelled A–G are the locations of soil pits for geochemical profiles (Fig. 9)**

In situ analysis of surface materials by PXRf confirmed Pb levels in the range 6.2–14.6 % in the tailings area and 0.1–11.9 % in the meadow soil (Fig. 5) (Moles *et al.* 2006). Lab analyses (AAS and ICP-MS) showed excellent agreement with PXRf analyses of dried and homogenised samples (for Pb,  $R^2 = 0.9989$ ). Lead concentrations decrease linearly along the axis of the ‘plume’ for a distance of 60 m from the tailings ingress point, but decrease rapidly over a few metres perpendicular to the plume axis. Pb levels of 1–2 % extend for 60–80 m eastwards of the plume axis, probably due to vehicular dispersion of enriched soil in the meadow. ‘Background’ levels of Pb in the meadow soil are ~0.1–0.2% (~1000–2000 ppm) which are considerably above current Soil

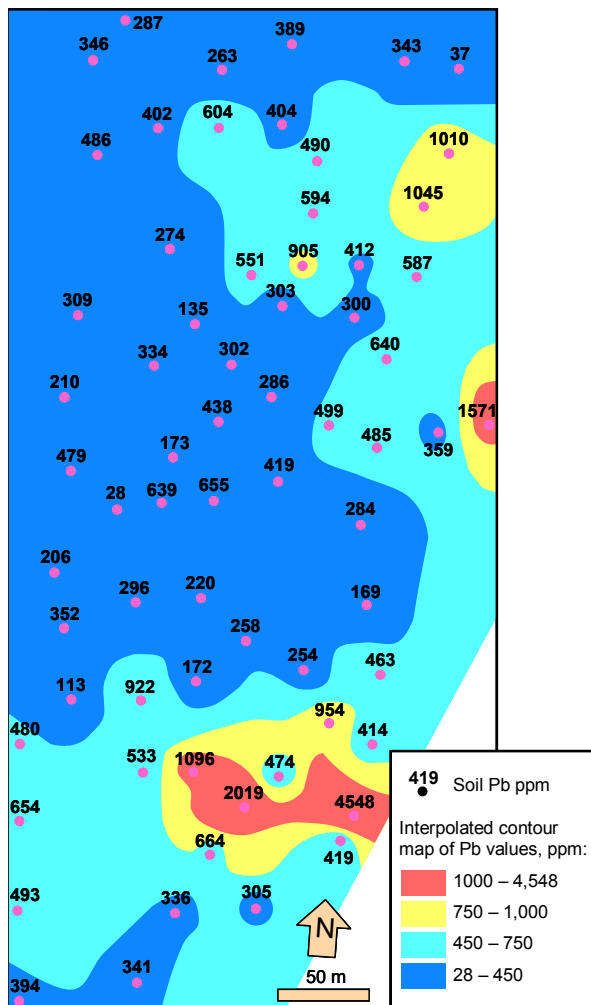
**Fig. 6: Interpolated contour map of lead concentrations, showing in situ PXRF measurement points and values in parts per million, in surface soil along paths and tracks on Whitespots hill west of the mine sett. Coloured map area corresponds to the dashed-line red box in Figs. 1 and 7**

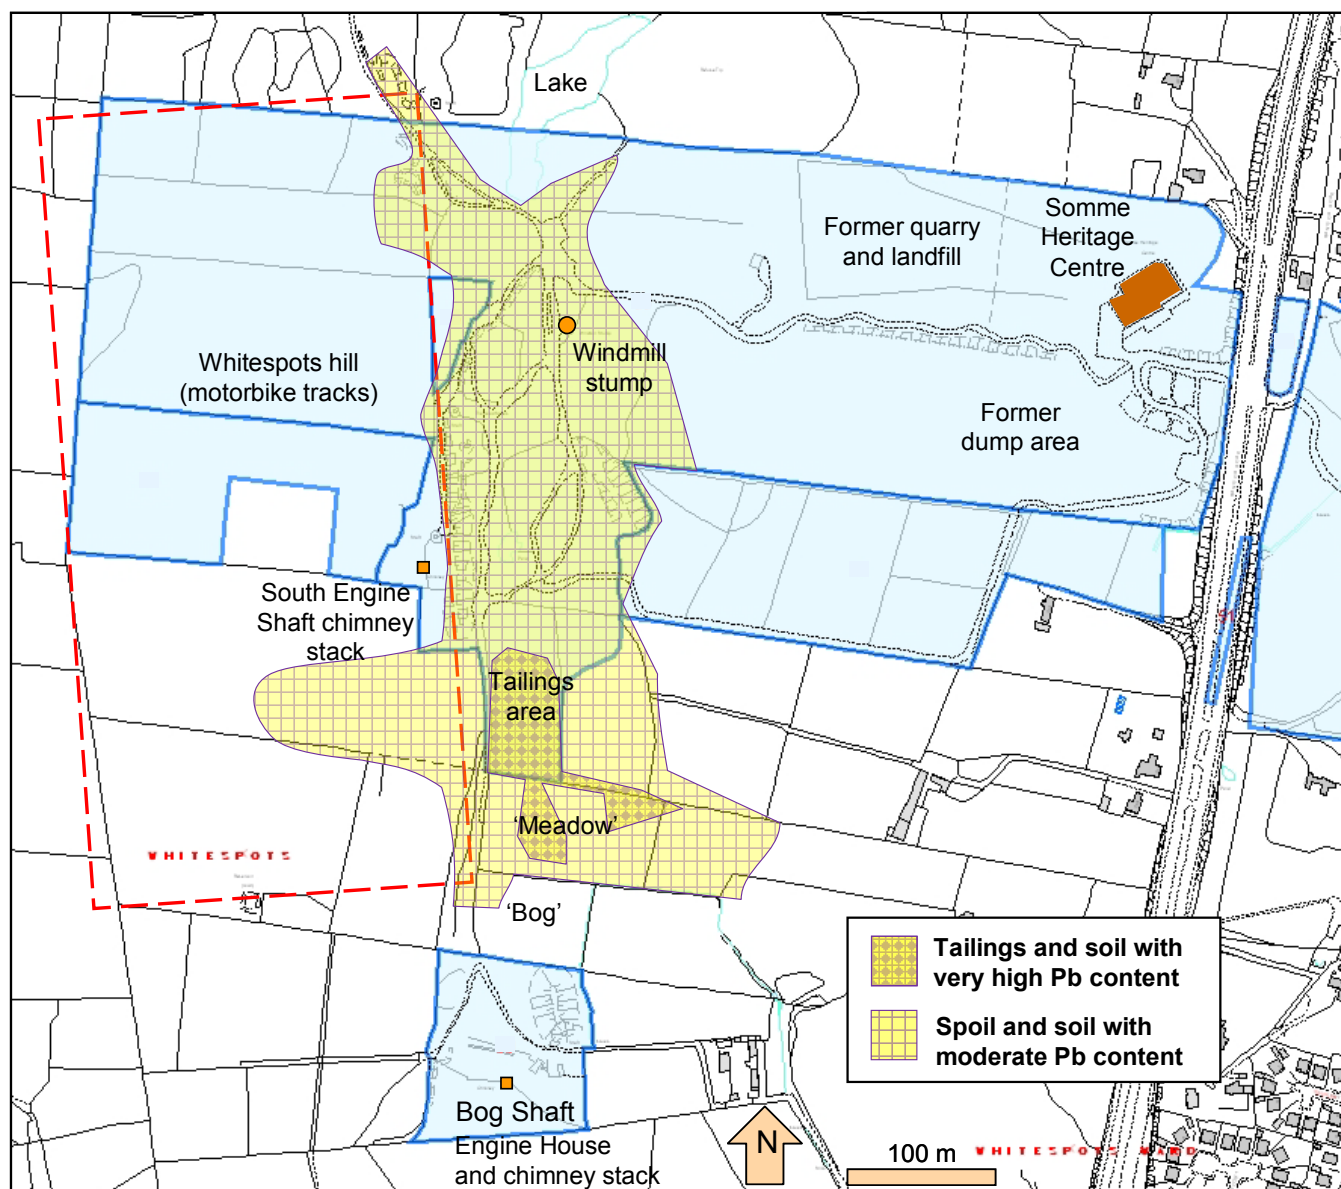
**Fig. 7: Distribution of soil Pb enrichment based on various surveys reported here, outlined on the OSNI base map (see Fig. 1): Crown Copyright reserved. ‘Very high Pb content’ indicates over ~2 % and ‘moderate Pb content’ indicates c. 0.5 to 2 %. The western and southern boundaries of the ‘moderate’ Pb content are well defined, whereas the eastern boundary is speculative**

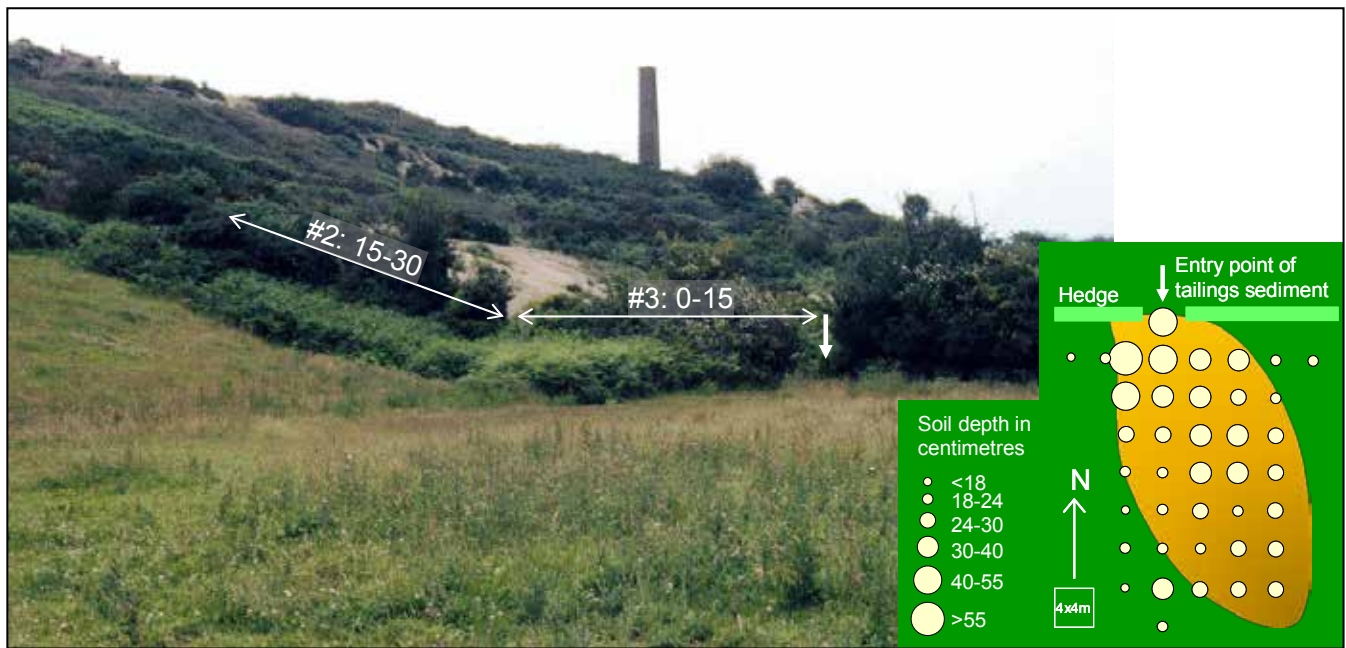
**Fig.8: Photograph taken in 2000 of the meadow looking northwest with the prominent South Engine Shaft chimney stack on the escarpment. Central in the photograph, the pale area bare of vegetation is an eroded tailings impoundment. Extending left to right is the hedgerow through which eroded tailings are washed into the meadow. Vigorous growth of pale green bracken is visible in an area where sandy, calcite-rich tailings have been deposited. Arrowed lines labelled 0-15 and 15-30 indicate lengths of hedge from which vegetation samples were taken for analysis (Fig. 11). Inset: map of the redeposited tailings plume in the meadow showing soil depths estimated by probing on a 4 m grid with an iron rod. The south-eastern extremity of the plume corresponds to the location of the photographer**

In the main tailings area, the covering of shallow soil and surface vegetation has been stripped by human activities, specifically the recreational use of 4x4 off-road vehicles, quad bikes and motorbikes. These have incised gulleys through the impoundments (Fig. 3). This has exposed the impermeable tailings to erosion by rain and wind. Rainwash and overland flow has relocated much of the tailings material from the original impoundments, downslope through gaps in the hedge into the topographically lower meadow. Here, inundation of the meadow grass and growth of distinctive calcium-looking plants (including orchids) formed a visible plume across the field (Fig. 8). Depth probing indicates that half a metre or

more of redeposited tailings has accumulated in the proximal part of this plume (Fig. 8) where overland flow passes through the hedge, which has been partially buried by the sediment.

As probing had demonstrated a considerable depth of probably redeposited tailings in the proximal part of the plume (Fig. 8), in 2011 the lead author supervised University of Brighton MSc student Boli Ajibola in a project to gain more information on the tailings influx by means of geochemical depth profiles. Six soil pits 10 m apart were excavated in an approximately north–south transect across the meadow, plus a control site 20 m north of the hedge. Sets of contiguous samples from the vertical profiles were analysed by PXRf (Fig. 9) with validation by ICP Mass Spectrometry. Pit A, located in the

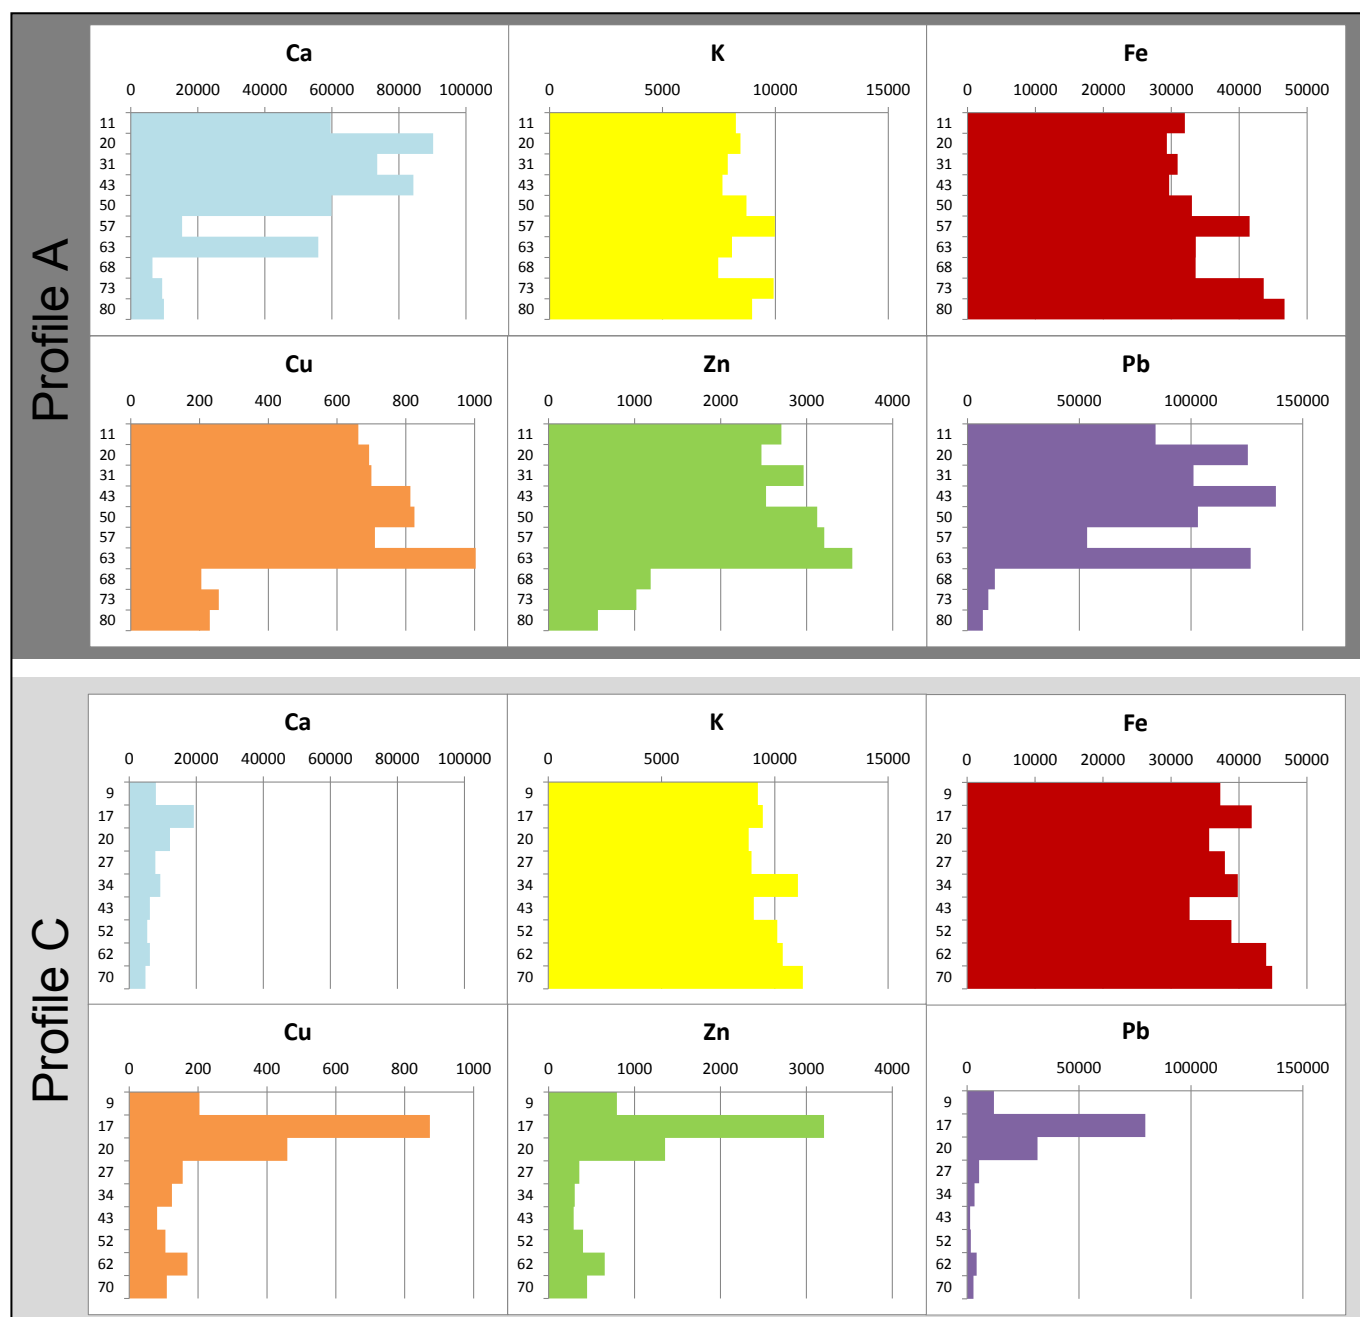
**Fig. 9:** Soil geochemical profiles for pits A and C in the meadow field, located on Fig. 5. Vertical axis is depth in centimetres. Horizontal axes are element concentrations in ppm measured by PXRF in homogenised samples representing each depth interval. Profile A is located 5 m south of the field boundary intersection, close to the tailings entry point. Profile C is located 20 m south of A

proximal plume area 5 m south of the field boundary, revealed tailings-rich material containing c.  $10 \pm 3$  % Pb to a depth of 63 cm. At this depth, there was a visibly sharp boundary with relatively normal soil containing 0.7–1.2 % Pb. Calcium shows a very similar profile to Pb. The redeposited tailings are enriched in Cu and Zn. Pit B 10 m to the south showed a similar geochemical profile but with tailings-rich material only in the upper 25 cm. Pit C a further 10 m south showed a tailings influence only in the depth interval 9–20 cm (Fig. 9) with similar Cu, Zn and Pb concentrations to the upper part of Pit A but much lower Ca concentrations. Pits D, E and F showed much lower levels of Pb (<5000 ppm) and also much lower Ca, Cu and Zn suggesting that an insignificant amount of tailings material had reached their location by overland flow.

The low calcium in profile C corresponds with a paucity of calcite and dolomite. This could be because the coarser particles of these minerals were not transported as far as cerussite by the overland flow, or because calcite and dolomite have dissolved after deposition (or both processes in combination). As noted by Moles *et al.* (2004), cerussite is the least soluble of these carbonate minerals in neutral pH conditions.

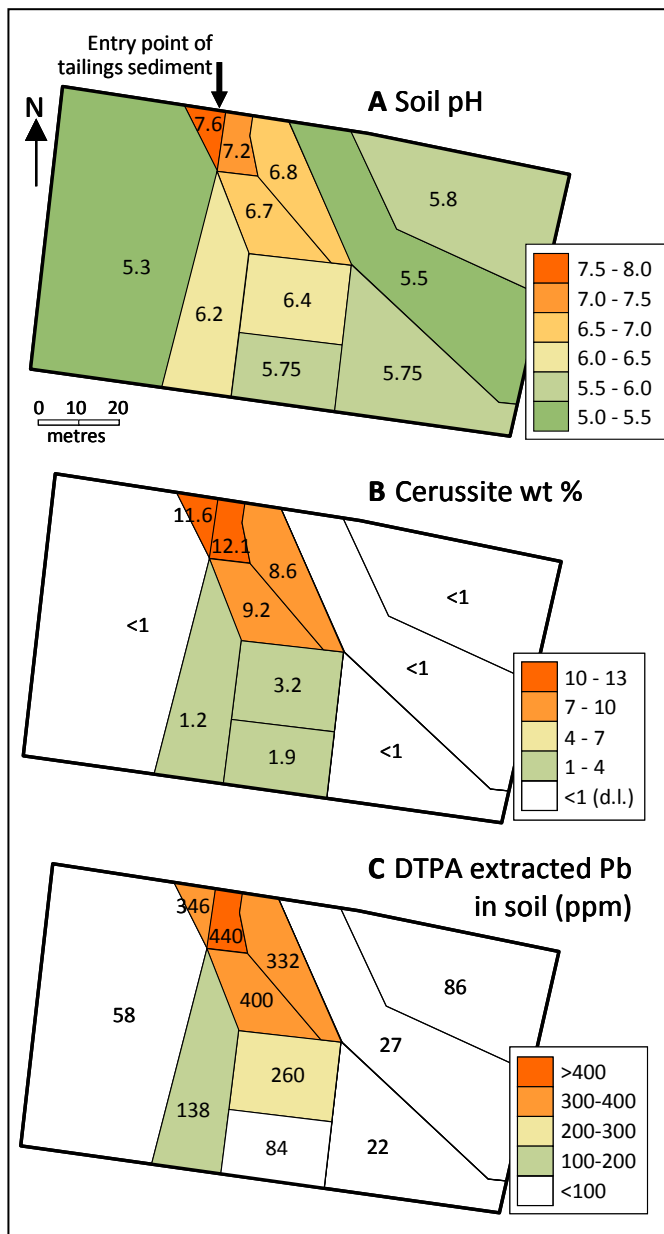
**Fig. 10: Maps of the tailings-enriched meadow showing sectors in which composite soil samples were analysed with results for: A. soil pH; B. cerussite content; and C. bio-available Pb content, from the MSc dissertation by Cecilia Maher in 2000. A version of the figures was published in greytone in Moles et al. 2004**

Cerussite concentration in surface soil from the meadow was measured using semi-quantitative XRD by Cecilia Maher in her QUB MSc project in 2000 (Fig. 10 B). In this study, the meadow area was divided into 10 sectors and composite soil samples were collected representing the average of each

sector. In the proximal part of the plume the soil contains around 12 wt% cerussite plus abundant calcite and dolomite, as also indicated by the alkaline pH of the soil (Fig. 10 A). Further across the field the average cerussite is around 9 wt%, and concentrations of around 2 wt% are found on the far (south) side of the field. This is at odds with the aforementioned soil pit analyses of Pb <0.5 %, perhaps due to the XRD over-estimating low abundances of cerussite. In her laboratory work Cecilia used a reagent named DTPA in solution to leach metals from homogenised soil samples: this extraction provides an estimation of the bio-available metal content i.e. that which can be taken up by plant roots. The results (Fig. 10 C) show a similar pattern to cerussite abundance with over 300 ppm Pb extractable in the proximal part of the plume. Cecilia investigated the correlation between DTPA-extractable (bio-available) soil metal content and metal enrichment in dock and plantain roots and leaves from the meadow sectors. She found positive correlations which are stronger in dock than in plantain and stronger in roots than in leaves, as reported in Moles *et al.* (2004).

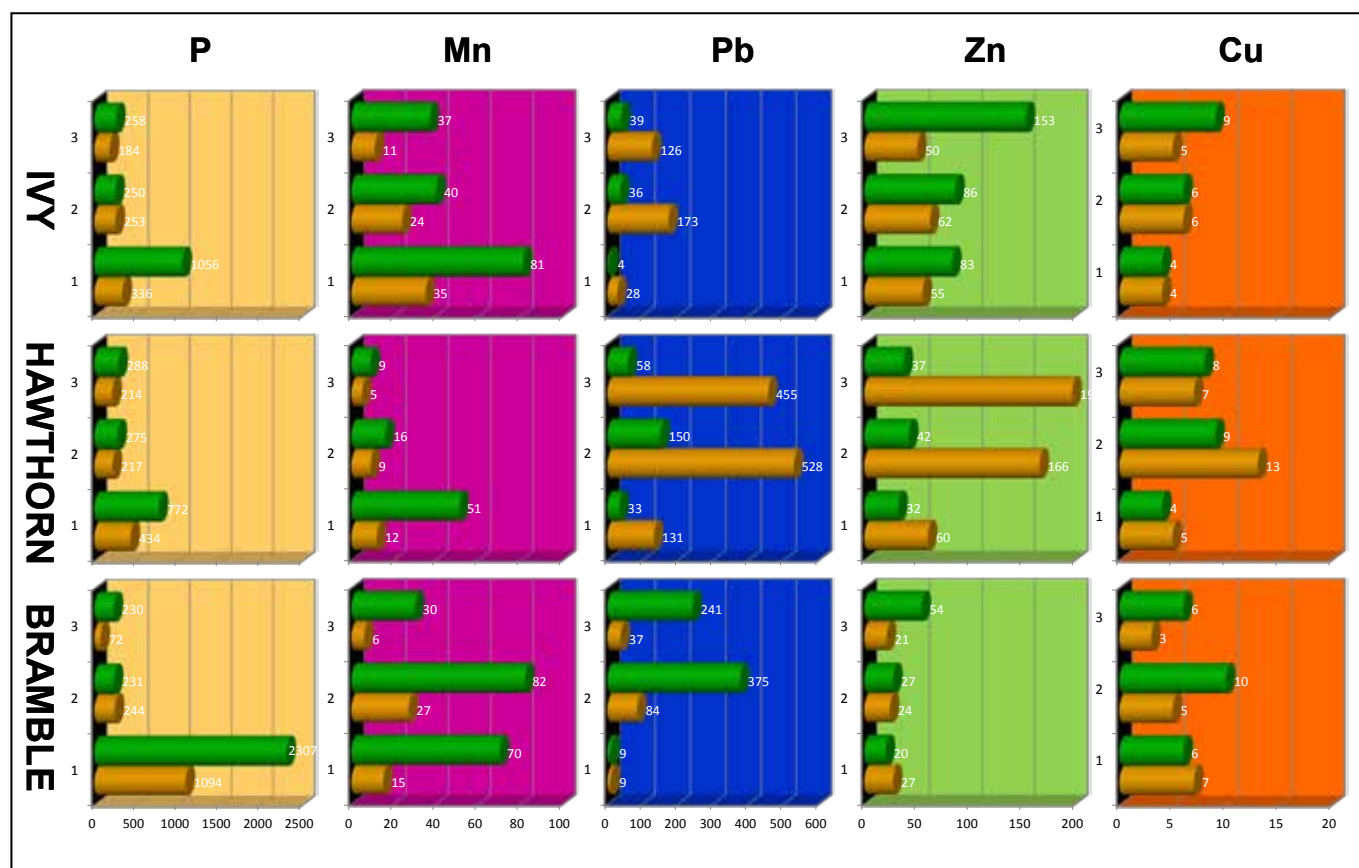
Fig. 11: Phosphorus and heavy metal content of ashed vegetation samples from the hedge between the tailings area and meadow. Data from Cecilia Maher's MSc dissertation (2000). All values in ppm (mg/kg). Orange bars = twigs; green bars = leaves of the respective plant. Numbers on vertical axes indicate sample location (see Fig. 8): 1 = control sample from hedge on the other (south) side of the field from the tailings entry point, 2 = hedge 15-30m upslope from the tailings entry point, 3 = hedge 0-15m from (adjacent to) the tailings entry point

Cecilia's MSc project also involved chemical (ICP-MS) analysis of plant material collected from the hedge bordering the meadow. We had noticed chlorosis and stunting of gorse and hawthorn where the hedge had been inundated by redeposited tailings, and wondered if this might be due to toxicity. Representative samples of ivy, hawthorn and bramble were collected along three 15 m lengths of hedge, sample 1 being a control sample from the south side of the meadow, on the opposite side to the tailings entry point. Sample 2 was

gathered from hedge 15–30 m upslope from the tailings entry point, and sample 3 from the partially inundated hedge adjacent to the tailings entry point (Fig. 8). For each plant type the twigs and leaves were ashed and analysed separately. The results for P, Mn, Pb, Zn and Cu are shown in Fig. 11. Phosphorus (P) values in sample 1 vegetation (the control) are much higher than in samples 2 and 3, whereas Pb values in sample 1 are much lower, as expected. Hawthorn twigs carry the highest concentrations of Pb, Zn and Cu in samples 2 and 3. In leaves, the highest Pb values are found in bramble in sample 2, and the highest Zn in ivy in sample 3. Vegetation in sample 3 contains lower concentrations of Pb and Mn than sample 2. We interpret this as lower metal uptake by the stressed plants in the tailings-inundated hedge, compared with
