## **A novel corrosion resistant repair technique for existing Reinforced Concrete (RC) elements using Polyvinyl Alcohol Fibre Reinforced Geopolymer Concrete (PVAFRGC)**

**Keywords**; corrosion resistance; fibre reinforced geopolymer concrete; repair material; reinforced concrete beams.

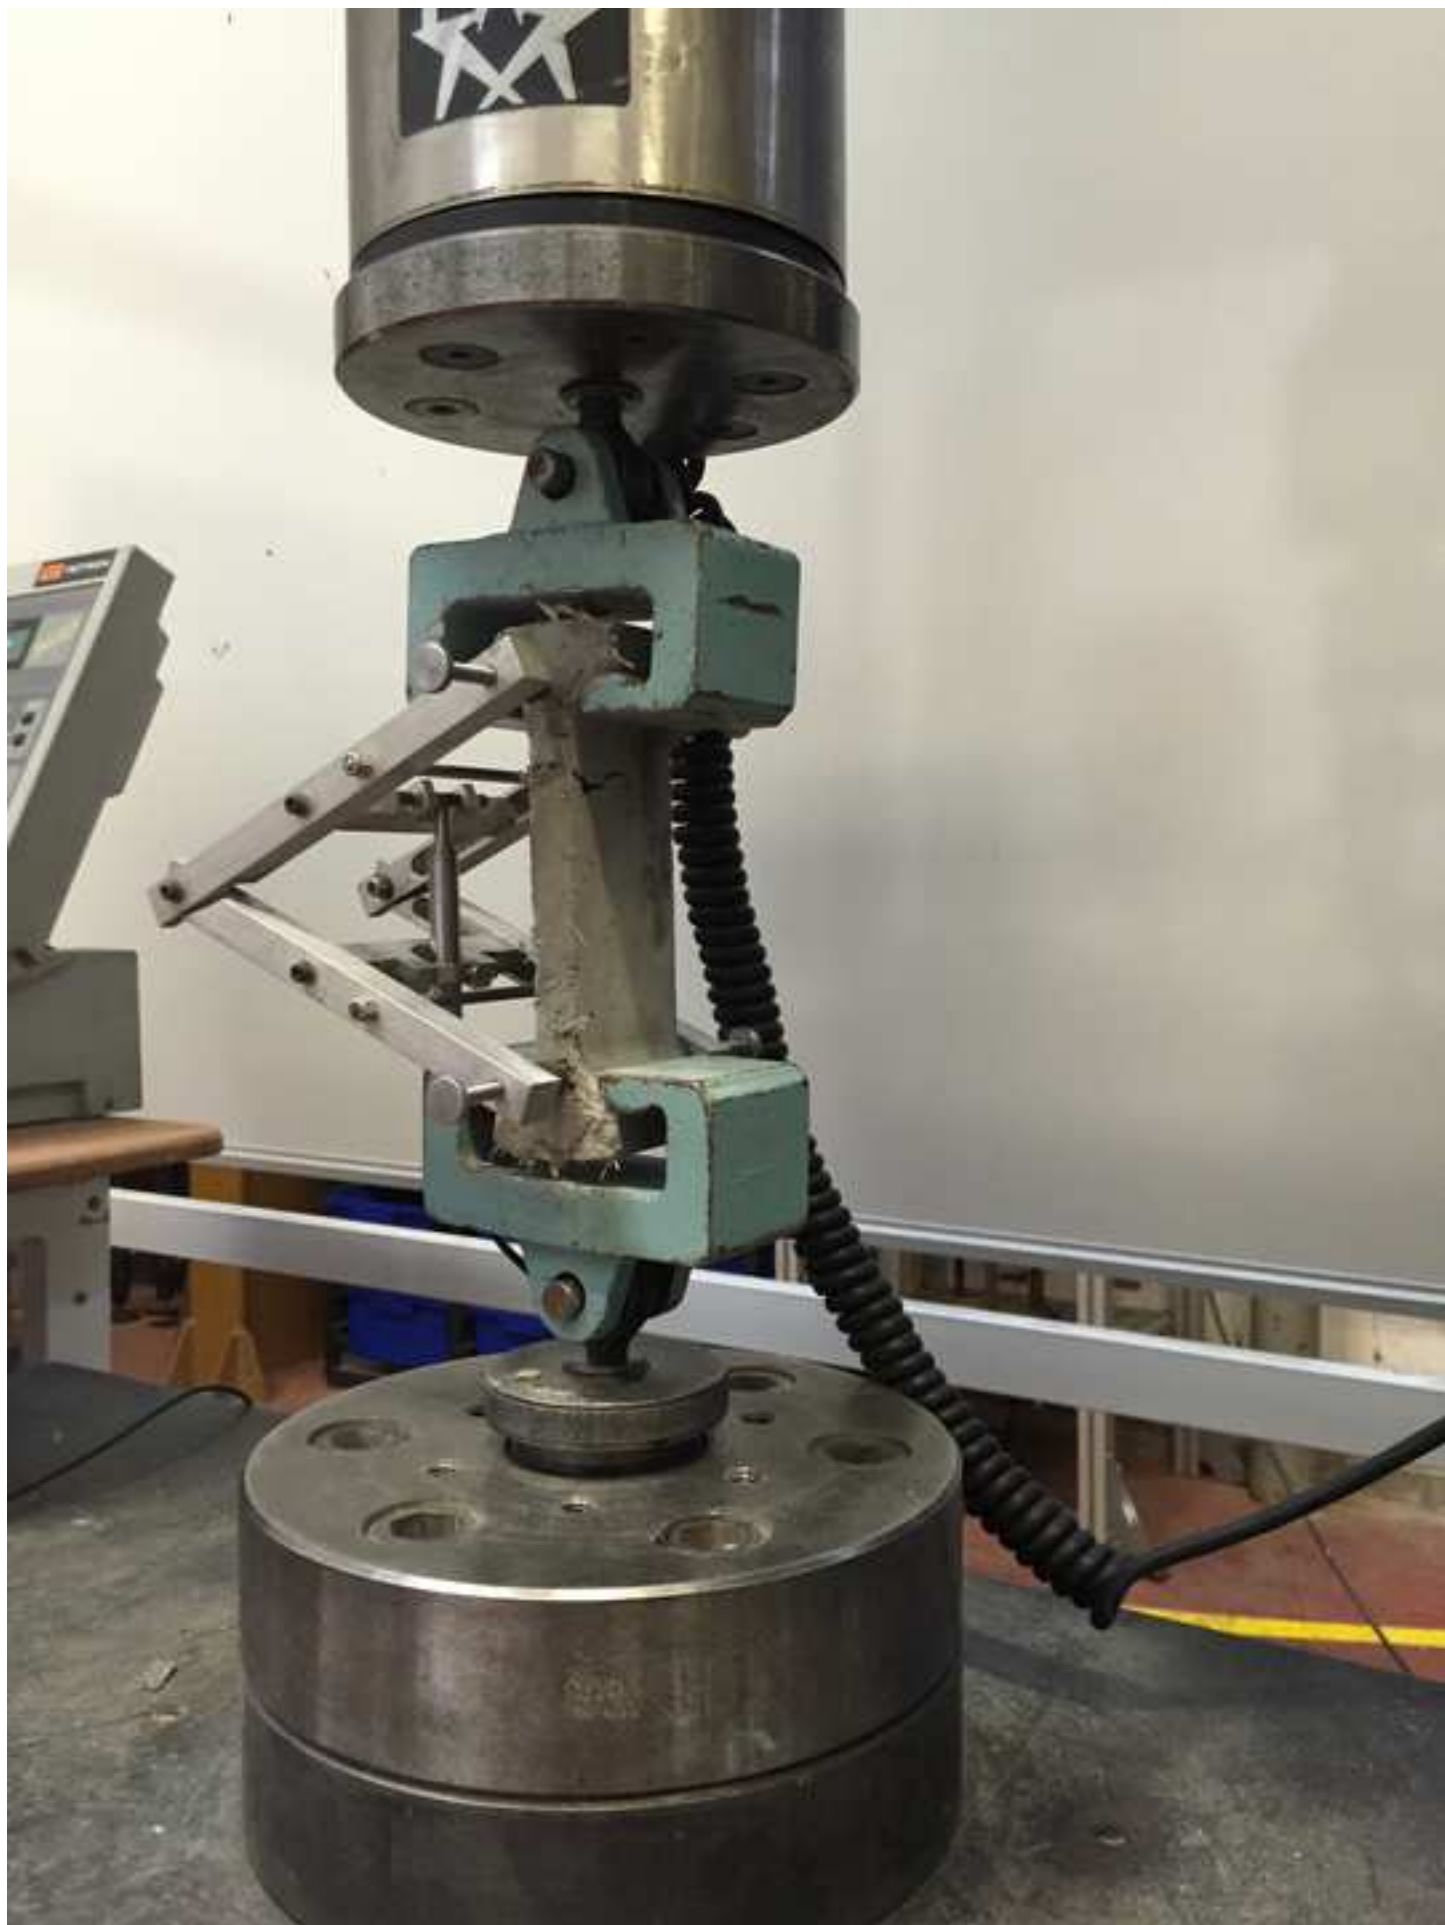
Fig. 1a  
[Click here to download high resolution image](#)

Direct tensile strength was determined using “dog-bone” shaped specimens of 13mm (mid cross section) by 50 mm (Figure 1a) [14, 23]. Flexural strength was assessed by testing standard prismatic specimens (100 x 100 x 500 mm) at 28 days curing using an Instron testing machine (the flexural test setup is shown in Figure 1b). It should be noted that these tests have been conducted in order to evaluate the flexural and tensile strength characteristics of the examined material, and these characteristics may vary from the actual characteristics of the repair layers which have different geometry compared to the standard beams and therefore different fibre orientation. Details of the testing set up are described in a previously published study [14].

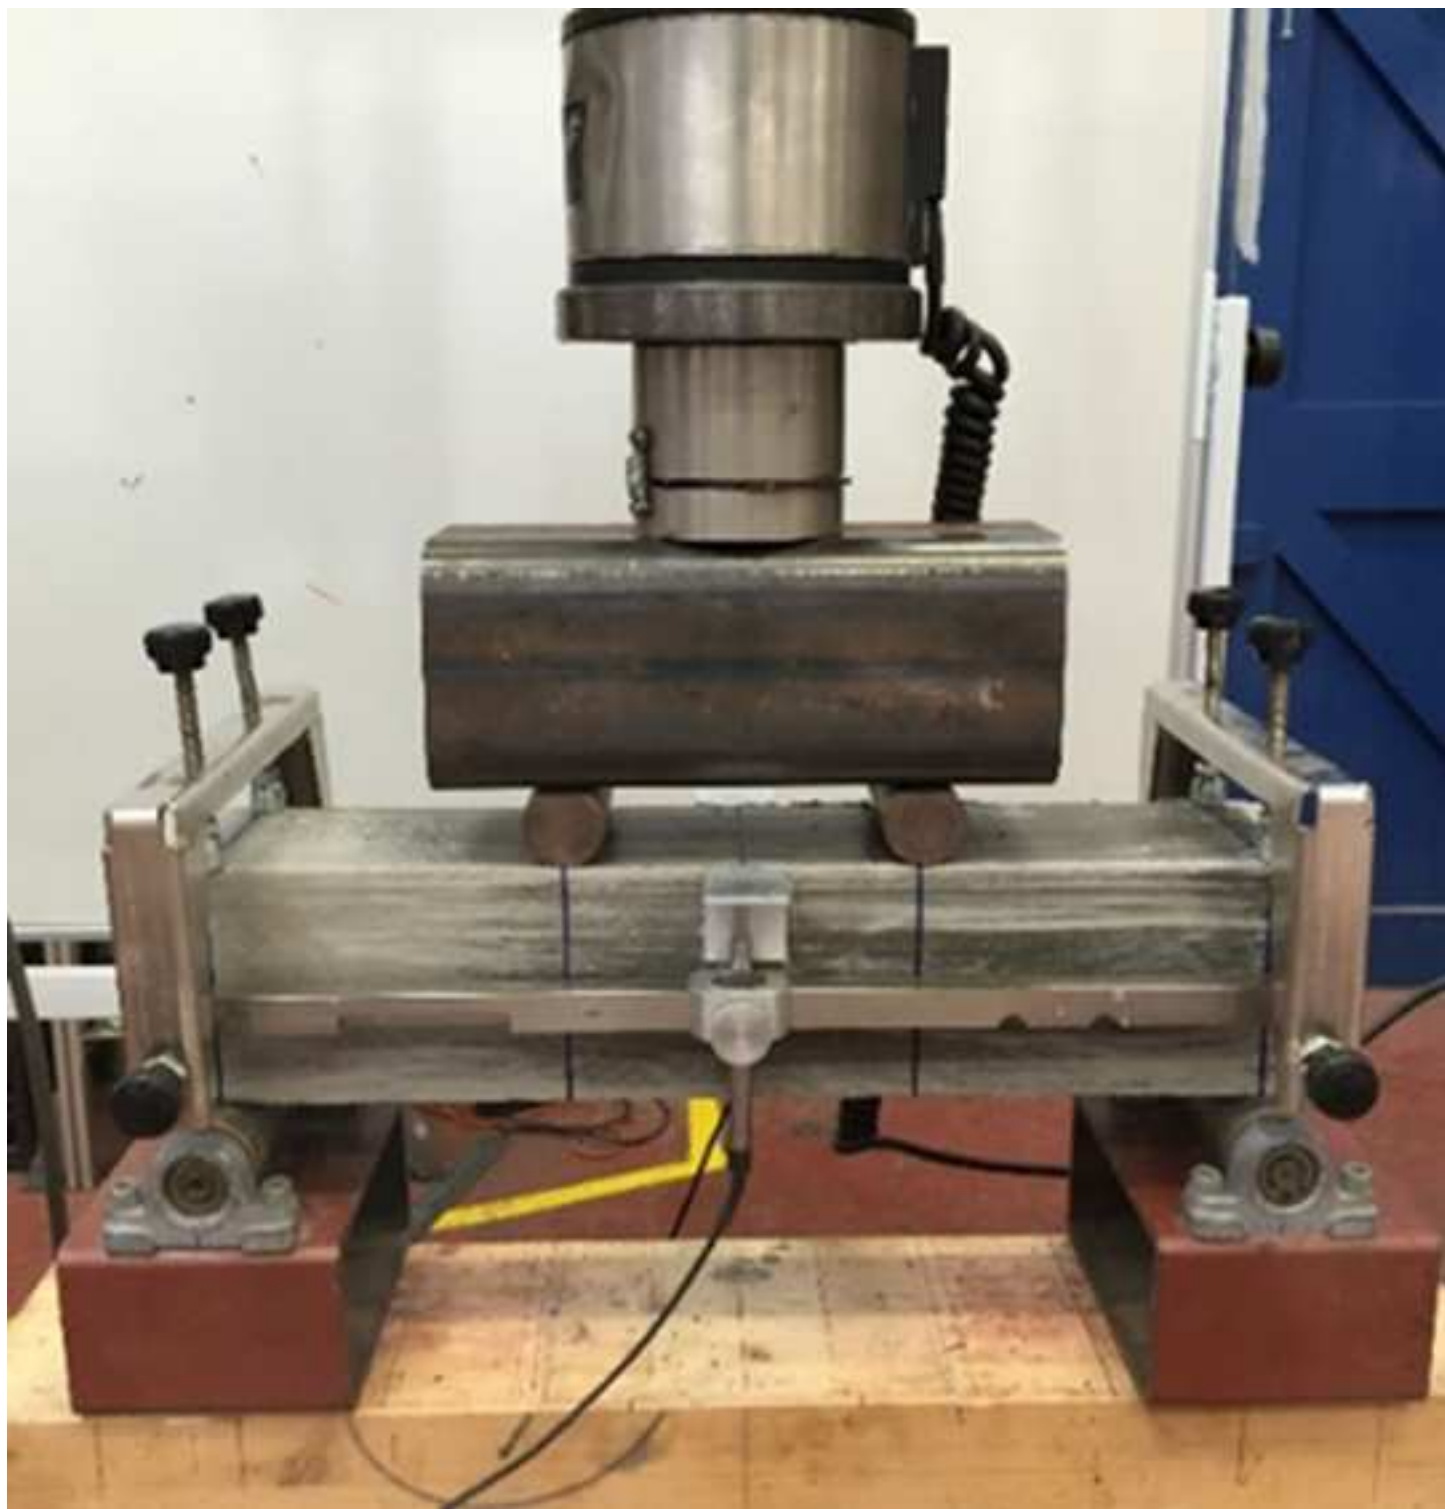
Fig. 1b  
[Click here to download high resolution image](#)

**Figure 1.** Testing set up; **a)** direct tensile test and **b)** flexural strength test.

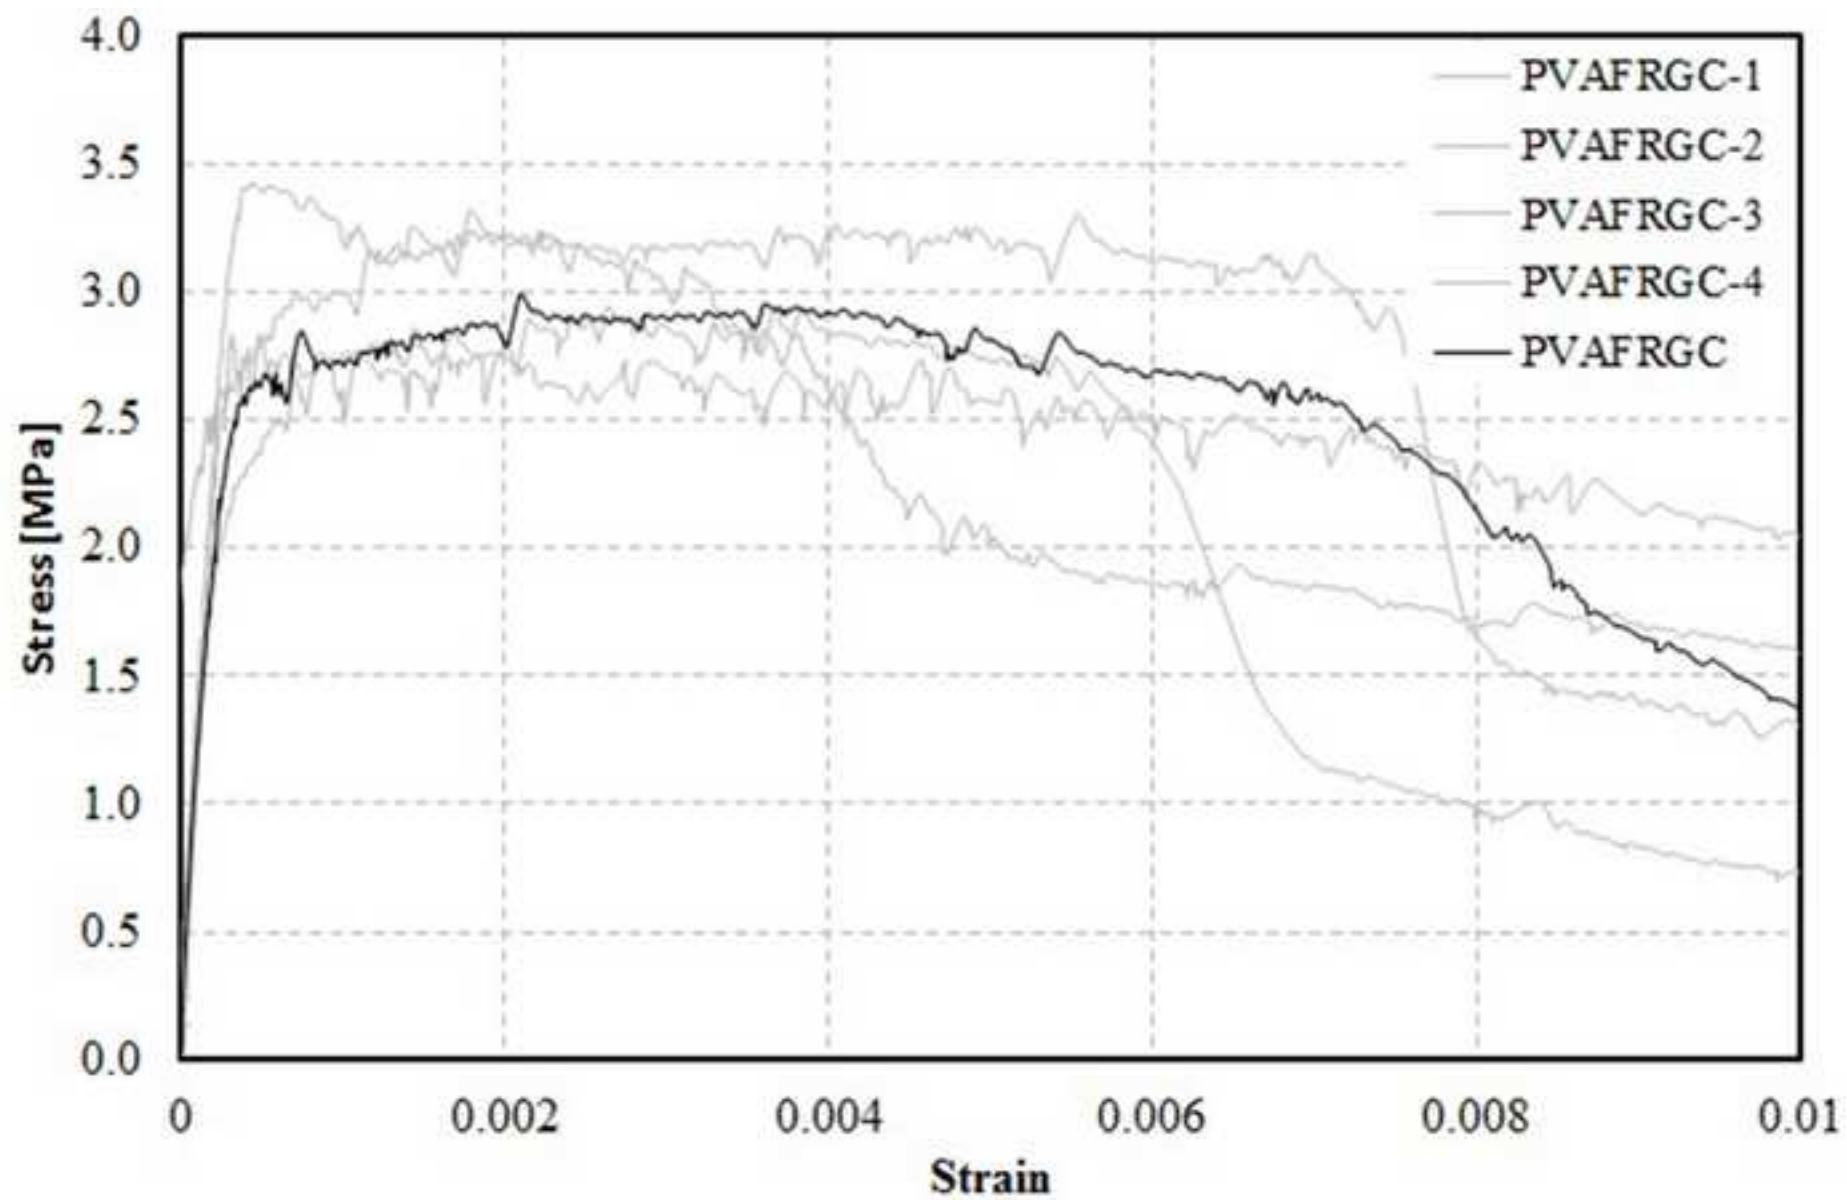
Fig. 2a  
[Click here to download high resolution image](#)

An average stress–strain curve was calculated and the average strength was found equal to 3 MPa (Figure 2a). This strength value refers to the ultimate tensile strength of the material obtained by the direct tensile (dog-bone) tests which occurs at a strain approximately equal to 0.004, a value which varies for the various examined specimens since there is a quite significant plateau where the ultimate stress remains almost constant (Figure 2a). The maximum stress value is similar to the tensile strength of conventional mortars, however PVAFRGC shows significantly enhanced stress-strain hardening characteristics as opposed to conventional mortars which are characterised by brittle behaviour. The Young's modulus was experimentally obtained from the slope of the initial linear part of the stress–strain graph and a value of 25 GPa was calculated. The experimental results in Figure 2b indicate strain hardening behaviour as the second peak load is greater than that at the first cracking load, and there is a large deflection gap between first and second peak loads. The load deflection curve further showed that after initial cracking, load increased with deflection with a low slope due to the fibre bridging action at the interface of cracks, up to the point at which slip between the fibres and matrix occurred. After this stage, the maximum load was achieved which was then followed by tension softening and load reduction which is attributed to crack opening, which is significantly increased at this stage. The enhanced strain hardening characteristics of the material, which are clearly illustrated in the stress strain (Figure 2a) and load-deflection (Figure 2b) curves, is attributed to the strong bonds between the PVA fibres and the geopolymer matrix [14, 23].

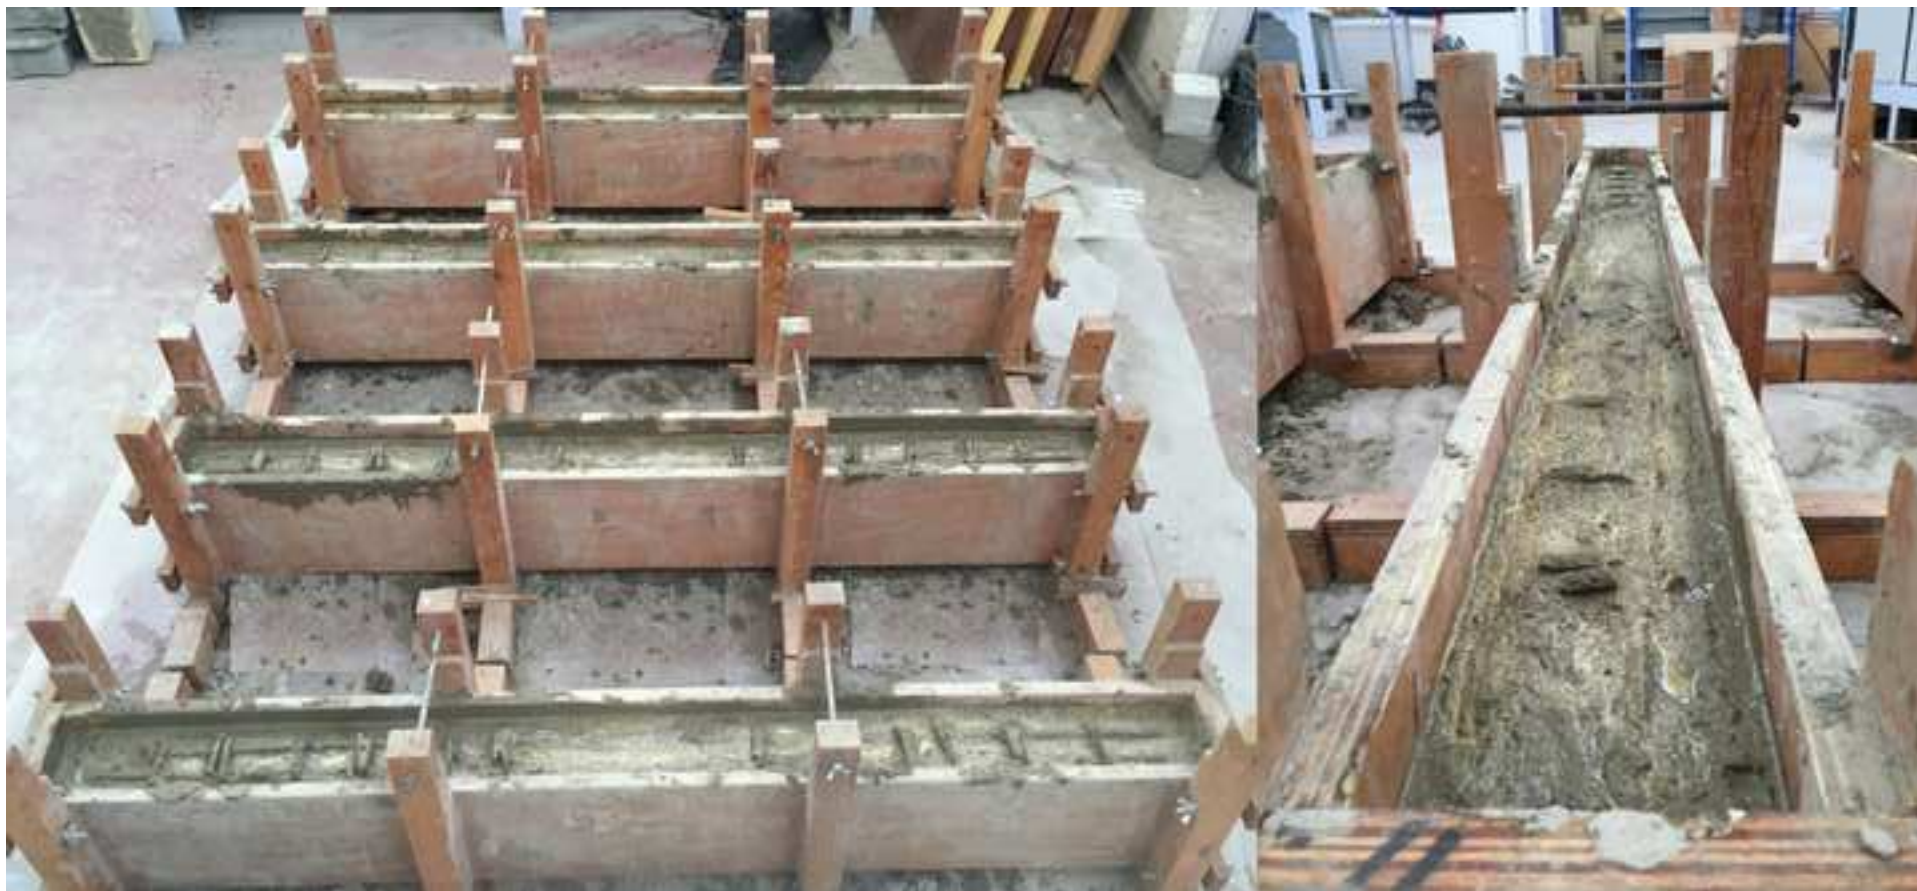
Fig. 4

**Figure 4.** Casting the substrate RC beams for repair purposes.

The RC beams with ordinary concrete were cast in a wooden mould up to 150 mm and 175 mm depths for PVAFRGC-50R and PVAFRGC-25R, respectively (Figure 4). Then the specimens were demoulded after 2 days and left to mature for 3 months. Since the concrete cover of deteriorated RC beams must be removed before the surface coating or the repair material is applied on actual deteriorated structures, in this study FRGC was overlaid on RC beams without initial deterioration of the reinforcement bars. The exposed steel reinforcements were cleaned using a steel brush (Figure 5), and an air chipping hammer was used for roughening the concrete surfaces followed by washing with a high-pressure water-jet to clean the surface of dust and to remove the weak layer of dry cement paste and loose aggregate. After 3 months, a 25mm or 50mm layer of PVAFRGC was cast directly on the concrete beam surface by overturning the RC beam upside down (Figure 6) in order to have repaired specimens with identical cross section with the control specimens (100 x 200 mm), which facilitates direct comparisons of the experimental results. The repaired thicknesses of 25 mm and 50 mm (Figure 7) correspond to the waterproofing layer of structural elements [37]. Since the curing of PVAFRGC was carried out at ambient temperature and humidity, a plastic sheet was placed on the surface in order to limit water evaporation.

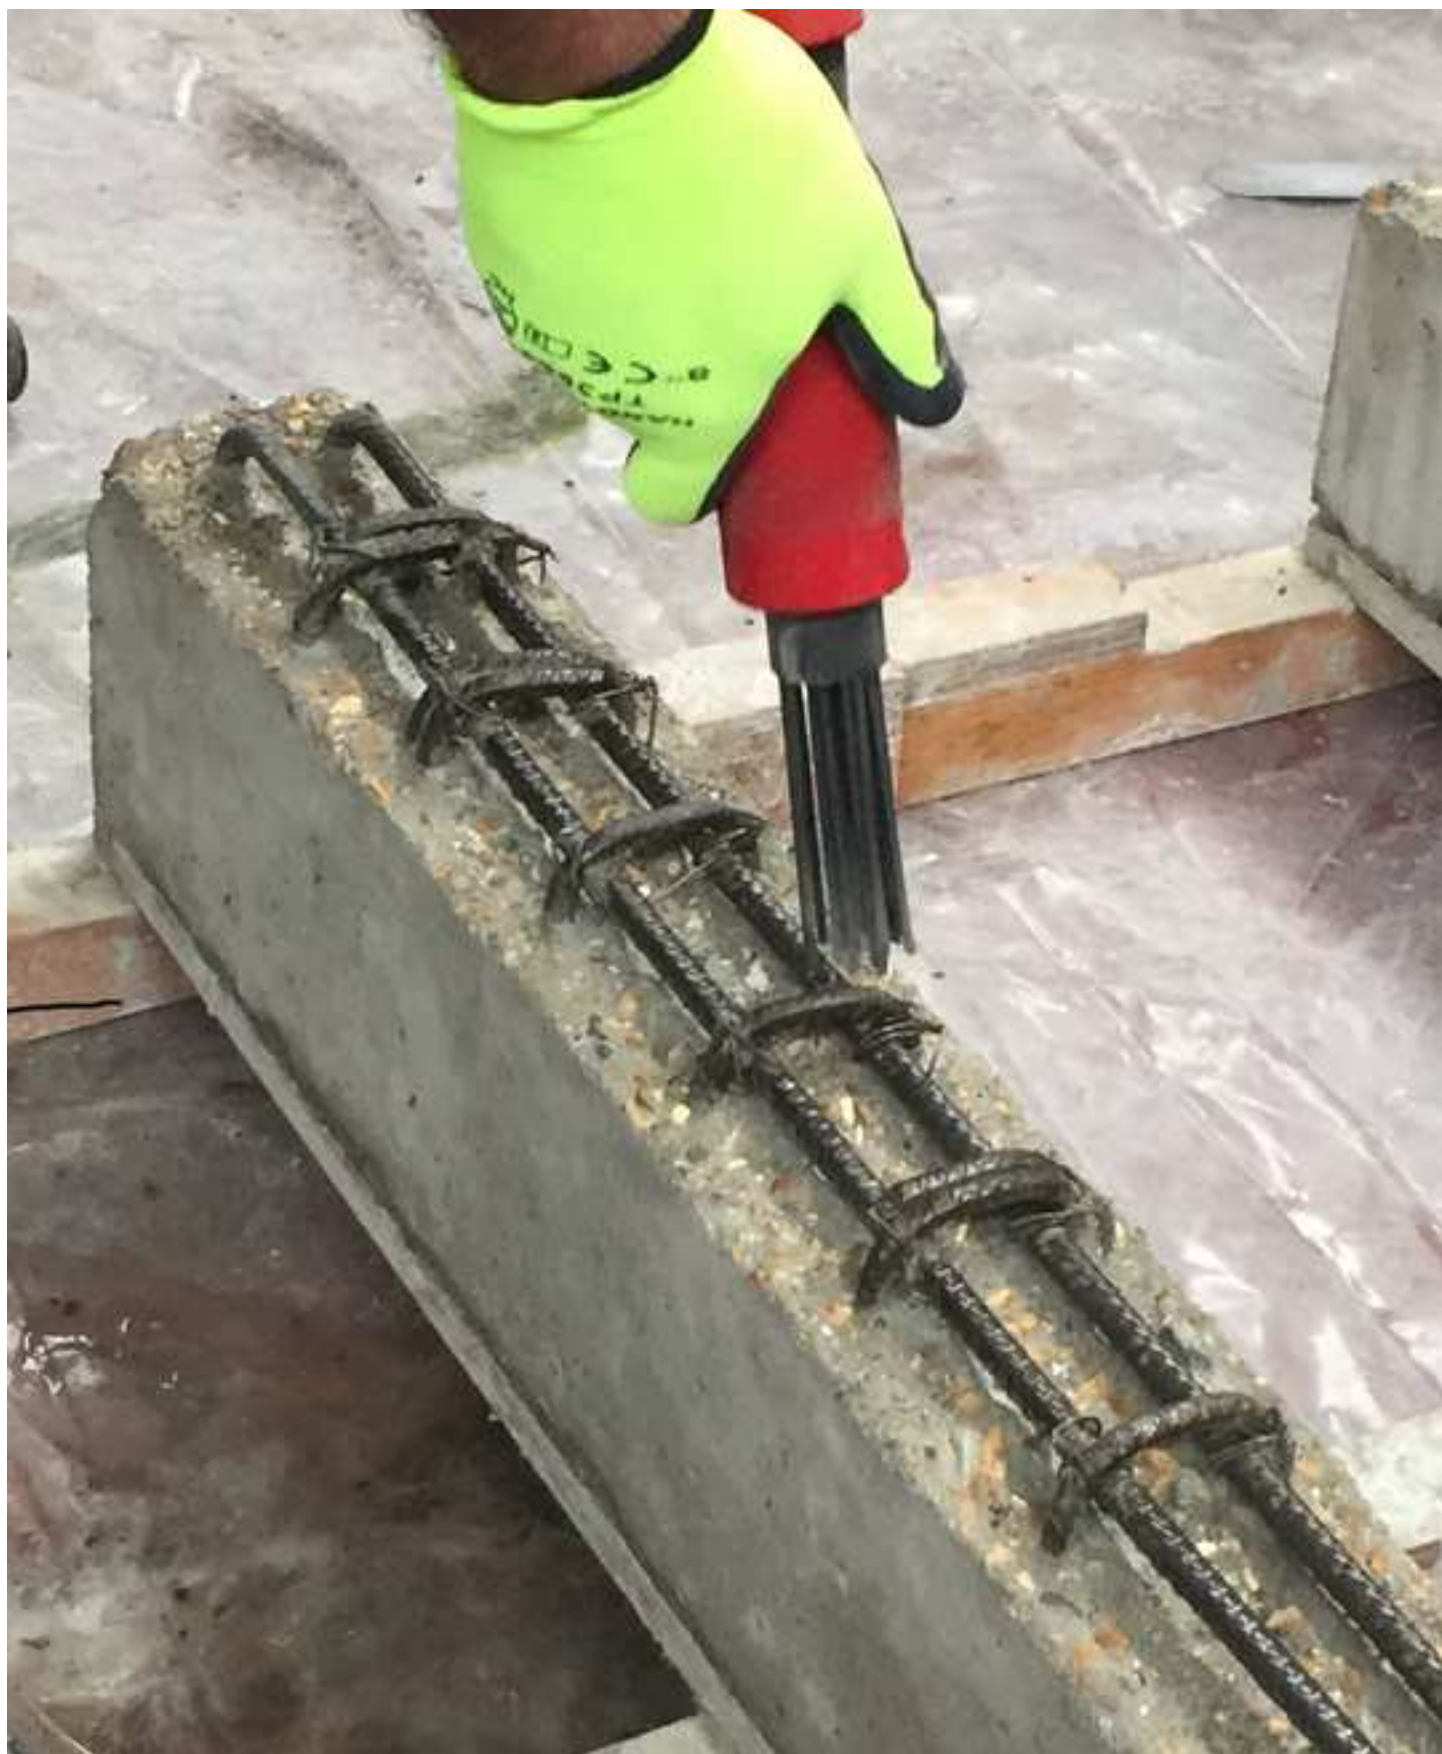
Fig. 5a  
[Click here to download high resolution image](#)

**Figure 5.** Preparation of the concrete surface; **a)** Roughening the concrete surface, and **b)** cleaning the reinforcement steel.

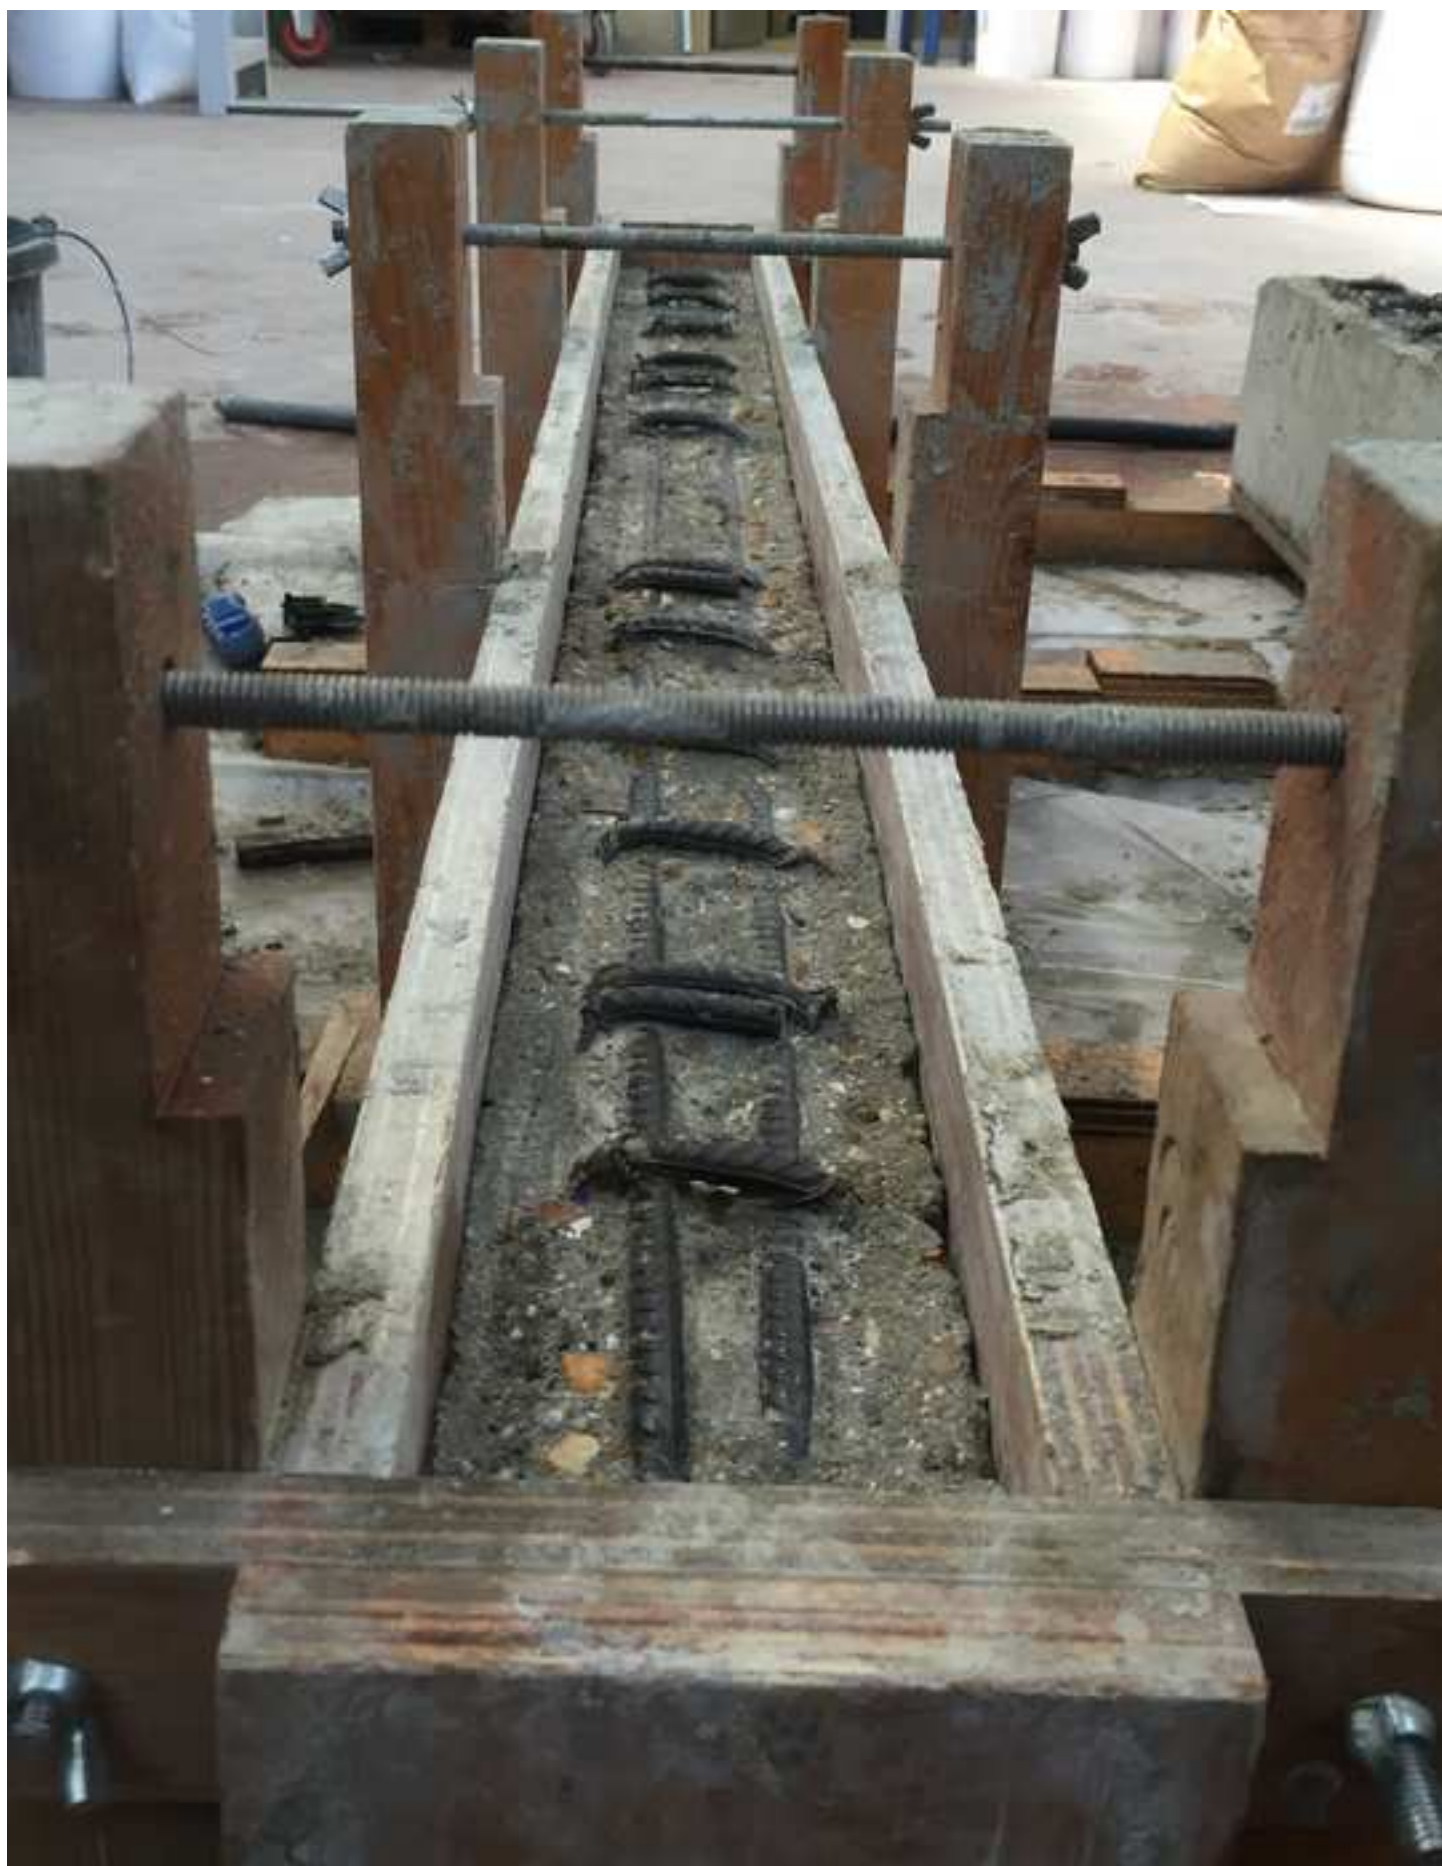
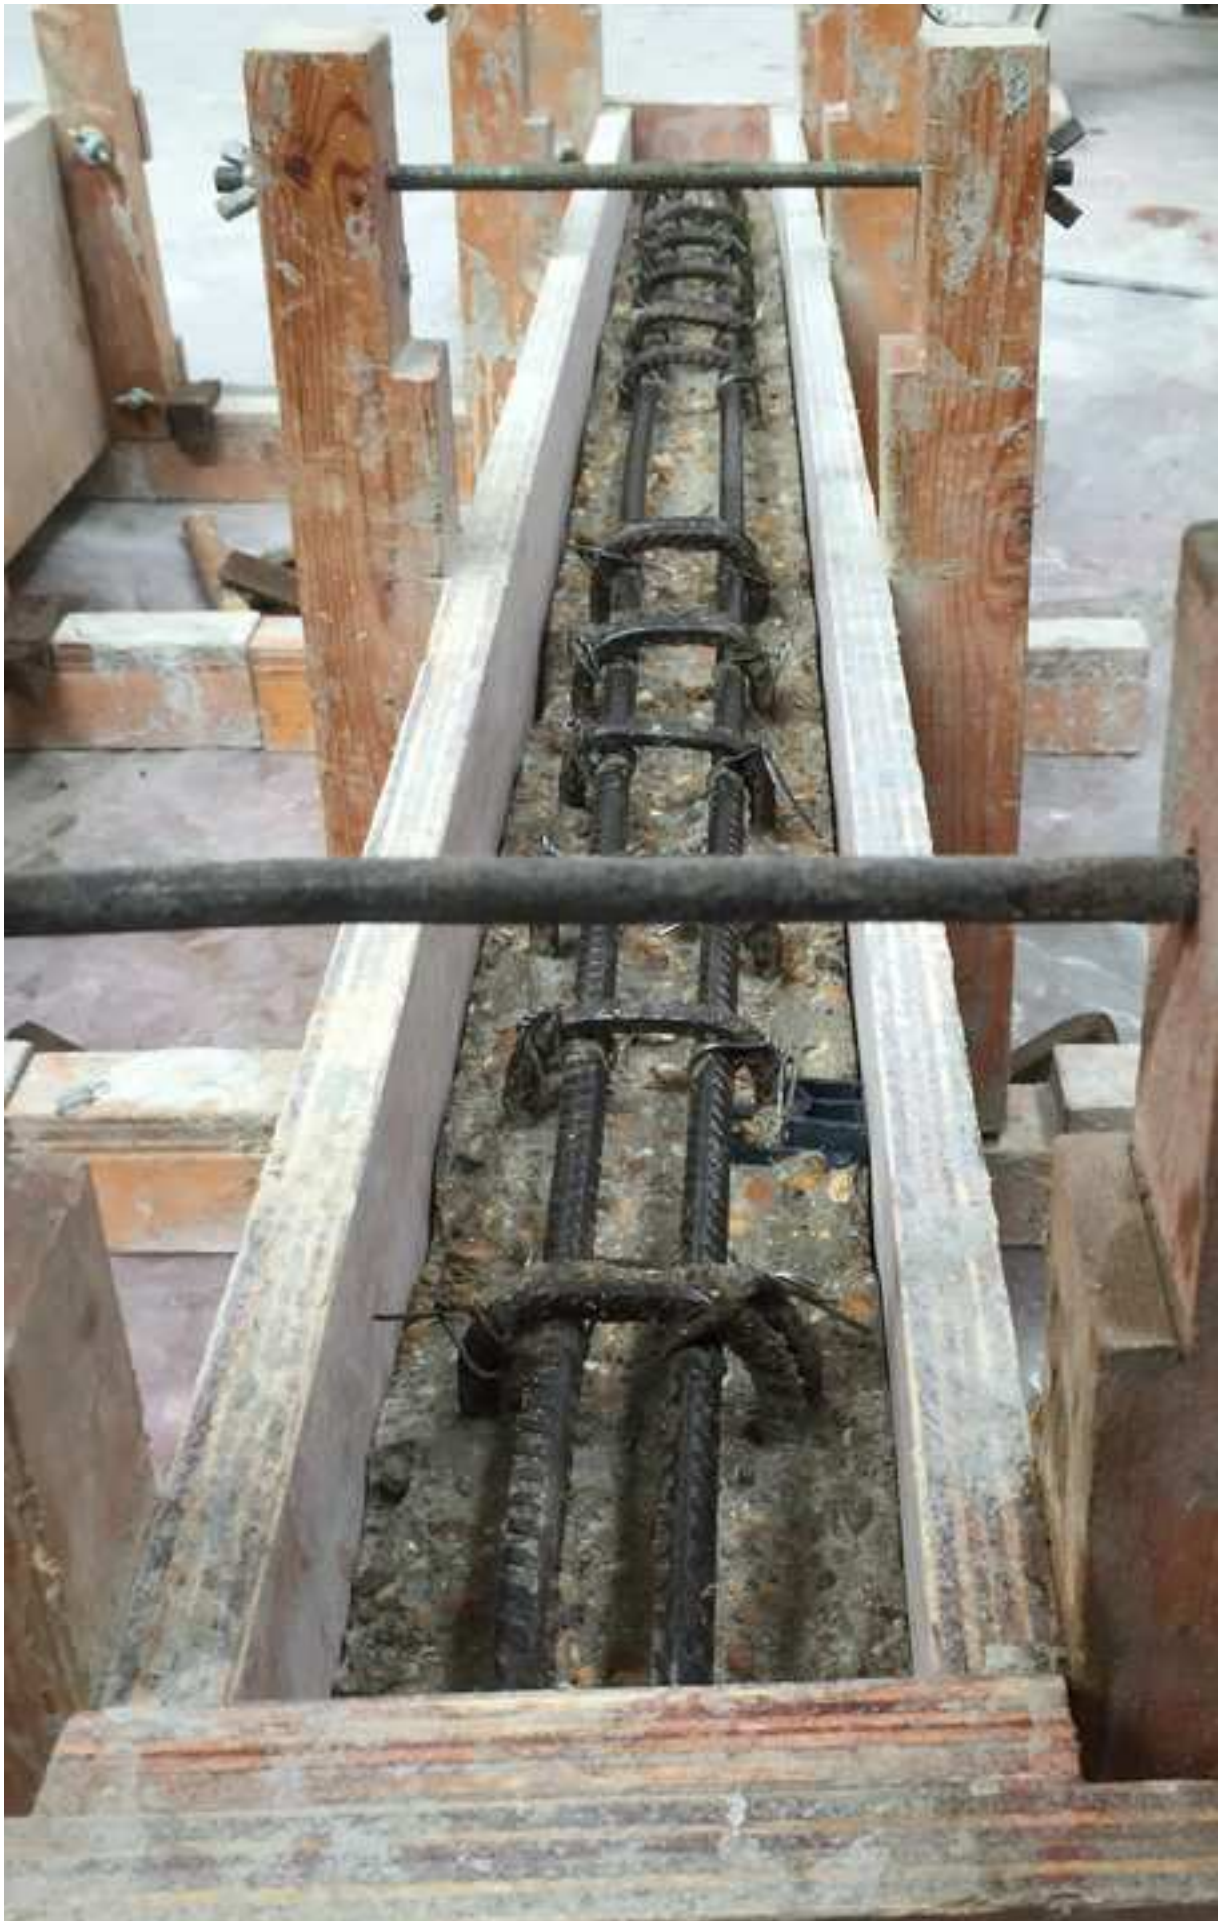
Fig. 6a  
[Click here to download high resolution image](#)

**Figure 6.** **a)** Initial beams ready for casting the repair layer at 25 mm thickness and **b)** 50 mm layer thickness.

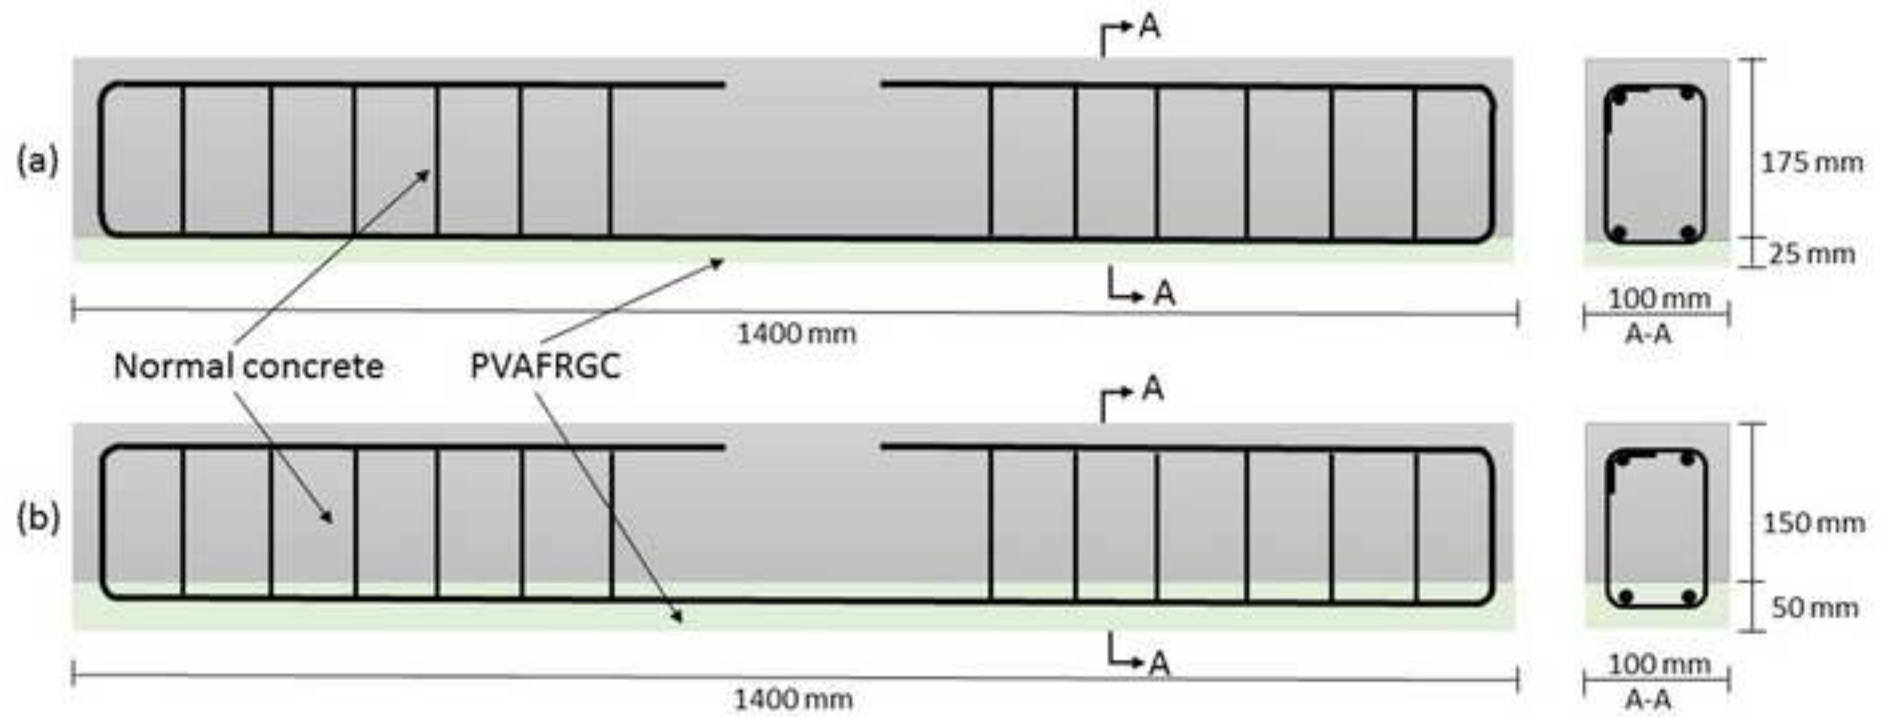
Fig. 7

**Figure 7.** Schematic diagram of repair technique.

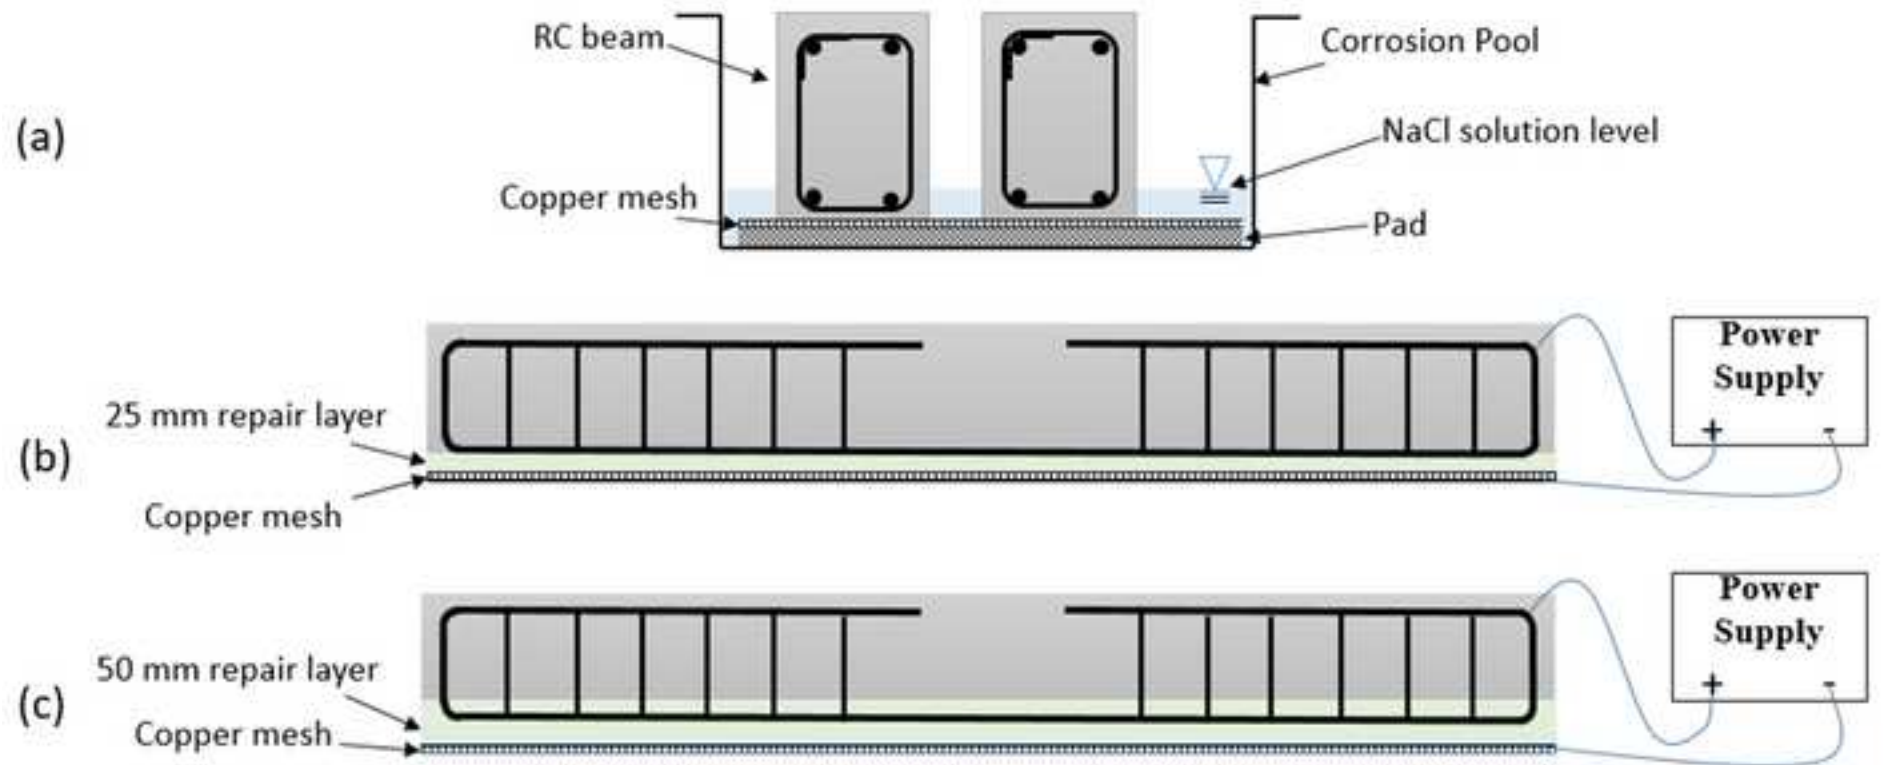
Fig. 8

**Figure 8.** Accelerated corrosion system; **a)** Schematic diagram of corrosion pool; **b)** 25 mm repair layer and **c)** 50 mm repair layer.

An induced accelerated corrosion test was employed to simulate the corrosion of steel reinforcement in concrete (Figure 8). Six RC beams were corroded by an accelerated corrosion system, and six specimens were left un-corroded to act as reference beams (Table 3). RC beams were first immersed in a 5% sodium chloride solution which was placed up to a 5cm height from the bottom side of the beams (Figure 8). The corrosion process was then accelerated by applying a constant current of 300 mA for 90 days between the reinforcement bar (anode) and a copper mesh (cathode) at the bottom surface of the container connected to the negative terminal of the DC power supply, as shown in Figure 9.
