## **A novel corrosion resistant repair technique for existing Reinforced Concrete (RC) elements using Polyvinyl Alcohol Fibre Reinforced Geopolymer Concrete (PVAFRGC)**

**Keywords**; corrosion resistance; fibre reinforced geopolymer concrete; repair material; reinforced concrete beams.

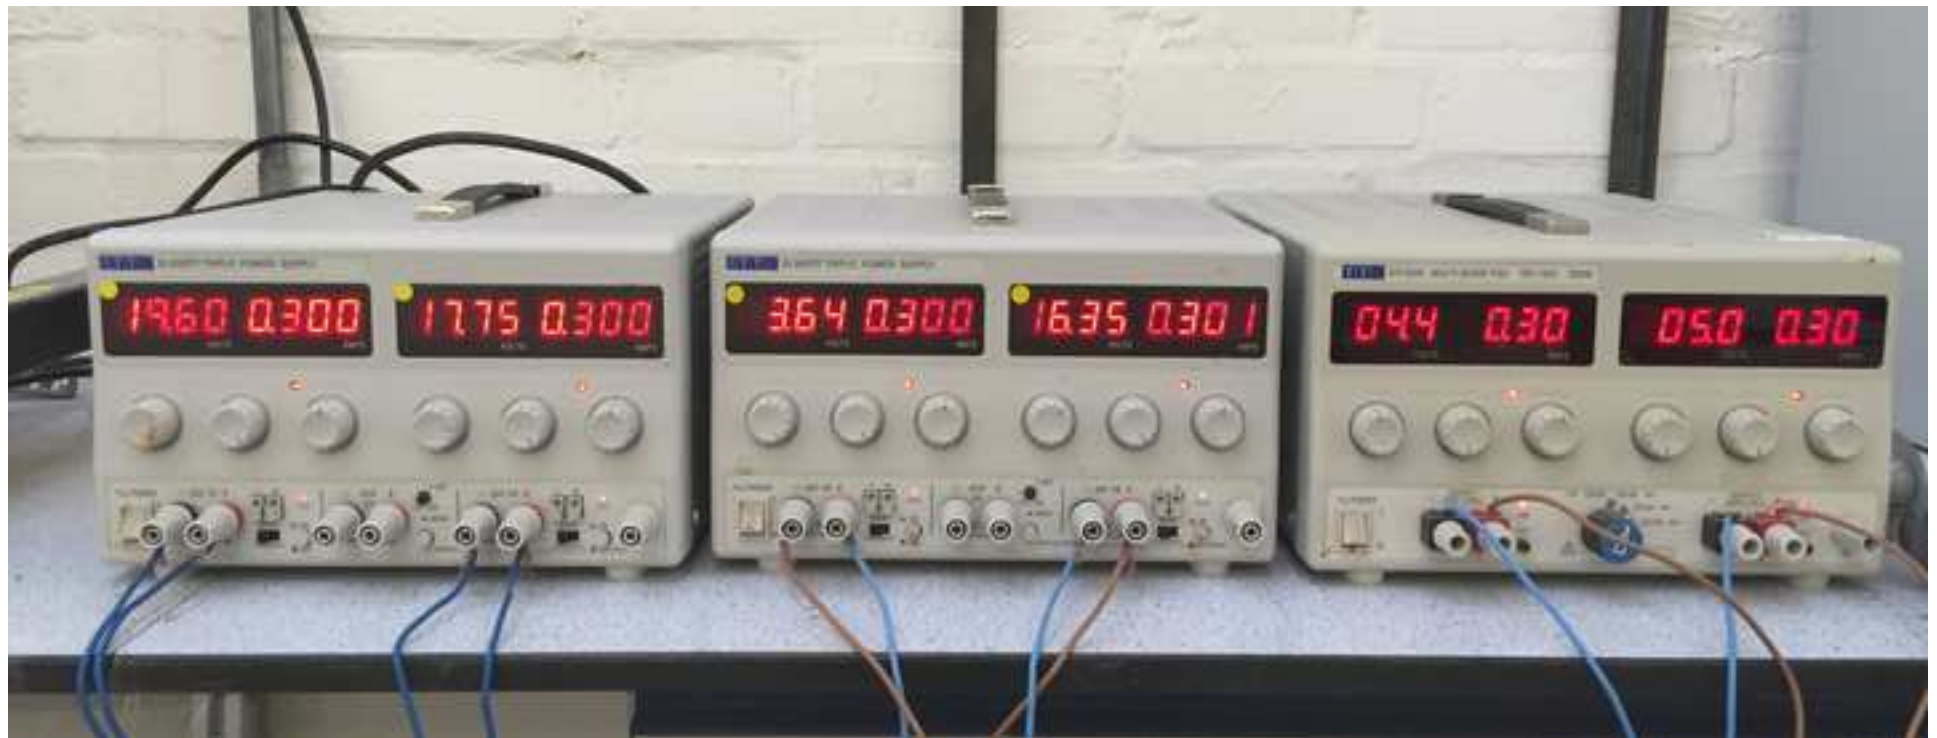
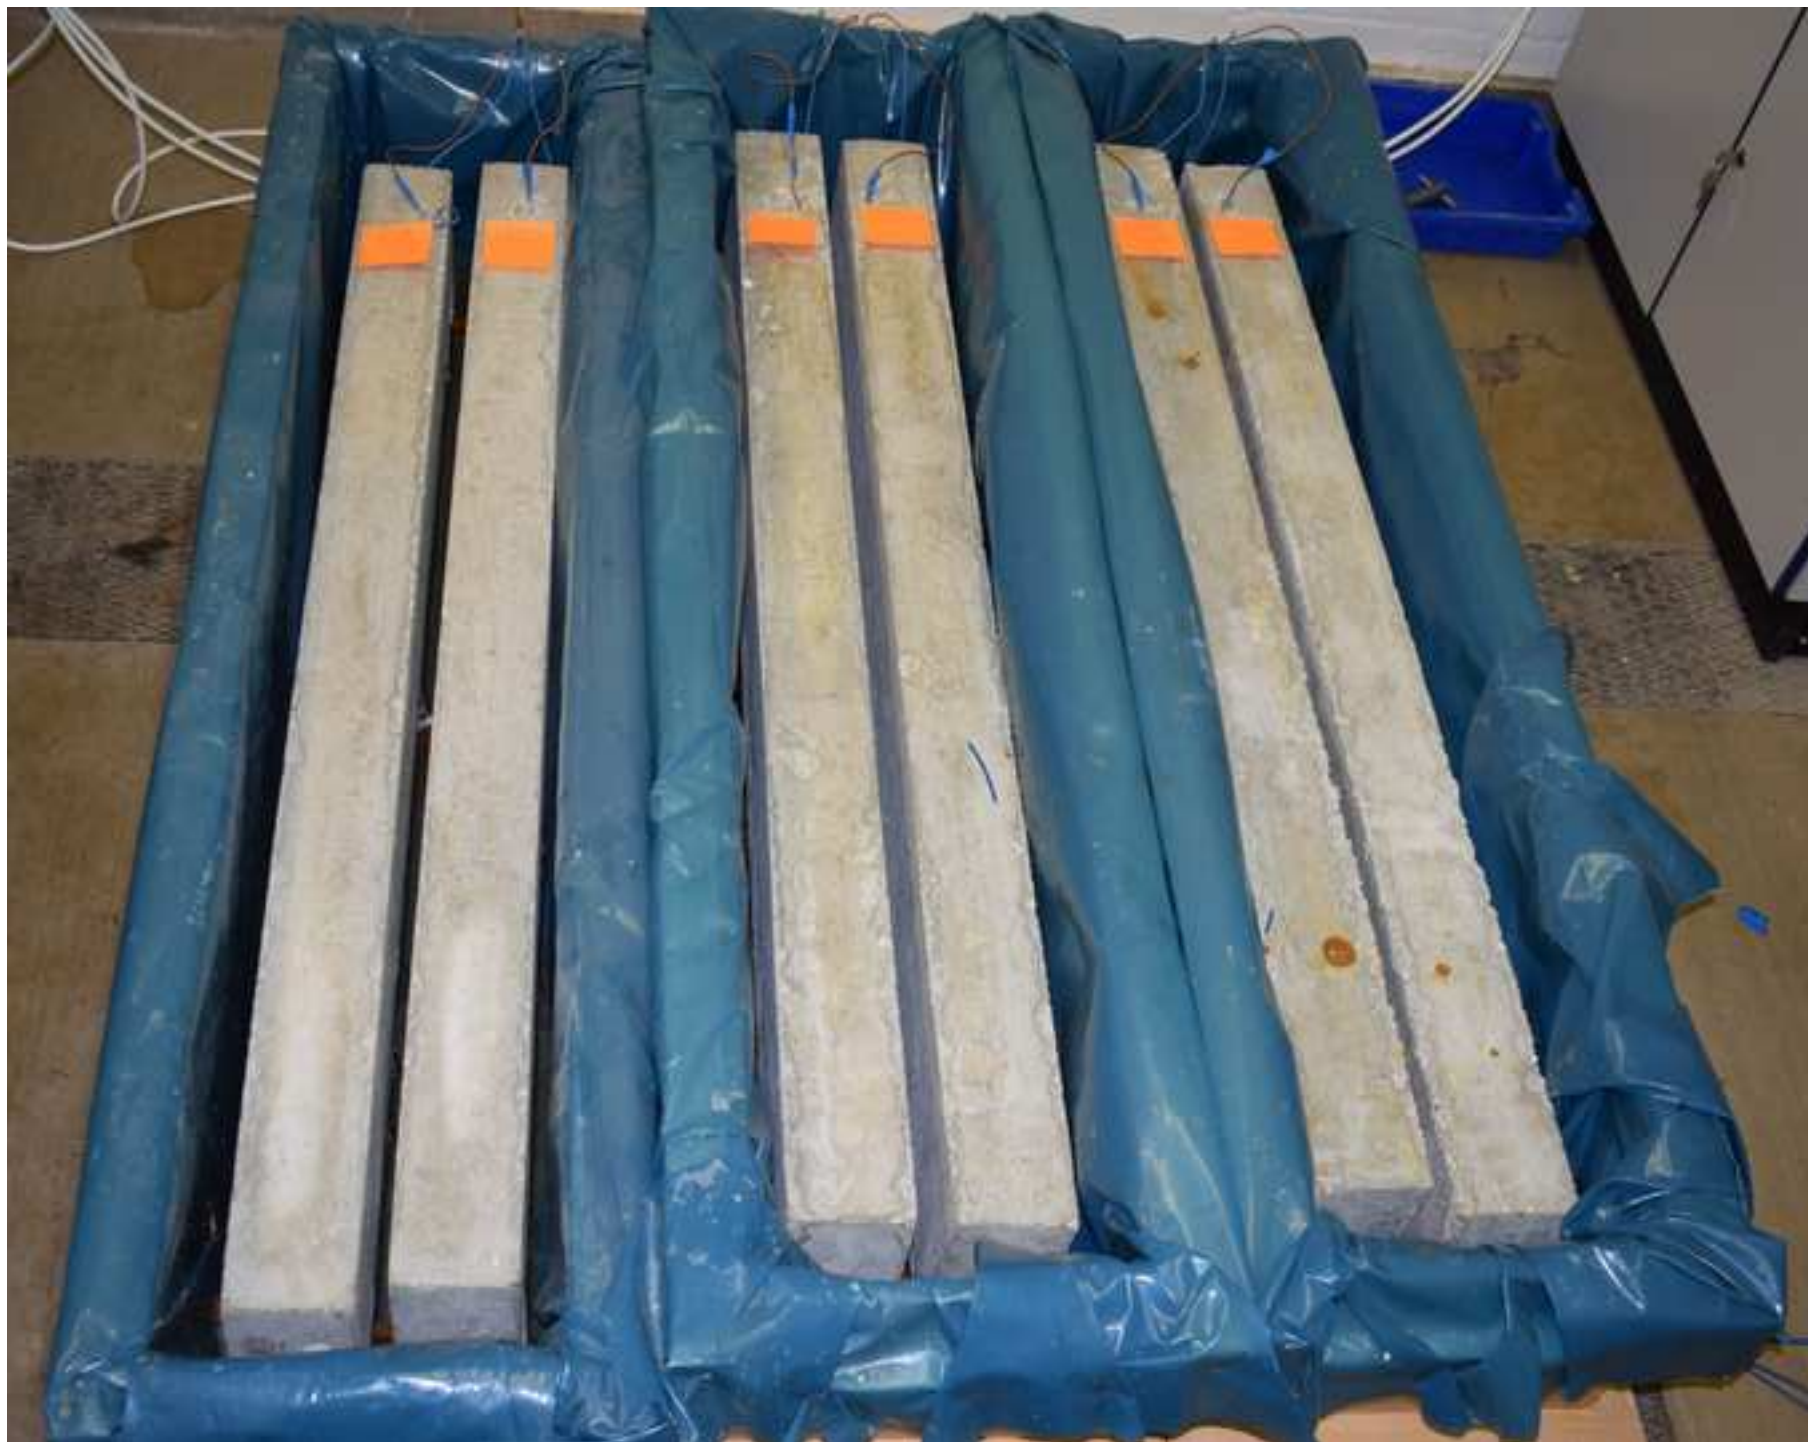
Fig. 9a

**Figure 9.** Set-up for accelerating reinforcement corrosion in RC beam specimens; **a)** Power supply and **b)** specimens under the accelerated corrosion process.

An induced accelerated corrosion test was employed to simulate the corrosion of steel reinforcement in concrete (Figure 8). Six RC beams were corroded by an accelerated corrosion system, and six specimens were left un-corroded to act as reference beams (Table 3). RC beams were first immersed in a 5% sodium chloride solution which was placed up to a 5cm height from the bottom side of the beams (Figure 8). The corrosion process was then accelerated by applying a constant current of 300 mA for 90 days between the reinforcement bar (anode) and a copper mesh (cathode) at the bottom surface of the container connected to the negative terminal of the DC power supply, as shown in Figure 9.

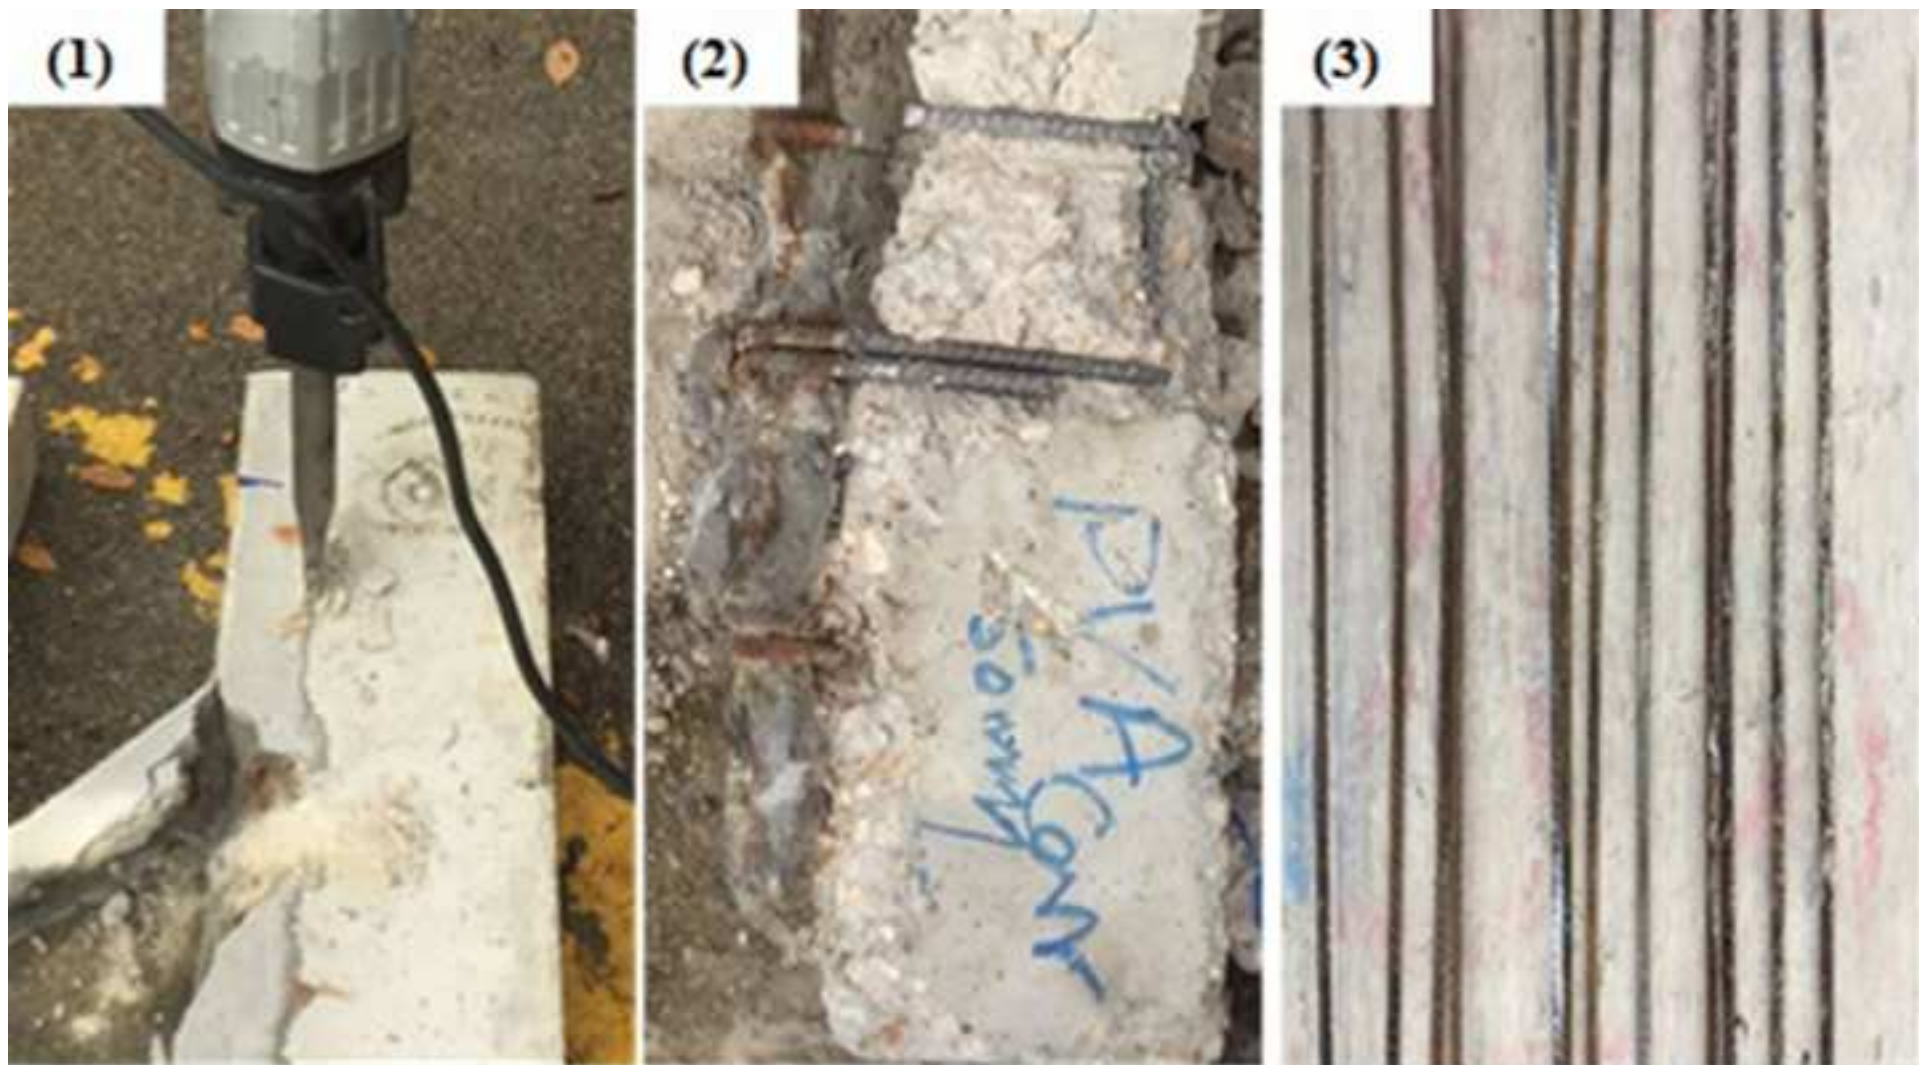
Fig. 10  
[Click here to download high resolution image](#)

**Figure 10.** Stages of removal and cleaning of corroded steel coupons.

After testing of the RC beams to failure, coupons of corroded steel reinforcement were removed from the tested beams to evaluate the mass loss of steel at the end of corrosion exposure. To remove the corrosion products from the steel, a number of chemical, mechanical and electrolytic techniques are described in the ASTM Standard G1-90. To ensure that the steel bar was free from any adhering corrosion products the rusted steel bars

were mechanically cleaned using a stiff metal brush. Stages of removal and cleaning of the corroded steel coupons are shown in Figure 10. The reinforcing bar was then weighed and the percentage mass loss was calculated using Eq. (2).

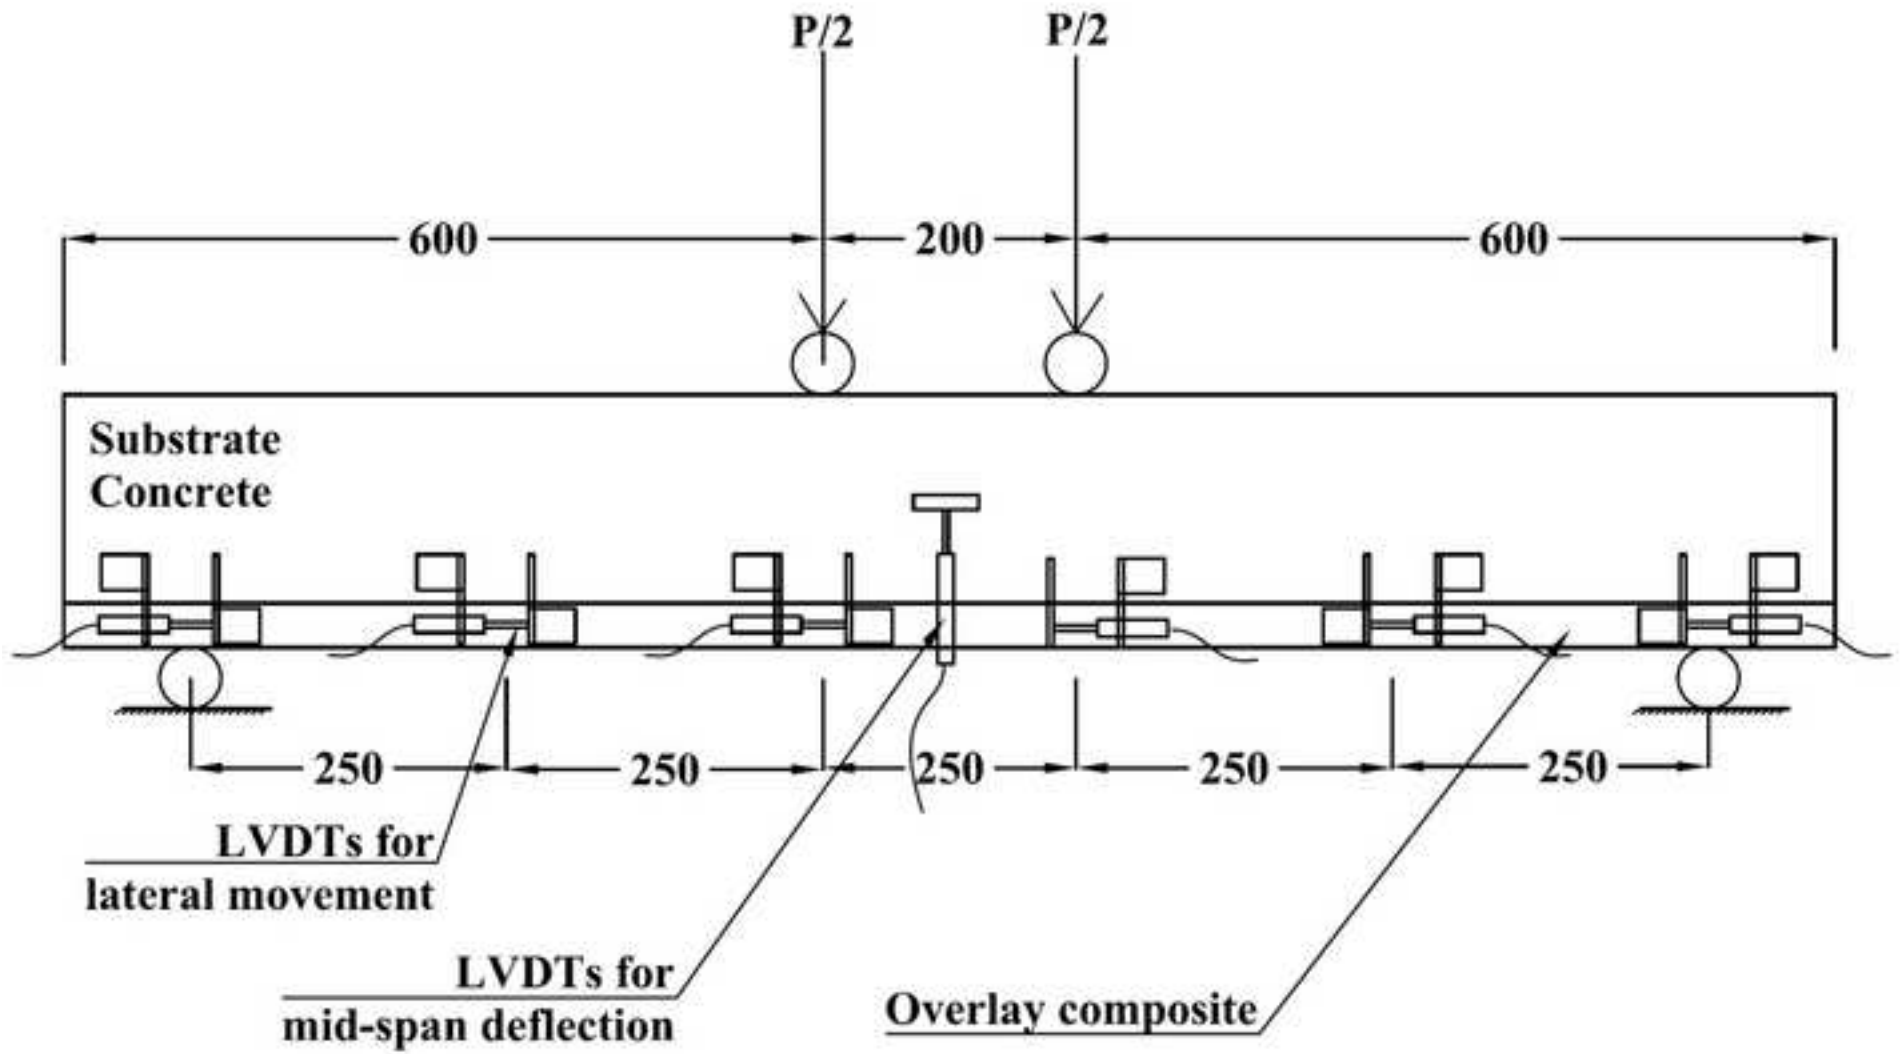
Fig. 11

All tested specimens (initial and repaired RC beams) were loaded under four-point bending with an imposed deflection rate of 0.004 mm/s (with an effective span equal to 1200 mm) using a Zwick testing machine (Figure 11). The displacement of the specimens was measured using Linear Variable Displacement Transducers (LVDT) placed at the centre of the specimen on each side. The results observed include the mode of failure, load carrying capacity and slipping at the interface.

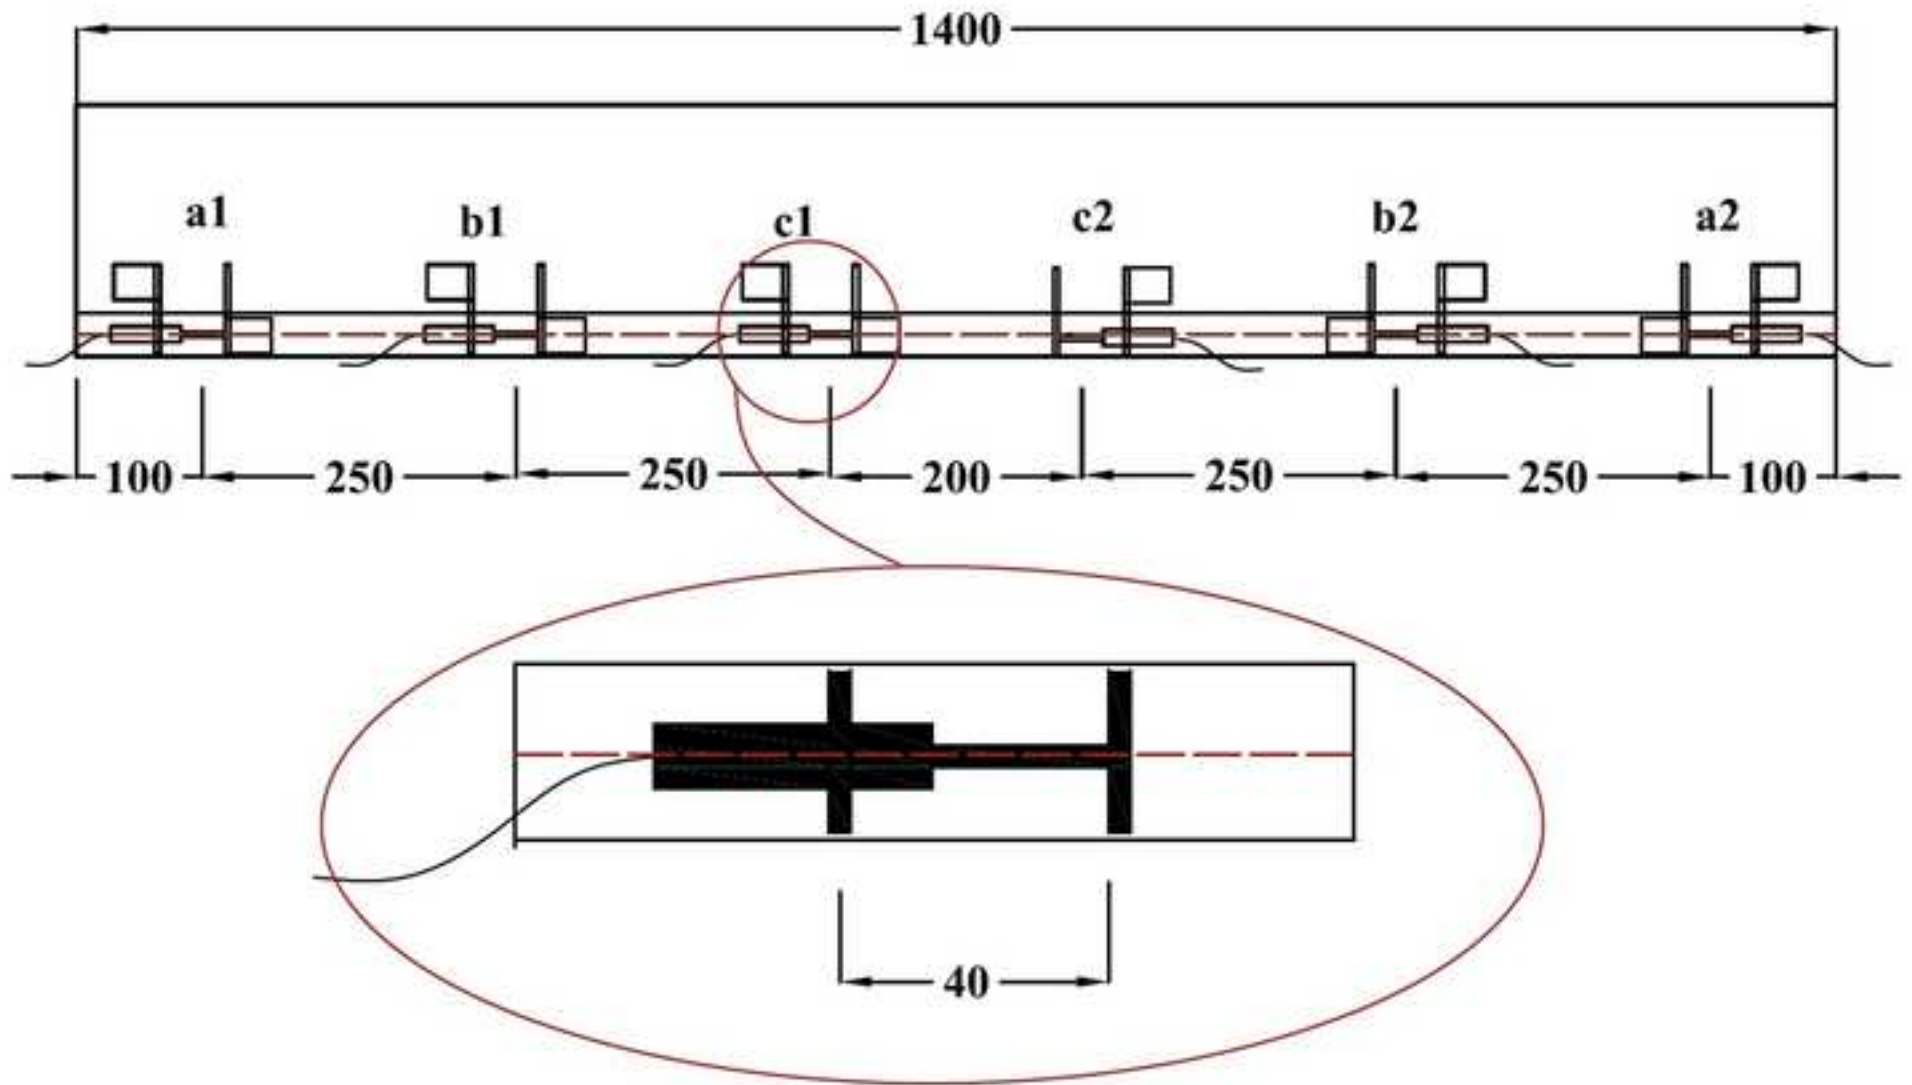
Fig. 12  
[Click here to download high resolution image](#)

**Figure 12.** Strain gauges layout (all dimensions in mm).

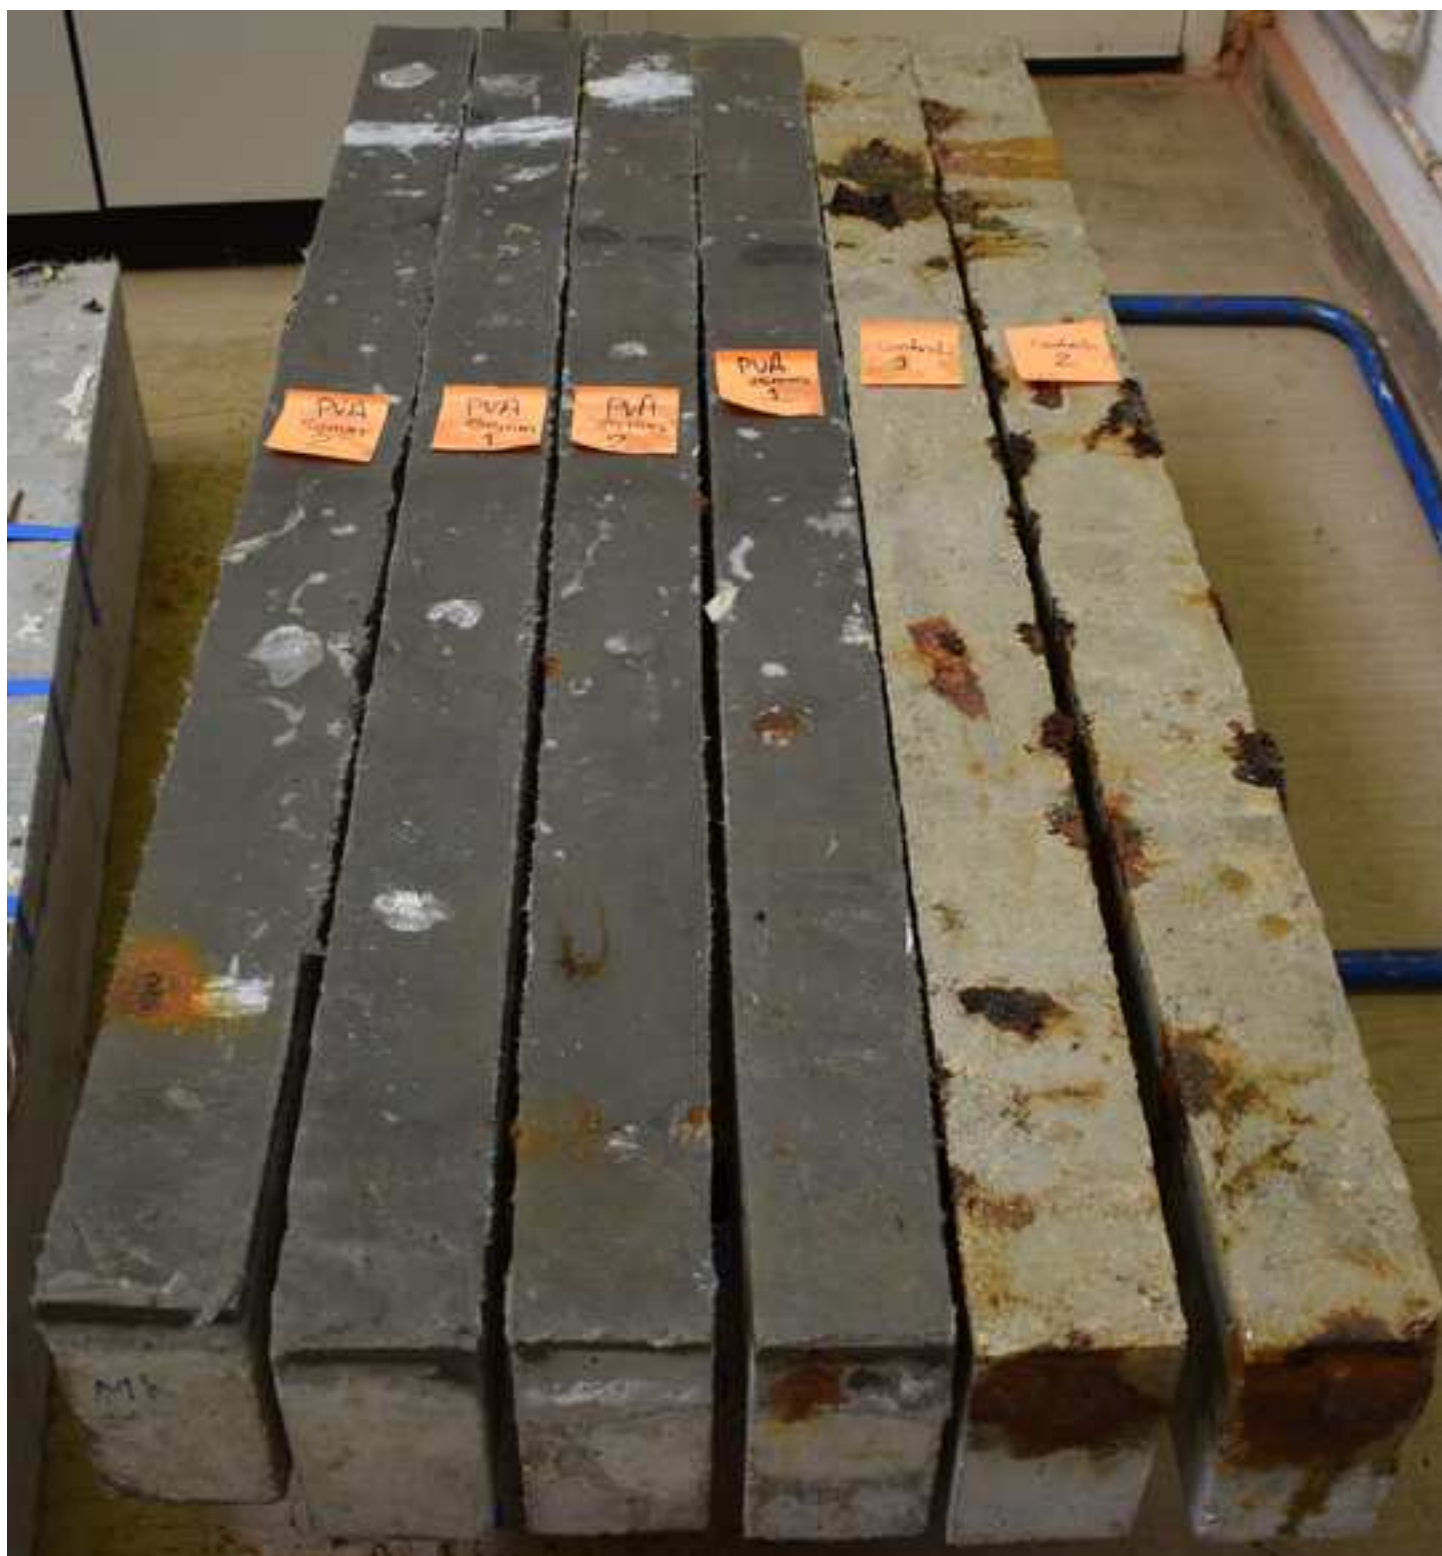
Fig. 14  
[Click here to download high resolution image](#)

**Figure 14.** Tensile side of the control (right) and repaired RC beams (left) after exposure to induced current corrosion.

Visual inspection of the corroded specimens showed that the control specimens had multiple corrosion stains and cracking on the tensile side. During the induced current test, it is

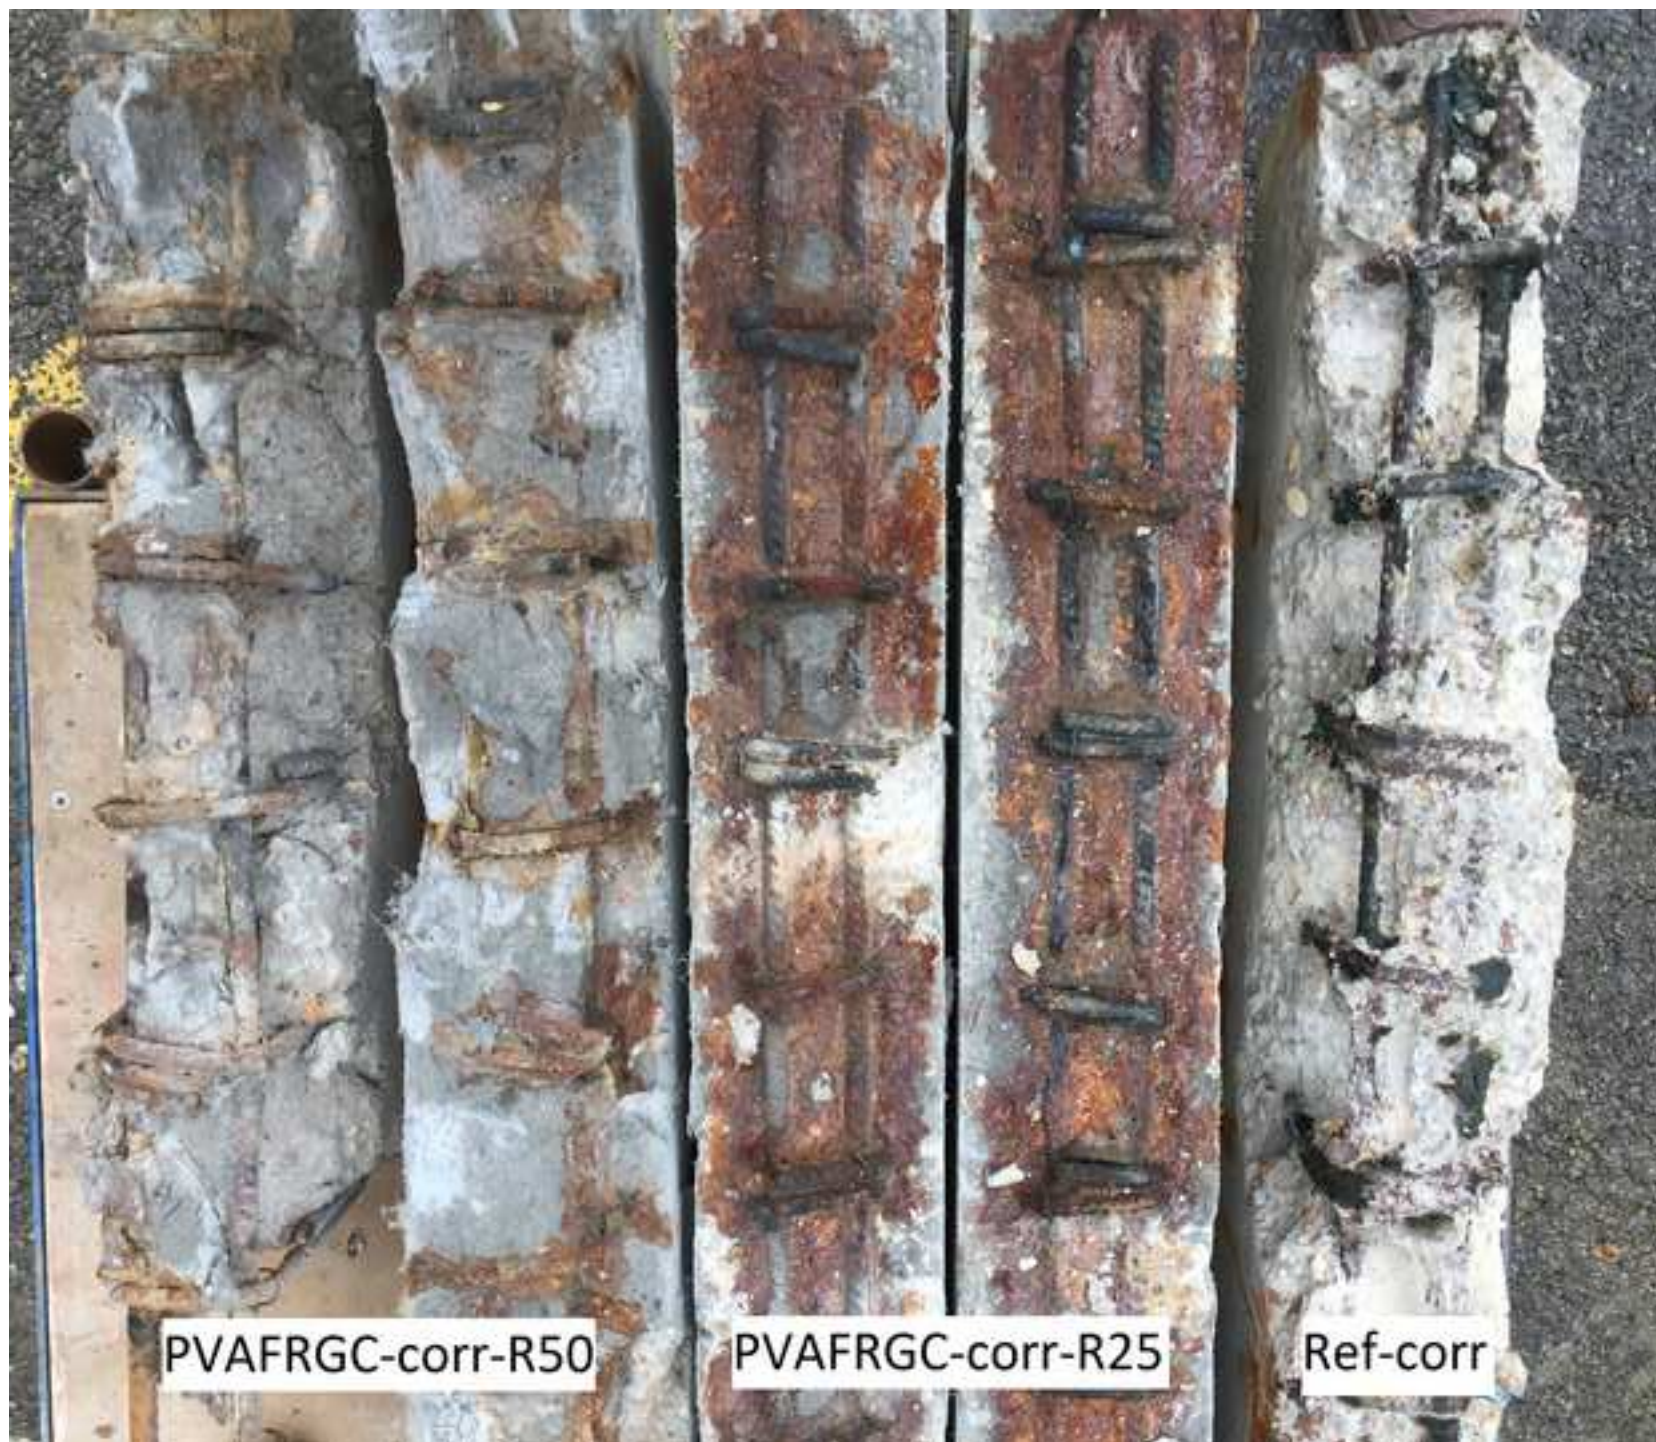
Fig. 15

**Figure 15.** The corrosion of tensile steel bears after specimen demolition – from left to right: RC beam repaired with 50 mm of PVAFRGC; RC beam repaired with 25 mm of PVAFRGC; control RC beam.

assumed that the current applied to the steel bar attracted negatively charged chloride ions from the NaCl solution into the concrete specimens, towards the positively charged reinforcements. As the chloride ions reached the steel-concrete interface above threshold concentrations, the steel surface began to corrode [5]. The expansive reaction products of the corrosion imposed tensile stresses on the conventional concrete / FRGC cover, resulting in cracking when the tensile stresses exceeded the tensile strength of the cover material. No delamination or spalling of concrete cover was observed. The RC beams repaired with PVAFRGC at different thicknesses (25 mm and 50 mm) showed small and relatively few corrosion stains on the repaired layer as shown in Figure 14. Visual inspection confirmed that the majority of the corrosion stains occurred at locations where initial hairline cracks were present, resulting from differential shrinkage. After the flexural test and removal of the overlay repair material, corrosion product stains from rusted steel bars distributed at the interfacial zone of RC beams repaired with 25 mm of PVAFRGC were more common than those for the RC beams repaired with 50 mm of PVAFRGC (Figure 15).

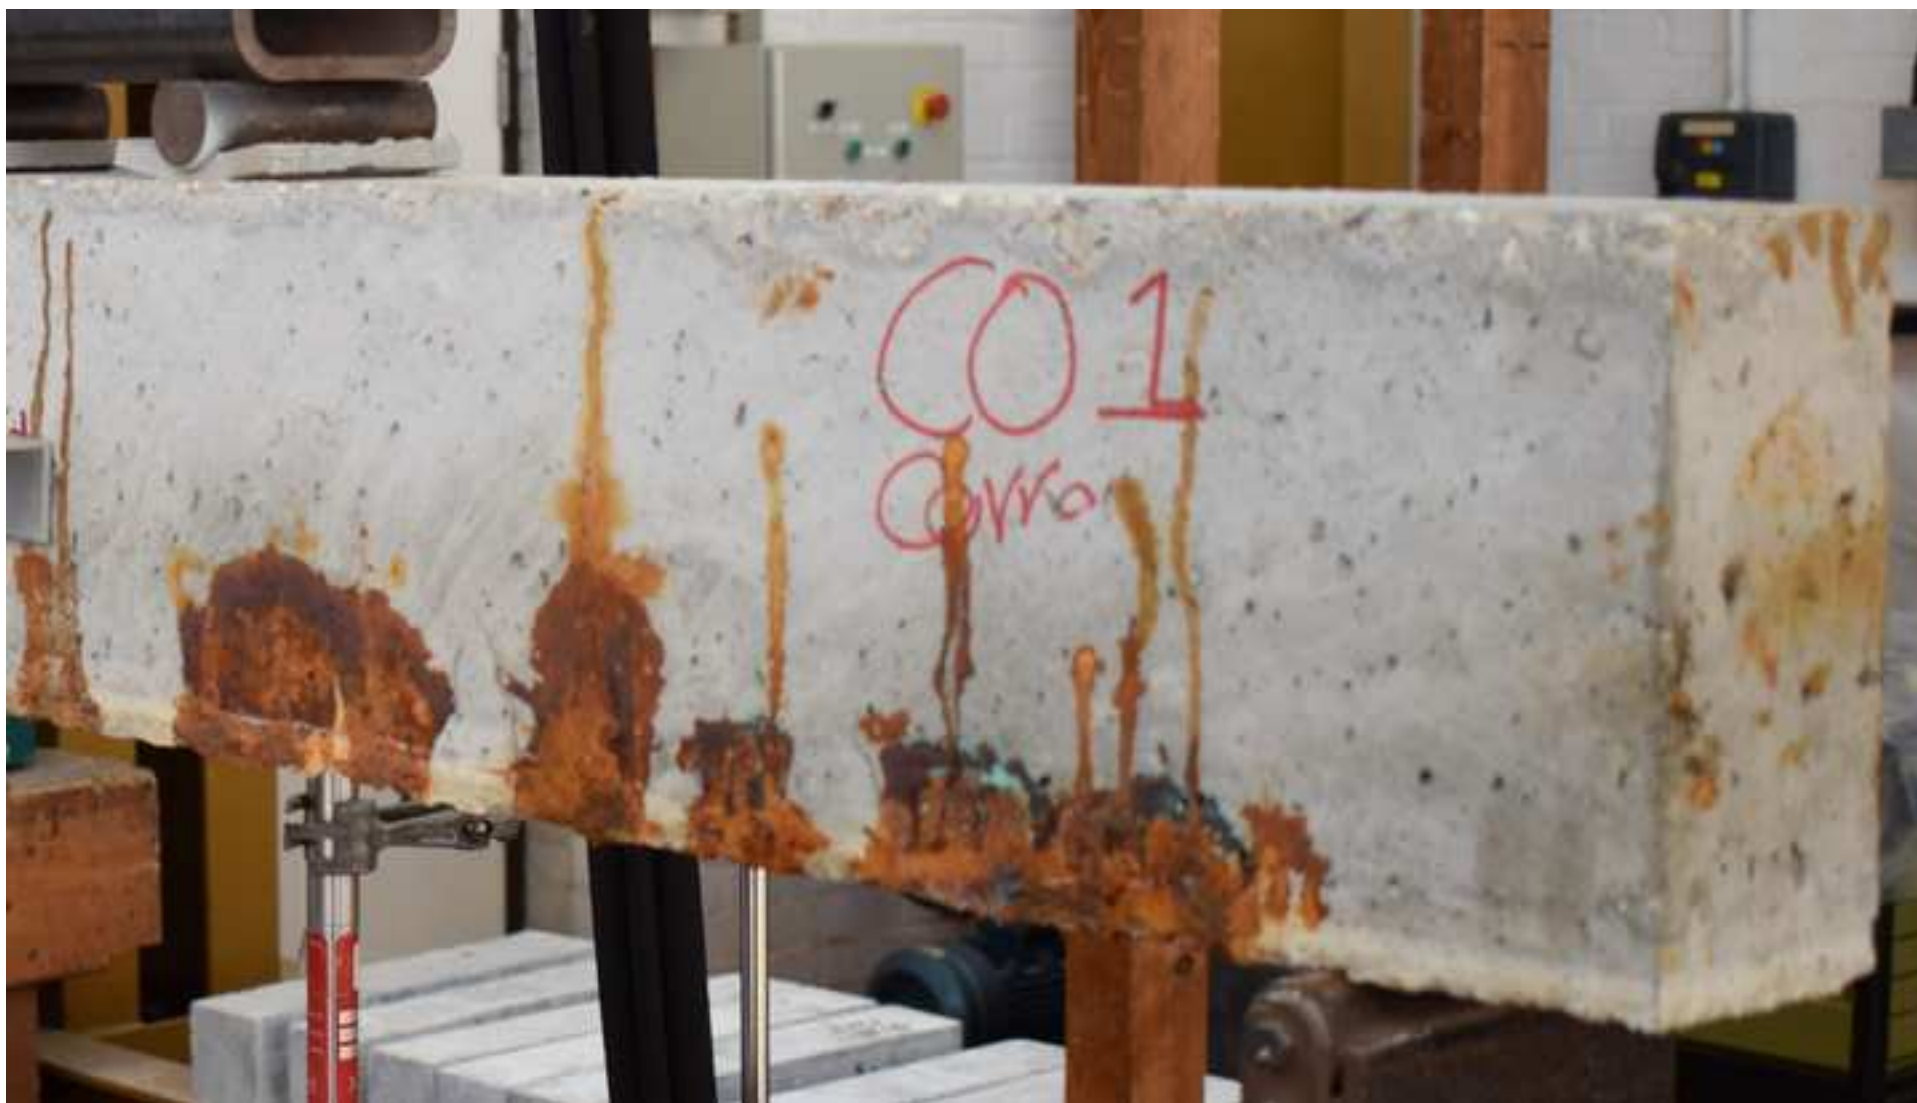
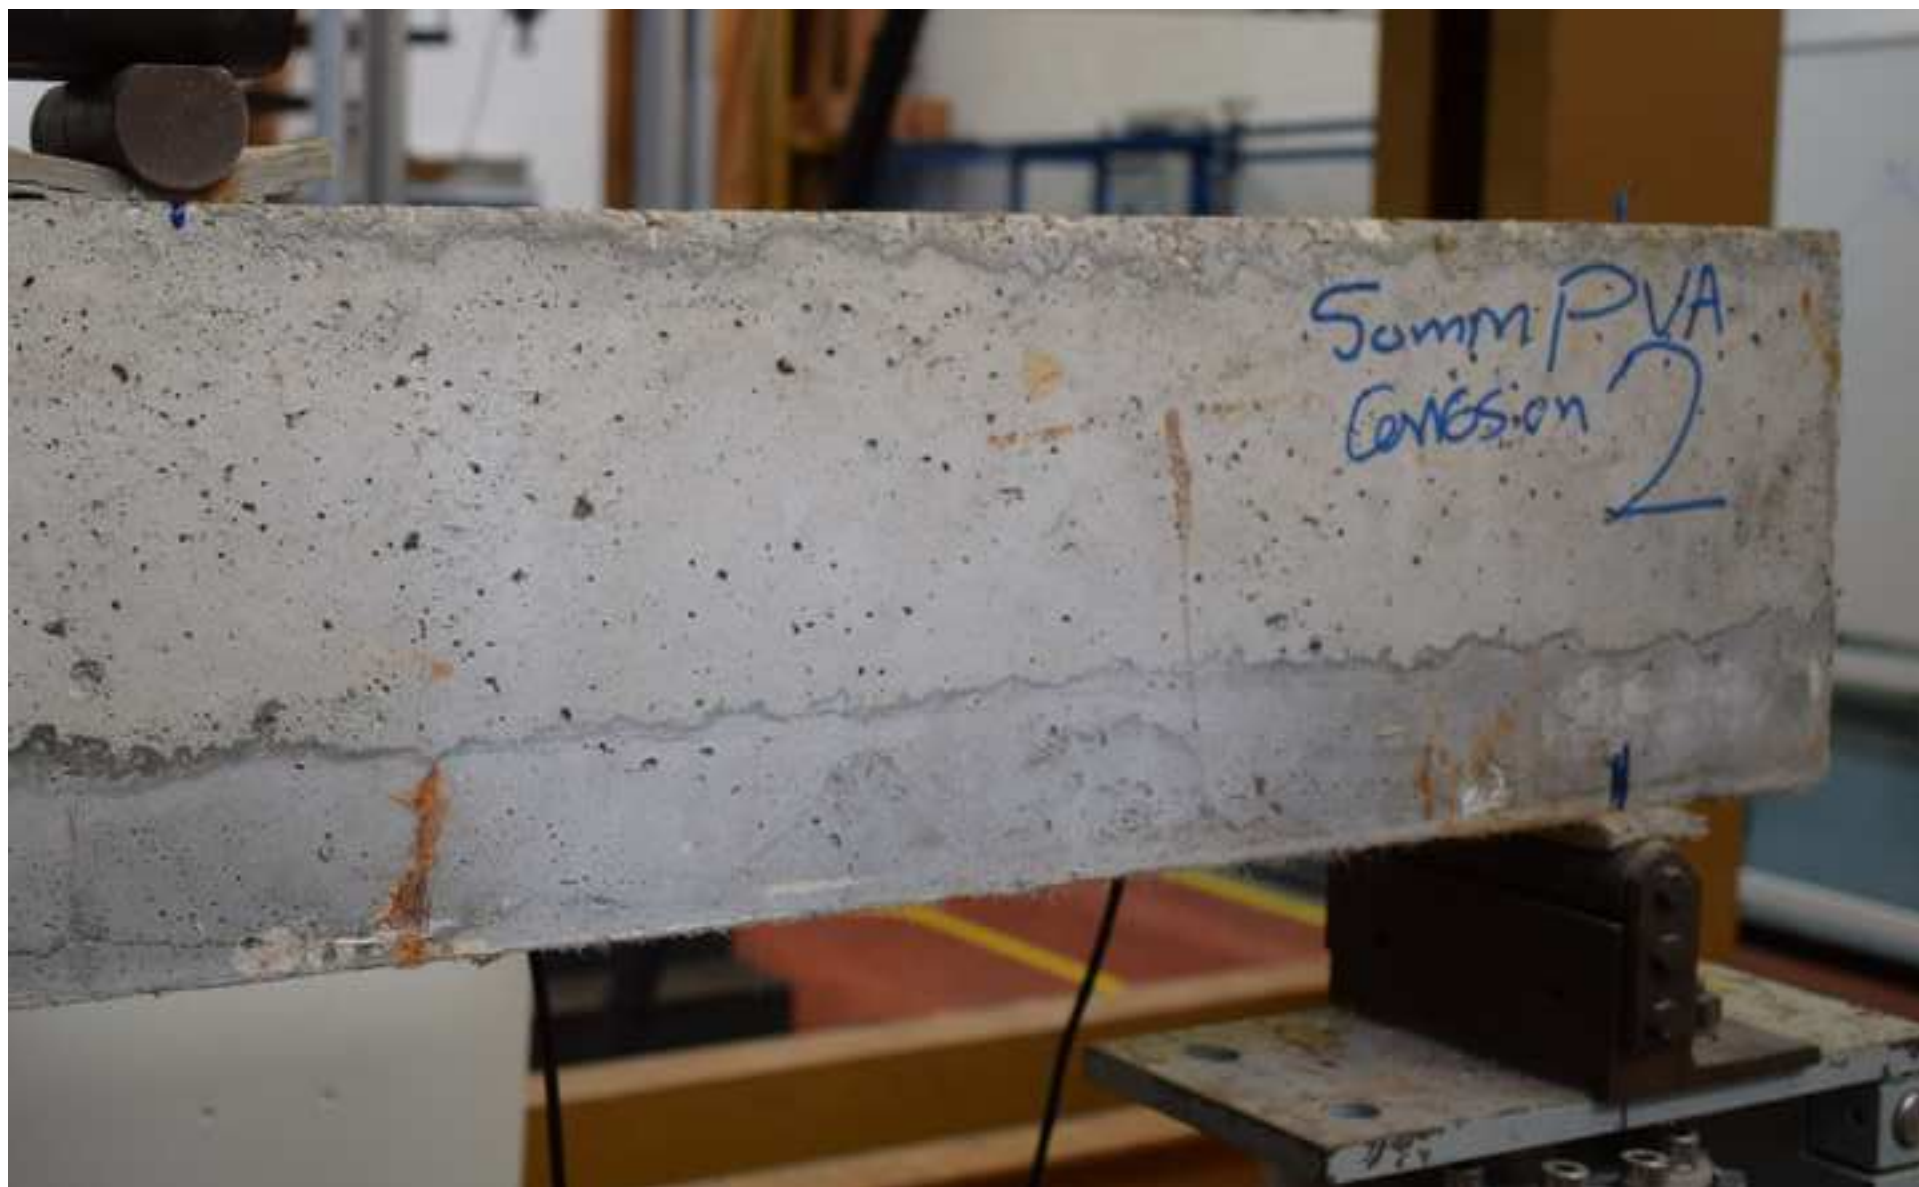
Fig. 16a  
[Click here to download high resolution image](#)

**Figure 16.** **a)** Side corrosion crack pattern for the corroded control beams and **b)** PVAFRGC-corroded beams.

After demolition of the specimens, the extracted tensile steel reinforcement coupons were cleaned, measured and compared to the non-corroded coupons. The average percentage of steel mass loss was at 8.5%, 7% and 5.5% for the control beam and RC beams repaired with 25 mm and 50 mm of PVAFRGC, respectively. The targeting degree of corrosion (10%) was close to the achieved mass loss for the control specimens (8.5 %) so it can be concluded that targeted corrosion levels can be reached with the accelerated corrosion duration calculated in accordance with Faraday's equation. The differences in the mass loss values for the specimens repaired with PVAFRGC are attributed to differences between the crack distribution and crack width formed in the control and repaired RC beams during the applied induced current. Large localized cracks formed in the control specimens, allowing easier migration of corrosion products, which was evidenced by excessive rust concentration on the cracked surfaces of the severely damaged specimens (Figure 16a). From the other side, hair cracks only were observed visually at the surface of the repaired RC beams with PVAFRGC. The reduced crack width for RC beams repaired with PVAFRGC reduced movement of the corrosion products, which was evidenced by the concentration of the corrosion products only on the interface between the old and the new material (Figure 16b).
