## **A novel corrosion resistant repair technique for existing Reinforced Concrete (RC) elements using Polyvinyl Alcohol Fibre Reinforced Geopolymer Concrete (PVAFRGC)**

**Keywords**; corrosion resistance; fibre reinforced geopolymer concrete; repair material; reinforced concrete beams.

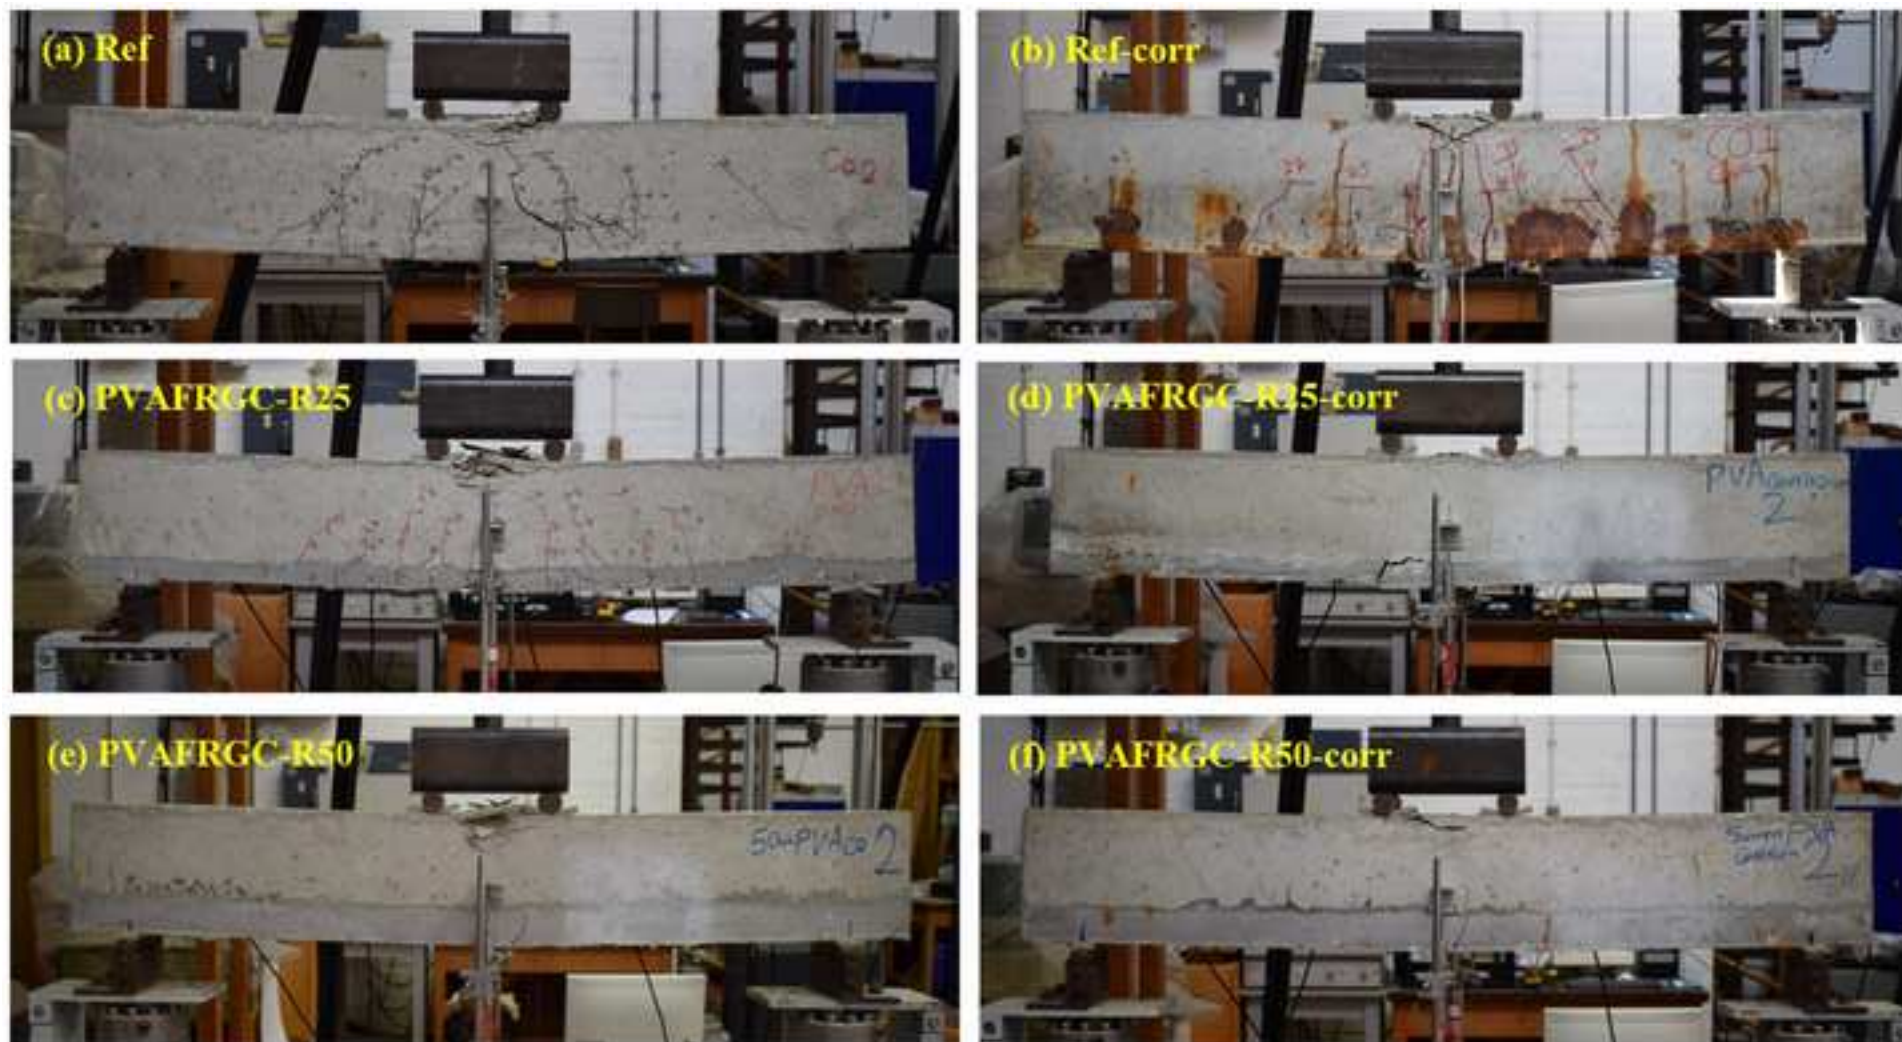
Fig. 17

**Figure 17.** Mode of failure of non-corroded and corroded of initial RC beam and repaired RC beams.

Failure of the control and repaired RC beams at the end of testing are shown in Figure 17. Failure of unrepaired beams, both corroded and un-corroded, occurred by flexural crack

failure followed by crushing of concrete in the compression zone as shown in Figure 17b. For the corroded unrepaired specimens, the loss of bonding due to cracking resulting from the volume expansion of the rebar after the electrical acceleration led to spalling of concrete cover at the bottom tensional face of the beam under loading. The RC beams repaired with 25 mm and 50 mm of PVAFRGC overlay failed by rupture of the PVAFRGC layer after yield of the tensile steel reinforcement followed by concrete crushing (Figure 17 c-e). The accelerated corrosion of the RC beams did not change the failure mode of the repaired material. The same crack pattern was noticed in 25 mm and 50 mm layer thickness repaired beams under flexural loading, where multiple cracks were observed in the PVAFRGC overlay layer. The localized large cracks that developed in the substrate RC beam diffused into many fine cracks when they met the PVAFRGC layer, leading to delay in the flexural failure. The cracks started to propagate with increasing loading in a direction perpendicular to the FRGC layer. At the final stage of the loading it was observed that only one crack was completely opened. This is due to the effect of the reinforcing fibres in arresting the cracks, and their stress transfer capability, which leads to effective stress redistribution. **The slipping of the steel bars was not monitored in the current study but from visual observations it was evident that there was not any significant slip in any of the examined specimens.**

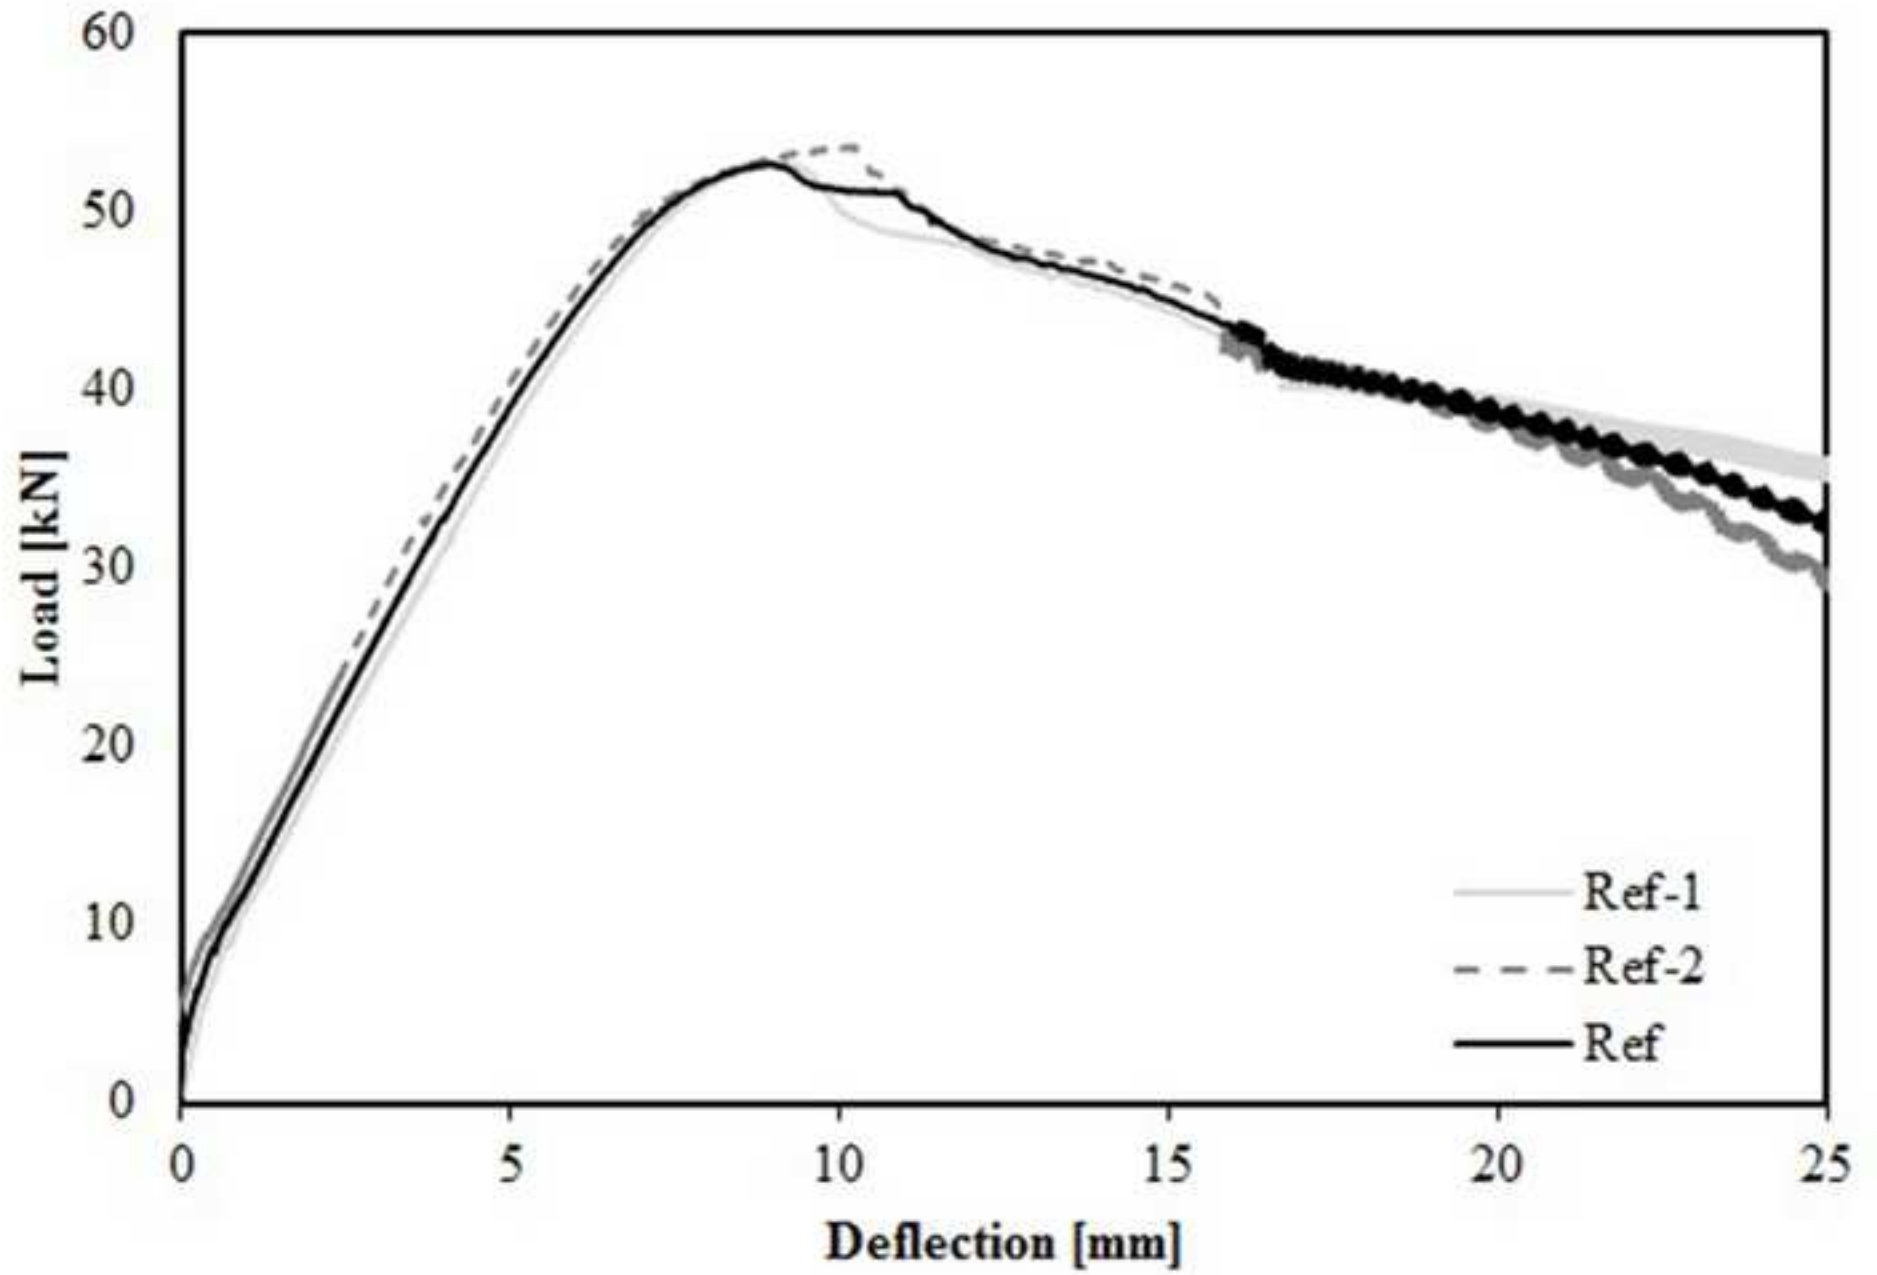
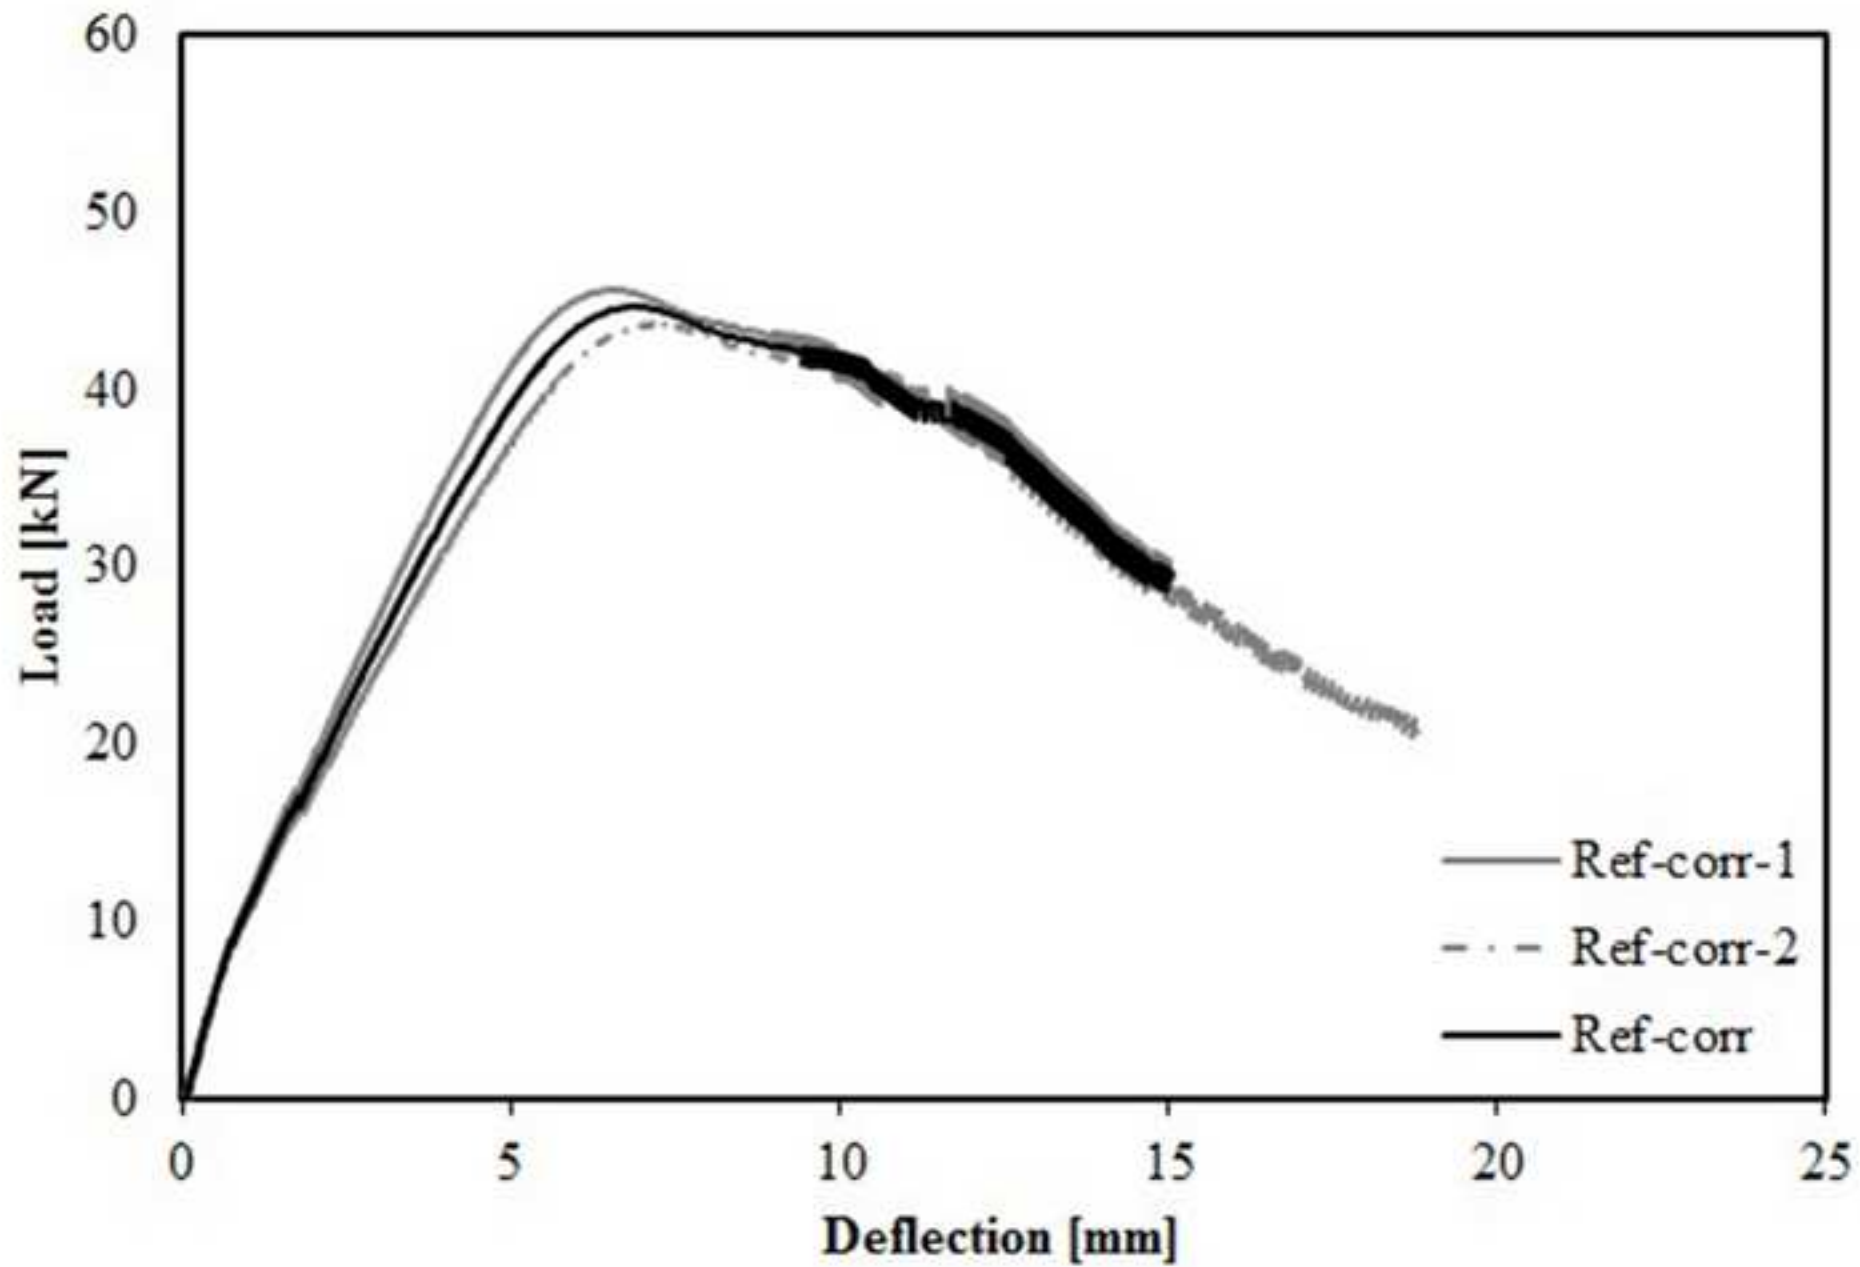
Fig. 18a  
[Click here to download high resolution image](#)

The load-deflection curves of the reference corroded and non-corroded RC specimens are presented in Figure 18 (a-b).

From Figure 18 and Table 4, it can be seen that the first cracking of non-corroded RC beams occurred at a load of 9 kN and 9.4 kN for Ref-1 and Ref-2 specimens, respectively. As the loading increased further, inclined cracks were distributed across the beam with major cracking initiated close to the centre of the beam. The load dropped at 52.5 kN and 53.4 kN and related deflections are 9.1 mm and 10.65 mm for Ref-1 and Ref-2 specimens, respectively. Subjecting the specimens to an induced current of 300 mA for 90 days for steel corrosion with 8.5% steel mass loss had significant effects on the structural response of the control RC beams. **The ultimate load of the corroded RC beams was reduced by 16% on average for Ref-corr-1 and Ref-corr-2, compared to the respective average ultimate load of the specimens without corrosion (Ref-1 and Ref-2).** The deflection at the ultimate load reduced to 6.86 mm and 7 mm for Ref-cor-1 and Ref-cor-2, respectively (Figure 18b). **This reduction of the ultimate load and the respective deflection is attributed to the reduction of**

the mass of the longitudinal reinforcement at the tensile side and the subsequent concrete cracking and loss of bond between the steel bars and the concrete which was observed after the application of the induced current.

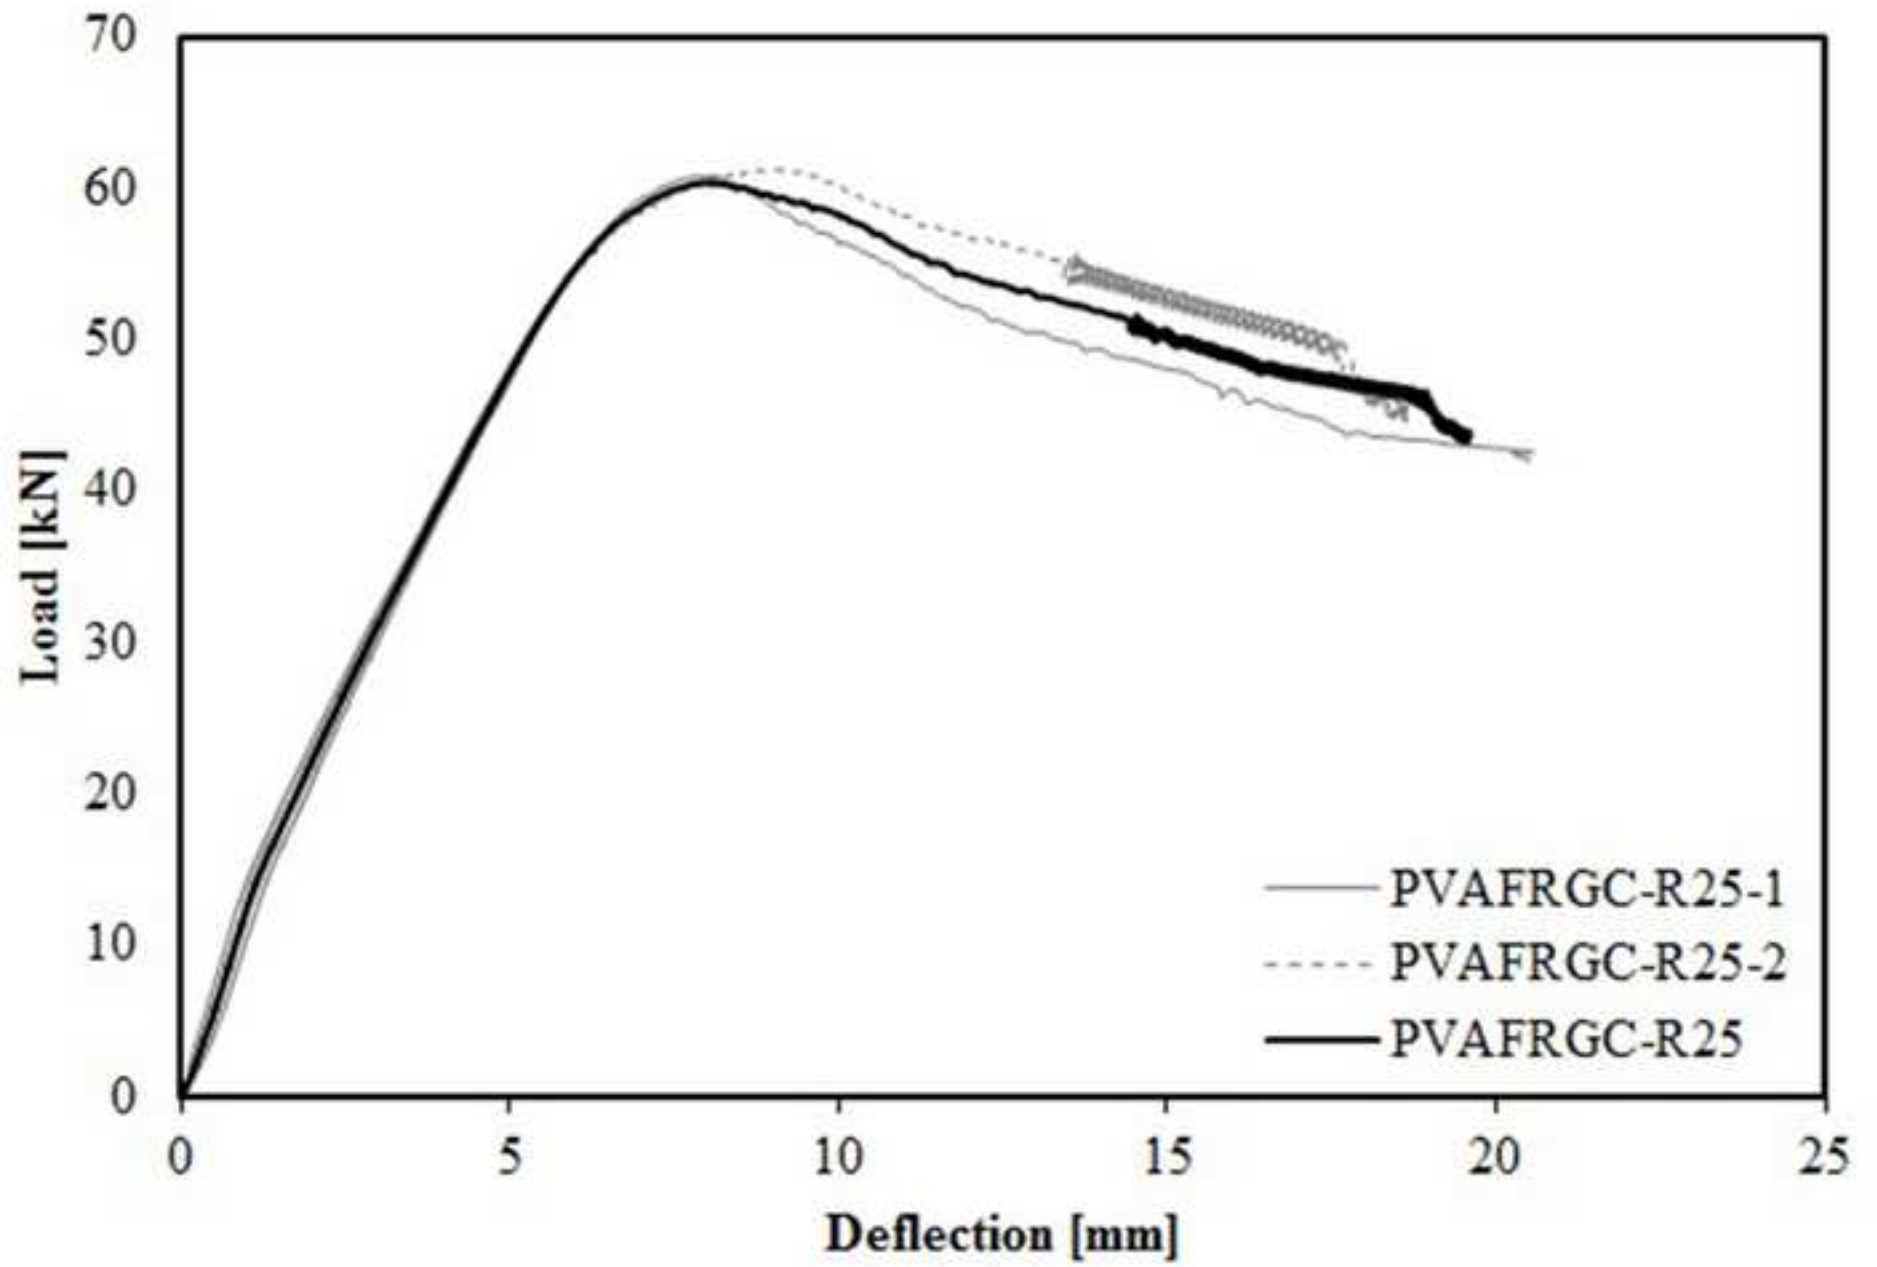
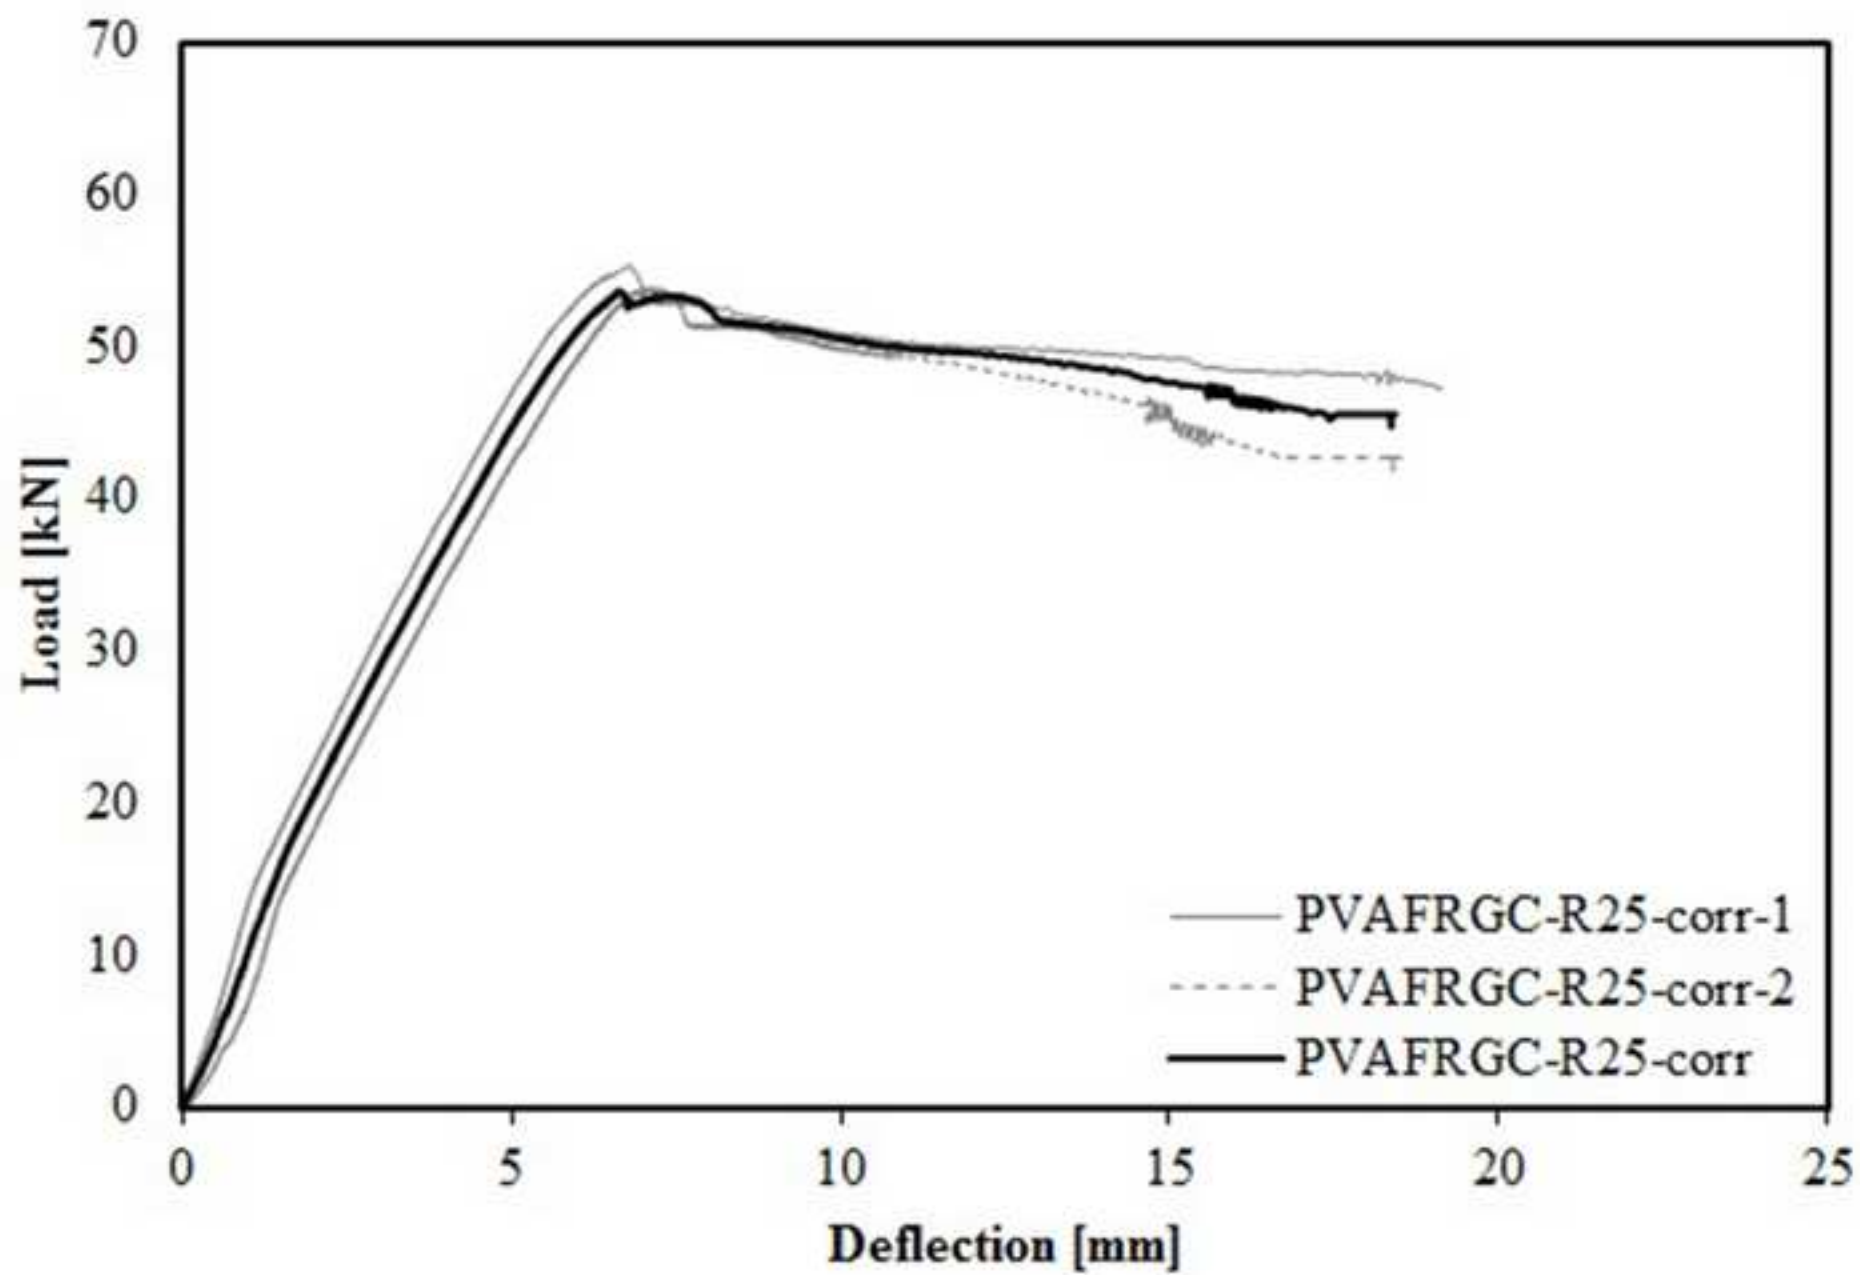
Fig. 19a  
[Click here to download high resolution image](#)

**Figure 19.** Load-deflection curves of repaired beam with 25 mm thickness of PVAFRGC material overlay.

The load-deflection curve of the corroded and non-corroded specimens repaired with 25 mm PVAFRGC overlay are presented in Figure 19 (a-b).

As shown in Figure 19 and Table 4, the failure mode of PVAFRGC-R25 specimens was similar to that of the control RC beams. Application of a 25 mm thickness of PVAFRGC overlay however improved the structural performance of the RC beams. The recorded first cracking load was increased by 41% on average for PVAFRGC-R25-1 and PVAFRGC-R25-2 specimens compared with the respective load values for the control beams (Ref-1 and Ref-2). As the loading increased further, the cracking across the substrate and the repaired layer increased, and crack width enlarged up to failure. The ultimate failure load was increased by 15% on average for both PVAFRGC-R25-1 and PVAFRGC-R25-2 compared with the control RC beams. This ultimate load increment is attributed to the enhanced stress strain characteristics of the PVAFRGC which was placed to the tensile side of the beams and therefore led to an increase in the internal stresses of the tensile stress-strain block of the specimens' cross section, and subsequent increase of ultimate moment and load capacity. The effect of steel corrosion (7% steel mass loss) on the structural response of the repaired beams was considerably reduced compared with the control RC beams. For corroded specimens, the ultimate load was decreased by 11% on average for PVAFRGC-R25-corr-1 and PVAFRGC-R25-corr-2 compared with the respective ultimate load value of the non-corroded repaired specimens. Despite corrosion damage and cracking at the interface between the repair overlay and the substrate (Figure 15), the ultimate loads of the corroded-repaired specimens were still higher than those of the control non-corroded beams (i.e. the Ref specimens). This improved behaviour of the PVAFRGC repaired specimens is attributed to the fact that PVAFRGC proved to be beneficial in limiting the effect of corrosion on the steel reinforcement mass loss, and also as subsequent concrete cracking at the tensile side was limited when PVAFRGC was used. This has contributed to the enhancement of the ultimate load capacity when compared to the respective results of the control specimens.

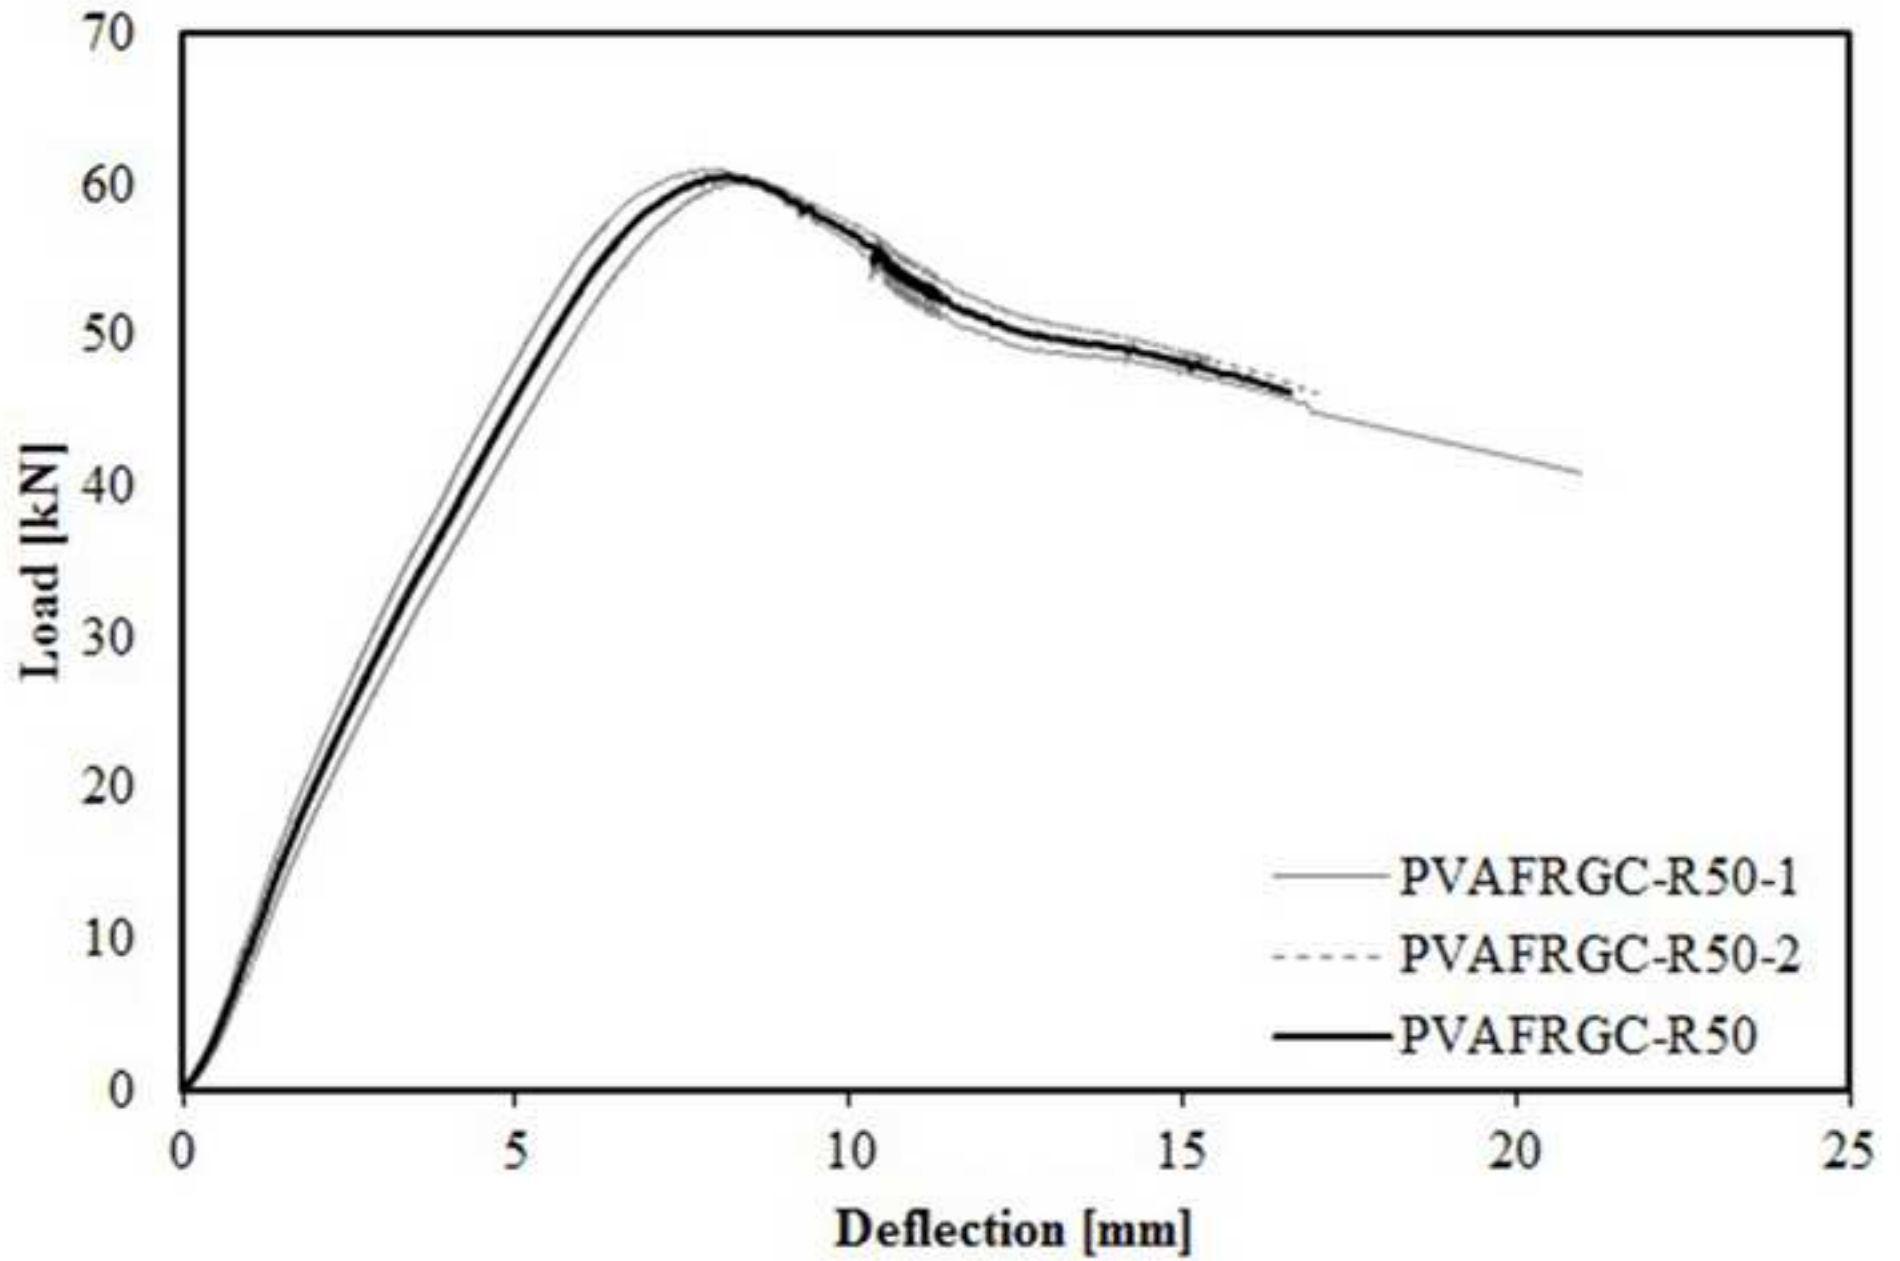
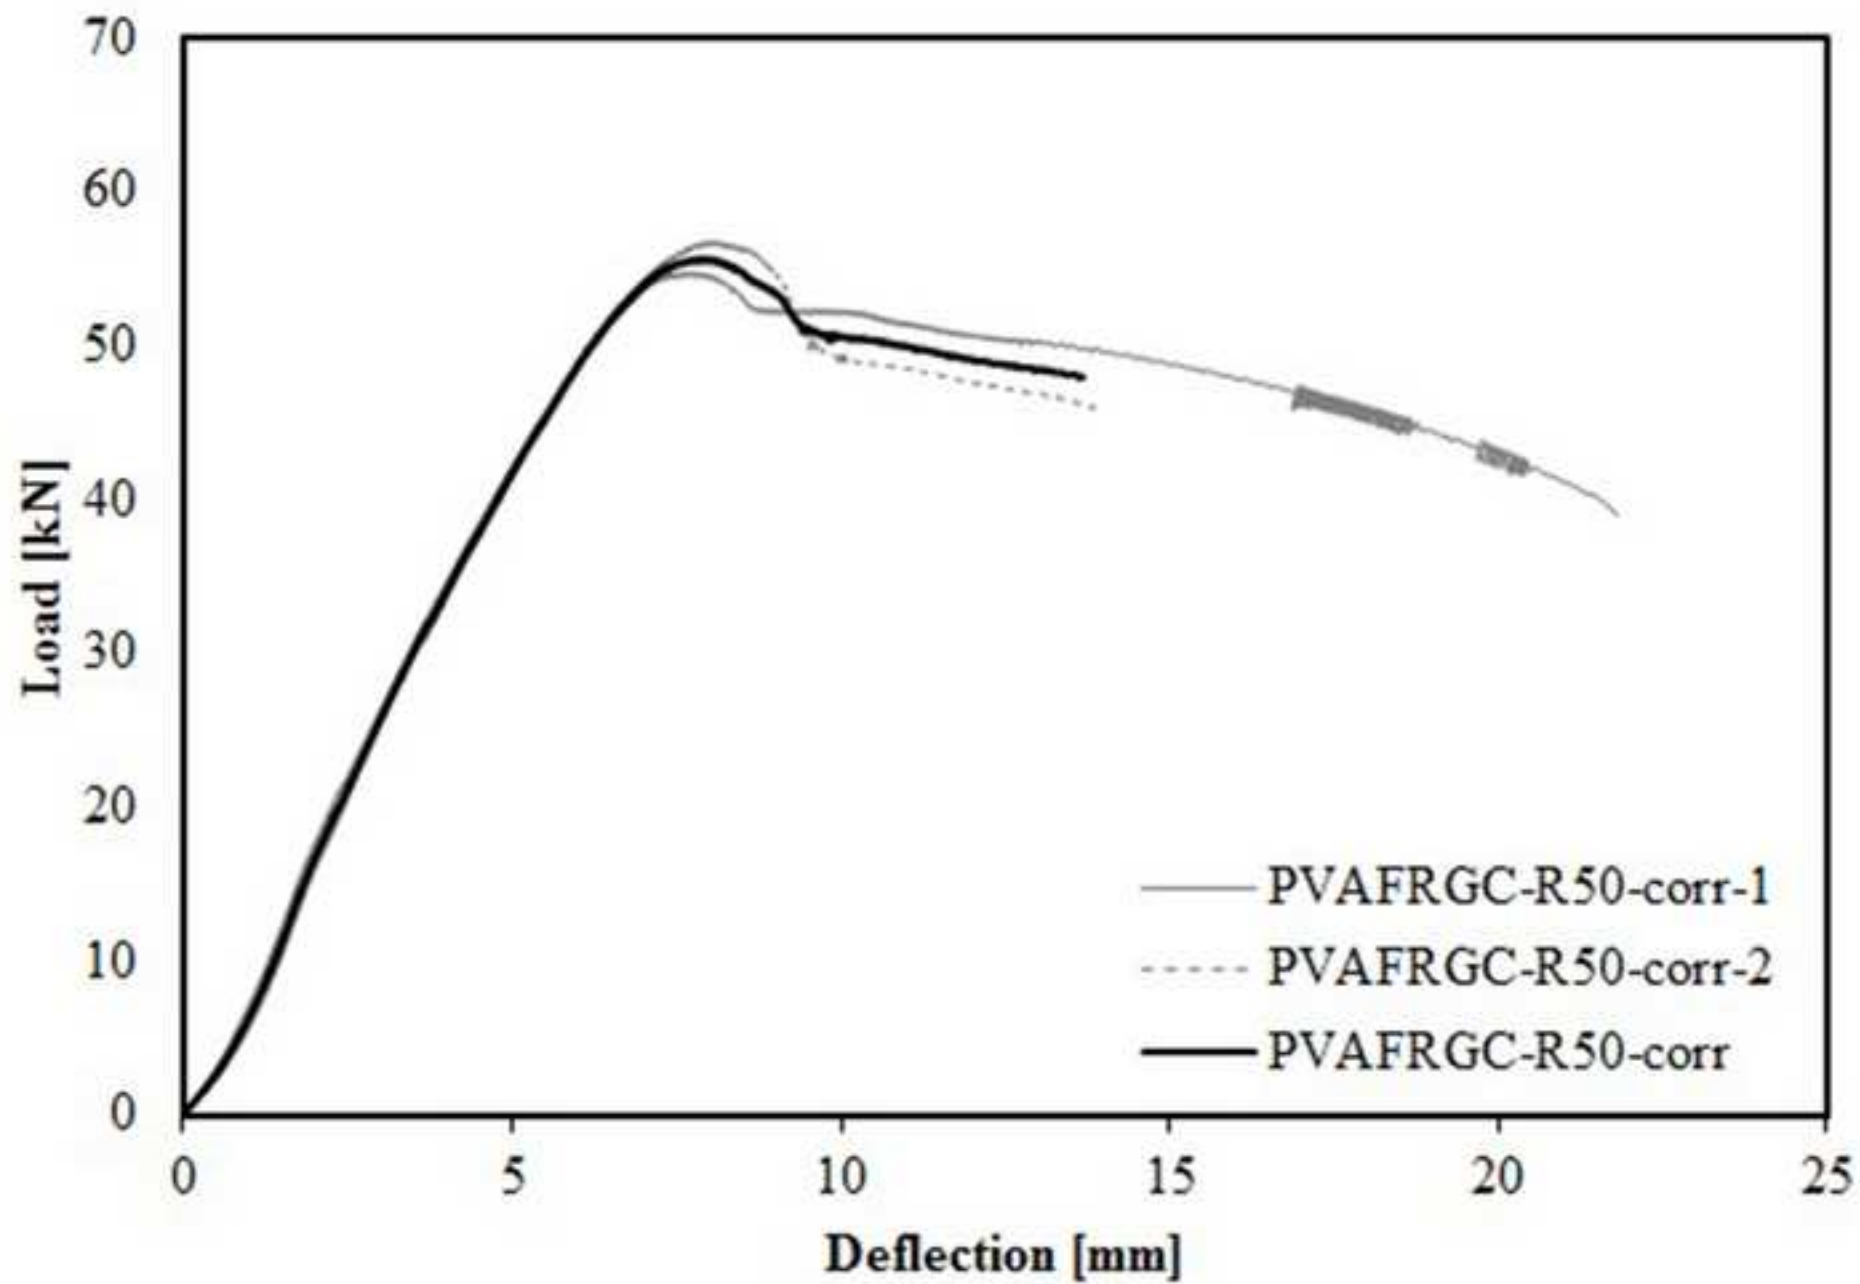
Fig. 20a  
[Click here to download high resolution image](#)

**Figure 20.** Load-deflection curves of repaired beam with 50 mm thickness of PVAFRGC material overlay.

The load-deflection curve of the corroded and non-corroded specimens repaired with 50 mm PVAFRGC overlay are presented in Figure 20 (a-b).

For RC beams repaired with 50 mm thickness of PVAFRGC material overlay, the first cracking load was higher than the respective values of the average of the two control (Ref-1 and Ref-2) and the two PVAFRGC-R25 specimens (PVAFRGC-R25-1 and PVAFRGC-R25-

2) by 63% and 15% respectively. However, increasing the repair overlay thickness from 25 mm to 50 mm did not change the ultimate load since there was not any significant change in the material of the outer tensile side, and the addition of PVAFRGC does not significantly affect the stress strain distribution at the tensile side of the specimens. With increasing load, multiple cracks in the repair layer were observed, and the crack widths were narrower than those observed in the repaired beam with 25 mm thickness overlay. The peak load and mid-span displacement at failure were 61 kN and 7.65 mm for the PVAFRGC-R50-1 specimen, and were 60 kN and 8.33 mm for the PVAFRGC-R50-2 specimen, respectively. The effect of corrosion exposure on the corrosion damage, cracking and structural response of RC beams (Figure 20b) was less pronounced compared with the control and repaired beams with 25 mm thickness of PVAFRGC. Visual inspection of the repaired beam after demolition confirmed that no corrosion products were present at the interface between the substrate and the overlay material (Figure 16b and 20b). For corroded RC beams repaired with 50 mm PVAFRGC overlay material, the ultimate failure load decreased to 55.47 kN and 56.40 kN for PVAFRGC-R50-corr-1 and PVAFRGC-R50-corr-2, respectively, which is approximately a 8% reduction compared with the values observed for the PVAFRGC-R50 non-corroded beams (Figure 20b). The results of this section indicate that the addition of PVAFRGC can considerably limit the effect of corrosion since the average ultimate load reduction due to corrosion for the control specimens was found to be equal to 16 %, while the respective reduction was reduced to 11 % for the 25mm PVAFRGC repair layer and was further reduced to 8 % for the 50mm PVAFRGC repair layer
